**Advisory Visit**  
**River Lugg, Herefordshire**  
**June 2015**

## 1.0 Introduction

This report is the output of a site visit undertaken by Tim Jacklin of the Wild Trout Trust to the River Lugg at Leominster, Herefordshire, on 15<sup>th</sup> June, 2015. Comments in this report are based on observations on the day of the site visit and discussions with Brecht Morris, Fisheries Technical Officer, Environment Agency (EA), and Ian Fullwood, Mike Onions, Peter Hutchinson and Robert Warren of Eaton Angling Club.

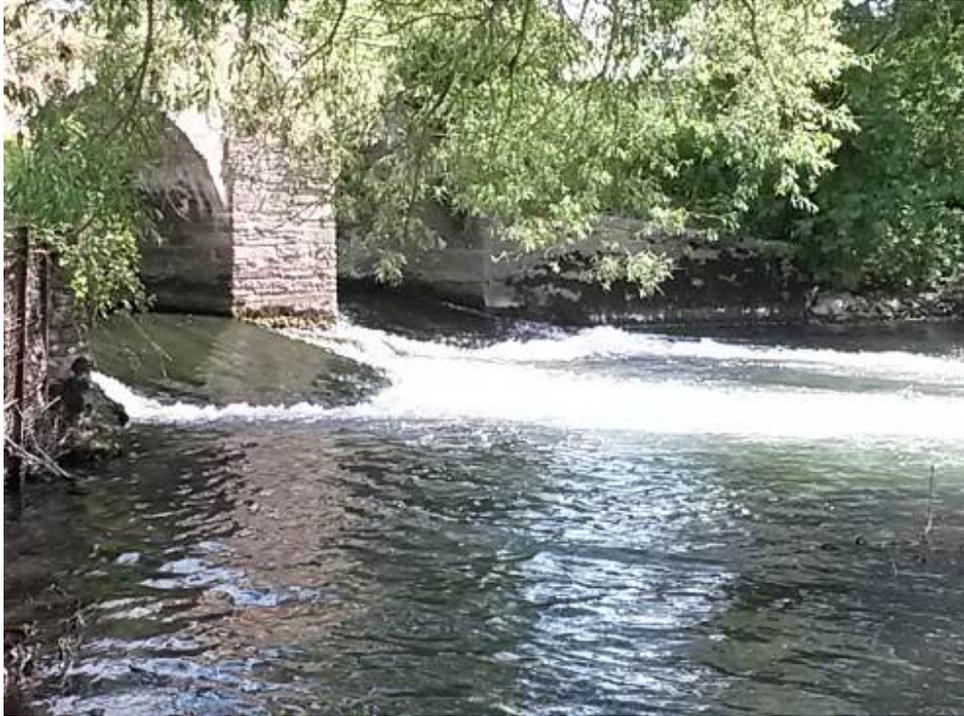
The weir at Eaton Hall bridge (Photo 1) forms part of the bridge footings and the river flumes between two arches, over smooth, sloping faces at an angle of approximately 30° from horizontal. Although there is a standing wave at the base of each flume, slack water is present on each side (Photo 2). In terms of fish migration, the weir is likely to be passable at certain flows to adult salmon and larger trout, which can utilise their leaping and high burst speed swimming capabilities. It is however a notable barrier and will be particularly problematic to sub-adult trout, grayling, eels and smaller fish species. It could also delay the downstream migration of salmon smolts, leading to increased losses through predation. The Environment Agency are working with the Wye & Usk Foundation (WUF) to improve fish passage at numerous barriers on the Lugg on a prioritised cost-benefit basis and are

**Photo 1 Weir at Eaton Hall bridge.**

currently focussing on other sites, including a weir removal upstream of Eaton. An easement such as low-cost baffles combined with eel tiles may represent an affordable improvement at this site.

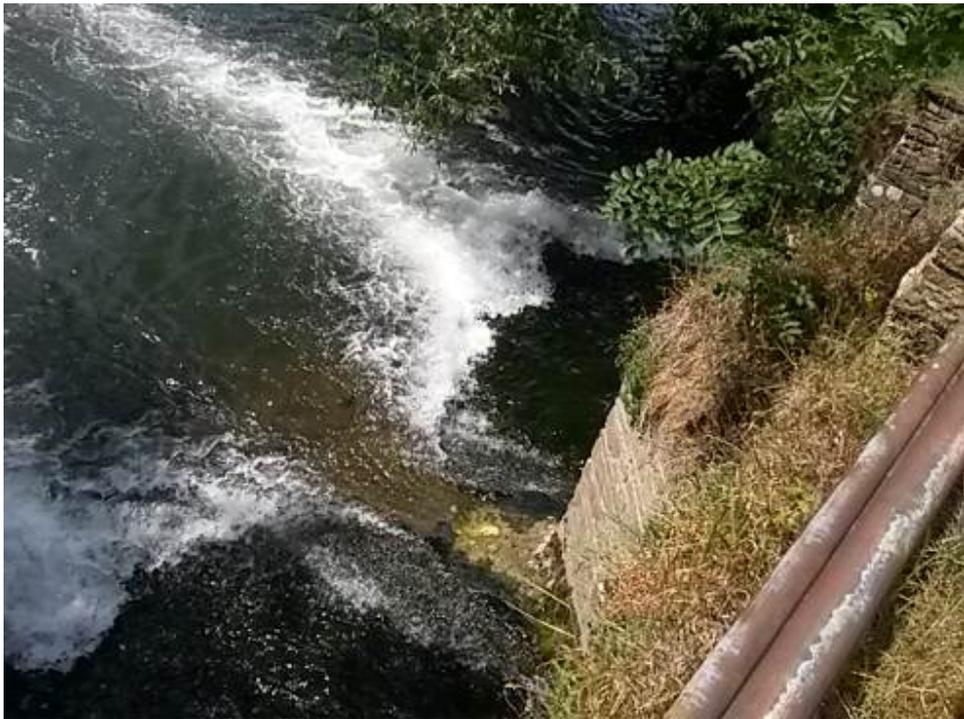
**Photo 2 Slack water alongside the flumes of the weir give stronger swimming species a point from which to leap onto the face of the weir and use burst-speed swimming to ascend. However, the high velocity and shallow depth remain a significant obstacle.**

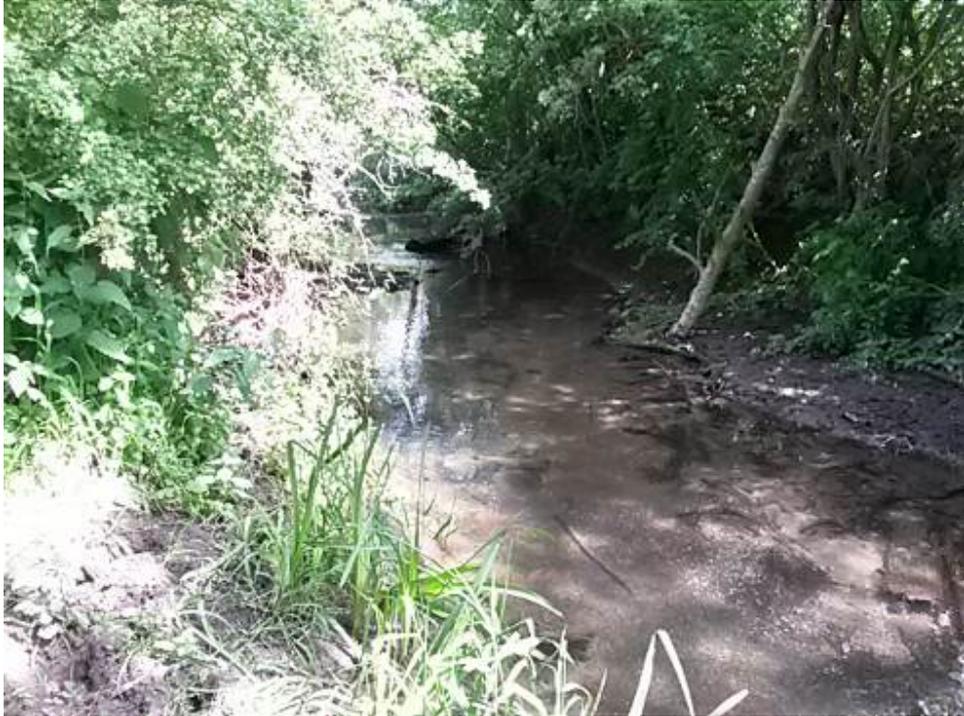
The weir provides a head of water that feeds into a former mill leat (Photo 3) running along the left bank of the river and re-joining at pool 4. The upstream end of the leat has a fixed crest height so the flow of water into the leat is entirely dependent upon river levels. It is evident from the un-vegetated "tide line" along the margins that water levels vary regularly in the leat. At the time of the visit, water levels were very low. The channel is heavily shaded and has a substrate dominated by fine sediment. Large woody debris is present at a couple of locations closer to the confluence with the river.

**Photo 3** The mill leat channel showing the very low residual flow when river levels are low. The substrate is dominated by fine sediment.

It was discussed whether the leat could be improved to provide spawning and/or nursery habitat for trout and grayling. There are a number of factors which work against this. Firstly, the substrate within the channel is mainly silt, sand and fine gravel which is not suitable for spawning. This suggests that coarser sediments are not being transported into the leat from the river upstream, and also possibly that when the river is high, water is backing up from downstream, promoting the settling out of fine sediments. Secondly, the low residual flow within the leat means that even if suitable spawning gravel were introduced, the flows may not be sufficient to attract adult fish to spawn, or to sustain eggs within the gravel throughout the incubation period.

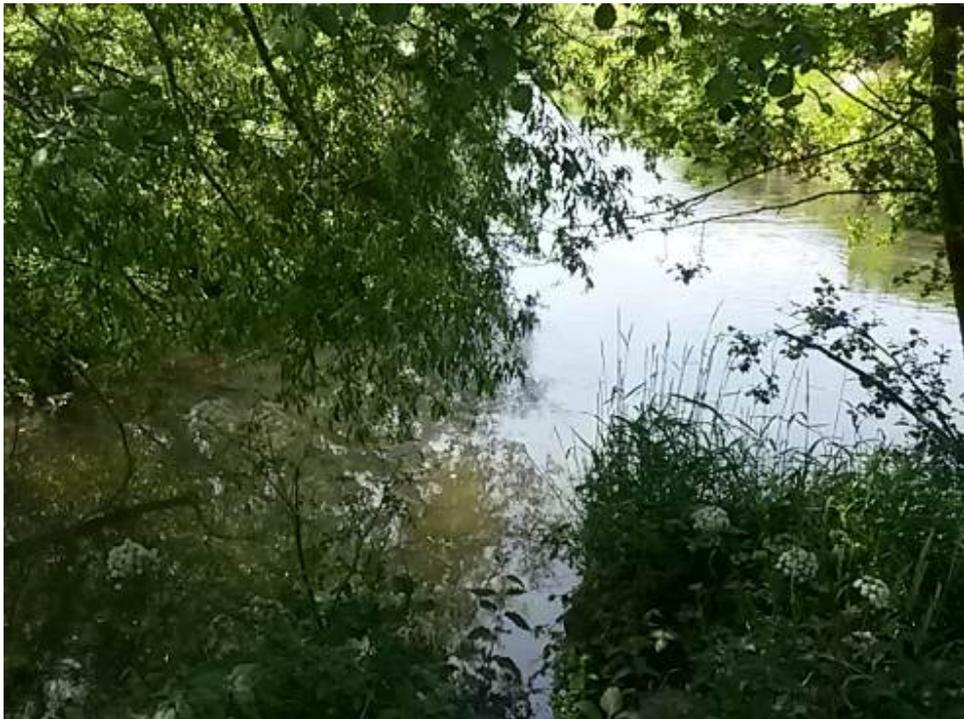
Despite the above, the mill leat does provide some good slack water habitat at its confluence with the main river (Photo 4) which will provide an important refuge area for fish during high water events, particularly juvenile grayling which can be vulnerable to floods during their first summer. The leat is also lined with trees and bushes which are perfect for hinging and laying into the margins. This will provide good cover for juvenile fish, let in light to the heavily shaded channel and hopefully create localised scour (depending upon how much the channel backs up).

**Photo 4** Confluence of the mill leat and the main river – a good high-water refuge area.

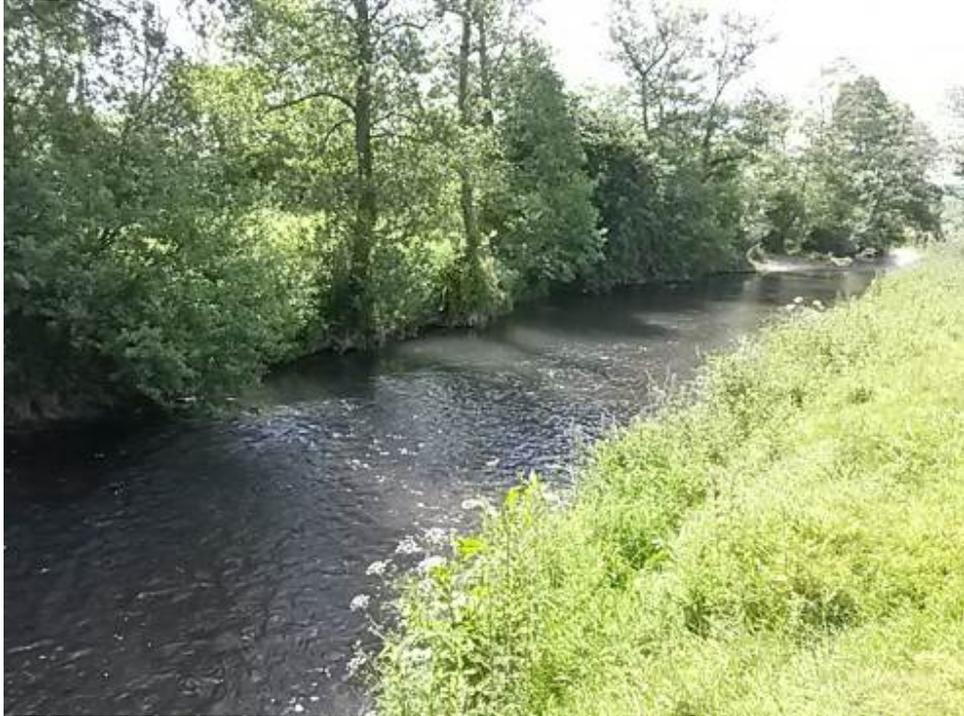
At the upstream end of the reach, there is good tree cover along the left bank, providing shade, low cover over the water and bank stability (Photo 5). In contrast, the right bank has fewer trees and livestock have unrestricted access (Photo 6). Grazing on the right bank has prevented taller vegetation and trees from becoming established and this has led to reduced bank stability and increased rates of erosion in places, particularly on the outside of bends (Photos 6, 8-10).

**Photo 5** Good tree cover along the left (far) bank provides good bank stability, shade and low cover over the water (Pool 1B / 2).

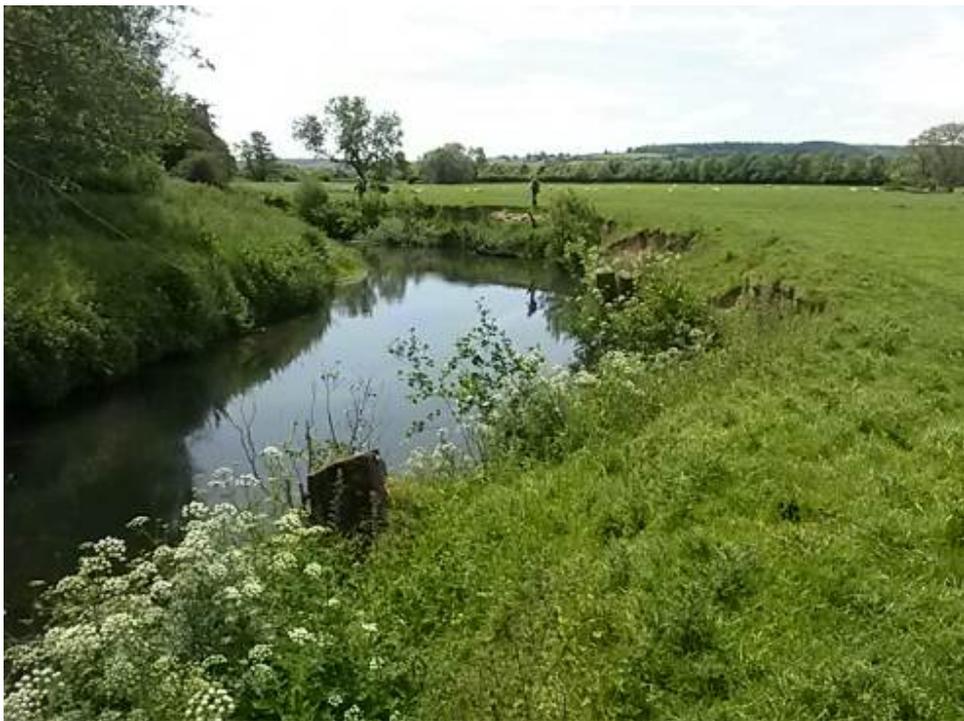
**Photo 6** In contrast, the right bank has fewer trees and livestock have unrestricted access. The steep bank profile prevents grazing to the very edge of the river, but such areas would benefit from fencing to allow tree succession (Pool 3).

The banks are generally steep, which has limited livestock access to a degree and allowed some smaller trees to take root near the toe of the bank, but these are vulnerable to wash-out at high water and continued grazing pressure, which may prevent them from reaching maturity (Photo 8). Fencing off the river to allow these trees and others to establish would increase bank stability, reduce erosion rates and provide benefits to the fishery. In some areas, livestock can cross the river and the farmer is keen to fence off these areas to prevent this happening (Photo 7).

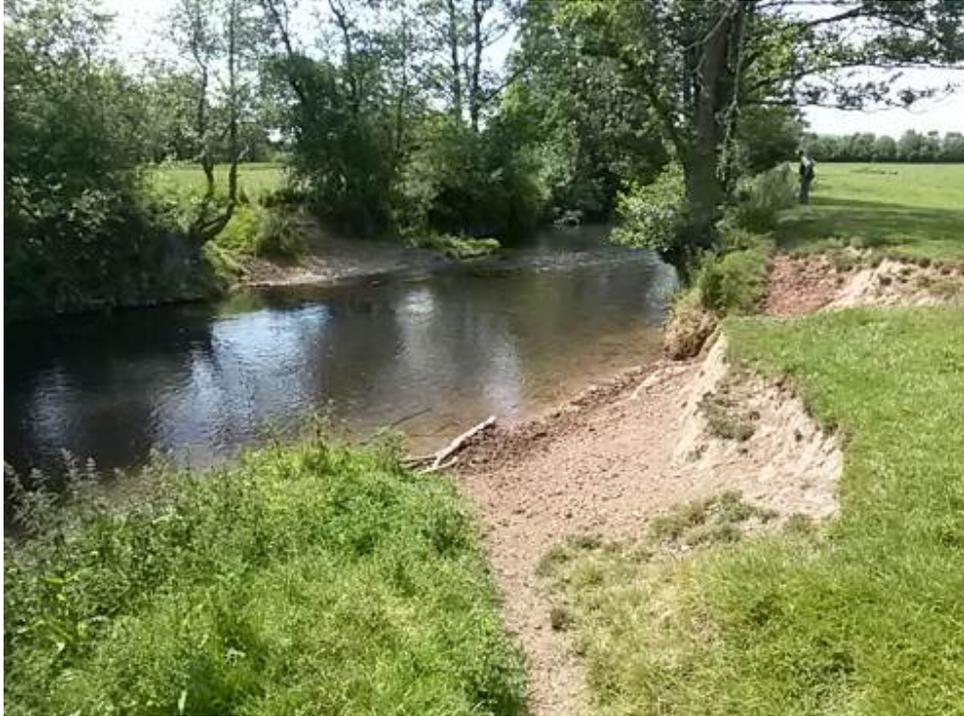
**Photo 7** In some areas livestock can access and cross the river. Fencing would prevent this and reduce fine sediment inputs to the river (Pool 2).

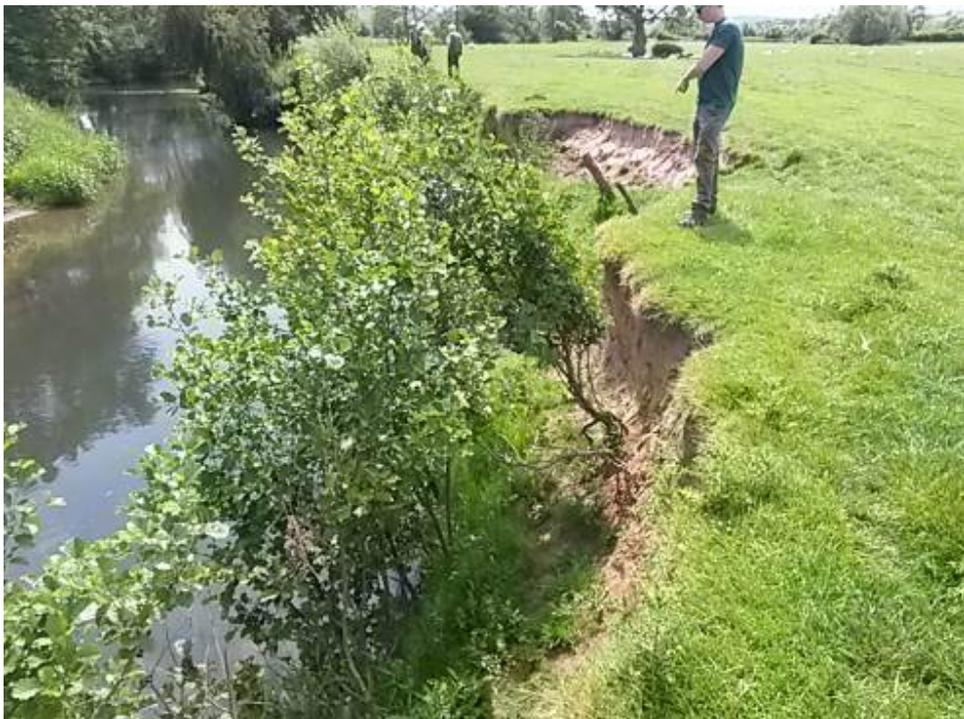
**Photo 8** Trees are colonising the right bank away from grazing pressure at the toe of the steep banks. However, these small alders are vulnerable to washout and sheep are making pathways behind them, grazing off lower leaves and undermining the roots. Protecting the trees will protect the bank from accelerated erosion (Pool 3).

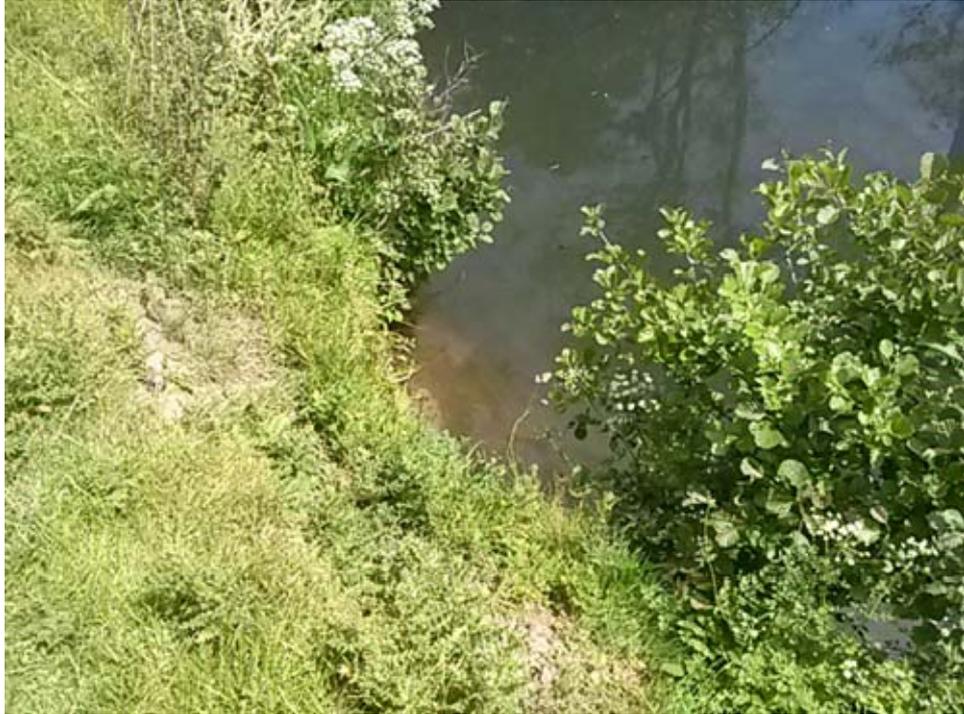
**Photo 9 Areas of bank in-between the alders in the previous photo could be protected with brushwood revetment which would reduce erosion rates whilst vegetation established behind a new fence line (Pool 3).**

Installing brushwood at the toe of the bank in selected areas would help to protect the bank in the short term whilst trees and herbaceous vegetation became established in fenced areas. Hinging of selected trees would also provide some bank protection and low cover for holding fish (Photos 9, 10).

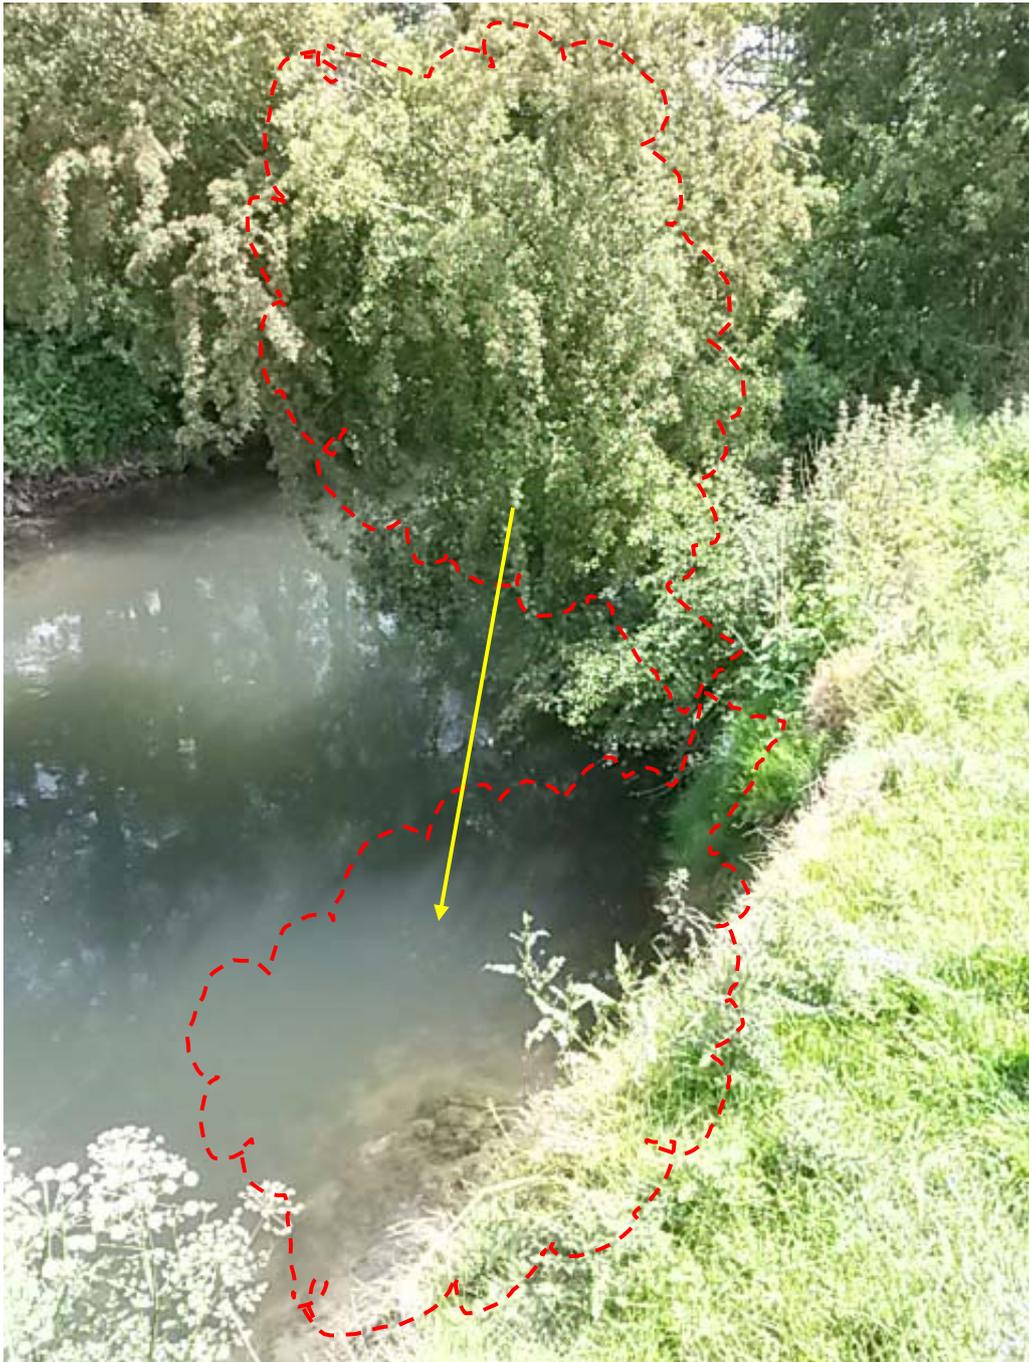
**Photo 10 Partially cutting and laying selected trees and staking in place would protect areas of bank such as this from erosion whilst vegetation established behind a new fence line (Pool 3).**

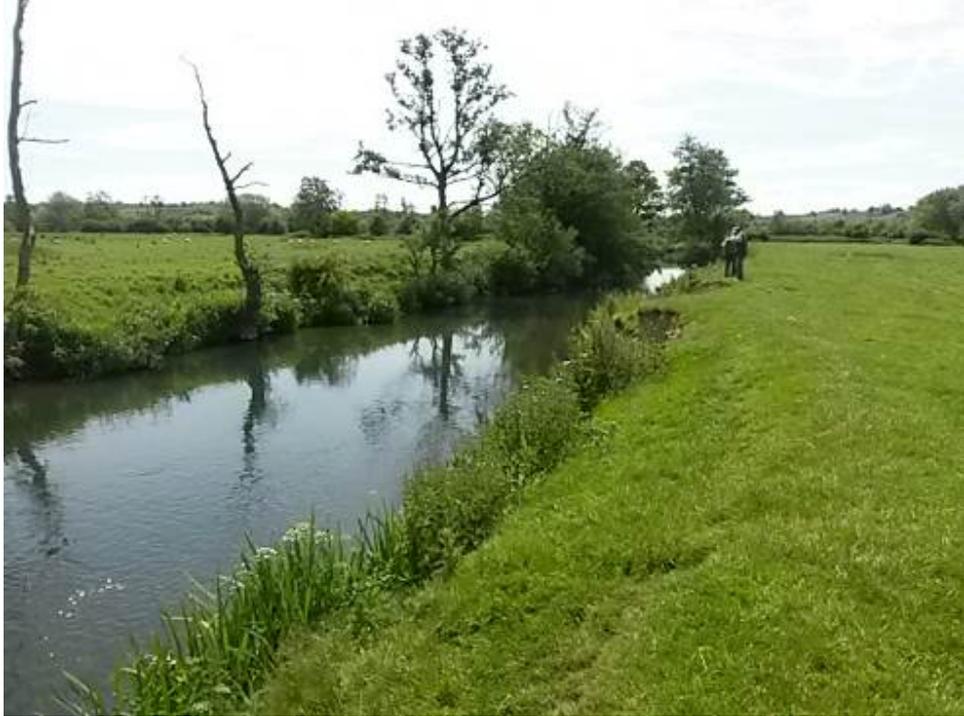
Some of the alder trees are displaying signs of *Phytophthora* disease and a number have already died, leaving some areas denuded of tree cover and with lower bank stability. Fencing these areas and allowing natural tree recolonization, or planting whips from nearby willows is recommended. In the short term, "tree kickers" (see recommendations) could be anchored to the bases of the dead alders to provide cover and bank protection (Photo 11).

**Photo 11 Alder disease has denuded tree cover in some areas. Fencing to allow tree succession is recommended here. Tree kickers (hawthorn) could be introduced along the toe of the left (far) bank. Dead wood should be left standing as habitat for woodpeckers, etc. (Pool 4).**

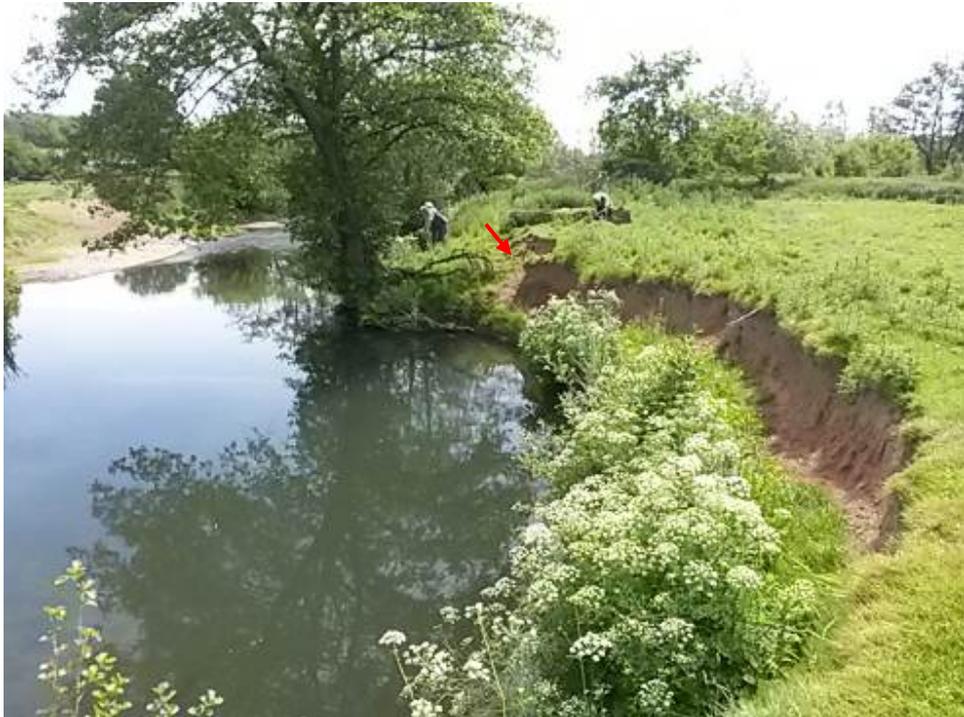
**Photo 12 Another example of bank erosion on the outside of a bend being exacerbated by livestock access. Although the toe of the bank is currently stable and vegetated, sheep pathways leave a line of bare earth which is easily eroded at higher flows, in this case threatening to outflank and undermine the mature tree (arrow). Fencing is recommended here (Pool 5).**

With progress downstream, there are further areas on the outside of bends where excluding livestock would improve vegetation cover and hence the resilience of the bank to erosion (Photos 12, 16 and 18). There are already plans to fence off some substantial headlands between meanders, including between 5 - 6B and 8 - 9 on the right bank and 7 – 9 on the left bank. Extending the fencing to include as much of the left bank as possible, especially the areas identified on the outside of bends, would be ideal.

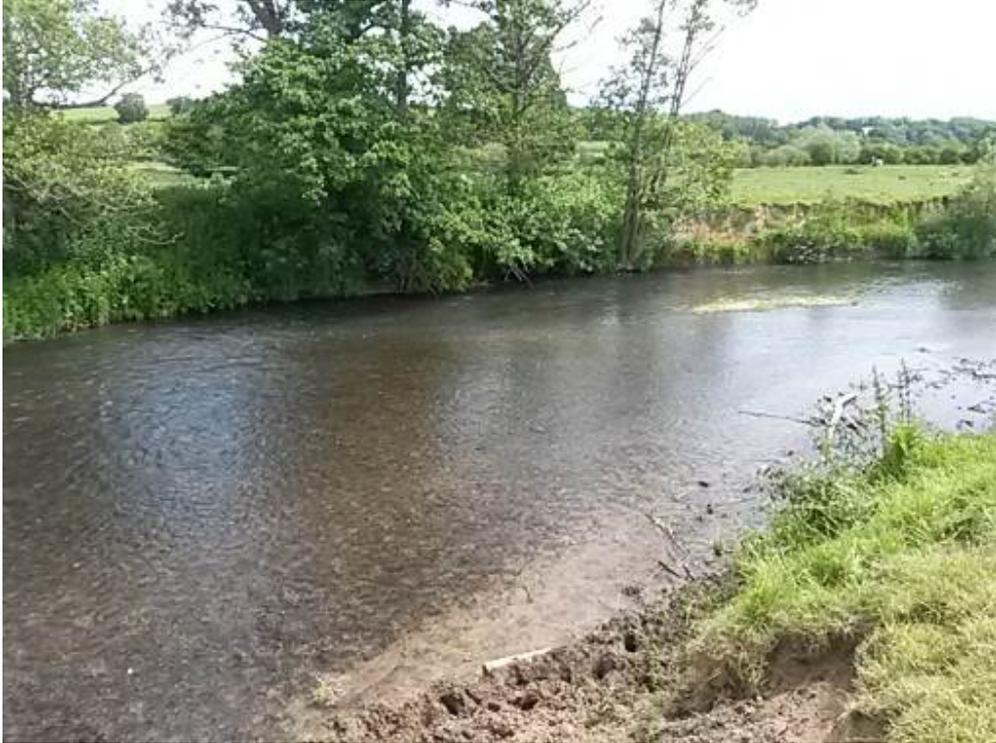
**Photo 13** A wide shallow riffle which falls within a headland which has been earmarked for fencing. This will prevent livestock access here and lead to natural recolonization with marginal plants and beneficial narrowing of the channel. This process could be speeded up by installing a brushwood “mattress” in the near margin (Area 6A).

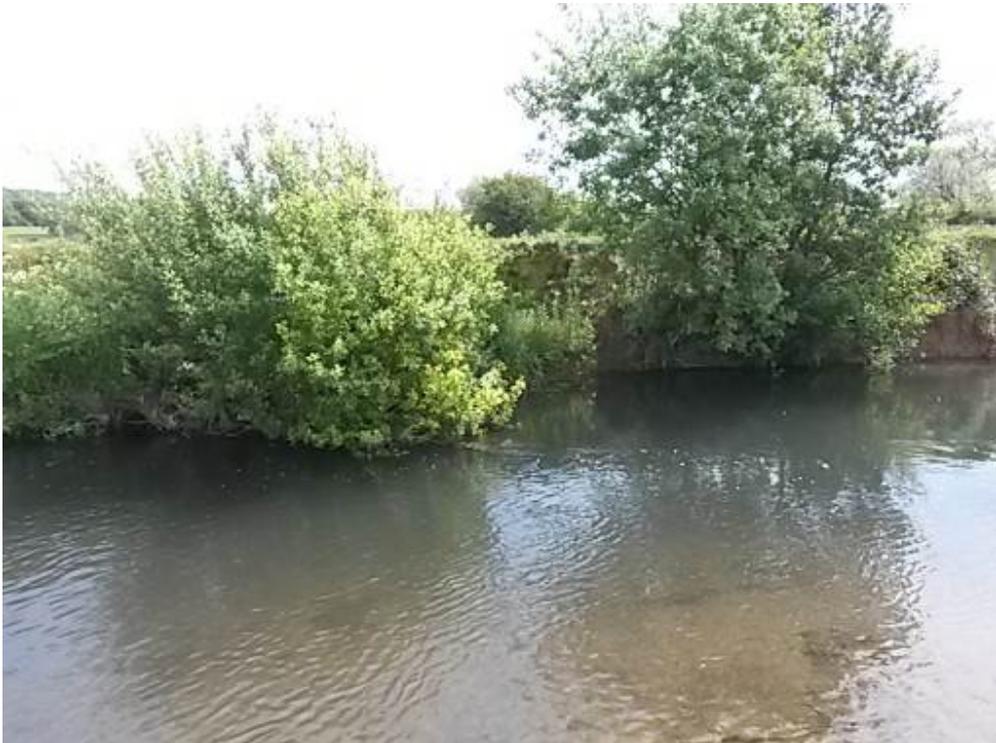
**Photo 14** Low cover over the water provides excellent holding lies for fish and should be retained (Area 6A / 6B).

Some excellent areas of low cover over the water were noted (Photo 14). These provide fantastic lies for trout and increase the carrying capacity of the river, so should be retained and not trimmed back. Equally, where woody debris is found within the channel the presumption should be to retain it (Photo 15). It provides multiple benefits to the fishery including refuge for fish from predators, habitat for invertebrates upon which fish feed and localised scouring and sorting of river bed sediments.

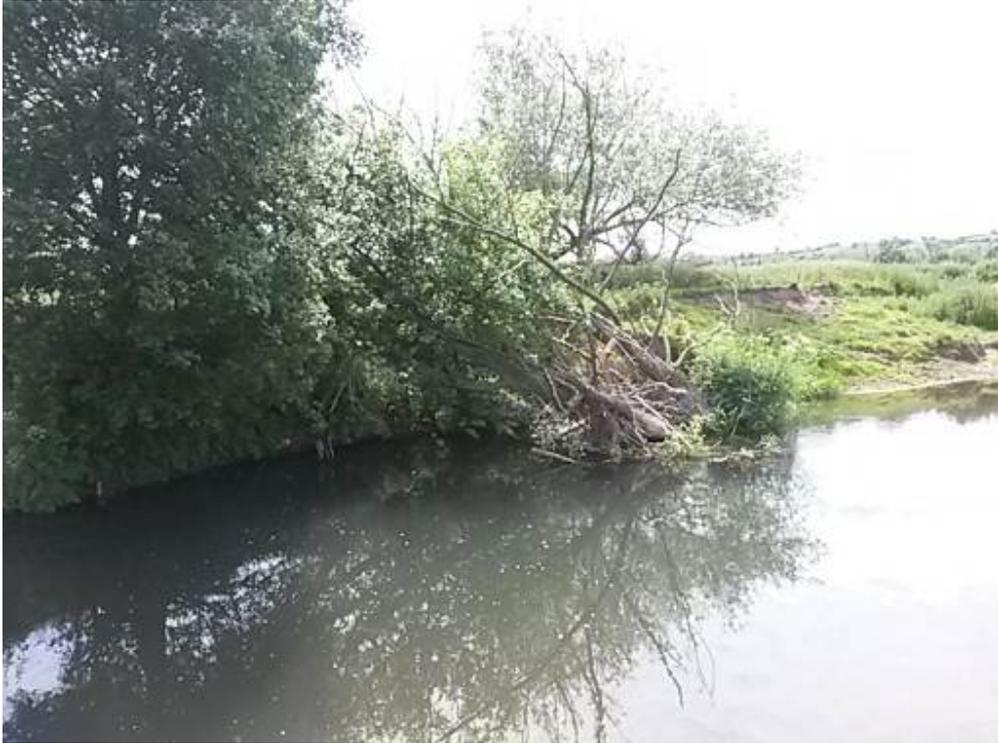
**Photo 15** Woody debris in the river is also excellent habitat, providing cover, refuge from predators (such as otters and fish-eating birds), and increasing the production of invertebrates. Leave it in place (Area 6B).

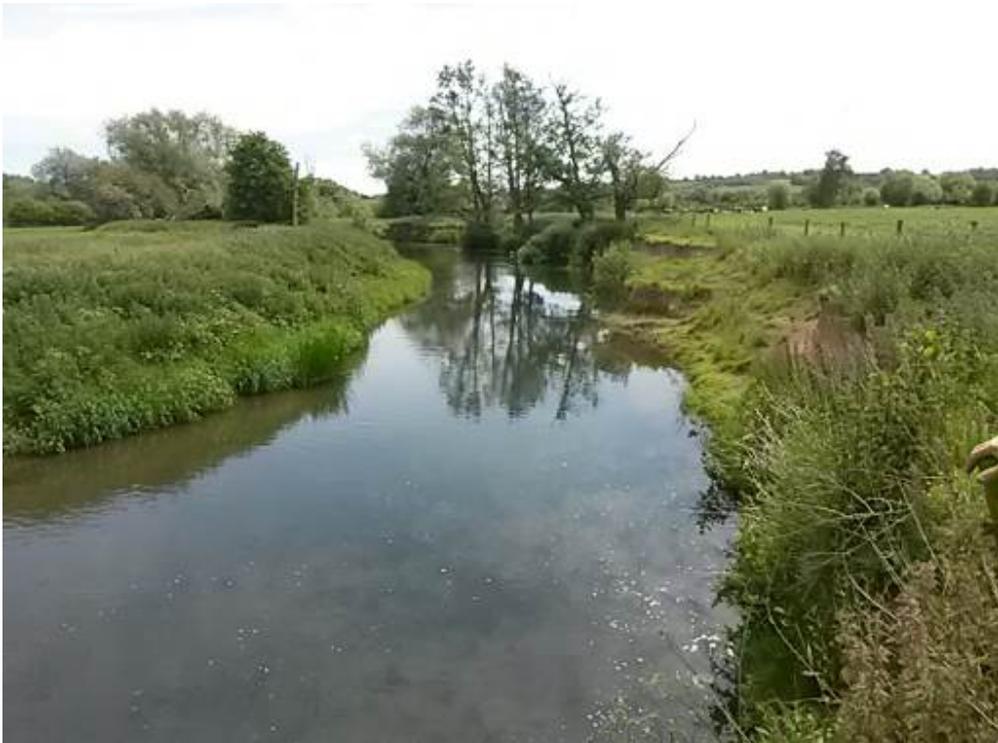
**Photo 16** Re-instating the fence at the top of the right bank here would benefit the marginal habitat and improve bank stability (Area 6B).

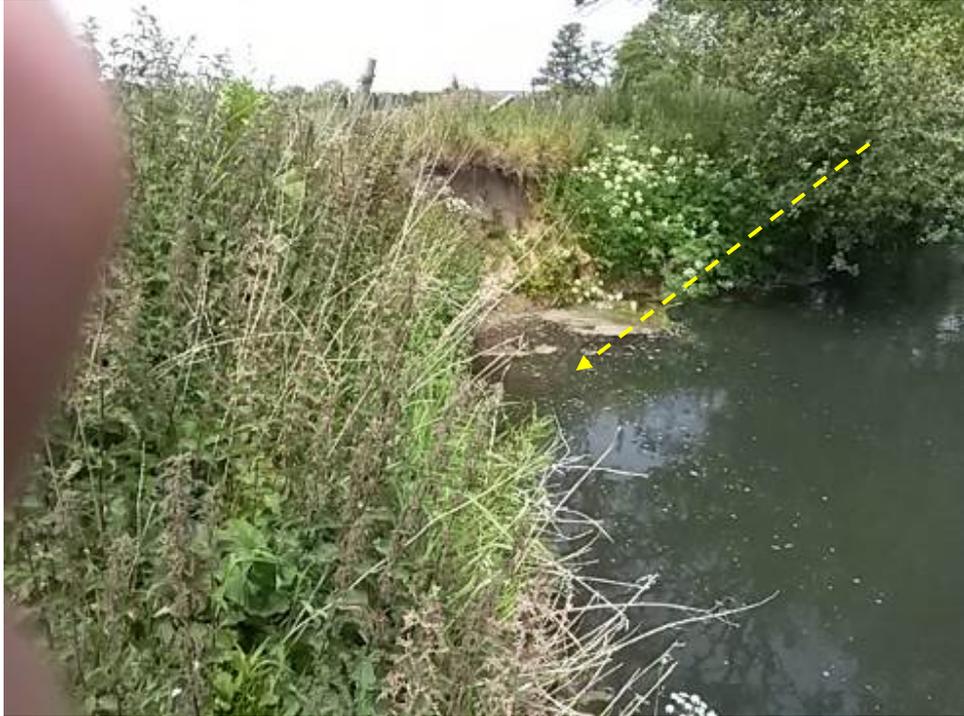
**Photo 17** Hinging and staking the tree into this back eddy as indicated would reduce the erosion currently occurring (Area 6B).

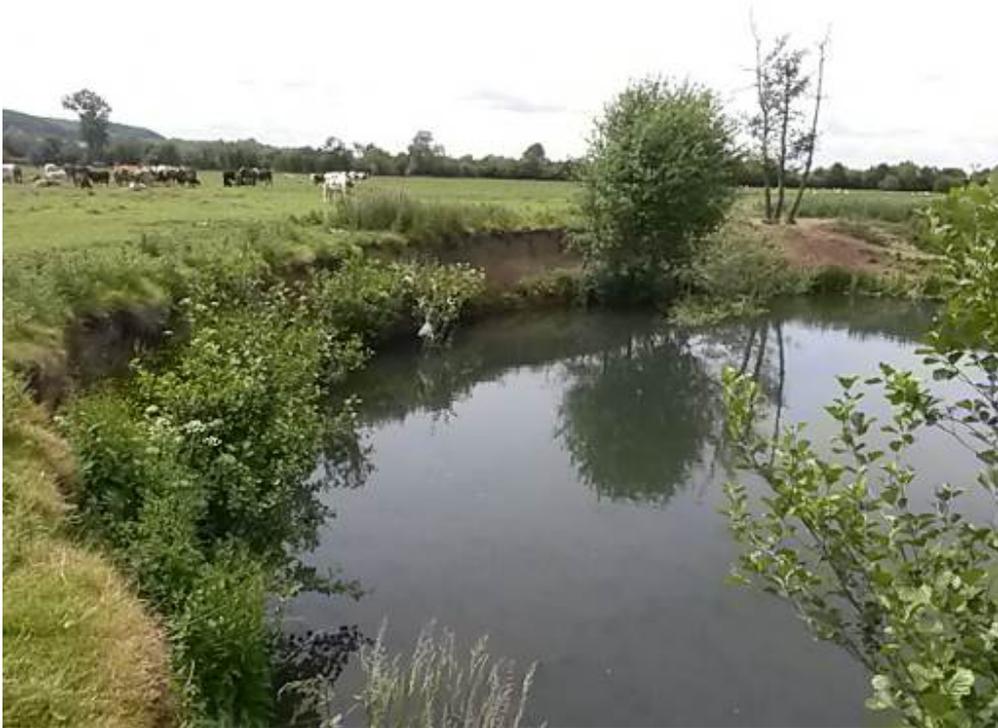
**Photo 18** A further example of vegetation establishing at the toe of the bank, but being restricted beyond there by grazing. Fencing back from the fall of bank would help increase bank resilience here (Area 8).

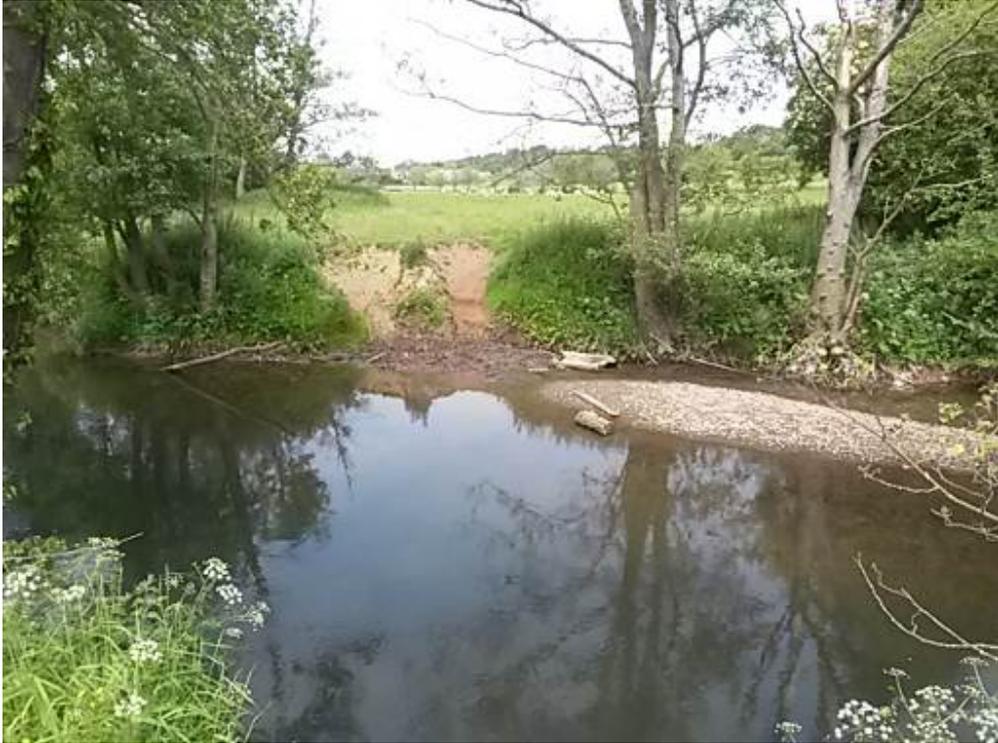
**Photo 19** A livestock access/crossing point that will fall within one of the planned fenced headlands.

At the downstream extent of the reach, the last field is under different land ownership. The river here is more tree-lined and shaded. There is a point where livestock can access and cross the river and there are plans to fence off the left bank to prevent this (Photo 19). The area on the opposite bank could be formalised to provide a hard-standing drinking area.

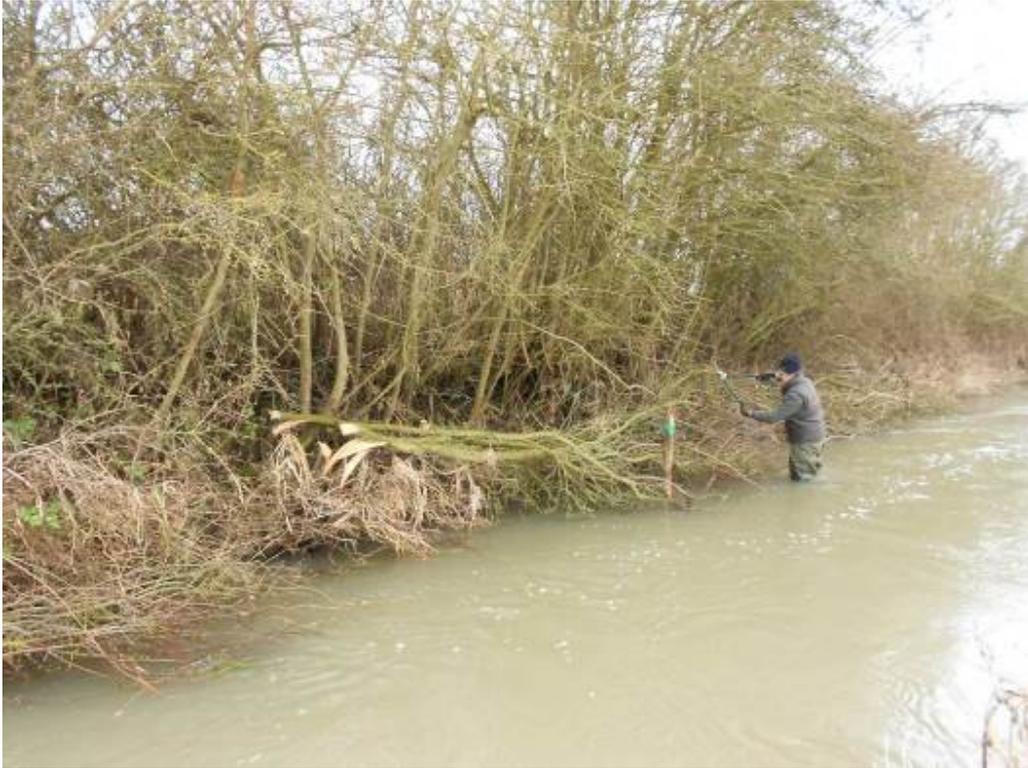
**Photo 21 Hinging and laying small trees to provide low marginal cover for fish.**

- Naturally occurring woody debris should be retained within the channel wherever possible. Hinging of trees and the introduction of tree kickers is recommended in selected areas and will be demonstrated during a practical visit later this year (Photos 21, 22).

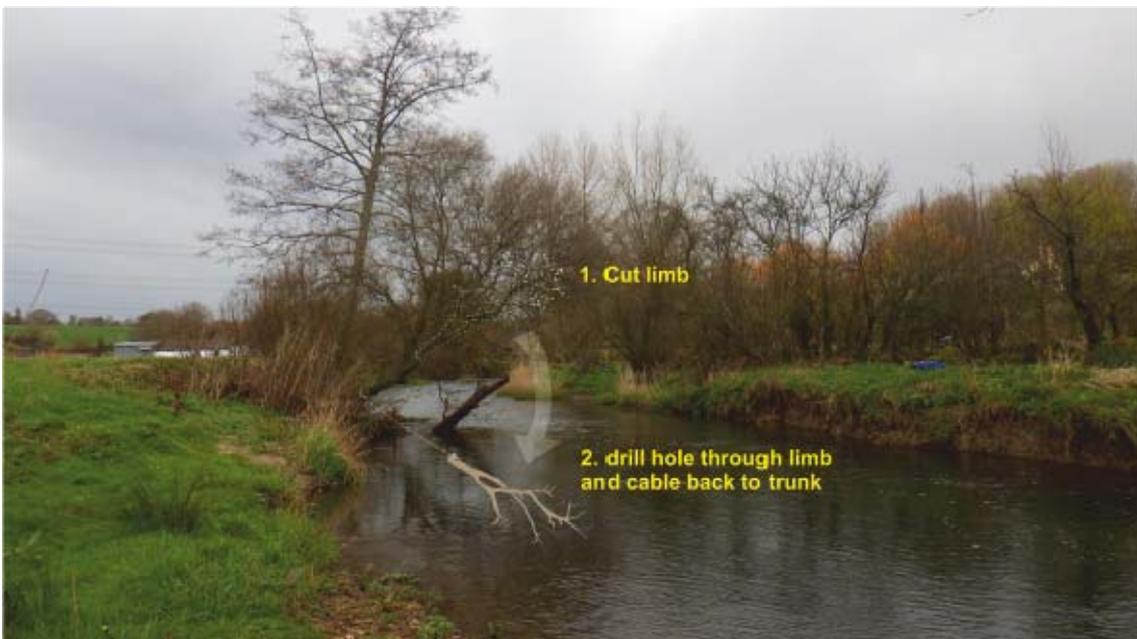
**Photo 22 Example of a tree kicker. A shorter cable can be used to restrict movement. The kicker rises and falls with water level, providing bank protection at all water levels.**

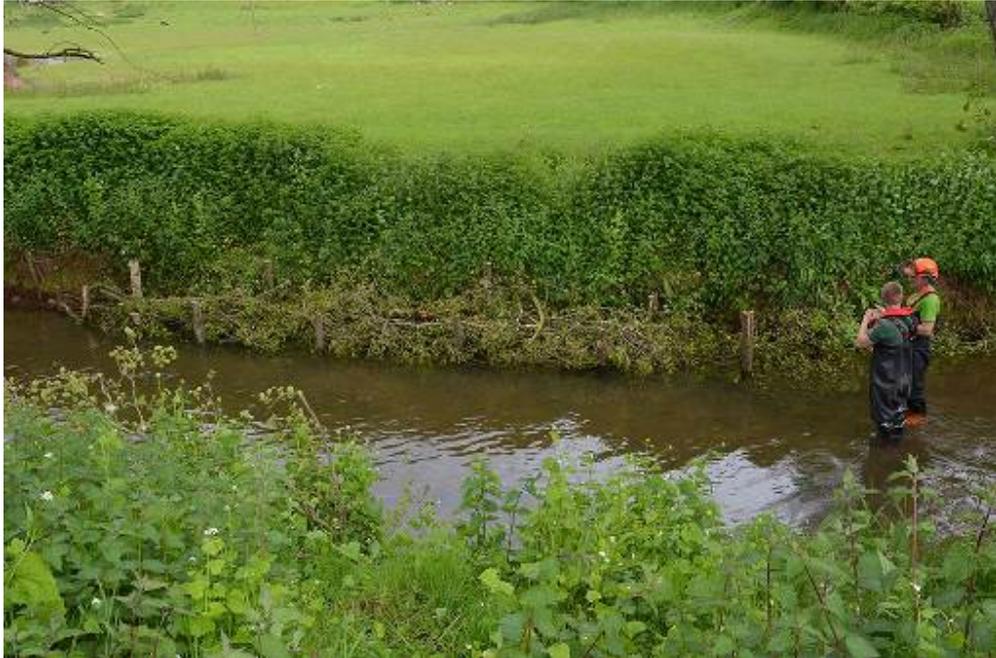
**Photo 23** Brushwood bank revetment installed on the River Leadon. This can be used to protect the toe of the bank from erosion.

- Bank revetment using brushwood should be carried out in the areas indicated, to reduce excessive rates of erosion and allow the banks to stabilise. This should be done in combination with fencing of these areas (Photo 23, 24).

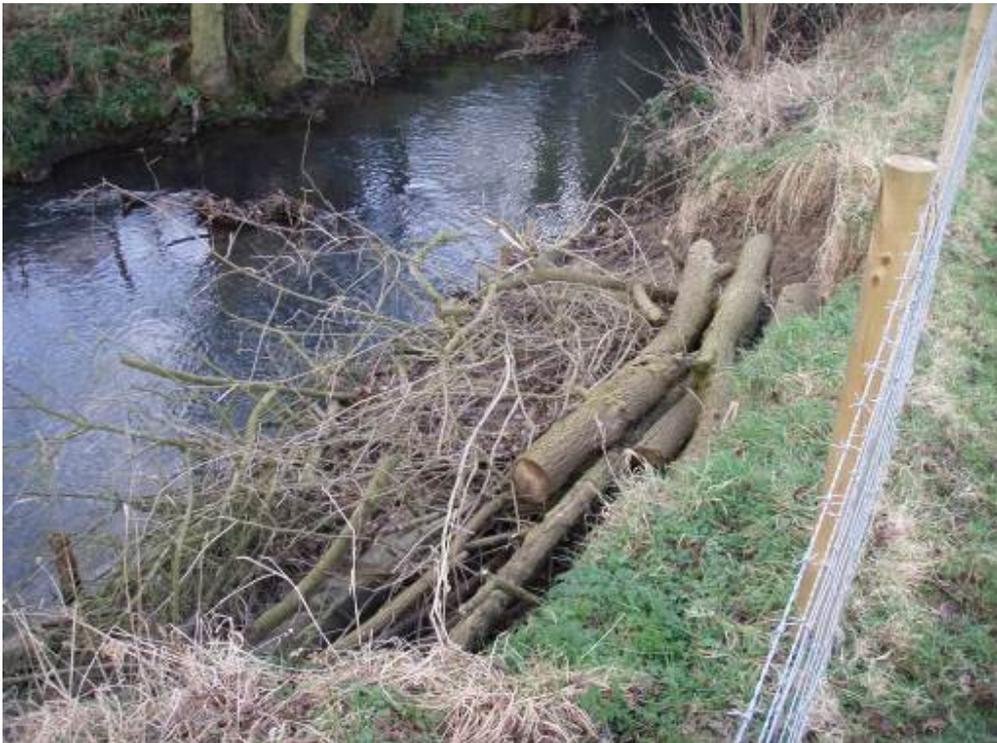
**Photo 24** Brushwood revetment wired and staked in place, in combination with fencing.

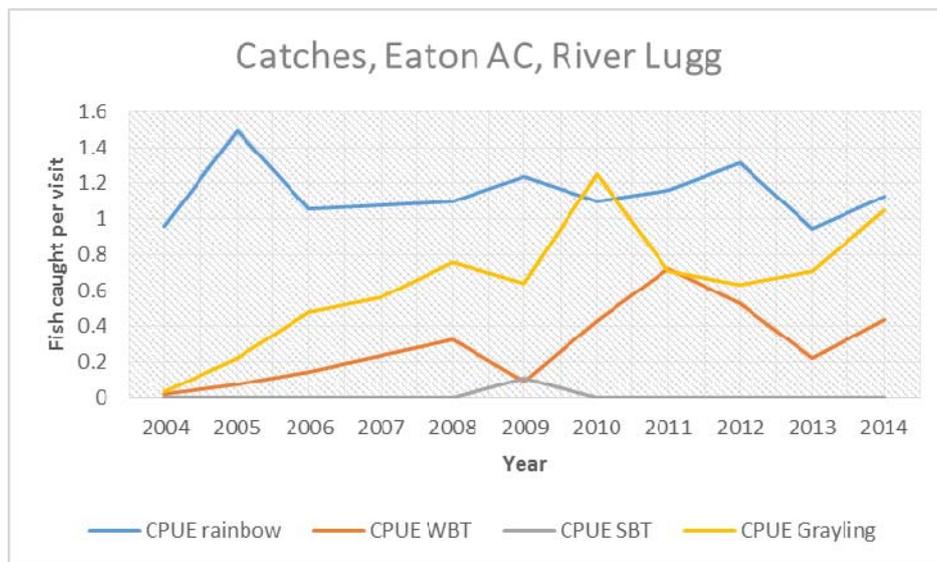
per visit (or per hour if length of fishing time is recorded) and allows comparison of seasons where more or less fishing took place. The CPUE for rainbow trout is consistent at around 1.2 fish per visit during the period, whereas CPUE for wild brown trout is lower and more variable, between 0.02 and 0.72 per visit. Grayling show a generally increasing trend. The troughs in wild brown trout catches have been attributed to periods of flood affecting fish numbers; this is unlikely given no corresponding impact upon other species. It is interesting to note that one of the dips in wild trout catches is in 2009 which is the year when a batch of farmed brown trout were stocked in addition to the usual rainbows. Whilst it is tempting to speculate that this maybe because of the competitive interactions noted above, it is not possible to say without future data as stocking levels are decreased. The reduction in stocking in 2015 of around 100 fish to a total of 420 is a reasonable annual incremental reduction, whilst monitoring the effect on catches.

**Figure 1** A graphical representation of Eaton AC catch returns based upon fishing effort. CPUE is Catch per Unit Effort (fish caught per visit), WBT is wild brown trout, SBT stocked brown trout.

The available catch return data for Eaton AC is shown in Figure 1 and Table 1 below. It is recommended that "catch per unit effort" (CPUE) is used for comparative purposes; this is usually expressed as number of fish caught
