Habitat Advisory visit to the River
Maine.

Undertaken on behalf of Gracehill,
Galgorm and District Angling Club,
Antrim, Northern Ireland,
by Vaughan Lewis, Windrush AEC
Ltd

April 2009

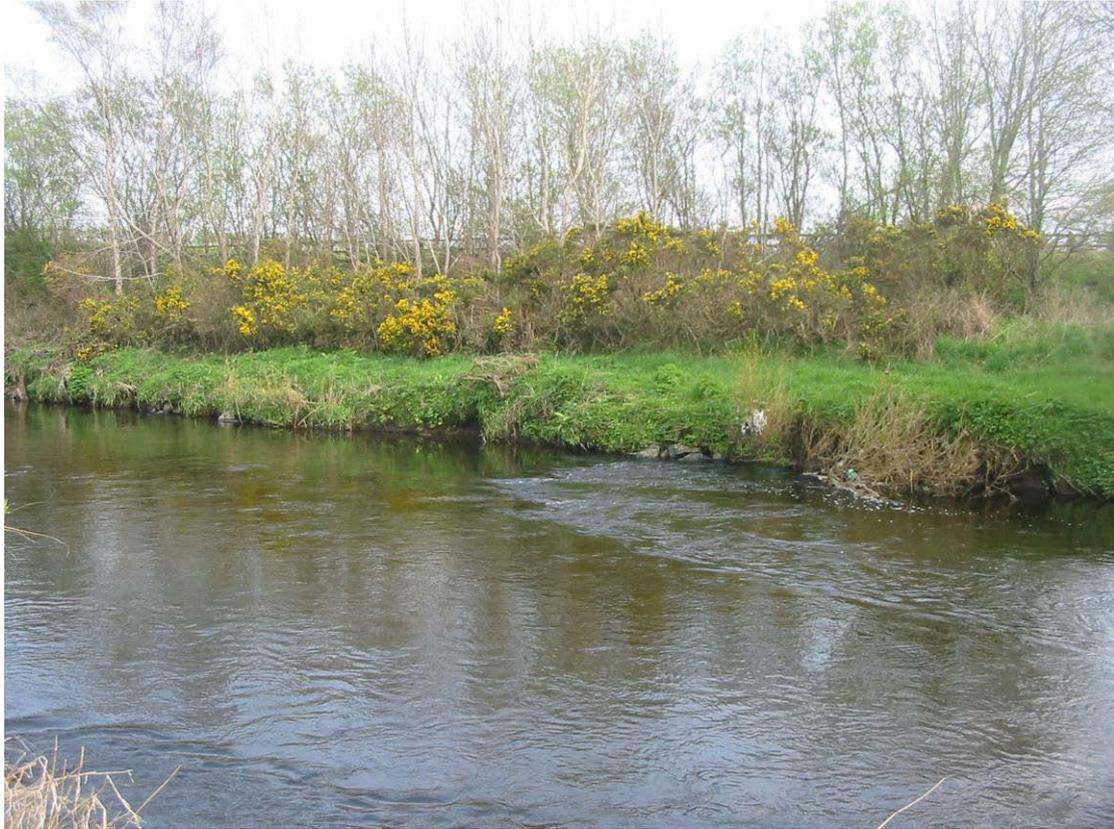
A major enhancement project had been undertaken over a section of 150m of the River Maine, funded by the EU. This comprised the provision of rubble mats, stone deflectors and large, individual boulders. The work had increased instream habitat diversity for all lifestages of brown trout *Salmo trutta* and Atlantic salmon *Salmo salar* and had been possible as this length of channel was upstream of the footprint of flood defence scheme.

Enhanced length of channel showing LB deflector

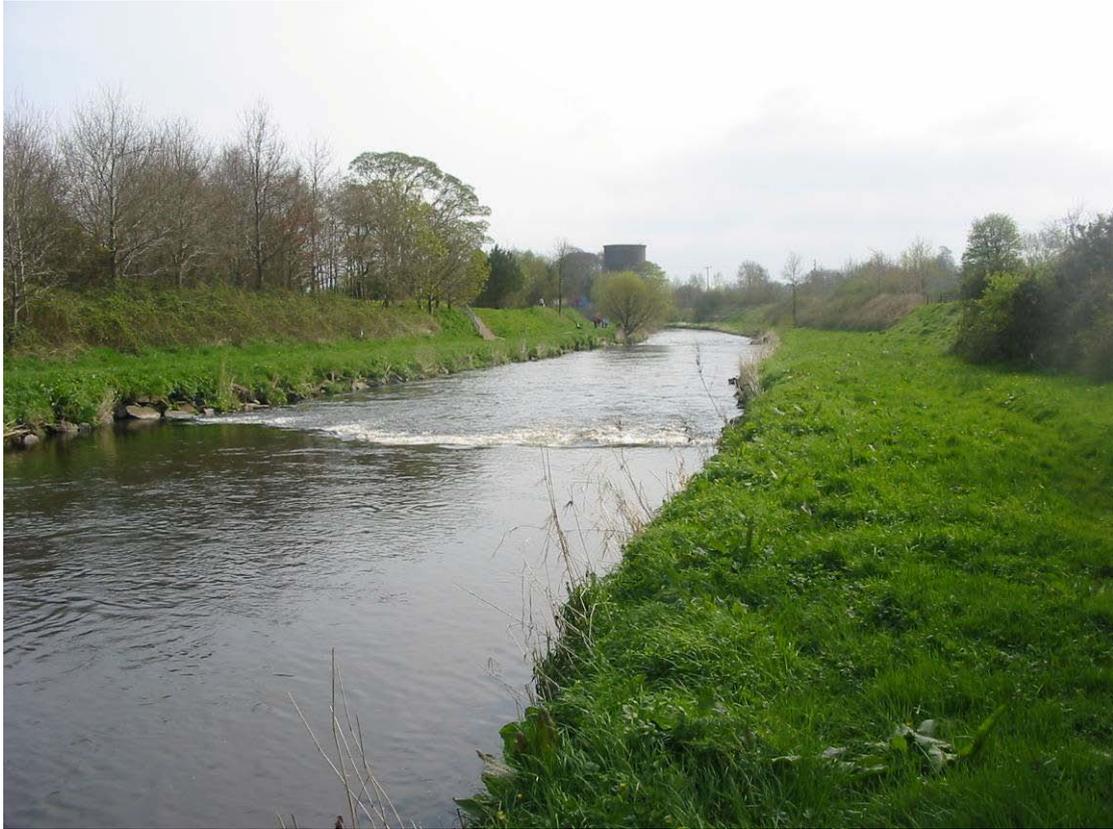
Downstream of Bridgend, the channel had been heavily dredged and flood banks constructed along both sides of the river as part of the major flood defence scheme. The lack of trees was apparent, with all bankside vegetation having been removed as part of the scheme. Subsequent to completion of the flood scheme, the club had installed a number of blockstone deflectors/weirs, in an effort to scour the bed and increase habitat diversity. There were approximately 8-10 of these structures along a length of several hundred metres, each with a head loss of approximately 300mm to 500mm. Erosion of some of the groyne was visible where they met the existing bankline.

Dredged section of river downstream of Bridgend, with flood banks visible on LB and RB. Note the blockstone weir subsequently installed by anglers

- The blockstone weirs constructed downstream of Bridgend have created a series of hydraulic checks within the channel. These act to control water level and influence the flood regime of the river. Where erosion of the bank is occurring adjacent to the weirs, repairs should be effected. Without this remedial work, the weirs will fail, resulting in a loss of benefit and the potential for significant bank slippage.

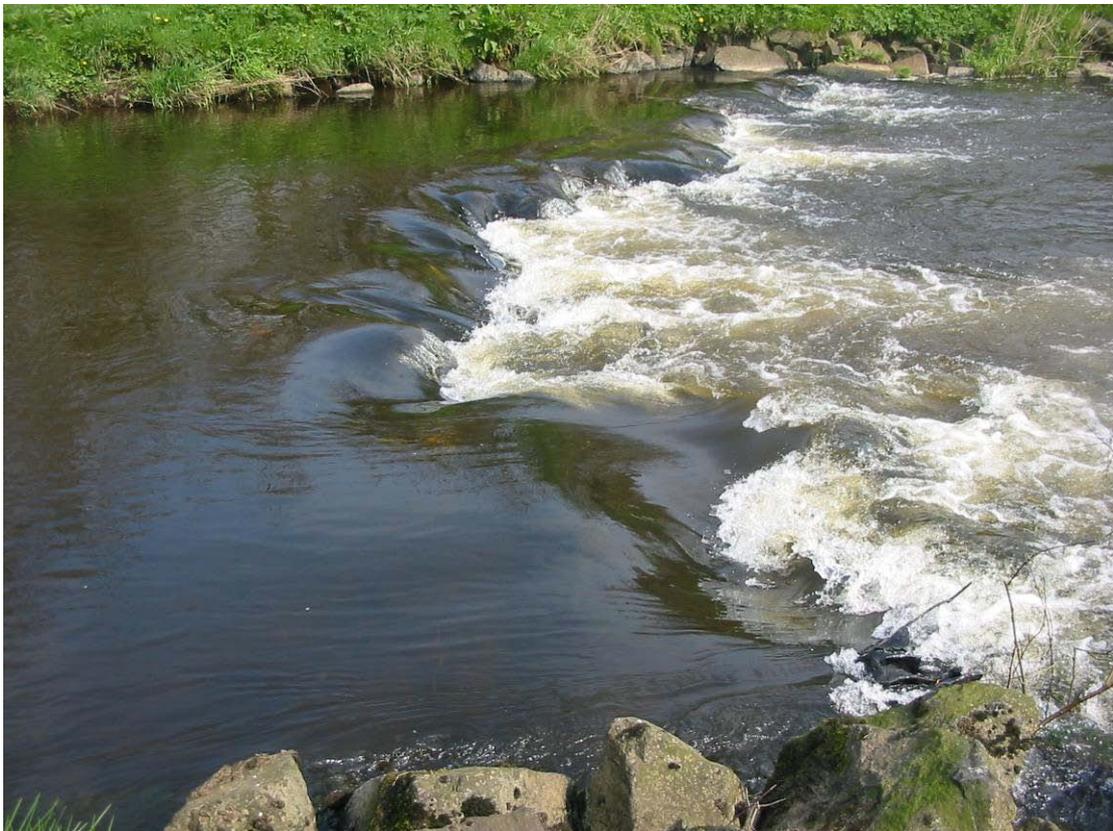
Detail of blockstone weir

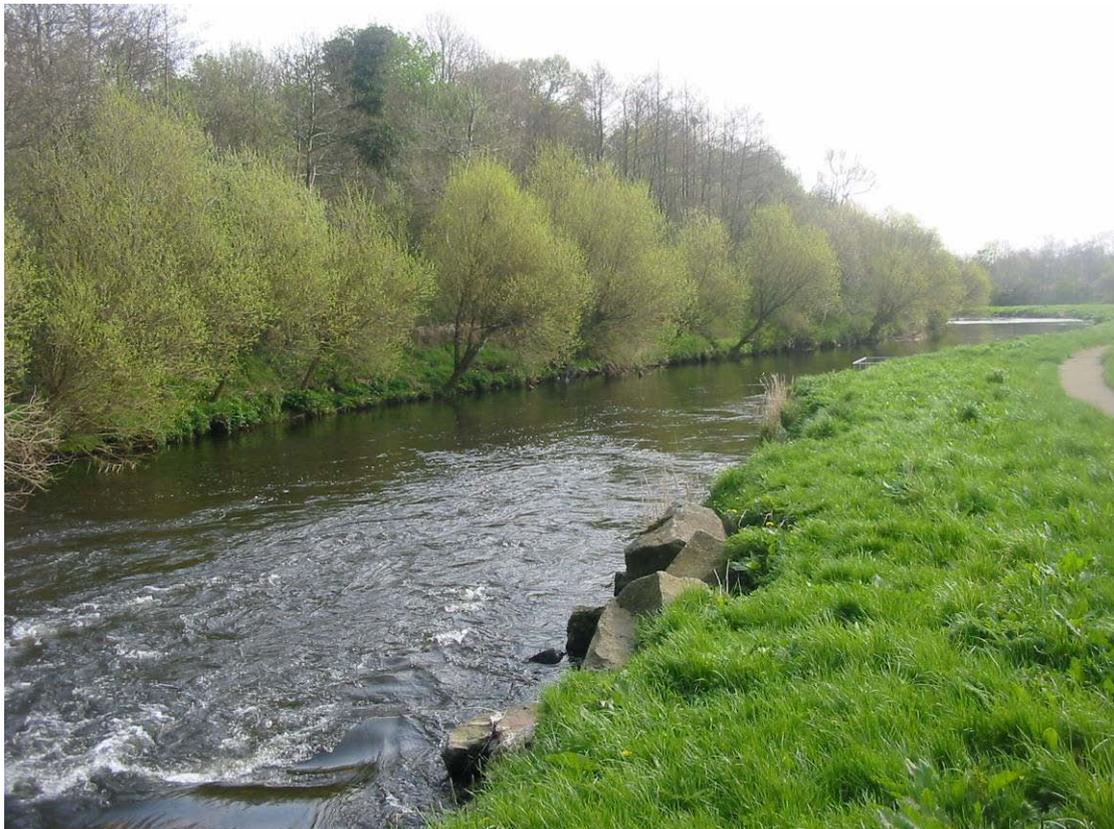
Club members had planted a number of willow trees along the LB of the river. These were now semi-mature.

LB willow trees planted by the club. Note also blockstone weir

- Selected willows (one in three initially) downstream of Gracehill Bridge could be 'cut and hinged' as described above. By carefully aligning the hinged limbs parallel to the bank, and fixing them in this position, valuable instream cover would be created without a significant increase in flood risk. The hinged limbs will also help protect the bank from erosion, with growth into the bank from the limbs offering further protection. The longevity (>5 years) of the group of three stakes driven into the river bed by the club shows that firm fixings can be obtained in the bed of the river at this location.

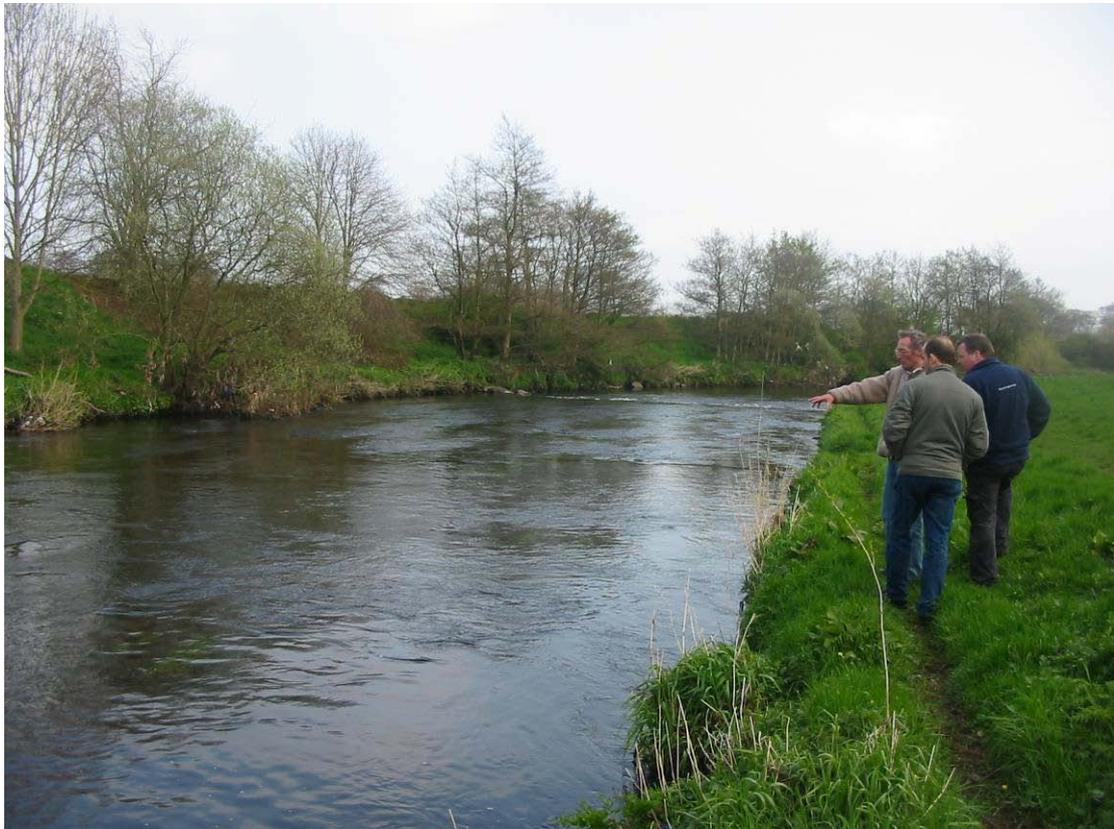
A series of rubble mats utilising 200 tonnes of introduced gravel, and large boulders had been constructed by the club. They had planted the mats with water crowfoot, with willow moss *Fontinalis antipyretica* and Hemlock water dropwort *Oenanthe crocata*

having colonised the gravel naturally. This work had formed an excellent section of spawning gravel and juvenile habitat for salmon and trout. Pre and post electrofishing surveys showed that trout fry numbers had quadrupled, with a similar increase noted in the numbers of parr present.

Gravel spawning area created by the angling club

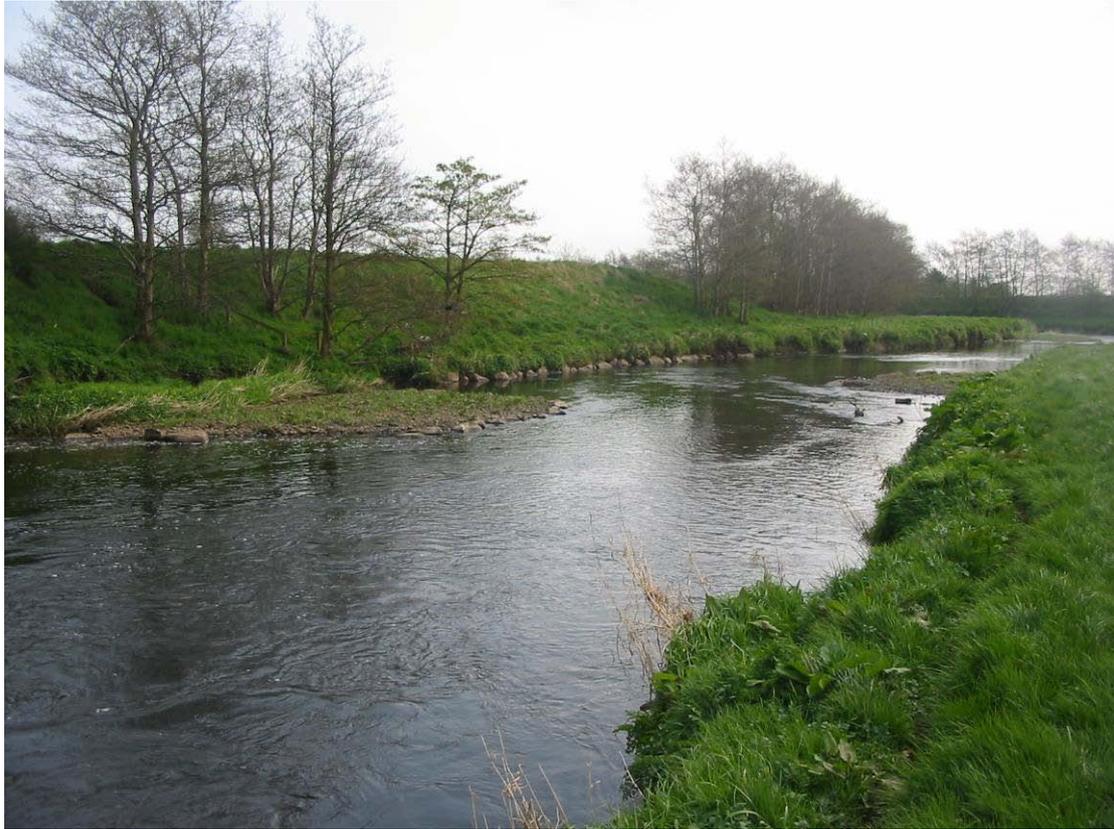
Immediately downstream of the rubble mats, a series of 'D' shaped bankside deflectors constructed of stone, had been installed under the EU funded salmon enhancement plan for the River Maine, approximately 2 years ago. They had begun to colonise with reed canary grass *Phalaris arundinacea*, along with other emergent vegetation, and had created significant sections of bed scour.

‘D’ shaped stone deflectors

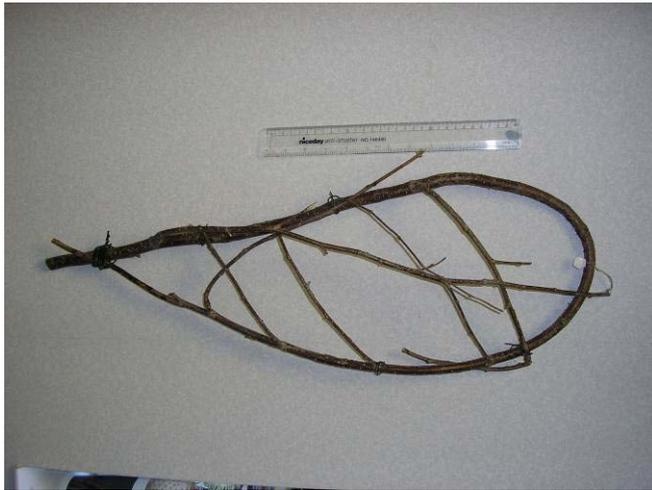
Snowshow ..

- In order to help re-establish water crowfoot in the channel, it may be helpful to utilise willow snowshoes. These are simply thin willow stems twisted and woven in order to make the rough shape of a snowshoe or tennis racket. Once complete, they are anchored to the river bed using wooden or metal pins. Weed passing down the river lodges on the snowshoes, allowing it to root into the bed. A similar effect can be obtained by driving small wooden stakes into the river bed. Further details on snowshoes and other uses of willow are provided in the WTT Chalkstream Habitat Manual. This is available as a series of downloadable PDF's from the Trust's website www.wildtrout.org Construction should be undertaken in April or early May to maximise growth of introduced plant material prior to high winter flows.

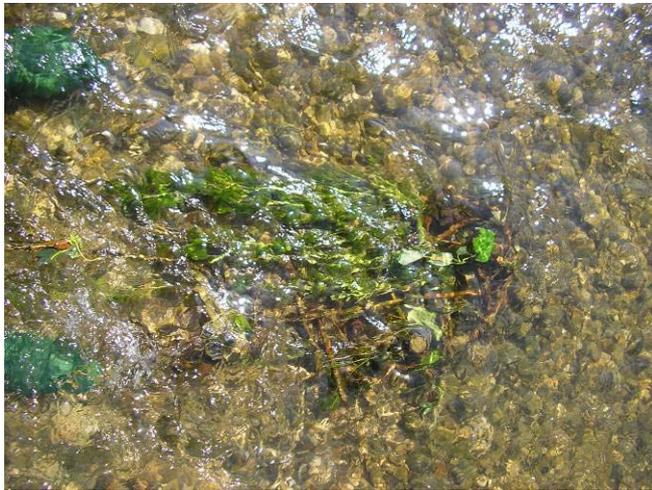
....and after installation showing collected weed

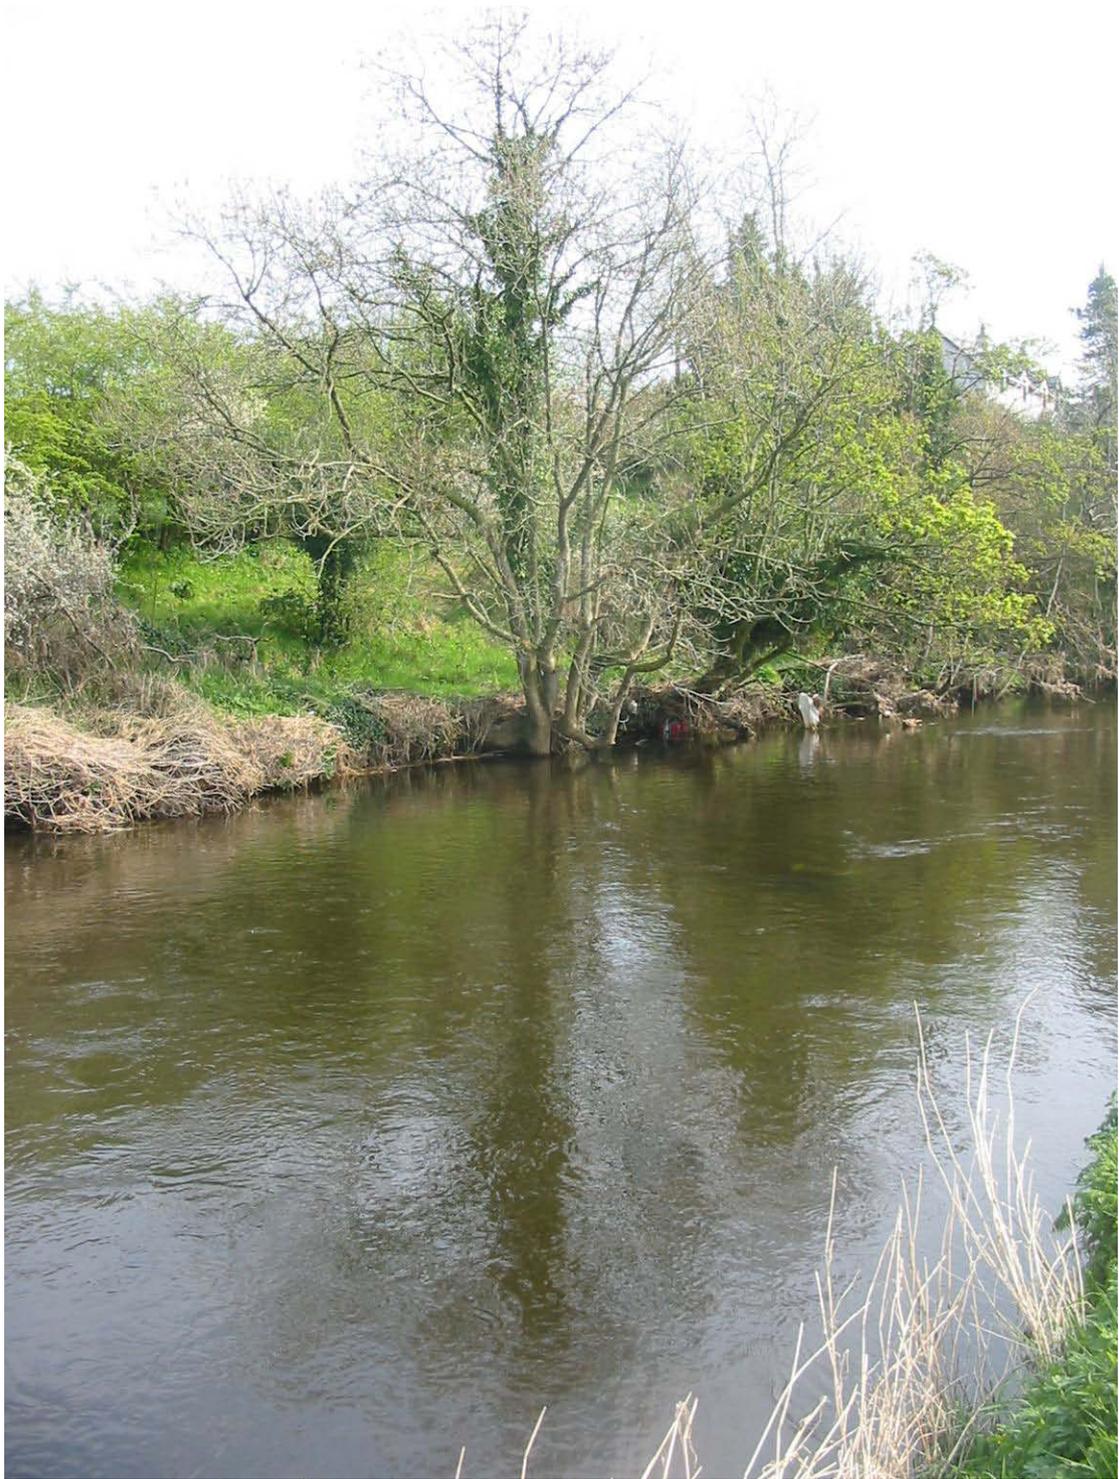
Tree suitable for 'cutting and hinging' into the river

- It would be also valuable to plant a number of deciduous trees, particularly along the LB. Species to consider include ash and willow, with individual trees protected from agricultural stock and rabbits. Additional instream habitat could also be created by partially cutting through the trunks of large individual bankside trees, near to their base, and ‘hinging’ them into the water. They could then be fixed in place roughly parallel to the bank, using 25mm reinforcing bar driven into the riverbed through holes drilled in the trunks. At least 3 sections of bar should be used, with each one driven at least 600mm into the riverbed. Additional fixing should be provided by wrapping galvanised cable laid steel wire around the trunk or passing it through a drilled hole at its butt, with the wire then attached firmly to the stump remaining on the bank. This provides a solid failsafe fixing in the event of the tree working loose from the rebar. Where erosion has resulted from angler access along the bank in the upper reach of the fishery, it would be prudent to densely plant willow slips (preferably osier *Salix viminalis* or goat willow *Salix caprea*) approximately 1m-2m back from the bank top to create a protective root

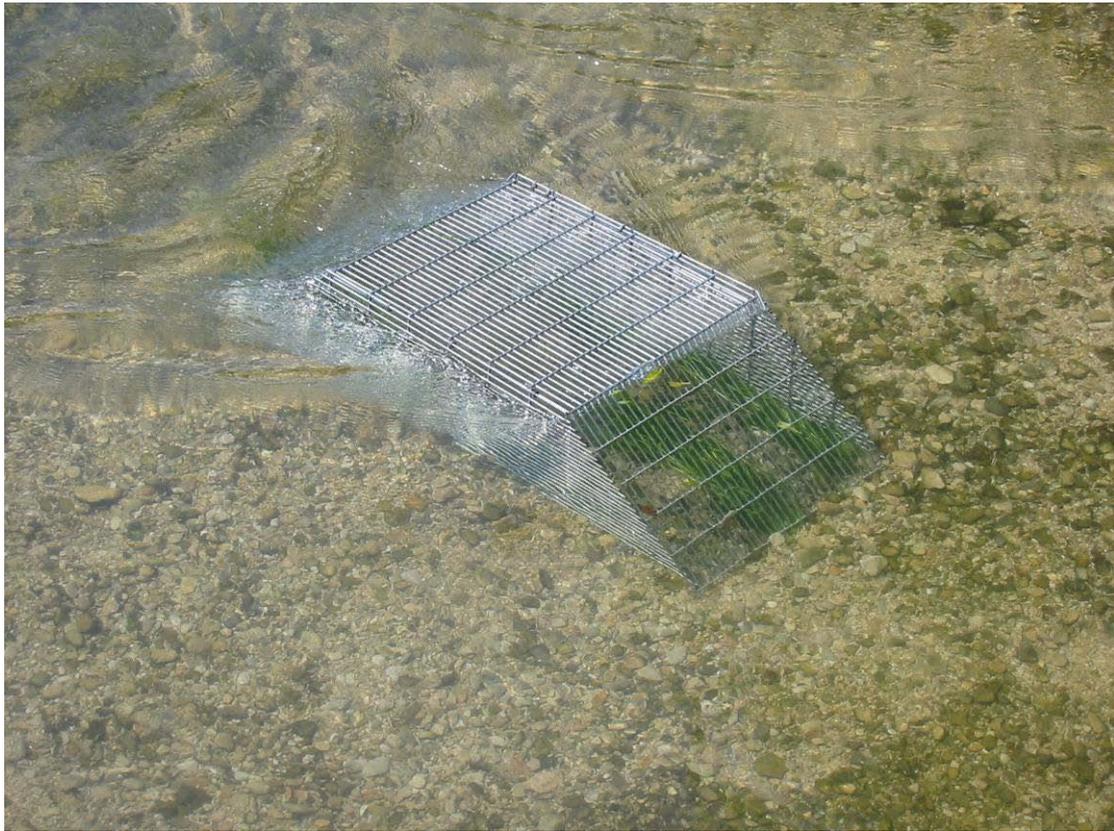
Freshly planted water crowfoot protected by mesh cage

- An alternative method of establishing water crowfoot is to transplant the weed from areas where it remains abundant. One simple way of doing this is to make a hole in the bed of a diameter of around 5cm-10cm using a crowbar or similar metal spike. Fold a good sized tress of water crowfoot in half and tuck the folded section of weed into the hole. Then push in the sides of the hole using boots, and place a small pile of stones over the base of the weed to prevent it pulling out in strong flows. If swans prove to be a nuisance, it may be necessary to put a metal cage over the newly planted weed until it is well established.
