**ADVISORY VISIT TO THE RIVER MANIFOLD,  
DERBYSHIRE,  
UNDERTAKEN BY TIM JACKLIN, WILD TROUT  
TRUST ON BEHALF OF SWAINSLEY FISHING  
CLUB  
JUNE 2008**

## **1.0 Introduction**

This report forms the output of a site visit undertaken on 3<sup>rd</sup> June 2008 to the Swainsley Fishing Club's fishery on the River Manifold, near Butterton, Staffordshire. The club's fishery runs from Ecton in the north to Wetton Mill in the south, a length of some 4 km, the upper part of the fishery (above Swainsley Bridge) being shared water with Derbyshire County Angling Club. Swainsley Fishing Club has 26 members and lease the fishing rights from the owners of Swainsley Hall. Land ownership comprises private individuals (farmers) on the northern part of the fishery, and the National Trust on the southern part.

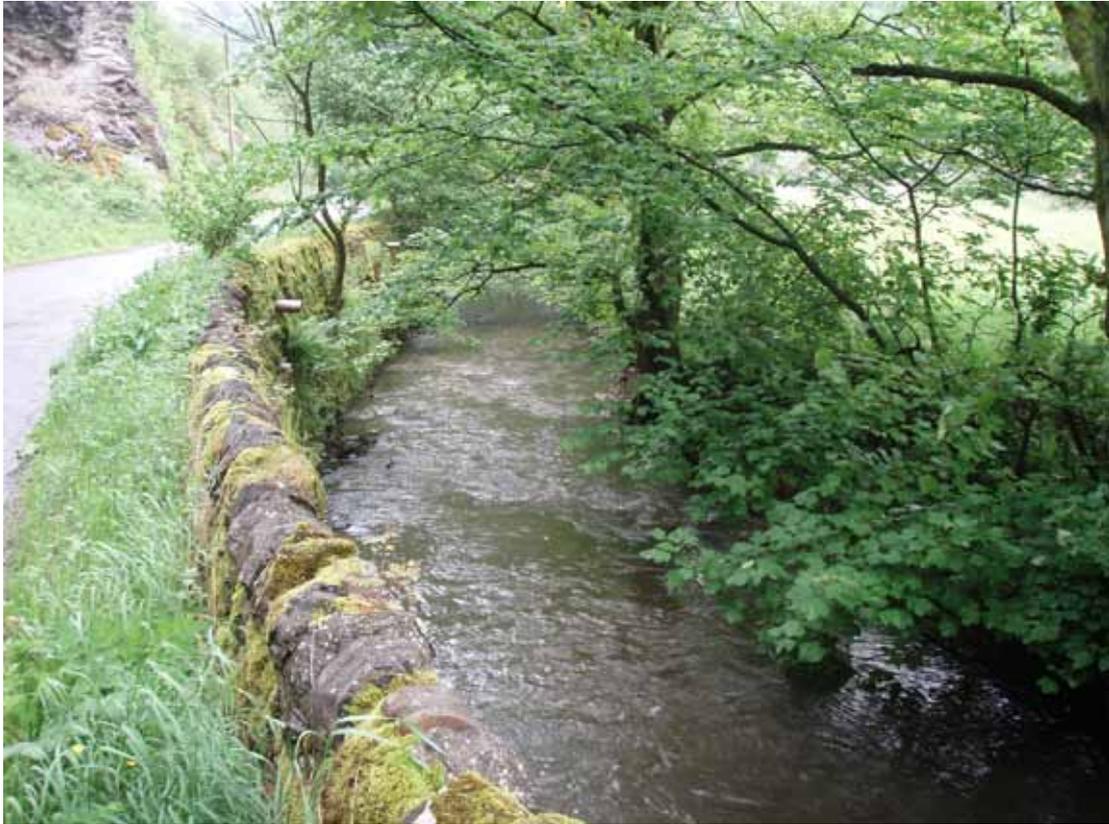
Ecton Road straight at the upper end of the fishery

Throughout the fishery instream habitat was good. There was a balance of chutes, gravel bedded riffles, shallow glides and deeper pool areas, providing habitat for all life stages of brown trout *Salmo trutta* and grayling *Thymallus thymallus*. There was good tree cover throughout the fishery, mainly alder *Alnus glutinosa*, willow and sallows *Salix* spp, ash *Fraxinus excelsior* and hawthorn *Crataegus monogyna*.

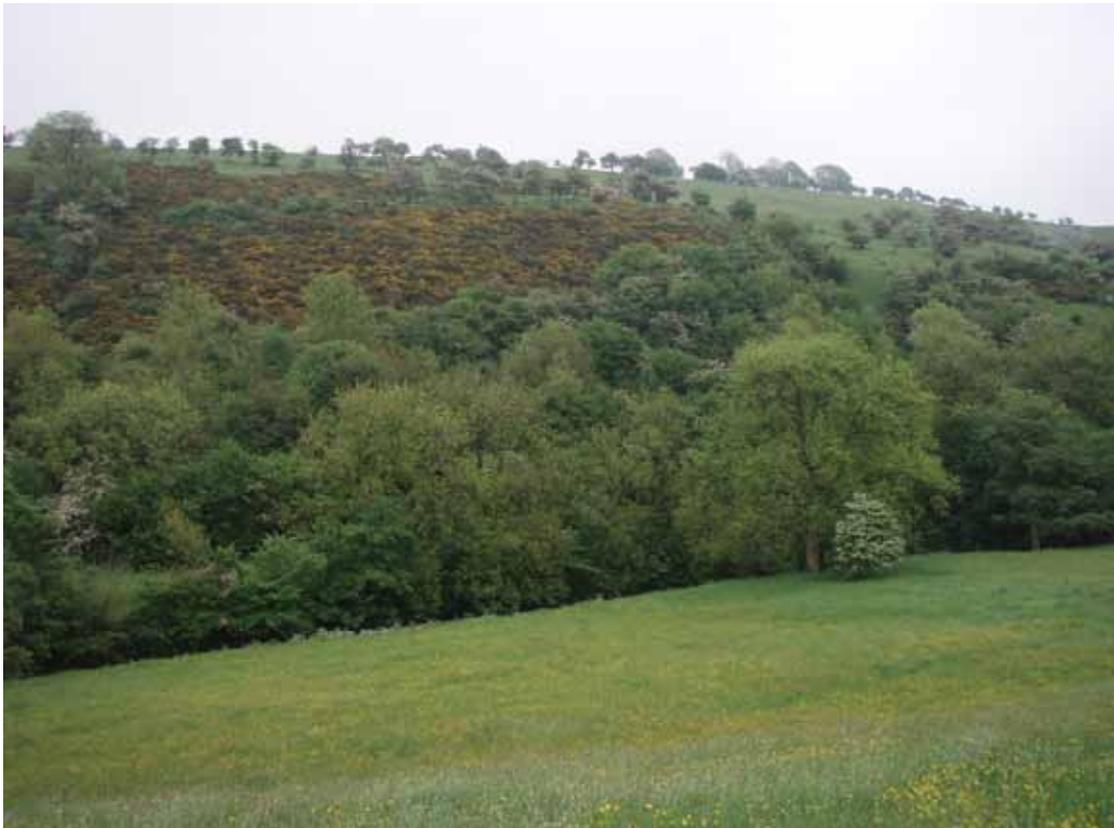
Adjacent land use is influenced by the steep valley sides and comprises mainly wooded valley sides or low intensity grazing and hawthorn / gorse scrub. Mowing grass is cultivated in some small fields on the valley floor, and there were a couple of fields with grazing horses. Most of the fishery was inaccessible to livestock because of fencing or steep banks, and there were no problems of stock poaching or bank erosion evident.

Typical land use alongside the river: grass meadow on the right bank, looking over the river to woodland, gorse and hawthorn on the valley sides (High Bank / Gate Bank Pool area)

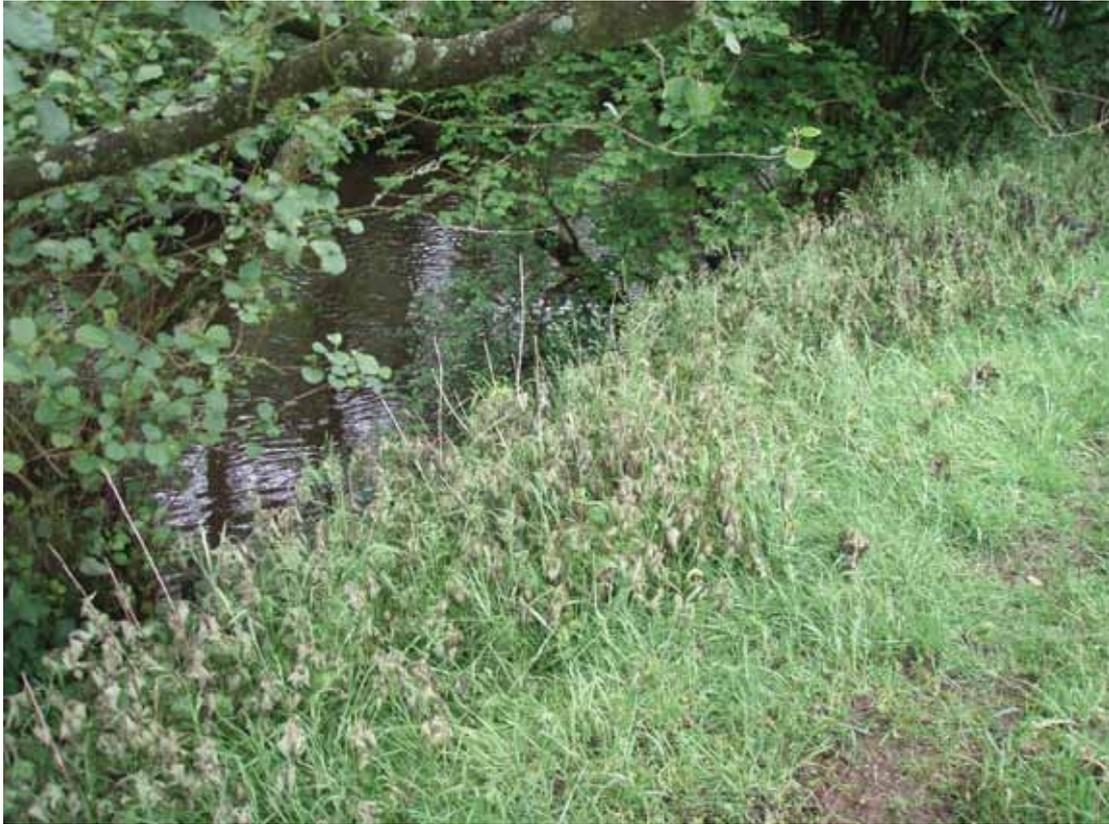
One area of the left bank next to Picnic Pool had signs of loss of vegetation, possibly because of livestock access, that could potentially cause erosion problems in the future. This field also showed clear signs of the use of selective herbicides on nettles and docks very close to the fall of the bank.

**Dying nettles indicating use of selective herbicide close to the river on the right bank alongside Picnic Pool**

- The use of herbicide close to the river in the field upstream of Wetton Mill was of concern given the proximity to the river, and the possibility of overspray. The Environment Agency regulates the use of herbicides to control aquatic or bankside weeds, and their written agreement is required ([http://www.environment-agency.gov.uk/commondata/acrobat/wqm1\\_notes201\\_1797478.pdf](http://www.environment-agency.gov.uk/commondata/acrobat/wqm1_notes201_1797478.pdf)). It is recommended that the club approach the National Trust (the landowner) to discuss this issue, and the possibility of the introduction of a buffer strip alongside the river. The latter would also prevent the worsening of the (currently minor) stock damage to the bank in this area.

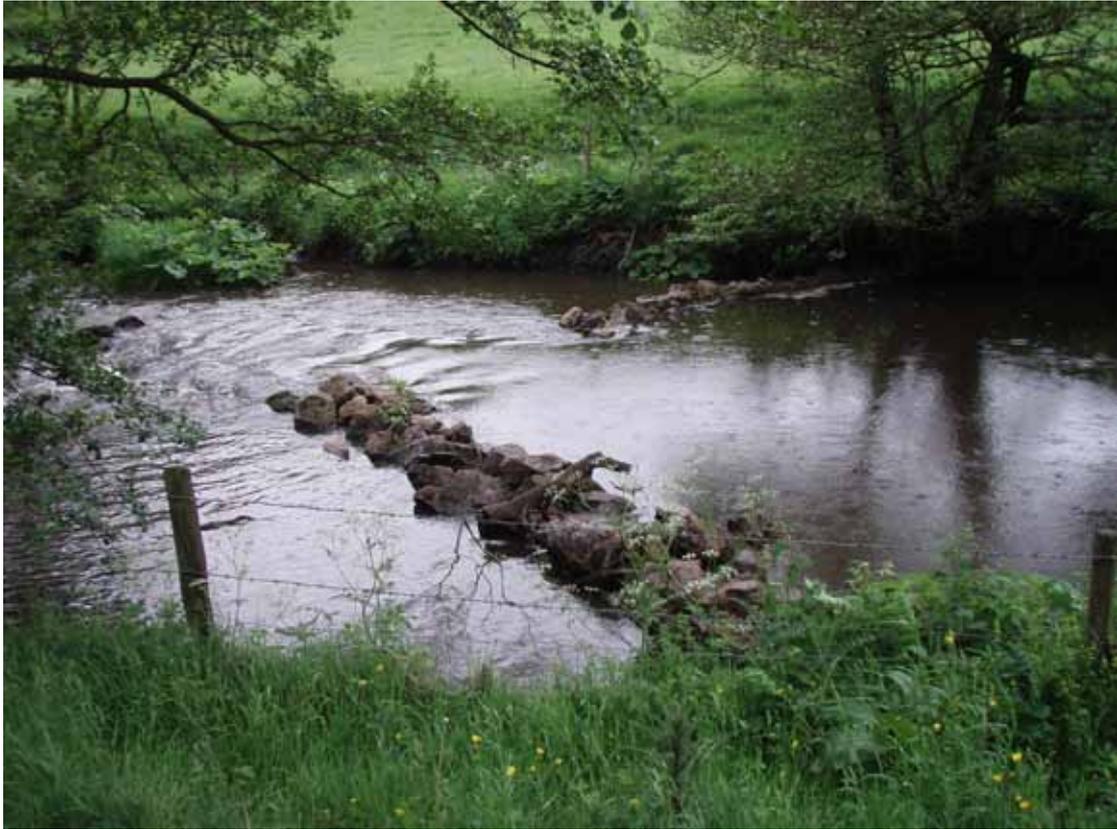
There is only one permanent weir on the fishery, a low structure at the tail of the pool below Swainsley bridge. The club have also installed a small number of stone groyne to maintain water levels in some pools. These structures are limited to a short section of river between Swainsley Bridge and Dovecote Pool.

Stone groynes at the tail of Dovecote Pool

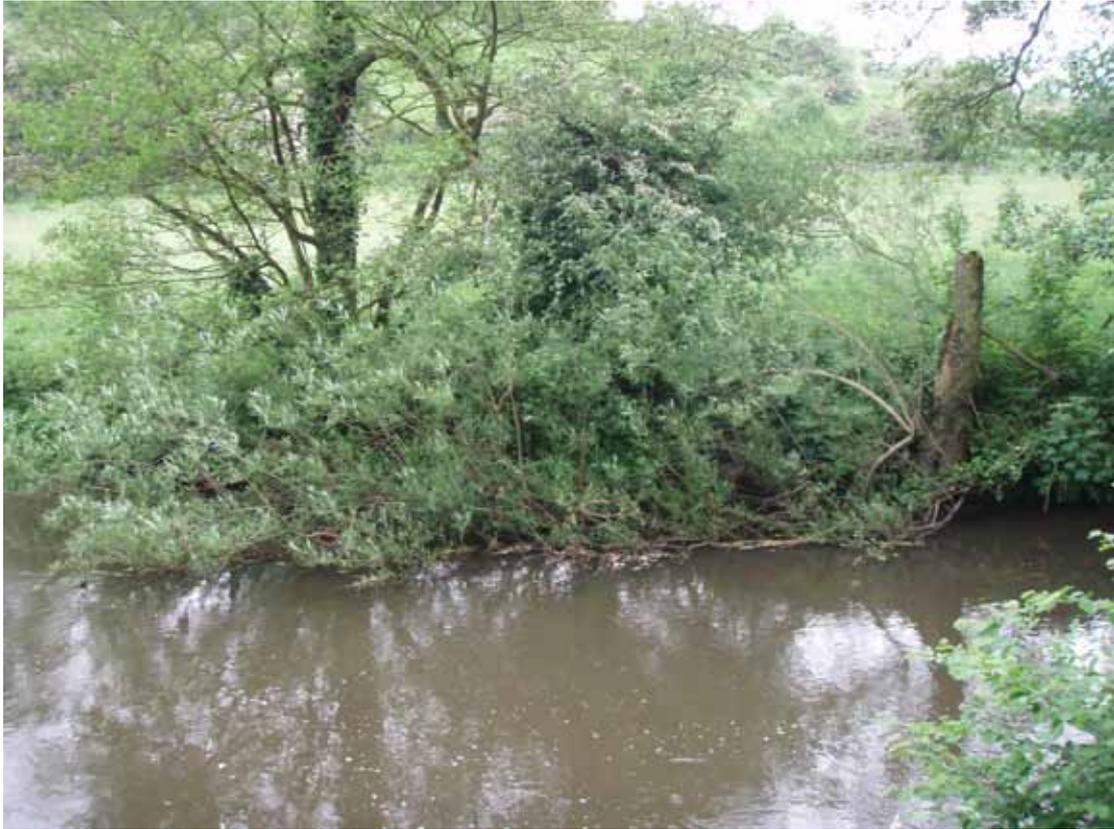
Despite the presence of large numbers of riparian trees, there was a general lack of Large Woody Debris (LWD) in the channel, limiting both overall diversity and the availability of cover for fish. The club have working parties on the river and generally remove LWD. A good example of LWD left *in situ* was a fallen willow in Willow Pool.

**Fallen willow which has taken root and become stable in Willow Pool**

· Generally the instream habitat throughout the reach is excellent, apart from the lack of LWD in the river channel. Where possible Large Woody Debris (LWD) should be retained in the channel. LWD is an integral component of stream ecology. The benefits for retaining it are clearly laid out in the recent EA R&D document, "Large Woody Debris in British Headwater Rivers". Key conclusions of the report include:

Given the possible impact of piscivorous birds on the grayling and trout populations and a possible lack of effectiveness of shooting as an aid to scaring as a control measure, it is recommended that woody debris is introduced in key areas to provide refuge areas for

Woody debris could be introduced by 'hinging' selected trees (partially cutting through the trunk and pushing over), or by the introduction of brushwood bundles anchored to the river bed with stakes and wire. The latter may be difficult given the extensive areas of bedrock in this part of the Manifold. The areas for introduction could be chosen based on club members' experience and observations of where bird predation has had the greatest impact. Also downstream of known fish spawning areas are prime points for brushwood bundles to provide refuge for juvenile fish.

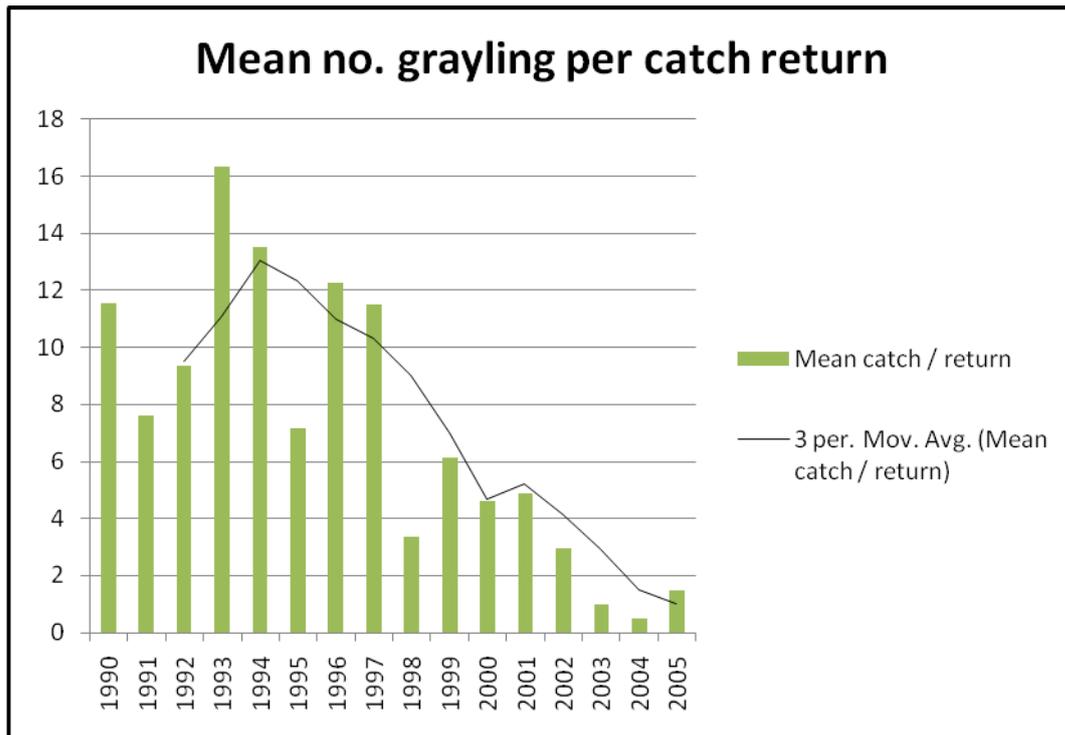
Table 1 and Figure 1 – Grayling catch records for Swainsley Fishing Club 1990 – 2005 (Source © H. Dutton, Swainsley Fishing Club)

Wild brown trout and grayling are present throughout the fishery, and around 800 trout were caught last season by Swainsley members. There has been a marked and persistent decline in the numbers of grayling caught over the last several years; it is now rare to catch them and those caught are large fish (over 1½ lb ) (Table 1 and Figure 1). This contrasts sharply with catches in the past when grayling were more numerous than trout. This is a pattern which has been repeated in many smaller Peak District rivers such as the upper Dove, Hamps and upper Manifold over the same timescale. The Environment Agency have stocked several thousand grayling fingerlings into these rivers in recent years in response to this decline, but it appears to have had little effect on grayling abundance.

There appear to be two possible local reasons for the decline in grayling numbers:

- Predation by sawbill ducks (primarily goosander). Increasing numbers of goosander have been observed on Peak District rivers in recent years, and a female with a brood of about seven young was observed during the visit. The author has also observed similar broods on the upper Dove and Hamps within the last month. Swainsley Fishing Club have held a DEFRA licence for five years to shoot up to 6 (now 5) goosander between August and 31<sup>st</sup> March, as an aid to scaring, and this has been fully utilised. This appears to have had little effect on either bird numbers or the decline in grayling and small trout. Shoaling species like grayling are particularly vulnerable to the hunting tactics of goosander as a number of birds can work together to herd fish upstream against shallower water at the head of pools; this contrasts with the more solitary and territorial trout which will dash for cover when disturbed.

- Water quality impacts via diffuse pollution on grayling egg and fry survival. Recent research in Germany has demonstrated poor survival of grayling eggs and fry in rivers affected by eutrophication (nutrient enrichment). Grayling deposit their eggs in river gravels on riffles in spring, often coinciding with algal blooms on the riverbed of enriched rivers. The algae

blooms have been shown to reduce water quality (lowering dissolved oxygen) in the boundary layer close to the riverbed adversely affecting grayling egg survival. Trout eggs are probably unaffected because their winter spawning and emergence of fry in early spring avoids the algae blooms.

Whilst the Manifold does suffer from catchment-wide diffuse agricultural pollution, and algae blooms are evident on the river bed, the large numbers of grayling juveniles stocked by the Environment Agency in recent years should have bypassed this bottleneck in grayling production, but have failed to increase numbers. This suggests that increased bird predation is an important factor in the reducing grayling numbers compared to previous years.

- The club should continue to maintain catch returns as these are a valuable source of information on the performance of the fishery. Ideally the returns should include a record of the amount of time spent fishing by each angler, in addition to the fish caught. The data will enable an objective assessment of the success of any management actions.
- Note that all works to bed or banks of the river or within 8m of its banks require the written consent from the Environment Agency under the Land Drainage legislation. The introduction of any fish or eggs into any inland water requires the consent of the EA under the Salmon and Freshwater Fisheries Act, 1975. It is imperative that all relevant consents are obtained by the club.

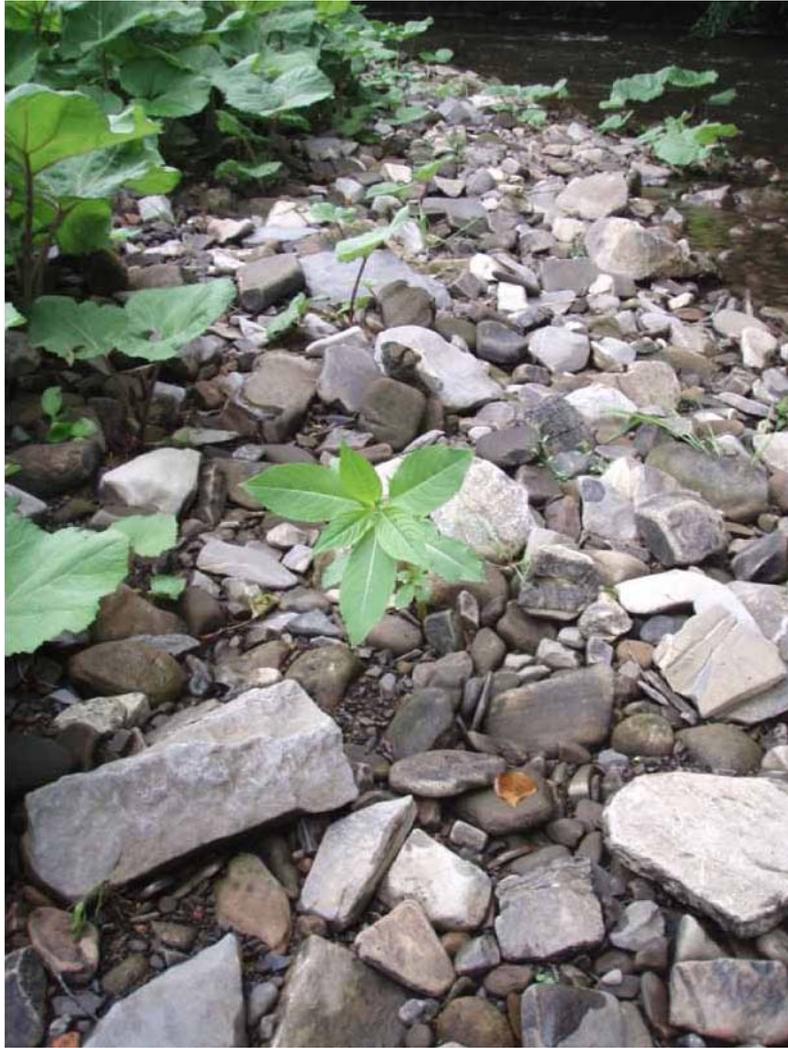
Himalayan balsam at the edge of the Manifold

- A few examples of Himalayan balsam *Impatiens glandulifera* were seen during the visit, growing on gravel side bars in the river channel. Introduced to the UK in 1839, it is now naturalised, especially on riverbanks and waste ground and has become a problematical weed. Himalayan balsam tolerates low light levels and, in turn, tends to shade out other vegetation, impoverishing habitats. Currently there is not a problem with balsam on this part of the Manifold, but club members should be encouraged to identify and pull up plants before they flower.
