Advisory Visit

River Maun, Nottinghamshire

May 2017

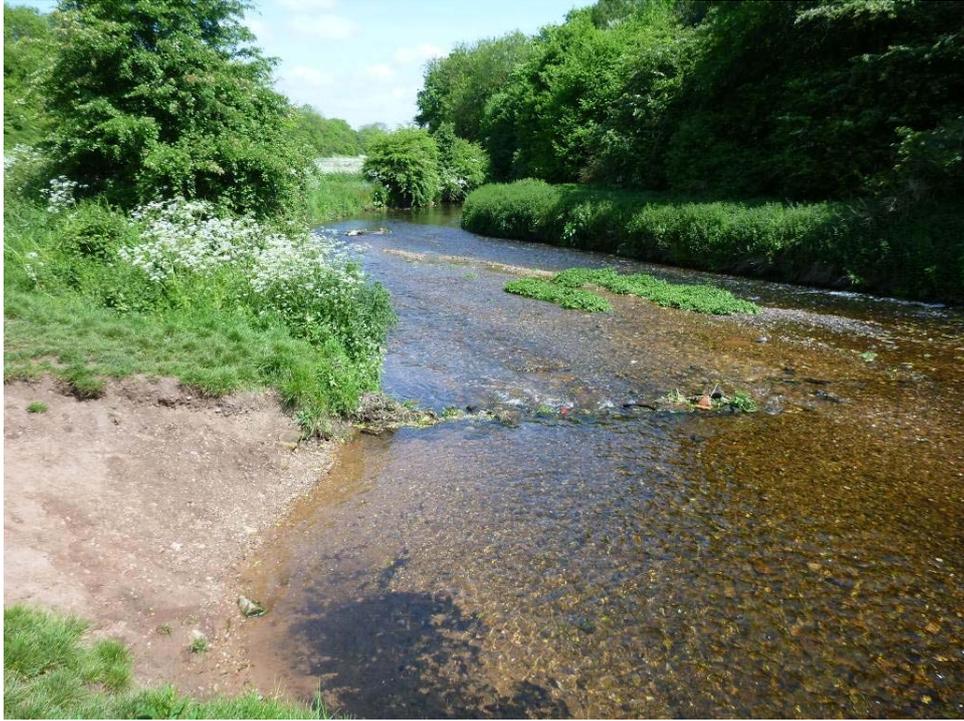
comprises rounded gravel and finer sediments, indicating the river is sourcing and transporting material through active geomorphological processes. There are several riffle areas which are suitable spawning habitat for gravel-spawning fish, including trout (Photos 5 and 9).

Photo 5 River-washed gravel of a suitable size for trout spawning is abundant in this reach of the River Maun. The river is over-wide here because of dog access, something common along the reach inspected.

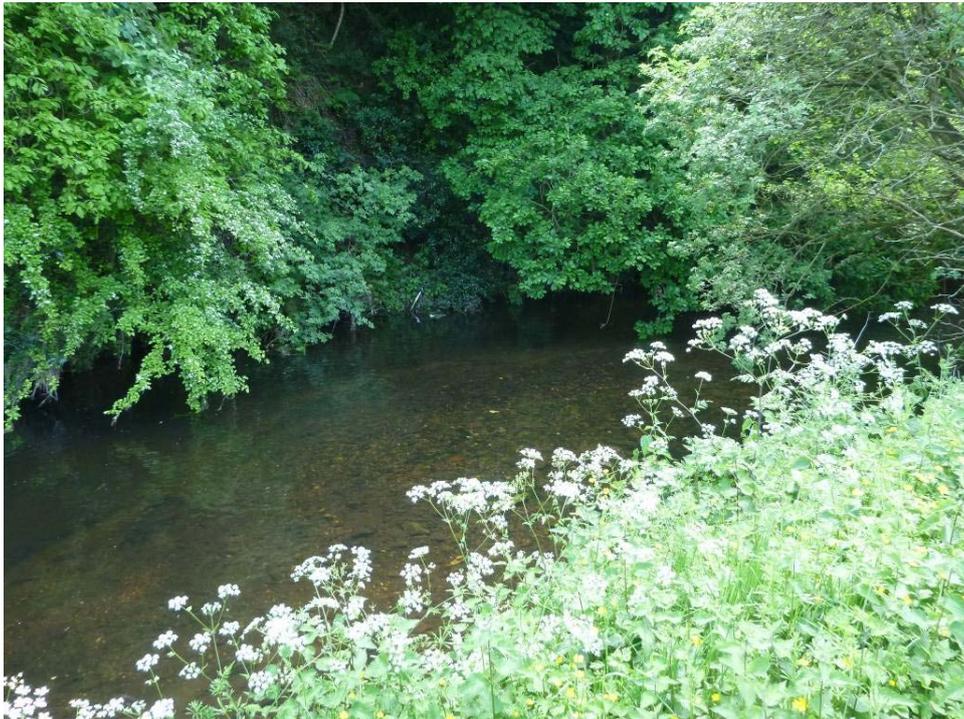
There are few areas of deeper water within this reach, such as that seen in Photo 6, where a shoal of chub (*Squalius cephalus*) were observed. The river here has evidently been the subject of past channel engineering given its straightened planform and uniform width. The legacy of this is a general lack of deeper pool habitat, the main habitat types being riffle and shallow glide (Photo 8). This restricts the amount of habitat available for larger fish, although several shoals of chub were seen, comprising individuals up to approximately 40cm length (this may not be typical, given that the visit was at the time of year that chub could be expected to frequent shallow, gravelly areas for spawning). Chub have been previously stocked into this section of river by the Environment Agency from their National Fish Farm at Calverton, Notts.

Photo 6 At the upstream end of the reach, there are reasonable amounts of low cover over the water which provide shelter to adult fish; shoals of chub were observed in these areas.

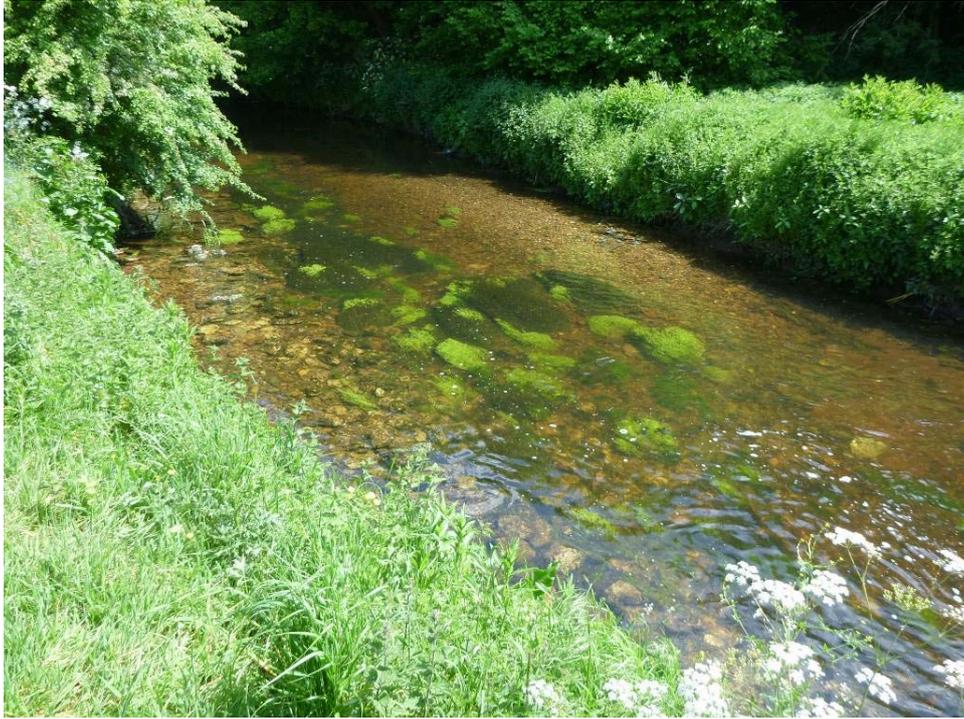
Photo 7 Aquatic macrophytes present in the channel, including *Callitriche* sp., *Elodea canadensis* and *Potamogeton pectinatus*.

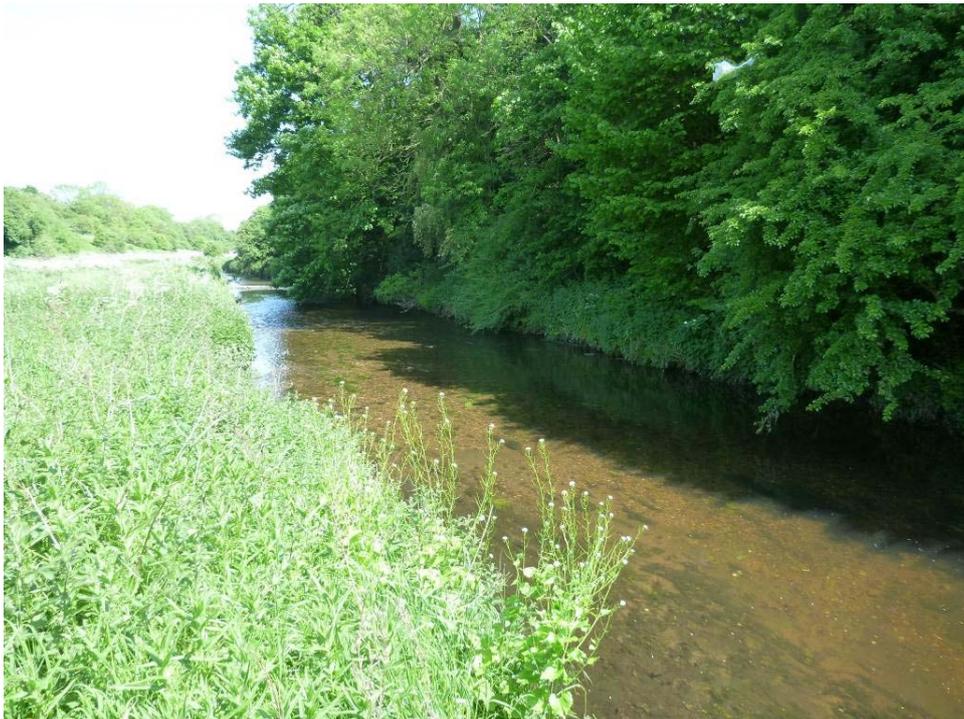
Photo 8 Long, shallow glides dominate the instream habitat, a legacy of past channel straightening and widening. Creating narrower “pinch points” within the low flow channel (with brushwood berms and anchored large woody material) would benefit habitat in these areas.

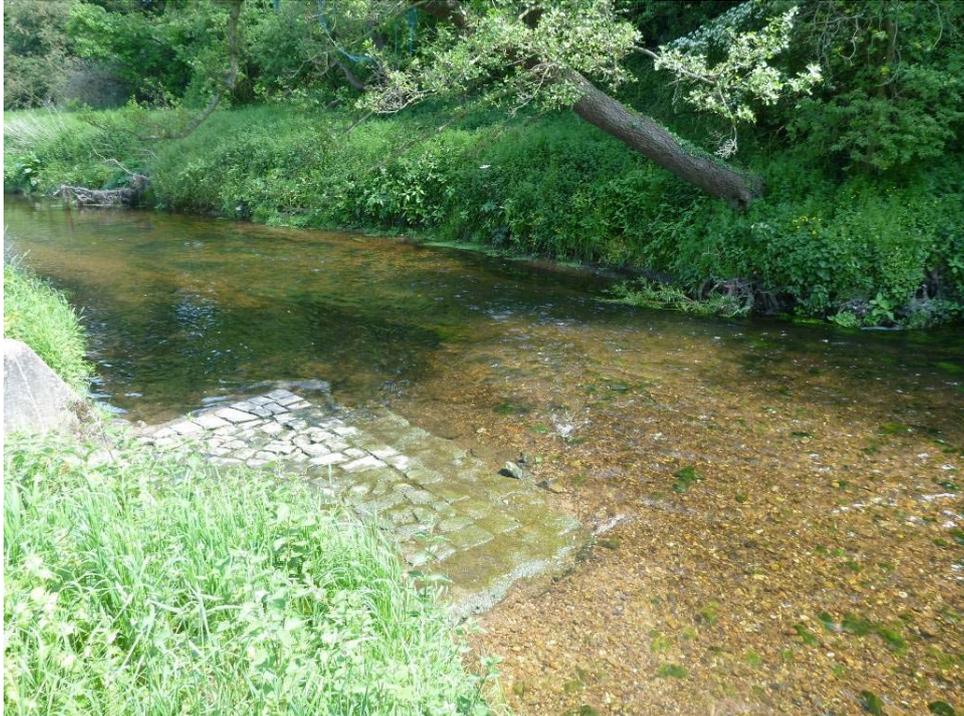
Photo 9 shows an area where the channel width has been pinched (at a low level) by the spillway from an outfall pipe. This narrowing has speeded up the flow and created bed scour and increased depth (aided by the tree opposite providing bank stability). This indicates the potential for creating similar effects with introduced structures, such as brushwood berms and anchored large woody material.

Photo 9 Pinch points in the channel, such as this spillway beneath an outfall, create increased scour and depth, providing better adult fish habitat. The bank stability and cover provided by the tree and roots on the far bank enhance the effect. Note how the width u/s allows the retention of gravels and potential spawning areas, while the pinch creates scour that creates and maintains pool depth.

- Narrowing the low flow channel with brushwood berms and bank re-profiling in selected areas (Photo 15). Guidance as to the extent of narrowing can be derived from areas such as Photo 9 above. The overall conveyance capacity of the channel can be retained by keeping the structures low level and re-shaping the banks. Flood risk in the immediate locality of the country park appears low.

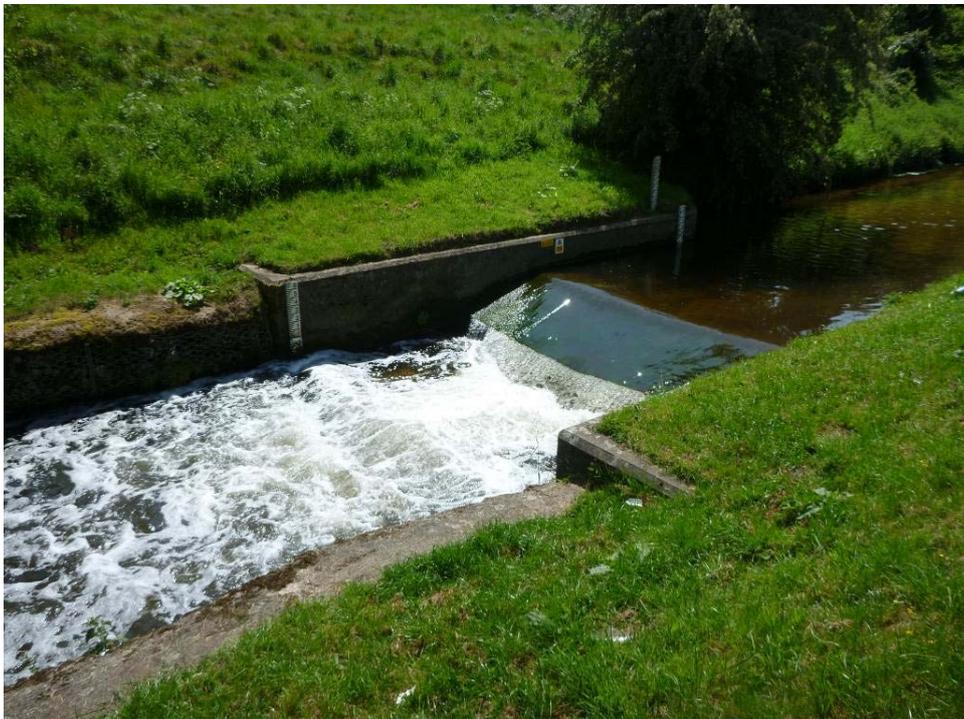
Photo 10 Flow gauging weir at SK5587763487. This is a barrier to fish migration. If the weir face was continued down to the bed, a low-cost baffle array could be fitted, or the weir replaced with an open-channel flow gauge.

Upstream of the gauging weir (Photo 10), the river is impounded for a short distance and finer sediment dominates the bed substrate. Downstream of the weir, the river channel has a higher gradient and the bed comprises mainly sandstone bedrock. Gravel is largely absent from this steeper section, indicating it is either being starved of sediment from upstream by the impoundment, or gravel is being transported through this section. Further downstream, where the channel gradient lessens, gravel substrate reappears (Photo 13); this may be locally sourced downstream of the weir, as areas of active bank erosion are present.

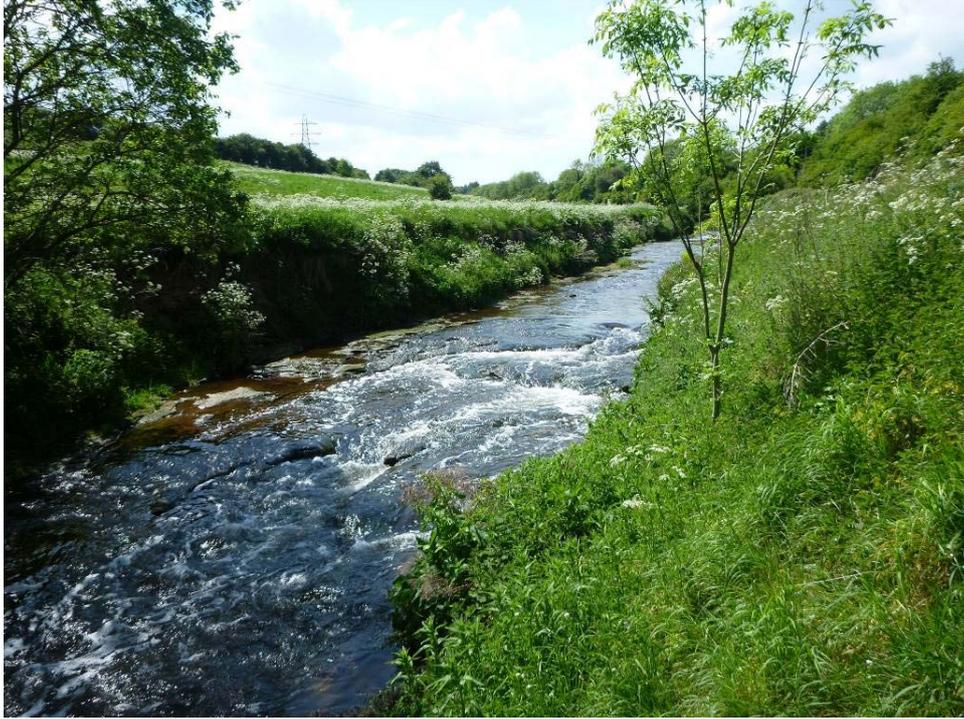
Photo 11 Downstream of the flow gauging weir the channel is steeper and dominated by sandstone bedrock, providing diverse juvenile salmonid habitat.

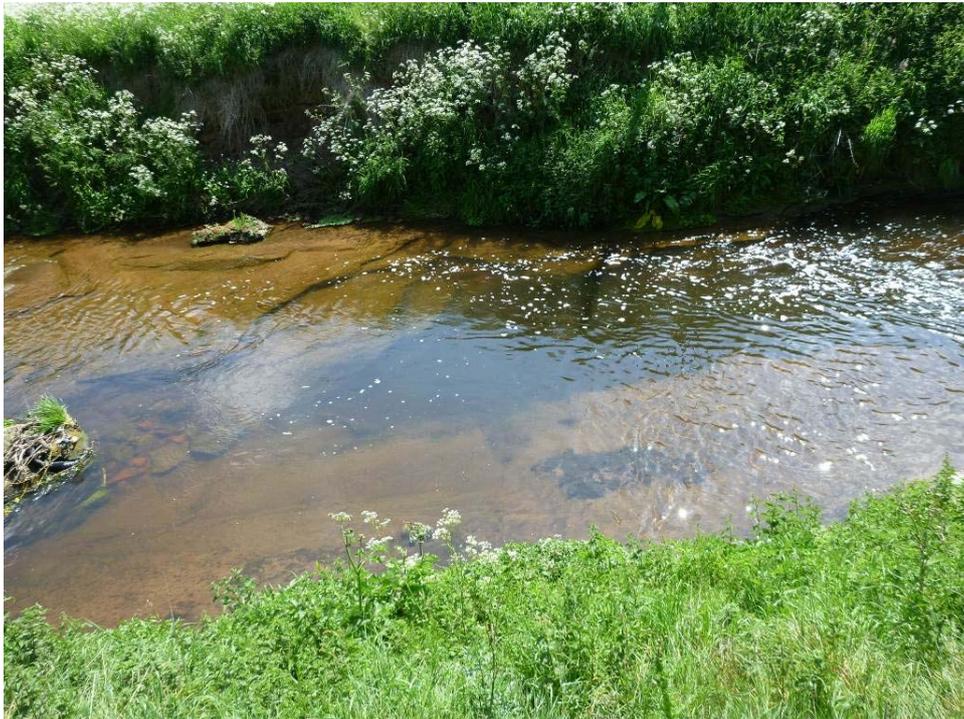
Photo 12 Deeper "pots" within the bedrock provide more adult fish habitat downstream of the weir.

The steeper bedrock section contains numerous deeper 'pots', bounded by rock shelves, providing both pool habitat and overhead cover for adult fish. Some perch (*Perca fluviatilis*) were observed here.

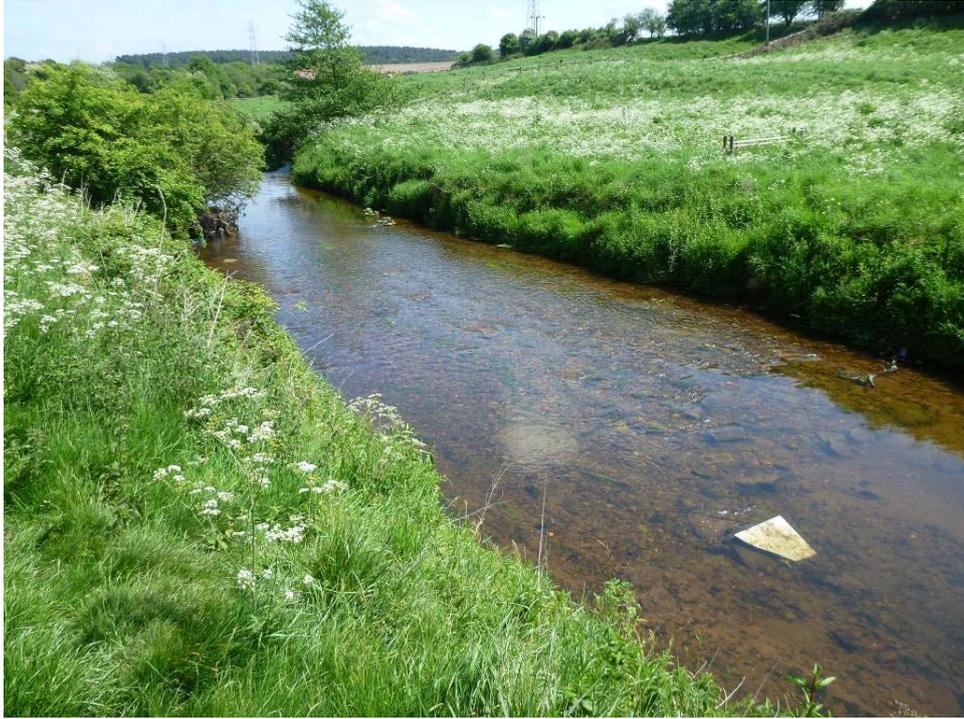
Photo 13 Gravel substrate returns downstream of the steep bedrock section below the gauging weir. The channel however remains uniformly straight and wide, leading to poor sorting of the gravel.

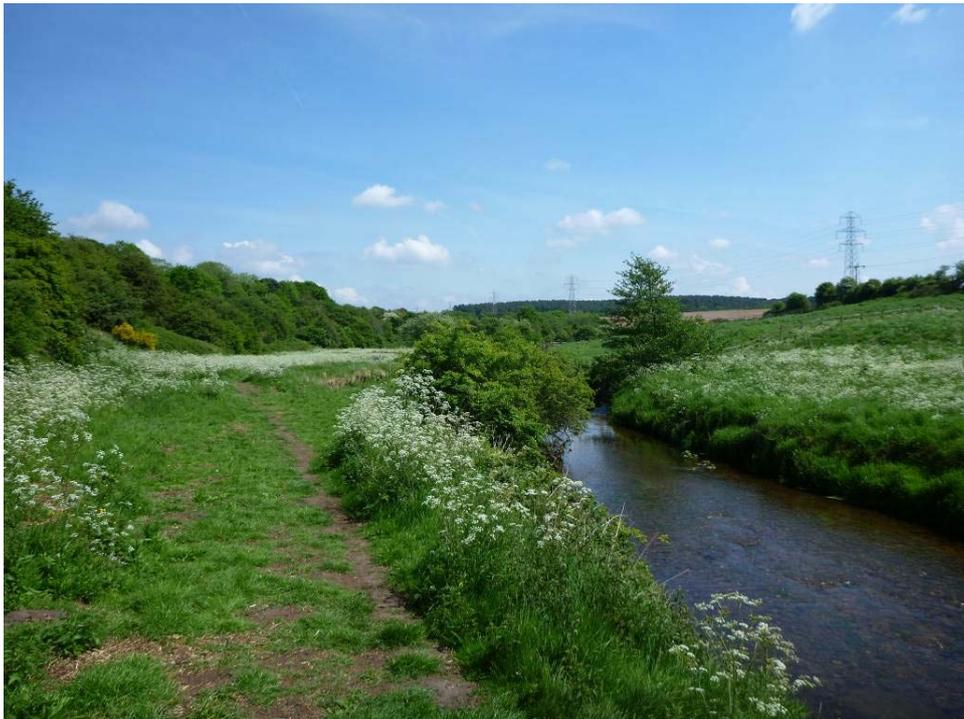
Photo 14 Low intensity land use within Maun Valley Country Park, and space for a river re-naturalisation project.

The width of the river corridor within the country park provides the potential, funding permitting, to carry out a river restoration project (re-meandering, floodplain re-connection), which would address the root cause of the habitat deficiencies (past river engineering) and potentially provide flood risk benefit. Presently, adjacent land use is low intensity within the country park and riparian habitat is reasonably good, with tall herbaceous vegetation and occasional bushes. The steep angle of the banks (because of past channel engineering) does, however, restrict the extent of overhanging riparian vegetation and hence its value as cover for fish. Trees are present along the right bank upstream of the gauging weir, providing shade and some low cover over the water, although this could be much more extensive. The excellent low cover in Photo 6 is the exception rather than the rule and open banks such as in Photos 8 and 13 are more typical. Increasing the amount of low cover from trees and bushes is recommended, for example on banks opposite where any channel narrowing structures are introduced.

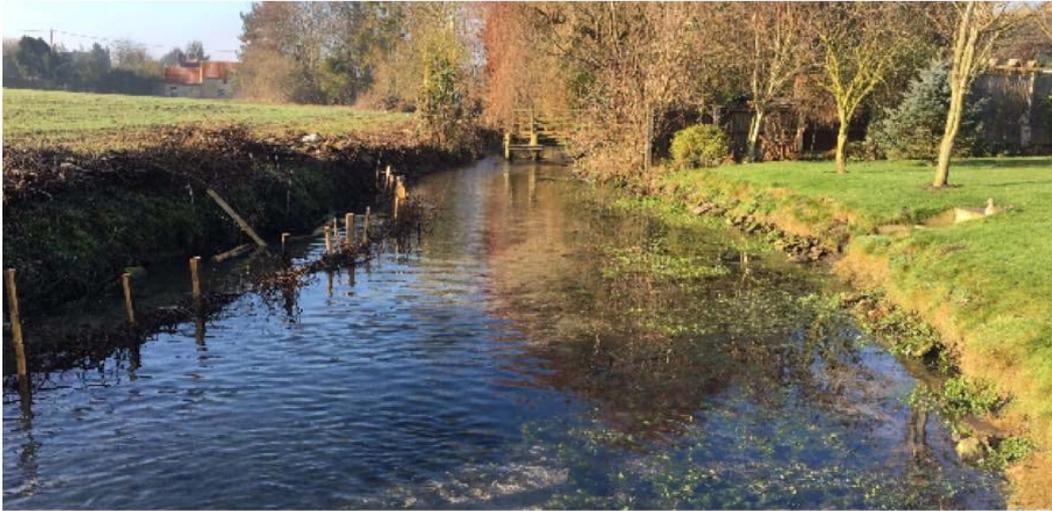
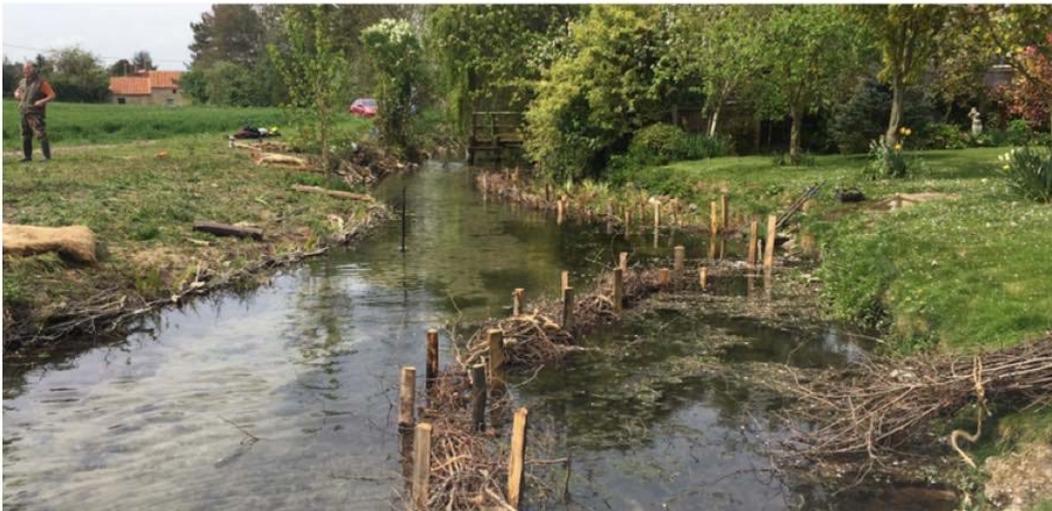
Photo 15 Installation of low level brushwood berms (before, above; after, below). Note the bank on the left of the picture, which has been re-profiled to a shallower angle to tie in with the new bank toe created by the brushwood bundles.

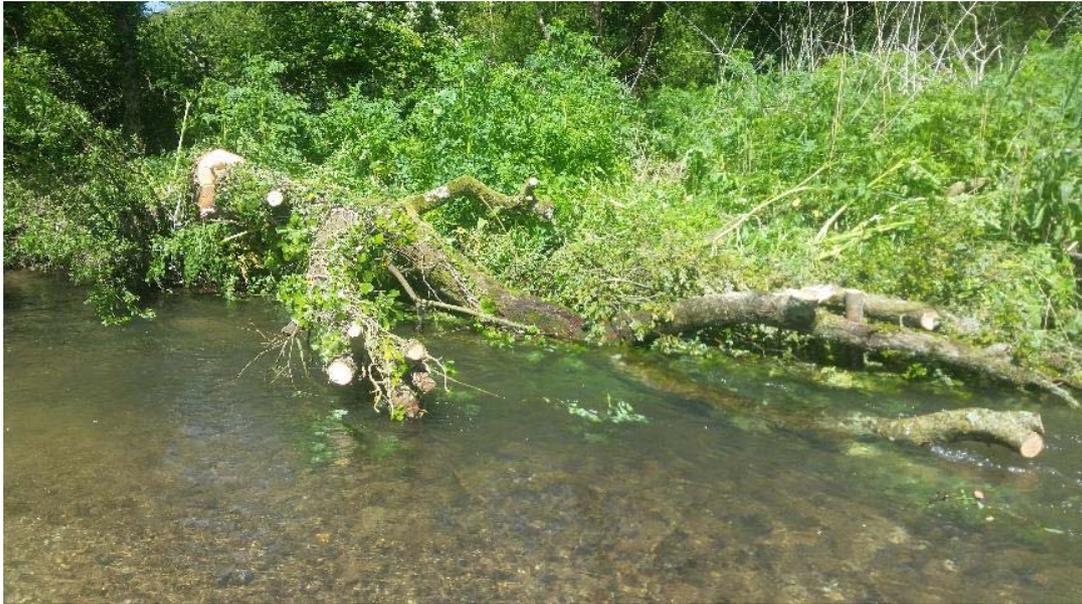
Photo 16 Example of large woody structure anchored in the channel margins.

- Introduction of anchored large woody material to narrow the low flow channel and create localised scour and depth variation (Photo 16).
