**Advisory Visit**

**River Maun, Nottinghamshire**

**May 2017**

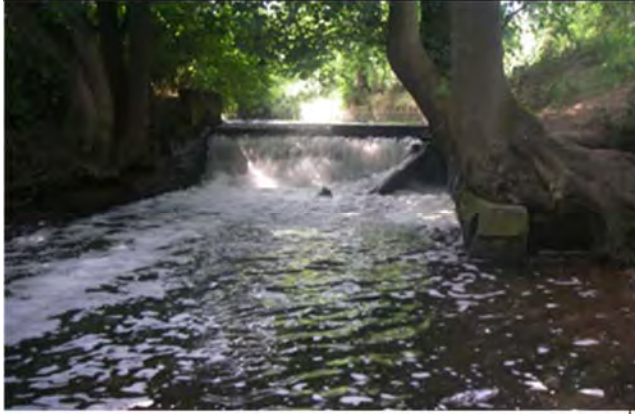
Photo 1 Edwinstowe

- As noted above, trout have only been found in the Maun downstream of the Meden confluence.
- Ten barriers to fish migration have been identified on the River Maun which appear to be preventing recolonization of trout in an upstream direction from the River Meden (Table 1, Photos 1 - 4). The cost of addressing fish passage at these weirs is estimated at £5 million.

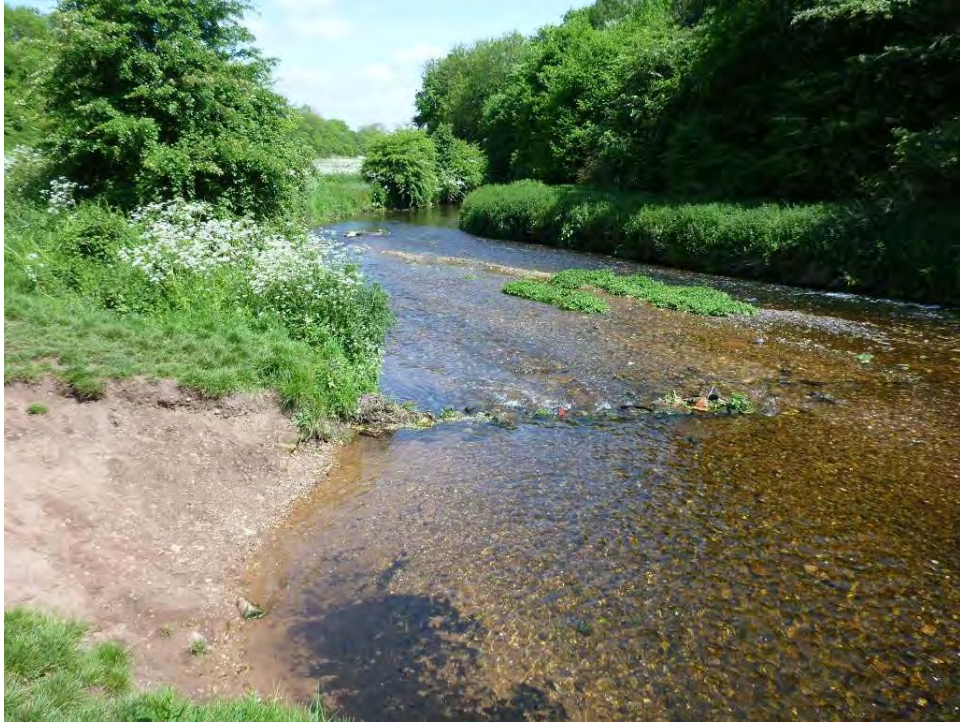
comprises rounded gravel and finer sediments, indicating the river is sourcing and transporting material through active geomorphological processes. There are several riffle areas which are suitable spawning habitat for gravel-spawning fish, including trout (Photos 5 and 9).

**Photo 5 River-washed gravel of a suitable size for trout spawning is abundant in this reach of the River Maun. The river is over-wide here because of dog access, something common along the reach inspected.**

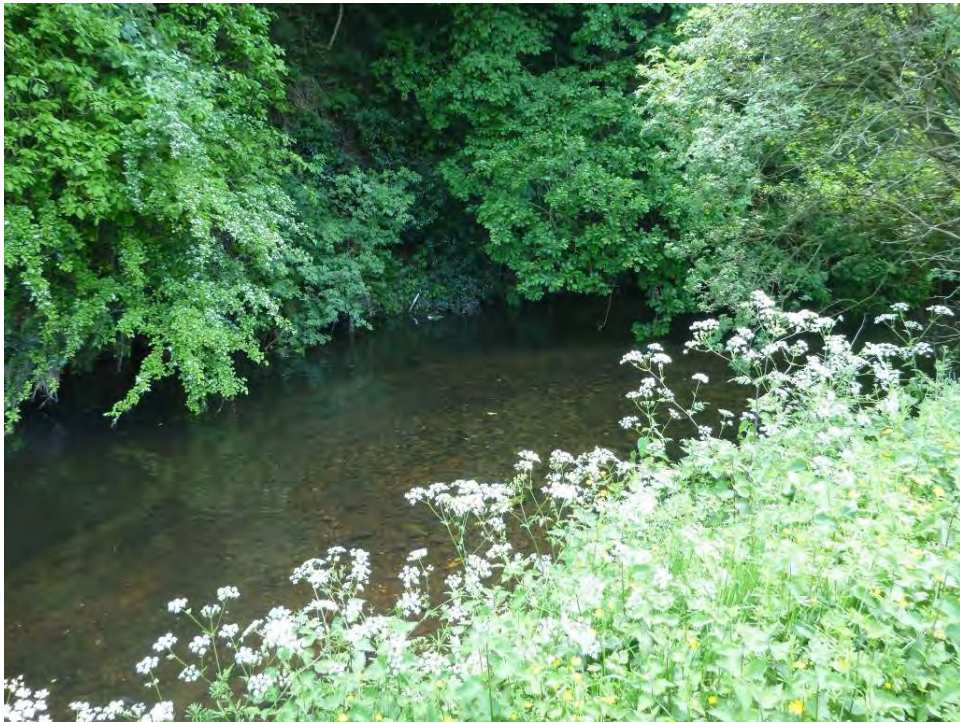
There are few areas of deeper water within this reach, such as that seen in Photo 6, where a shoal of chub (*Squalius cephalus*) were observed. The river here has evidently been the subject of past channel engineering given its straightened planform and uniform width. The legacy of this is a general lack of deeper pool habitat, the main habitat types being riffle and shallow glide (Photo 8). This restricts the amount of habitat available for larger fish, although several shoals of chub were seen, comprising individuals up to approximately 40cm length (this may not be typical, given that the visit was at the time of year that chub could be expected to frequent shallow, gravelly areas for spawning). Chub have been previously stocked into this section of river by the Environment Agency from their National Fish Farm at Calverton, Notts.

**Photo 6 At the upstream end of the reach, there are reasonable amounts of low cover over the water which provide shelter to adult fish; shoals of chub were observed in these areas.**

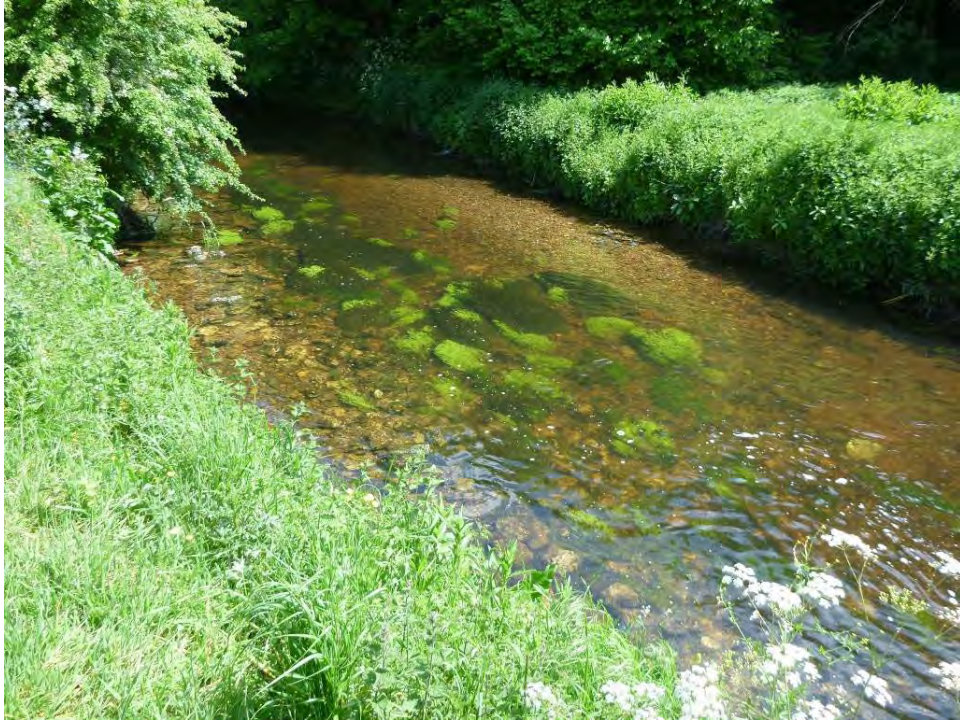
**Photo 7** Aquatic macrophytes present in the channel, including *Callitriche* sp., *Elodea canadensis* and *Potamogeton pectinatus*.

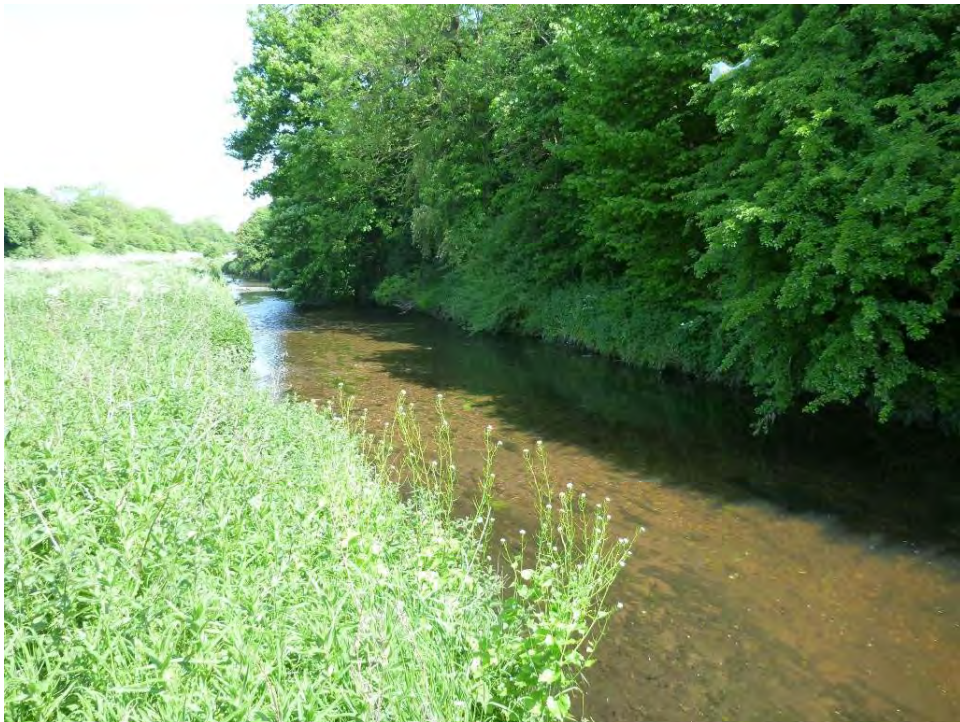
**Photo 8** Long, shallow glides dominate the instream habitat, a legacy of past channel straightening and widening. Creating narrower “pinch points” within the low flow channel (with brushwood berms and anchored large woody material) would benefit habitat in these areas.

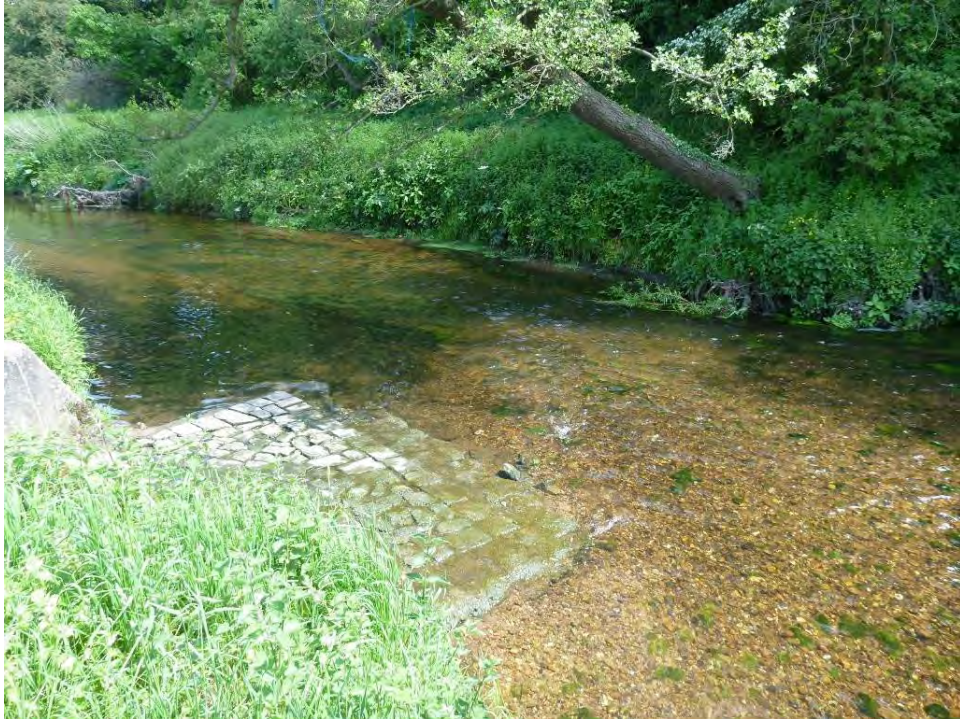
Photo 9 shows an area where the channel width has been pinched (at a low level) by the spillway from an outfall pipe. This narrowing has speeded up the flow and created bed scour and increased depth (aided by the tree opposite providing bank stability). This indicates the potential for creating similar effects with introduced structures, such as brushwood berms and anchored large woody material.

**Photo 9** Pinch points in the channel, such as this spillway beneath an outfall, create increased scour and depth, providing better adult fish habitat. The bank stability and cover provided by the tree and roots on the far bank enhance the effect. Note how the width u/s allows the retention of gravels and potential spawning areas, while the pinch creates scour that creates and maintains pool depth.

- Narrowing the low flow channel with brushwood berms and bank re-profiling in selected areas (Photo 15). Guidance as to the extent of narrowing can be derived from areas such as Photo 9 above. The overall conveyance capacity of the channel can be retained by keeping the structures low level and re-shaping the banks. Flood risk in the immediate locality of the country park appears low.

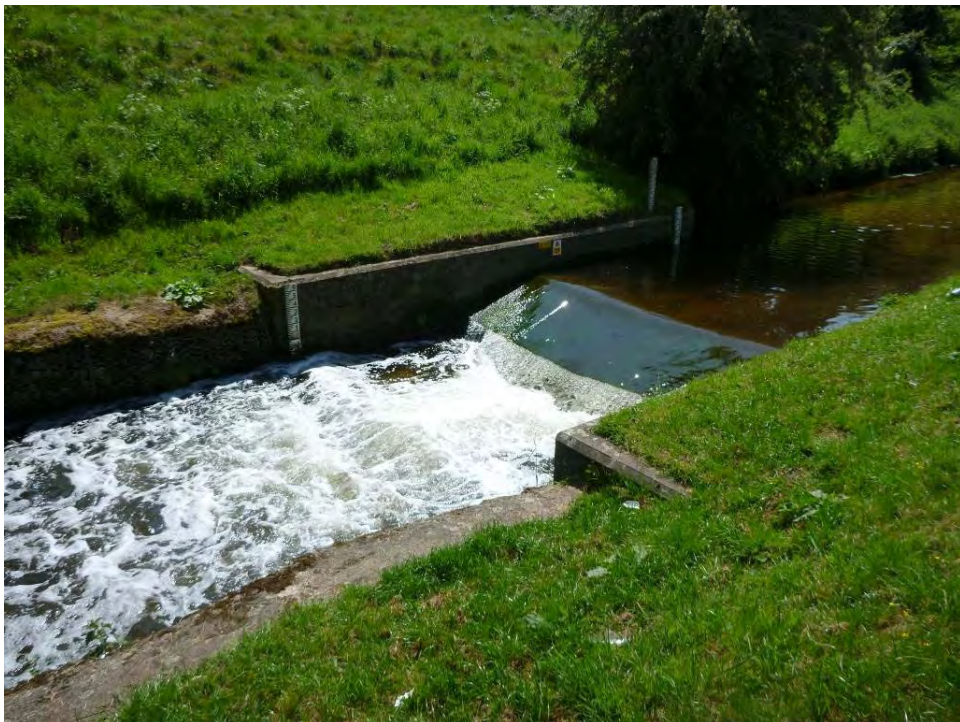
**Photo 10** Flow gauging weir at SK5587763487. This is a barrier to fish migration. If the weir face was continued down to the bed, a low-cost baffle array could be fitted, or the weir replaced with an open-channel flow gauge.

Upstream of the gauging weir (Photo 10), the river is impounded for a short distance and finer sediment dominates the bed substrate. Downstream of the weir, the river channel has a higher gradient and the bed comprises mainly sandstone bedrock. Gravel is largely absent from this steeper section, indicating it is either being starved of sediment from upstream by the impoundment, or gravel is being transported through this section. Further downstream, where the channel gradient lessens, gravel substrate reappears (Photo 13); this may be locally sourced downstream of the weir, as areas of active bank erosion are present.

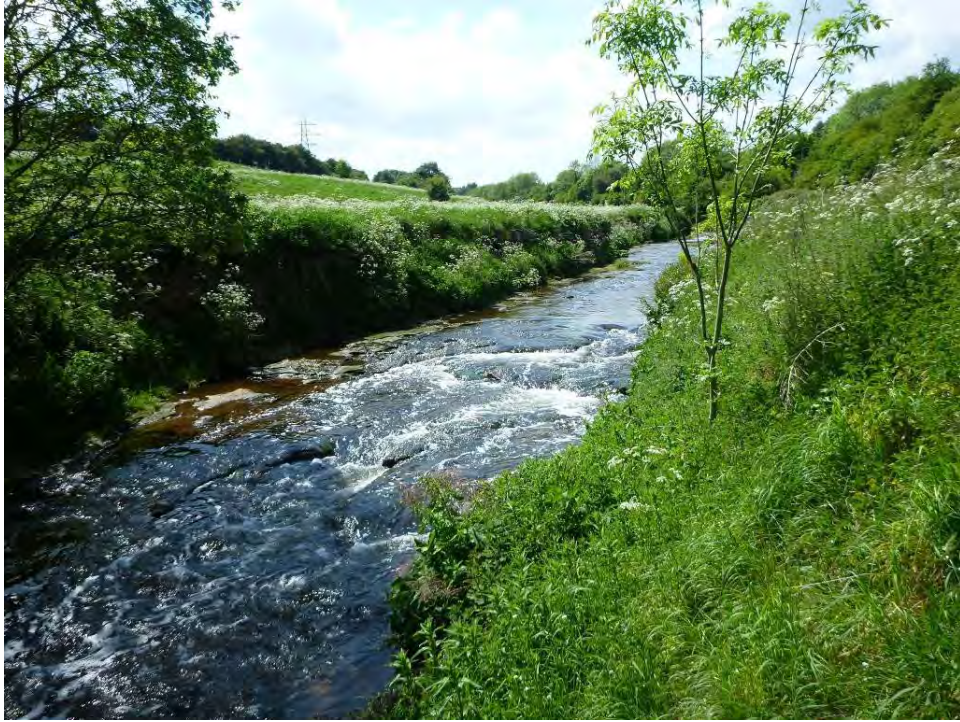
**Photo 11 Downstream of the flow gauging weir the channel is steeper and dominated by sandstone bedrock, providing diverse juvenile salmonid habitat.**

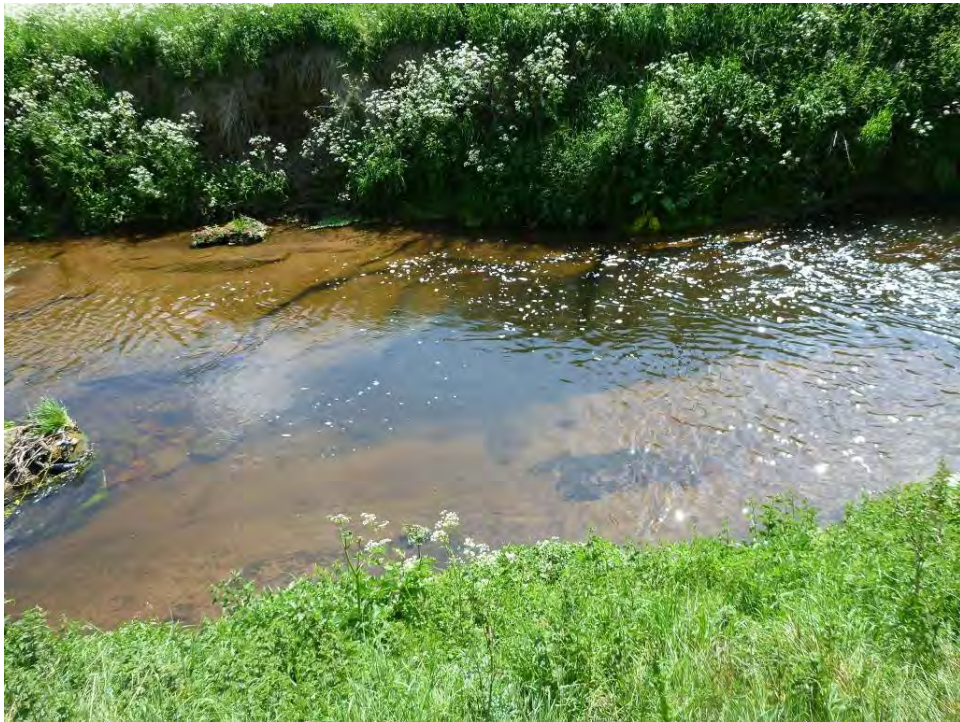
**Photo 12 Deeper "pots" within the bedrock provide more adult fish habitat downstream of the weir.**

The steeper bedrock section contains numerous deeper 'pots', bounded by rock shelves, providing both pool habitat and overhead cover for adult fish. Some perch (*Perca fluviatilis*) were observed here.

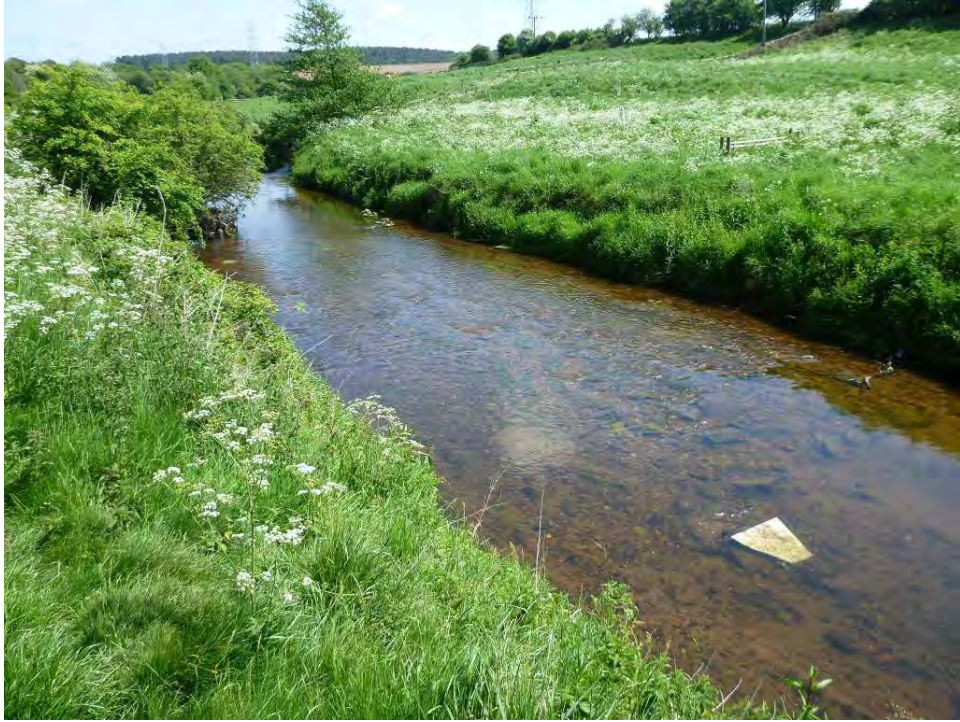
**Photo 13 Gravel substrate returns downstream of the steep bedrock section below the gauging weir. The channel however remains uniformly straight and wide, leading to poor sorting of the gravel.**

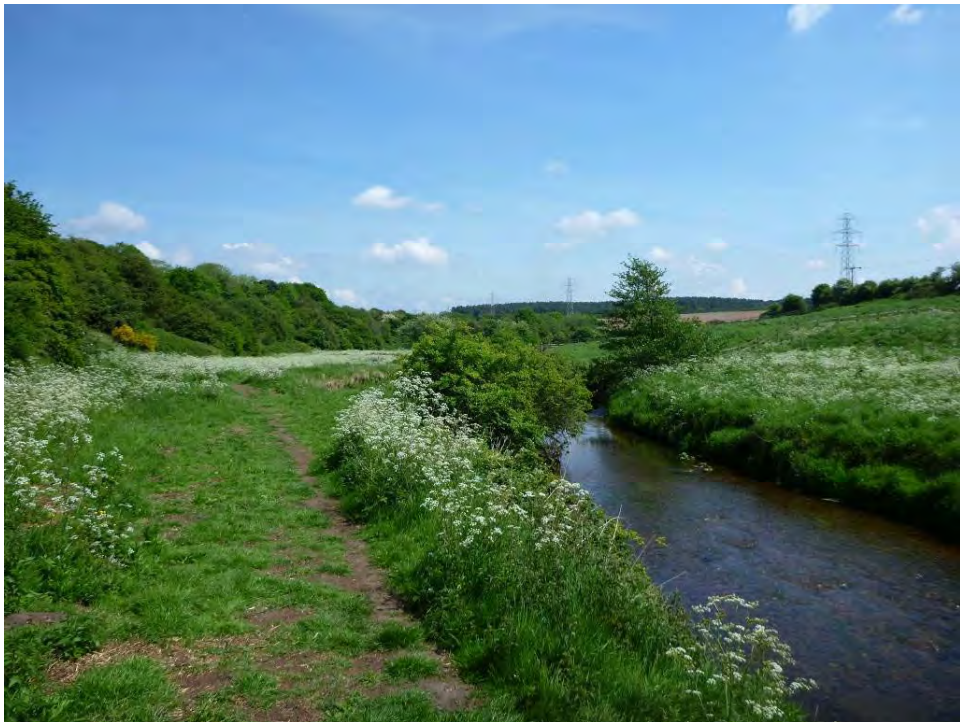
**Photo 14 Low intensity land use within Maun Valley Country Park, and space for a river re-naturalisation project.**

The width of the river corridor within the country park provides the potential, funding permitting, to carry out a river restoration project (re-meandering, floodplain re-connection), which would address the root cause of the habitat deficiencies (past river engineering) and potentially provide flood risk benefit. Presently, adjacent land use is low intensity within the country park and riparian habitat is reasonably good, with tall herbaceous vegetation and occasional bushes. The steep angle of the banks (because of past channel engineering) does, however, restrict the extent of overhanging riparian vegetation and hence its value as cover for fish. Trees are present along the right bank upstream of the gauging weir, providing shade and some low cover over the water, although this could be much more extensive. The excellent low cover in Photo 6 is the exception rather than the rule and open banks such as in Photos 8 and 13 are more typical. Increasing the amount of low cover from trees and bushes is recommended, for example on banks opposite where any channel narrowing structures are introduced.

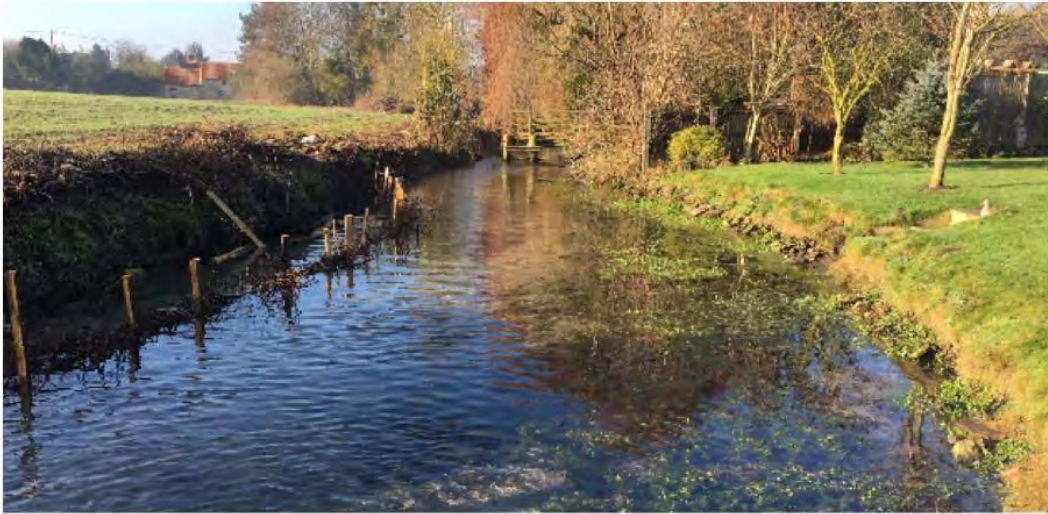
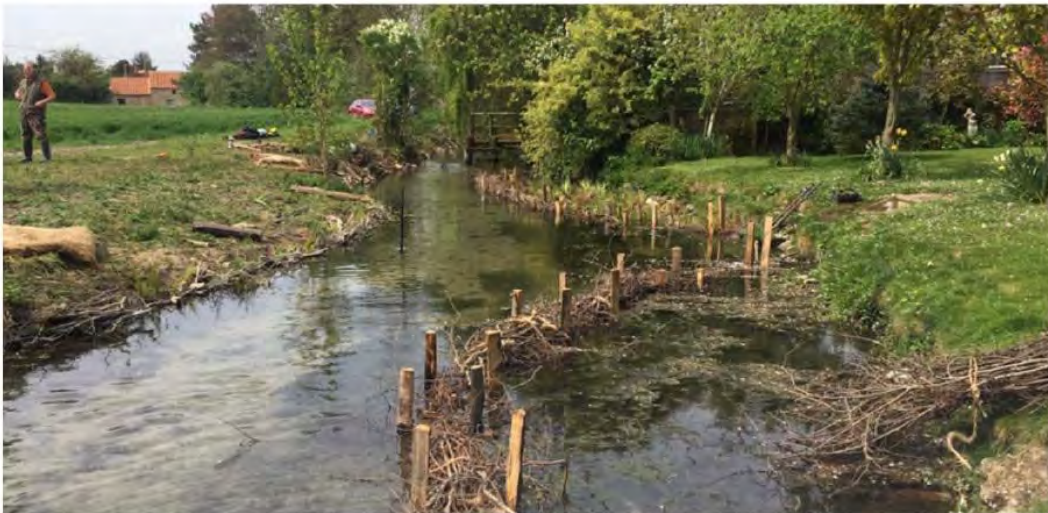
**Photo 15 Installation of low level brushwood berms (before, above; after, below). Note the bank on the left of the picture, which has been re-profiled to a shallower angle to tie in with the new bank toe created by the brushwood bundles.**

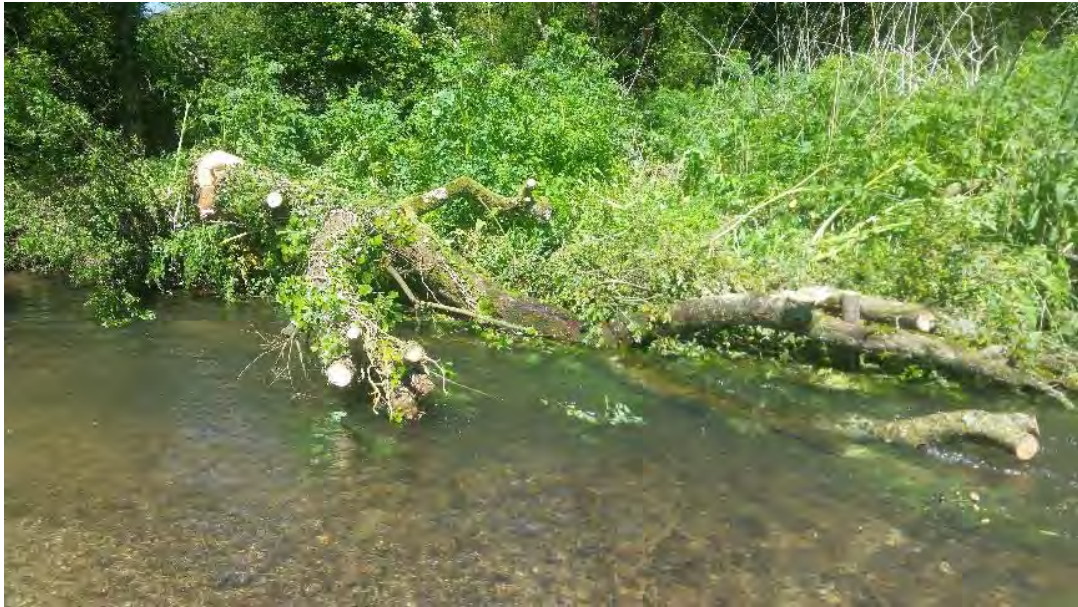
**Photo 16 Example of large woody structure anchored in the channel margins.**

- Introduction of anchored large woody material to narrow the low flow channel and create localised scour and depth variation (Photo 16).
