**HABITAT ADVISORY VISIT TO THE RIVER  
MEDWAY, EAST SUSSEX/KENT**

**UNDERTAKEN BY VAUGHAN LEWIS,  
WINDRUSH AEC LTD ON BEHALF OF THE  
ENVIRONMENT AGENCY, SOUTHERN REGION  
AND ROYAL TUNBRIDGE WELLS ANGLING  
SOCIETY.**

**DECEMBER 2007**

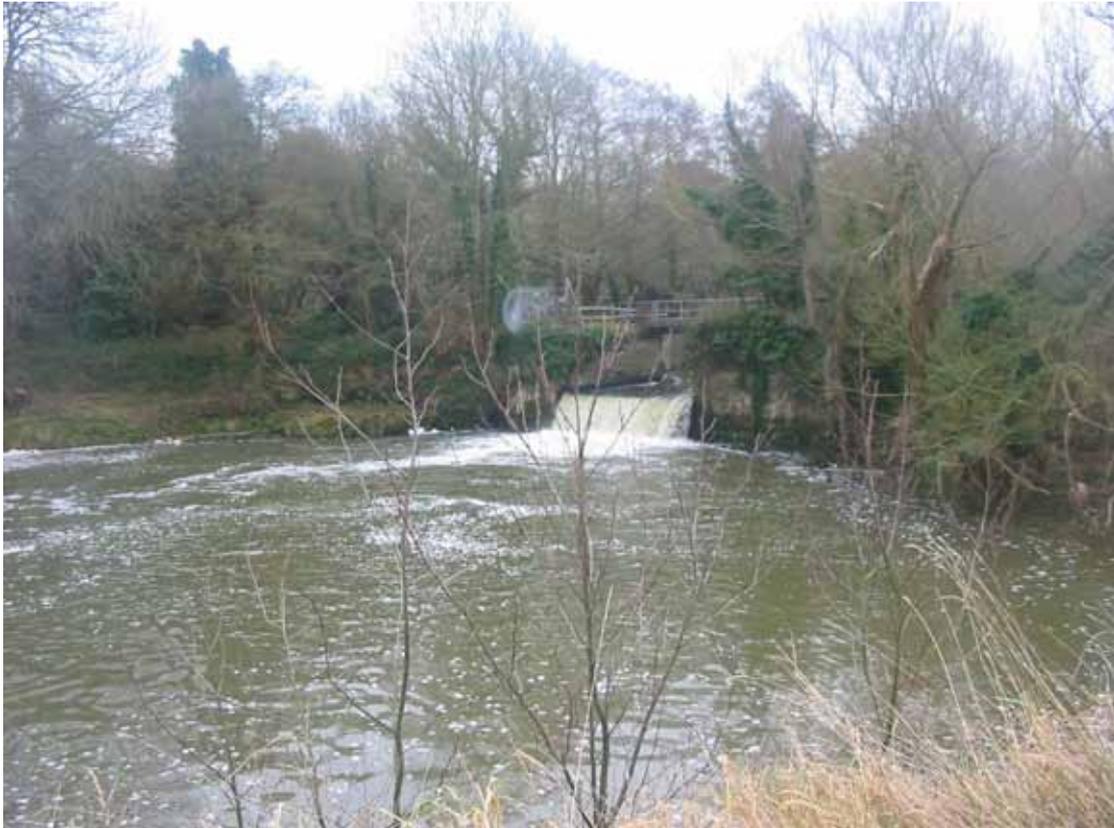
A large weir upstream of Ashurst Bridge, effectively prevented upstream migration of fish except in very high flow events. The head loss across the weir was in the order of 1.5m.

### **Ashurst weir**

- Providing an easement for passage of fish over Ashurst weir would be of significant benefit, linking the presently isolated reaches upstream and downstream of the structure. Ideally, the weir would be breached or demolished, not only allowing passage of fish, but also reducing the retained head upstream with an associated improvement in habitat quality and probably water quality. This option should be reviewed as to its practical and financial viability.

In the event that partial or total removal of the weir proves unacceptable, then the provision of a near natural bypass channel through the LB field represents a robust and viable option. Provided that a gradient of <1:100 can be achieved (i.e. an excavated channel length of approximately 150m) then all species and length of fish should be able to utilise the bypass. The longer the channel, the greater the length of good quality habitat created. However, increasing the length of the excavated channel clearly has significant cost implications.

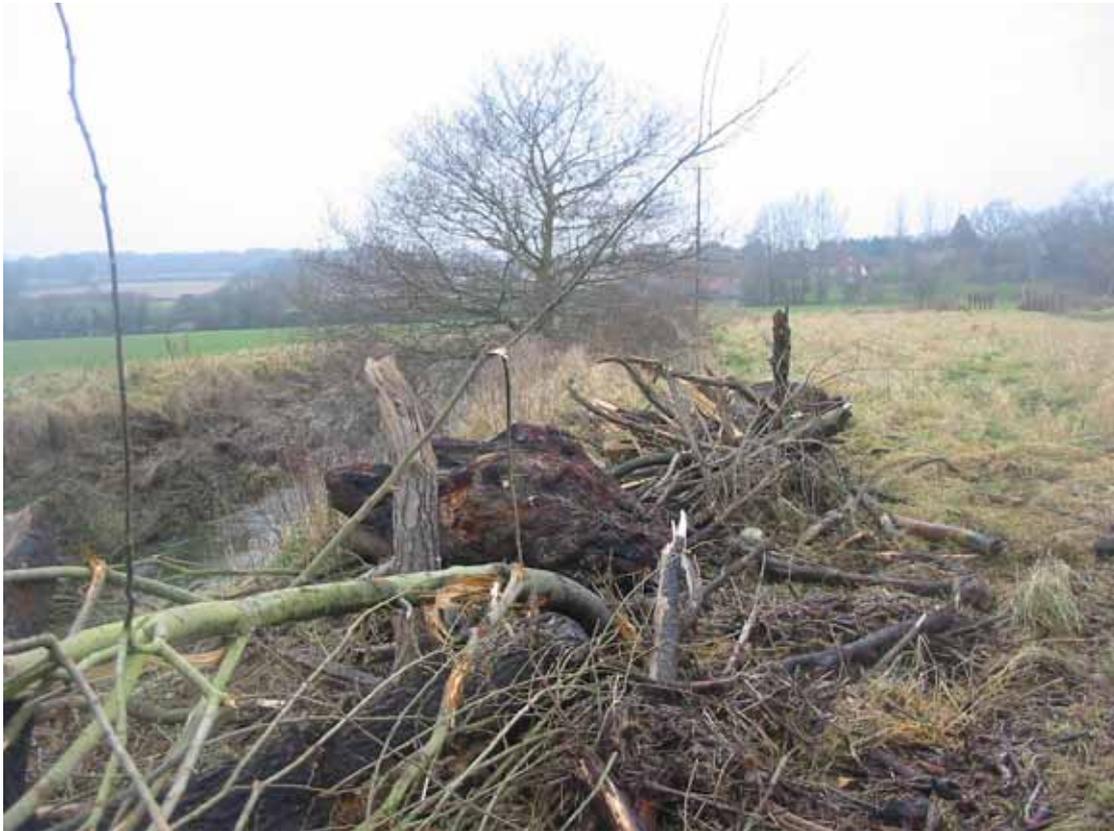
with a thin layer of shaley–gravel substrate. Evidence of one or more recent high water events was clear, with debris strewn more than 2m up the banks. Work was underway to remove Large Woody Debris (LWD) and overhanging branches from the channel (probably by the Environment Agency, although there were no identifying marks on the excavators being used). As a consequence of this work, there was little or no instream cover left in the channel, reducing its holding capacity for all species of fish, with early life stages particularly vulnerable.

#### **LWD recently removed from the channel at Ham Farm.**

If angling groups and landowners are to promote the retention of LWD within the channel, it is vital that the EA co-operate with this policy. The regime of routine removal of LWD should cease, with only those limbs and trunks that pose a clear threat to increased flooding of property removed. Where possible, the LWD should be stabilised within the channel using stakes and high tensile wire, with the latter material being used to attach the timber to bankside tree stumps or strategically located ground anchors where appropriate. Not only would this approach improve

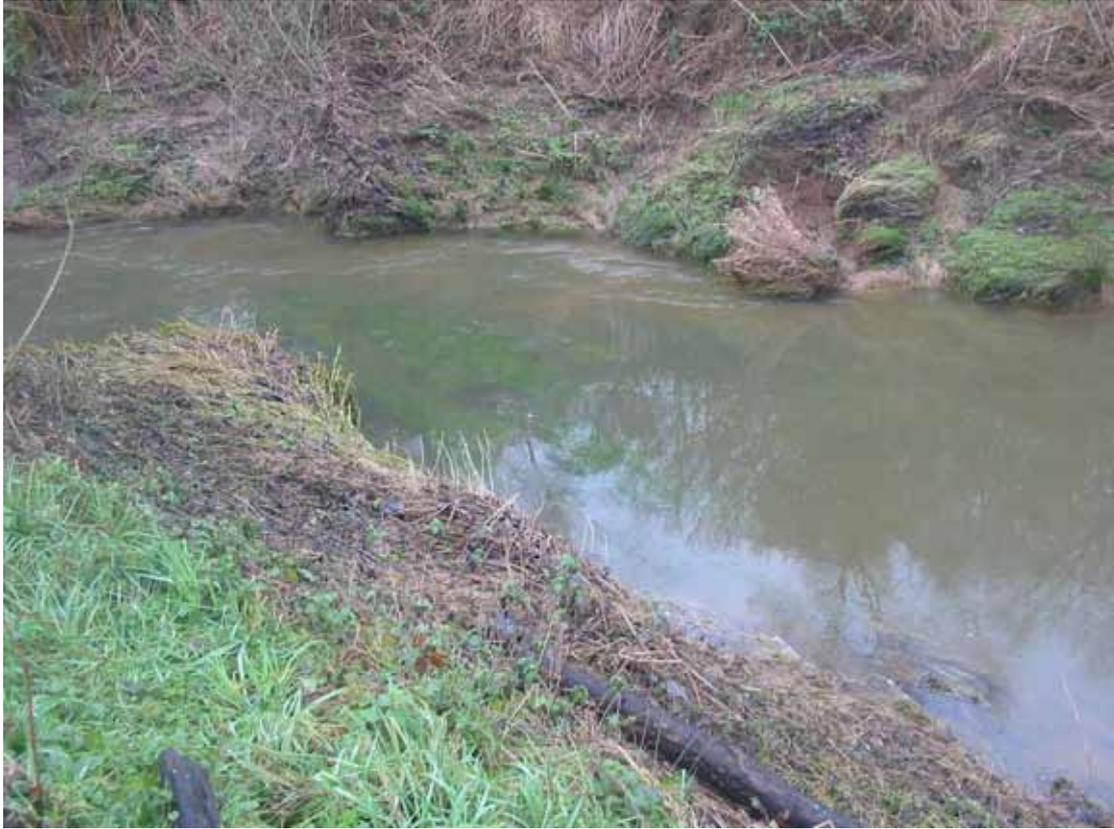
Further upstream the gradient of the river increased, with gravel and sandstone bedrock increasingly abundant. The banks were primarily friable sandstone, which was easily eroded during high flows periods, a process exacerbated by the presence of Himalayan Balsam.

**Water crowfoot on shallow riffle. Note easily eroded sandstone bank**

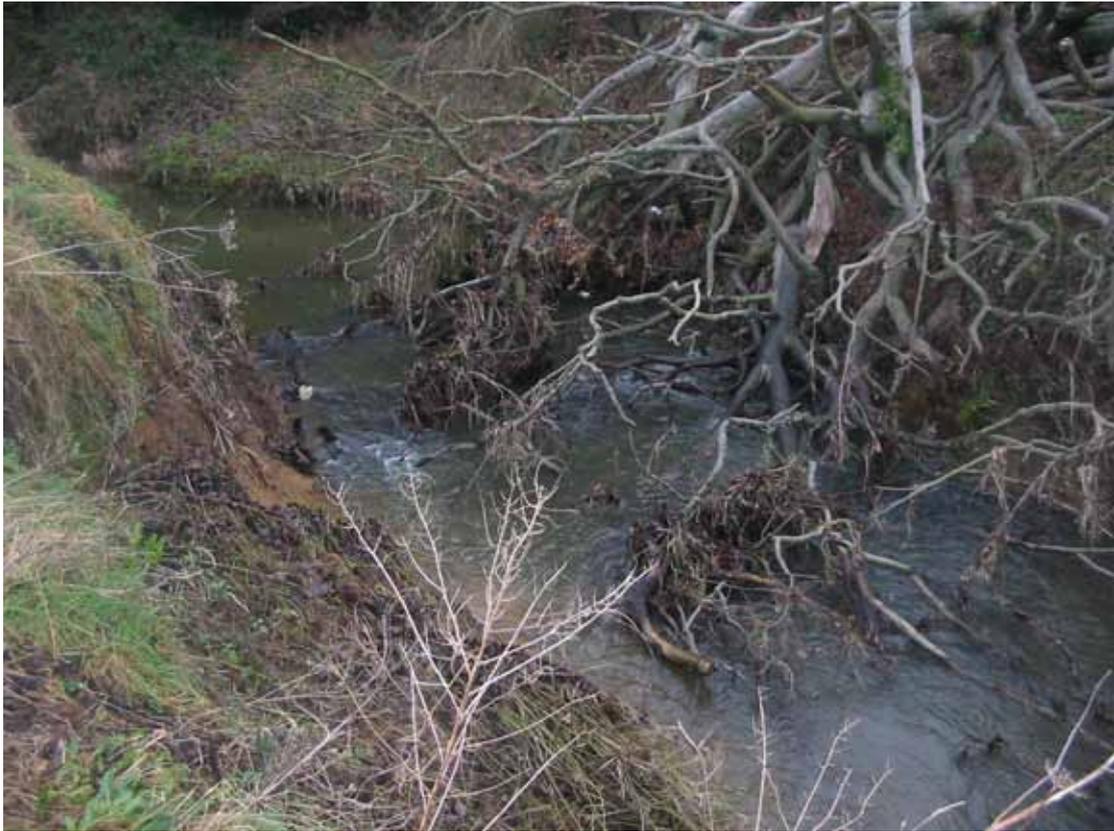
There were a number of LWD dams and 'groynes' in this reach, providing excellent cover and promoting habitat diversity.

**LWD in the channel resulting from a fallen tree.**

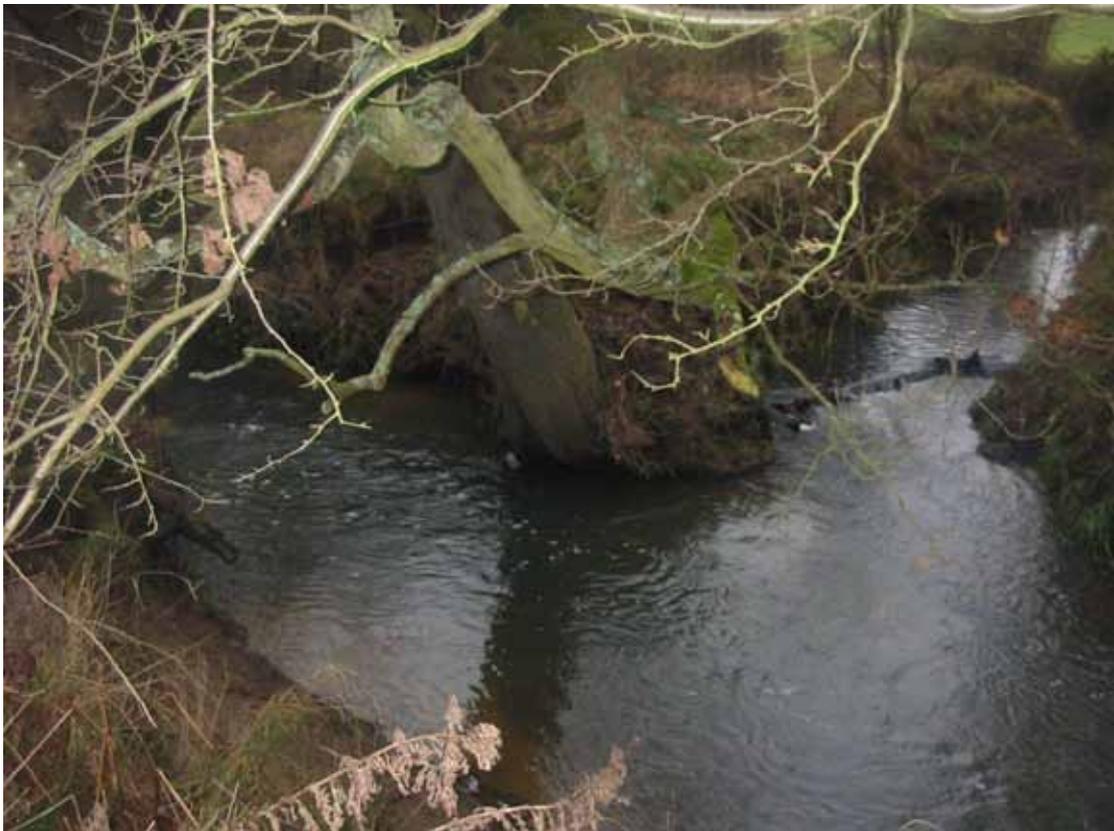
**And a naturally occurring LWD groyne in a LB tributary**

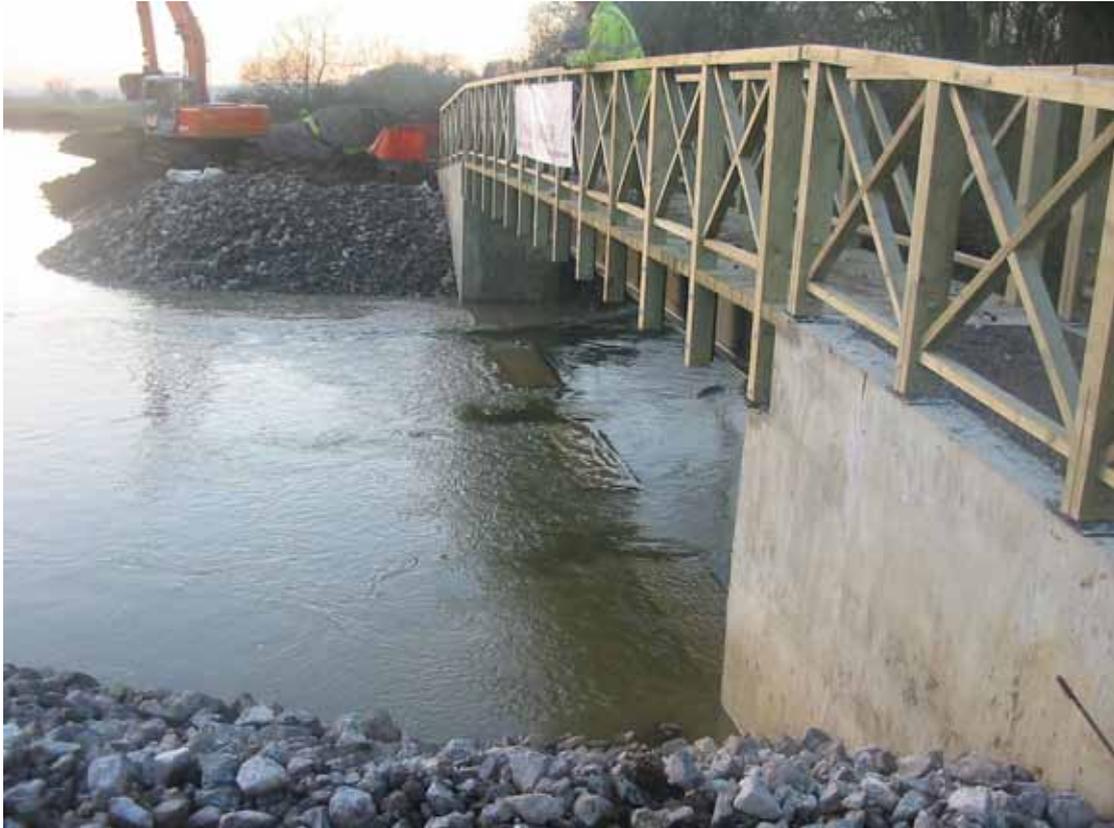
bypass channel has recently been successfully constructed on the Upper River Thames in Buckinghamshire.

**Newly constructed bypass channel on R.Thame. Note partially submerged off-take structure**

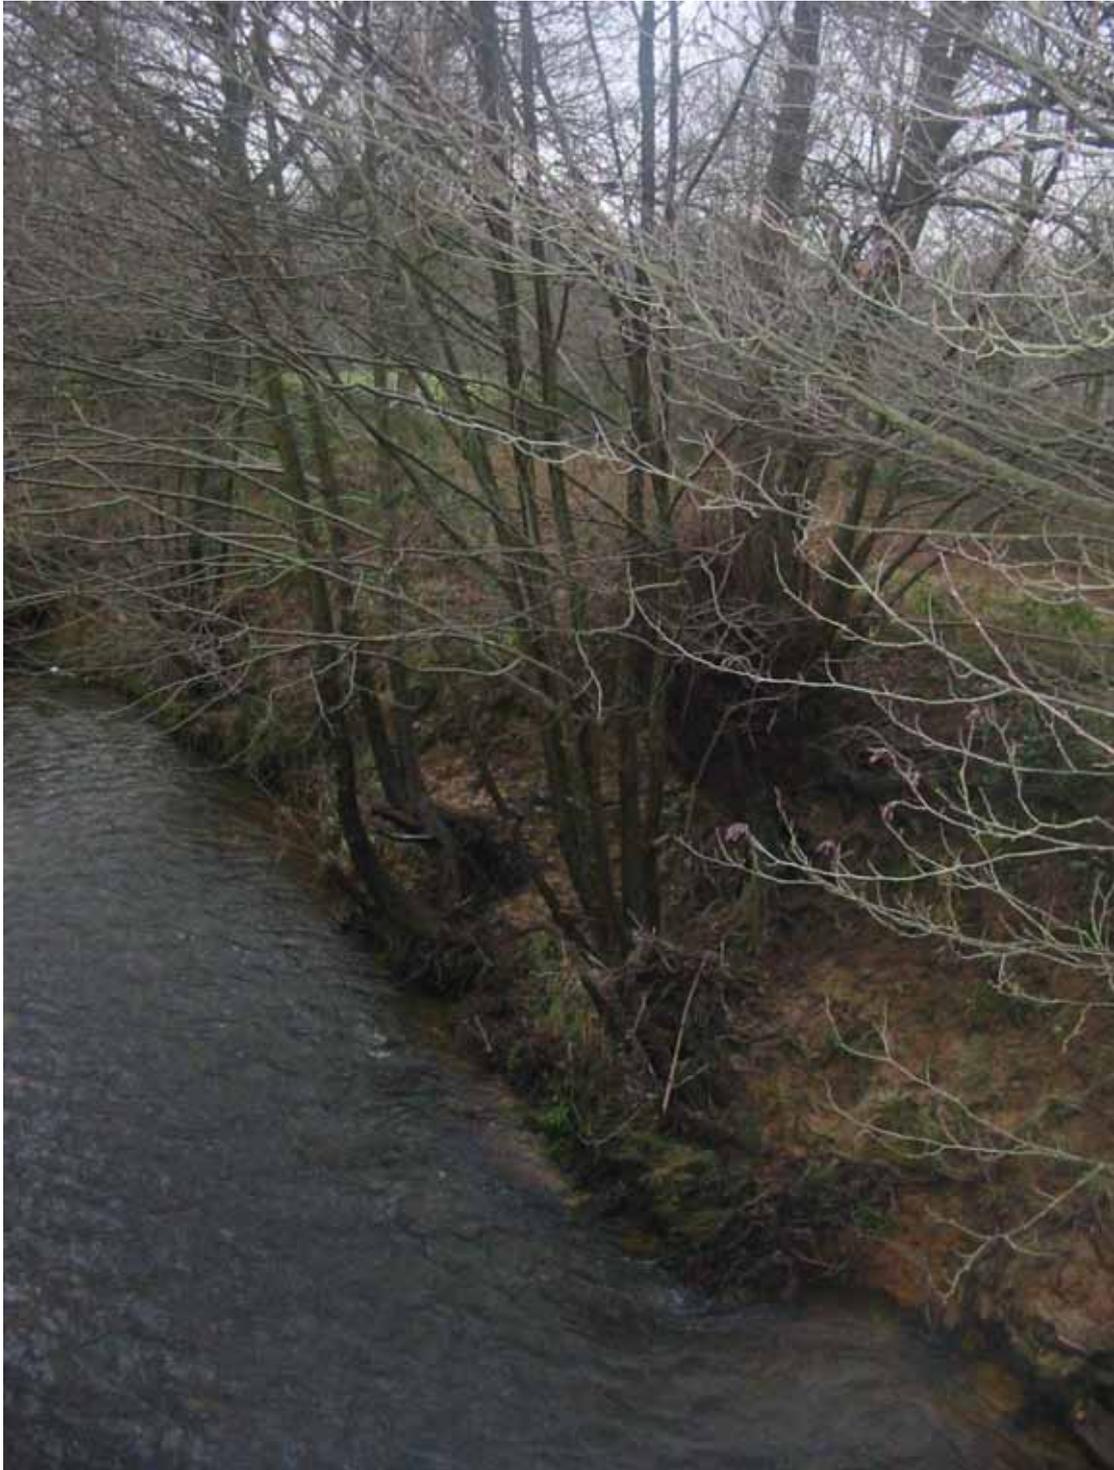
**Bankside sycamores on the Buckhurst Stream that could be usefully ‘hinged’ into the channel to provide cover.**

An alternative approach to increasing the amount of LWD is to partially cut through the trunks of riparian trees, and 'hinge' them into the channel. They can then be additionally secured using wire and stakes. This approach allows the trees to continue growing, whilst providing valuable instream cover.

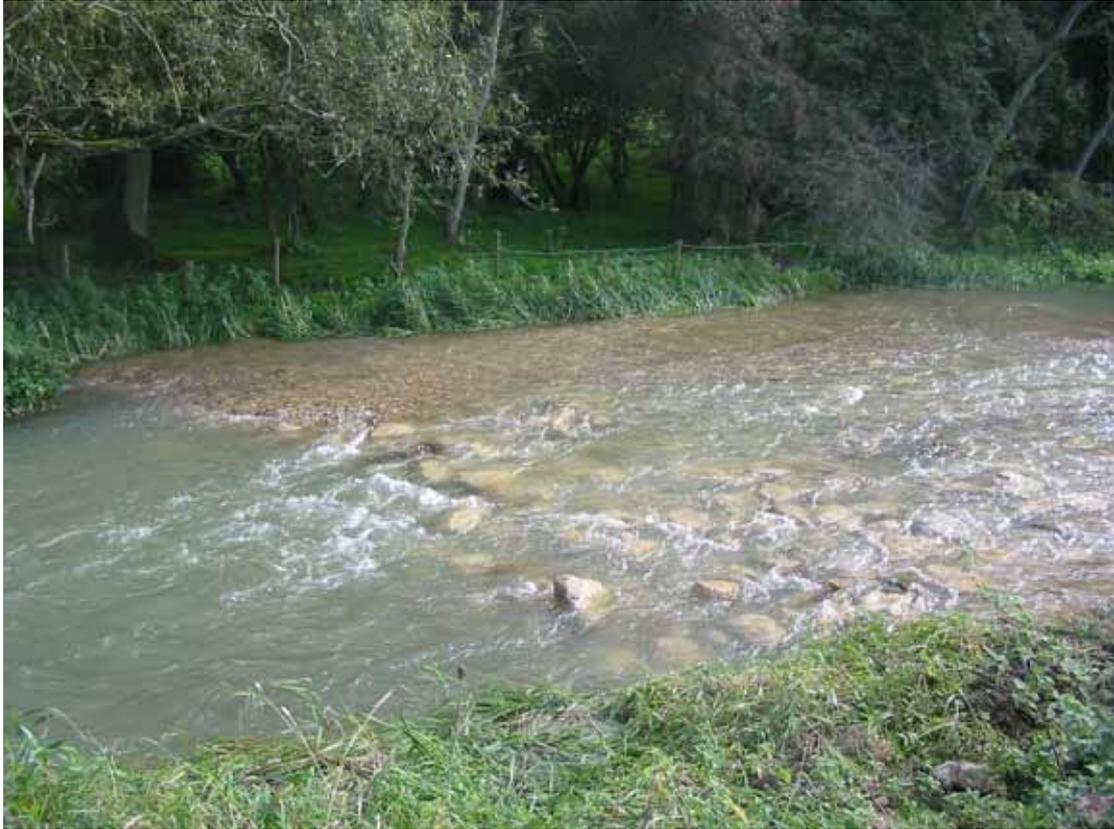
The riffles should be constructed from large blocks of as-dug local stone (if available), overlaid with a layer of pebble reject gravel. Stone and gravel for the riffle construction will need to be imported onto the site from the nearest quarry, unless on-site investigation show a source locally within the floodplain. If this is the case, then possibilities exist to create additional wetland habitat as a result of the excavation of gravel/stone.

**Part-constructed riffle showing base layer of large stone with partial covering of smaller gravel**
