## River Menalhyl – St Mawgan

An advisory visit carried out by the Wild Trout Trust – April 2009

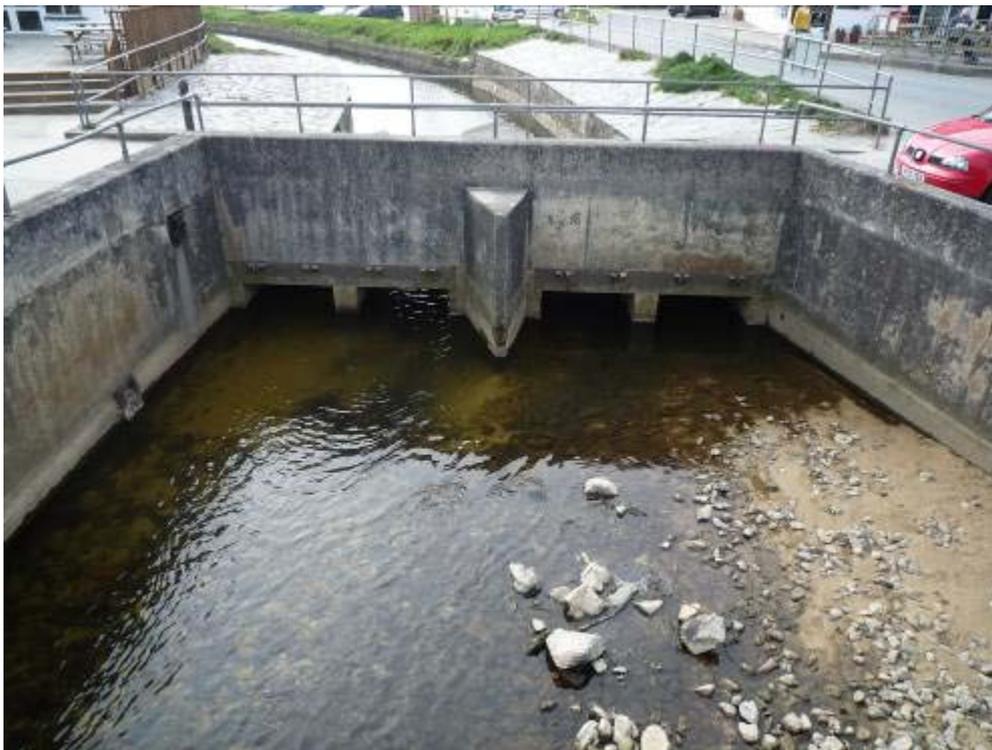
At the very bottom end of the river there is an old tidal sluice structure beneath the coastal road bridge. The structure is made up of four rectangular apertures, each being approximately 1.25 m wide. At some time (presumably recently) it appears that the structure had four undershot tidal gates which have now been removed. From inspection and discussions it is not obvious if the gates were used to lock out tidal ingress or retain upstream freshwater levels, either way, the fishery will benefit enormously from having these apertures kept open at all times.

Structure at the mouth of the Menhalhyl

- Improve the trout habitat quality of the whole reach by retaining as much fallen LWD as possible.
- On two or three locations on the bottom reach discuss the options of promoting some pool habitat creation with the Environment Agency. The simplest option is to import some sections of tree trunk and secure to the river bed using steel re-enforcing bar. Flood risk constraints can be minimised if the flow deflectors are made up of individual sections of trunk of less than 1.2m in length. Should any piece be displaced following a heavy spate they will be able to pass through the box culverts at the bottom of the river. Large pieces of imported stone could be an alternative option.

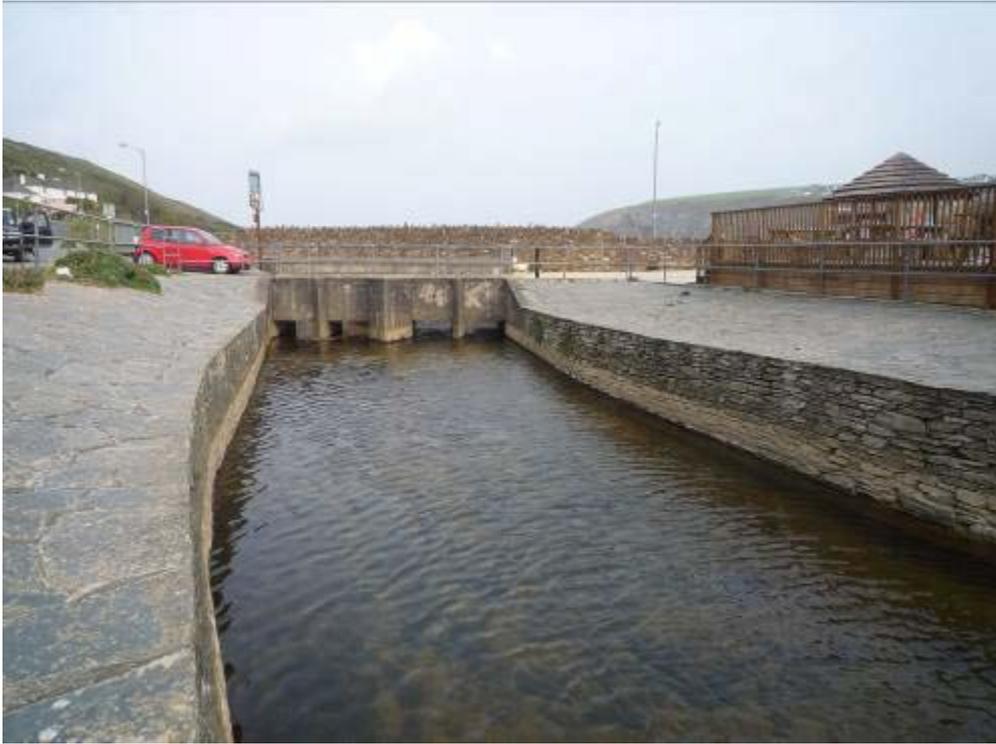
Downstream view of the same structure – Note the limited flood capacity caused by the restricted flow through the small apertures

It would be unacceptable and illegal to contemplate building structures or weirs that are specifically designed to slow down or block the progress of migratory salmonids. Promoting better quality lying up areas through the use of secured woody debris would seem to be perfectly sensible and reasonable (and beneficial to the fish themselves). Before embarking on any programme of improvements it will be very important to have a dialogue with the local Environment Agency Office. Flood risk, particularly to local homes and businesses would be a key concern in any proposed enhancement, particularly following several extreme events in the South West in recent years. It is not clear if the land drainage work carried out on the lower sections of river were designed to protect the coastal community of Mawgan Porth or purely to drain the riparian farm land that lies just upstream. If flood risk to the local community is considered a key concern then it would seem strange that the small box culverts on the downstream structure have not been removed or modified to increase flood water capacity.

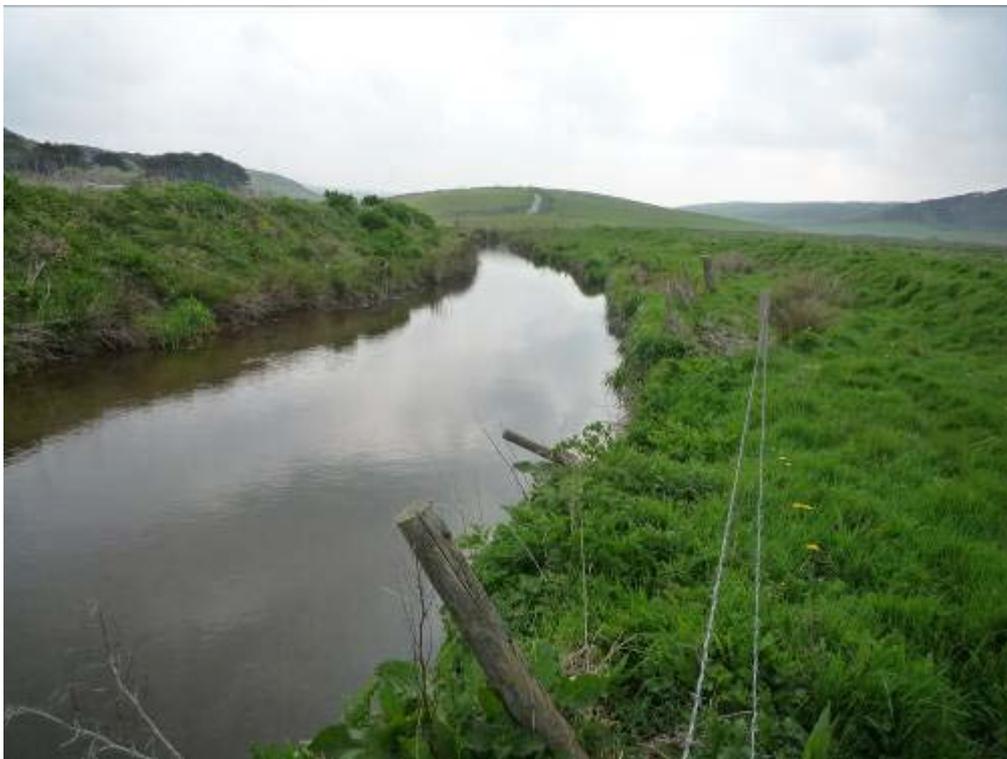
Walking upstream from the structure it soon becomes apparent that the river has been heavily modified. The channel throughout this bottom reach is uniformly wide and shallow with very little in-channel diversity or marginal scrub or tree cover. The banks on both sides are flood bund constructions, probably containing previously dredged river bed material. Both banks are raised well above the local flood plain, giving the river the appearance of purely a drainage channel rather than a functioning river. Due to the wide and uniform shape of the channel no significant geomorphological features exist with the river made up of one long shallow glide flowing over a substrate of mixed gravels and sediments. Despite the very poor habitat, decent numbers of small trout could be observed within the channel. Many of these small fish were darting around looking for a suitable hiding spot (which were in short supply). The section was virtually devoid of any significant holding habitat for mature fish.

Lower reaches of the river with clear evidence of large scale modification with flood bunds on both banks with evidence of previous dredging and widening of the channel. No marginal cover, no in-channel diversity – a river clearly not in good ecological condition.

This whole bottom section of river is ripe for large scale river restoration or enhancement. Work of this kind can be hugely expensive and likely to be beyond the scope of a WTT or fishing club project. The very best we can propose are small scale measures designed to mitigate against the adverse effects of the dredging and over widening. In the recommendations section of this report there will be some suggestions of how to increase the fishery potential of this, and the upstream reaches.

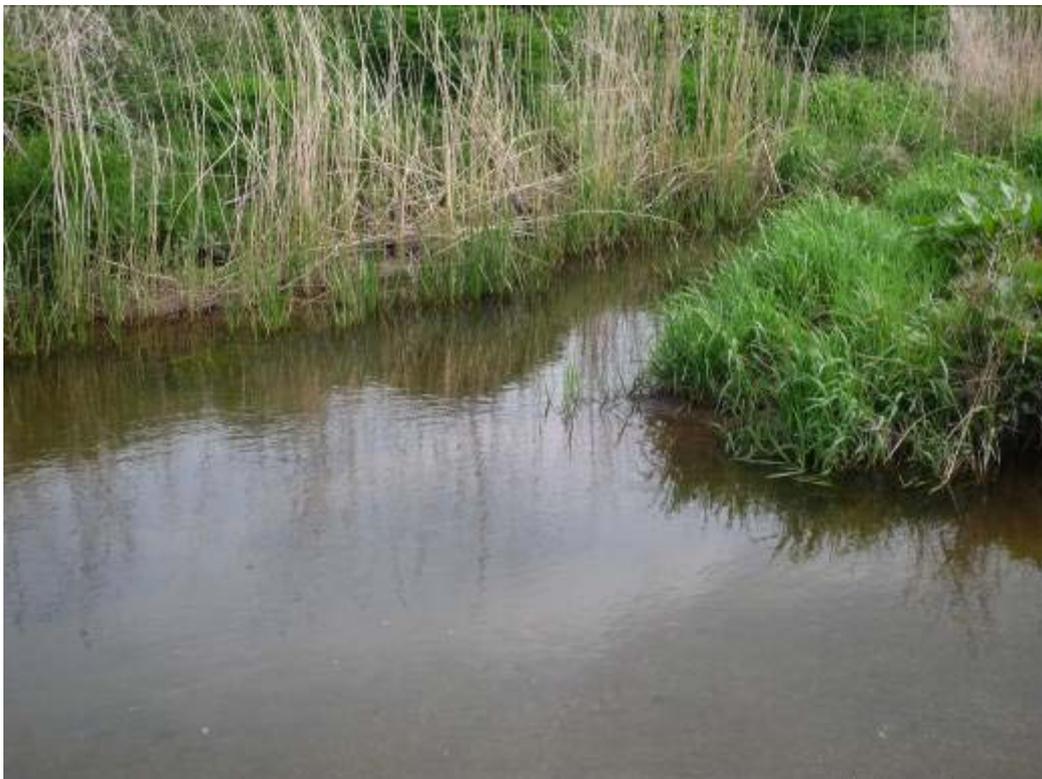
The run of mainly poor habitat extended up and beyond the Gluvian stream confluence. This joining tributary has been identified as an excellent trout nursery stream. It is highly likely that a significant proportion of the brood fish are migratory trout which will pass through this lower reach before ascending either the main channel or the tributary. The provision of two or three decent holding pools on the section below the confluence could enable the fishing club members to legally and sustainably exploit some returning adult sea trout and make this section of river infinitely more interesting as a fishery. It is possible that the provision of better quality holding habitat on the lower river for migratory fish will also boost trout production. Currently there appears to be precious little opportunity for early running fish to come in and safely hold up before continuing with any spawning migration.

Gluvian Stream confluence. Precious little holding habitat below this point. Migratory fish either have to run or retreat for safety.

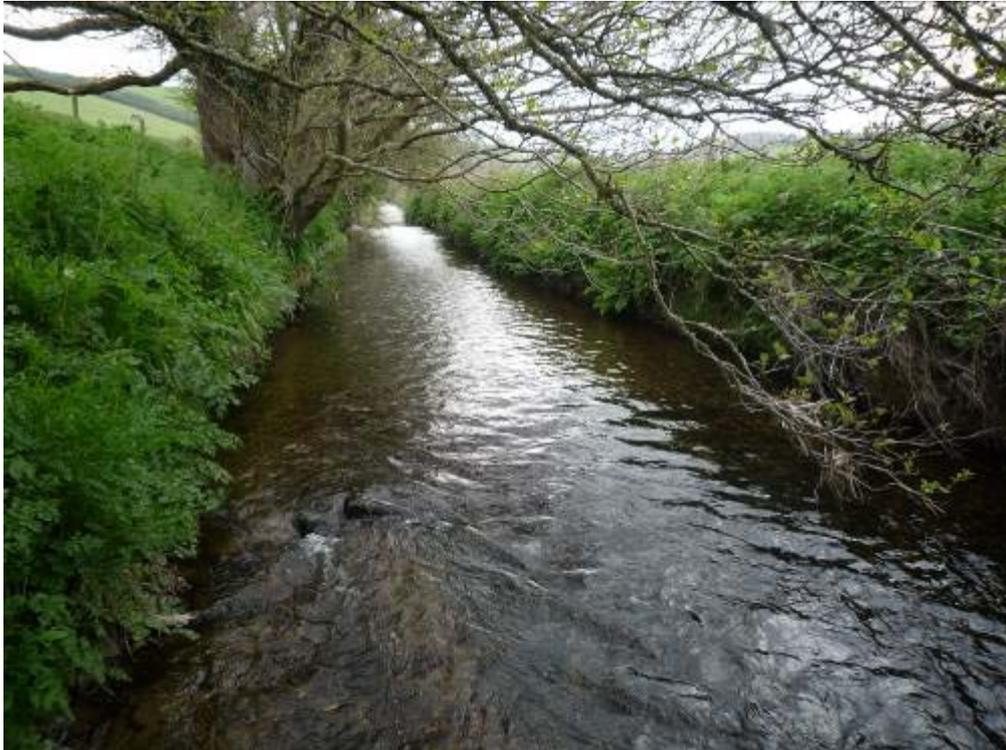
A short section of river lying just to the south of the Gluvian Farm area was inspected. This section belongs to club member Mr Tony Palmer and is slightly more diverse than the bottom reach; but also looks to have been heavily modified in the past. The channel is comparatively straight with a moderate gradient in places. This has enabled some riffle areas to form which, combined with the good quality gravel bed substrate, provides some potentially good trout spawning and nursery habitat. Unlike the bottom section, the RB was quite

heavily shaded with dense stands of riparian trees. Despite this there was very little low marginal cover and no real evidence of woody debris within the channel. It is the presence of fallen trees and large woody debris (LWD) that is often the catalyst to creating the pool and riffle habitat features so essential on good quality trout streams.

An upstream view on the central section. Straight, shallow and again devoid of significant holding habitats for mature fish. Dappled light and shade from the tree canopy on the RB but no fallen woody material to create in-channel interest.

- On the heavily shaded central section, coppice the odd marginal tree to promote some enhanced dappled light and use timber to peg into the channel to promote some local bed scour.

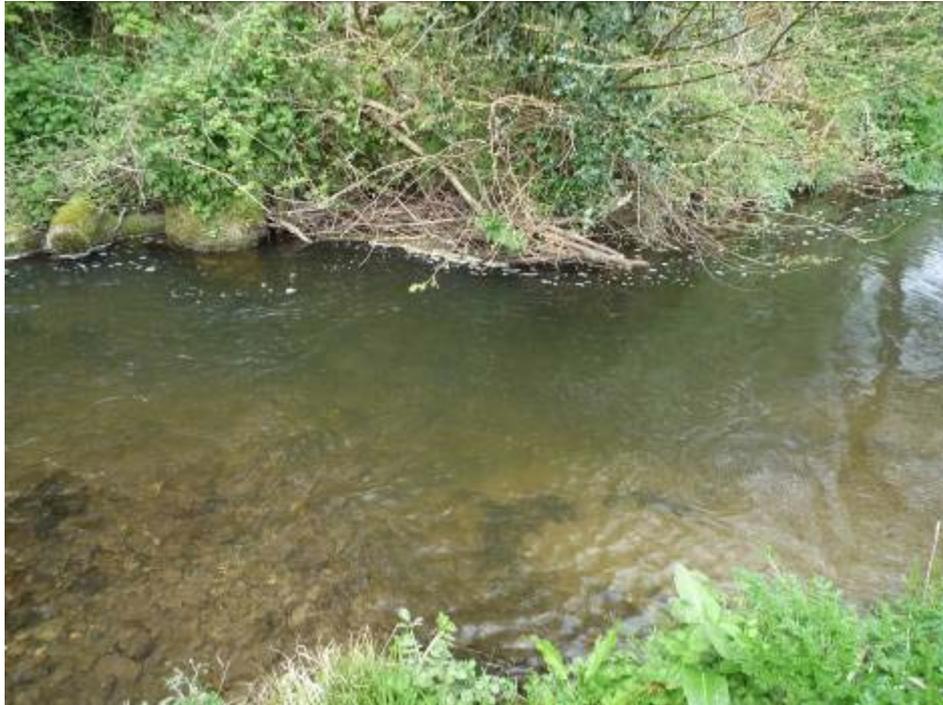
A great holding pool created by a previously fallen tree. The low fringe of cover at the tail of the pool will only improve its holding potential

Further improvements to holding pools could be made by encouraging marginal fringes of low scrubby cover to develop. Much of the LB shading was comparatively high and a fringe of low cover provided by trees such as the goat willow or sallow (*Salix caprea*) will provide better quality holding habitat.

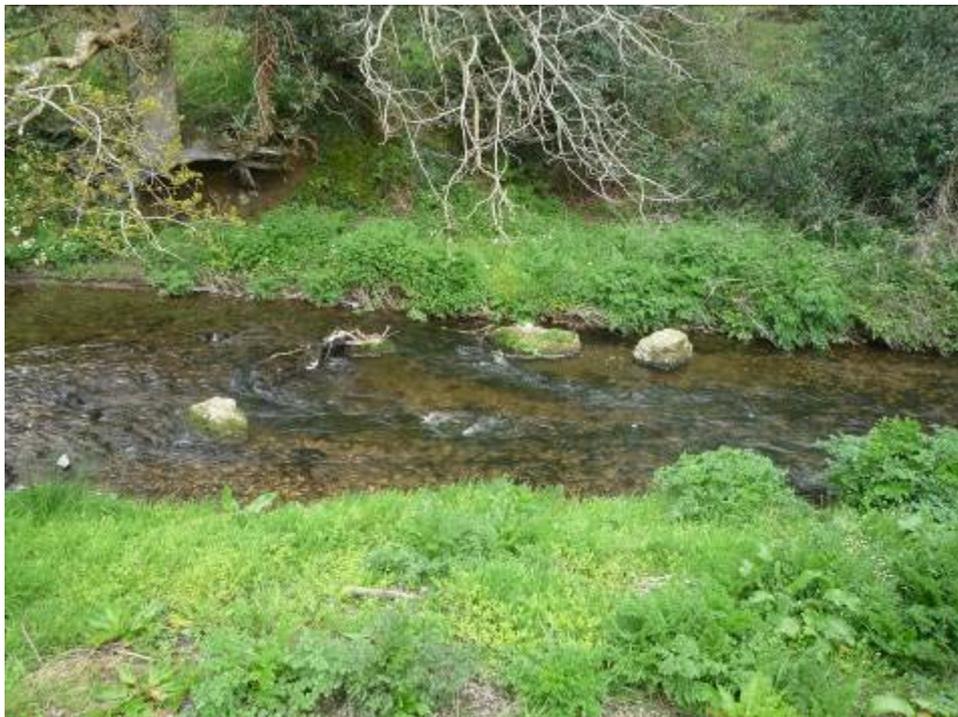
Some diverse habitat promoted by the large stones dotted across the channel

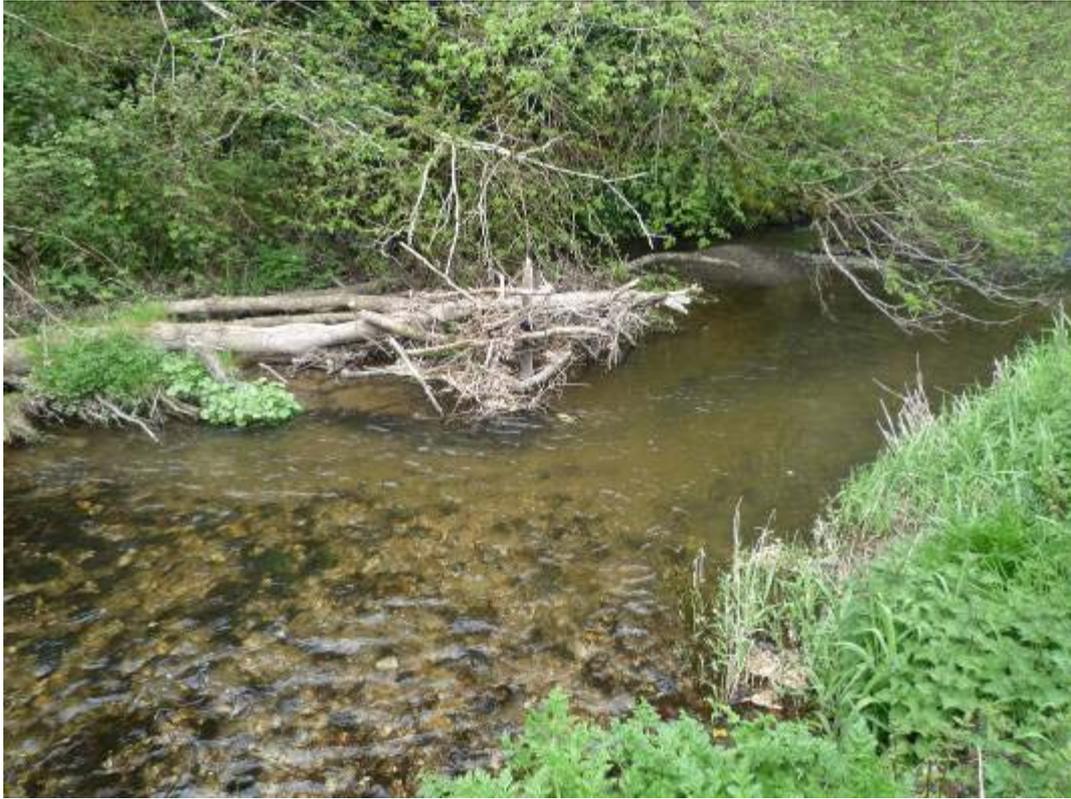
A partial LWD debris dam acting as a flow deflector – great trout habitat

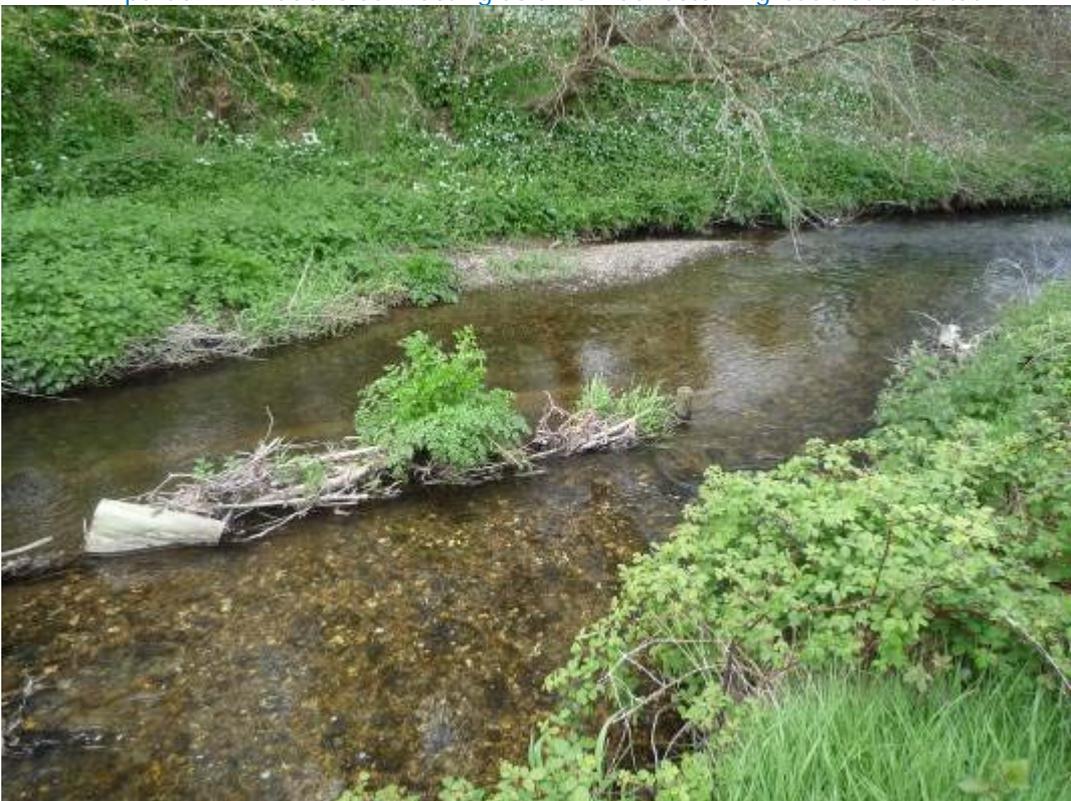
The remains of some old inchannel flow deflectors. These are much more effective when placed at right angles to the flow or pointing slightly upstream.

- Newly installed flow deflectors should be no closer together than a distance of six multiplied by the average width of the channel.
- Plant some small willow whips, particularly adjacent to improved holding areas to promote low scrubby cover.
