River Meon at Ripling, near Drayton.

An advisory visit carried out by the Wild Trout Trust – September 2014

1. Introduction

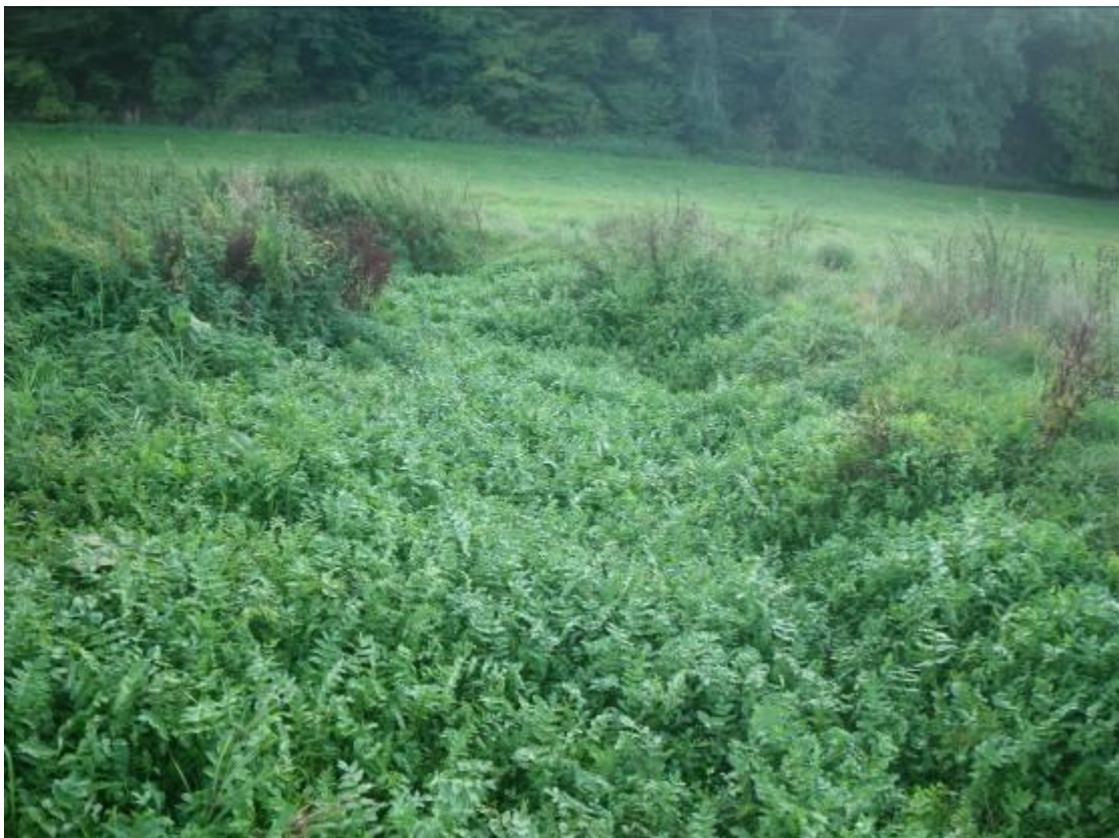
At the time of inspecting this particular section of the Meon in late September, the flows were extremely low and encroaching marginal vegetation was lush (photo 1). Sections of 'open' flowing channel could scarcely be seen, other than immediately below an existing water meadow hatch (photo 2) and beneath a handful of overhanging trees.

Photo 1. Wide, shallow channel choked with Water parsnip (*Berula erecta*) and Fools cress (*Apium nodiflorum*)

On the longer sections of weed choked channel, the channel width should be radically reduced by at least 50% and in places by approximately 75%. In very wet years, winter and early spring flows will result in 'out-of-bank' flooding of the adjacent meadows. Where there is no risk of damage to local infrastructure,

The quickest and easiest way to create a narrower, more sinuous channel is to manipulate the existing banks and bed with a tracked excavator. Creating two or three narrow, appropriately sized pools (must not be too large or too deep) could be achieved by excavating bed materials and using them to narrow the channel width at the neck of the pool. Some log, or faggot bundle revetment might be required on the outside of bends and backfill obtained from newly created river-side scrapes, which will create valuable wet habitat in their own right. A project where the bed and bank is to be manipulated with a machine will require a detailed consultation and written consent from the Environment Agency. The WTT can help with this process. .

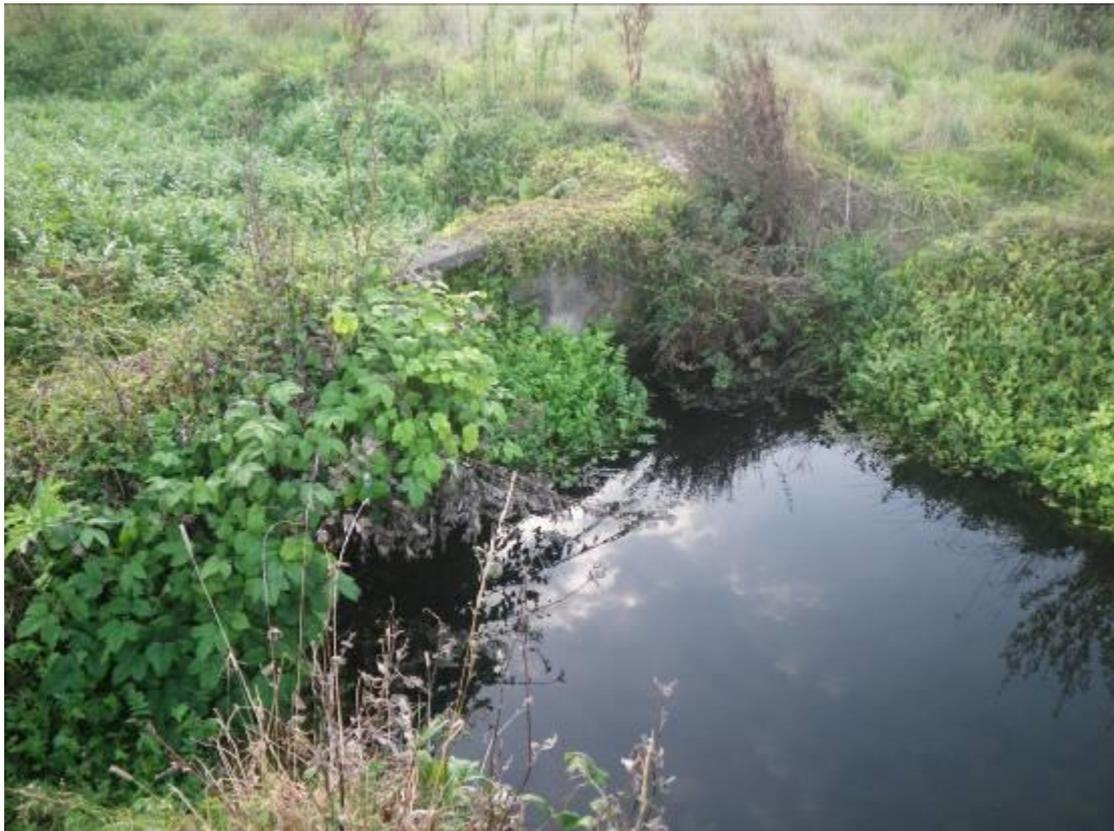
Photo 2. An old water meadow hatch structure straddling and impounding the channel.

The first priority is to investigate the weir structure and at the very least remove any stop boards that may still be in place. Ideally the whole structure should be removed but care must be taken to ensure that the weir has no archaeological or heritage significance.

- Remove any remaining stop boards in the existing hatch structure and investigate the historical significance of the structure. If it is a recent construction then consider its complete removal.
- Plan a scheme to radically narrow the existing channel width by at least 50%. Using a tracked machine to redistribute river bed and flood plain materials can be a very effective and relatively cheap option. Some log or faggot revetment might be required to create a new toe to the outside of any new bends.
- If the meadows are to be grazed with horses or cattle in the future then some temporary fencing will be required to protect any recovering banks.

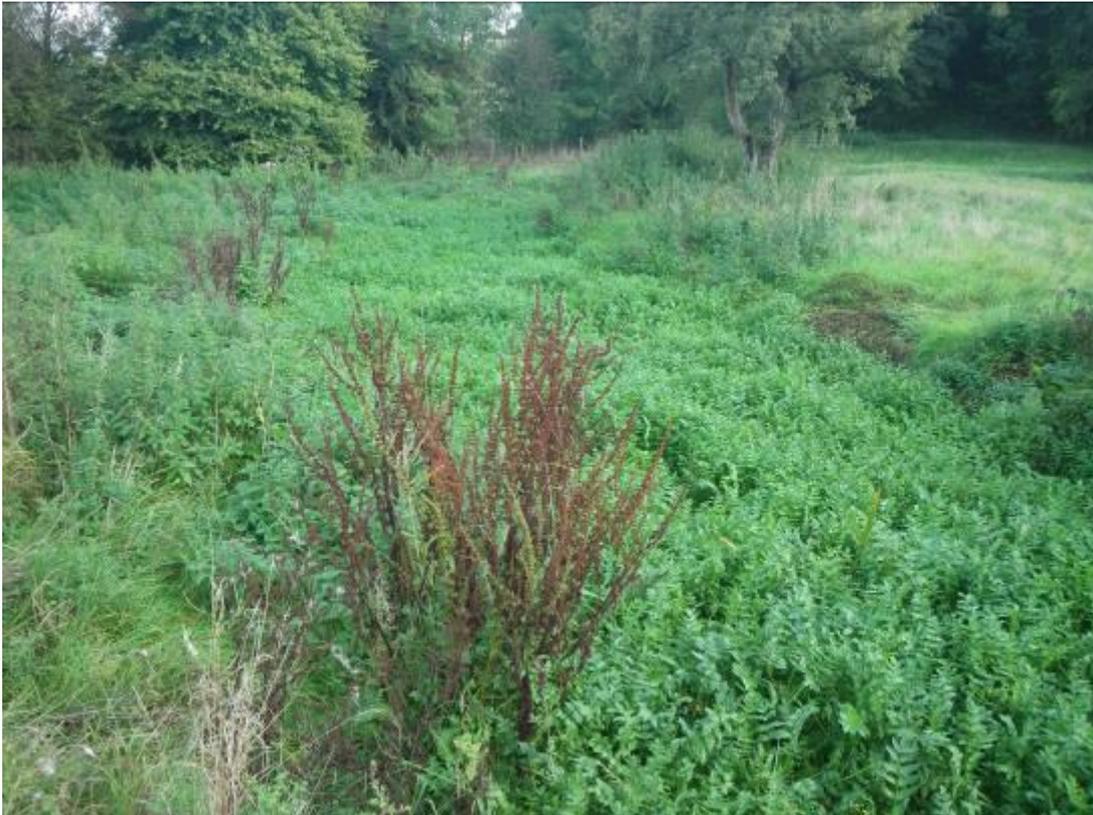
Substantial lengths of the existing channel are much too wide for the average flow discharge, with banks that appear to have been badly degraded through previous poaching by livestock (photo 3). The net result of the overly wide channel has been to reduce flow velocities, which has enabled chalk stream emergent plants to thrive, not just in the margins but right across the channel. Channels without any access to open water can be a hostile environment for fish.

Photo 3 A wide, shallow and flat section of chalkstream channel with the definition of bank and bed lost through previous livestock poaching.
