**River Meon at Riplington, near Drayton.**

**A Project Proposal by the Wild Trout Trust – January 2016**

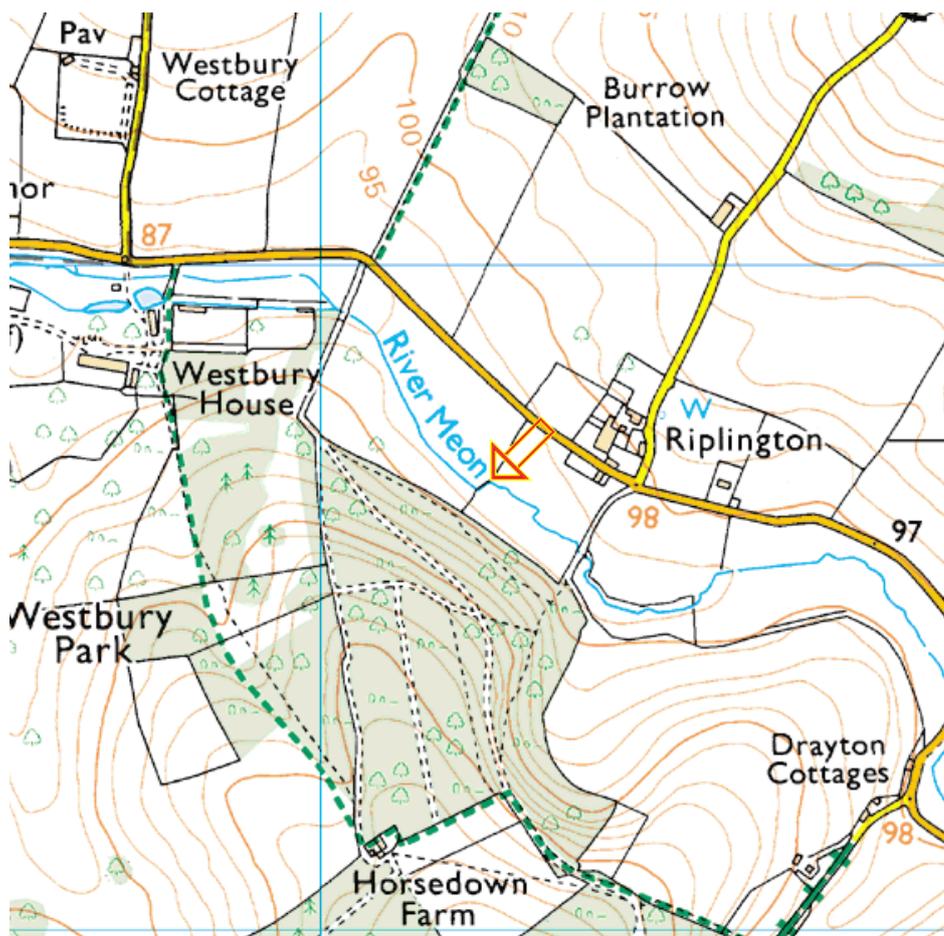
Map 1.

This Project Proposal follows on from a Wild Trout Trust advisory visit and report carried out in 2014 on a 0.5km section of the upper Meon at Riplington, near Drayton in Hampshire. The reach inspected runs from NGR SU 662236 down to SU 663235 at the bottom boundary, indicated by the arrow on map 1.

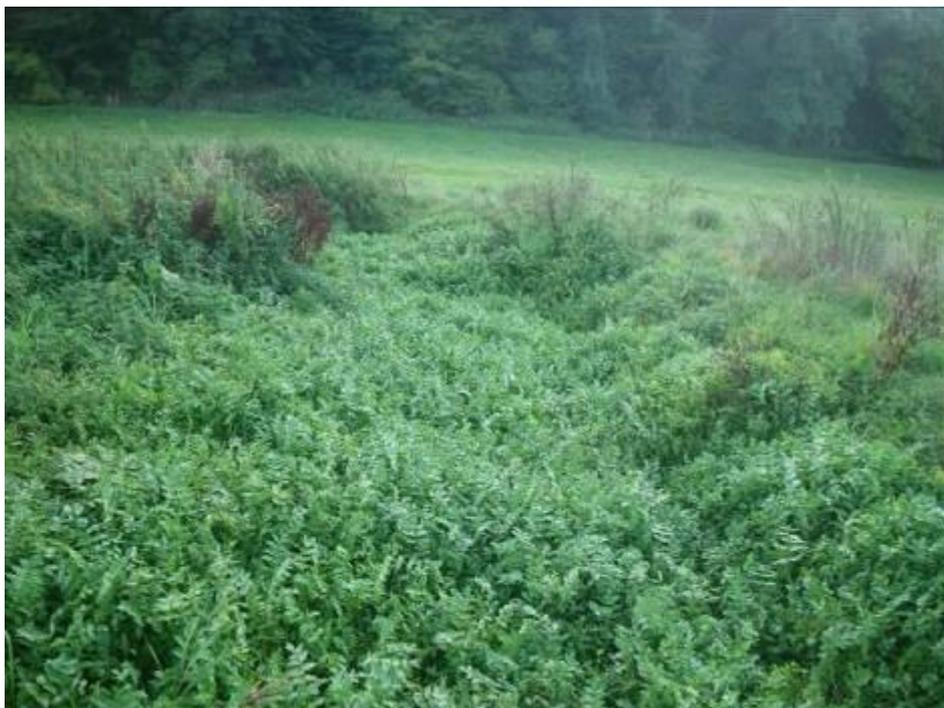
Photo 1. Wide, shallow channel choked with Water parsnip and Fools cress

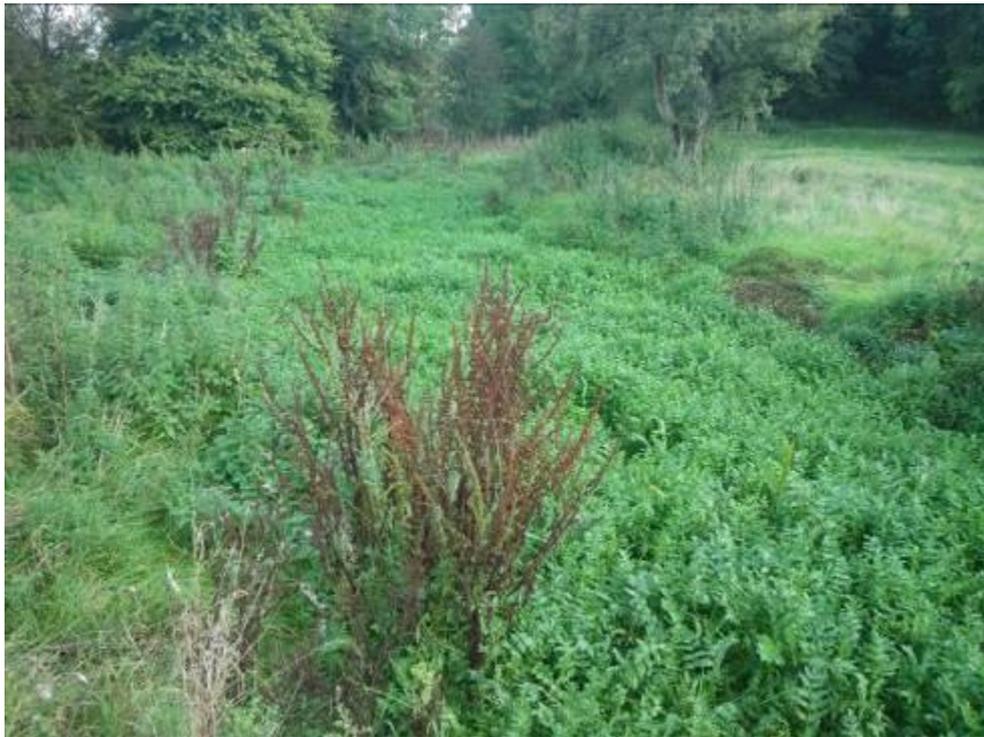
Photo 3 A wide, shallow and flat section near the upstream boundary. Here the definition of bank and bed has been lost through previous livestock poaching.
