River Meon – Midlington Farm, Droxford

An advisory visit carried out by the Wild Trout Trust – March 2009

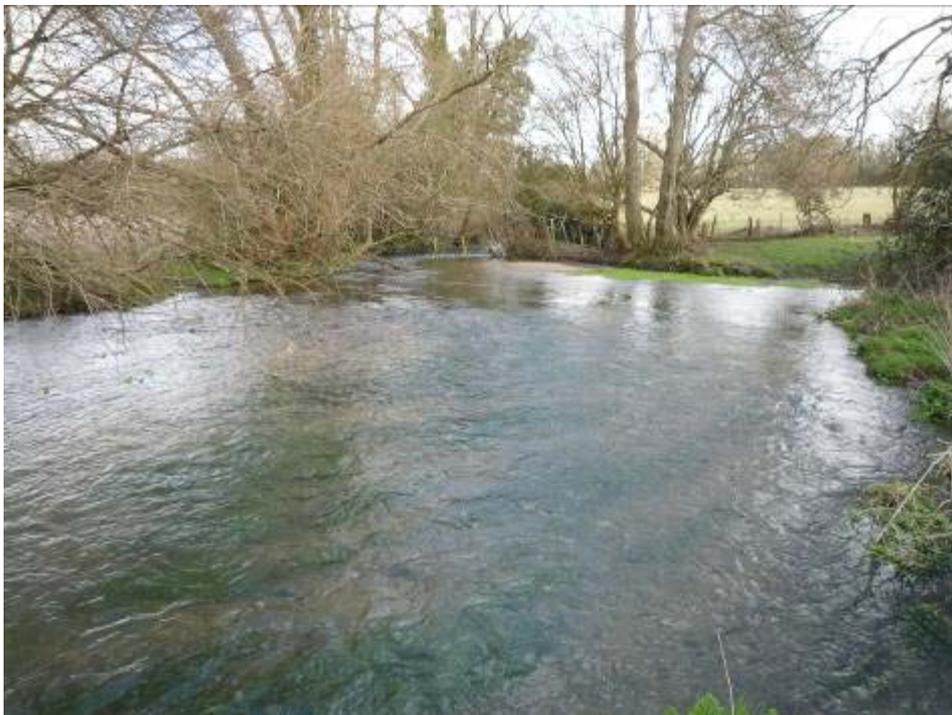
Top boundary of the fishery. The wide shallow channel is potentially a good spawning and nursery area and ideally located at the head of the fishery.

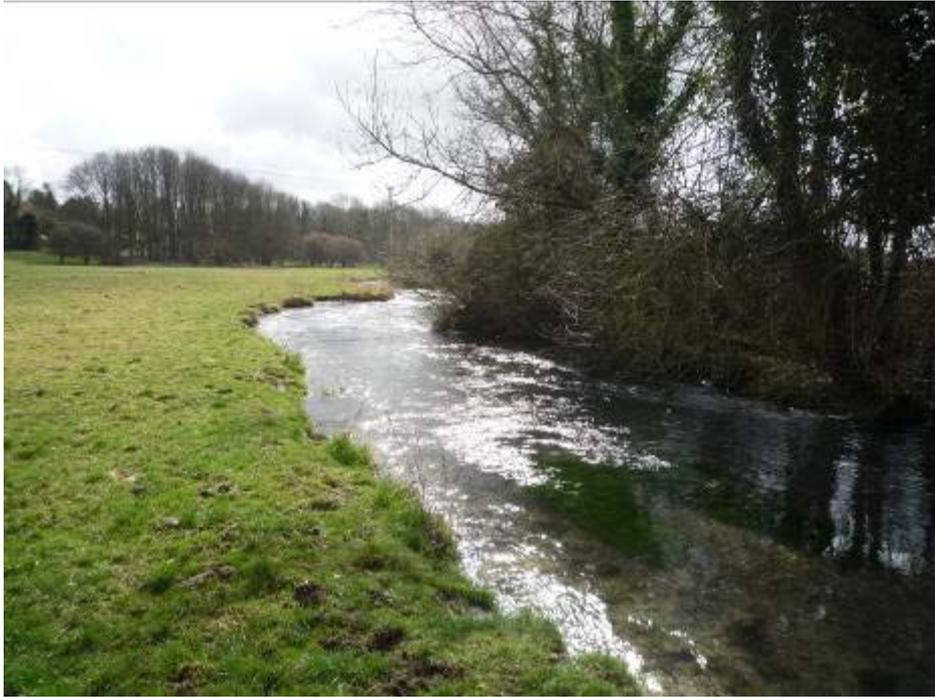
A good section just below the top boundary where the channel is slightly pinched before becoming wider, more open and comparatively shallow.

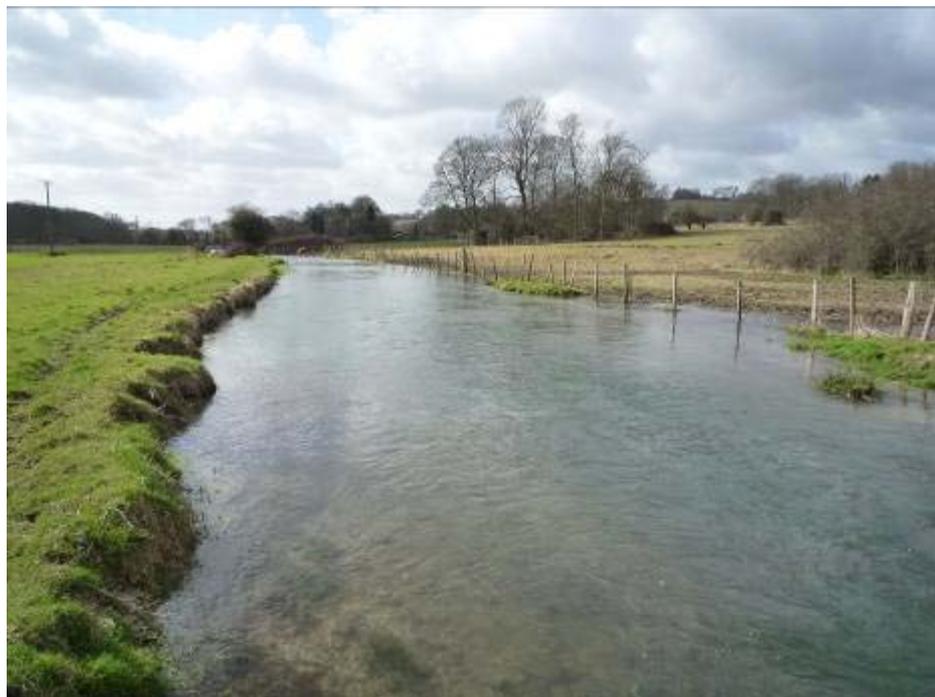
Wide, open channel on the top beat with evidence of margin damage on both banks associated with cattle poaching

The prescription put forward by Dr Holmes is to restrict cattle access for 5 years by erecting a temporary fence, planting some willow trees and creating some deeper pools using a machine to dig gravel from the centre of the channel and side cast it to create some marginal berms.

The conclusion from this report is that the fencing is an essential element of any habitat improvement initiative on this section. Restricting access to cattle will allow the margin to recover and gradually encroach, pinching the channel and promoting enhanced habitat quality through increased water velocities. Purpose-built drinking areas adjacent to the river can be provided or alternatively the installation of pasture pumps could be employed where beef cattle can access drinking water through a self-activated pump that does not compromise the river margin habitat.

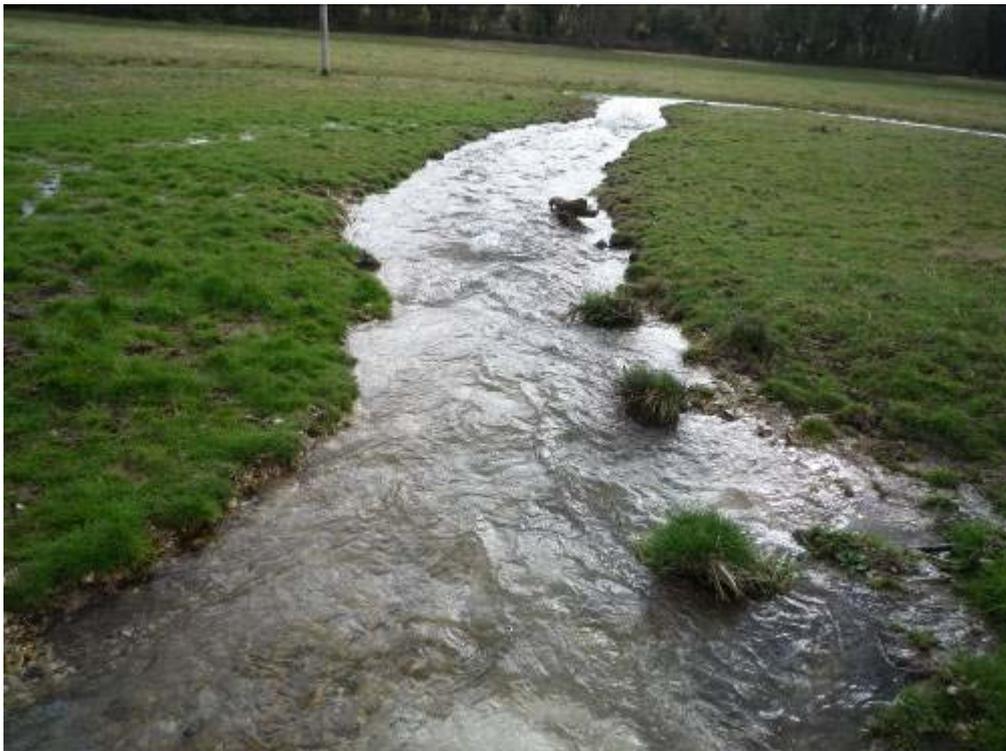
As the river winds its way towards the road bridge it is evident that the channel has been diverted in the past to maintain a head of water for an old water meadow system. Some of the old structures are still visible. As a perched channel, the margins are vulnerable to erosion and a bank breach has allowed water to loop down into the bottom of the meadow before rejoining the main channel.

[New channel forming via a bank breach from the perched channel.](#)

This newly formed channel has the potential to provide some excellent spawning and nursery habitat with the provision of some in-channel cover. Some intervention will be required to stabilise the breach and limit the amount of flow entering the new channel. An alternative is to let the breach run its course and allow the river to eventually find its way to the bottom of the valley. This scenario will in all probability be unacceptable to landowners, particularly to the property currently backing onto the main channel a short distance downstream of the breach.

Work to stabilise the bank adjacent to the current bank breach should be undertaken before next winter's high flow period.

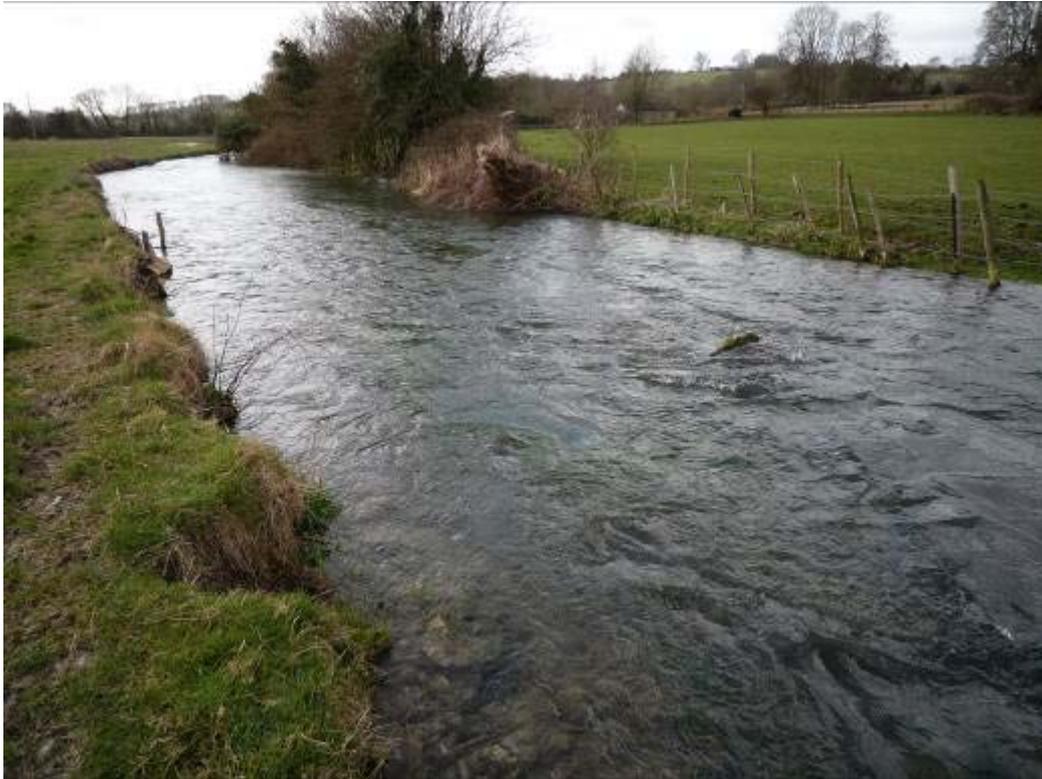
Good weed cover, strong flows and a decent gradient provide some good habitat for juvenile trout. Some deeper holding pools and a low scruffy margin on the LB would greatly enhance its ability to hold adult fish as well.

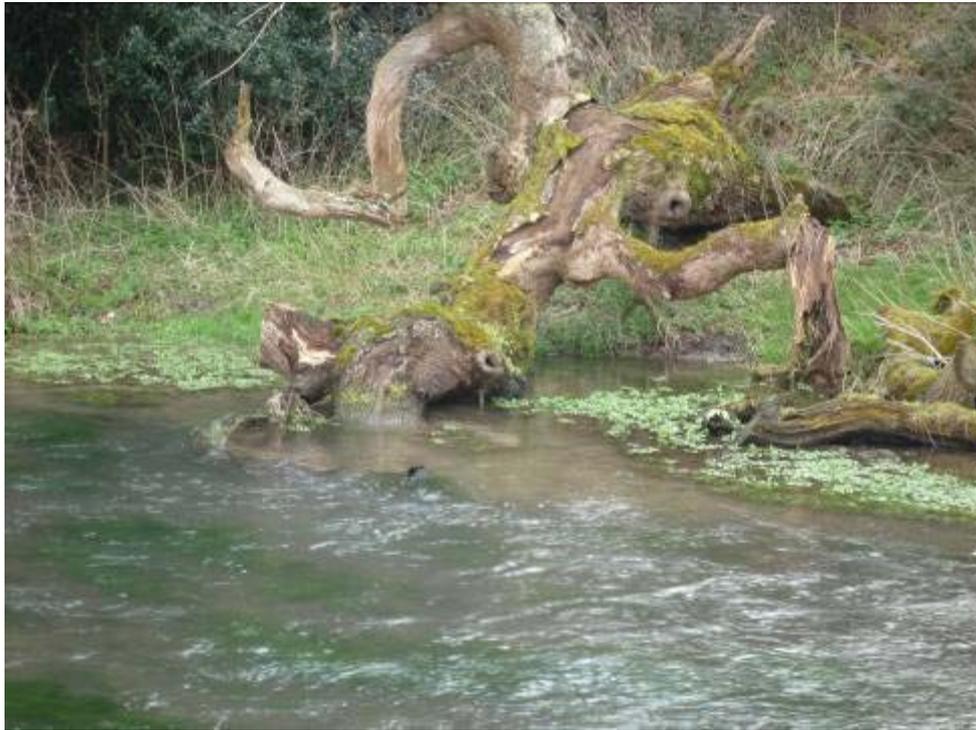
A piece of LWD that could be easily winched further into the channel to promote some local bed scour. A good margin for juveniles

Despite the previous dredging work the bottom section appears to be in very good order, thanks mainly to the relaxed approach to marginal tree and shrub maintenance. There were numerous examples of good holding, spawning and juvenile habitat. Further improvements could be made by utilising some of the existing LWD that is to be found in the locality and securing it onto some of the shallow riffle habitat to improve the quality of the spawning gravels.

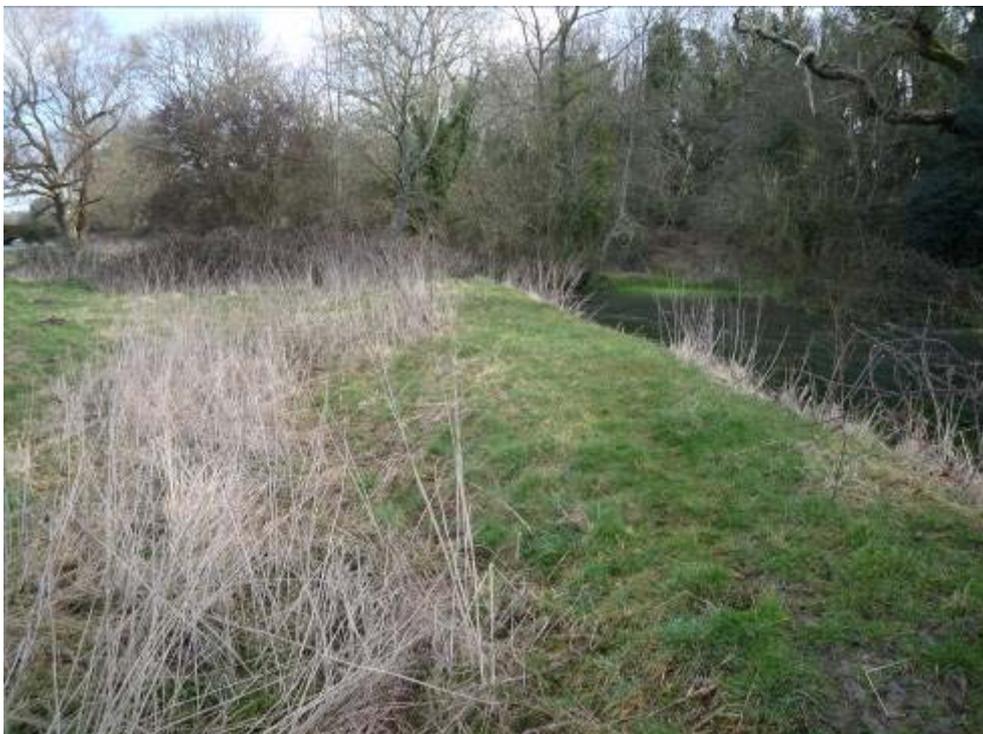
Evidence of past dredging on the RB. Not a classic chalk stream bank but it has enabled a margin of scrub to develop and provide cover for trout.

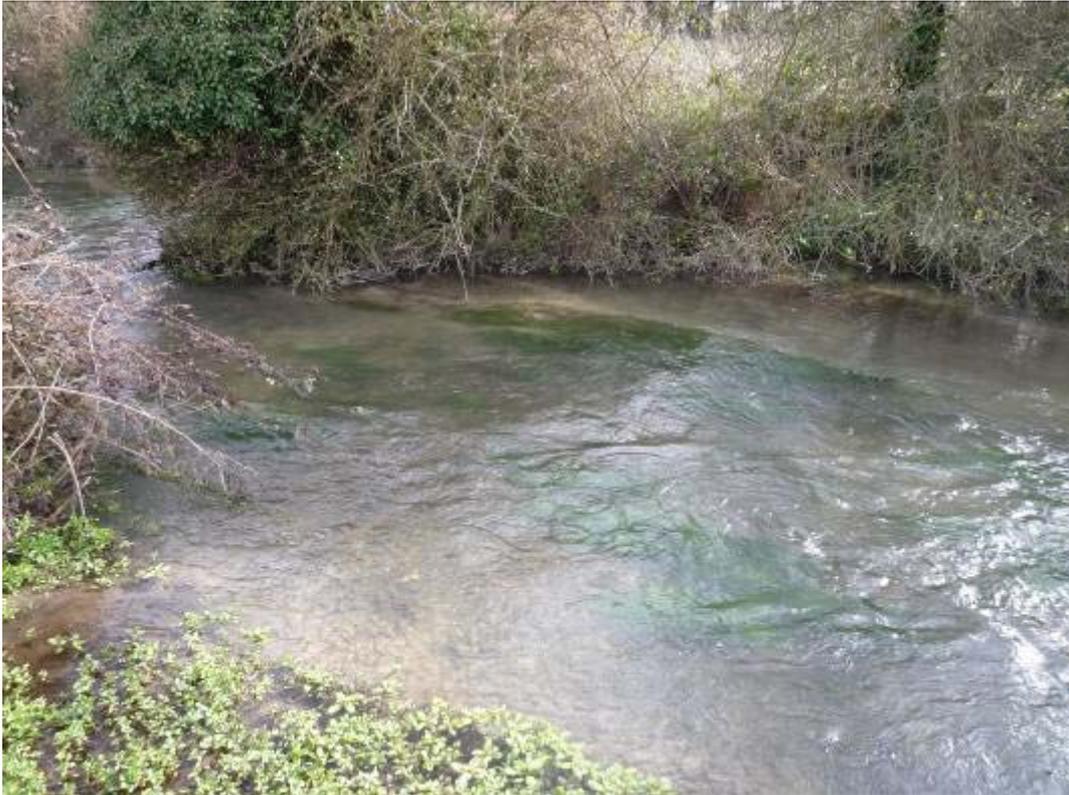
Good habitat for adult and juvenile trout

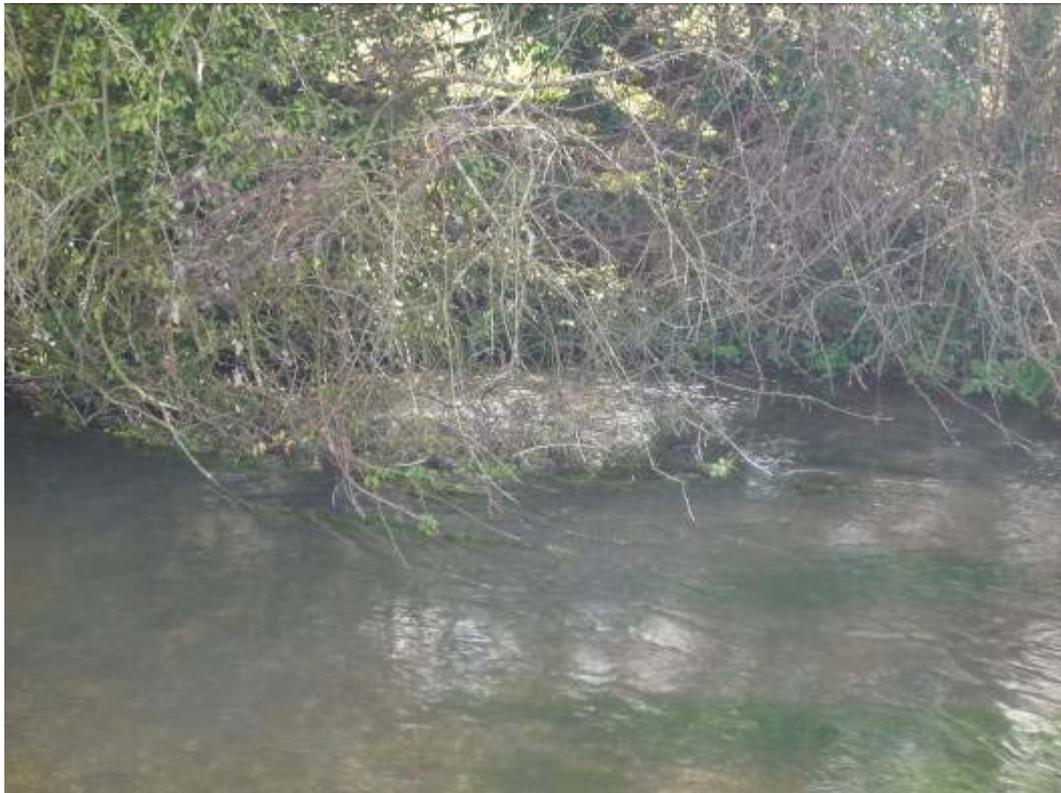
A bird proof refuge. Adult trout will feel comfortable in spots like this

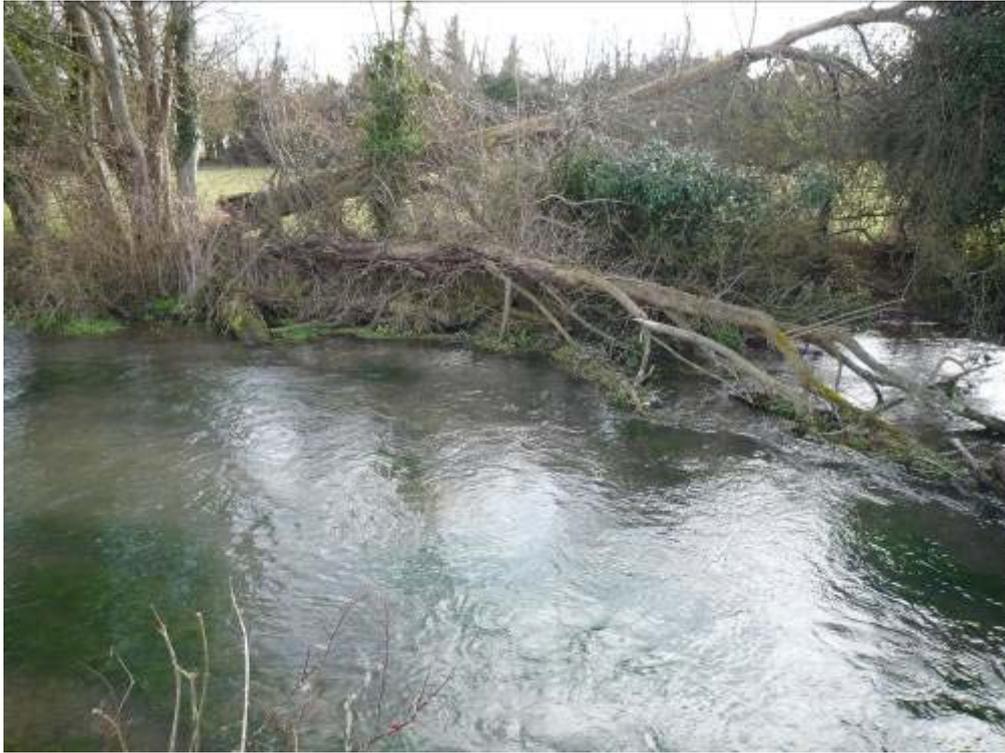
More LWD within the channel. Great habitat and a rare site on a Hampshire chalkstream

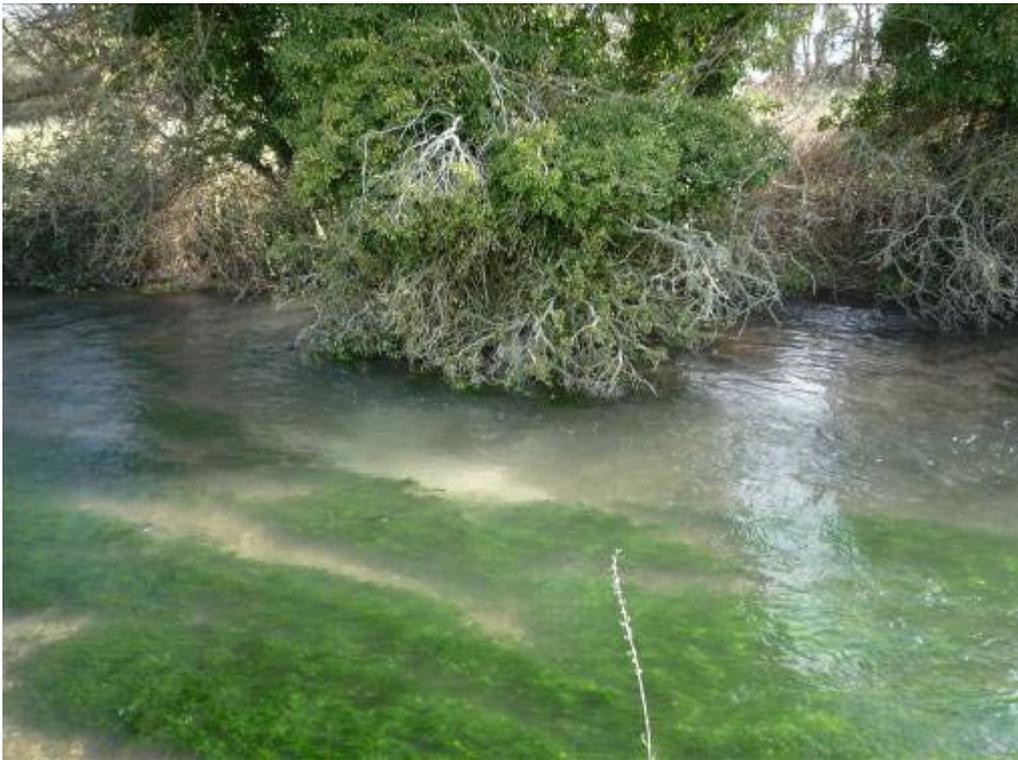
Another good holding spot for adult trout

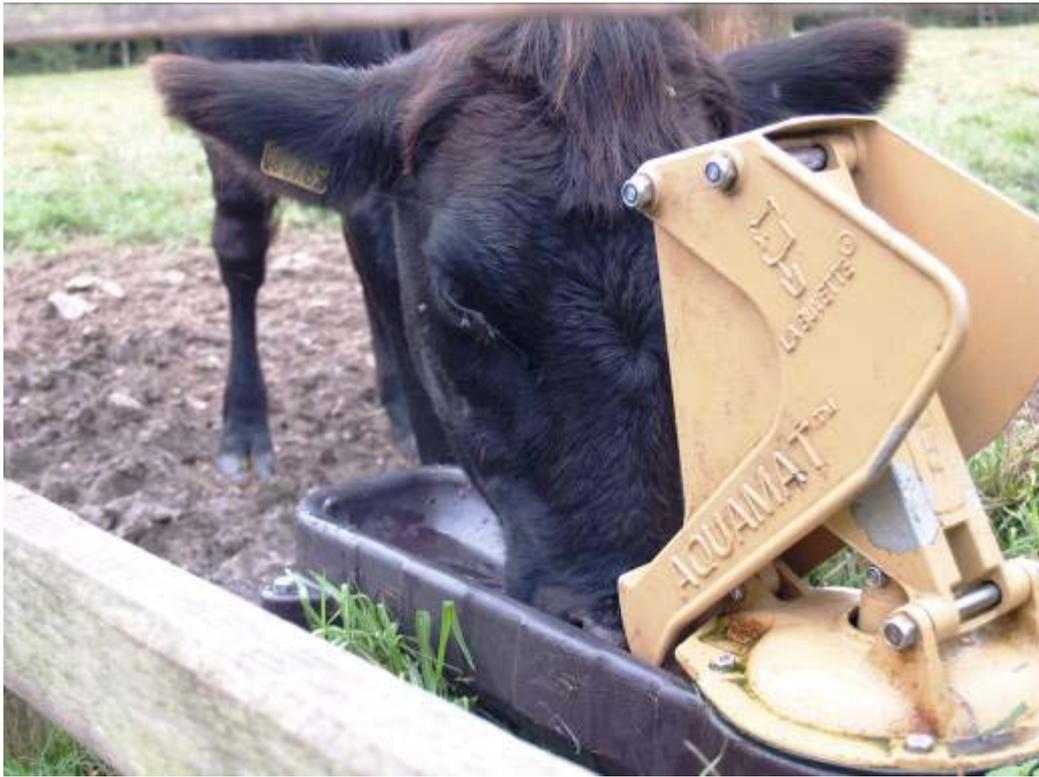
Pasture pump in operation adjacent to the River Test

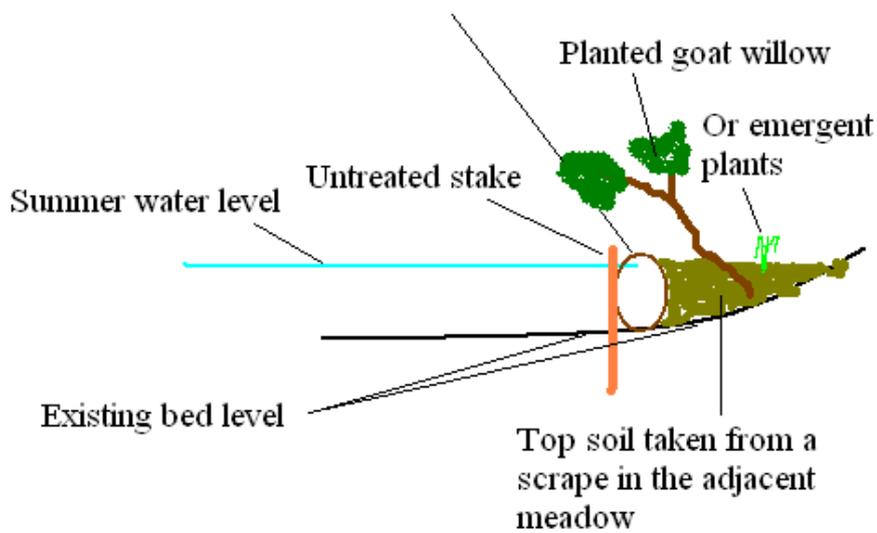
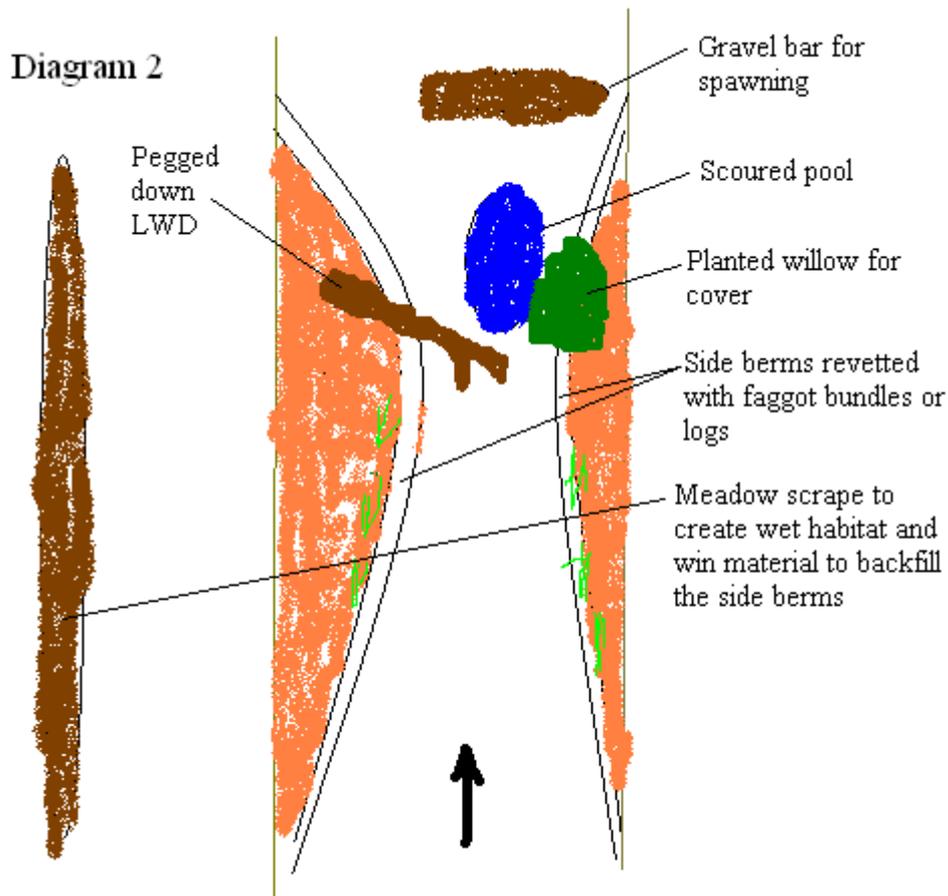
Diagram 1

300mm (approx) diameter faggot with top level set at 100mm-150mm above normal summer water level

The idea of creating some marginal berms, or shelves to locally pinch the channel and blow the water through some deeper pools would provide improved holding habitat for adult trout. Creating pools by digging gravel from the centre of the channel can be risky because it can leave deep silt filled holes in times of low flow. An alternative approach is to revet the outline of some new marginal shelves with faggot bundles (diagram 1) or tree trunks and peg them in and backfill with material won from the meadow. Digging some very shallow scrapes next to the river where material can be won will also promote some new wet meadow habitat, ideal for wading birds. The newly formed low soft margin can be planted with willow, sedge or reed or allowed to develop naturally. The machine can be used to gently loosen bed material at the bottom of the run and some pegged down LWD can be imported to promote the necessary scour which will help blow out the bed material and form a sustainable pool habitat (diagram 2). This method is more likely to look natural and function properly over a wide range of flow scenarios.

In narrowing the channel in three or four locations there will be scope for utilising the extra velocities to create scour pools and improved holding habitats for adult trout and other fish species. A combination of narrowing and the use of LWD will often provide fish with an ideal lie as well as additional cover from predators. Extra depth in a few locations will also help to make the section more resilient against the adverse effects of low flow conditions, providing vital pools when water levels shrink during prolonged drought periods.
