Moat Brook (The upper River Penk): Advisory Visit & Initial Project Proposal

Paul Gaskell Wild Trout Trust (WTT) 06/10/2016

Groundwork West Midlands/Friends of Bilbrook/Environment Agency
River	Penk (Moat Brook)
Waterbody Name	Penk, Source to Saredon Brook
Waterbody ID	GB104028046680
Management Catchment	Trent Valley Staffordshire
River Basin District	Humber
Current Ecological Quality	Poor
U/S Grid Ref inspected	SJ8754204172
D/S Grid Ref inspected	SJ8823303720
Length of river inspected	~750m in total

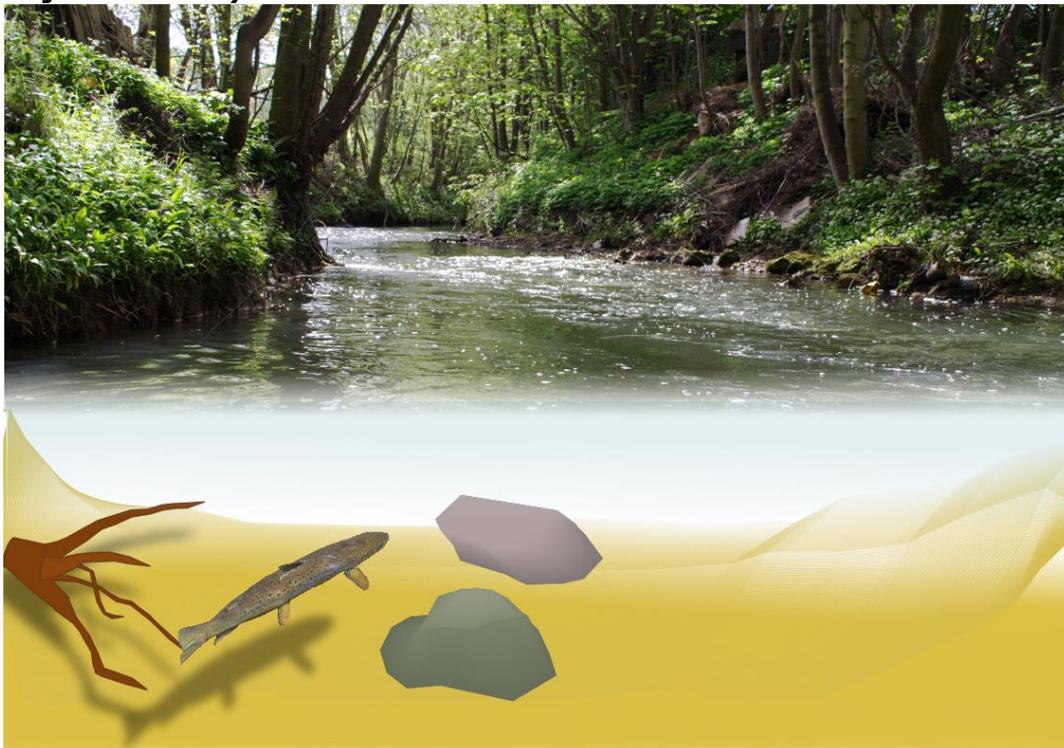
Figure 4: The availability of deeper water bolt holes (>30cm to several metres), low overhanging cover and larger submerged structures such as boulders, fallen trees, large root-wads etc. close to a good food supply (e.g. below a riffle in this case) are all strong components of adult trout habitat requirements.

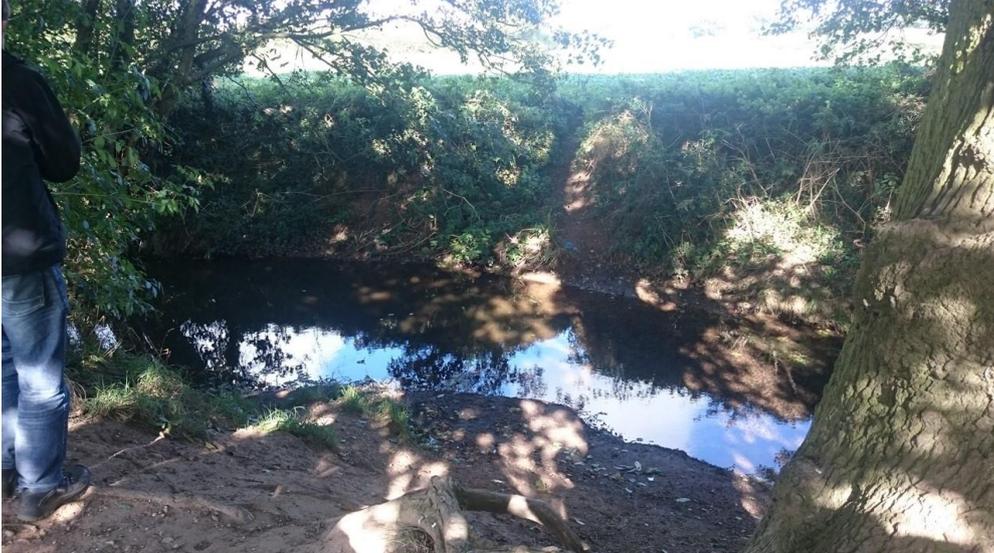
The agricultural use of land on the LB, combined with an apparent access point used by walkers and possibly pet dogs, has created an obvious input pathway for fine sediments to be washed into the channel (Fig. 5). This is, of course, unlikely to be the only input point – but runoff pathways like this will be responsible for greatly elevating the bed-load of fine sediment (sand and clay particle-sizes). Evidence of this is seen in the stream-bed itself with the compaction of the “interstices” (spaces between ill-fitting gravel particles) with fine sediment. This is likely to significantly reduce the survival prospects of eggs and baby fish that rely on a continuous flow of water through those interstitial “pores” in gravel beds.

Figure 5: Access point from both the near (RB) and opposite (LB) banks of the river. The fine sediment supply, and associated nutrients or chemicals, from surrounding agricultural land and roads appears to be contributing to ecological degradation in the channel.

Exploring and encouraging catchment-sensitive (and economically-beneficial) farming methods provides simultaneous and dramatic benefits to watercourses. Specialist advice should be sought on factors such as the timing and identity of crops that are planted, direction of ploughing, stubble/harvesting practices that reduce particulate runoff and increase fertility/porosity of soils, field entrance/exit siting to tackle runoff pathways along roads/directly into rivers, buffer strips and many other methods that control the runoff of water and sediment from agricultural land. An overview of these issues and their control is available in this pdf published by the Environment Agency on Rural Sustainable Drainage Systems (RSuDS):

- Initiate a process of improved agricultural land management to minimise/intercept sediment runoff pathways
- Identify and tackle runoff pathways as they enter the river (e.g. dog-access points, sediment runoff pathways discharging into the river)
- Create more staggered canopy within the densely-wooded river corridor areas
- Seek opportunities to install tree kickers using material arising from canopy works
- Utilise any trees or root wads that may arise from tree work - or even local forestry - to create focused bed scour to create higher quality spawning areas (via gravel "sorting")
- Seek opportunities to hinge (lay) saplings into margins to produce refuge habitat
- Install interpretive signage at prominent points associated with habitat works (e.g. footbridge crossing and/or Jubilee woods path leading to river)

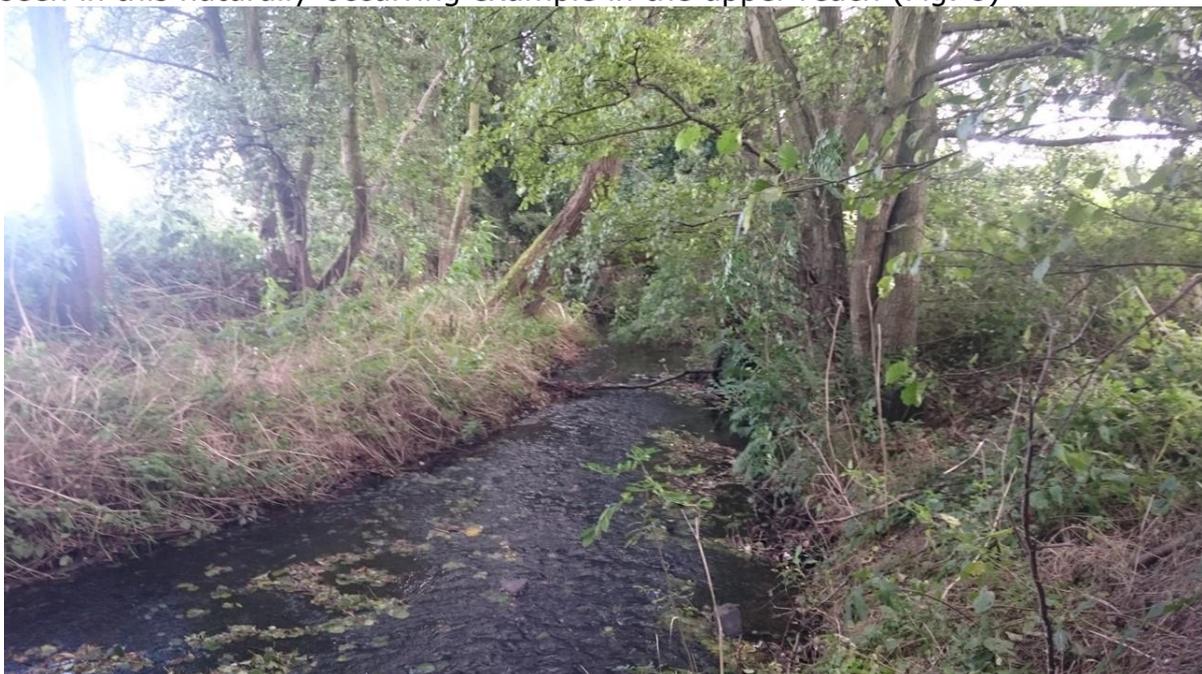
A clue to the form and the associated functional benefits accrued by increasing the amount of woody structure in the margins and within the channel can be seen in this naturally-occurring example in the upper reach (Fig. 8)

Figure 8: Natural woody material leaning into the channel, combined with some gradient and a natural channel width. Some variation in bed-scour and retention of leaf litter (while maintaining a gap underneath much of the trunk) is providing some much-needed overhead cover and structural variety to the channel at this point.

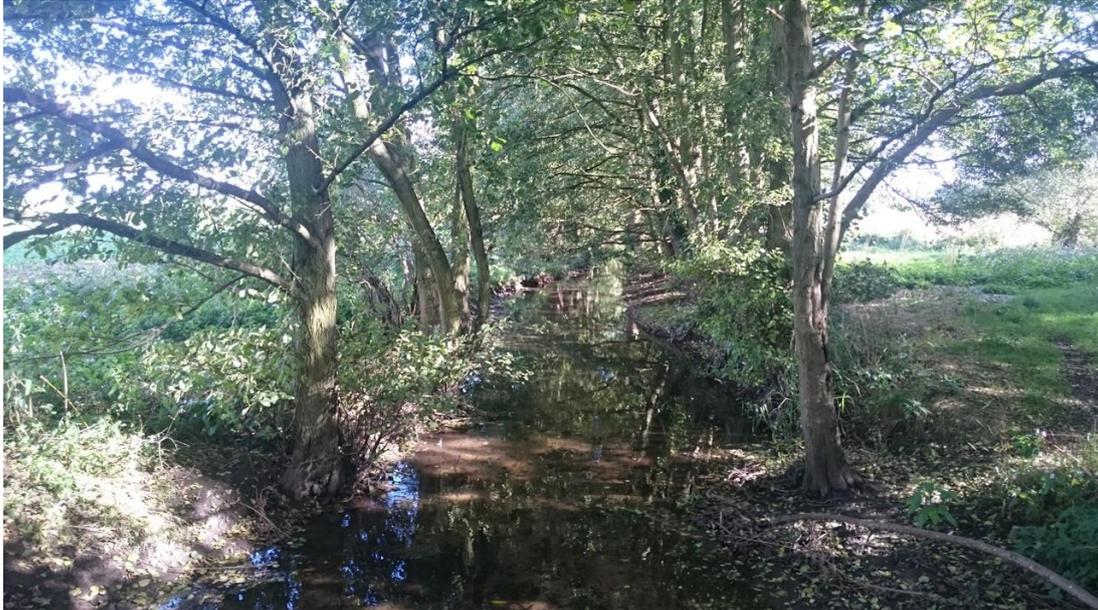
the physical habitat (whether in terms of flow velocity, depth, substrate-size or structural cover). The degree of straightening is illustrated by the photographs taken from the footbridge crossing point at (Fig. 9)

Figure 9: Completely straightened channel with uniform fine-sediment bed and low flow velocities under base-flow conditions.

The contrast of this almost stationary flow during dry weather to wet-weather flows where there is very little “roughness” to slow the progress of water downstream has important implications for aquatic foodwebs. Firstly, there is little refuge for fish to hold station against the flow (unless the river spills out onto the floodplain). Secondly, and more broadly, there is little opportunity for leaf litter and coarse-woody substrate to be retained in this straight, smooth chute. That means a loss of much of the nutrition accumulated in leaf litter that is exported out of the reach.

Overall, this is extremely degraded river habitat – the uniform depth at base-flow condition is too shallow to provide opportunities for the adult (and many juvenile) stages of most British freshwater fish species. The homogenous substrate also provides very little niche diversity for aquatic plants, invertebrates or vertebrates. There is little potential for in-stream productivity since photosynthesis is limited by shade as well as a lack of suitable surfaces for many microscopic primary producer species that a wide variety of stream invertebrates commonly graze on.

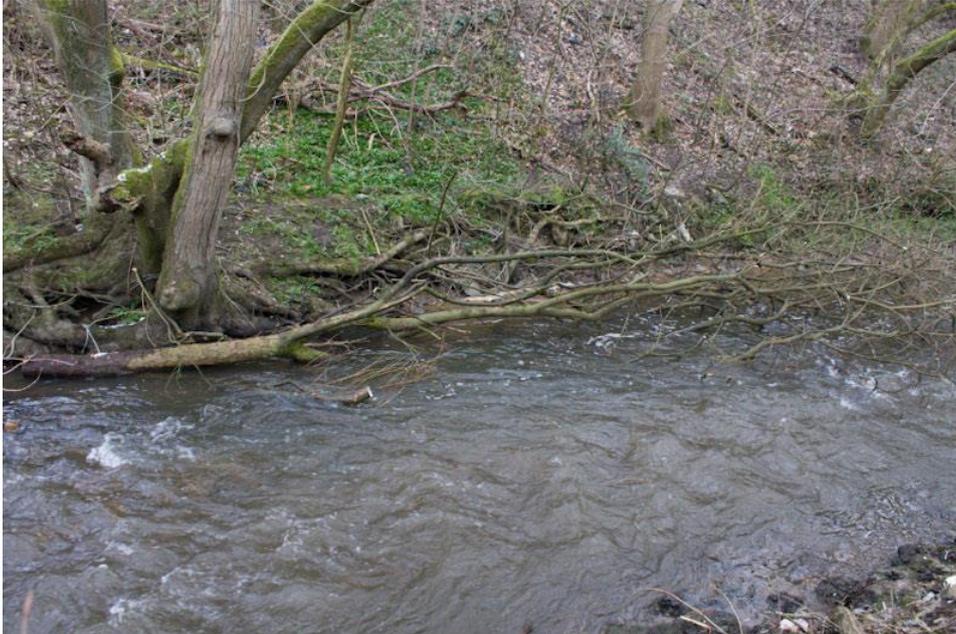
The "sorting" of gravel can be achieved by promoting localised bed-scour. As well as providing an excellent structural refuge and promoting some sinuous flow, a limited amount of such gravel-sorting is often associated with marginal tree "kickers" (Fig. 10).

Figure 10: Newly-installed tree "kicker" (attached to a secure anchor point using braided steel cable).

A guide to installation and the typical effects of a tree kicker can be seen in this video: <https://vimeo.com/72720550>.

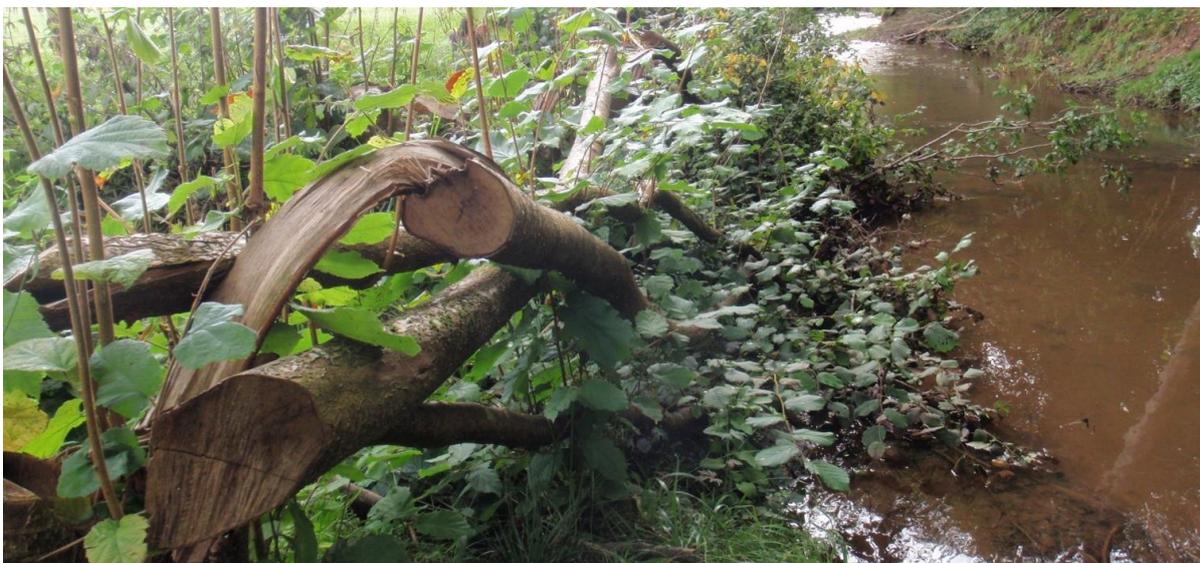
A suite of benefits comparable to those associated with tree-kickers, can be won by using simple "hinging" or "laying" (as in hedge-laying) of riverside saplings into the channel (Fig. 11). Tree species such as willow and hazel – or any species that thrives after being hinged – should be chosen for this technique.

Figure 11: Hinging or laying of saplings to create marginal cover (in this case using hazel).
