**River Mole and Yeo
West Wiltshire Flyfishers Guild**

An advisory visit carried out by the Wild Trout Trust – 30th October 2008

1. Introduction

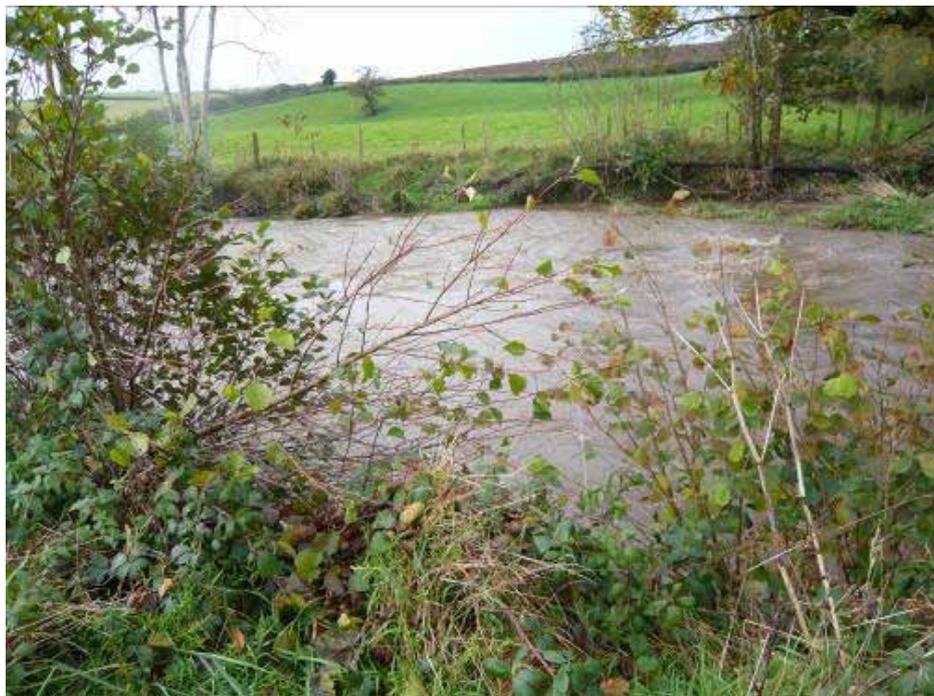
The programme of tree works already undertaken was designed to allow more light into the channel. This has undoubtedly benefited the river. There was clear evidence of coppicing along significant lengths of both rivers which, coupled with a programme of fencing, has given rise to improved low bushy cover interspersed with blocks of shading. Research has indicated that productivity of streams can be severely restricted by heavy shading. Riparian trees and their associated root systems play a vital role in protecting river banks from excessive erosion. Sensitive coppicing also preserves the life of some trees. Alder in particular can be preserved by coppicing when it becomes tall and leggy and vulnerable to collapse, especially when it becomes infected with *Phytophthora* disease which is rampant in some parts of the country.

A section where coppicing has taken place adjacent to good quality spawning and nursery habitat

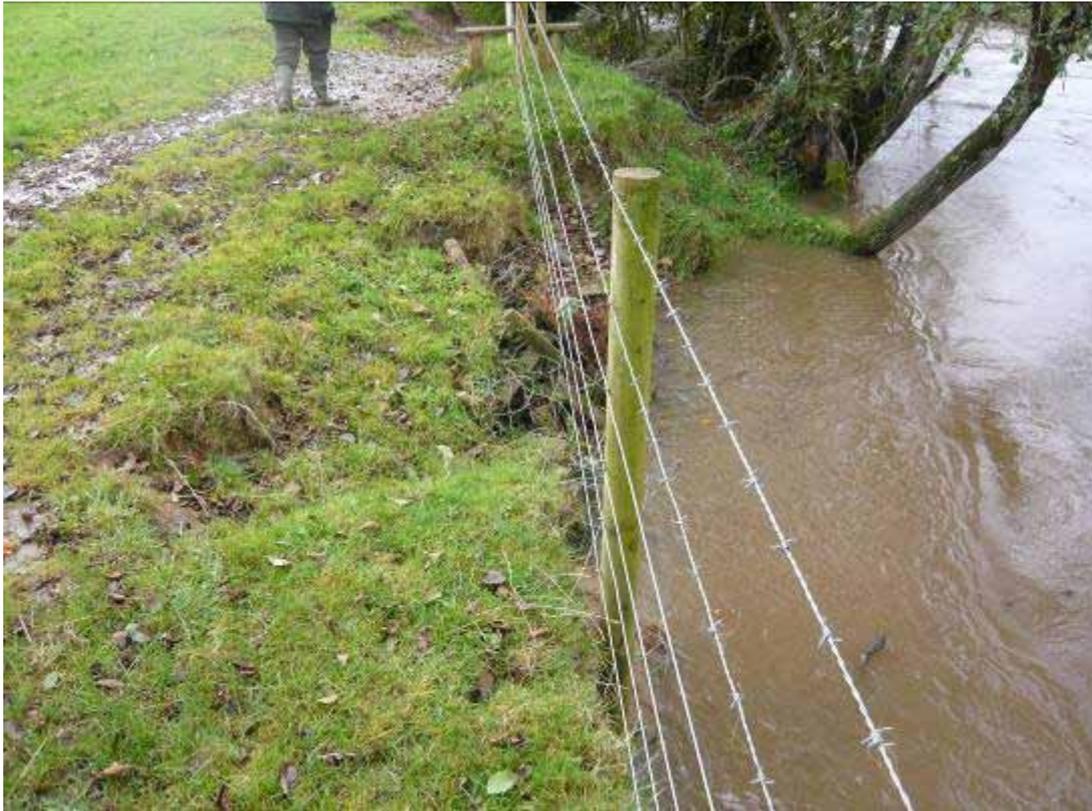
The programme of coppicing and stock fencing has been very extensive. There were some sections however, where the fence line had not been taken back enough to provide adequate protection for the bank. Although the fence does not adversely impact on angling (most fishing is carried out via wading), a larger buffer strip between fence and bank top would have encouraged thicker growth of riparian vegetation which provides more protection from diffuse pollution. A thicker fringe of riparian vegetation would also help to knit the soils together and combat marginal bank erosion.

Fence post hanging in “fresh air”. A wider buffer strip avoids constant re-alignment of fences and provides better protection for river and bank.

Opening a dialogue with the landowners over gradually increasing the width of the riparian buffer strip will also help to stabilise the banks and reduce amounts of diffuse pollution running in from adjacent meadows.

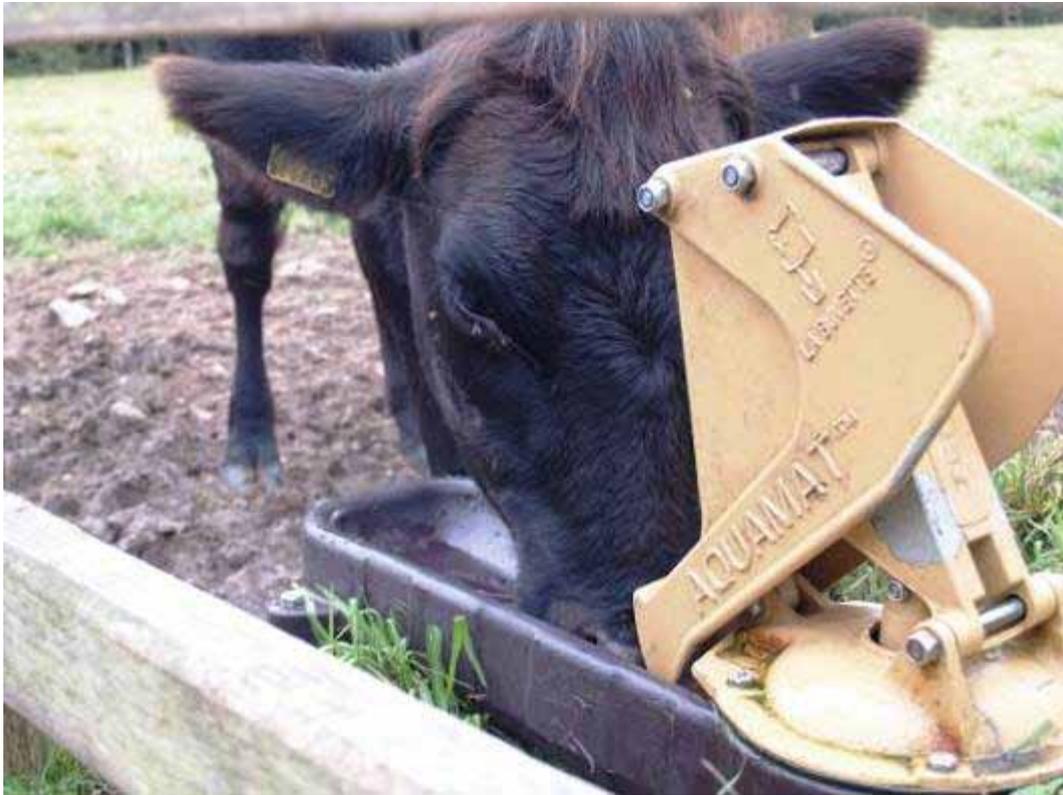
Several cattle drinking stations were observed throughout the reach. On the whole these did not appear to be excessively large or located in areas likely to damage sensitive habitats. One possible method of removing the need for any drinking stations would be to use a pasture pump which can be set up back from the river bank allowing safe and reliable drinking for cattle without the associated bank damage and threat of pollution. These devices do not require power or excessive maintenance but they are only suitable for beef cattle. Cattle soon get used to operating the pump and where they have been installed use the device in preference to conventional cattle drinking bays. These devices have been mainly used on rivers with stable water levels. Care needs to be taken to ensure that the delivery pipe is kept in the water at all times. This may be

difficult to achieve in a spate river like the Mole or Yeo. An alternative would be to consider mains supplied drinking troughs.

Bullock operating a pasture pump. A good method of protecting the river bank.

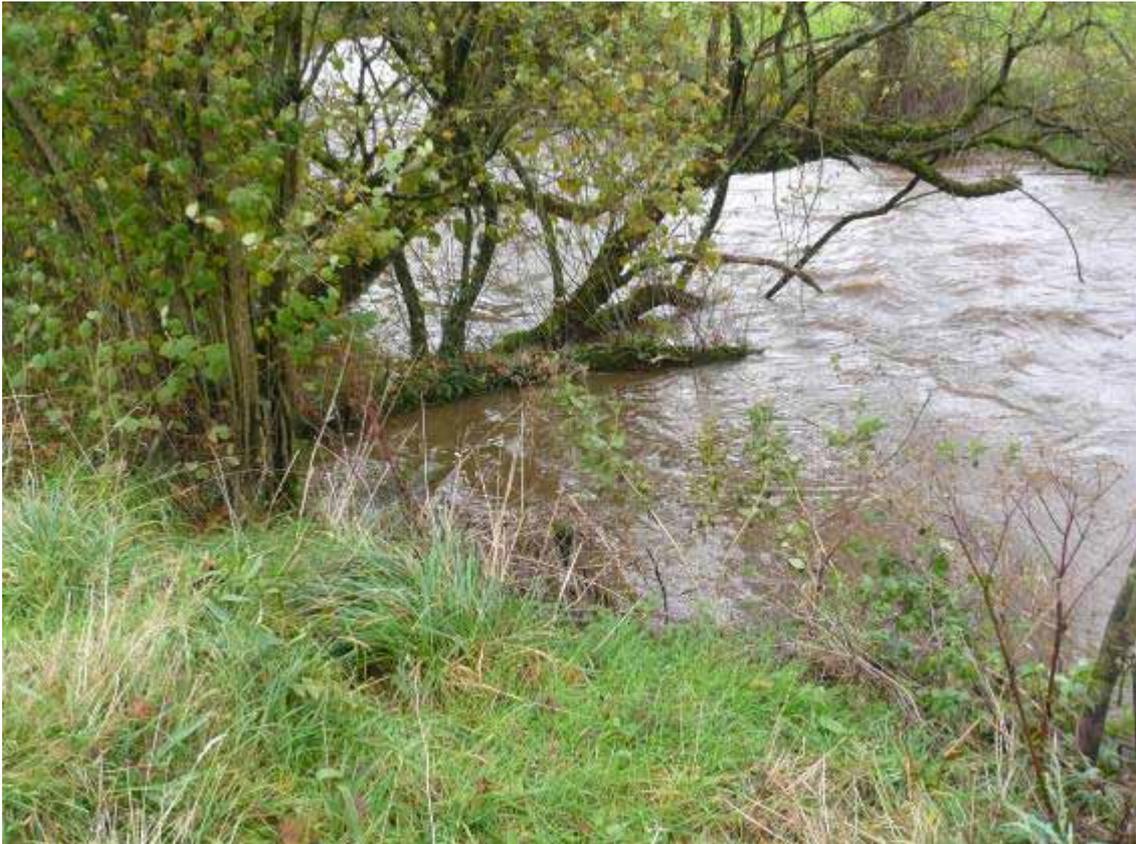
Due to the high flows it was difficult to see much in the way of in-channel features. The coppicing regime undertaken would have provided plenty of opportunities to use large sections of tree trunks and branches to improve trout habitat. Retaining Large Woody Debris (LWD) in a spate river can be difficult although there were some good examples of fallen, or half fallen live trees providing excellent in-channel habitat.

A perfect example on the Mole of how a live fallen tree can be stable and provide cover and habitat diversity

Should further tree coppicing be planned it may be possible to suggest that some species are hinged into the channel. The technique employed is to make a long, near vertical cut through the trunk, similar to that employed during hedge laying and winch the tree over into position, topping and securing as necessary. The technique works best with willow but can also be used on alder and ash trees. The undershot scour found below such fallen trunks promotes pool habitat and often blows up fresh gravels into ideal spawning ramps at the tail of the pool. To stop the tree from washing away in a spate it is recommended to secure them to adjacent live tree with cables.

We recommend that the fishing club should adopt a policy of retaining LWD in the river channel wherever possible. The West Country Rivers Trust provides a useful guide to the management of natural LWD:

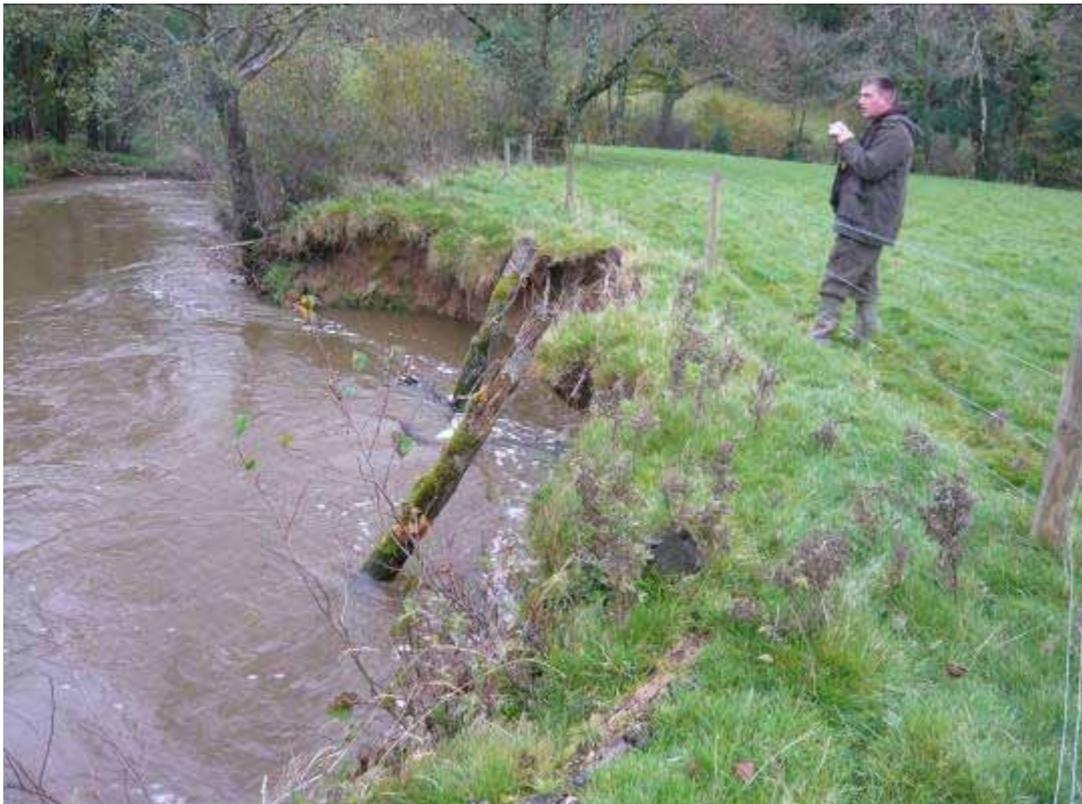
In most areas the banks were relatively stable. There were a few areas where erosion may be of some concern but generally the banks were well vegetated and relatively stable. One section of the Yeo had undergone some works using vertically driven poles designed to address erosion, however this did not appear to be working very well.

An eroding bank on the Yeo

One technique that can be employed to slow down the rate of erosion on the outside of deep bends is to use a "tree kicker" (see diagram below). These are whole fallen or cut trees that can be wired to existing live trees and back filled with brushings or faggot bundles. The "kicker" will rise and fall with varying water levels and help to absorb erosive high velocity flows thus helping to reduce bank side erosion.

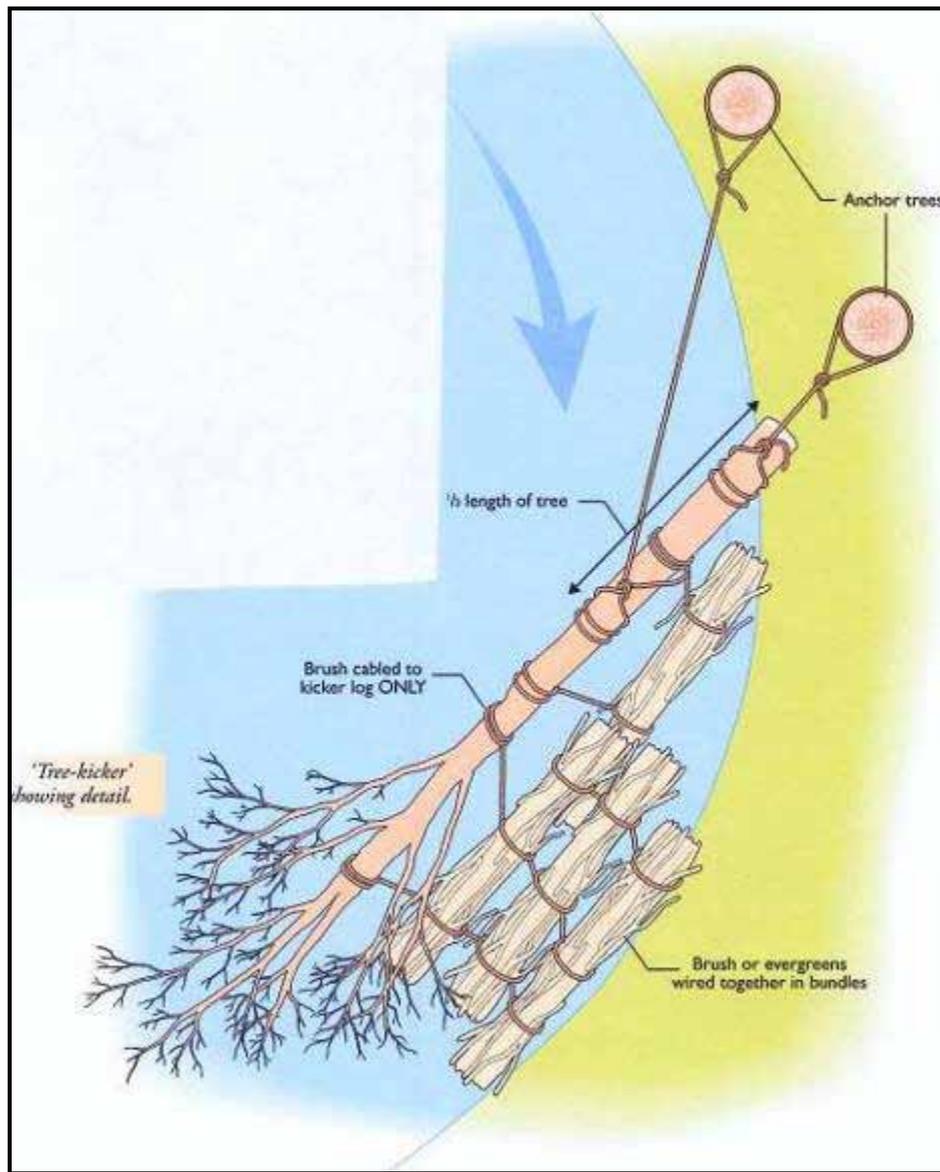
Tree Kicker used to combat erosion

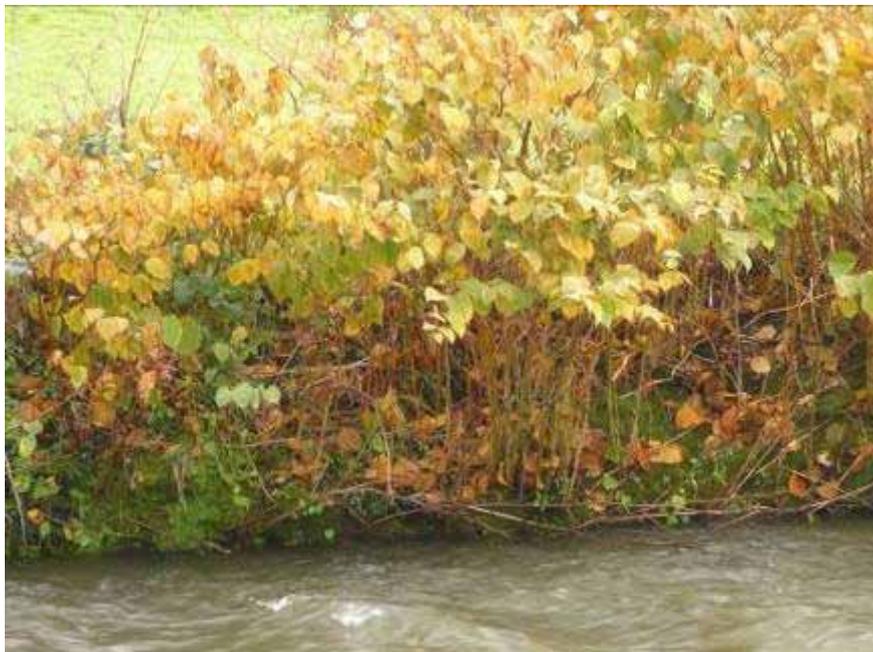
One area of concern relates to the presence of a large clump of Japanese knotweed *Fallopia japonica*, which was seen on a section of LHB on the River Mole about 500m upstream of its confluence with the Yeo.

A large clump of Japanese knotweed on the LHB of the Mole

This plant, along with Himalayan balsam *Impatiens glandulifera*, are non-natives and considered to be a real threat to bank stability, especially on spate rivers. Both plants suppress other ground vegetation and coupled with winter die back leave areas of bank bare and vulnerable to excessive erosion.

The eradication of knotweed is generally best tackled through the application of herbicide by qualified personnel. Any application of a herbicide within 8 m of a river will require a written consent from the Environment Agency. An application form WQM1 is available at:

- Introduce an annual programme of spawning enhancements by raking and cleaning known spawning sites each autumn.
- Encourage local scour on potential spawning sites through the use of pegged down LWD.
- Continue the programme of thinning any heavy canopy of tall shading trees to promote dappled light and utilise material for improving in-channel habitats. An ideal balance to aim for is 40% shading.
- Seek support and help from the local land owners in protecting banks by encouraging a gradual increase in the width of the riparian buffer zone.
- Retain and promote low scrubby marginal cover for both adult and juvenile trout.
- Continue to explore methods of reducing sediments loads and diffuse pollution in partnership with local land owners. Introducing pasture pumps and reducing the number of cattle drinks would be a great contribution.
- Remove the area of Japanese knotweed

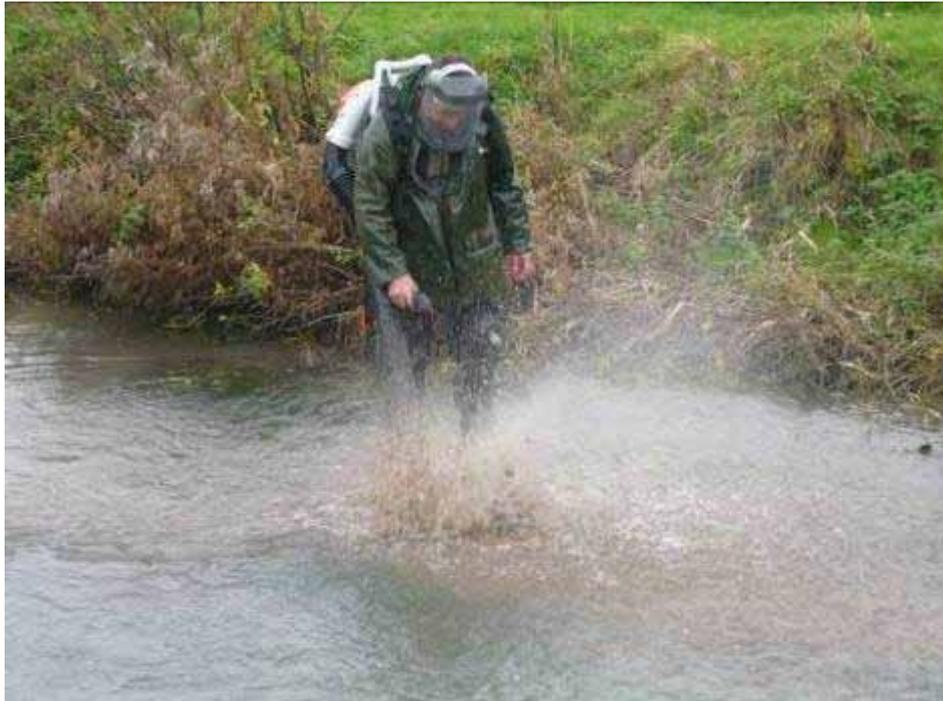
Sites currently identified as providing good spawning potential should be raked or pressure washed every autumn to leave gravels loose and silt free prior to spawning. Time spent looking at where trout spawn is often very useful in helping to plan further improvements. Gravel washing will have a temporary impact on invertebrates so do not clean areas that are not suitable for spawning. Note: These areas soon recover and clean loose gravel opens up habitat opportunities for stone loving insects as well as boosting egg to fry survival rates. Research carried out by the Centre for Aquaculture and Fisheries Science (CEFAS) has shown that salmonid egg survival on known spawning sites can be significantly improved by reducing sediment loads.

Gravel cleaning using a backpack leaf blower
