Moneypool Burn Habitat And Electrofishing Survey 2007

1 Introduction

Following concerns regarding declining sea trout catches on the Moneypool Burn (tributary of the River Cree), Galloway Fisheries Trust (GFT) were requested by the Wild Trout Trust (WTT) to examine the watercourse and advise on the health of sea trout stocks and suggest possible enhancement work if necessary. Data was collected by GFT staff by undertaking a habitat and electrofishing survey of the burn.

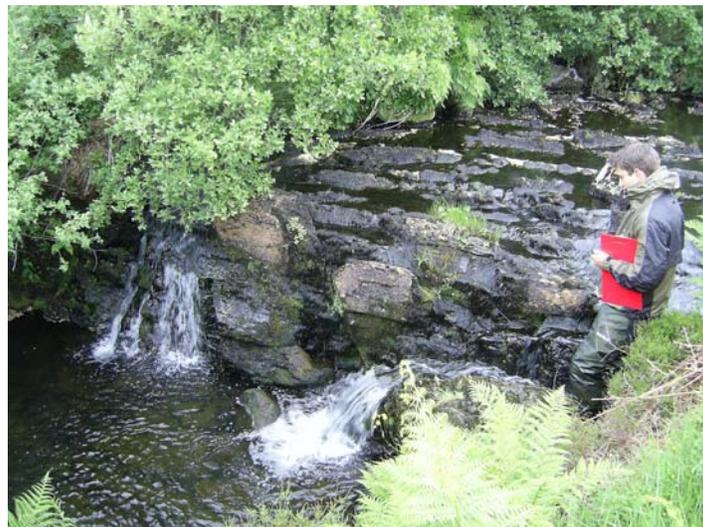
The upper reaches of the Moneypool Burn at MB5 contained a number of potential obstructions to fish migration. Two watergates situated a short distance upstream of the confluence with the Culcronchie Burn were easily passable, but should be monitored in case of future debris collections. Three waterfalls were located at Foremore. While two were large and potentially problematic, all three were considered passable given that suitable flows are present (*Fig. 1*). It may be that during drought years or periods of prolonged low flows, these waterfalls may prove impassable and limit fish access into the headwaters of the burn.

Figure 1: Waterfall at Fore Moor

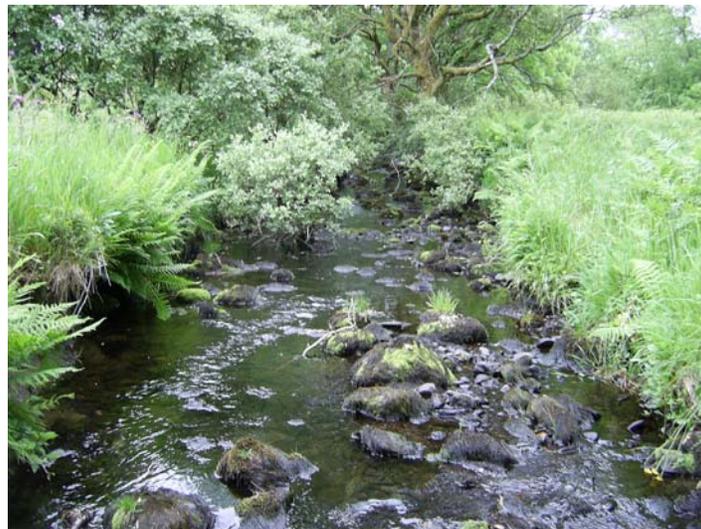
Where the burn effectively splits into two at the Culcronchie Burn confluence, the Moneypool Burn at MB5 becomes narrower and more stable. MB5 supports good-excellent juvenile habitat (Fig.2), with a high % of cobble and pebble substrate, with some boulder. This section of the burn potentially supports the best fry habitat, with numerous shallow riffles and runs present. There are a few areas of the burn at MB5 which flow over bedrock, particularly at Fore Moor, which will limit instream cover.

Figure 2: Example of excellent instream habitat on the Moneypool Burn (MB5)

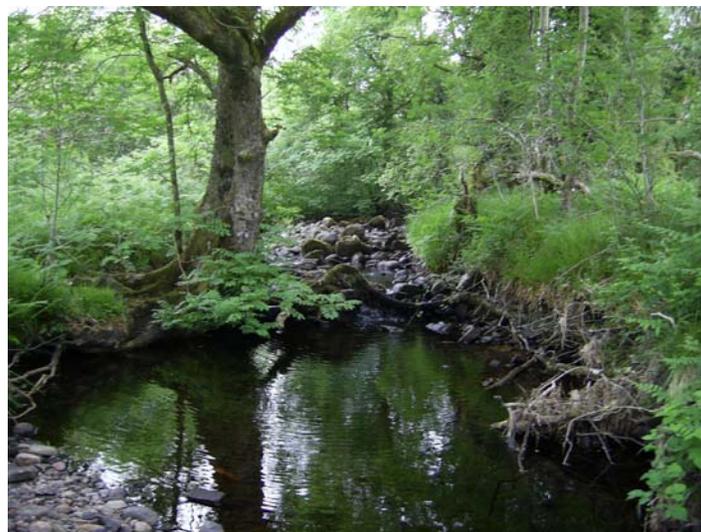
Riparian fish cover was highest in sections MBC1 and MB5, where the burn splits in two and becomes narrower. At these sections, bankside fish cover is more abundant on the main stem, with undercut banks, root wads, draped vegetation, and large rock providing cover (*Fig.3*). Both these tributaries were considered to support the best riparian habitat in the catchment.

Figure 3: Good riparian habitat – fish cover provided by root wads, draped and undercuts

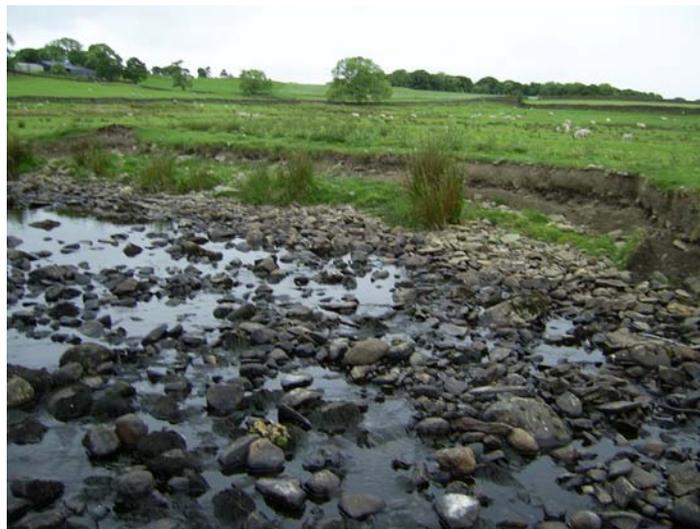
One area of MB5 at Fore More was the only section of the burn suffering from over-grazing and trampling (*Fig. 4*). This part of the burn is unfenced from NX 506 610 – NX 508 610 (approximately 500m of both banks).

Figure 4: Over-grazing and trampling at MB5

In this case over-grazing has led to trampling of the left and right banks, which has increased the channel width and reduced instream cover. Trampling has reduced fish cover along both banks and has exacerbated erosion.

Over-grazing and trampling was only considered a problem in one section of the burn in section MB5 at Fore Moor. This situation has exacerbated erosion and has reduced both instream and bankside fish cover. As this survey has highlighted this section of the burn as an important area

As this section of the burn supports the best spawning and juvenile habitat in the catchment, this section should be fenced or have some other stock exclusion in place to avoid further degradation.

for juvenile production and spawning, GFT would recommend that both banks are fenced to avoid further degradation.

1. Fence both banks of the Moneypool Burn at Fore Moor (MB5- NX 506610 – NX508610).
2. Coppice branches and thin out woodland on main stem of the Moneypool Burn between Creetown and the Culcronchie Burn confluence (MB1-4, NX 473 589 – NX 611 505).
3. Monitor trends in juvenile salmon and trout abundance in the Moneypool Burn, by carrying out annual or biannual electrofishing surveys.
4. Expand electrofishing survey to include a greater number of sites to determine distribution, as well as juvenile abundance and production in other areas of the catchment.

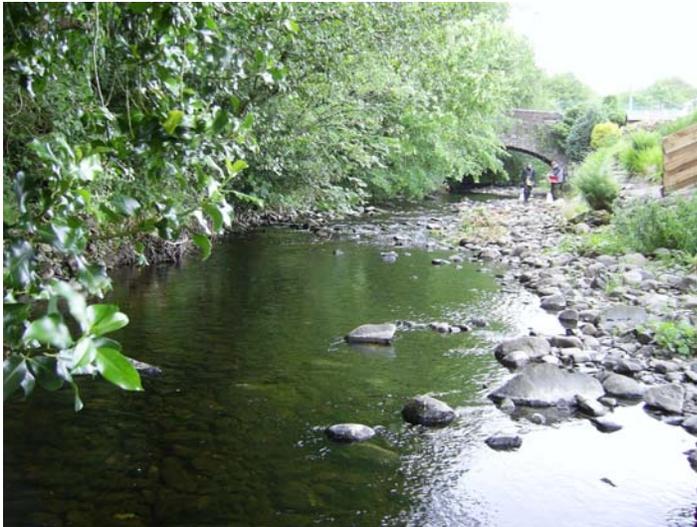
Site 1 – Moneypool Burn at Creetown

This site was chosen to assess juvenile densities in the lower reaches of the burn and was situated a few 100m upstream of the tidal limit.

Healthy densities of juvenile salmon and trout were recorded at this site. A moderate density of salmon fry (>12 per 100m²) were recorded along with a very good density of salmon parr (>12 per 100m²). While trout fry numbers were low (>6 per 100m²), trout parr numbers were also very good (>15 per 100m²). Eels were also recorded at the site.

Substrates were dominated by cobble and boulder, which provides good instream cover for salmon parr. Some pebble and gravel was also present. The flow was generally comprised of run, shallow glide and riffle.

While instream cover was good, there was only a small amount of fish cover (10%) on the right bank, provided by a small undercut with some draped vegetation. The left bank provided no fish cover and was 100% bare. Canopy cover was provided by broadleaf trees on the right bank.

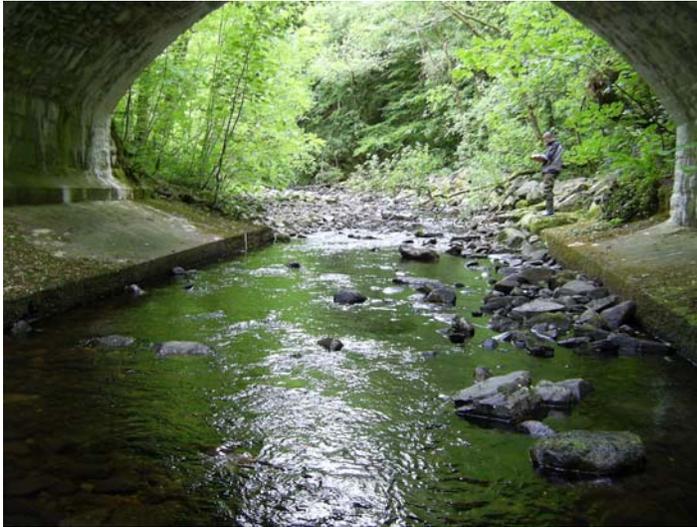
Site 2 – Moneypool Burn – Road bridge at Chain Wood

This site was located at Chainwood and was below the road bridge. This site was chosen to assess juvenile production in the middle reaches of the catchment.

Both salmon and trout were present at this site. Salmon fry numbers were good (>33 per 100m²), while salmon parr numbers were very good (>11 per 100m²). Low numbers of trout fry (>2 per 100m²) and trout parr (>3 per 100m²) were recorded at the site. A few eels were also recorded.

Water flow depths up to 40cm were recorded at this site. The upper section of the site was predominantly of run, while the lower section was a mixture of shallow and deep glide flows. Substrate was dominated by cobble and boulder, with some small pockets of pebble.

With such a high % of boulder (50%), instream cover for parr was regarded as good. Both banks were recorded as bare (100%) and supported very little cover. Canopy cover was provided by large broadleaf trees on either bank and was regarded as optimum for fish cover and primary production (50%).

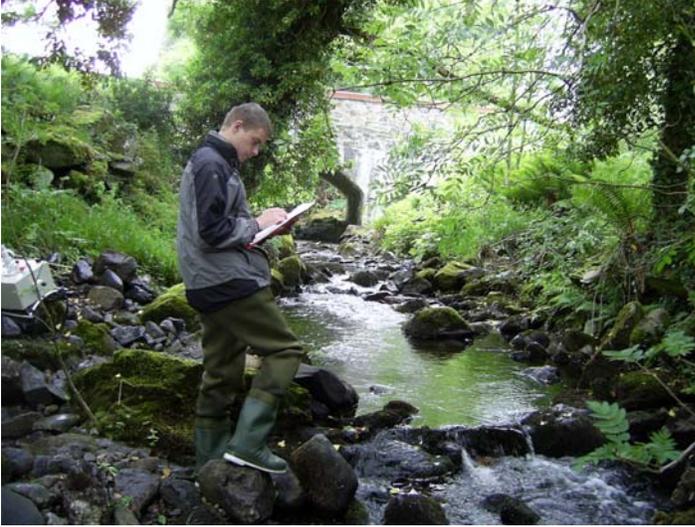
Site 3 – Culcronchie Burn

This site is located 30m downstream of the road bridge at Culcronchie Farm. A low density of salmon fry (>6 per 100m^2) were recorded at this site, while salmon parr were absent. Trout fry numbers were also low (>8 per 100m^2), while trout parr numbers were moderate (>7 per 100m^2). A good number of eels were also recorded at this site.

A range of water depths were recorded at the site, predominantly between 11-40cm. Boulder and cobble were the dominant substrate, with also an area of bedrock, some pebble and gravel present. The substrate was generally stable and uncompacted. The flow was composed primarily of run and deep glide, with some riffle and shallow glide also present.

Instream cover was classed as moderate, as areas of bedrock which provide little fish cover was present. Bankside fish cover was low on both banks, with only a small % (10) available on the left bank from a group of large rocks. Canopy cover was high at 60%.

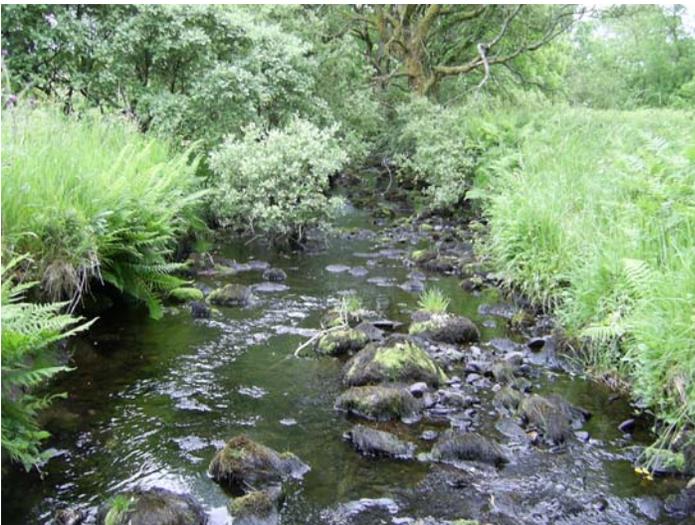
Site 4 – Moneypool Burn at Fore Moor

This site is located approximately 60m upstream of the confluence with the Culcronchie Burn. This site was surveyed to assess salmonid accessibility and juvenile production in the upper catchment.

An excellent density of salmon fry (>134 per 100m²) were recorded at this site. Salmon parr numbers were low (>2 per 100m²). Trout densities were low (>2 per 100m²), while trout parr densities were moderate (>6 per 100m²). A good number of eels were also recorded.

Water depth of up to 30cm were recorded, with the majority <20cm. The flow was mainly comprised of run (50%), with some shallow glide and riffle. The substrate was mainly composed of pebble (30%) and cobble (40%), with boulder, gravel and sand also present. The substrate was stable and uncompacted.

Instream fish cover was generally good. Bankside fish cover was also good, with undercut cover on the right bank and draped fish cover on the left bank. Canopy cover was moderate at 40%, provided by a few broadleaf trees on either bank.
