Upper East Stour, Monks Priory, Kent

Advisory visit May 2016

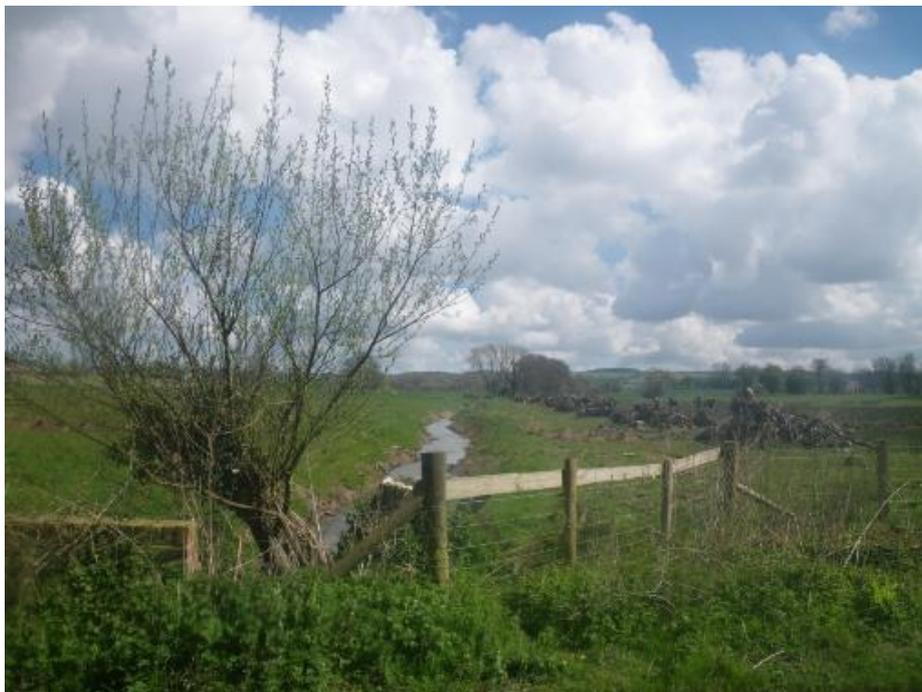
In the reach immediately upstream of the Monks Priory water there has been some recent in-channel dredging work which has included the removal of large numbers of trees, including their root systems (photo 1). Presumably this work was undertaken by the neighbouring land owner, or tenant in an attempt to improve local land drainage. This potentially damaging work will have resulted in notable destabilisation of the banks and large quantities of fine sediment being

mobilised which will impact upon habitat quality within the Monks Priory reach. Any mobilised sediment that then settles onto shallow gravel runs can catastrophically impact on fish spawning success by filling the gravel matrix with fine sediment and potentially smothering fish eggs, resulting in poor egg to fry survival rates and degrading invertebrate and plant habitats. Hopefully any damage incurred as a result of the redistribution of fine sediment at Monks Priory will be temporary as silt is gradually moved on by natural river processes; however, any long-term bank destabilisation could create an ongoing issue.

Unfortunately, the work undertaken upstream will also be resulting in the stream warming up. Tree shading is very important for small streams and is particularly important for species like brown trout that require cool, well oxygenated water. Research carried out by the Forest Commission and others has clearly identified how even comparatively short sections of tree shading can help to moderate water temperatures in flowing streams. Conversely, wholesale tree removal can result in a warming effect, especially under low flow conditions, with the stream less able to retain the high levels of dissolved oxygen required to sustain a trout population.

Photo 1. The section upstream has been badly degraded by the wholesale removal of all tree cover, including root systems.

- Engage with your upstream neighbour over methods for managing the stream and banks.
- Coppice occasional stands of mature alder to preserve the life of long, leggy trees, particularly those with exposed root systems.

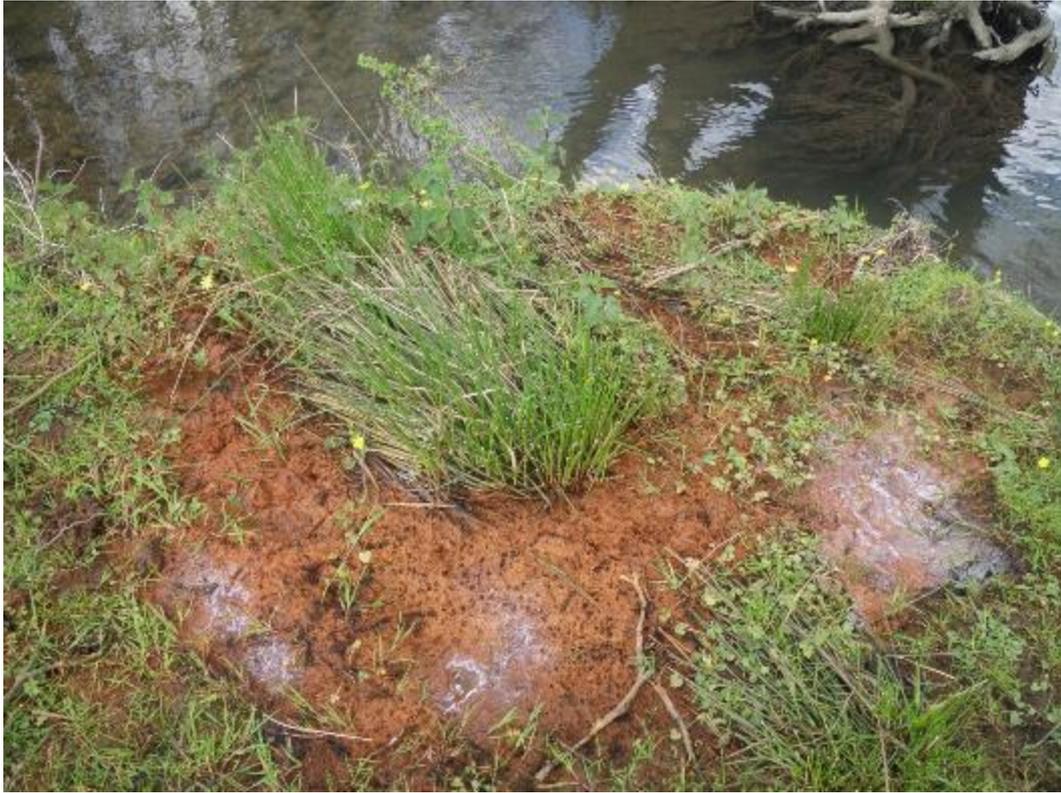
Photo 2. Iron rich groundwater source adjacent to the stream.

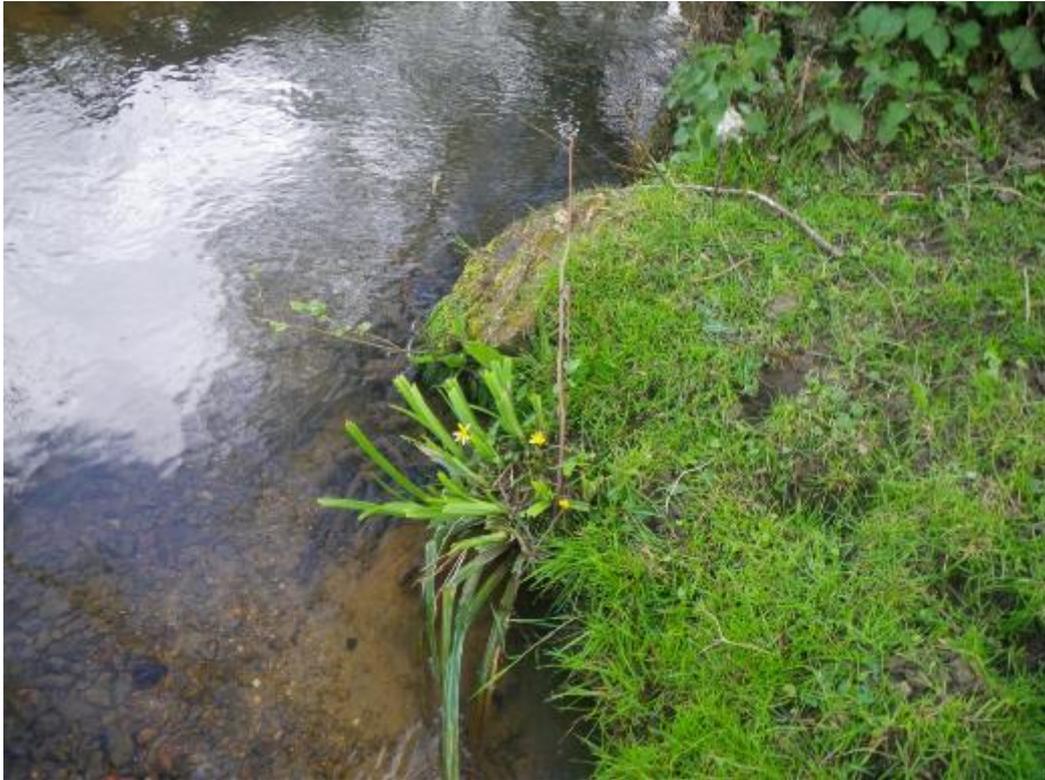
Meadows adjacent to the left bank are being used for grazing livestock. There was evidence of excessive grazing pressures (photo 3) which is impacting on bank-side plants, reducing their capacity to provide a biologically rich river margin, as well as leaving the banks more vulnerable to increased river erosion pressures. Excluding grazing animals from selected sections of sensitive river bank via targeted stock fencing will help the margins to develop a more diverse and healthy range of plants. This in turn will provide improved habitats for invertebrates and ultimately more food for fish, while also stabilising the bank.

Photo 3. Marginal sedges are considered to be very good for bank protection and providing habitat for invertebrates. Less nibbling will result in a thicker fringe developing.

- Encourage rougher, more naturalistic river margins to develop by reducing bankside grazing pressures. This can be achieved via permanent or temporary fencing and will help to protect the banks and provide habitat for fish and the food of fish. It must be ensured that any subsequent grazing does not compromise the establishment of herbaceous vegetation and shrubs.

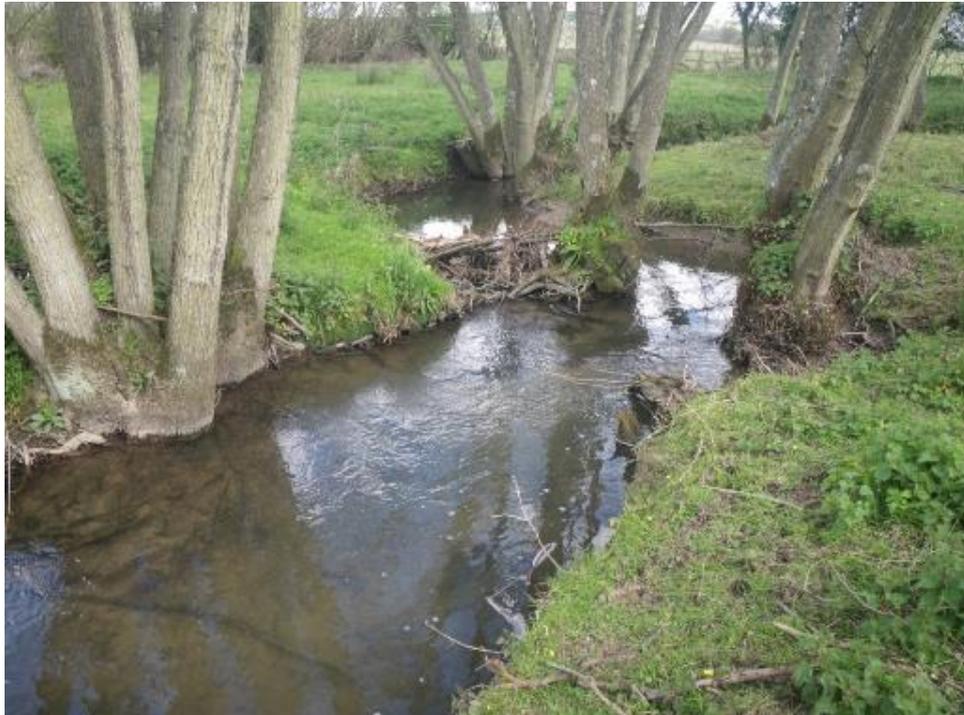
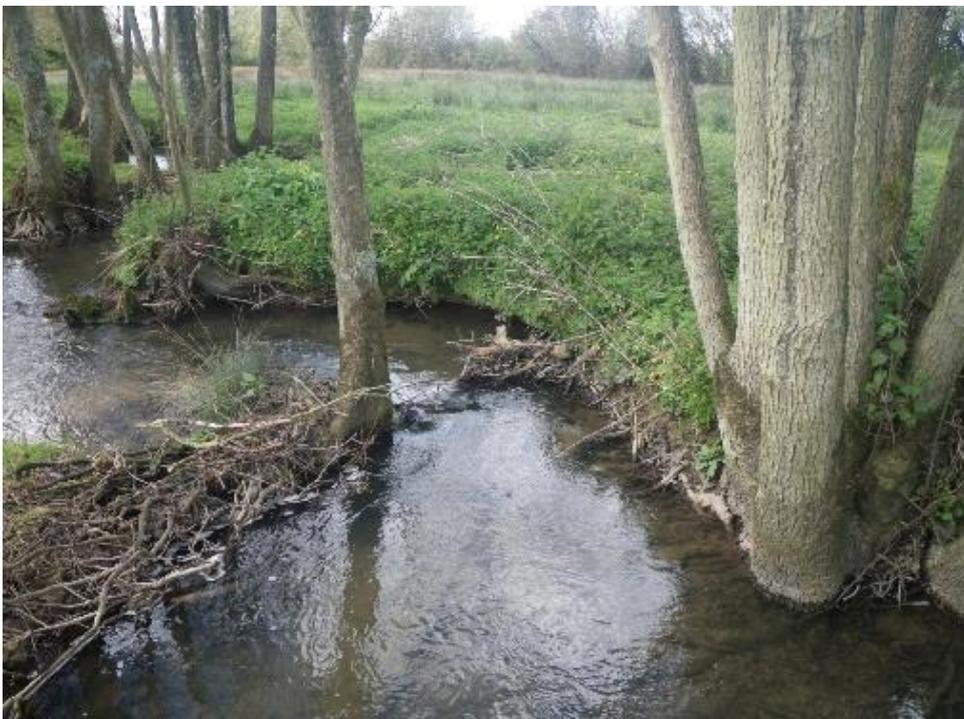
In some areas, there is evidence that marginal alder trees have been previously coppiced. Consideration should be given to carrying some further light coppicing work to introduce some variety into the height of the tree canopy and also to preserve the life of some of the stands. A good example is where a tree is in danger of being washed out and the root system exposed (photo 4 & 5). Coppicing the tree on the mini island will reduce the risks of this particular tree falling over and causing a full-width debris dam from forming. Again, this should only be undertaken after exclusion of livestock, otherwise you will simply lower the canopy into their reach.

Photo 4 & 5. The alders in the centre of the channel should be coppiced to preserve the tree and root systems.

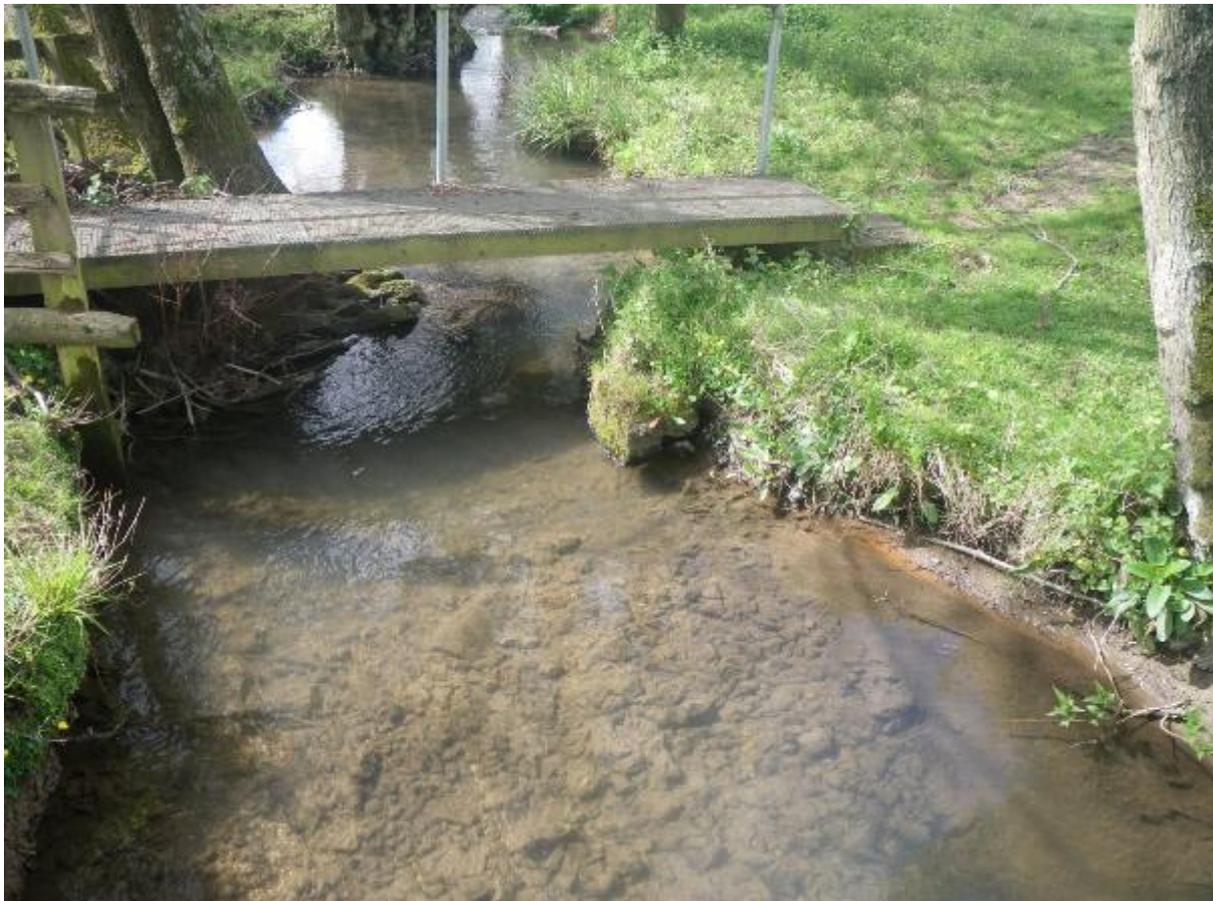
There were some good examples of shallow, gravel-lined runs, which potentially can provide high quality spawning opportunities for a range of fish species, including trout. Much of the gravel appeared to be covered in a thin layer of fine sediment and as previously discussed, this may be due, in-part, to issues further upstream. Trout spawning success can be enhanced on sites like this with a few hours of work undertaken just prior to trout spawning season in the November to January period. Raking the gravels to reduce the fine sediment loads can significantly help to boost spawning success.

Photo 6. A potential spawning site coated in fine sediments.

Further information on exactly how and where to undertake gravel cleaning can be found on the Wild Trout Trust website, including instructional videos.

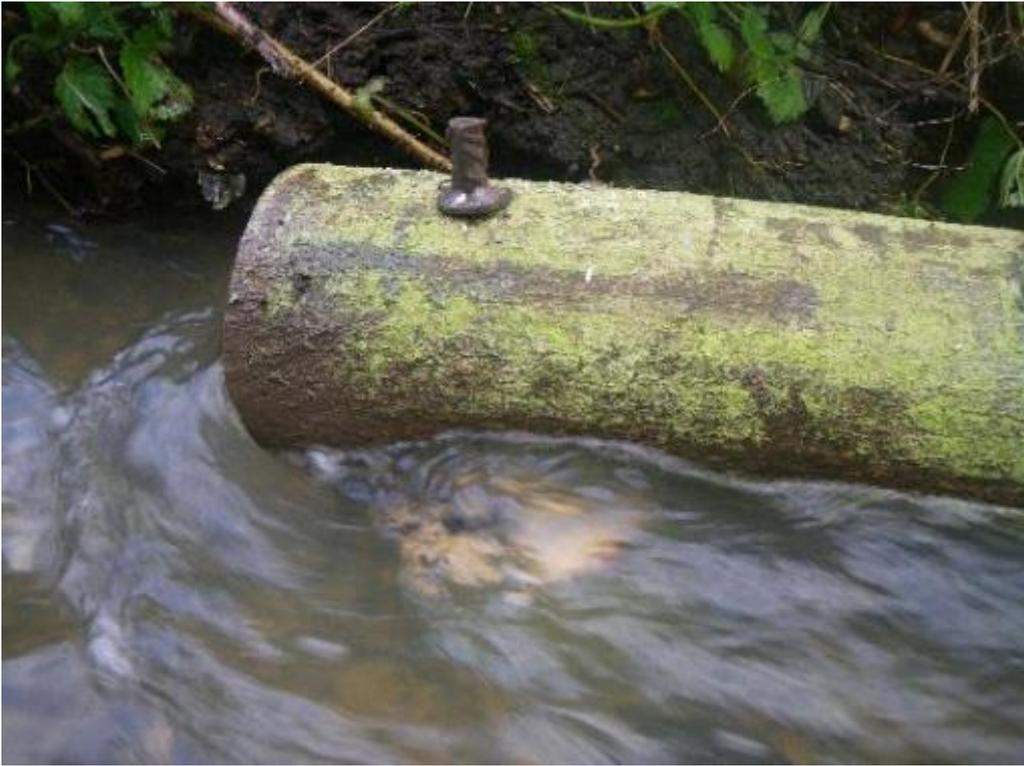
Photo 11. Correctly installed parallel to the flow and tight against the river bank.

On sections where in-channel cover is scarce, consider introducing woody material to create cover and promote bed scour. 'Cover' logs popped in parallel to the flow and adjacent to the toe of the bank can also encourage trout to take up residence in open, shallow environments. The principle of the cover log is that there is a gap underneath where trout can safely hide from predators but also safely nip out into the flow to intercept passing food items. To be effective they need to be positioned adjacent to the margin that carries the majority of the flow velocity. A cover log is shown up on the bank ready for deployment in photo 7 and how they should look once installed into the channel, mimicking an undercut bank (photo 8). Simple brushwood bundles installed (photo 12) in similar fashion are also hugely effective, especially on sections immediately downstream of known spawning sites.

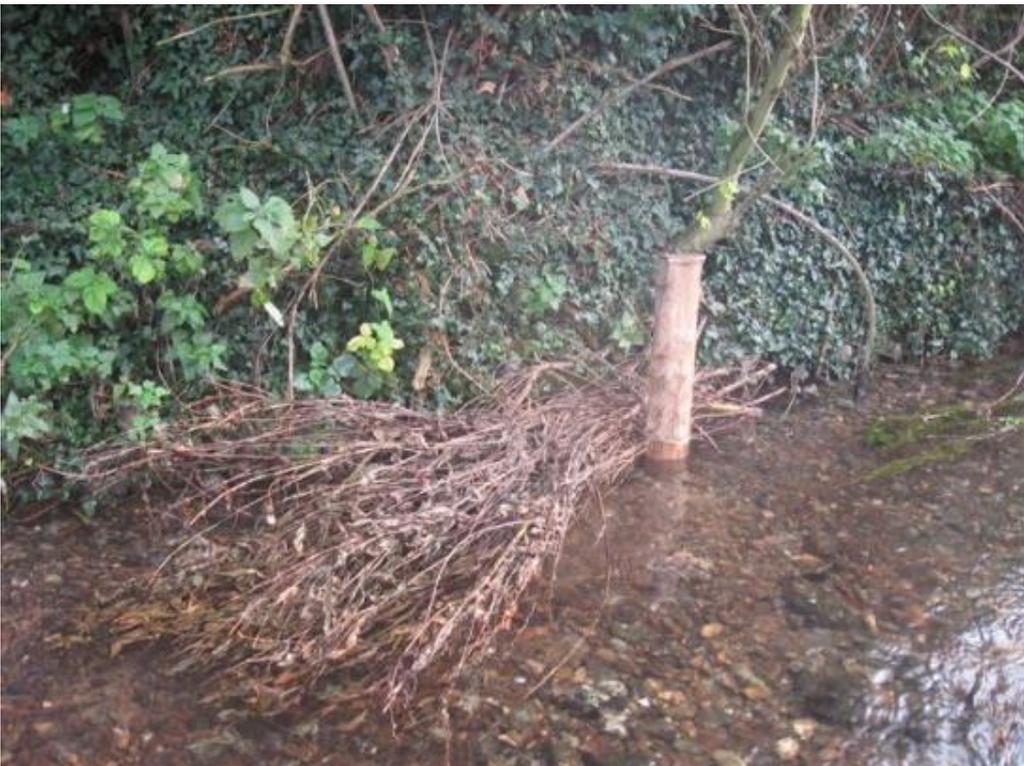
Photo 12. A simple brushwood bundle wired to a driven chestnut post providing cover for newly hatched trout fry in a shallow gravelly margin.

- Introduce woody material to the channel to promote bed scour/sorting and provide cover. Use large woody material to promote bed scour, parallel cover logs for adult trout cover, and brushwood for enhanced fry and parr cover.
