River Monnow – Monmouth & District Angling Society

An advisory visit carried out by the Wild Trout Trust – April 2011

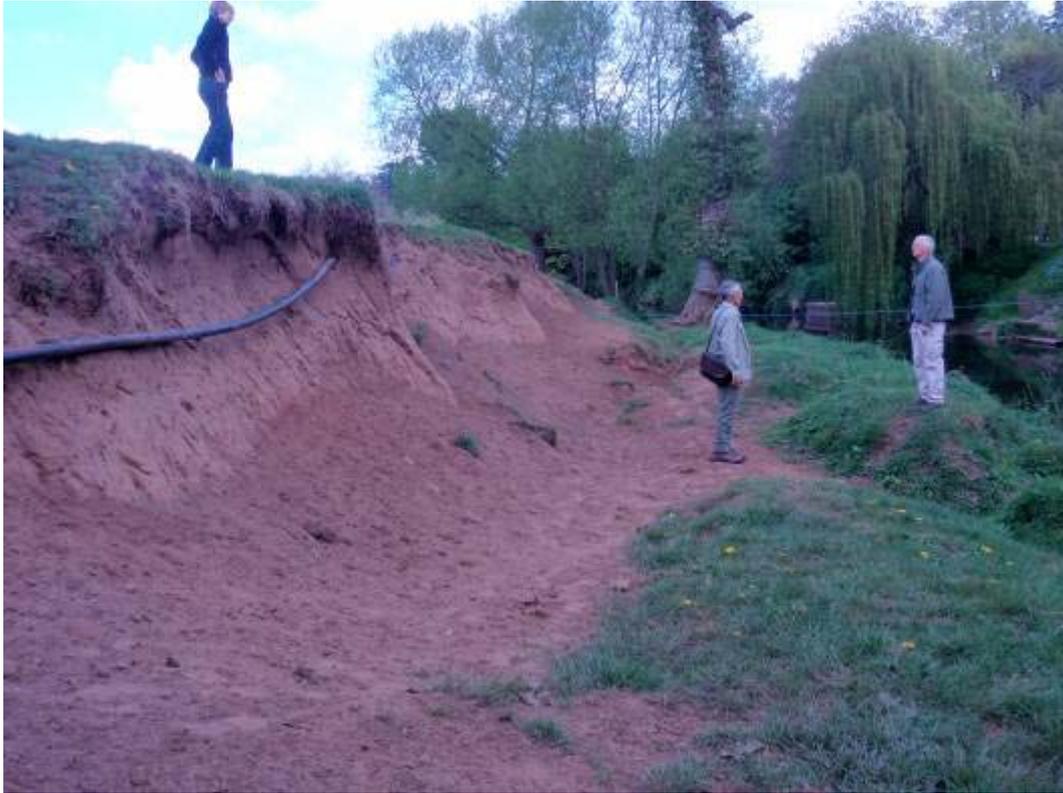
The section of bank causing concern is situated on Vauxhall Meadows on the inside of a sweeping bend. The length of bank which has been eroded extends to approximately 50 metres. The trigger for the initial erosion is not known but in recent years the line of the RB has been nibbled back by the river and a large gully has been eroded, exposing the soft friable soils to further wear.

Eroded bank with exposed water pipe. Note the river bank margin appears to be relatively stable at this location.

The upper section where the gully has formed should be regraded with an excavator ideally to a batter of at least 1:3. To achieve this, the very top of the cliff will need to be excavated and the arisings placed in the depression and then the whole bank graded back to achieve the required slope. The surface must be stabilised with a biodegradable geotextile and either seeded with an appropriate approved seed mix and/or planted with plant plugs, local sods and willow whips. The whole area will then need to be fenced for at least two full growing seasons to enable the planting to become well established. Cutting the bank back and excluding grazing animals may prove to be unpopular with the land owners. However, without remedial action it is likely the gully will get bigger and land will be permanently lost as the river creates a new course. It will also be important to exclude anglers and walkers (and their dogs) from the area until such time that the bank has fully recovered.

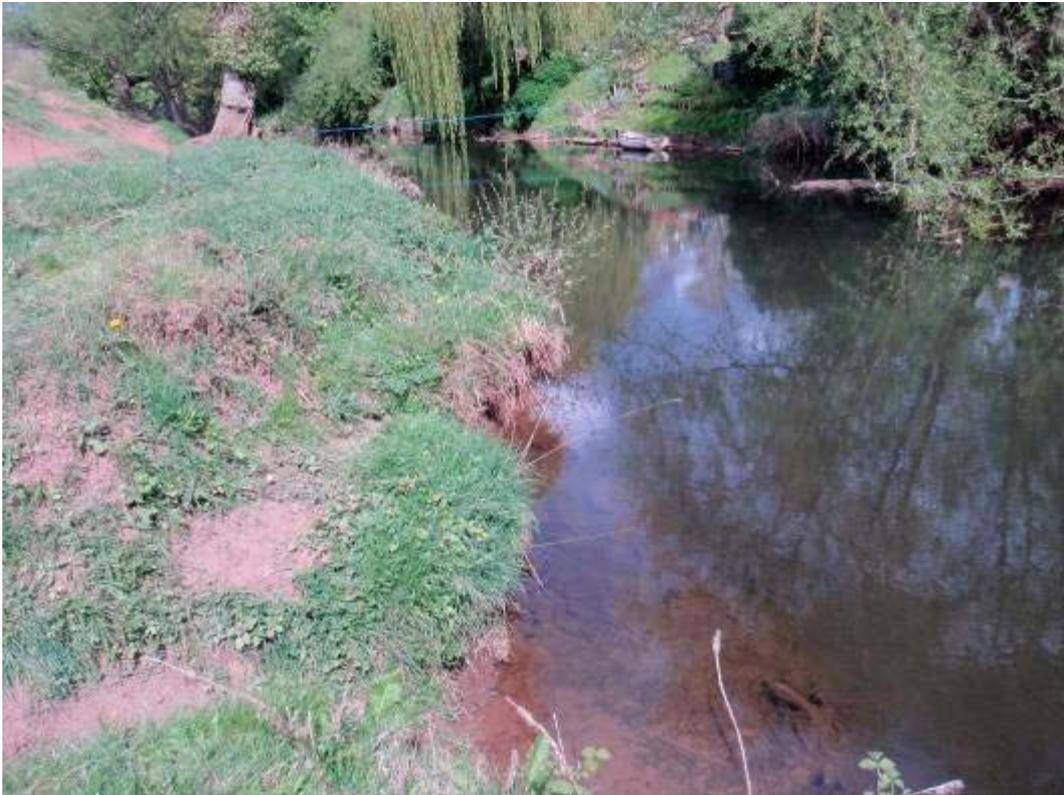
The toe of the bank is reasonably well vegetated and looks to be relatively stable

On the downstream apex of the bend the erosion is more problematic because it extends right down to the toe of the bank. In areas like this the bank is extremely vulnerable to further erosion causing the river to gradually become wider. It is important that the river has some wide, shallow sections of channel, which are extremely valuable habitats for juvenile fish. However, the margins are critically important and the complete lack of any vestige of cover will render this section a very poor habitat for juvenile fish.

On the lower section where the erosion has occurred right down to toe of the bank a different solution is recommended. Here some parallel tree trunks should be pinned to form a new solid toe to the bank. This will provide an anchor for a brush mattress which should be laid up against the eroded face and either wired down to driven clefts, or secured with cross laths nailed over the top.

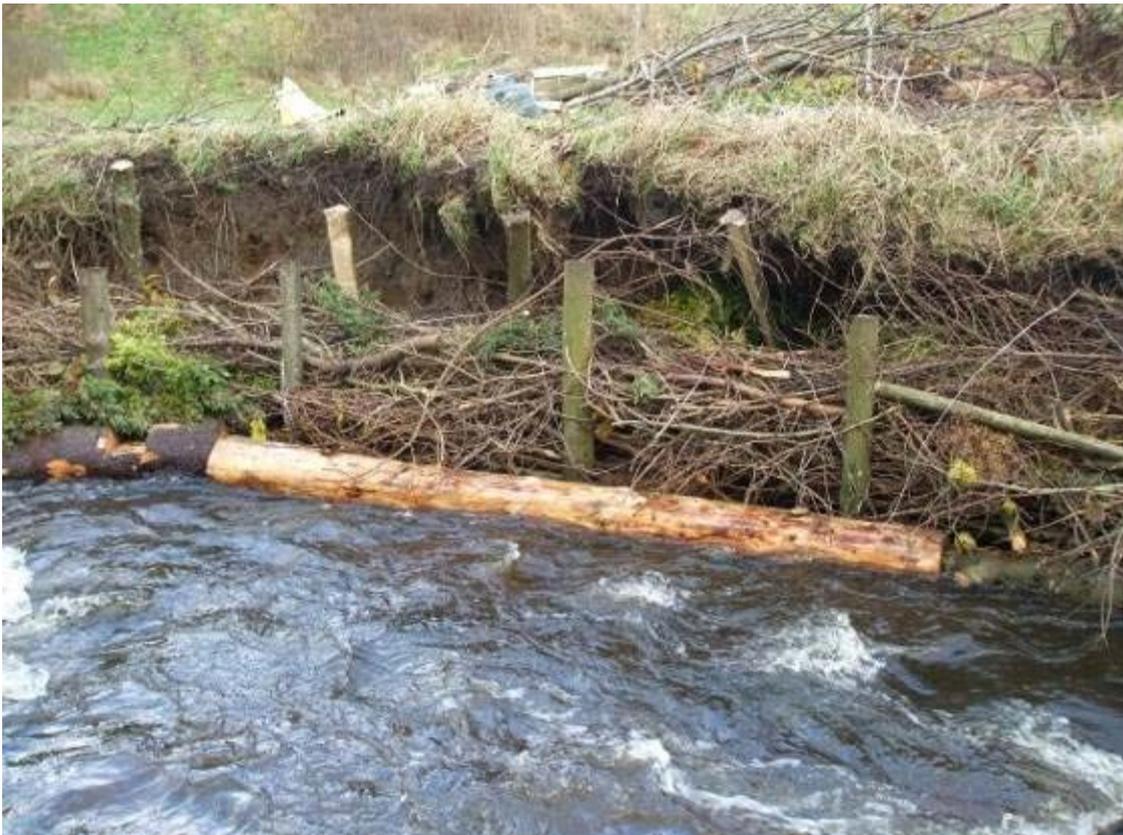
Work in progress. Tree trunk sections pinned to the toe of an eroded bank to be backfilled with wired down brush on the River Colne in Lancashire

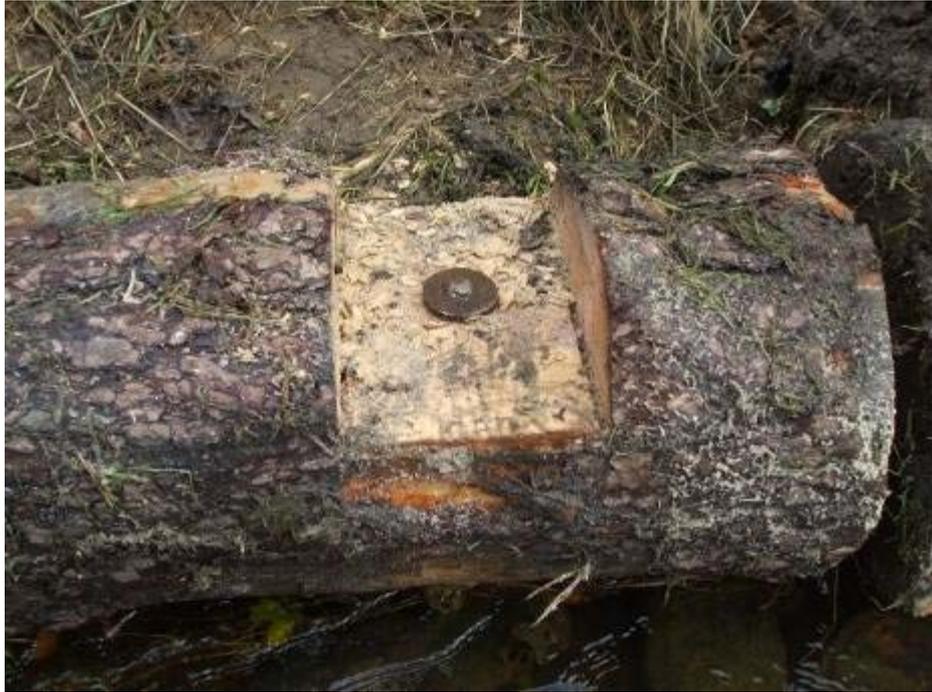
Trunks can be secured to the river bed using 2m lengths of 18 -20 mm steel re-enforcing bar at 2m centres. The trunk is pre-drilled with a wood auger and the trunk is secured in place with a large washer either pre -welded to the bar or alternatively cross pinned (see below).

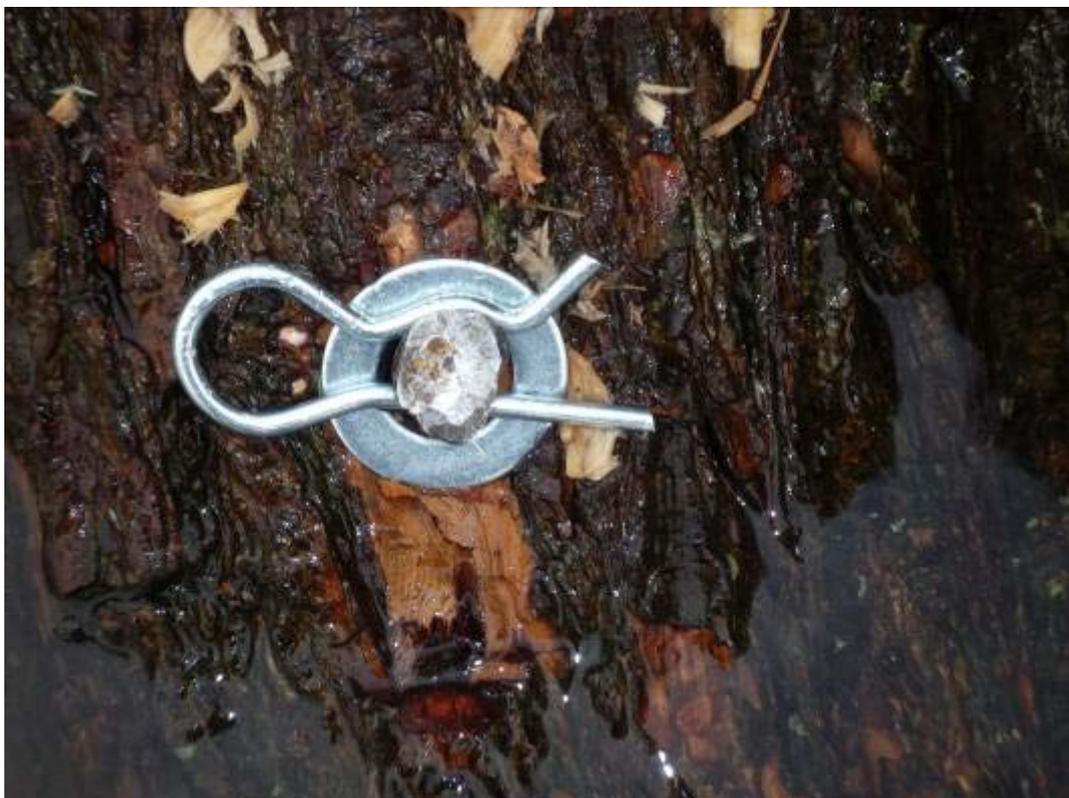
Cross drilled and pin method

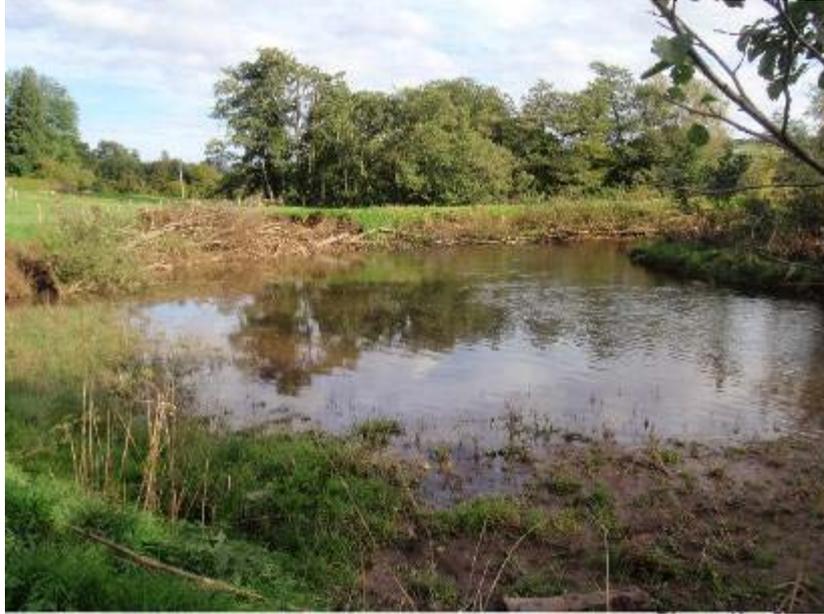
A large eroded bend on the Monnow at Pandy defended with “whole” tree revetment

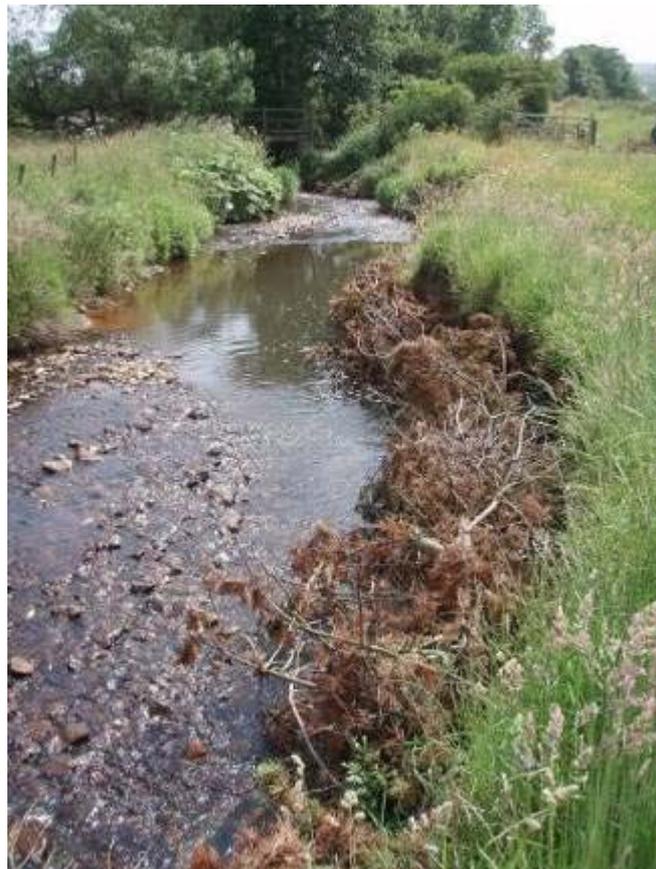
Soft revetment using brushwood against an eroded bank on the River Manifold – this has provided excellent marginal cover for small trout as well as for riverfly species such as the southern iron blue.
