Advisory Visit

River Nidd, Harrogate Angling Association

15/06/2018

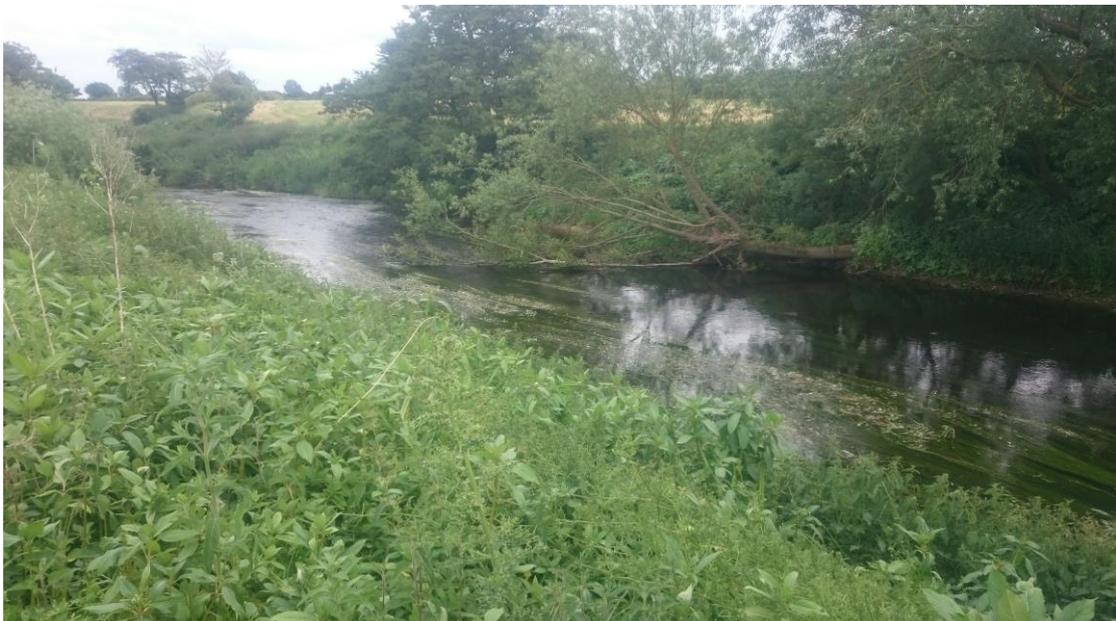
- Both instream and bankside (riparian) habitat are generally good throughout Harrogate Angling Association waters. Indeed, buffer strip maintenance in the eastern half of Ribston Park is exemplary. However, the presence of historic flood bunds is causing considerable incision of the channel and leading to some sluggish impounded sections.

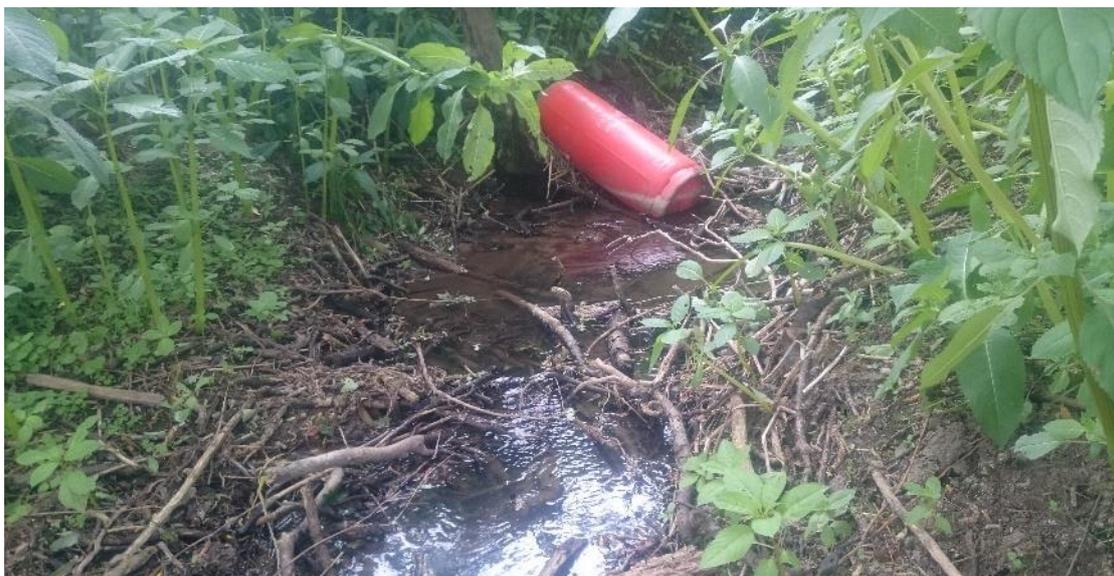
The small (un-named?) beck joining the Nidd from the LB marks the upper limit of the HAA waters (Fig 1). The confluence was assessed and while passable to small fish, the incised nature of the tributary channel, shallow depth of water of the featureless silty bed, and the dense stands of Himalayan balsam (*Impatiens glandulifera*) indicate that the beck is probably fishless. A quick scan of maps online points to New Cut and Great Dike upstream, hinting at the degradation of a former beck into a ditch system which probably conveys a considerable amount of fine sediment from agricultural practice into the Nidd during spate flows.

Fig 1. The mouth of the small (un-named?) beck that joins the Nidd from the LB and marks the upper limit of HAA waters. The beck is heavily incised and the bed a deep fine silt. Himalayan balsam was rife.

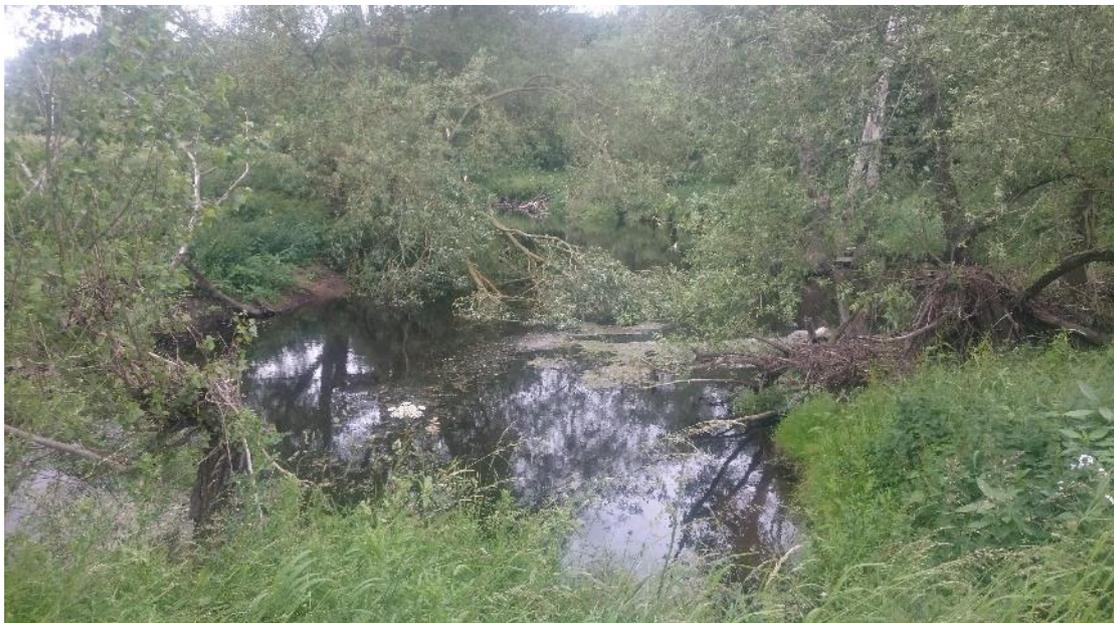
Fig 2. Recent storm damage and clear evidence of bankside trees trapping flood debris. All this low cover is vital for protecting fish from predation and providing flow refugia.

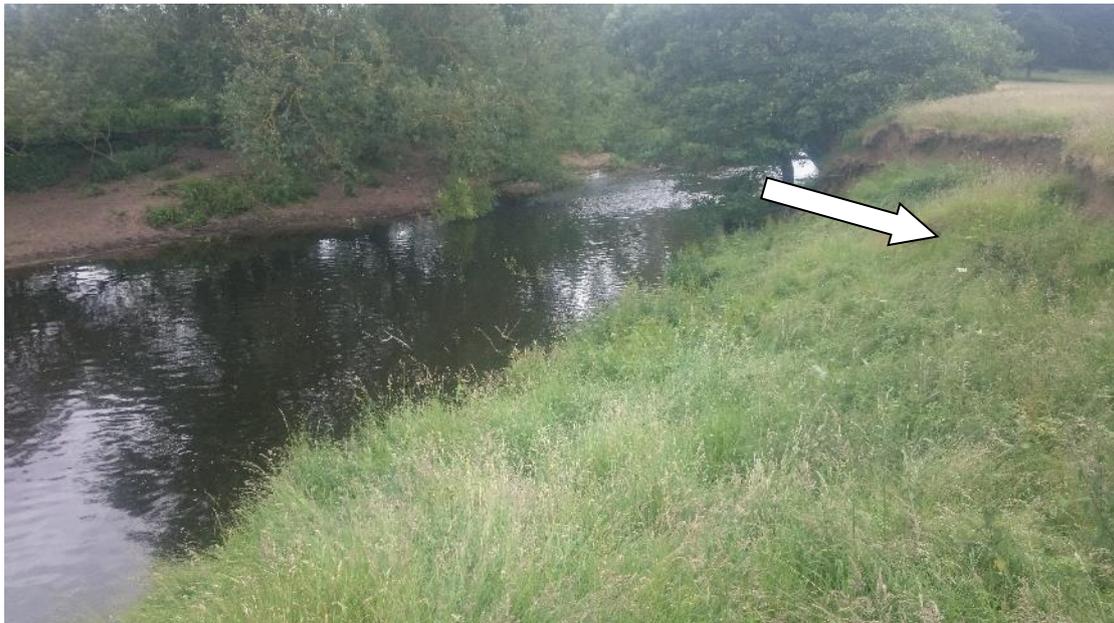
Under different ownership and livestock regimes, it is clear to see the contrasting grazing pressure on opposing banks (Fig 3). Low density of livestock on the LB has resulted in a diverse sward where even slumps in the bank have revegetated and stabilised, as compared to the heavily grazed and almost monoculture grass with evident erosion patches on the RB. However, even on the LB, there was a distinct lack of tree regeneration via self-setting, except in very inaccessible areas; livestock will favour browsing on saplings because of their higher nutritional content (see Fig 5). Set back from the bank top, near to Ribston Hall, are several small fenced exclosures where trees have been planted. As many of the trees lining the river bank are mature, it will be necessary to exclude livestock in this manner to establish a more diverse age structure to the riparian tree community. The lack of age diversity means that there are no or few trees to replace those that will, with time, be lost.

Fig 3. Both banks are grazed by livestock, but the LB (right of picture) is at much lower livestock density and the difference in sward height and composition is evident. The arrow highlights a former slump in the soil which has been almost completely revegetated and stabilised, creating a better bank profile.

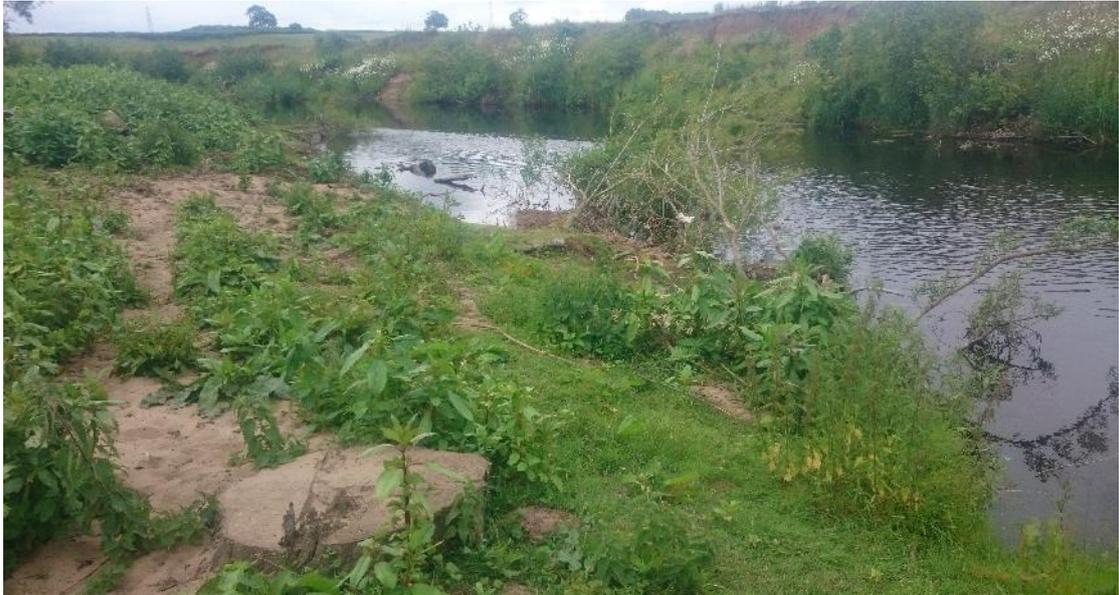
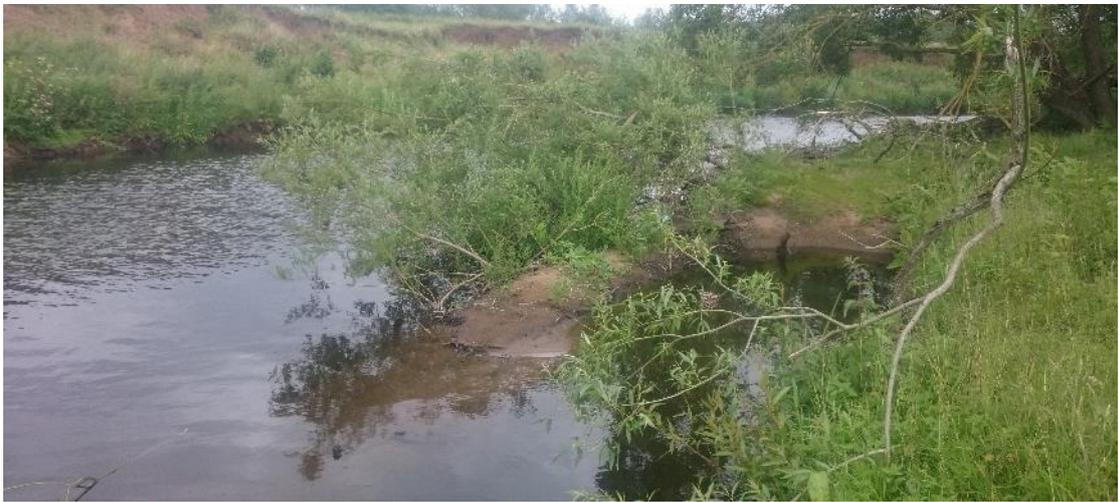
On the inside of a sweeping bend, several large crack willow (*Salix fragilis*) had been recently removed, presumably to reduce erosion pressure on the RB (Fig 4). However, at the top of the RB, there was an obvious lack of root structure (caused by the continual grazing of the shoots; see Appendix) which should provide a matrix to bind soils together (Fig 4; lower panel). Hence, as was clearly evident elsewhere both u/s and d/s, if a natural and diverse flora is maintained (by livestock exclusion or substantial reduction in density), then river banks are much more resilient to erosion during spates, even on the outside of bends. The retention of the crack willow stumps maintains slack water refugia which will be of benefit to fry and invertebrates favouring more depositional habitats.

Fig 4. Clearance of large crack willows on the LB, presumably to reduce erosion pressure on the RB on the outside of the bend. However, a high density of cattle with unfettered access to that bank will always cause erosion issues. Lower panel highlights backwaters created by remnants of willow from the clearance; these are important refuge areas for fry.

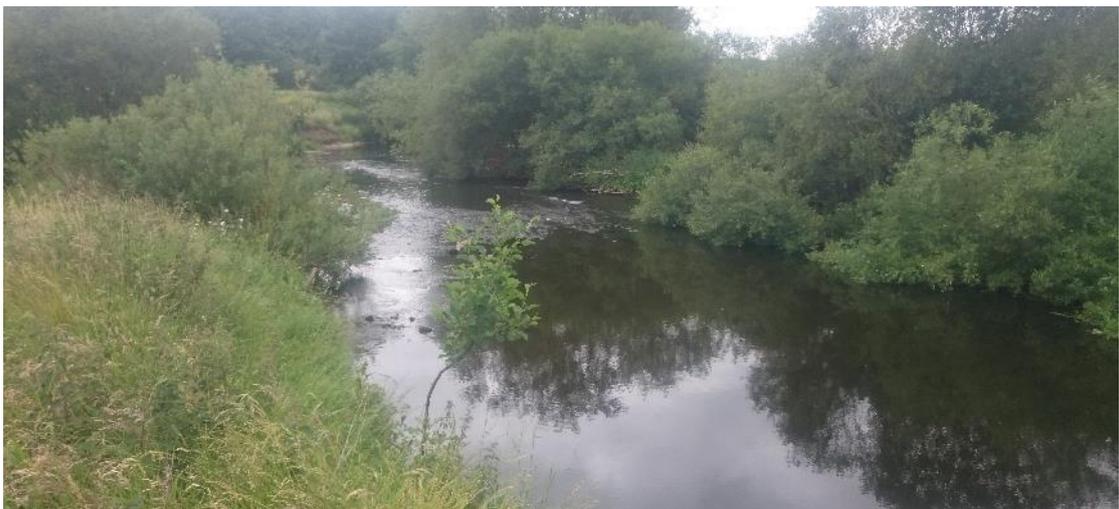
Fig 5. Fantastic low cover (fry habitat) provided by willow immediately adjacent to a shallow riffle (potential spawning and later juvenile habitat). Close linkage of habitats is important to maximise wild fish production. Note the lone willow in the foreground – despite low livestock density, young self-set trees were comparatively rare because they are preferentially browsed upon.

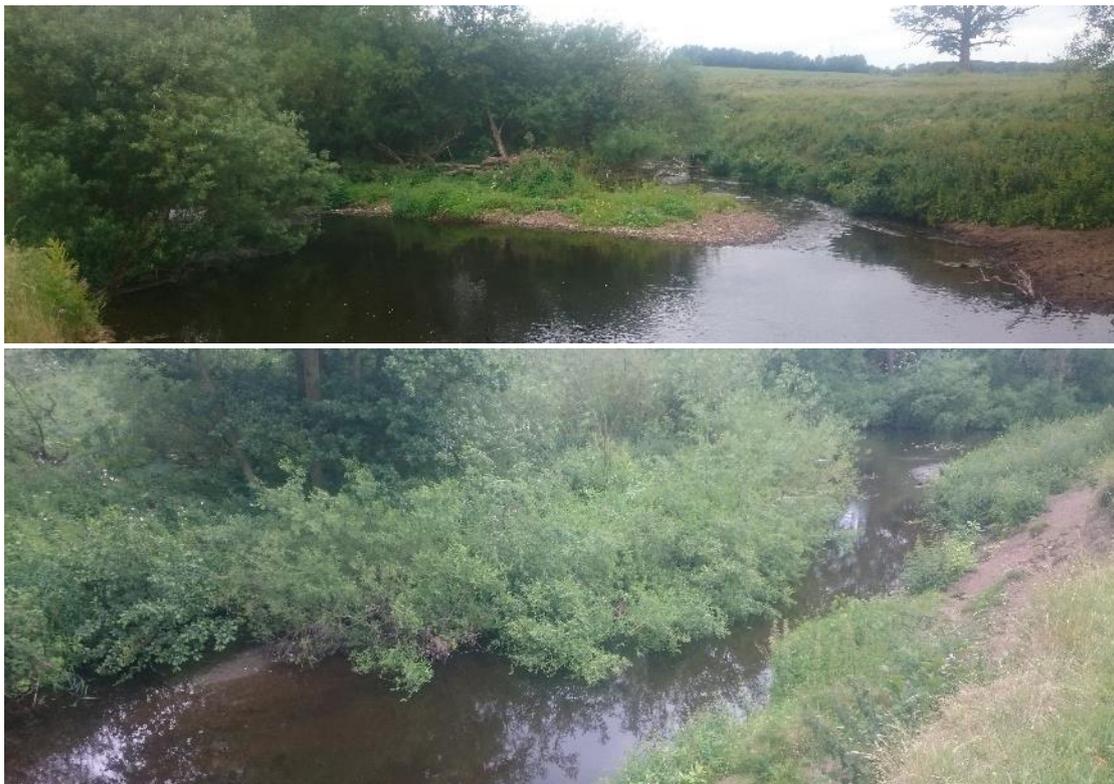
At several locations within Ribston Park, the Nidd has split around an island (Fig 7). Typically, there is a deeper and wider channel carrying the majority of flow and a shallower, narrower 'backwater' channel providing very different flow characteristics and habitat features. The latter will be typically used by smaller individuals or at specific times of the year, e.g. as a nursery for fry, but may also feature as a temporary spate refuge for larger individuals. While the smaller channel may not have much direct worth for angling, it must be remembered that such habitats are vital for fish of different life stages at specific times of the year.

Fig 7. Two examples of where the channel has split around an island with each sub-channel providing different habitat features and, hence, contributing to greater diversity overall.

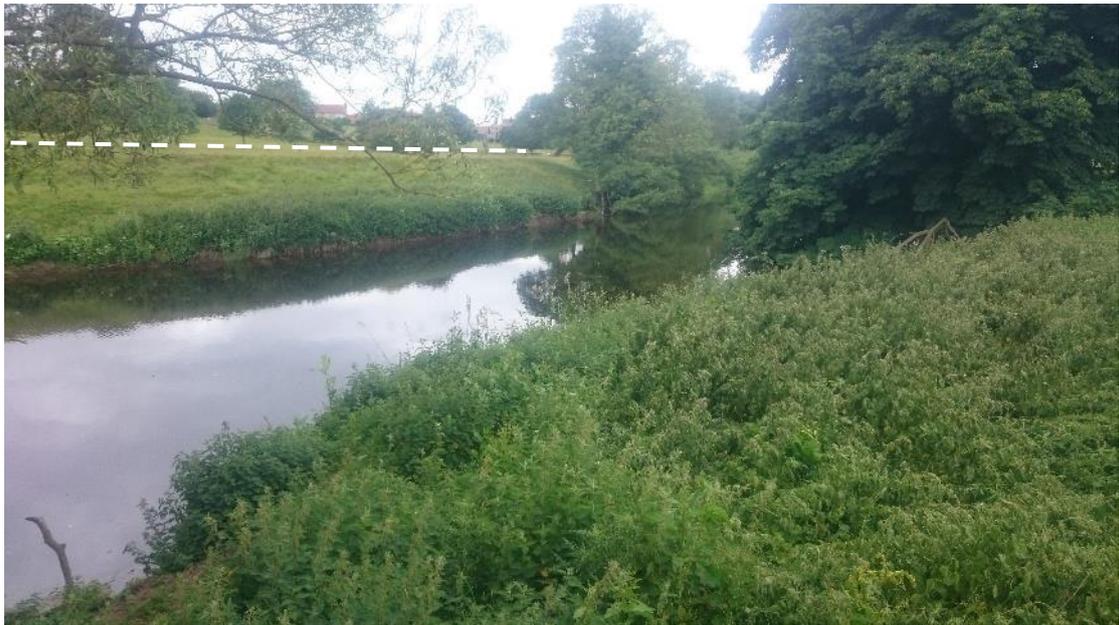
Some sections within the upper part of Ribston Park are quite sluggish and canal like. The actual impounding features appear quite natural; seams of bedrock. However, the depth and lack of energy in the reaches u/s have been historically (and are still) exacerbated by the flood defence bunds, probably derived from dredged material, evident on both banks (Fig 8). These constrain the lateral movement of water (and hence energy) under spate flows, resulting in the erosive power digging ever deeper into the bed. Only by removing the bunds and allowing the river to reconnect more naturally with its flood plain, will any significant rehabilitation of the channel cross-section be achievable.

Fig 8. A deep, sluggish, impounded section. While the actual structure causing the impoundment was a seam of bedrock and hence entirely natural, the bunds (highlighted by the dashed white line) exacerbate the problem.

This would be a major undertaking and would obviously involve considerable landowner buy-in (and funding). However, the single most beneficial action along the majority of the mainstem river would be to reconnect it with its floodplain and thereby reduce the incised nature. Regrading or reprofiling the banks would allow more energy dissipation over the floodplain and prevent the river continually digging deeper, reducing the number of canalised sections, renaturalising the channel, and improving access. It would also reduce flooding issues further d/s.

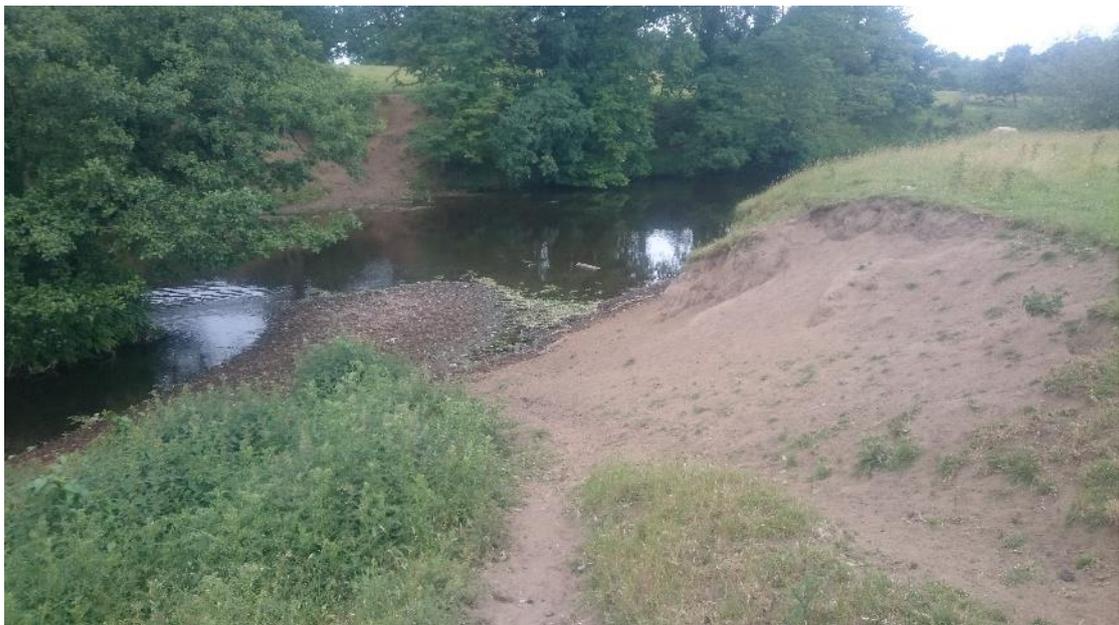
Fig 9. Considerable erosion where livestock are accessing the river and crossing. This is exposing the roots of the stand of mature trees on the far side (RB) and will cause ingress of the fine, friable soils via guttering during rainfall, ultimately leading to the loss of those trees. This will, in turn, lead to further, more serious bank erosion.

One of the seams of bedrock was being used by cattle as a crossing point (Fig 9). While the low density of stock is retaining the bank profile and vegetation structure in reasonable condition elsewhere (while noting the lack of self-set trees), the erosion is focussed at the access points on both banks, leading to considerable areas of bare soil and guttering along the tracks, in turn leading to soil ingress to the river. It does not appear necessary for cattle to cross here, and ideally should be discouraged.

If livestock poaching becomes an issue anywhere, then fencing should be considered and access to drinking water provided via mains supply (reduces issues with disease) or via solar (Fig 22) or pasture pumps (Fig 23). Watering points should be sufficiently removed from the watercourse so any poaching and accumulation of faecal material that develops around the focal point does not act as a source of sediment to the river.

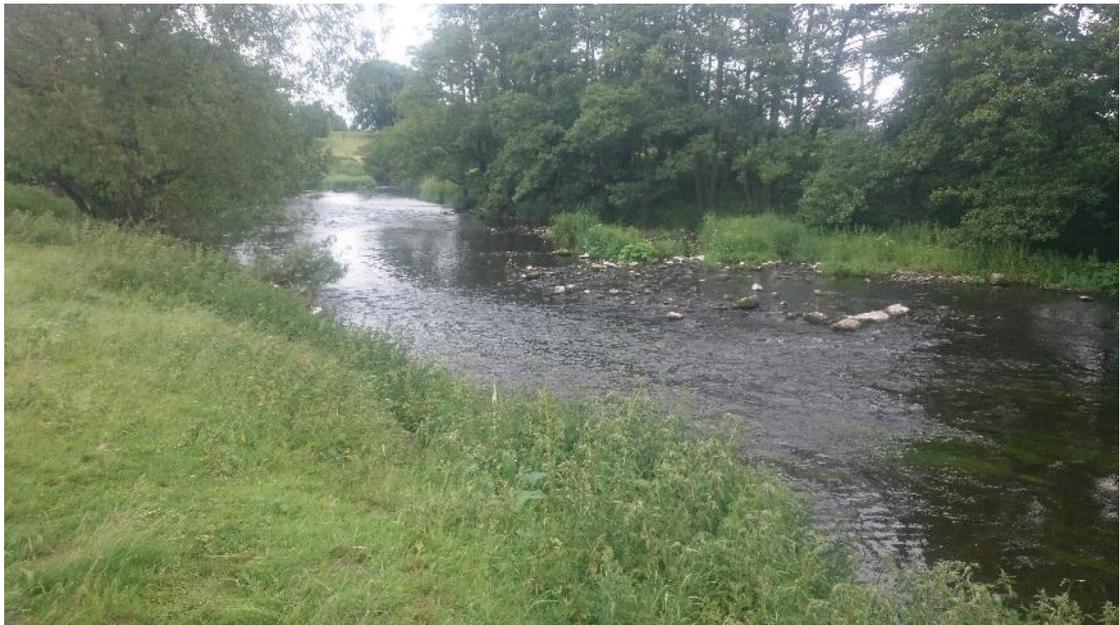
Fig 10. Some fairly natural sequences of pool-riffle-glide were evident above the main Ribston Park bridge, with the shallows well populated by water crowfoot and starwort.

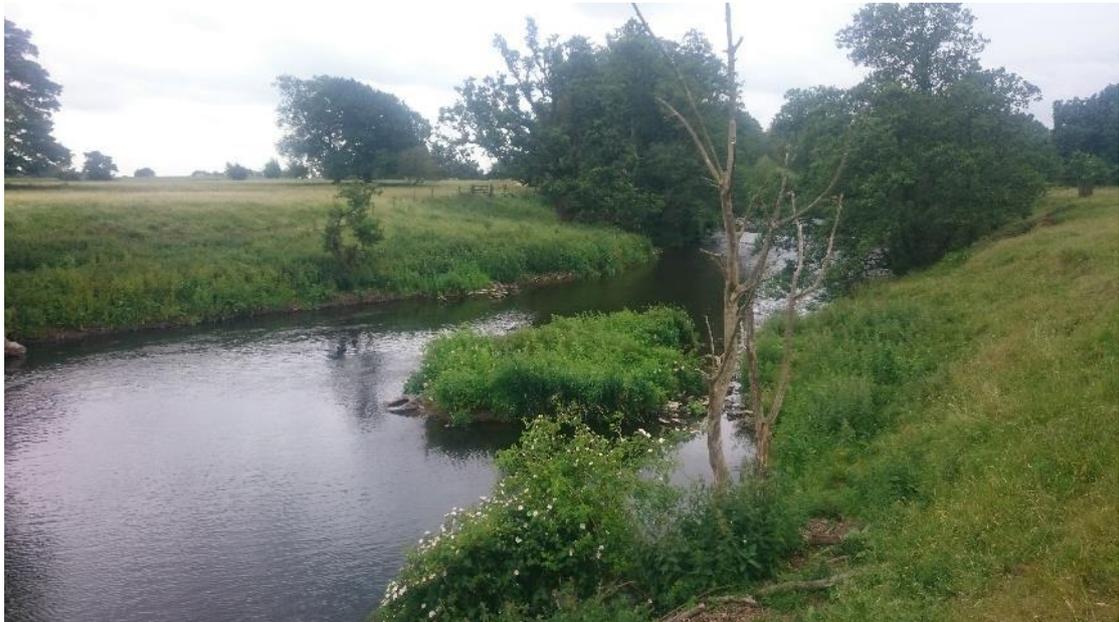
Fig 11. Colonisation of a deposition bar by terrestrial plants has consolidated it into another small island that diversifies the channel shape. It was good to see dead wood left standing; it provides important habitat for many decomposer invertebrates and potentially as a roost for bats.

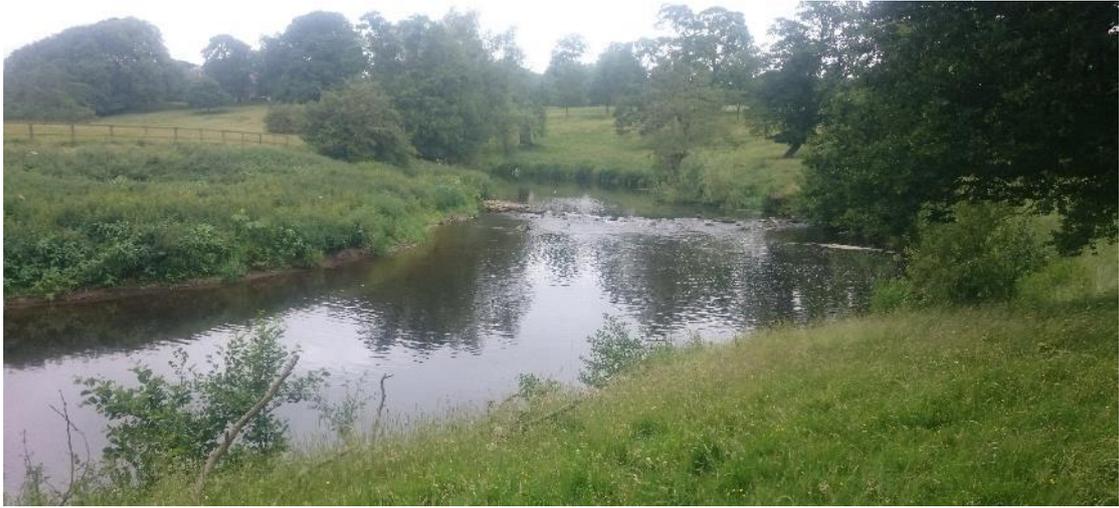
Despite still being heavily incised (the river level is a long way below bank top level; again, a function of the flood bunds), the channel is sufficiently wide above Ribston Park Bridge to allow the (re)development of natural features: deposition bars, meanders, islands, and pool-riffle-glide sequences (Figs 10 & 11). In the shallow riffles, there were luxuriant stands of water crowfoot and starwort, perfect for macroinvertebrates. This mosaic of habitat is ideal to host a greater range of species and life stages, both for fish and their food. The remnants of a stone check weir u/s of the bridge does not pose any issues for fish passage (Fig 12).

Fig 12. The remains of a low, stone check-weir to align the river with the ornamental bridge is degraded sufficiently so as not to obstruct fish passage.

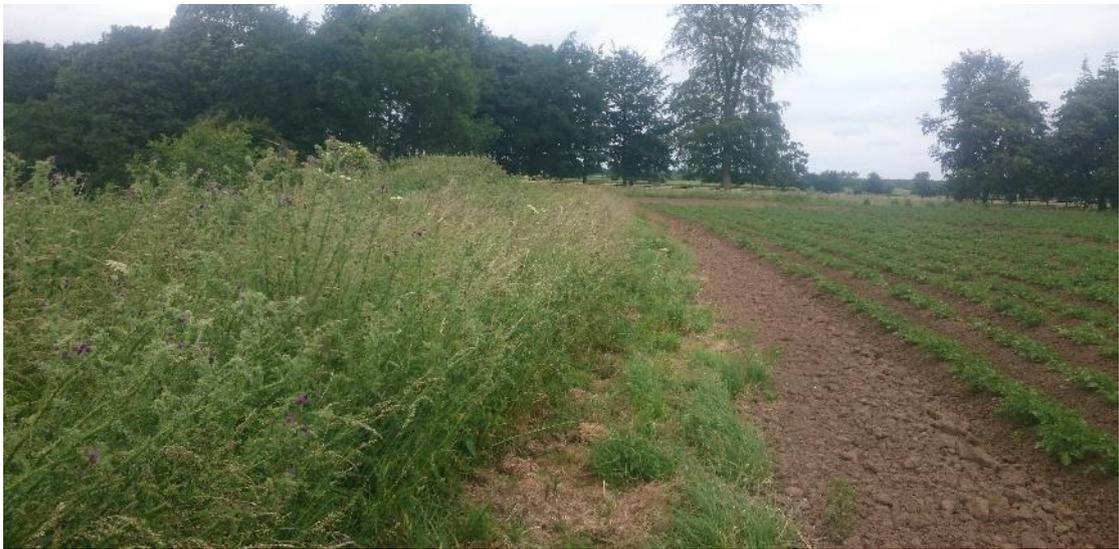
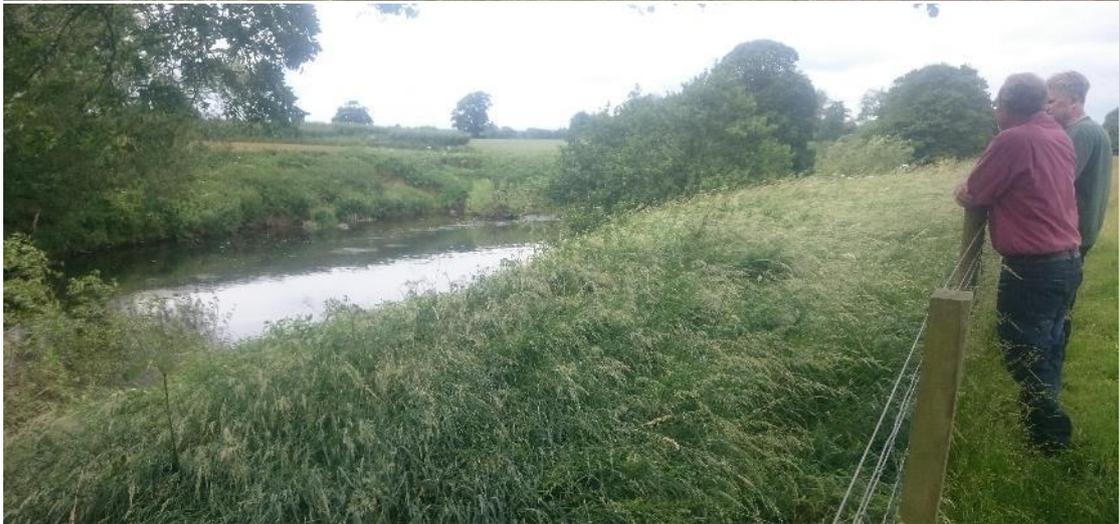
Fig 13. Examples of relatively generous riparian buffer-strips protecting the river.

Downstream of the bridge, the banksides (riparian zone) take on different characteristics as the livestock are excluded by fencing and, even in the arable fields, the river is protected by an ample buffer strip, generally >8m and in some places up to 30m (Fig 13). This is

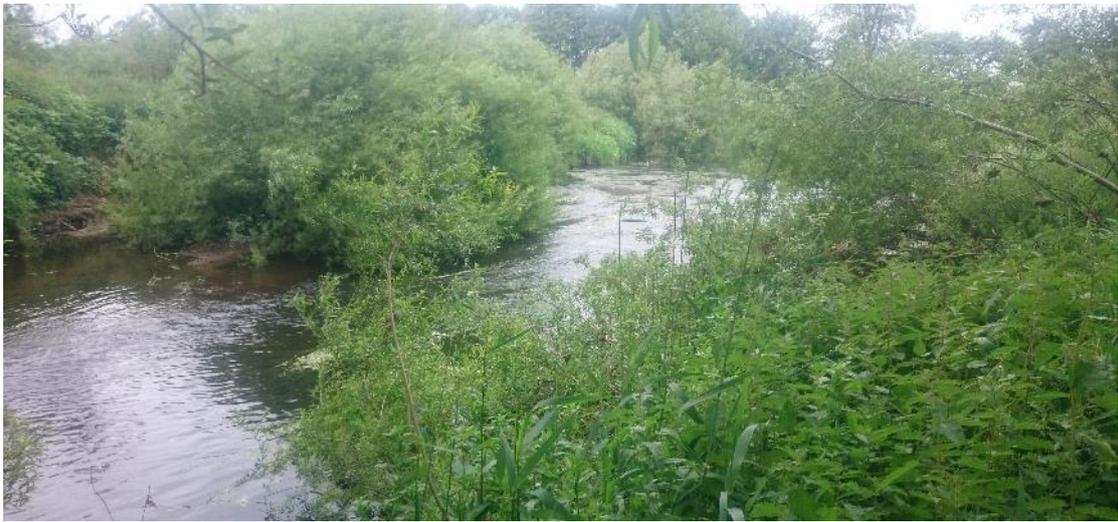
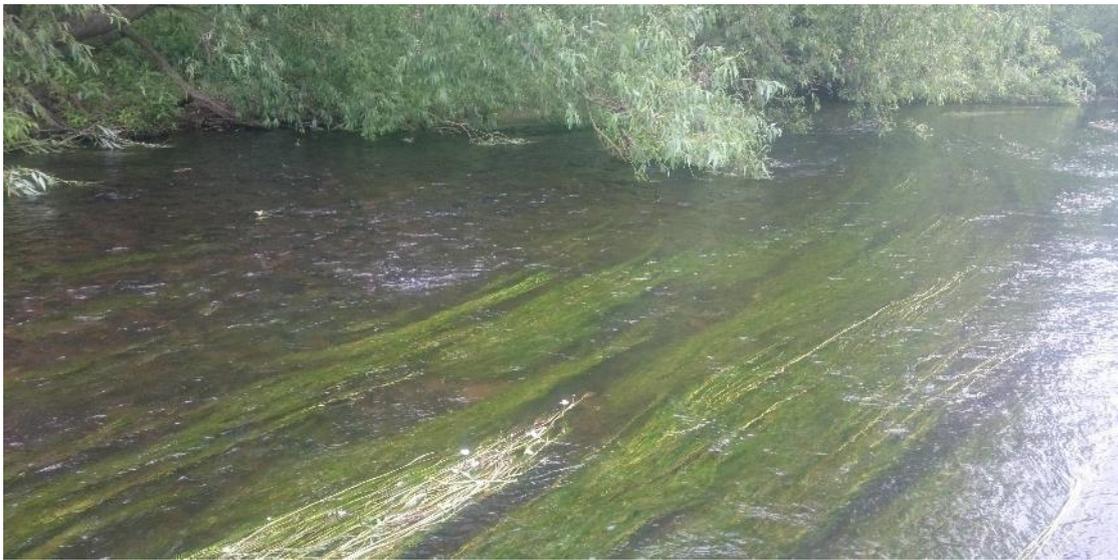
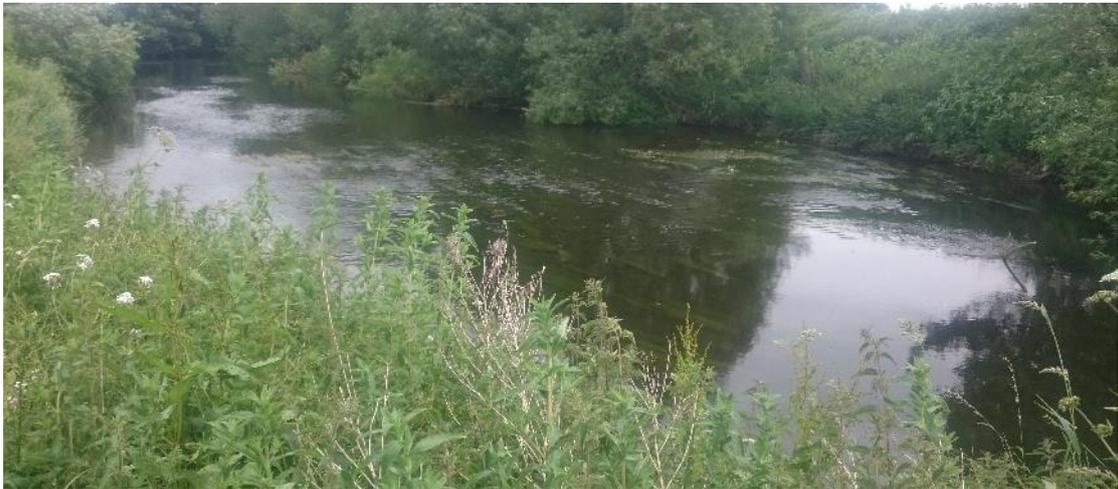
Fig 14. Abundant overhanging and trailing branches from willow provide excellent refugia from spate flow and predators. Water crowfoot dominates the shallower riffles and glides between pools, again providing cover and no doubt full of food.

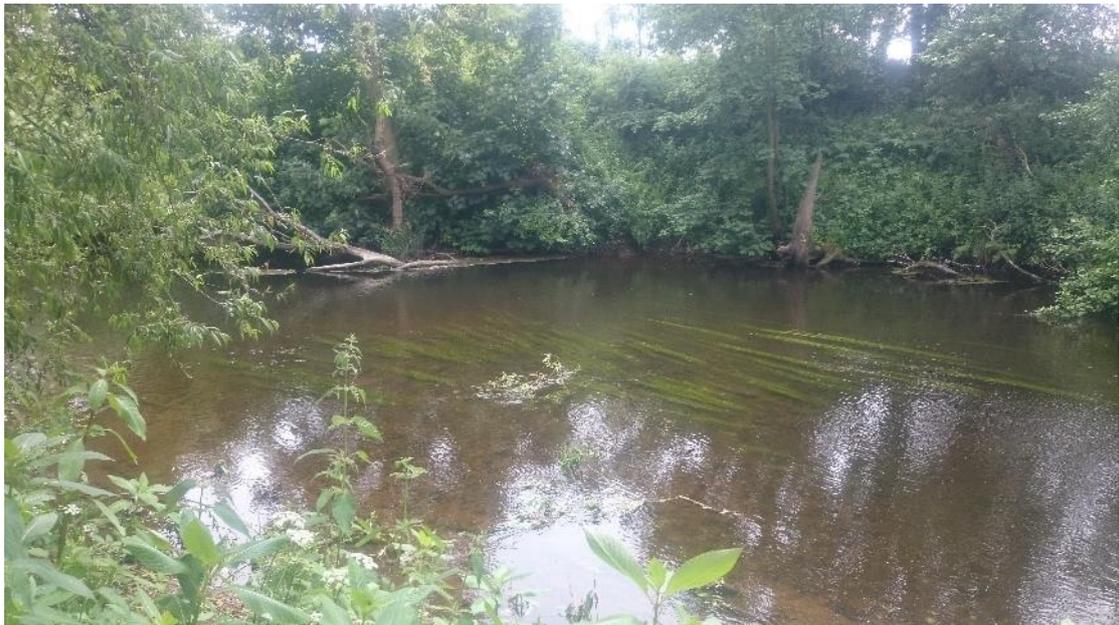
Fig 15. A 'Mr Crabtree' swim if ever there was one! Good depth variation in cross section and plenty of natural low cover for fish.

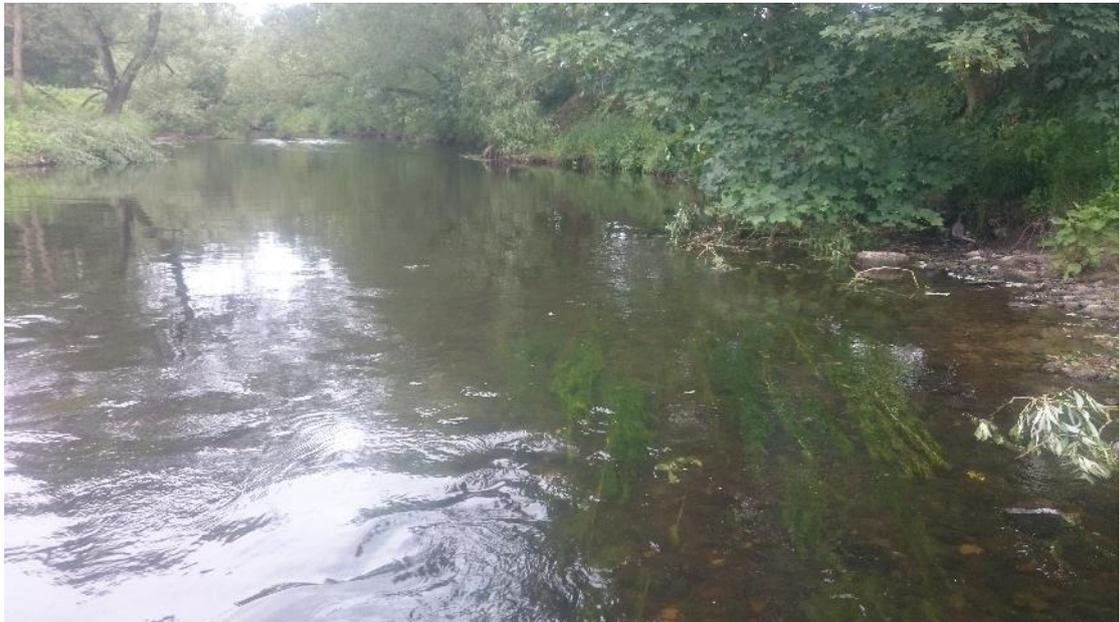
Fig 16. The tail end of a glide, into a shallow riffle. Streamers of water crowfoot help to focus the flow energy and keep the gravels loose and sparkling.

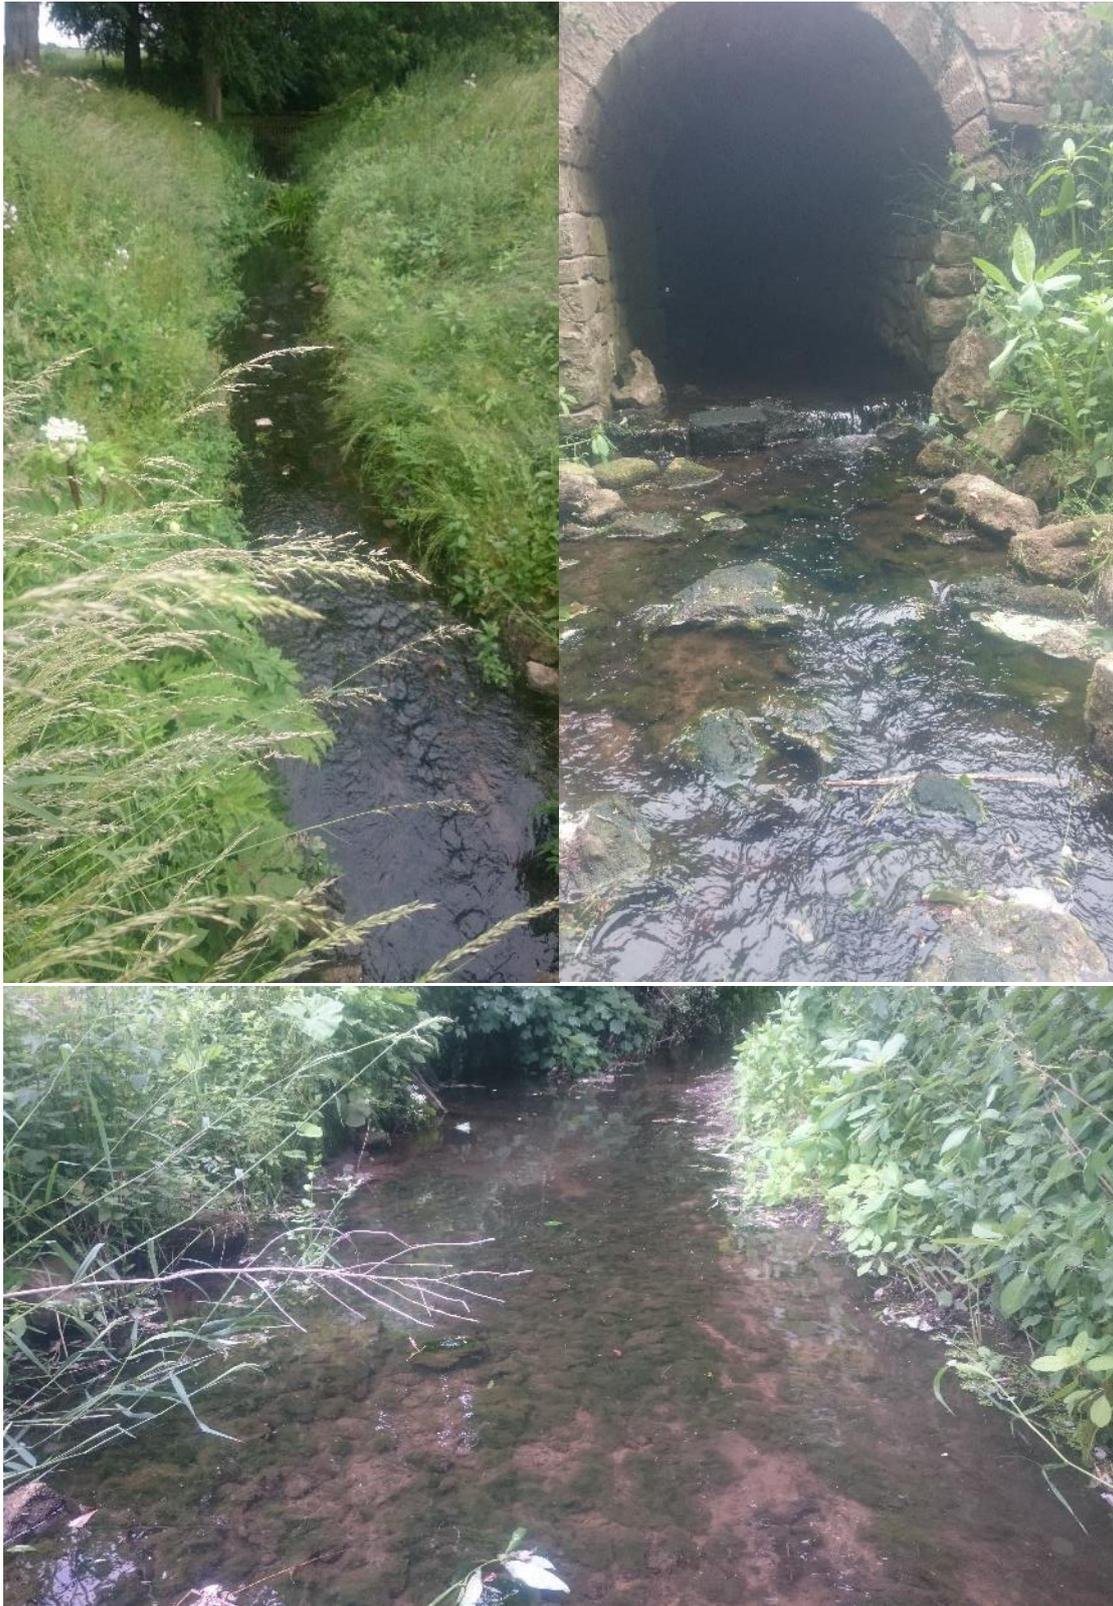
At the eastern side of Ribston Park, a small tributary enters the river near to the gatehouse (SE 41193 53239; Fig 17). It was only viewed from The Avenue and walked to its confluence. As for the tributary forming the u/s limit of HAA waters, this has clearly been straightened and dredged to act as a drain for farmland. Silt and nutrient problems were evident, but gravels were in abundance, so the lowest 100m or so might be worth investing a bit of time in to improve conditions for spawning habitat.

Fig 17. Upper left panel: looking u/s from the bridge (The Avenue) near to the eastern end of Ribston Hall at the incised and straightened tributary channel. Upper right panel: a small step into the bridge culvert is mostly passable and natural substrate throughout the culvert retains water depth. Lower panel: the tributary u/s of its confluence with the Nidd indicates fine sediment and excess nutrient ingress is an issue, but gravels hint at suitable substrate for spawning.

The small beck at the eastern end of Ribston Park would benefit from some TLC to flush out some of the silt (although it would be wise to investigate the source and prevent it from entering the system).

Currently, it maintains a trapezoidal channel with little sediment sorting. By installing a series of off-set woody deflectors, a focal flow of water could be encouraged to meander more, thereby diversifying the depth regime. Interspersed, via the installation of paired deflectors, it is relatively simple to scour and sort clean gravels into specific locations that could be used by trout for spawning.

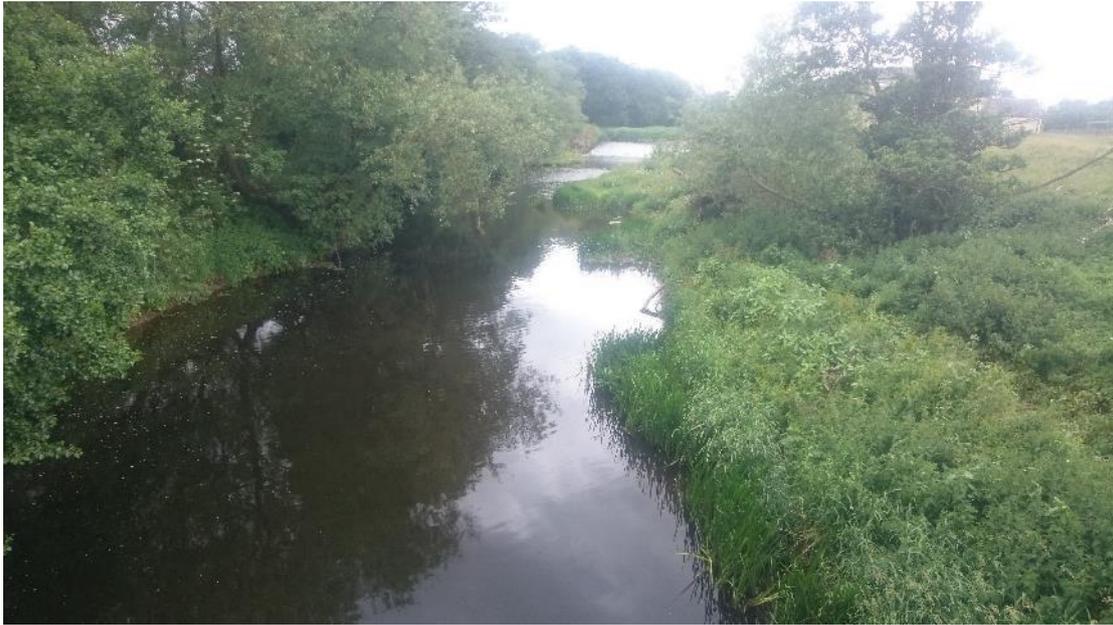
Fig 18. Looking u/s from the footbridge at Hunsingore to the weir. The river is dominated by deeper glides but still with relatively natural riparian vegetation providing good cover.

A short section of HAA water at Hunsingore (SE 42832 53015) was viewed from the LB, between the substantial weir and the footbridge. The weir is an obvious barrier to fish movement, but it appears to be on the EA priority list to improve passage prospects; it will be worth the club keeping tabs on developments for this site with the local fishery officer. Giant hogweed was prolific near to the weir. Otherwise, emergent macrophytes (LB) and low, overhanging native tree cover (RB) provided good habitat.

As noted in the main text, the weir at Hunsingore was the only major obstruction noted on the Nidd during the visit, and should be in line for fish passage improvement by the EA in the very near future. The weir on the Crimple is likely to be the focus of another WTT visit (invited by the EA in early 2019), so access along the Crimple is likely to improve soon.

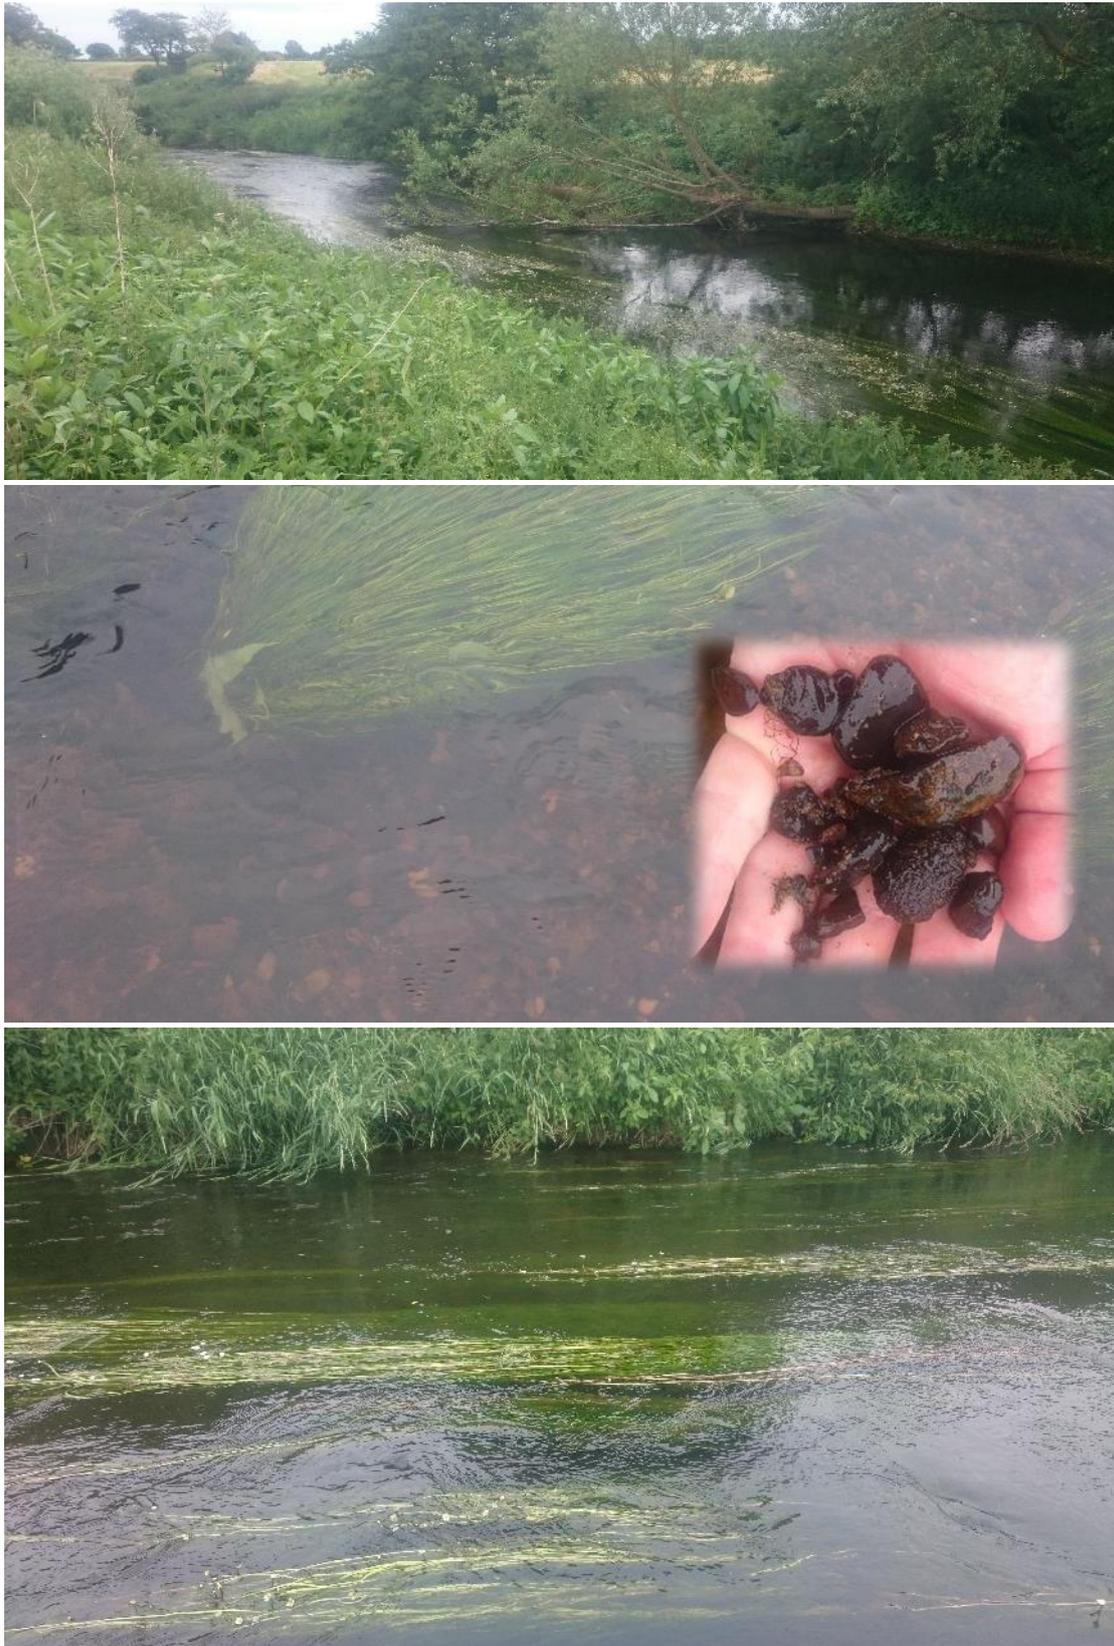
Upstream of Cattal, a spot check was undertaken on 'the match section'. Despite being constrained within flood bunds and thus maintaining a relatively uniform width, there were clear and marked depth changes in the channel profile, probably accentuated by the

Fig 19. Shallow riffles with abundant submerged weeds force the water around the stands and through the gravels, keeping them clear of silt. Shaggy marginal vegetation slows the flow at the banks and provides refuge for smaller individuals and fry. Overhanging willows create deeper scour pools for larger fish.

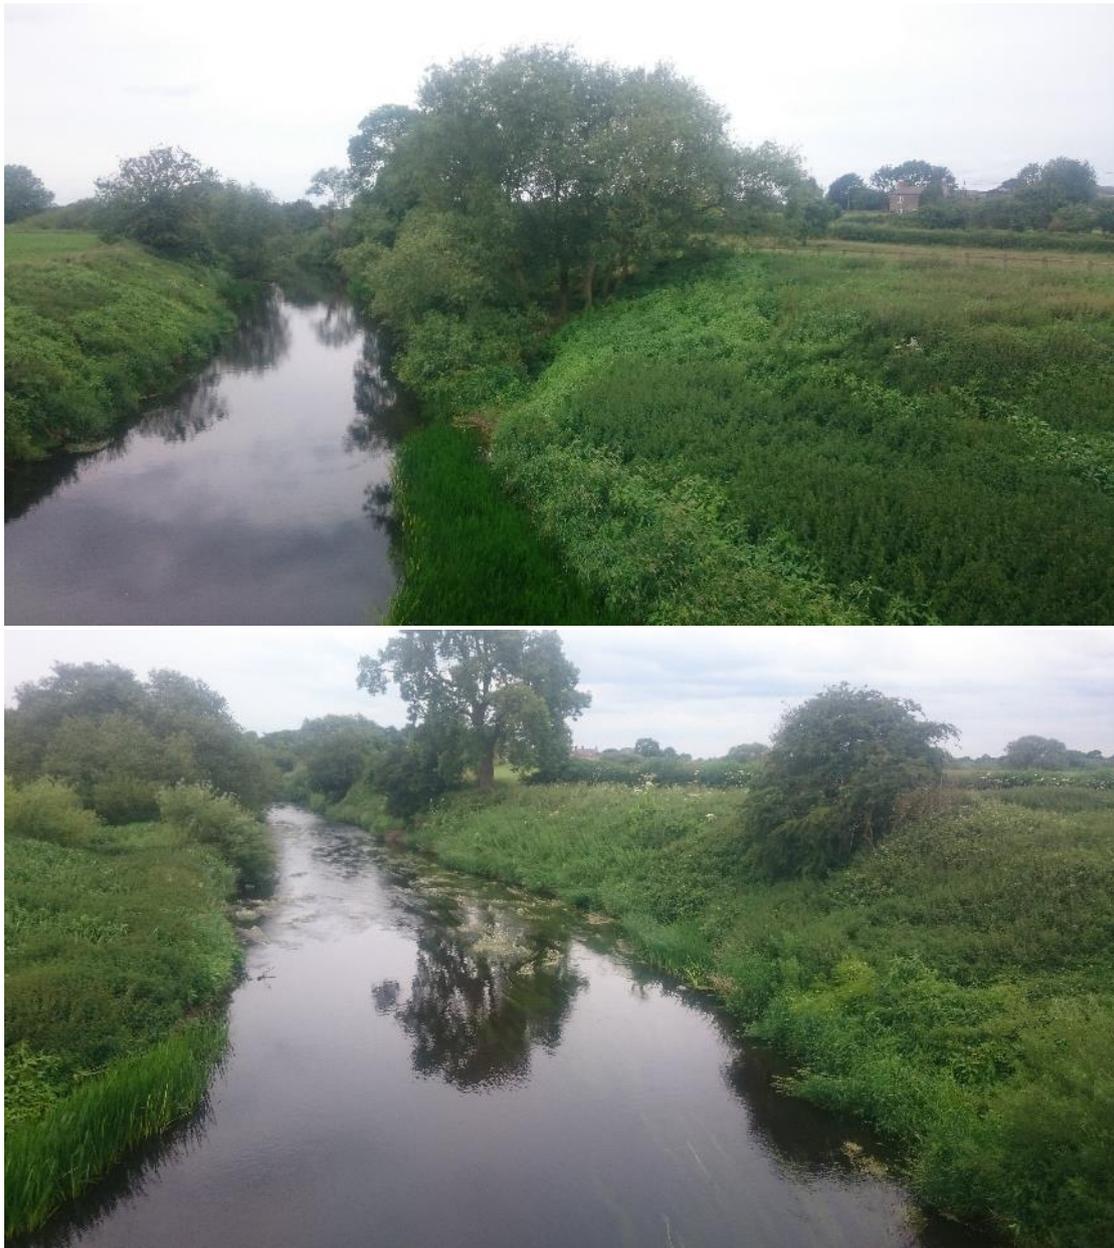
At Cattal village, the channel is clearly incised and straightened to maintain its course through the historic bridge and hence the cross-sectional plan of the river is more uniform; it is relatively deep with sluggish flow (Fig 20). Water crowfoot and other submerged macrophytes provide the only instream habitat diversity, while emergent macrophytes line the banks. Some willows have been allowed to grow close to the waterline and their low trailing branches provide good cover, which should be maintained.

Fig 20. Looking u/s (upper panel) and d/s (lower panel) from Cattal Bridge.
