Advisory Visit

River Nidd, Harrogate Angling Association

15/06/2018

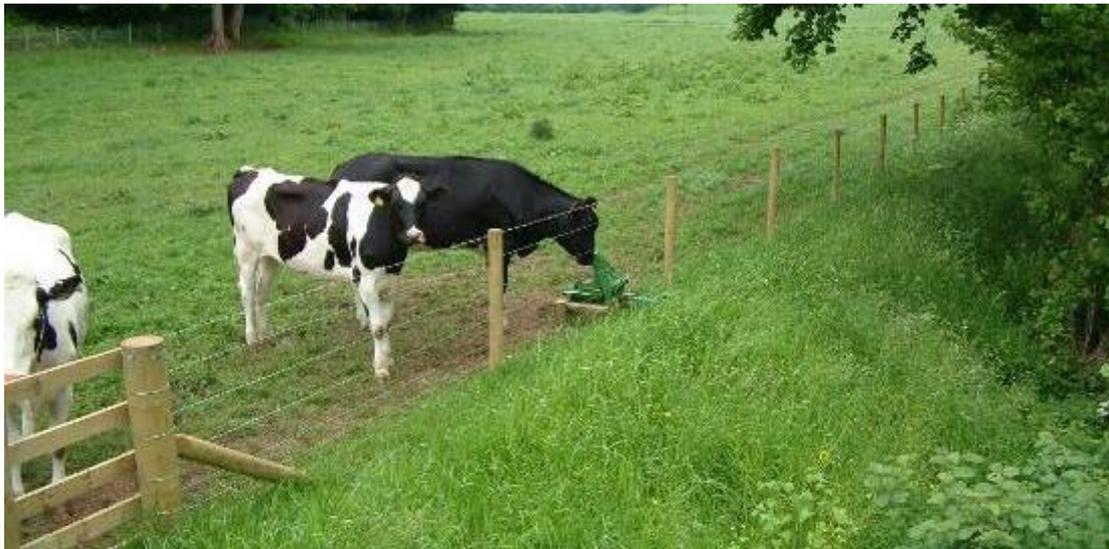
Fig 22. Cattle excluded from a river bank and drawing water from the river via a pasture pump which they activate themselves by pushing it with their noses.

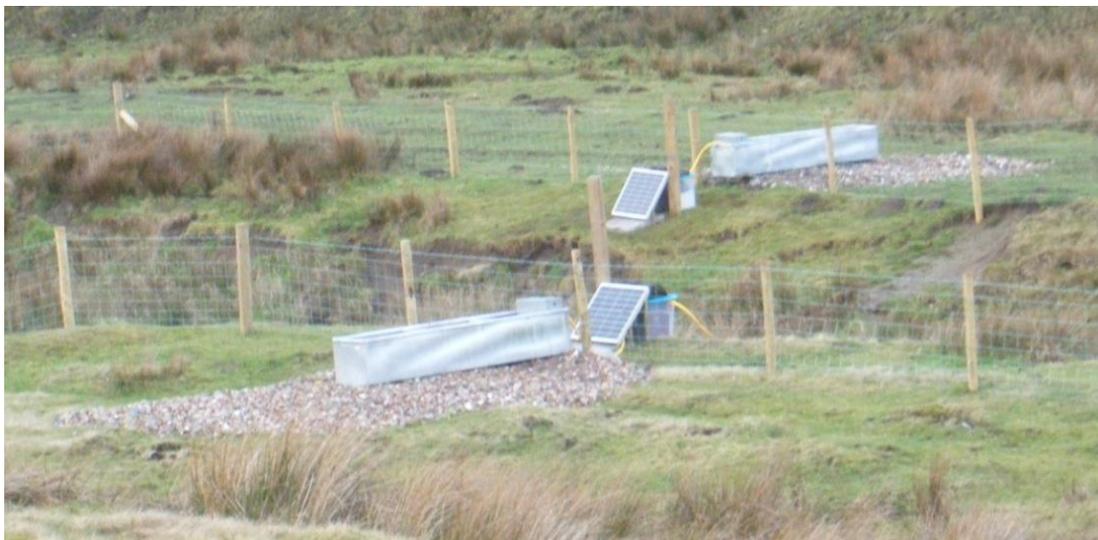
Fig 23. Solar-powered pumps to fill water troughs. Image courtesy of Ribble Rivers Trust.

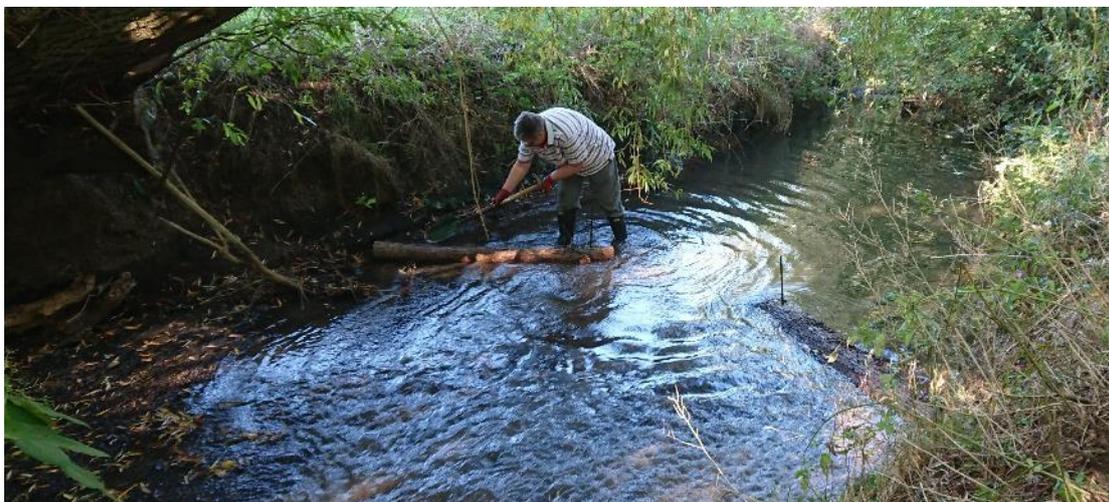
Fig 25. Paired upstream deflectors being installed into Cock Beck, a tributary of the Wharfe.

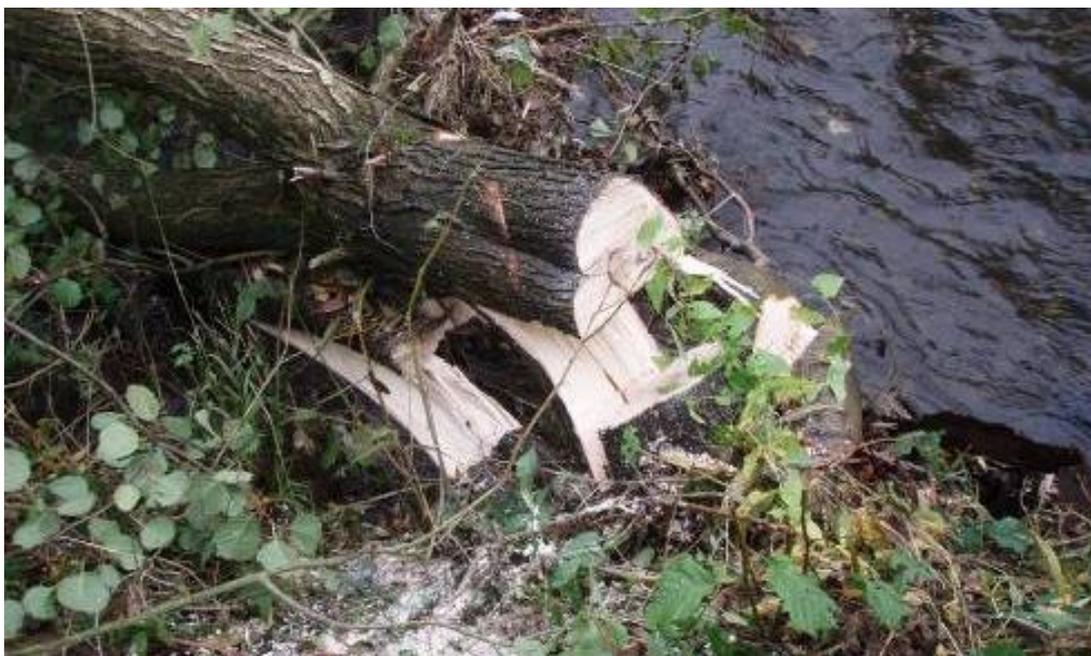
The process involves cutting part way through the stem/trunk, a little at a time (like laying a hedge), until it can be forced over into the channel (Fig 26). The depth of the cut should be limited to only that which is required to bend the limb over, as this will retain maximum strength in the hinge and maintain the health of the tree/shrub.

Fig 26. Hinged willow.
