Advisory Visit for Knaresborough Angling Club

River Nidd

Date 16/04/12

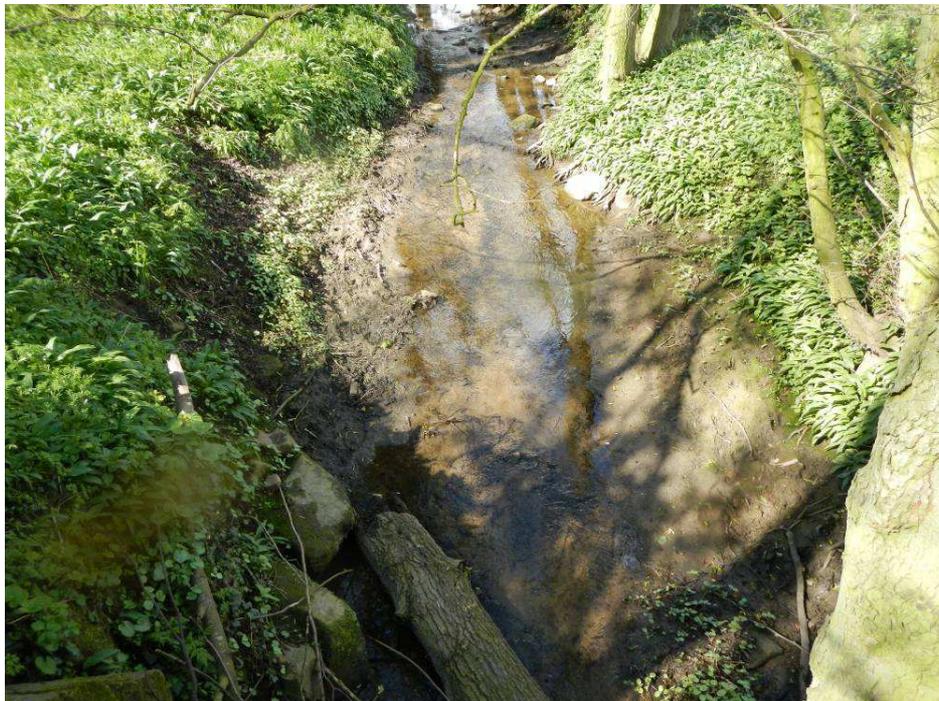
Major siltation issues were identified on the Cockhill Beck (SE2693958934) where much of the bed was smothered by fine silt (Picture 1), particularly in the lower reaches where the Beck is likely to be backed up from the main river in high flows. Sedimentation within the Beck not only creates a large input to the River Nidd, but is also likely to limit successful utilisation of the Beck as a spawning tributary for trout. For this reason, it is recommended that the Cockhill Beck catchment is walked in an attempt to identify potential sources of sediment. Once identified, it would be worthwhile contacting local Environment Agency (EA) fisheries staff, as there may be money available for projects to address this issue.

Picture 1. High levels of silt on the bed of Cockhill Beck. While siltation of the bed is exacerbated where the Beck backs up from the River Nidd, it highlights the issue of high sediment supply within the Beck.

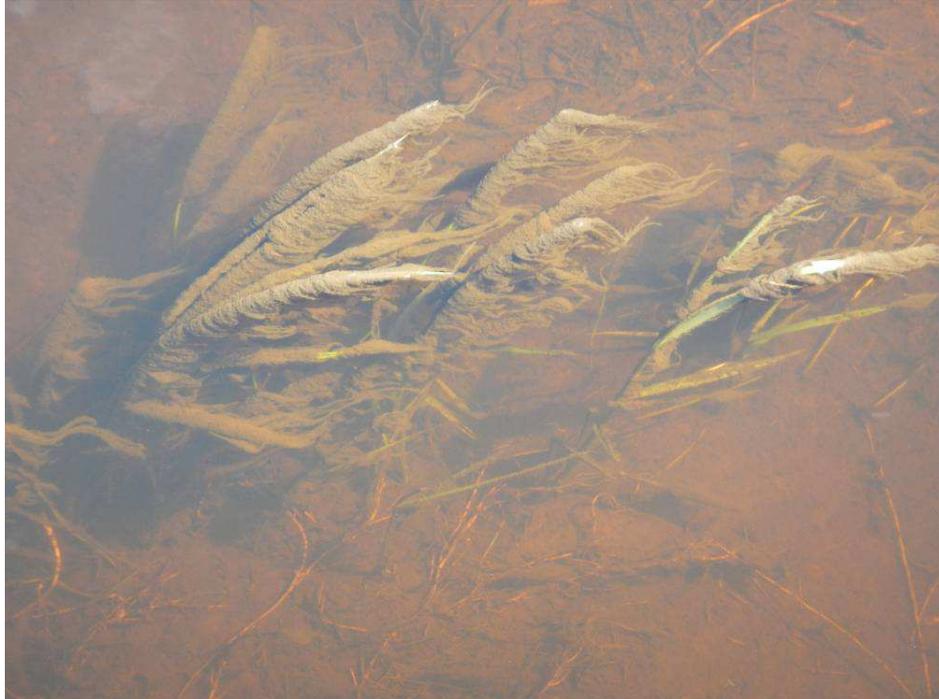
A significant increase in algal growth downstream of the sewage works was observed, which suggests additional nutrient enrichment of the river towards the downstream end of the section (Picture 2). The associated reduction in water quality could also be one factor affecting the prevalence of larger grayling in the middle and lower areas of this section of river. This is because grayling are one of the more susceptible freshwater species to poor water quality, particularly larger fish.

Picture 2. Excessive algal growth on vegetation downstream of the sewage works.

- Retention of woody debris and branches that naturally occur in the river.
- Contact the local area EA to investigate the increased algal growth, and perceived reduction in grayling numbers downstream of the sewage works outfall.

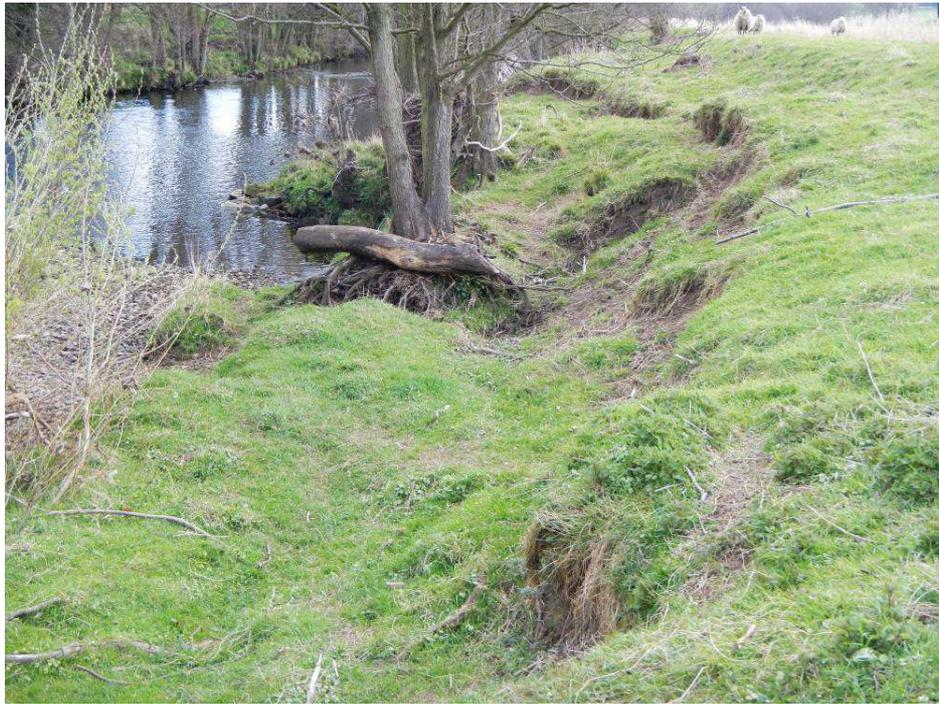
Where sheep had access to the riverbank, increased erosion was observed (Picture 3) but at the current rate and stock density, this was not considered

Picture 3. Areas of damaged bank resulting from livestock access and grazing (SE2726959684).

to be a major problem as it was limited to a relatively short section. It is advised that the rate of erosion and impact on marginal vegetation is monitored, and if an increase is observed, it may be worth excluding livestock completely from the riverbank, or greatly decreasing stock densities in fields adjacent to the river.

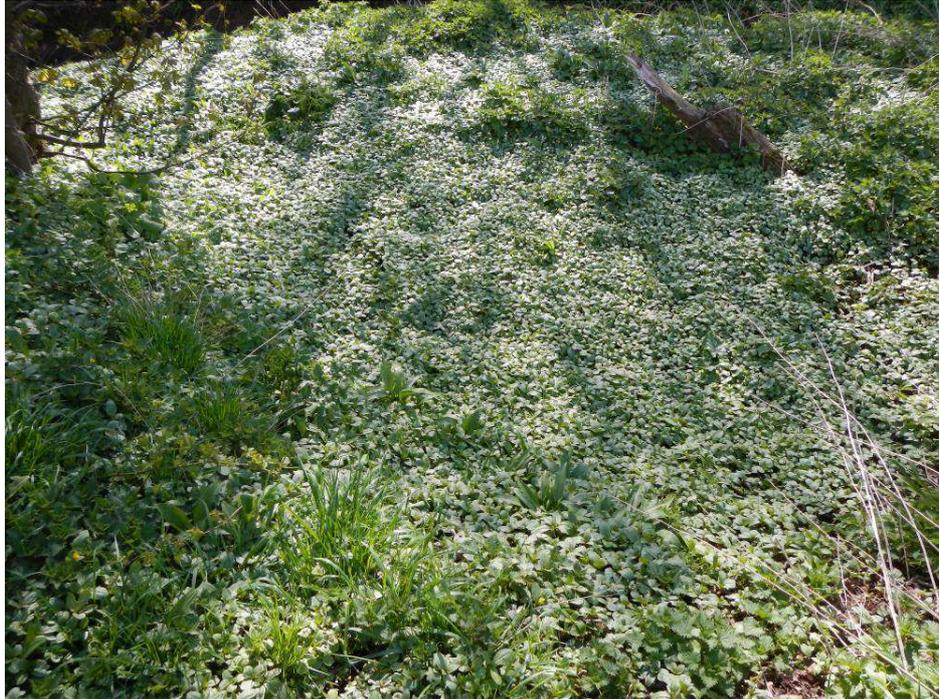
Around the confluence of the Cockhill Beck and the River Nidd a large stand of Himalayan balsam (*Impatiens glandulifera*, Picture 4) was present, which is likely to increase winter erosion rates and should be removed. Himalayan balsam can be dealt with through spraying (more information can be found at <http://www.environment-agency.gov.uk/homeandleisure/wildlife/31350.aspx>), or by pulling and strimming, which can be undertaken by angling club working parties.

Picture 4. Large area of Himalayan balsam at the confluence of the Cockhill Beck and the River Nidd (SE2693958934) that is beginning to sprout. Balsam can lead to serious erosion issues in the winter as it out-competes other species, then when the balsam dies back in the winter large areas of bare earth are left susceptible to erosion.

If pulling is the preferred option, the waste material should be composted above the flood line, with monitoring undertaken to ensure that the re-growth does not occur. Strimming is a very fast method of treatment, but if undertaken, the plants must be cut before the seeds start to develop and the site should be re-strimmed as necessary throughout the season (several treatments are likely to be required). Equally, hand pulling should be undertaken before the balsam produces seed.

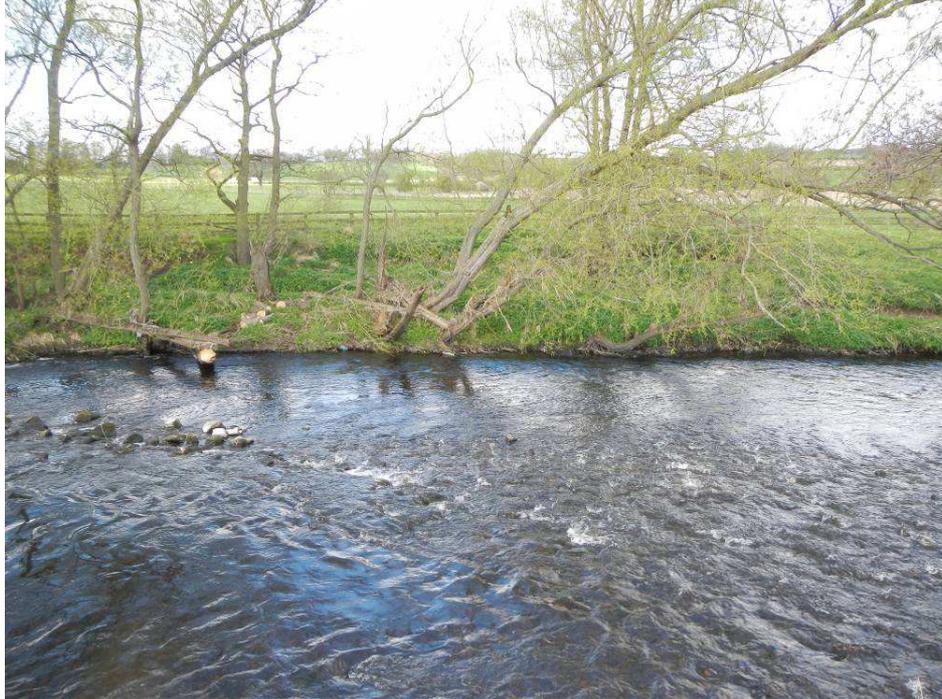
Tree management has historically been undertaken by the club, both to prune low hanging branches, and to remove fallen trees/limbs, as in picture 5, often in an attempt to improve angler access. While this may seem appropriate to keep the river tidy and allow angling access, these actions have actually reduced the low level cover in some areas, potentially reducing the number of fish that area can support. Picture 6 also shows an area where pruning has resulted in loss of fish habitat, with little remaining low-level cover. In such areas, selective coppicing of some trees would greatly increase low level cover by encouraging low-level re-growth (as demonstrated in the before and after photographs in appendix 3).

Picture 5. The cut limbs to the left of shot were removed to increase angler access. Where work like this is undertaken it is beneficial to mitigate the habitat loss by increasing habitat locally. Here the tree in the centre of shot could be hinged along the bank, so that its branches trail in the water.

For this reason, it is recommended that future tree work is restricted to the enhancements suggested. Tree and branch clearance for angler access should only be undertaken as a last resort, and only then in small areas. With this form of management angler access may be slightly more difficult but with a greater abundance of high quality trout and grayling habitat available, fish abundance and quality of angling should increase. It is also worth bearing in mind that where tree work is undertaken for other than fishery reasons or habitat management, it may be useful to consider incorporating some additional habitat enhancement as mitigation.

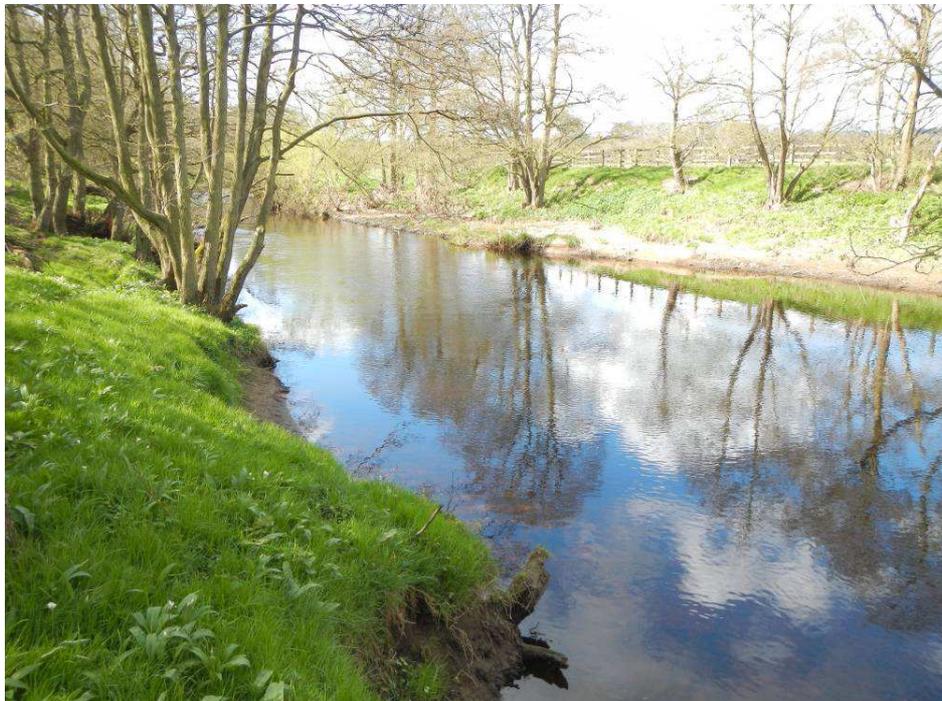
Picture 6. A very open pool with no low level cover. Habitat here could be greatly enhanced by coppicing, or creating kickers out of some of the trees to the left of shot.

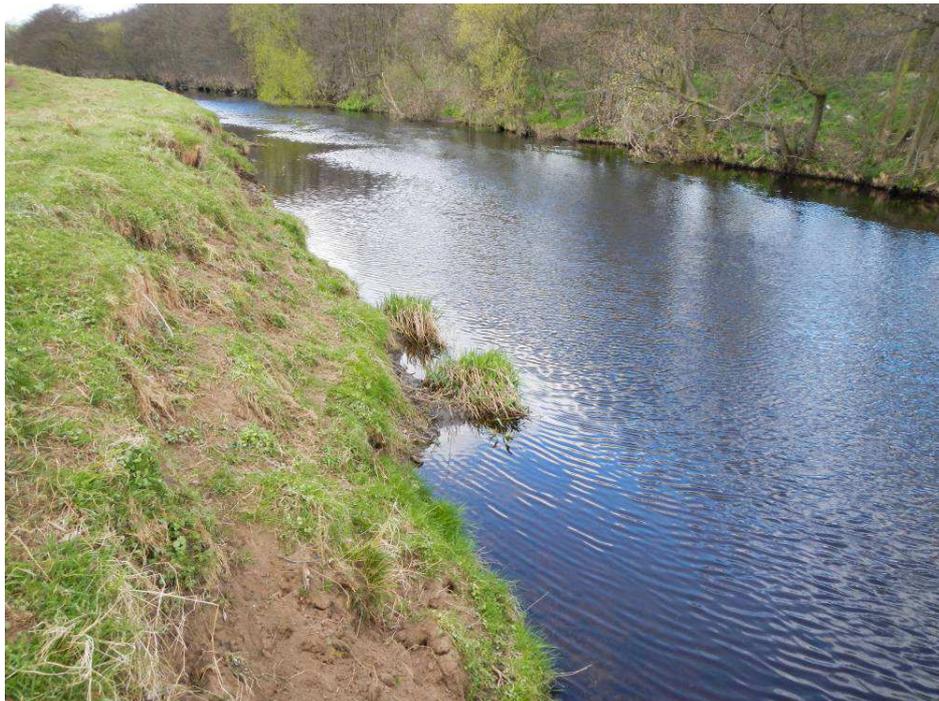
Picture 7. Looking upstream along a section of open bank on the inside of a bend (RB), where fry and juvenile habitat could be greatly increased by the installation of living willow bundles (SE2759559593).

The quality and availability of habitat could also be greatly increased on sections of open bank like those displayed in pictures 7 and 8. Bundles of willow branches can be staked into the margin of the river to increase flow diversity and cover. Bundles should be located so they are partially submerged at summer water level. This creates an area where sediment will accumulate and the willow will start to root. Where this is undertaken in faster flowing areas it is likely to benefit larger fish, but if also undertaken in lower flow areas can also increase the shelter available for fry and juvenile fish in the river margins.

Planting of willow could also be employed in these areas by driving willow whips or stakes into the river bank, just above the waterline. Ideally, half to two thirds of the stake should be submerged is below water level, with no more than 60cm (24") above the ground. In the majority of cases these will take root and grow into new trees/shrubs. These shrubs will require maintenance over time, but periodic coppicing or hinging would further enhance their benefit and increase the value of the new structure created.

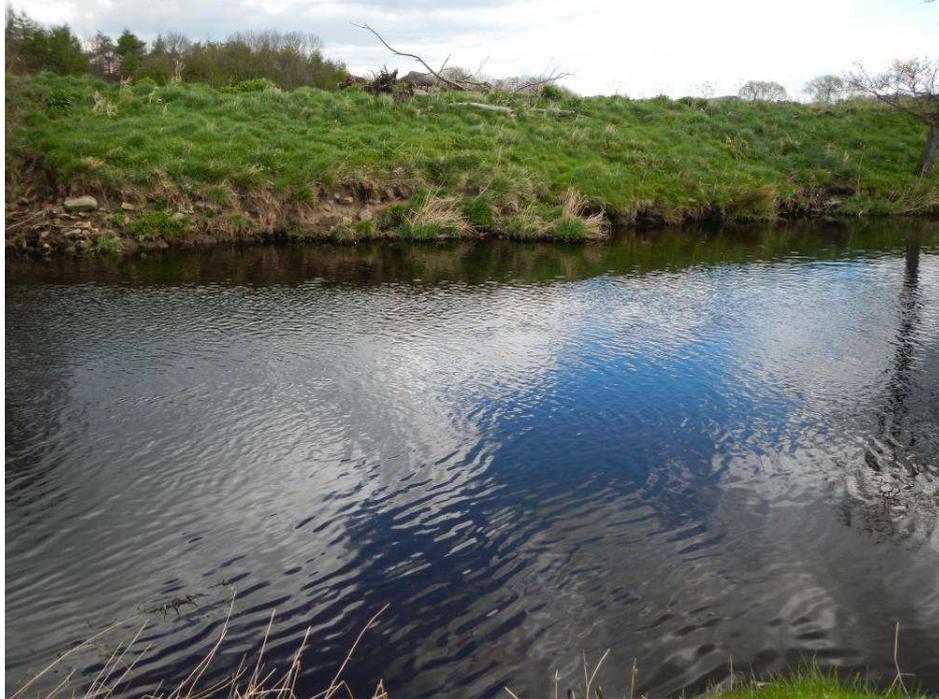
Picture 8. Looking across to the outer side of a bend on the LB, with greater flow present, where adult trout habitat could be enhanced through the installation of living willow bundles (SE2762359565).

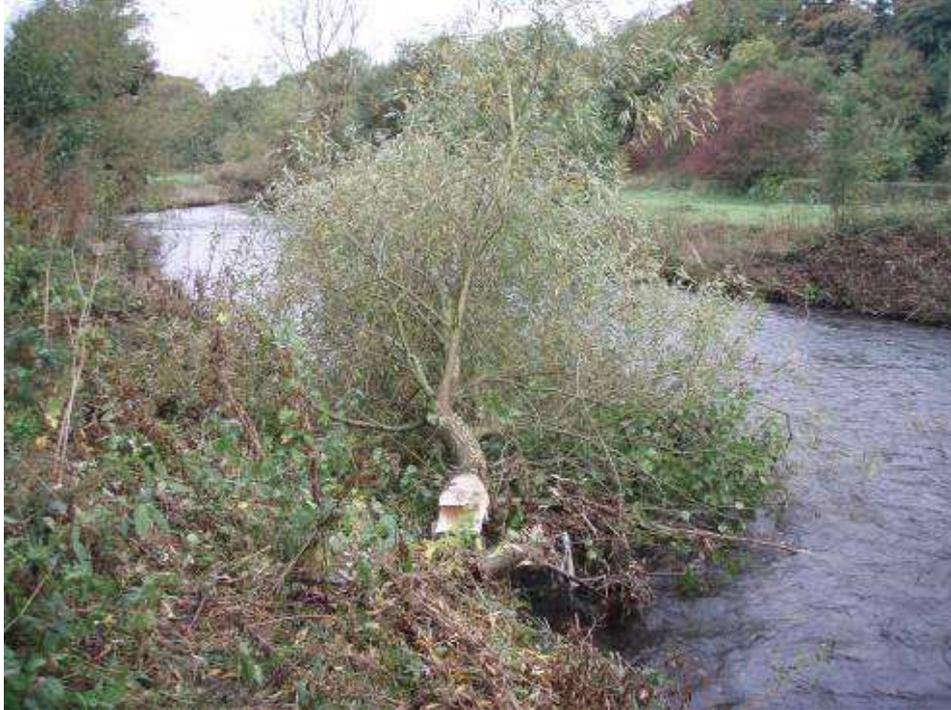
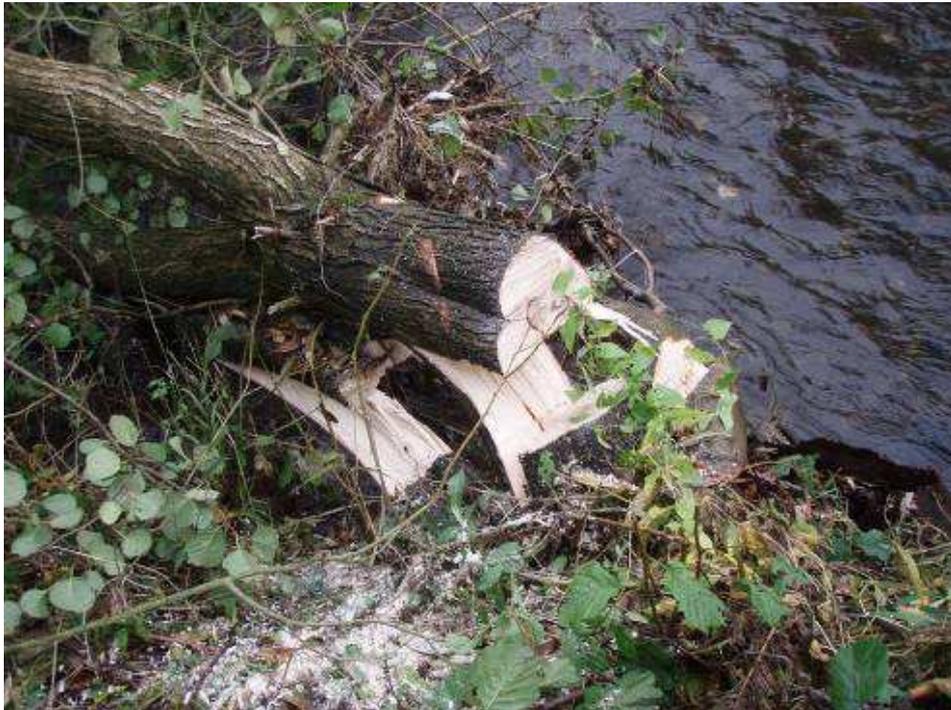
Appendix 1

Partial cutting and hinging/laying of willow (like hedge laying) is a quick way of creating low cover which is firmly fixed to the bank. The willow should root along its length.

This type of habitat can be easily increased with the use of hinging techniques, where young supple tree species such as willow are present. The technique involves partially cutting through the trunk at a low level, then pushing the tree or shrub over, along the rivers edge (as demonstrated in appendix 1). Alternatively, tree kickers could be employed to create similar habitat, by felling the tree into the river and tethering it to its own stump. This retains the trunk in place to increase cover and structure within the channel (as demonstrated in appendix 2).

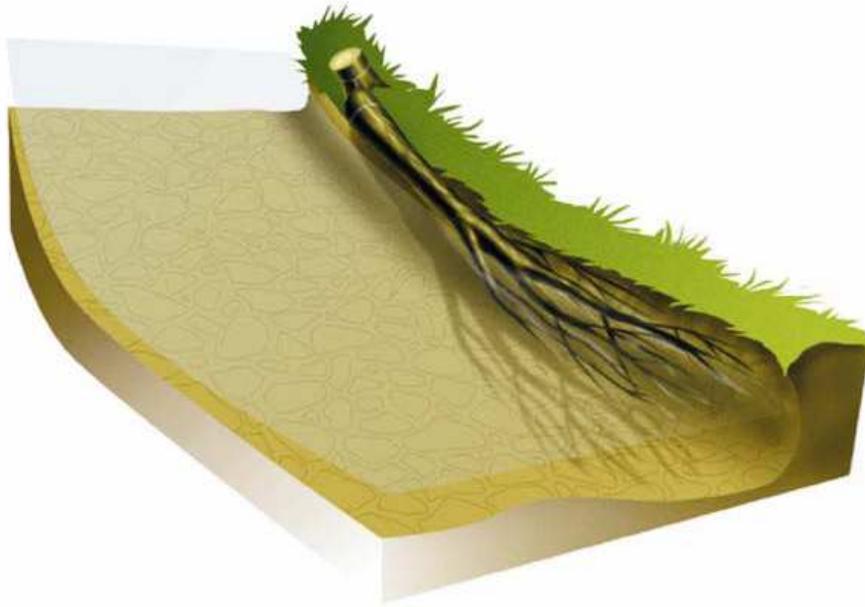
Cut-away diagram, looking upstream at a tree kicker installed along a river bank.

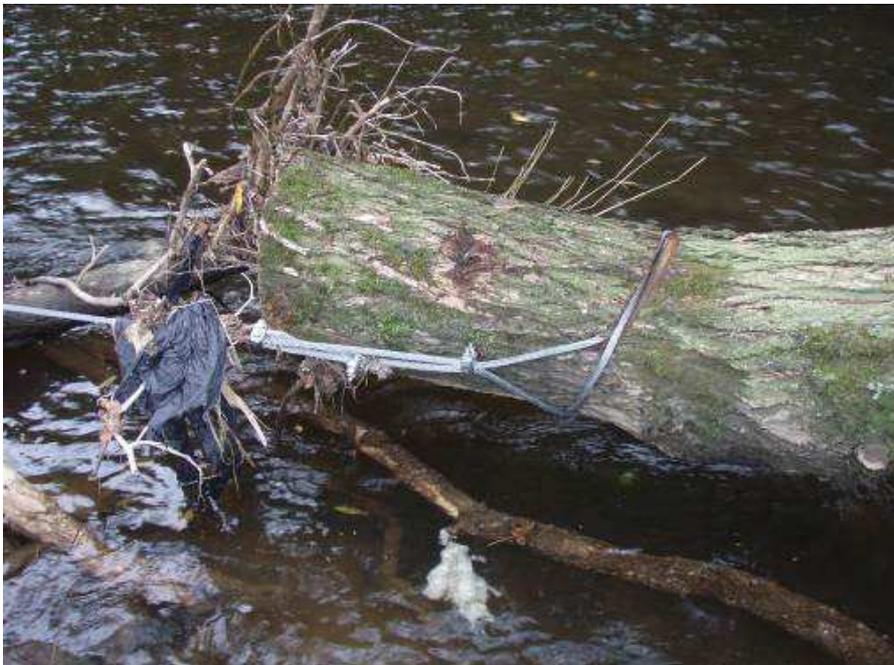
Detail of cable fixing for a tree kicker.

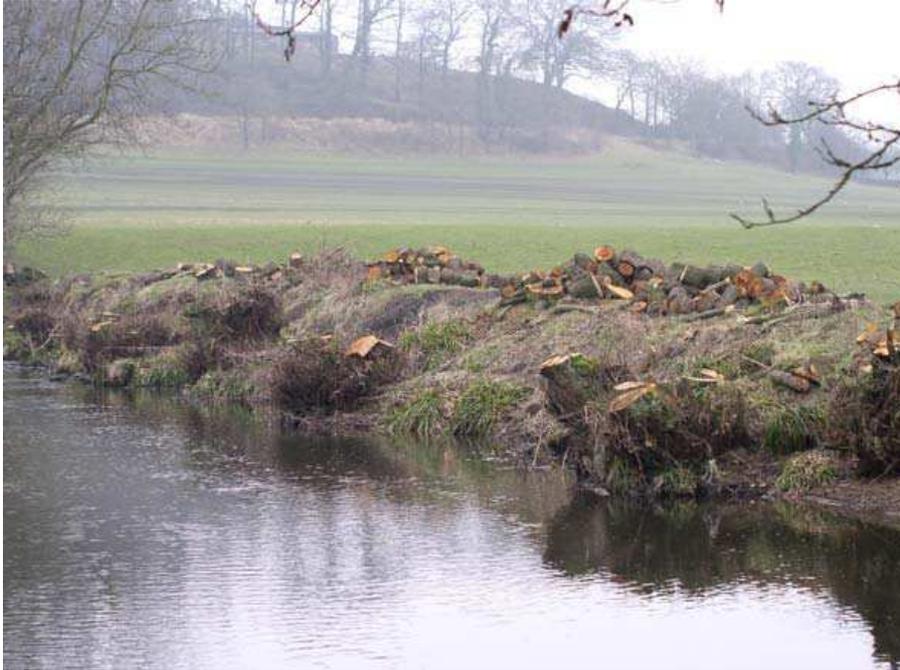
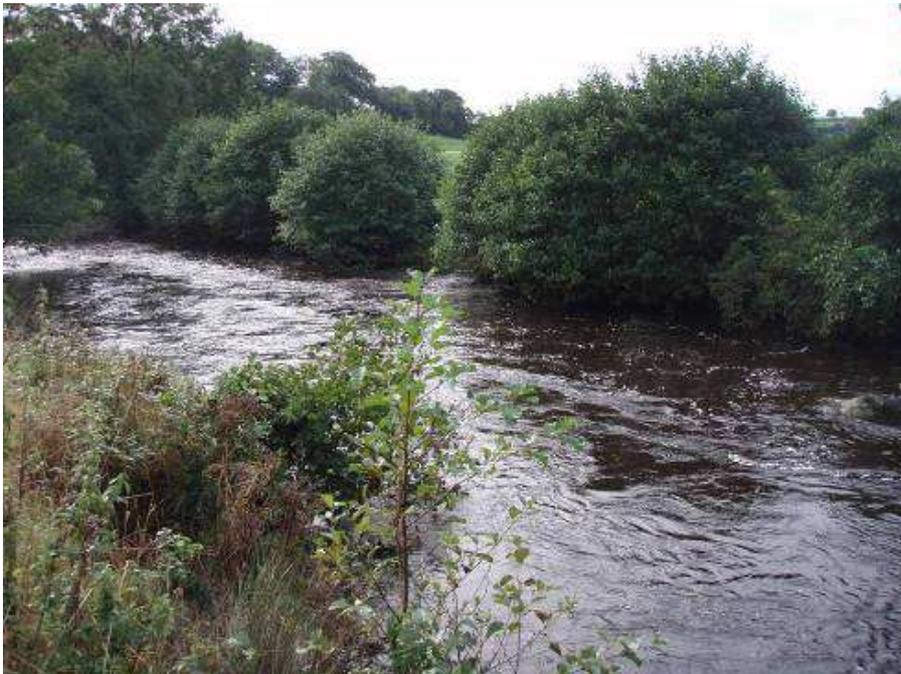
Appendix 3

Coppicing trees produces bushy re-growth which creates excellent low cover over the water. This method should be used sparingly, ideally only on a few trees in a section/year. It is important to protect the re-growth from livestock, where grazing occurs. (Picture represents 4 years re-growth)
