**Advisory Visit**

**River Noe, Derbyshire**

**June 2014**

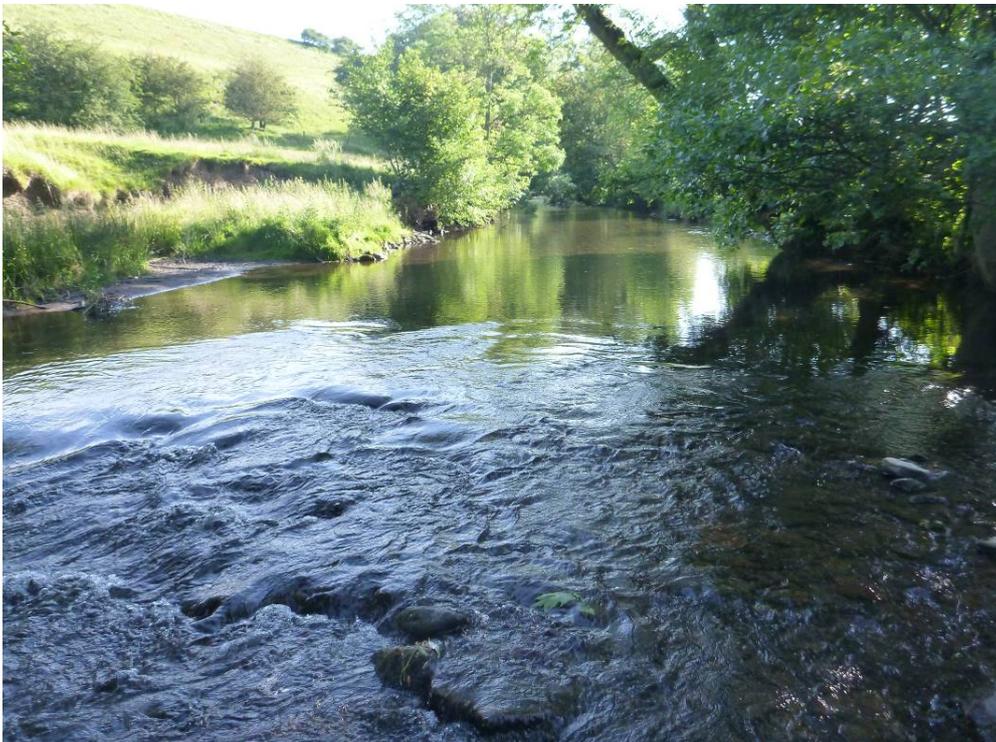
The section of river in question is on beat 3 and formerly a pipe bridge / ford consisting of a row of large concrete pipes was present across the river channel. This was removed about two years ago because the river was cutting around the edge of the structure, eroding the right bank; the cover photo shows the site now. Prior to removal, there was an area of deeper water associated with the structure caused by scouring of the river bed; this area held fish and was a popular spot with club members. Since removal, the area has filled in with gravel and become a uniform and shallow glide.

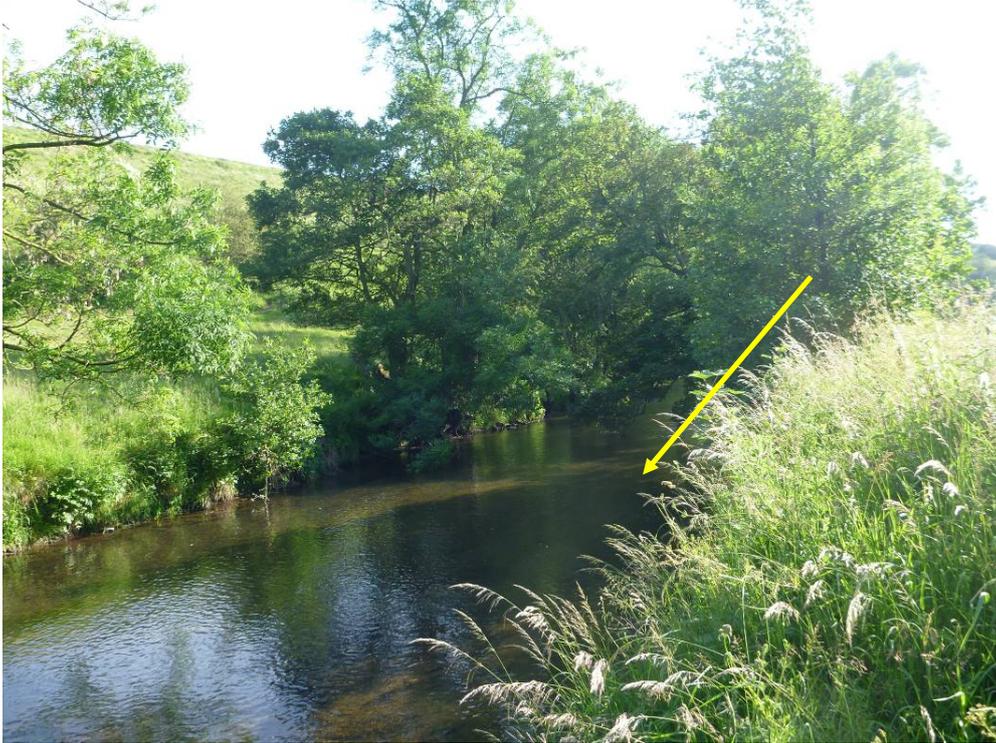
**Photo 1** The young alders indicated could be hinged into the river margins, using the method in photos 3 and 4

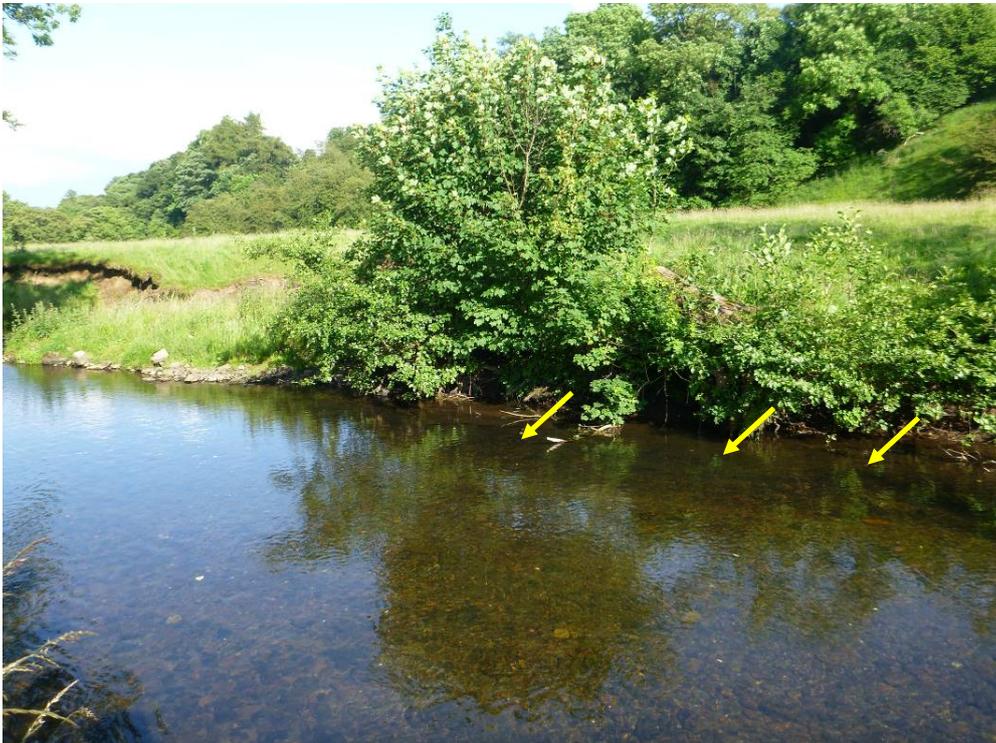
**Photo 2** Hawthorn bushes could be anchored to the root structures of the trees on the right bank, using the method shown in photos 5 and 6. Water crowfoot could be planted in the open shallow areas.

- Cut some hawthorn bushes and introduce them whole to the river, fixed to the right bank. This is a proven and established method (known as "tree kickers") which provides instant cover for fish, has a narrowing effect upon the channel (promoting bed scour and increased depth), and protects banks from erosion. There are suitable hawthorns present in the field on the right bank (subject to landowner permission). These would be fixed to existing tree roots/trunks on the right bank with steel cable (Photos 2, 5, 6).
- Partially cut and lay into the river margin some of the young alder trees on the left bank (like hedge laying) (Photos 1, 3, 4).
- Plant some water crowfoot (*Ranunculus* sp.) in the open, un-shaded section. The club have recently undertaken similar planting further downstream.

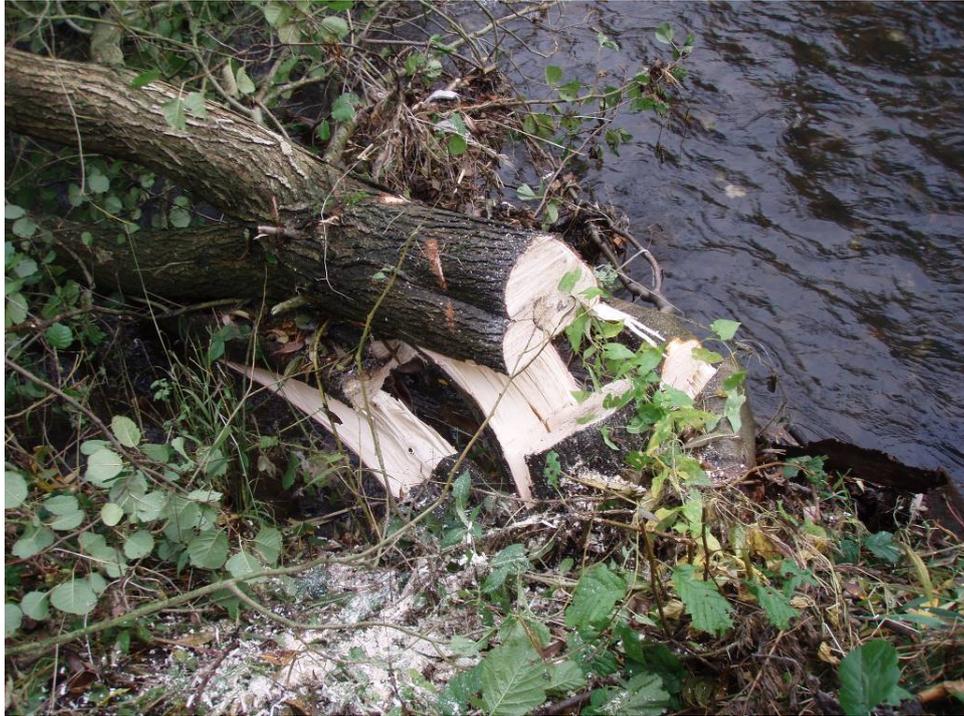
**Photo 3 Partially cut and laid tree. This provides a securely fixed cover which will hold fish.**

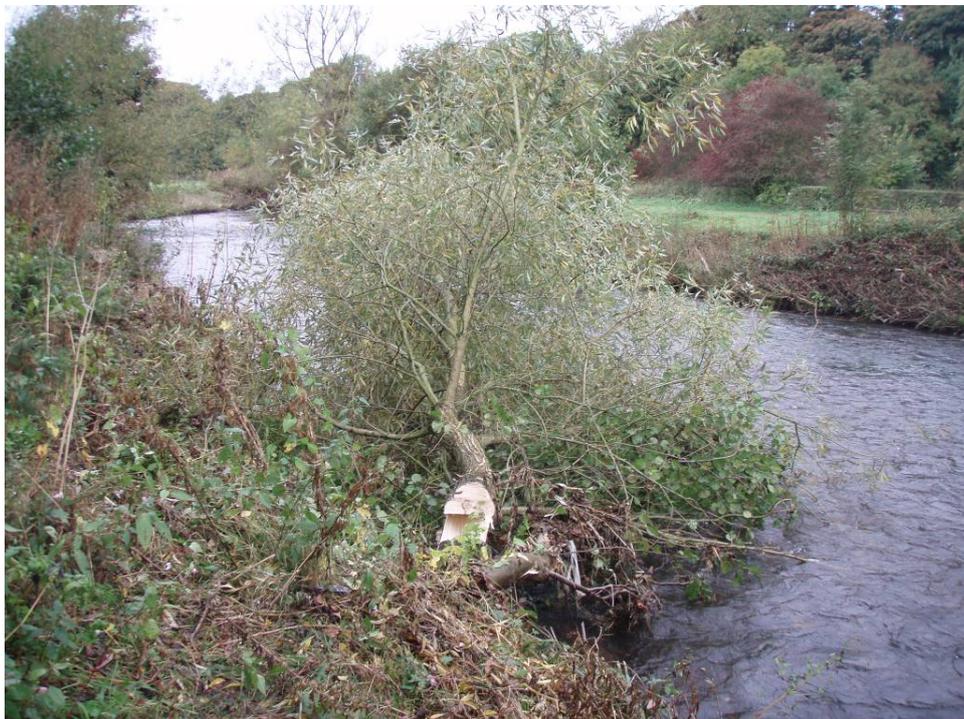
**Photo 4 As above, wider view (River Goyt, Derbyshire). Young trees such as alder, willow and hawthorn up to about 15cm trunk diameter are most suitable.**

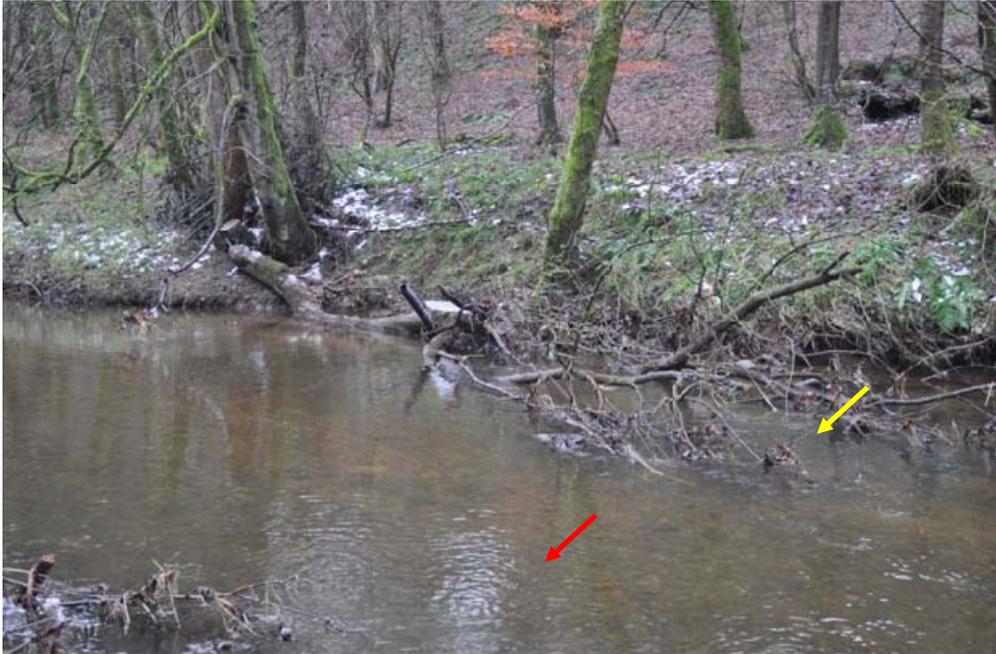
**Photo 5** A “tree kicker” installed in the River Petteril, Cumbria, securely cabled to a tree stump. This provides cover and changes the depth profile by promoting deposition (shallowing, yellow arrow) amongst the branches and scour (deepening, red arrow) of the open channel.

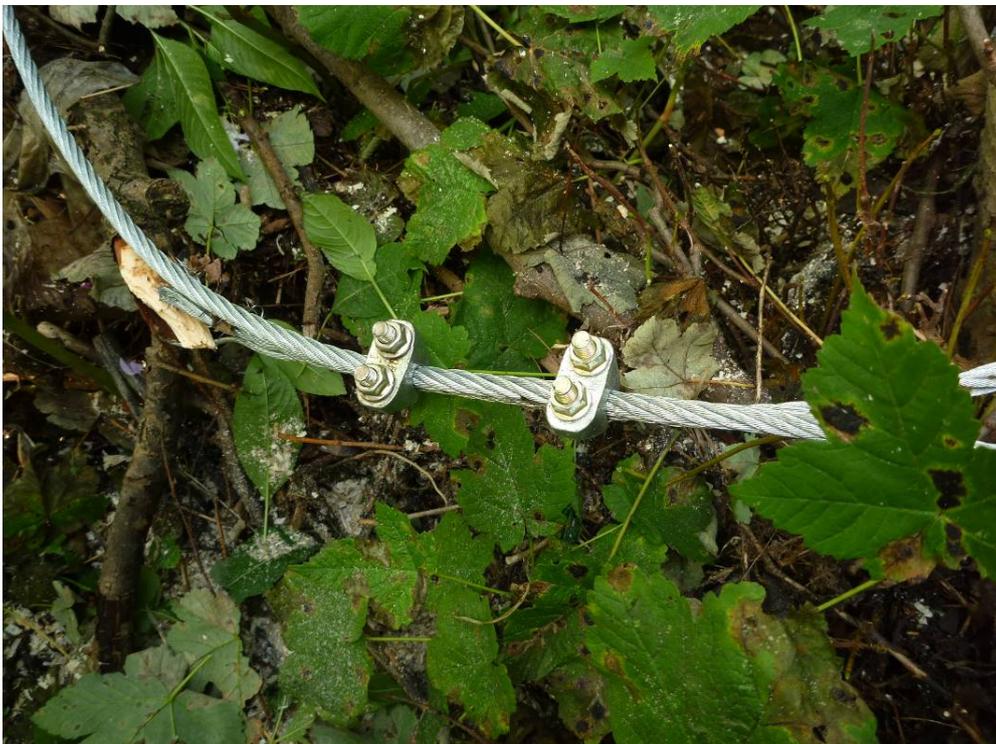
**Photo 6** Steel cable used to securely anchor tree kicker structures.
