**Advisory Visit**

**River Noe, Derbyshire**

**July 2018**

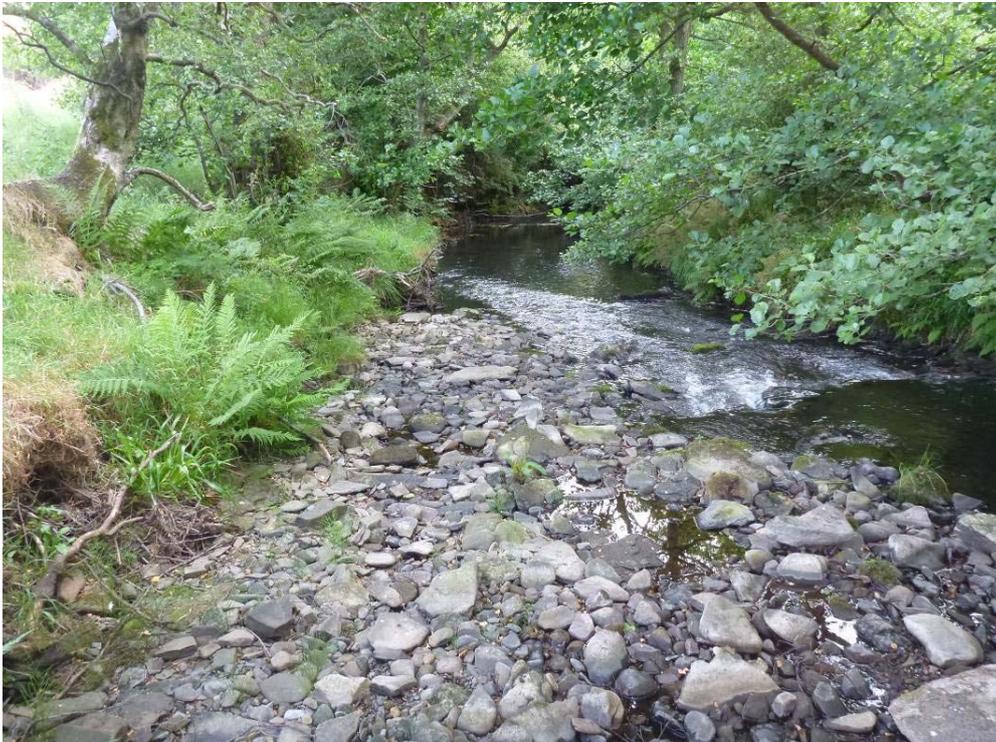
The in-stream habitat observed during the visit was generally very good. The downstream half of the reach has a pool-riffle sequence which provides good habitat for larger trout (in the deeper pools) and good habitat for spawning and juvenile trout in the shallower, gravelly runs (cover picture, Photo 2).

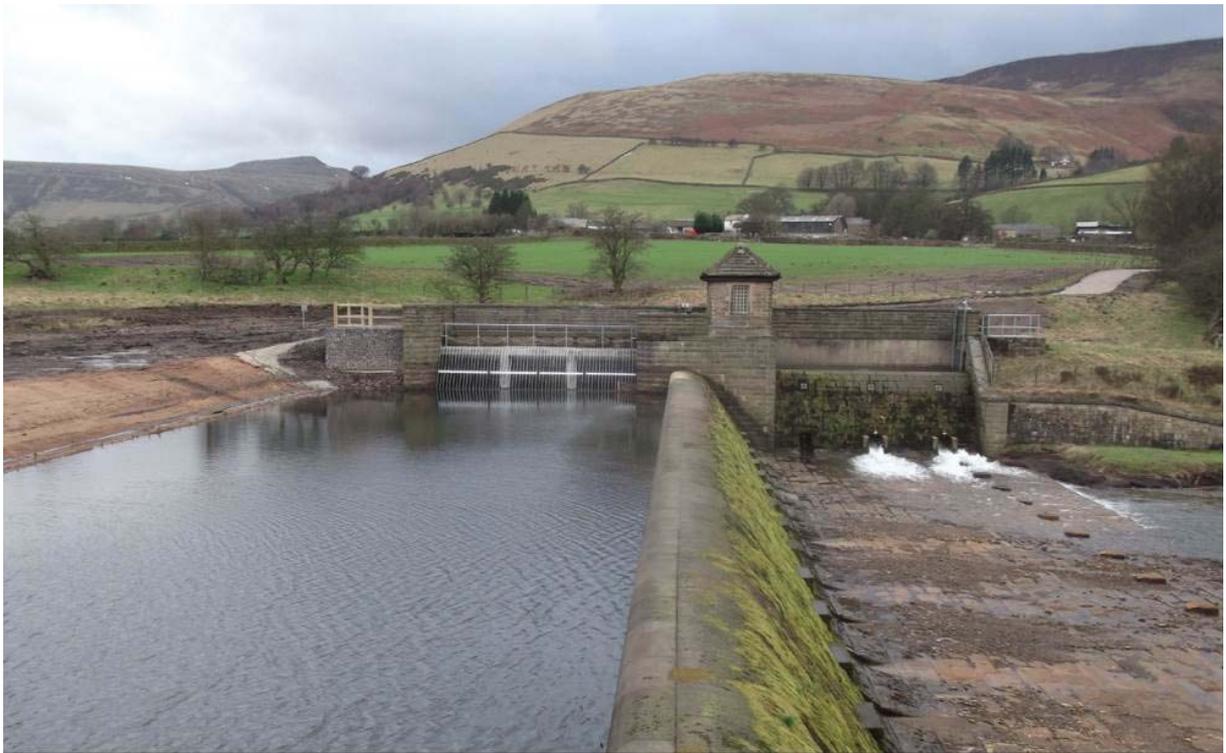
The section of the River Noe visited is situated between the Nether Booth reservoir abstraction point (Photo 1, SK1457785838) and the confluence with Jaggars Clough, a tributary of the River Noe (SK1610286254). Water is drawn from the River Noe at Nether Booth into Ladybower reservoir via a tunnel. In the past, the river downstream of this point was often completely dry for prolonged periods. The length of river affected extended downstream to the Jaggars Clough confluence, the latter watercourse having an artificially elevated flow through the release of compensation water.

**Photo 1 Nether Booth dam and abstraction point.**

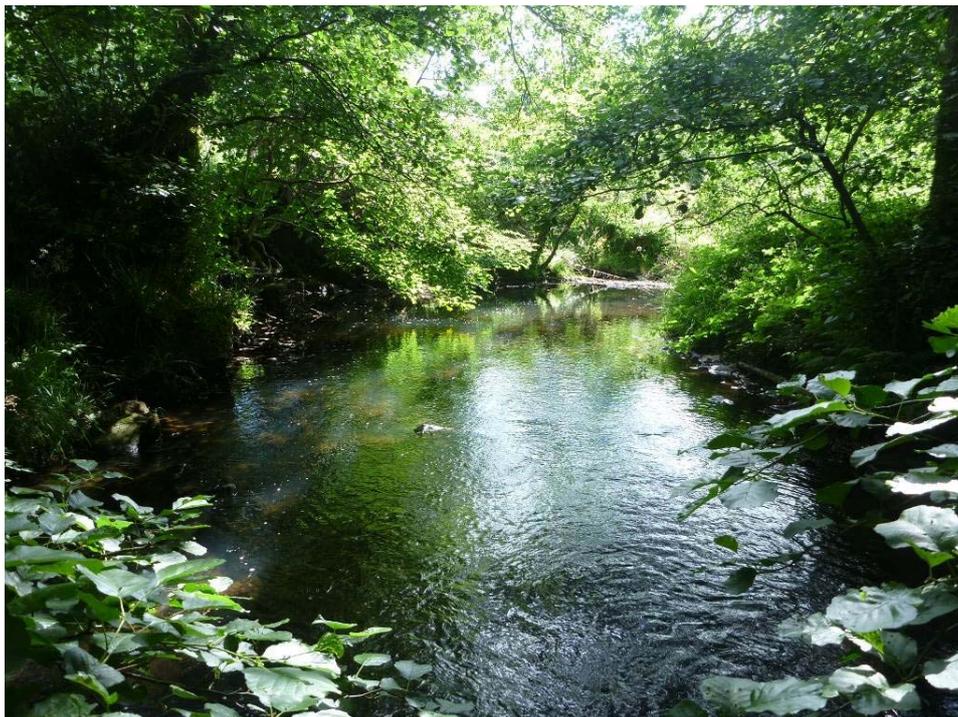
**Photo 2 Variation in depth and flow, good shading and good water quality – all good trout habitat and one was observed in this area.**

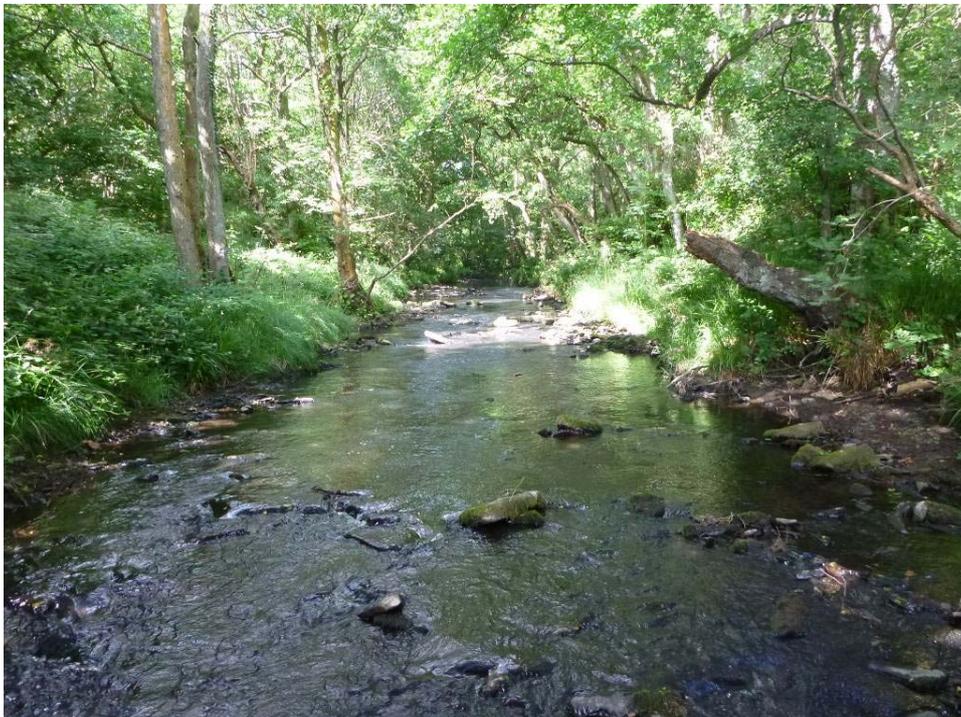
The channel in the upstream half of the reach has unfortunately been straightened, probably several decades ago when the road and bridge culvert was constructed. Remnants of what is likely to be the original river channel can be seen on the right bank. Straightening a river channel has a negative impact on the in-stream habitat because it destroys the natural pool-riffle sequence, replacing it with steeper, shallower riffles and glides. The greater gradient of the straightened channel has more energy and tends to transport finer sediment (sand and smaller gravels) through, leaving only larger gravels, cobbles and boulders; this can adversely affect fish recruitment by reducing the availability of suitably-sized spawning gravel. The increased stream energy can also lead to greater erosion of the river banks and down-cutting of the river bed, leading to an incised channel.

**Photo 3 Straightened section of channel – no pools.**

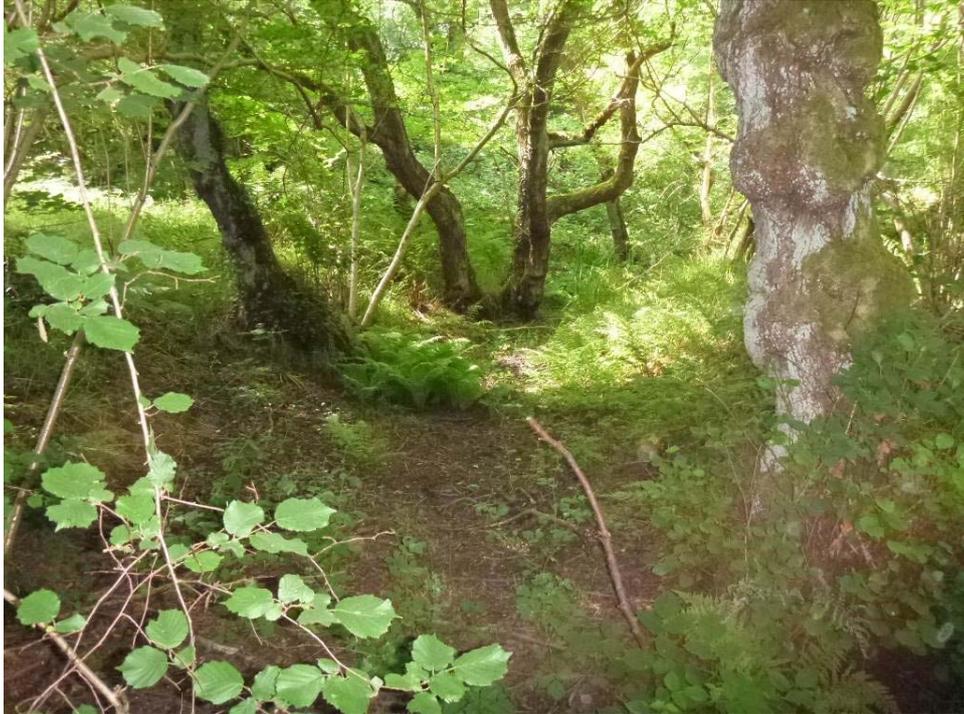
**Photo 4 Remains of original channel on the right bank.**

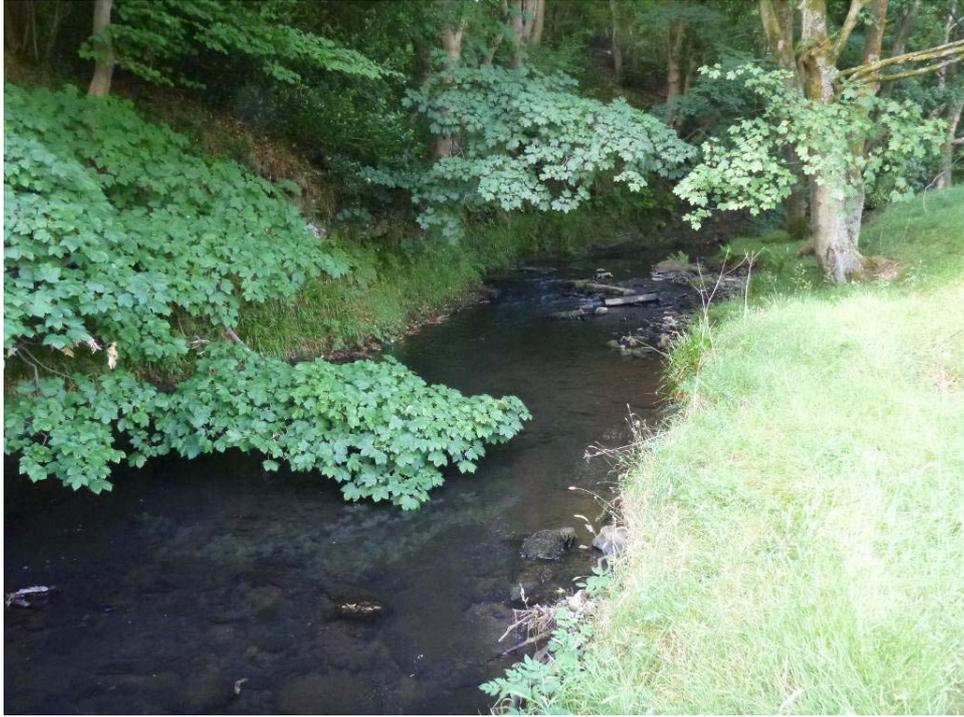
The bankside vegetation throughout the reach is good, with plenty of shading from mature trees. The upper temperature limit for trout is in the low twenties Celsius so shade is extremely important in keeping rivers cool, especially ones like the Noe fed by surface water rather than groundwater. Where tree branches reach low over the water, the temptation to trim them back to facilitate casting should be resisted. Low cover over the water is often the difference between an area holding fish or not, particularly in shallower water. Adapting the angling approach to fish around the feature, rather than removing it (and the fish) is the best approach.

**Photo 5 Low cover like this is often the difference between presence and absence of fish, especially in shallower areas.**

- Keep an eye on flow levels and the amount of fine sediment in the river. Report any concerns to the Environment Agency and inform the fishing club.
- Restrict livestock from grazing the river banks.
- Maintain the tree cover (shade) and low branches and trailing vegetation as fish cover.
- Retain large woody material in the river channel.
- Keep an eye out for Himalayan balsam (and pull it up) and Japanese knotweed (inform the fishing club).

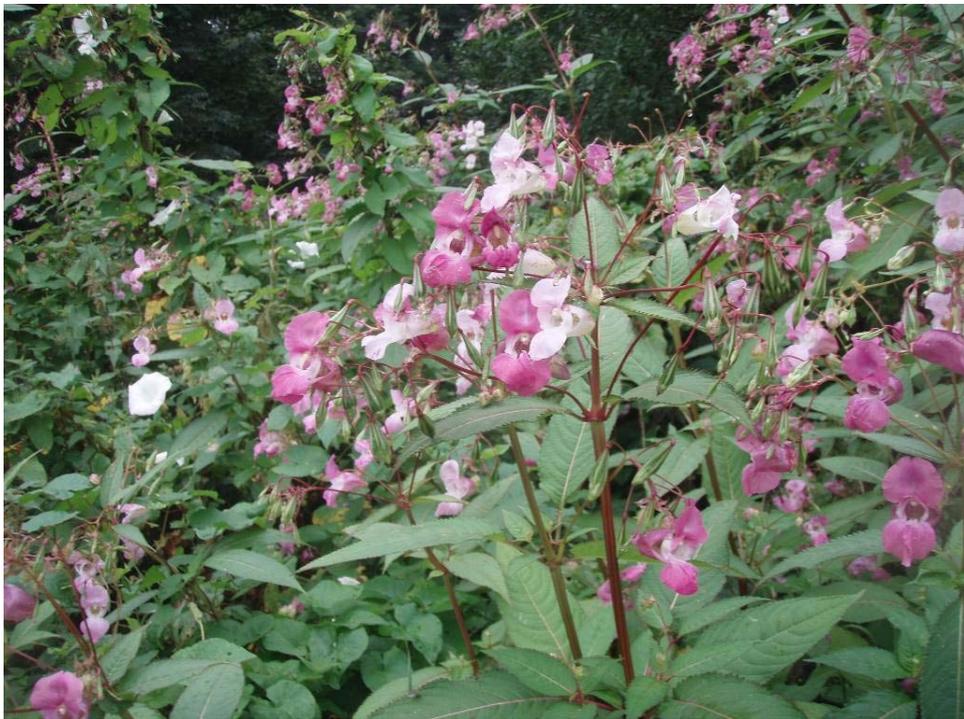
Native bankside vegetation can be swamped by non-native invasive plant species such as Himalayan balsam (*Impatiens glandulifera*) and Japanese knotweed (*Fallopia japonica*), both of which are present on the River Noe (Photos 6 and 7), although not observed on this reach. Balsam is an annual plant and can be controlled by hand-pulling, or strimming below the first stem node, before it flowers in early summer. Knotweed is persistent and easily propagated from small fragments, so requires a specialist approach. PFAC are undertaking a programme of knotweed control by stem injection of herbicide by qualified contractors. If any knotweed is observed, please contact the fishing club and let them know.

**Photo 6 Himalayan balsam**

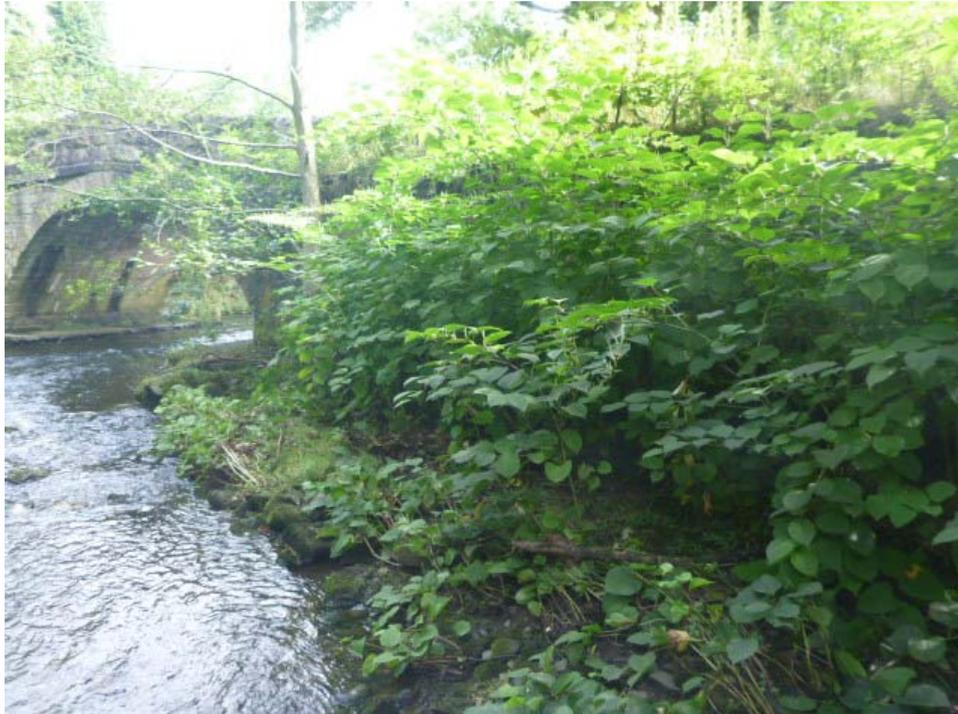
Photo 7 Japanese knotweed
