North Lake, West Compton, Dorset

An Advisory Visit by the Wild Trout Trust, March 2016

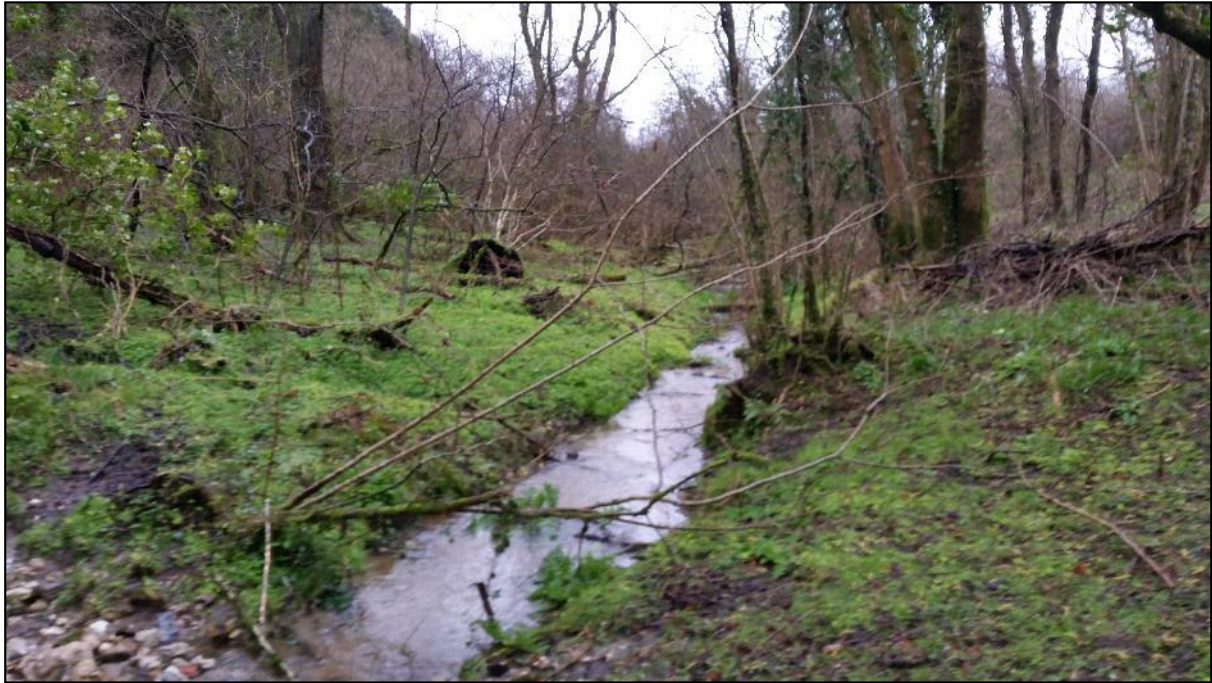
Figure 2: The stream above the lake

The stream above the lake flows through a densely-wooded valley. The bed mostly consists of small flint gravels and could potentially provide spawning habitat for wild trout. However, only a short section of the stream was inspected as this is the upstream boundary of the Mirchandani's land.

The wooded valley casts dappled shade over most of the stream which is important as shade plays an important role in regulating temperature in rivers. In small headwater streams, where trout prefer to spawn, this function is especially important as low flows during periods of prolonged dry weather can leave many temperature-sensitive species of fish and invertebrates vulnerable; not only does warmer water contain lower concentrations of dissolved oxygen, but it can also increase the effect of pollutants and the susceptibility of trout and other species to a range of pathogens. Although salmonids are able to acclimate somewhat to different average temperatures, one week at 25°C, or only 16 minutes at 27°C will be lethal to brown trout. Any temperature above 19.5°C will severely stress trout, potentially threatening long-term survival. Temperature also regulates the incubation period for trout eggs (~100 days at 5°C or ~50 days at 10°C) and the period in which alevins consume their yolk sack (~38 days at 7.5°C). Further details summarised by the Environment Agency can be found here: https://www.gov.uk/government/uploads/system/uploads/attachment_data/file/291742/scho1008boue-e-e.pdf

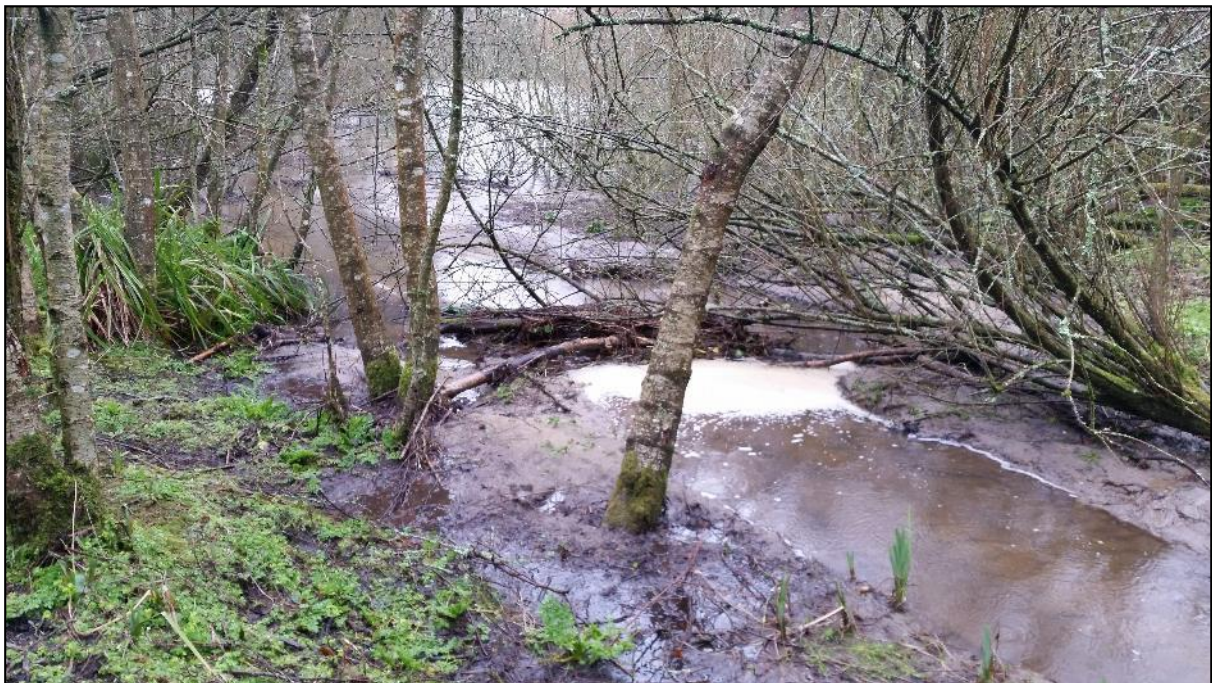
Sedimentation near the inflow of the lake (Figure 3) is a classic sign of stream-fed siltation. The sudden drop in flow speed at the mouth of the stream allows sediment to drop out of suspension and accumulate on the bed. This process causes the lake to shallow around the mouth.

The dense willow thicket at this end of the lake may be preventing marginal plants from colonising and consolidating the sediment deposits. Cutting this back and allowing more direct sunlight onto this end of the lake may promote the development of a bed of marginal plants which will improve biodiversity and also provide cover for adult trout running up to spawn in the stream and a vital refuge for any juvenile trout dropping back down. In lakes with wild trout populations, young parr dropping into the lake will rely heavily on the 'shaggy' marginal habitat provided by emergent plants, roots and fallen trees. This not only protects them from predation, but also allows a greater number of juvenile trout to occupy a certain area without feeling threatened by each-others presence. From the moment they emerge from the gravel, trout are territorial and do not remain

Figure 3: The inflow of the stream into the lake is heavily silted

Creating marginal reed beds could help to filter water from the stream and could help to trap sediment at the upstream end of the lake, potentially making it easier to manage. This option will however require some initial works followed by occasional maintenance to prevent bankside vegetation from encroaching into the lake or blocking upstream migration. Marginal encroachment could reduce the size of the lake over time and potentially impeding upstream access for trout. However, if undertaken as part of a broader suite of actions as outlined in the *Recommendations* section, annual maintenance can be kept to a minimum. Re-profiling the lake around the mouth of the stream to create a gentle slope down from the vegetated bank will create a marginal zone where a succession of different plant species, favouring different levels of saturation, will continue to flourish. A relatively abrupt increase in water depth from the marginal zone down to the benthic zone (lake bottom) will prevent marginal plants from encroaching further into the lake.

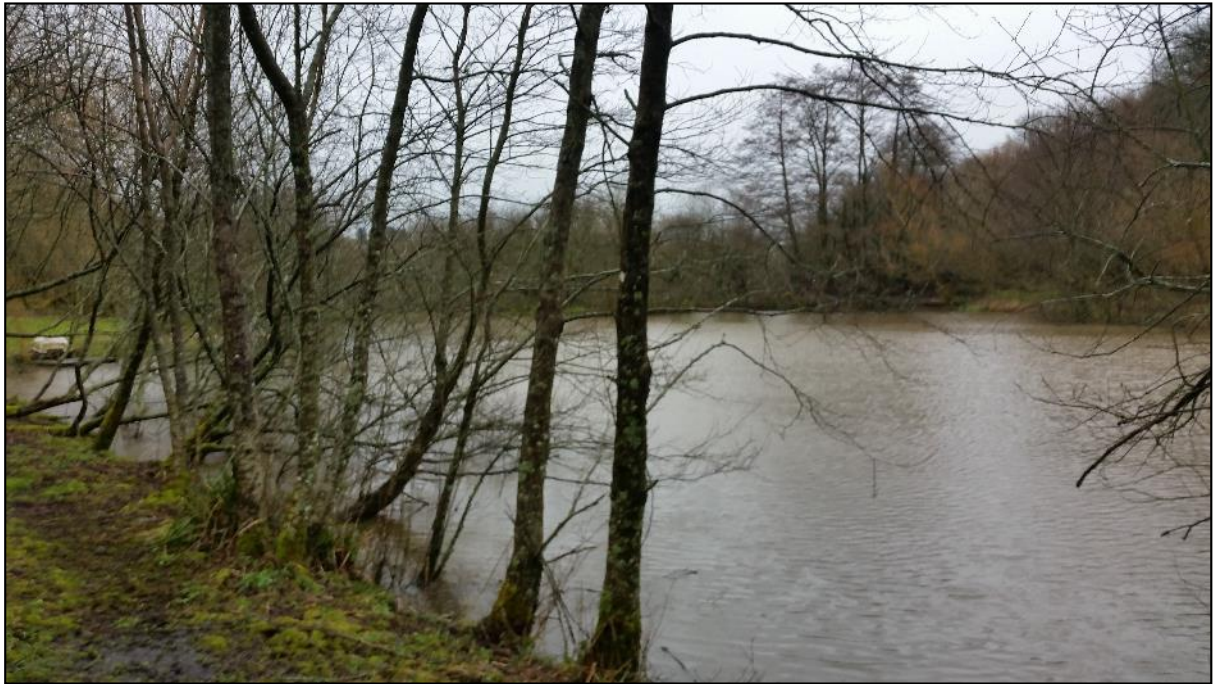
A short distance downstream of the inflow are some relatively small and low-growing bankside trees with low, trailing branches (Figure 4). These should be retained as the marginal cover habitat they provide is extremely valuable. Other taller trees further back from the bank edge should be prioritised for tree works.

Figure 4: Bankside trees providing some good low cover habitat

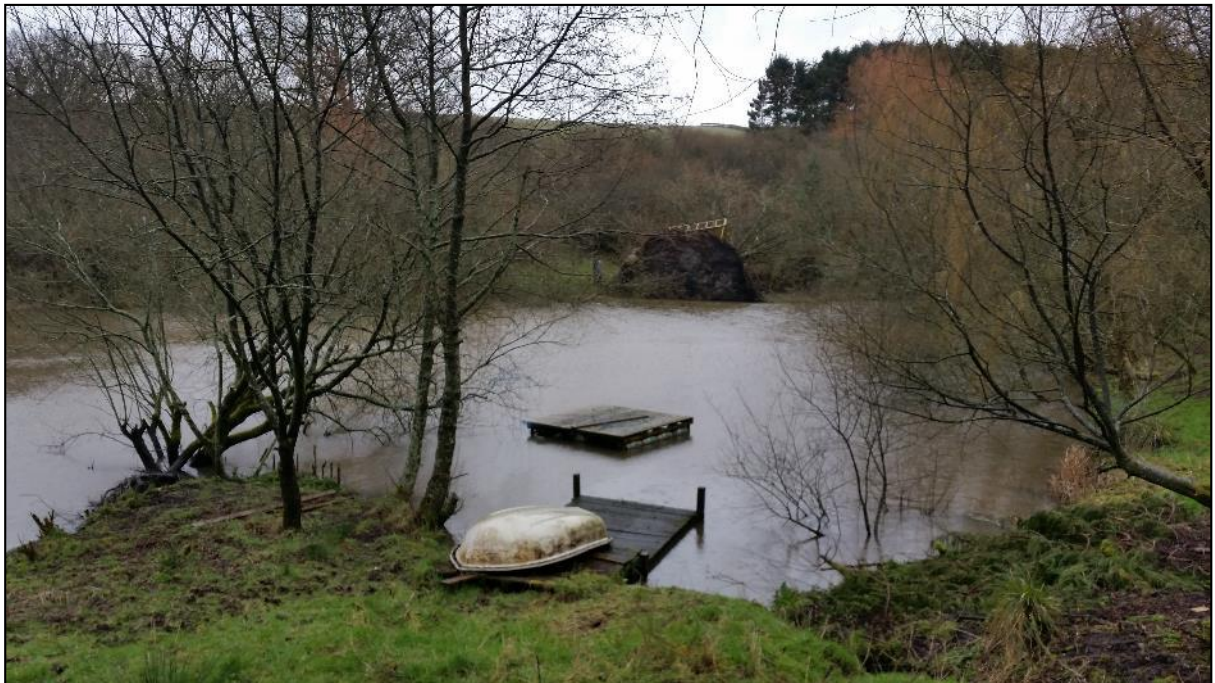
assessment of the aquatic plant community, and a large white poplar had been blown over on the eastern side of the lake (Figure 5).

Figure 5: The root ball of the fallen poplar (background).

White poplars are notorious for having shallow roots and are particularly vulnerable to high winds once they have grown to a certain height. Cutting the fallen tree near the stump may allow it to right itself and the tree may yet survive. However, it would probably be better for the lake to remove the tree completely and instead provide habitat for marginal and emergent wetland plants.

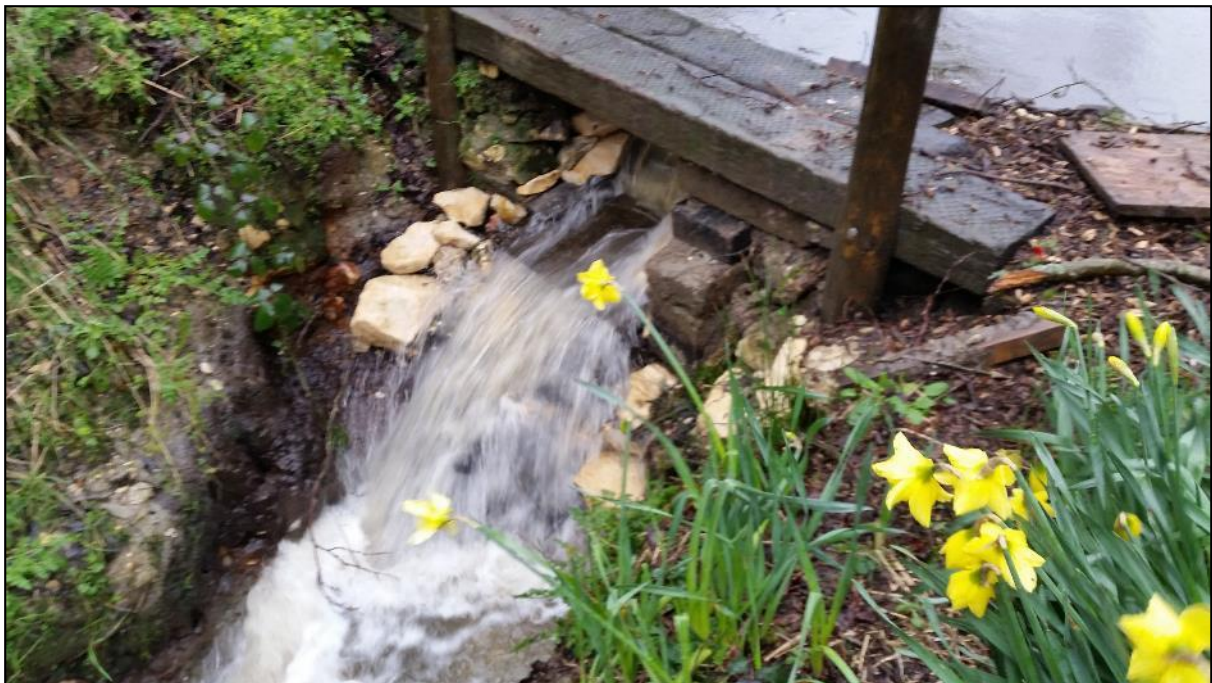
At the western end, the lake discharges back into the stream over a small weir (Figure 6). At present this structure is a complete barrier to upstream fish migration. This isolates fish populations within the lake and makes them particularly vulnerable to pollution, predation, habitat degradation or other scenarios that could lead to fish mortality. Without good access for fish attempting to run upstream, the lake would not be able to naturally repopulate following a fish kill event.

The bed of the stream immediately below the lake is undergoing head-cut erosion, causing the stream to become incised and leading to bank erosion and slumping (Figures 7 and 8). This appears to be largely due to the head drop from the outfall of the lake to the stream below (Figure 6) and the resulting turbulence stripping away coarser sediment and gravel. However, it is also worth noting that the lake is a significant barrier to sediment transport meaning that the gravel transported downstream from below the lake cannot be replaced by gravel from upstream. Once the natural gravel seam of the bed has been removed, the underlying alluvial clay is easily eroded and the rate of channel incision can become accelerated. Left unaddressed, the rate of erosion in the channel could risk the integrity of the lake dam.

Figure 6: The outfall of the lake is impassable for fish and is contributing to erosion

The straight drop from the lake outfall to the stream also makes it a barrier to fish passage and prevents any trout that may inhabit the stream from accessing the lake or any habitat above it. Installing a series of pre-barrage structures in the stream below the lake could help to improve fish passage and also reduce the rate of bed and bank erosion. This is explored in greater detail in the *Recommendations* section of the report.

1. Address the erosion and improve fish passage at the outfall of the lake by installing a series of pre-barrage structures. This will spread the head drop from the weir over a greater distance, reduce turbulence and help to stabilise the bed and banks. The outline design shown in Figures 14 and 15 consists of site-won logs stacked and secured with steel rebar driven through holes drilled in them. A notch with a curved nape on the downstream side should be cut in the top log to provide a solid flume of water with as little entrained air (white water) as possible. In order to improve fish passage, the head drop over each of the barrages should be no greater than 100-200mm. A non-woven nylon soil retention geotextile is shown affixed to the upstream side of each barrage with a long skirt to prevent the river undercutting the structures. This design is an outline design concept and it is recommended that further advice be sought from an experienced consultant/contractor before construction. WTT can recommend contractors in the area that may be able to help.

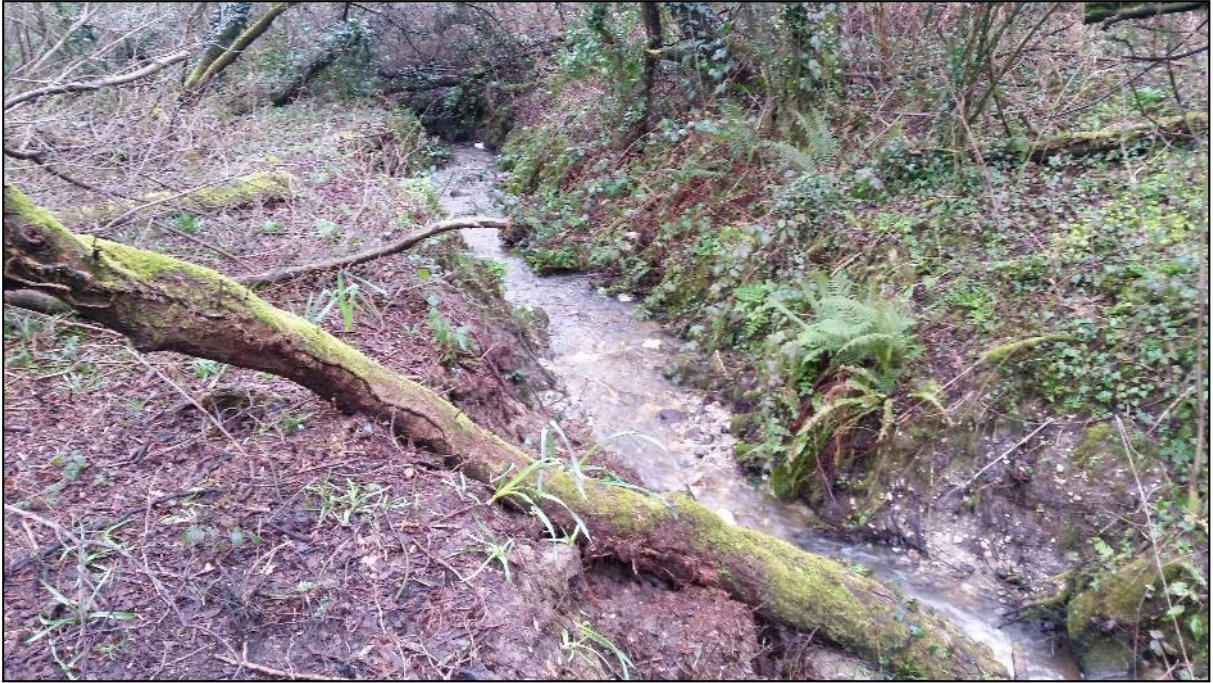
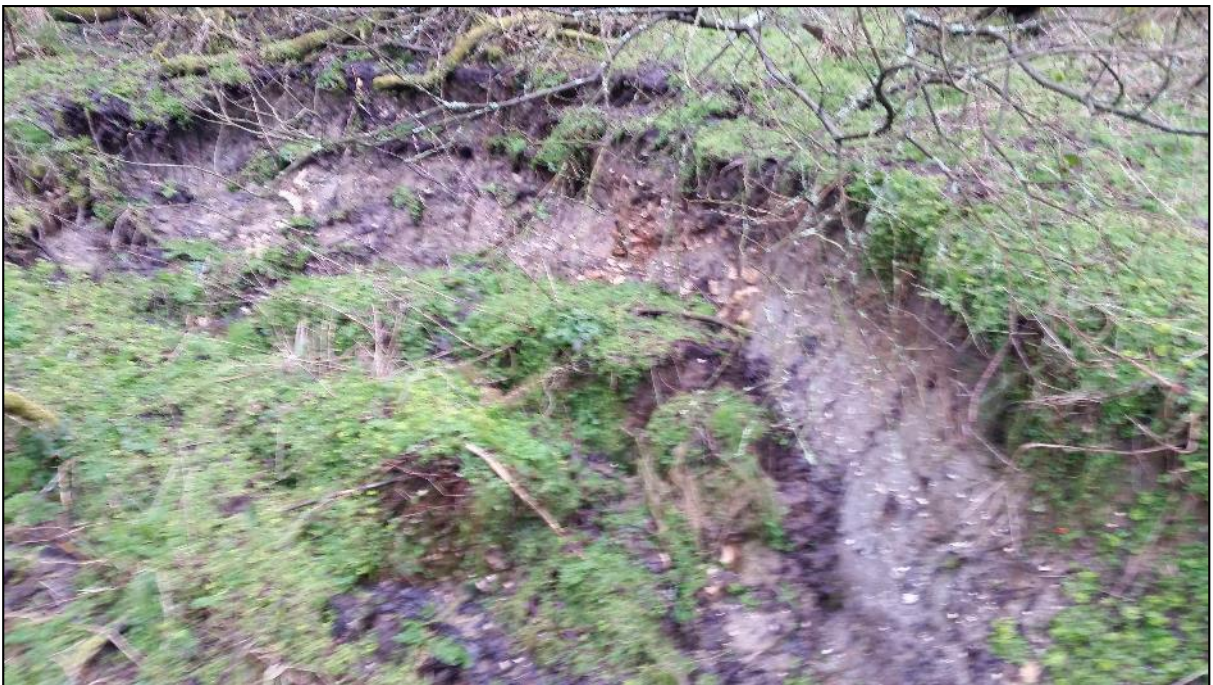
Figure 7: The channel downstream of the lake is incising as the bed erodes

Figure 8: A bank slip as a result of the bed erosion destabilising the banks

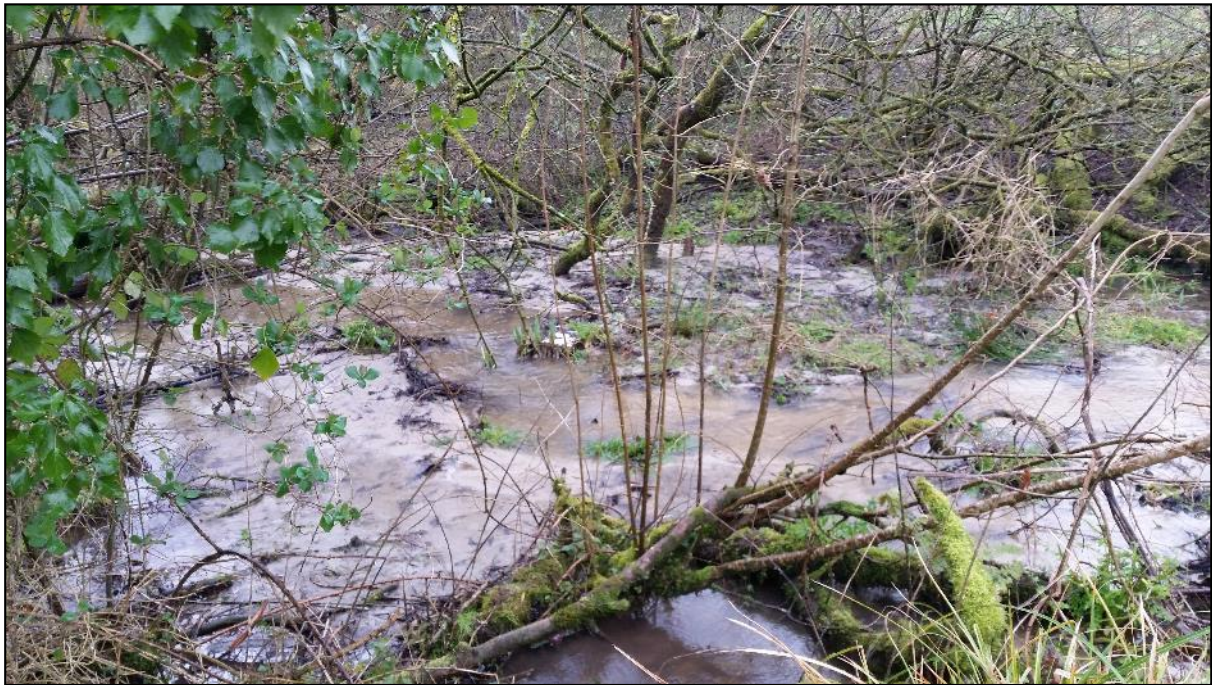
A section of the stream below the lake was also inspected toward the downstream end of the Mirchandani's land. Here the gradient of the land is shallower, the wetted perimeter becomes wider, and the stream flows through a diffuse channel choked by thick deposits of fine, sandy sediment (Figure 10). A certain proportion of this sediment is likely to have originated from the erosion immediately below the lake but it is also likely that a great part of it comes from land use practices within the wider catchment and from the recent de-silting of the ponds further up the valley.

Figure 9: The heavily-silted stream below the lake

2. Measures should be taken to improve the heavily-silted section of the stream shown in Figures 9 and 10. This can be achieved by making use of the abundance of hazel around the lake to create faggot bundles of hazel brushwood (branches) and densely packing them into the soft margins of the stream. In addition, some of the willows around the stream should be coppiced or pollarded to allow more sunlight onto the bed and banks. This in turn will allow marginal plants to quickly take root and further consolidate the banks, replacing the hazel brushwood as it biodegrades. Some translocating of the existing marginal plants from the centre of the channel to the margins will also be required. This will focus available flow through the central channel and help keep it scoured clean.

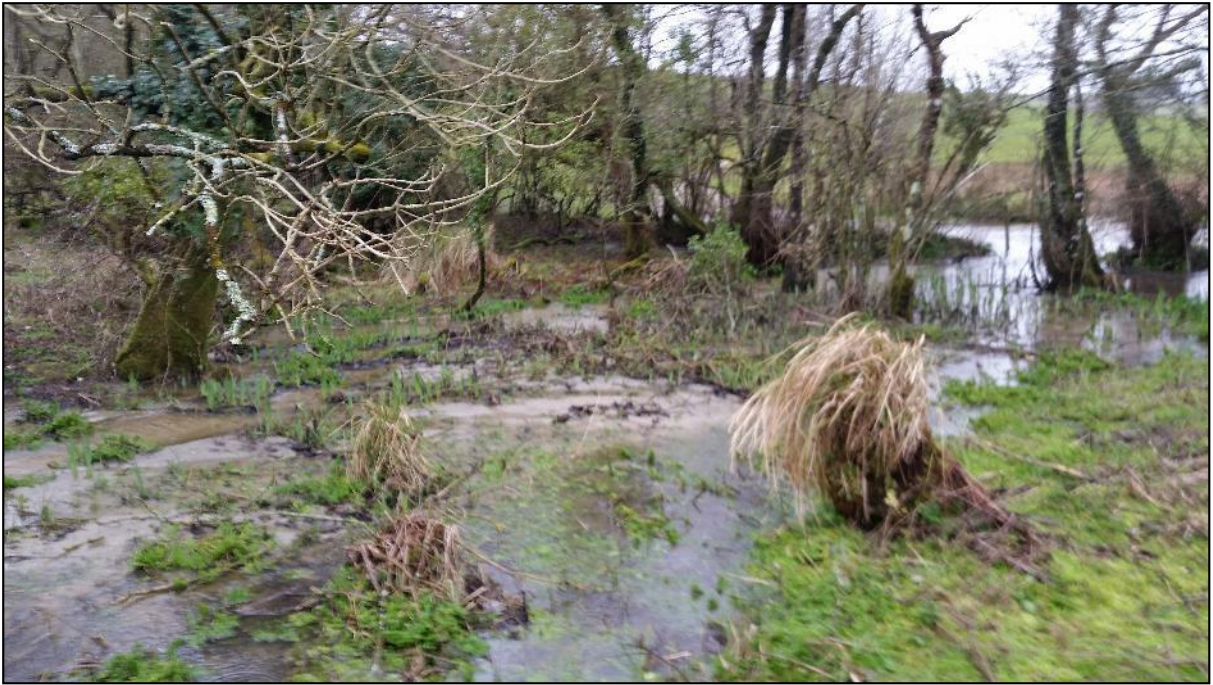
A relatively high abundance and diversity of wetland plant species is present and these have encroached across the channel in places, compounding the diffuseness of the stream habitat (Figure 11). Consolidating the fine sediment in the margins of the stream and focussing available flow through a sinuous central channel will help to restore the stream in this location and may improve habitat diversity and fish passage. Techniques for achieving this are outlined in the *Recommendations* section.

Figure 10: Marginal plants encroach across the stream

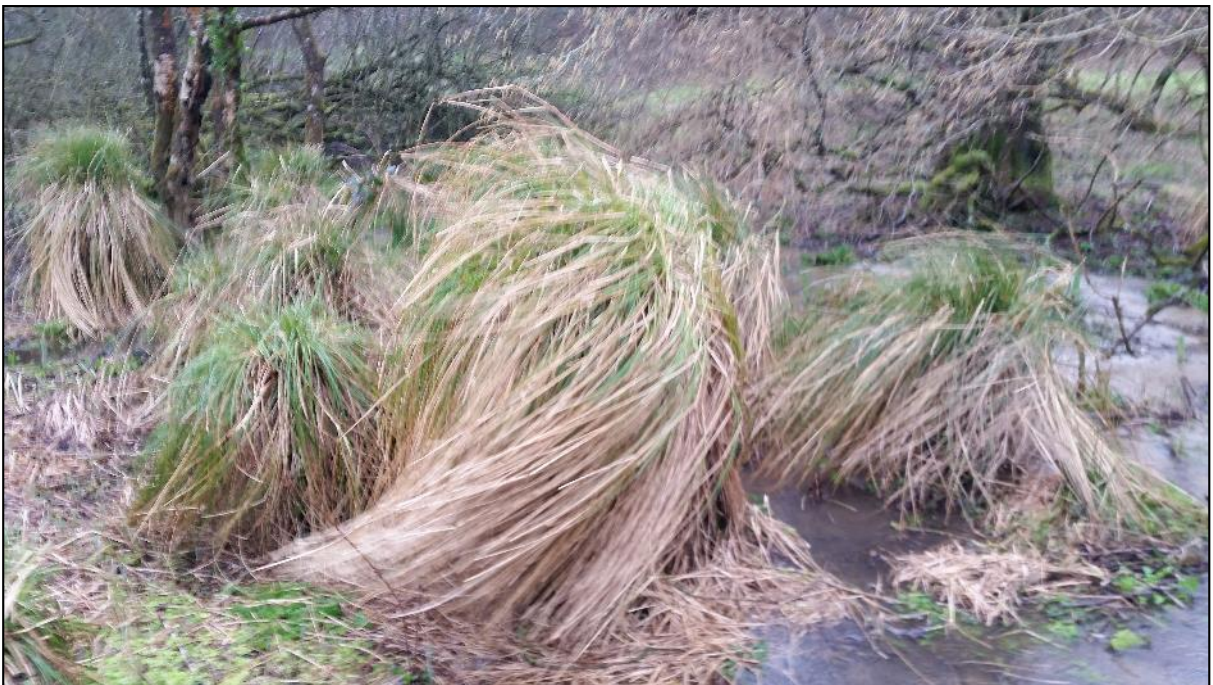
A number of large greater tussock-sedges (*Carex paniculata*) were observed next to the stream (Figure 12). These specimens should be conserved as they will be quite old to have reached such a size and will provide valuable habitat for a number of invertebrate species.

Figure 11: Tussocks next to the stream provide valuable invertebrate habitat and should be conserved

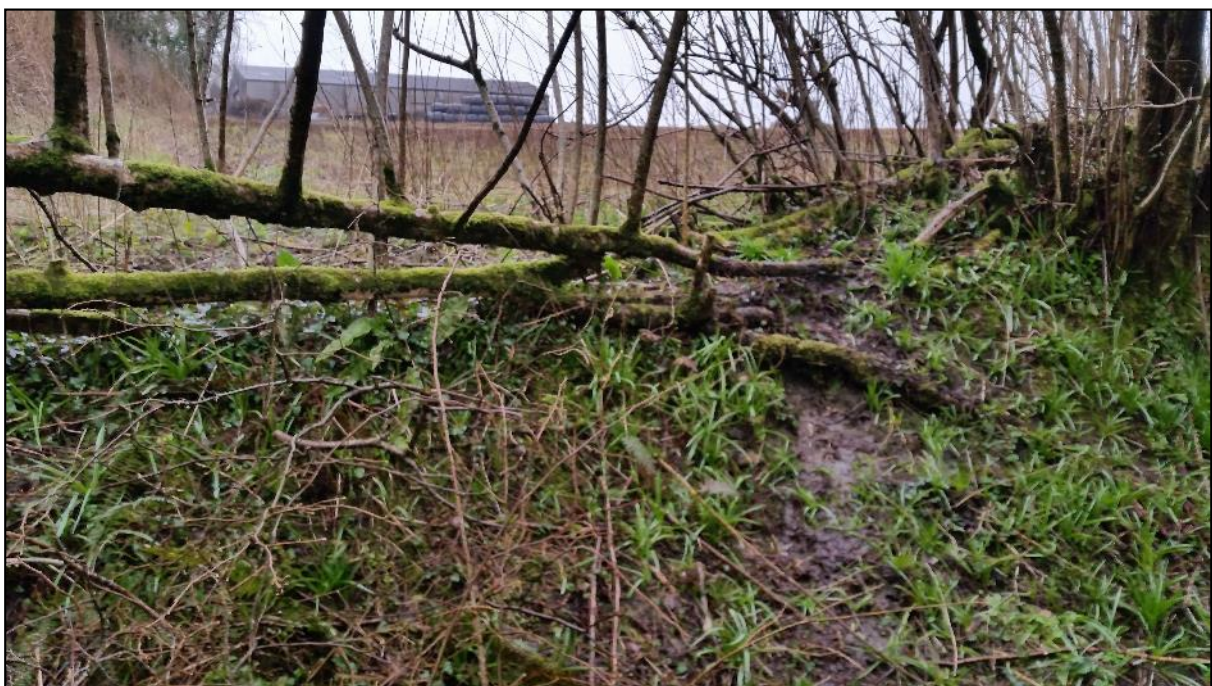
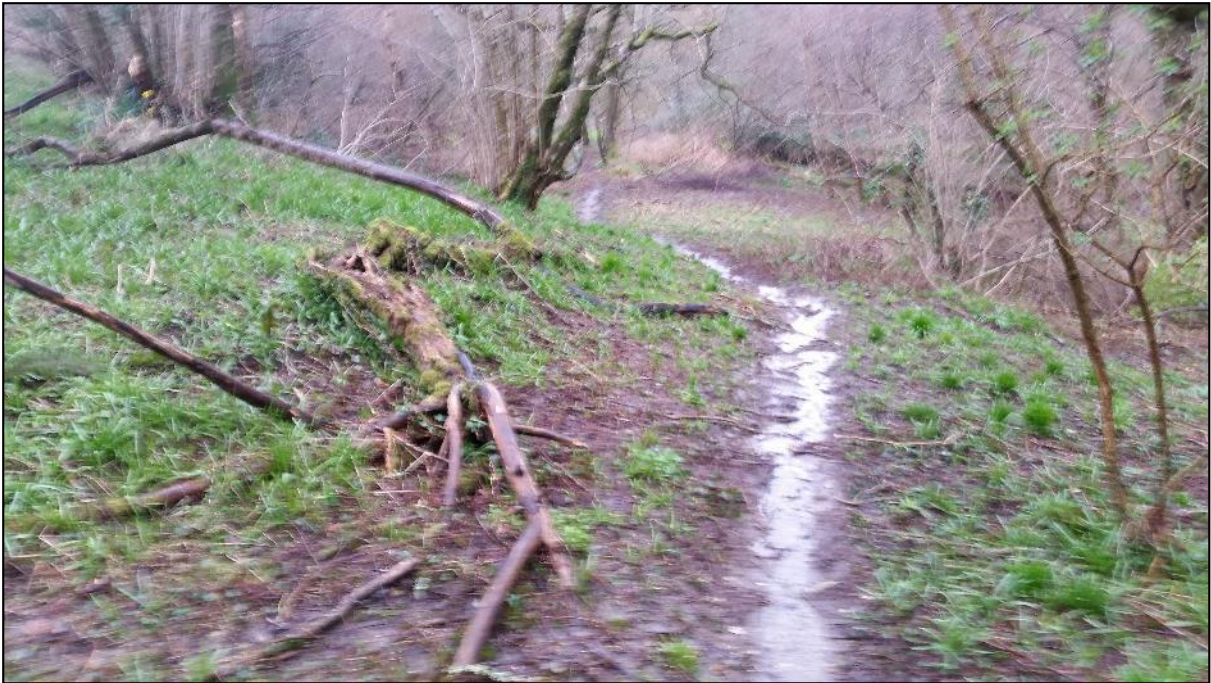
A significant input of sediment was observed draining from a nearby arable field (Figures 12 and 13). Placing brushwood bundles across silt pathways may help to reduce the rate at which sediment enters the lake. However, the best way of reducing the volume of run-off would be for the farmer to retain a buffer margin of un-ploughed grass around the boundary of the field. This will help to naturally filter surface run-off.

Figure 12: A point-source of fine sediment drains from an adjacent field

Figure 13: A sediment pathway winds its way down to the lake

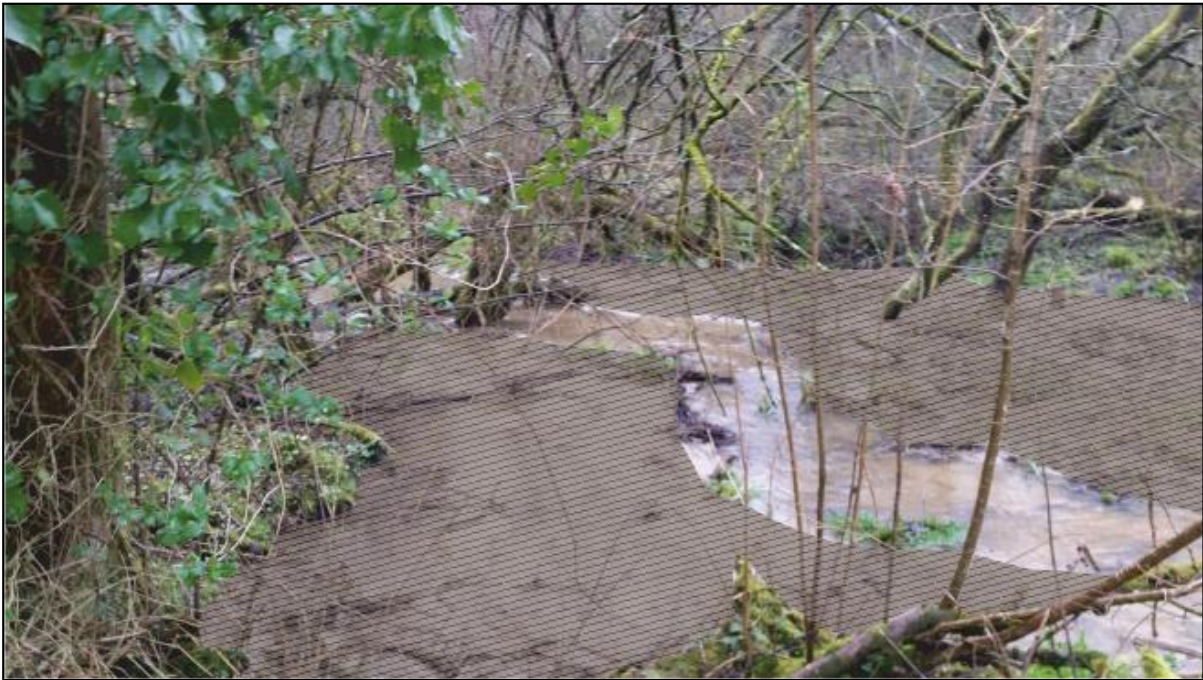
Figure 16: An illustration showing where hazel brushwood can be packed into the soft stream margins to consolidate the fine sediment.
