## **River North Tyne Tributaries**

**An Advisory Visit by the Wild Trout Trust – April 2014**

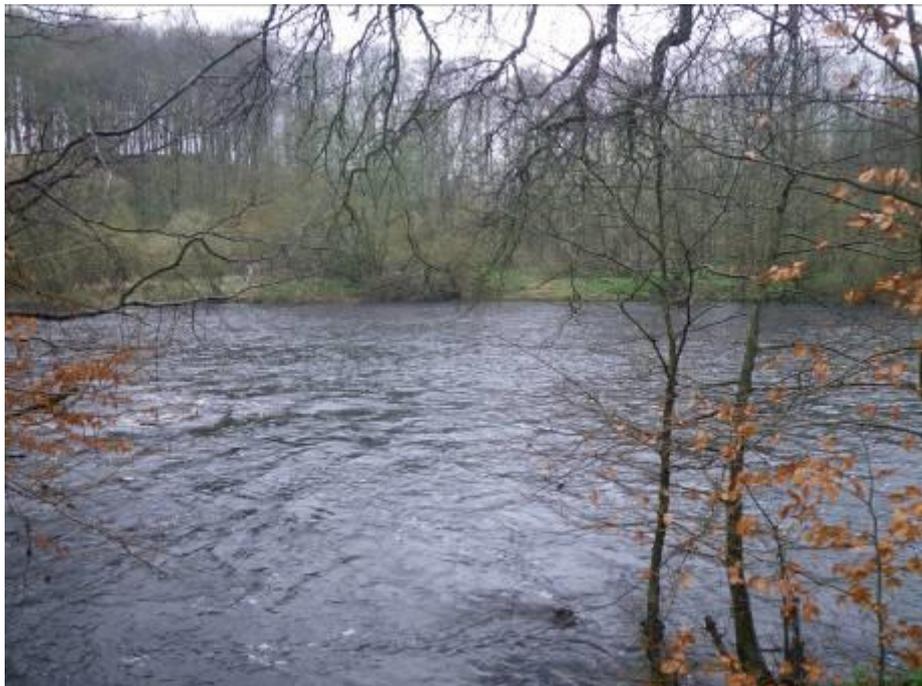
Photo 1. A long shallow glide at Chipchase. Potentially an important spawning and nursery area. This reach is well managed with plenty of trees on the bank and woody debris left lying in the margins.

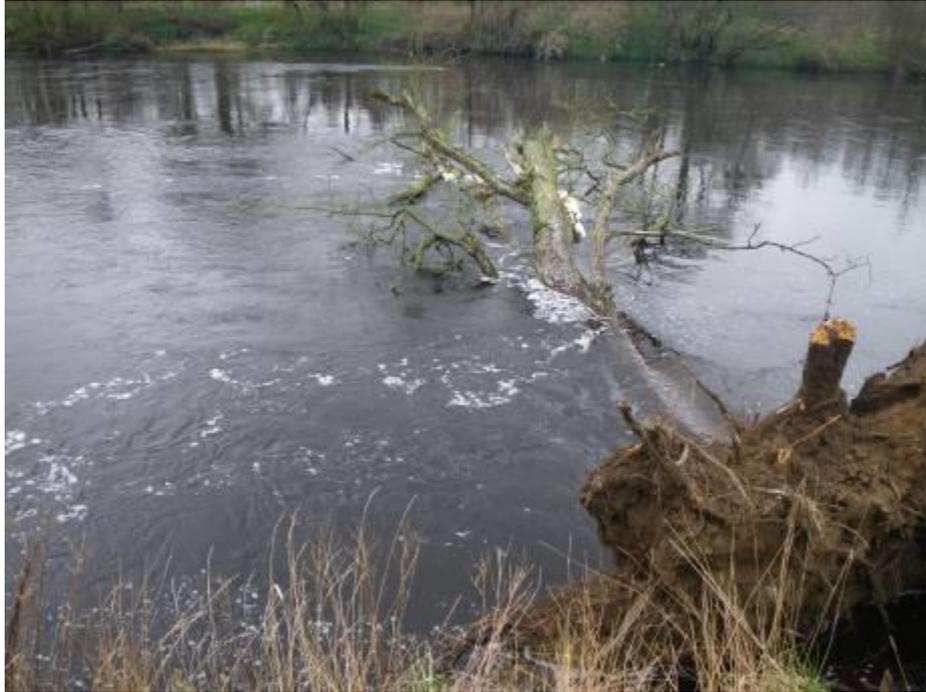
Photo 2. A fallen tree in the Channel at Chollerton. This tree will help to sort and shape river bed material and potentially create a holding pool, as well as promote improved opportunities for spawning downstream.

When trees fall at right angles to the bank, as in the example seen at Chollerton (photo 2), or if they fall angled slightly upstream, they rarely cause any significant bank erosion. If the root wad is still buried into the bank then these natural flow deflectors can remain in place for several years. During this time they can transform the shape of the river bed. If a tree falls into the river at a vulnerable location, or at an angle where it might promote unacceptable bank erosion, or if the tree risks blocking a weir or narrow bridge, then it can sometimes be winched into a safe orientation and secured with a "catch" cable. If the tree can be secured to another live tree, or sometimes its own root system (example photo 3) then if it does move in a big spate, it will simply swing around and into the margins.

When large trees collapse into the river channel there is often a temptation to remove them immediately. The value that large fallen trees bring to the river environment cannot be overestimated. Large pieces of woody debris provide natural flow deflectors and promote local river bed scour, carving valuable holding lies for adult salmonids and redistributing cleaned and sorted river bed cobbles and gravels into potentially valuable spawning sites.

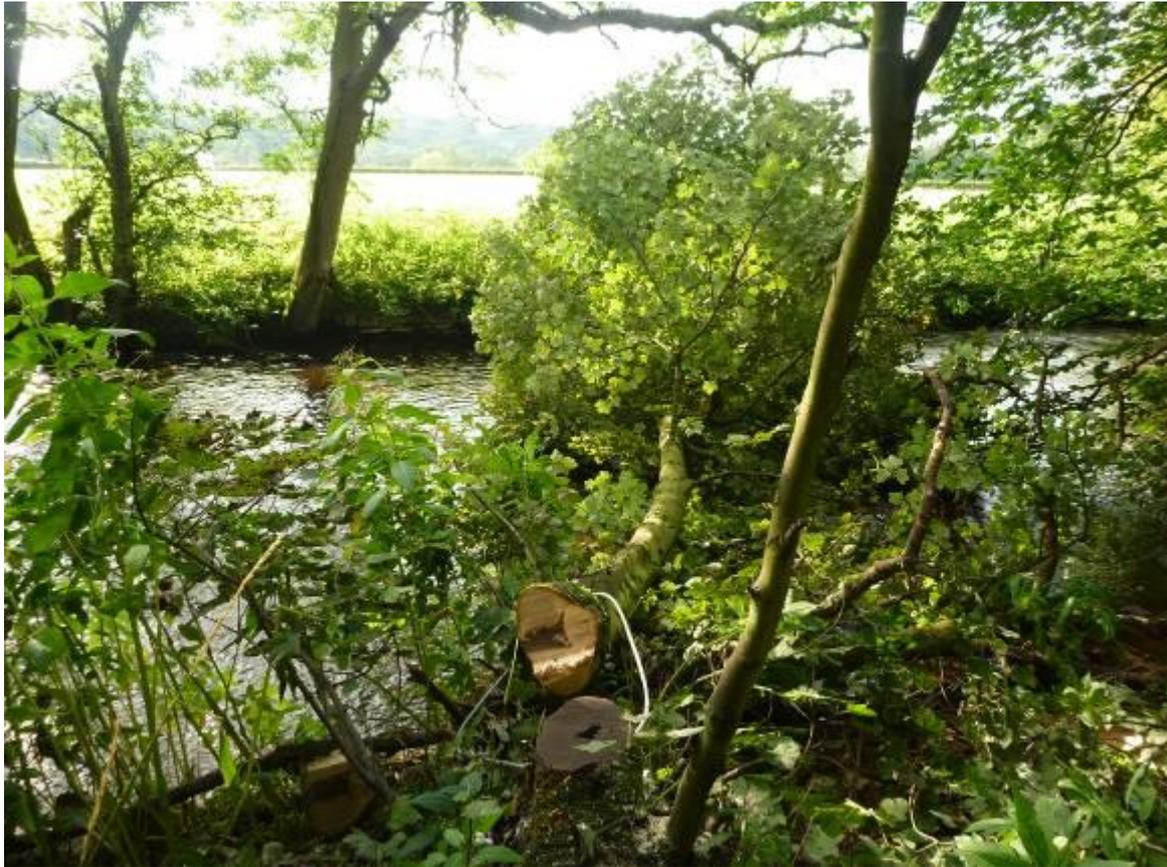
Photo 3. A large sycamore deliberately dropped into a Welsh spate river and cabled to its own stump.

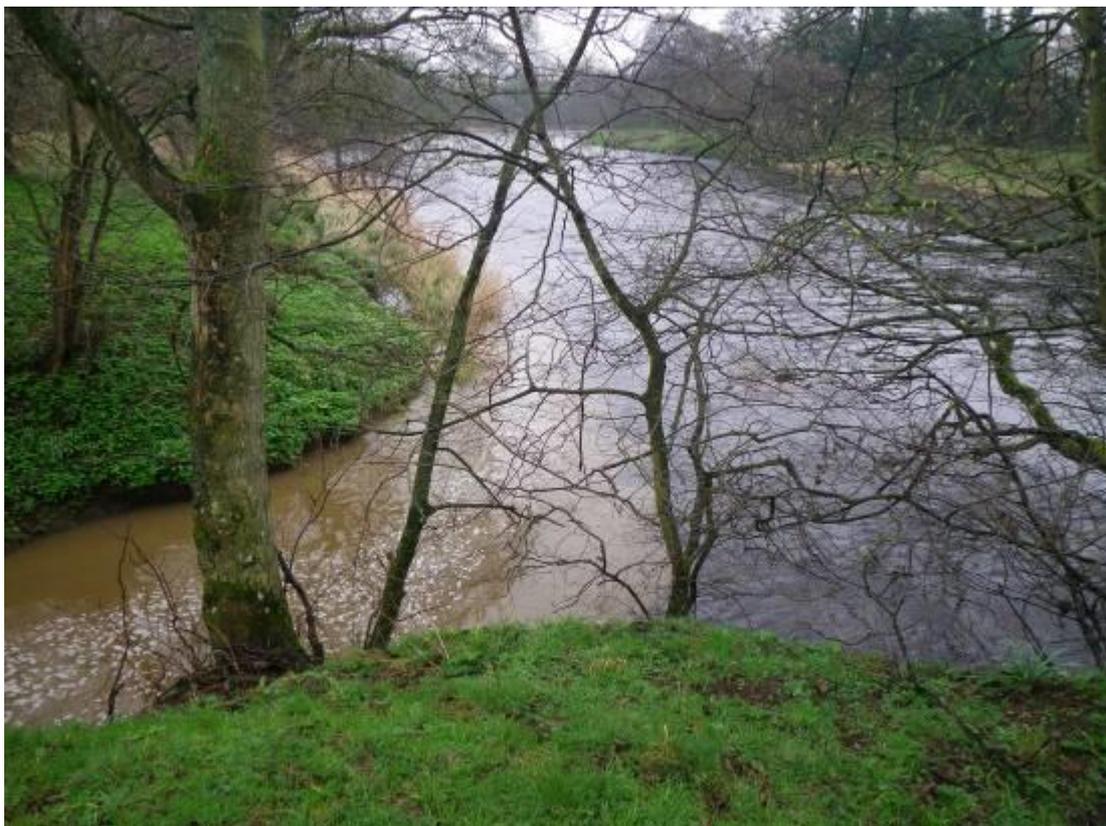
On the day of the site visit, the Gunnerton Burn was carrying a heavy suspended sediment load (photo 4). The weather conditions on the day of the site visit were reasonably dry and despite an upstream investigation, it was not obvious where the source of the additional colour was coming from but the sediment loading is characteristic of agricultural run-off.

Photo 4 Confluence of the Gunnerton Burn with the main river. Note the heavy discolouration indicating heavy suspended sediment loading.

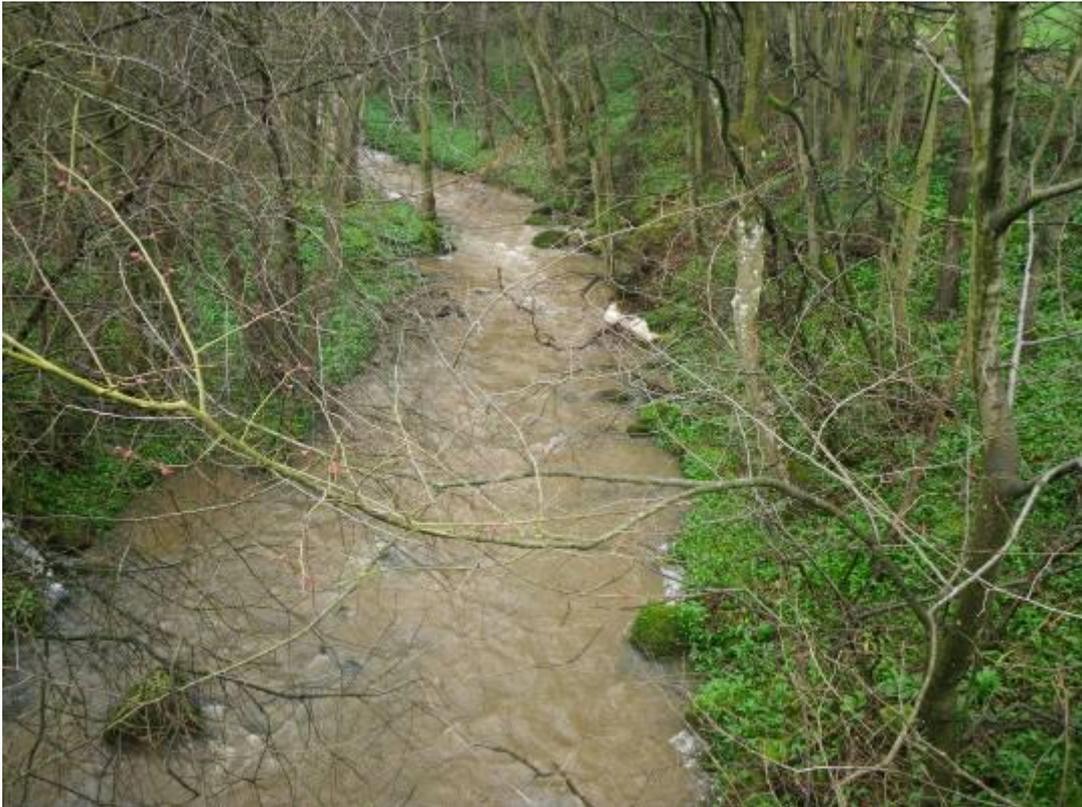
Photo 5. Gunnerton Burn appears to have excellent habitat suitable for a high quality spawning stream with classic sequences of pool, riffle and glide with plenty of riparian cover.

The shape and the form of the stream was considered to be favourable for salmonids; however, due to the turbid nature of the stream it was not possible to fully inspect the river bed gravels.

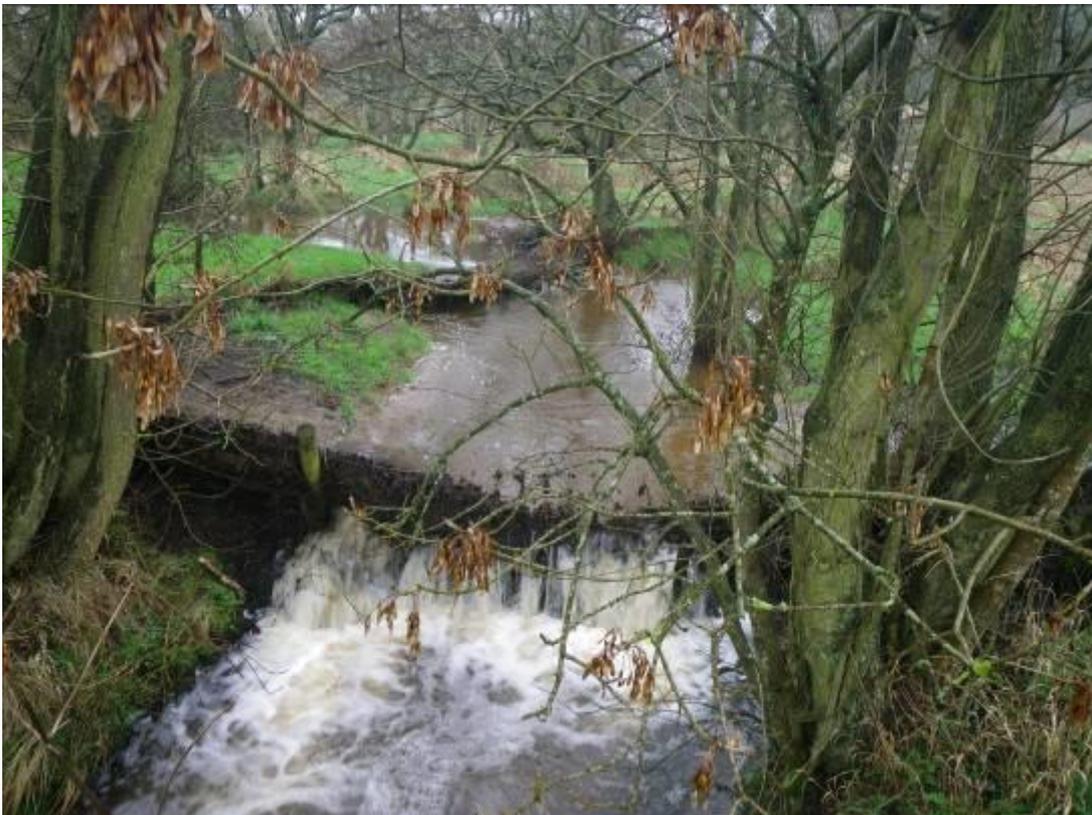
The last site to be inspected on the Gunnerton Burn was approximately 2km upstream of Gunnerton at NGR NY 912 769. The water clarity here was much improved, though the stream still held more colour than might be expected. At this location some sheep fencing was causing a debris dam to form in the channel (Photo 6), backing up the stream flow and potentially creating an issue for free fish migration. This problem has been slowly getting worse because there was evidence that the stream bed has significantly risen over downstream bed levels.

Photo 6. A sheep fence causing a debris dam to form, creating problems for fish migration and also resulting in the river bed levels rising upstream.

This issue can easily be resolved by cutting away the existing fence line and reconnecting with the field fence lines on either side of the river or building a watergate.

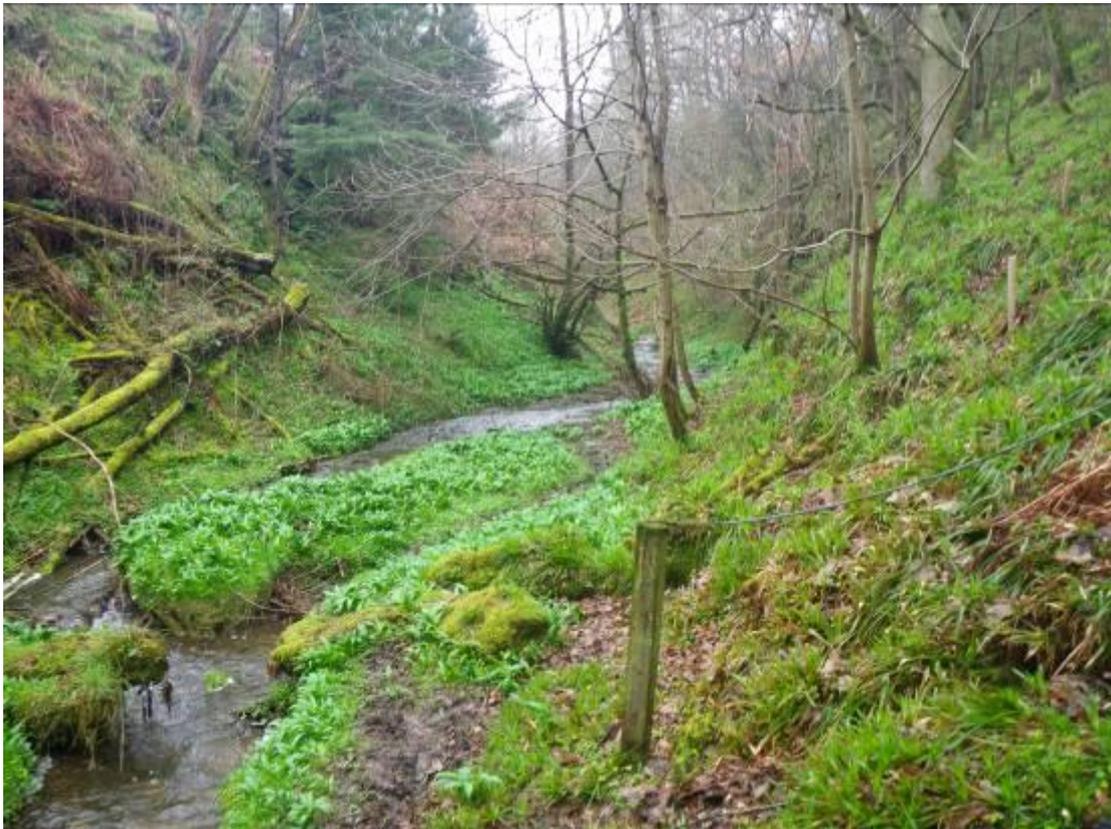
On the day of the visit, the Mallow Burn (photo 7) was running low and clear and a cursory inspection of the river revealed good numbers of caddis, shrimp and olive nymph species present in the mainly gravel and cobble river bed substrate. The Mallow runs in a deep V-shaped valley down a comparatively steep gradient. In the reach inspected, the adjacent land use was considered to be "river friendly" being mainly deciduous woodland on the steep valley sides.

Photo 7. The Mallow Burn. Everything that a small spawning stream should be!

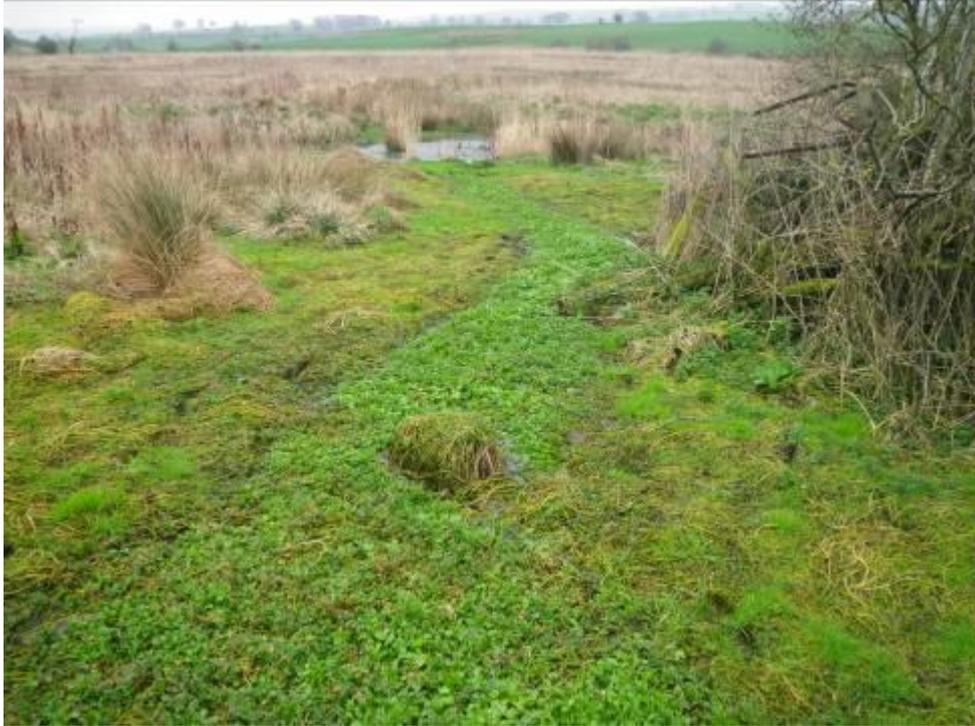
The final tributary inspected was the Erring Burn. This North Tyne tributary was very interesting and appeared to have a slightly different chemistry to the other local streams inspected. Groundwater fed springs (Photo 8) rising from very near the access point just south of Chollerton seemed to indicate water emanating from limestone rich deposits. This was reflected in the local aquatic flora, with cress and water moss evident as well water crowfoot (photo 9). These plants are usually but not exclusively associated with alkaline environments. A brief assessment on the day suggested that the Erring Burn may well be slightly more productive in terms of invertebrate biomass than the Gunnerton system.

Photo 8. What appears to be an alkaline spring source trickling into the Erring Burn. Note the wonderful wet meadows adjacent to the stream.

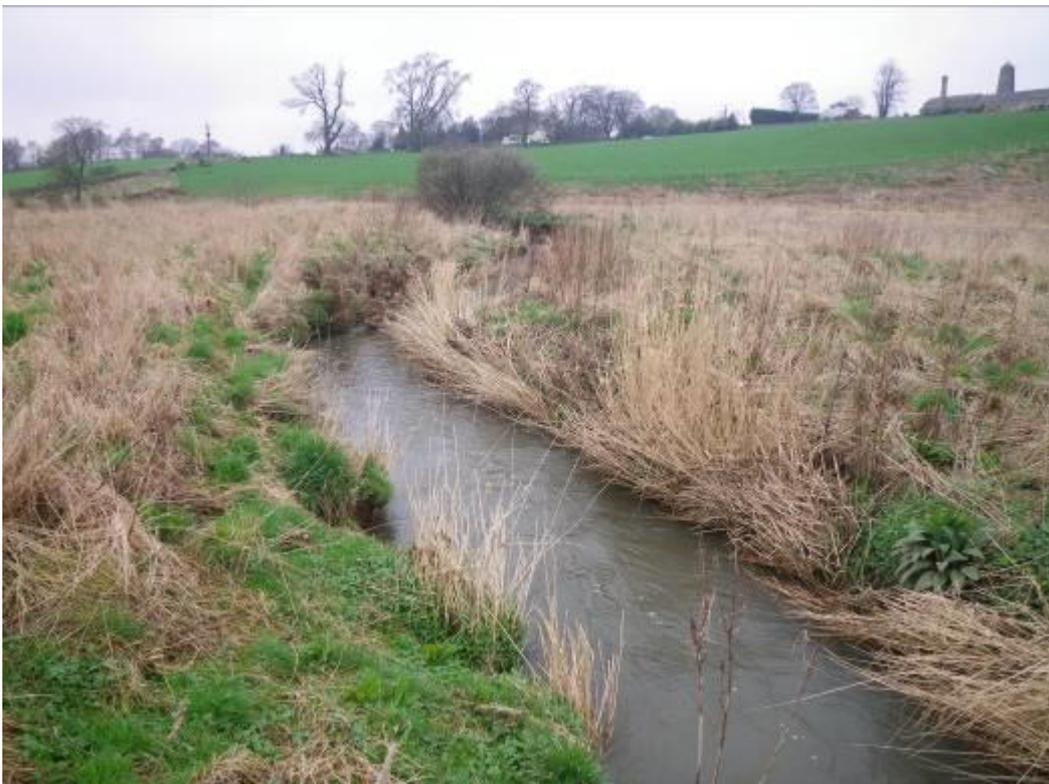
Any increased productivity will obviously have implications for how the stream performs as a spawning and nursery stream. The lower reaches of the Erring Burn are more akin to a lowland stream, with comparatively deep glide sections interspersed with pools and occasional shallow riffles, all within a meandering planform (photo 10). It is likely that this reach will be very attractive to adult trout and possibly sea trout and this section of stream could make an interesting fishery in its own right.

Photo 10. Low banks, slightly deeper channel and a meandering planform. A fishery as well as a nursery site perhaps?

It is highly likely that large migratory fish will lie up in the deeper, better covered pools and glides. Some tree planting with low scrubby species such as willow *Salix caprea*, especially over the outside of bends and pools will help to make this stream even more attractive for adult brood stock. Some additional shade, planted adjacent to the left (south) bank will also help to ensure that marginal reed canary grass (*Phalaris arundinacea*) does not completely dominate the channel.

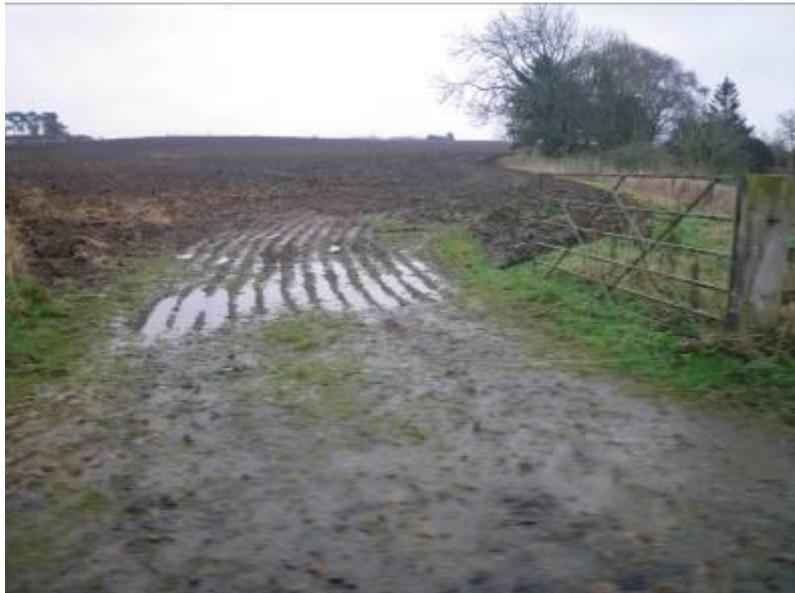
One arable field near Chipchase with a pathway for sediments to run out and onto the road and into a Tyne tributary. Easy options are available to help intercept run-off and are urgently needed in fields like this.
