## **River Ogmore – Ogmore Fishing Association**

**An advisory visit carried out by the Wild Trout Trust – July 2012**

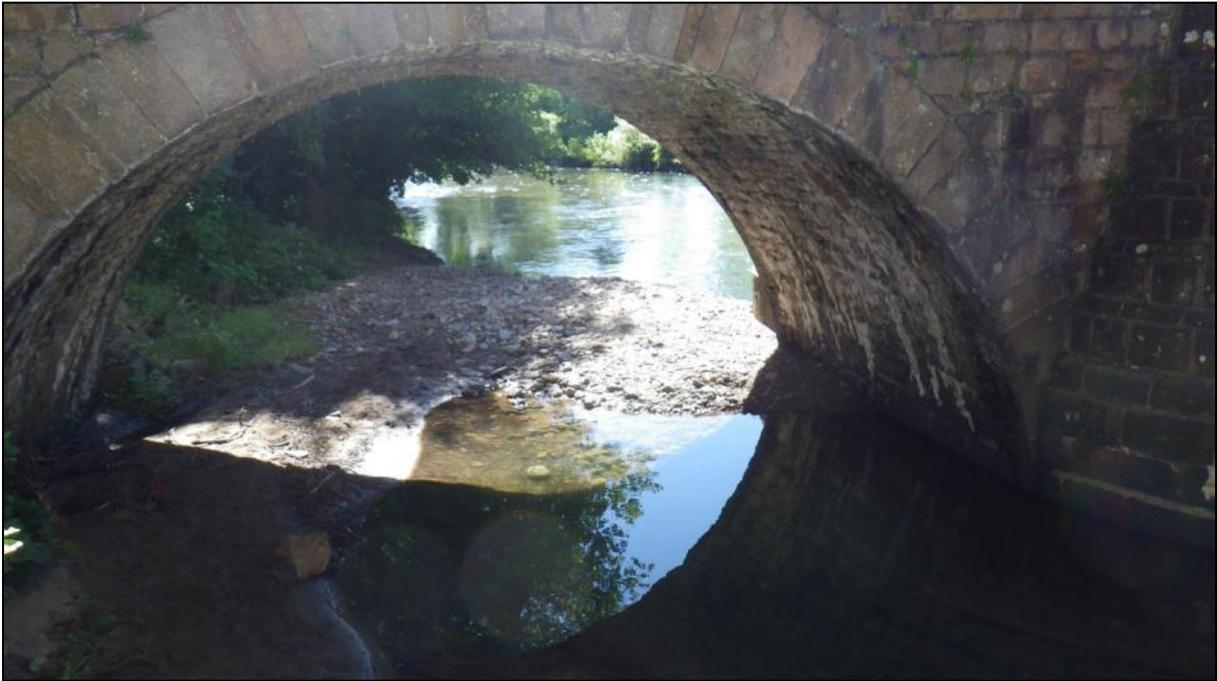
**Above: The mobile bed load contributes to a shifting and changing geomorphology with shoals of debris being deposited after spate flows.**

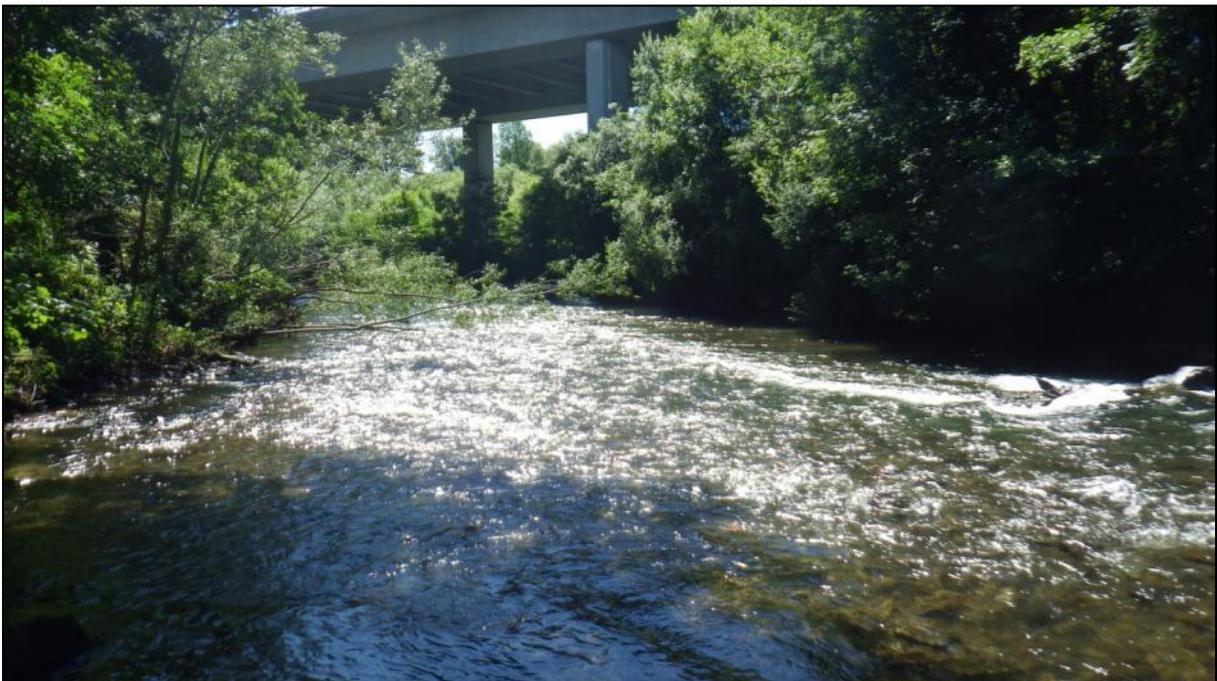
**Riparian trees, where present, provide cover, shade and subtle changes to flow patterns**

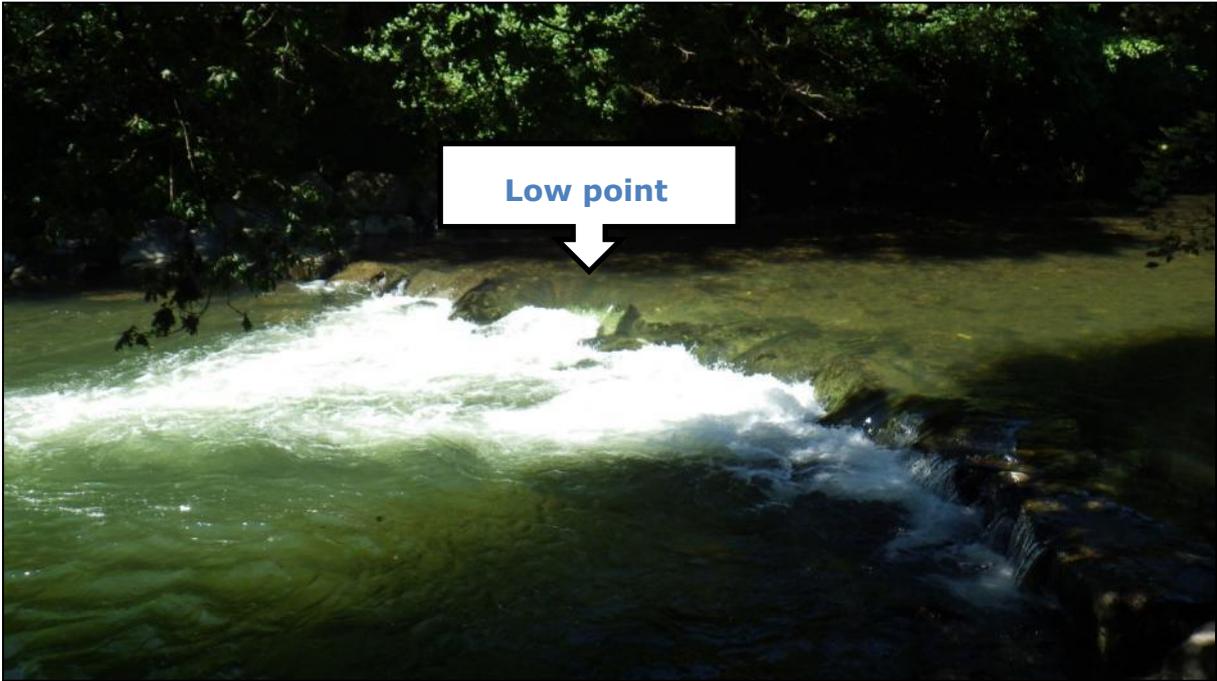
**The weir between bridges on the A4063 and the M4. A low point in the weir helps to ease fish passage. Although probably challenging for smaller fish, the weir is unlikely to significantly delay Salmonid migration.**

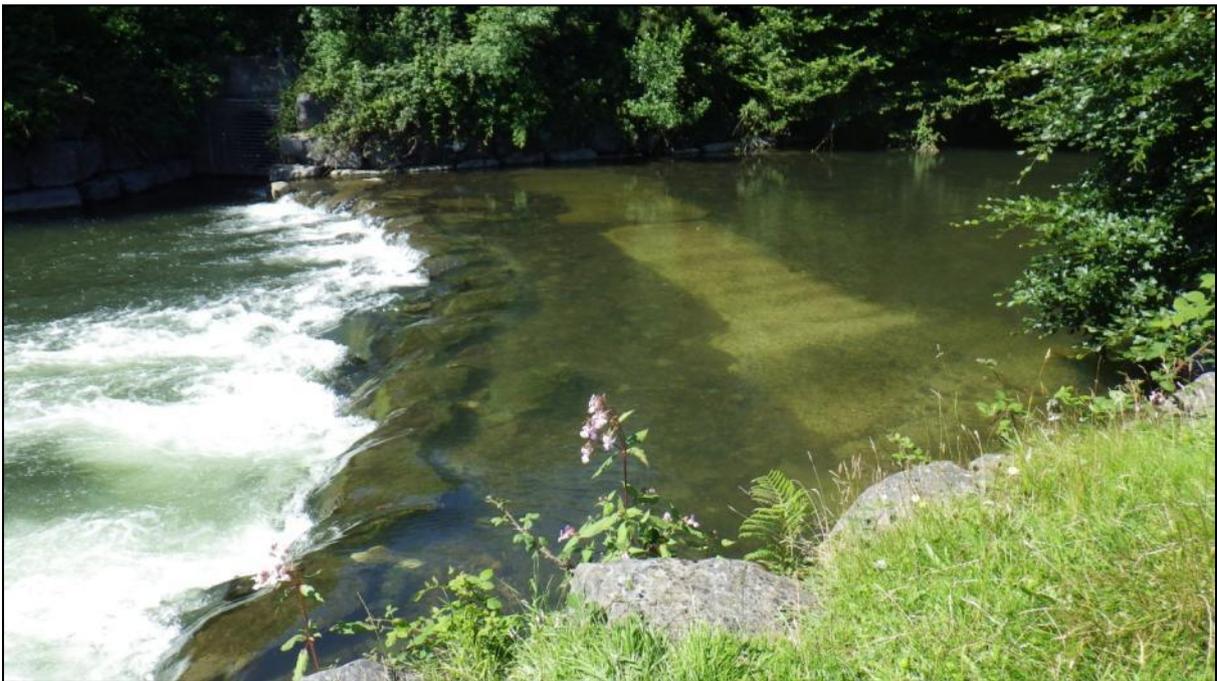
**A similar weir between bridges on the A48 and New Inn Road Southwest of Bridgend. Although not impassable in medium-high flows, the weir could become a substantial obstacle during periods of low flow. Weirs near the bottom of the system are a higher priority for action.**

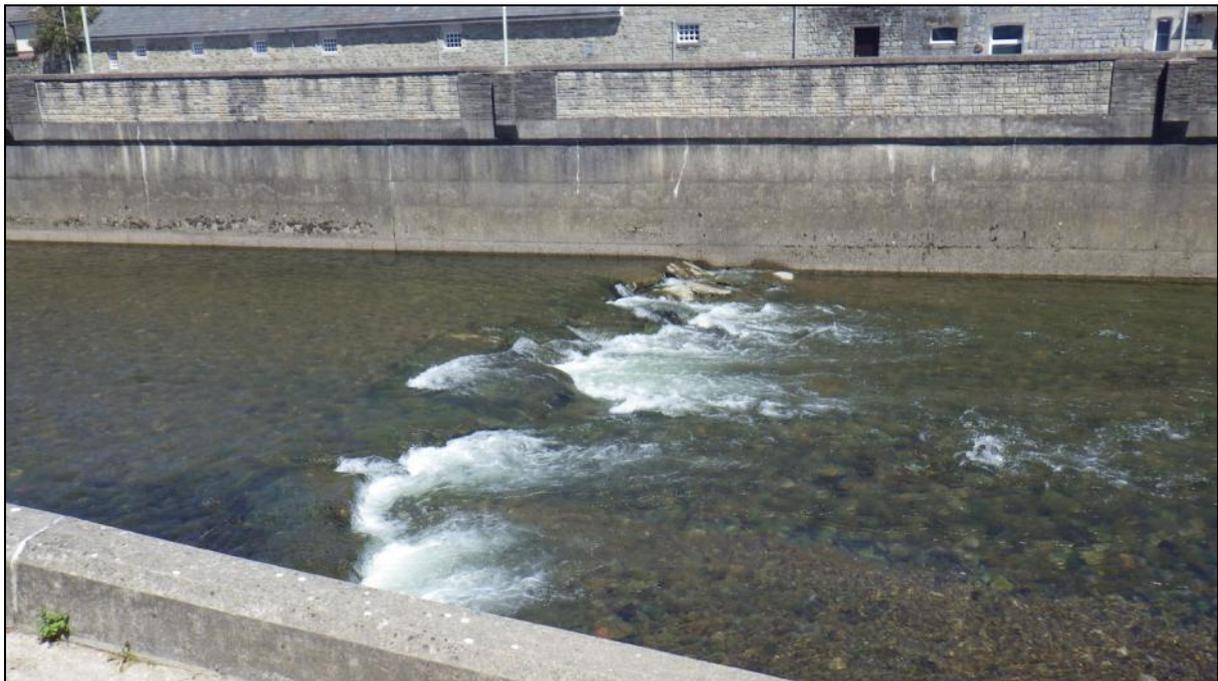
The vertical concrete flood walls are barren of any significant vegetation and provide very little cover for fish. Some shade is provided by the sheer height of the walls but at midday, especially during low flow conditions, the river channel could be regarded as a poor environment for salmonids.

**Above: The concrete flood defence walls through the centre of Bridgend deprive this stretch of marginal habitat, cover and shade. The straightened channel has created a homogenous bed form broken only by the weir pools.**

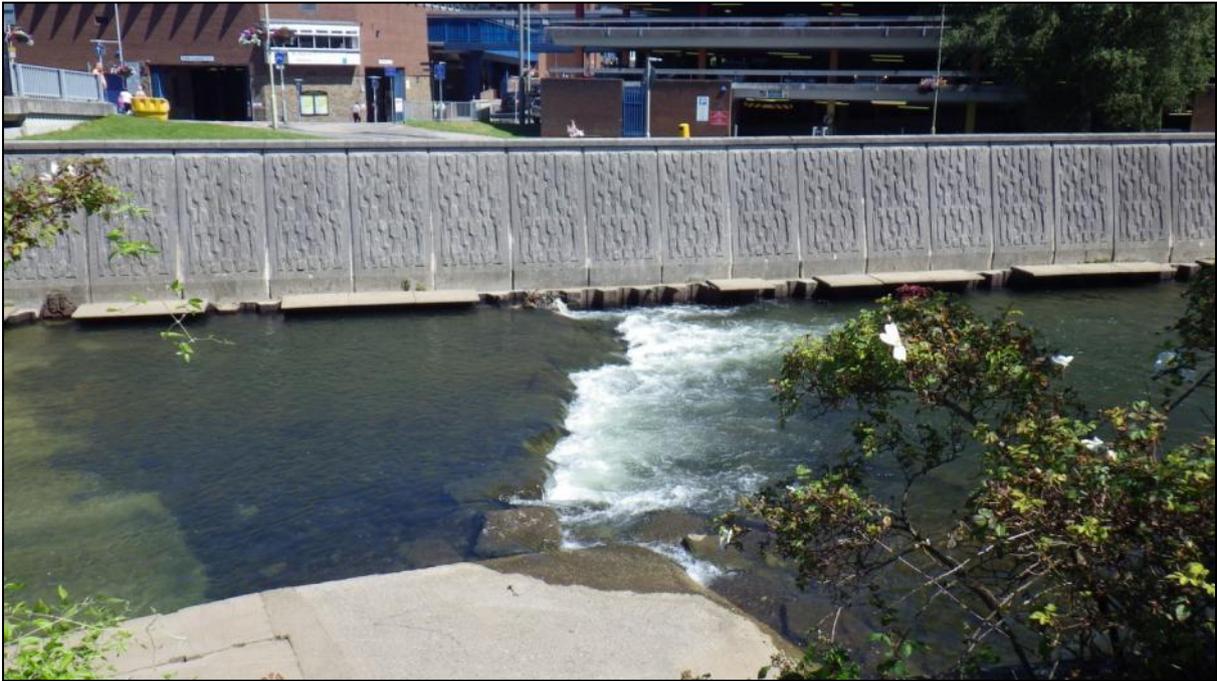
In one area visited concrete plinths overhang the channel providing some limited shade and cover. However, in some areas these plinths are situated on the shallower side of the channel and not over the deeper sections where fish tend to lie.

**Overhanging plinths (LB) providing token cover and shade.**

The concrete plinths observed in the channel could be used as bases for growing marginal plants. Gabion baskets could be purchased and cut and shaped to form a sloping basket, filled with stone and soil, and planted up with local willow, sallows or similar firm-rooted plants.

Provided the baskets are securely bolted to the plinth and wall, and are lined with a soil retention fabric to prevent wash-out, a man-made marginal shelf could be constructed that would create extra cover, invertebrate habitat, and improve the aesthetics of the sterile channel.

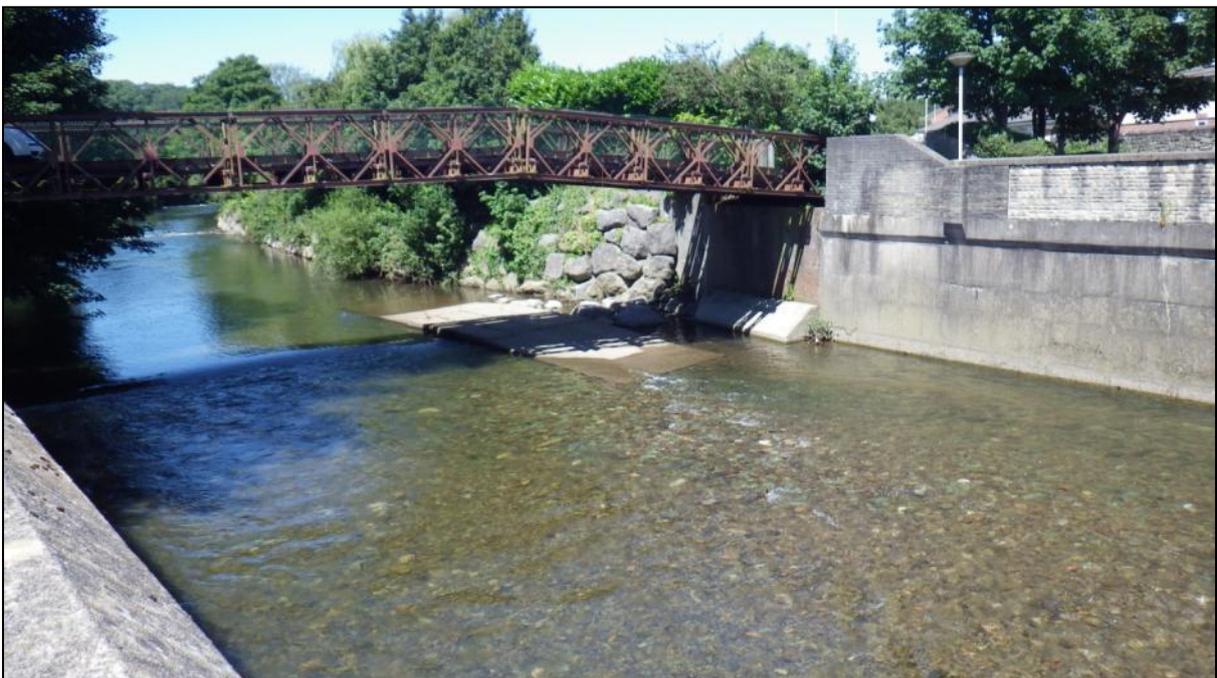
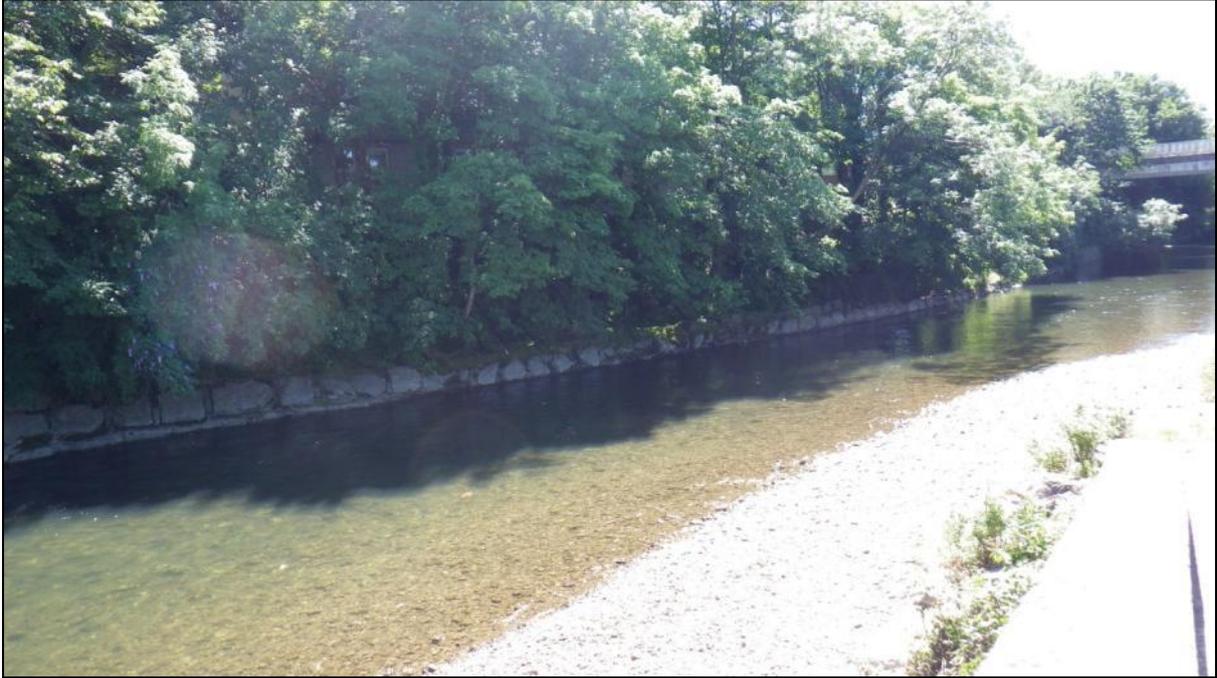
In some places through the town the banks consist of large rip-rap style flood defences and here at least some vegetation has colonised and is established enough to overhang the channel. Through such an urbanised stretch of river these pockets of overhanging branches are highly important for fish populations and provide not only cover but also a food source for juvenile fish as terrestrial invertebrates occasionally drop from the overhanging vegetation and into the river.

**Above and below: Vegetation growing over rip-rap flood defences providing some cover through the more urbanised stretches of the Ogmore**

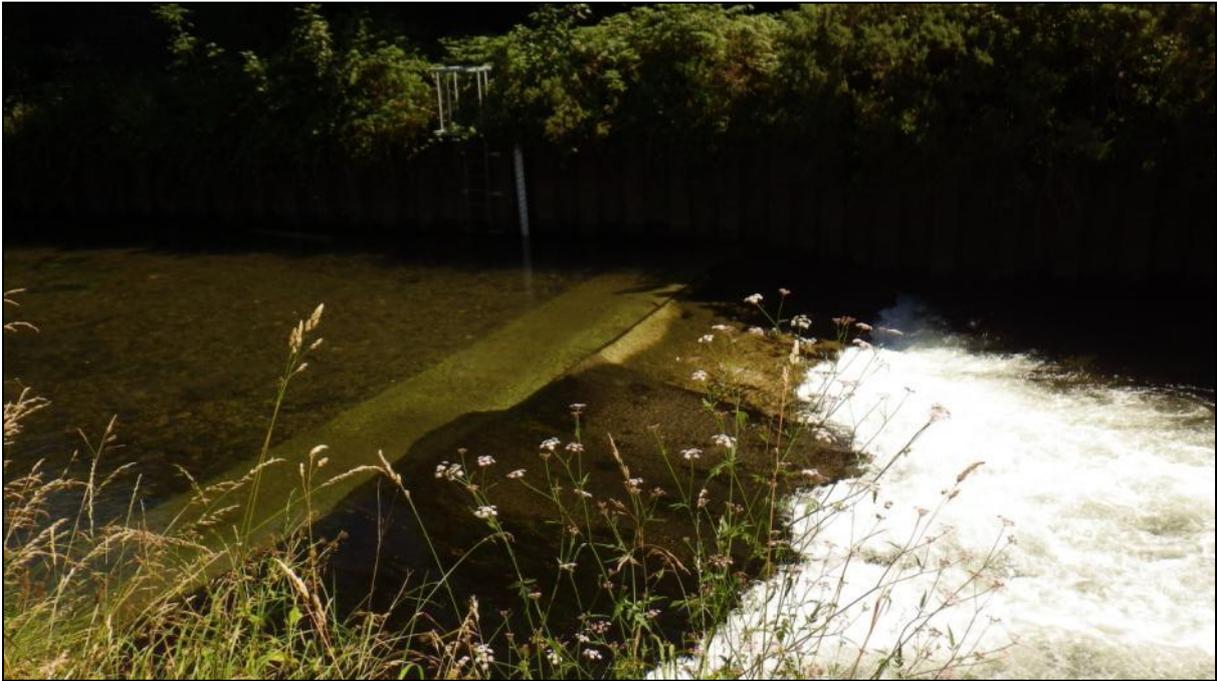
During the advisory visit two EA flow gauging weirs were inspected. The first was the crump weir situated adjacent to Ynysawdre School, upstream of the confluence of the River Llynfi. Water flows over the shallow crest of the weir structure and down over a smooth concrete ramp to the sill. Flow gauging crump weirs are known to be problematic for migrating fish. Although passable under high flow conditions, the structures are well known for delaying and even blocking upstream passage for smaller salmonids. In addition to the energy sapping nature of the obstacle, the waters at the base of the ramp are visibly aerated and probably provide very little resting opportunity for fish.

**The weir adjacent to Ynysawdre School; potentially a significant obstacle to fish passage on the Ogmore.**

The EA are currently planning to install an eel pass on the structure but have no immediate plans to improve connectivity for fin fish.

The modification of the EA gauging weirs mentioned in option 3 should be considered a priority. The bottom weir was the largest obstruction to fish passage observed on the day of the visit. It is recommended that the EA's National Fish Passage Panel is consulted for ideas in this regard.

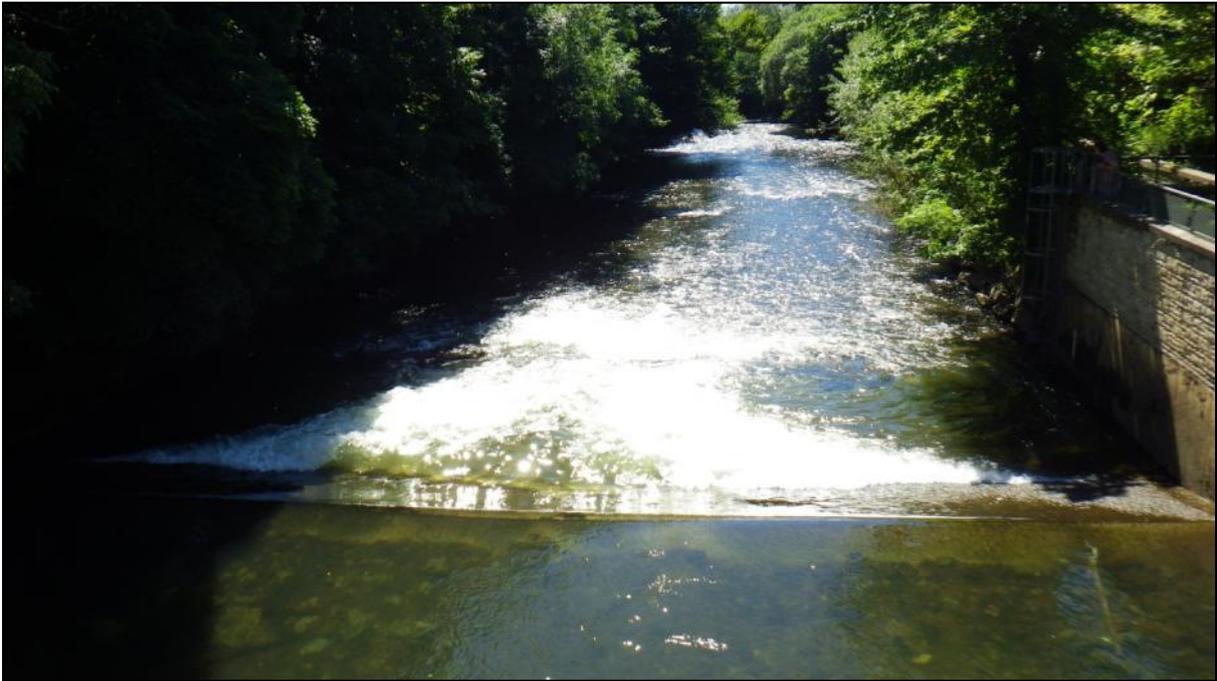
The second EA gauging weir visited is situated next to the Bridgend Recreation Centre just downstream of the A473. This weir appears to have a significant head-loss and generates high flow velocities over the downstream face. As with the gauging weir upstream, the river flows rapid and shallow. On the day of the visit the weir was almost dry on the far right hand side suggesting the depth of water flowing over the structure is critically shallow and that the structure represents a significant barrier to fish passage.

It is likely that only large migratory fish would have the strength to pass over such a barrier during average flows.

**The EA gauging weir in the centre of Bridgend. A standing wave hints at the force of the water flowing over the weir and the subsequent obstruction the structure poses to fish passage.**

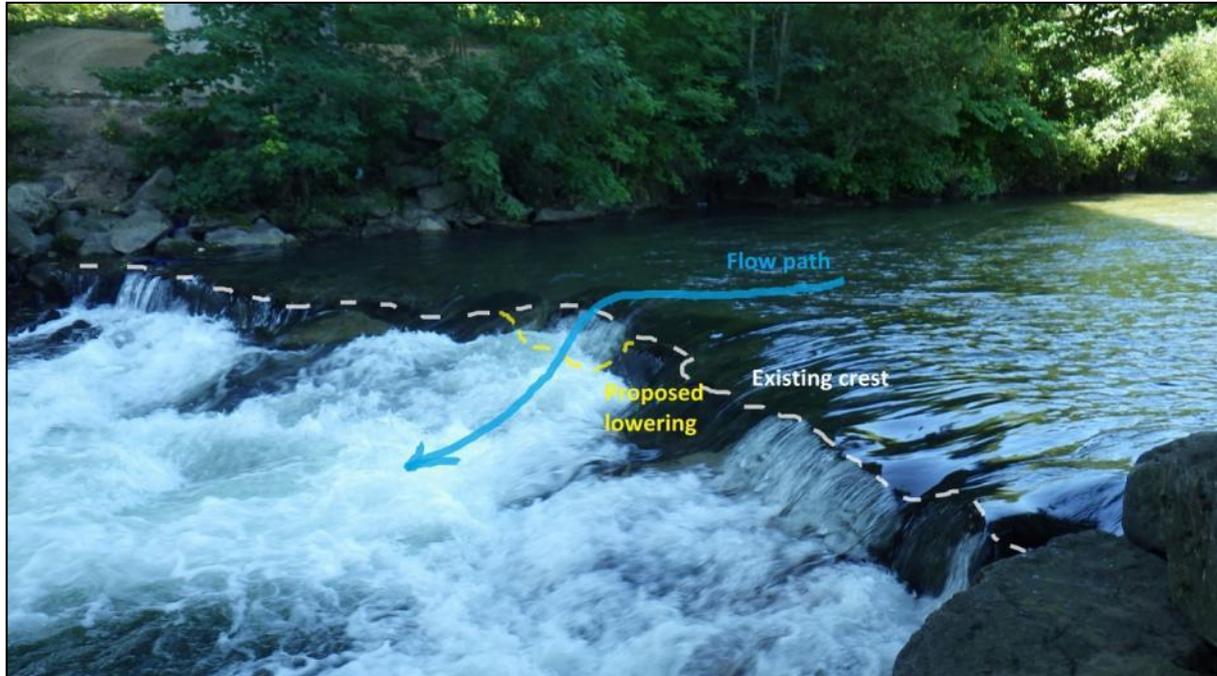
**Proposed easement by removing or lowering a central boulder in the rock weir creating a solid central flume of water for easy fish migration.**

Removal of the central boulder or two from each weir, or repositioning of stones to configure a low central plume. The shape of downstream pools would change but they are likely to be effective holding pools for angling without delaying active migration.

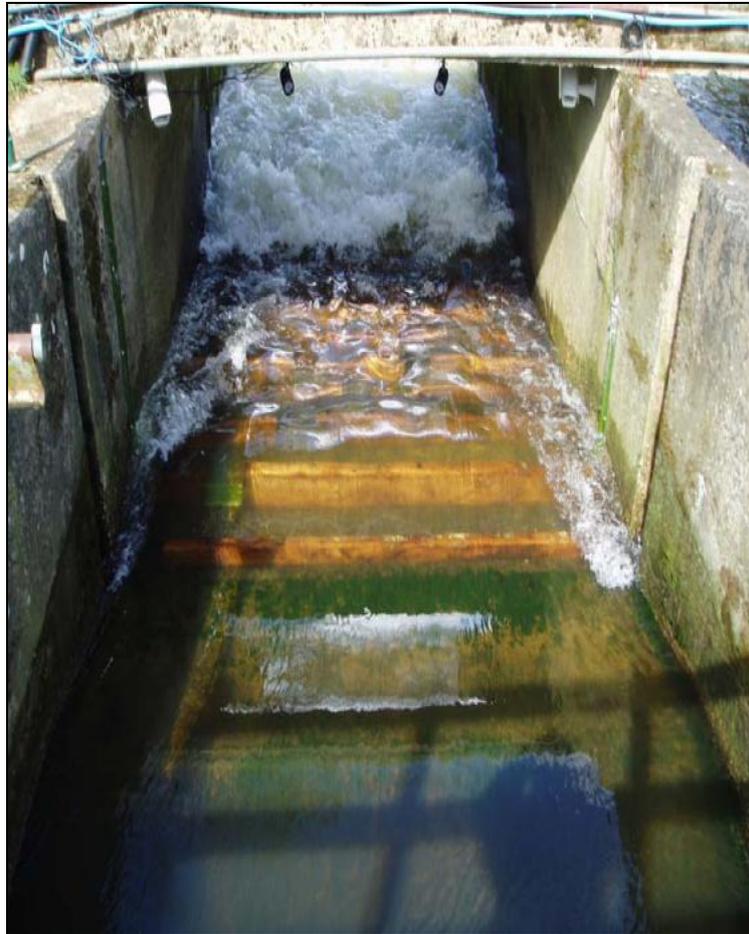
Low cost baffles installed onto an EA gauging weir on the River Enbourne.

If the complete removal of the EA gauging weirs is deemed unacceptable in the short term, modifications to ease fish passage by installing a low cost baffle system to the downstream slope should be explored. It is possible to slow flows on the downstream face of the crump weir by installing low cost baffle systems. This can be achieved without adversely impacting on the efficacy of the structure to measure flows. Projects exploring opportunities for

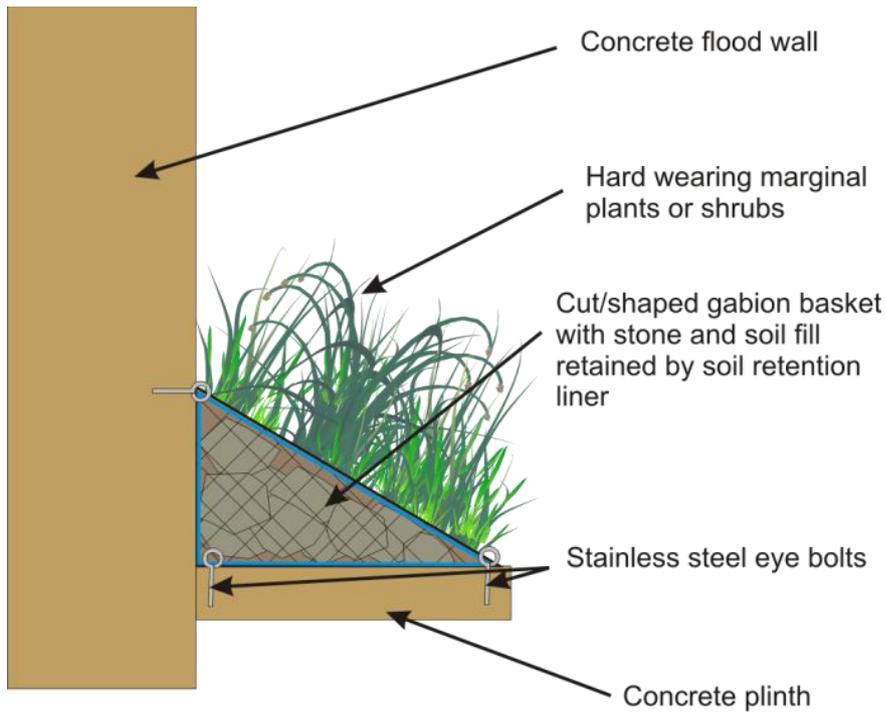
**Above: A suggested technique for 'greening up' the concrete plinths overhanging the channel in Bridport centre**  
**Below: In pan shelves fixed to the sheet piling to hold overhanging plants**

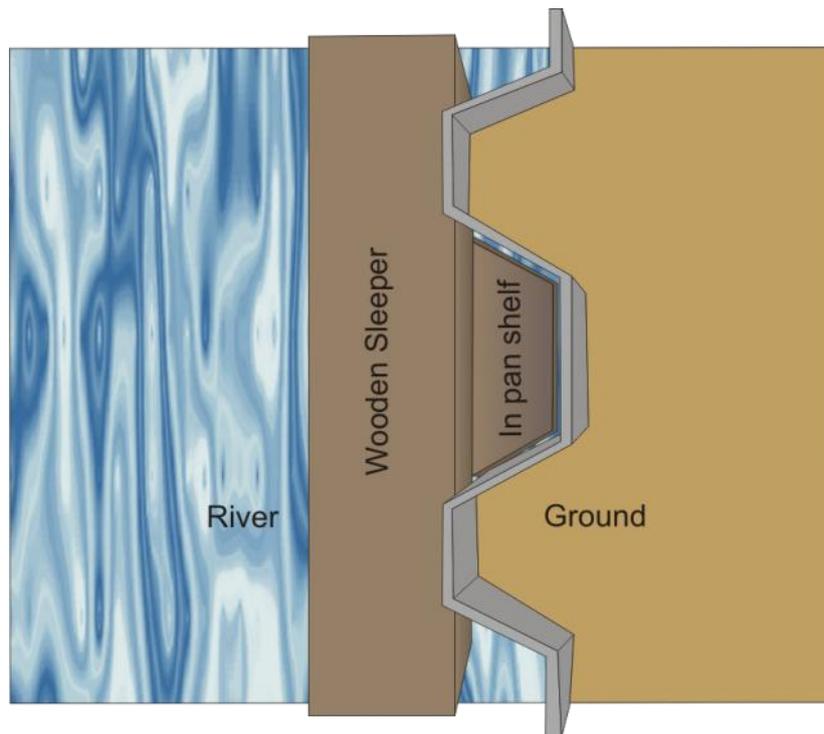
Another option for greening up the engineered channel could be to fix shelves into the in-pans on the sheet piling revetments. This technique has been installed in other parts of the country with some success.

Shelves to fit into the sheet piling can be cut from marine ply and attached to a wooden sleeper. The sleeper can then be bolted onto the sheet piling and each shelf lined to prevent soil wash-out and planted with hard-wearing species that will overhang the channel

Once planted, a cage of rock netting (gabion basket material) could be fixed onto the sleeper to ensure the plants are not pulled free by cavitation forces during flood events.
