River Otter, Tipton St John, Devon

An Advisory Visit by the Wild Trout Trust June 2015

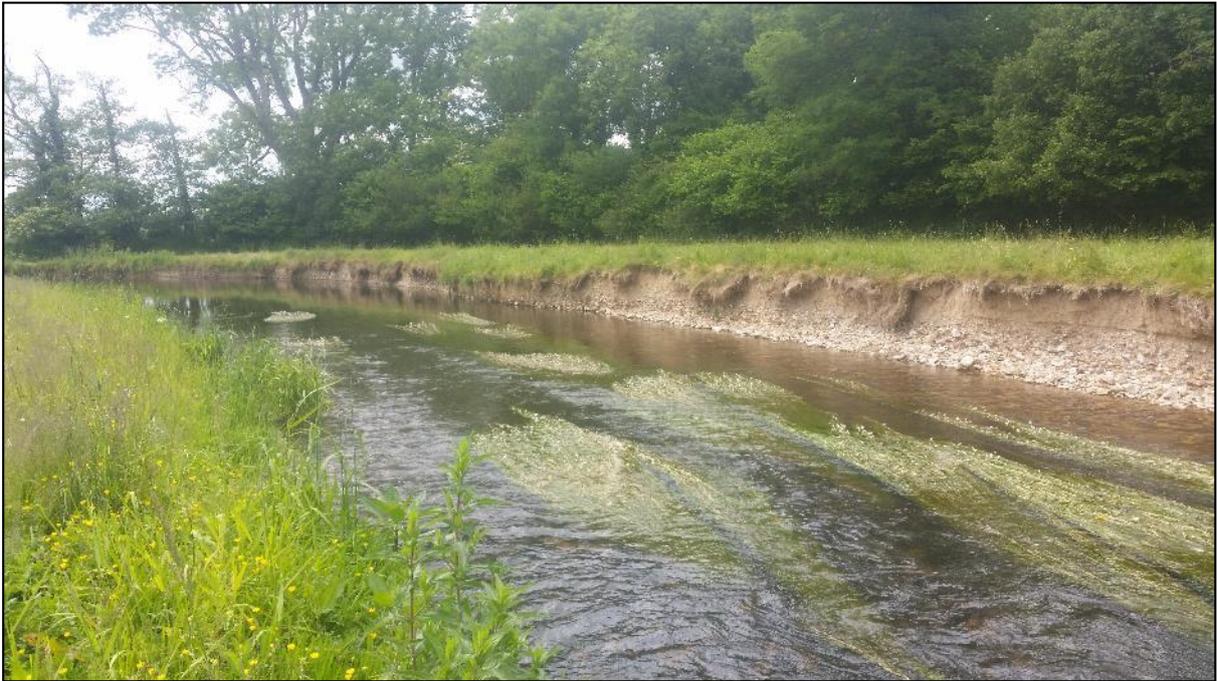
Figure 2: Bank erosion exposes a rich seam of river gravel

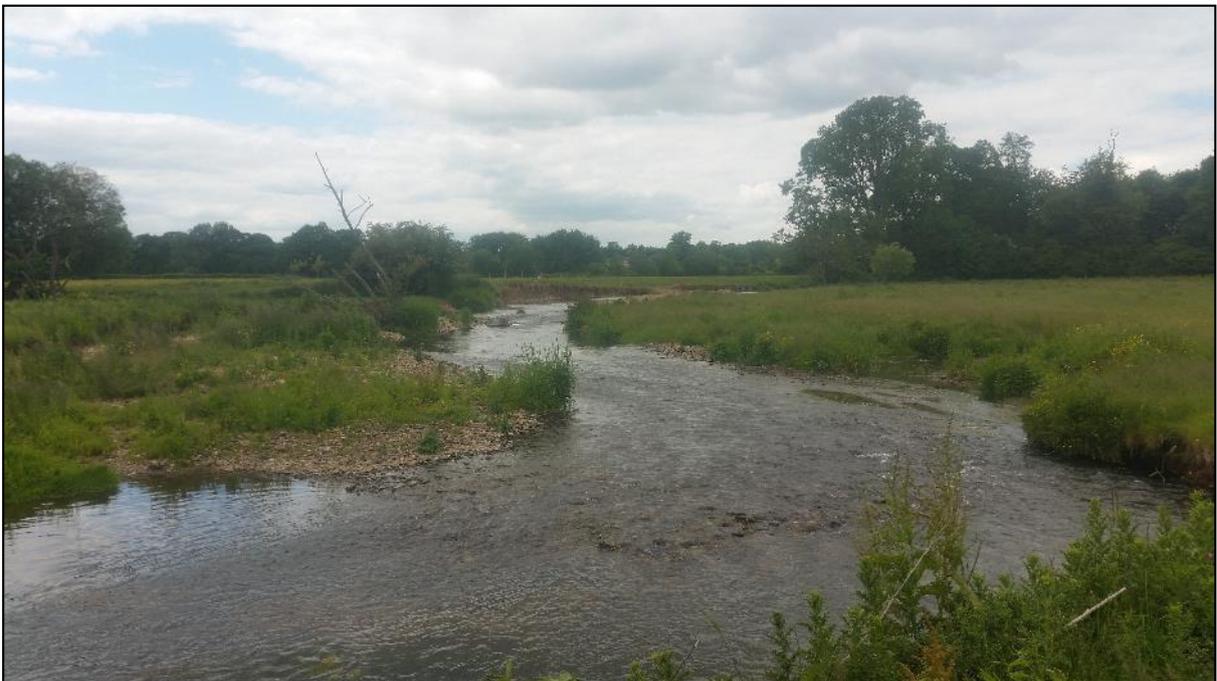
Figure 3: Areas of deposition create low-gradient, saturated margins to the riverbank

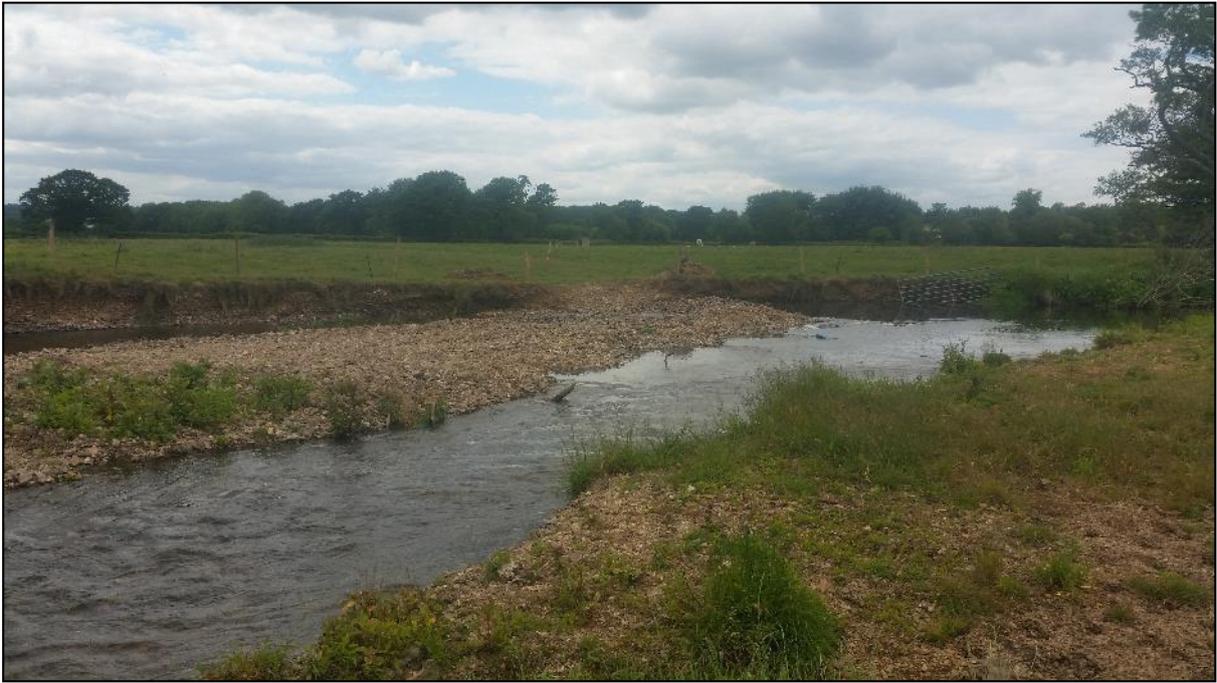
The land owner/tenant farmer of the land shown in Figure 4 appears to have attempted to protect his bank by constructing a bar of gravel to push flow across the channel away from his field. The land owner/farmer may respond well to being informed of more appropriate and effective means of bank protection. Simply engaging with land owners and discussing effective and low cost alternatives to illegal or harmful channel modifications is often the most productive means of improving their bank and river management practices.

The gravel bar is very unlikely to remain in place for long as the next spates will almost certainly re-distribute the gravel downstream and the main force of the flow will return to acting against the bank on the outside of the meander. Alternative solutions for protecting the bank at this location are outlined in the *Recommendations* section of this report.

Figure 4: An artificially repositioned gravel bar appears to be an attempt to reduce erosion against an over-grazed and poorly vegetated bank

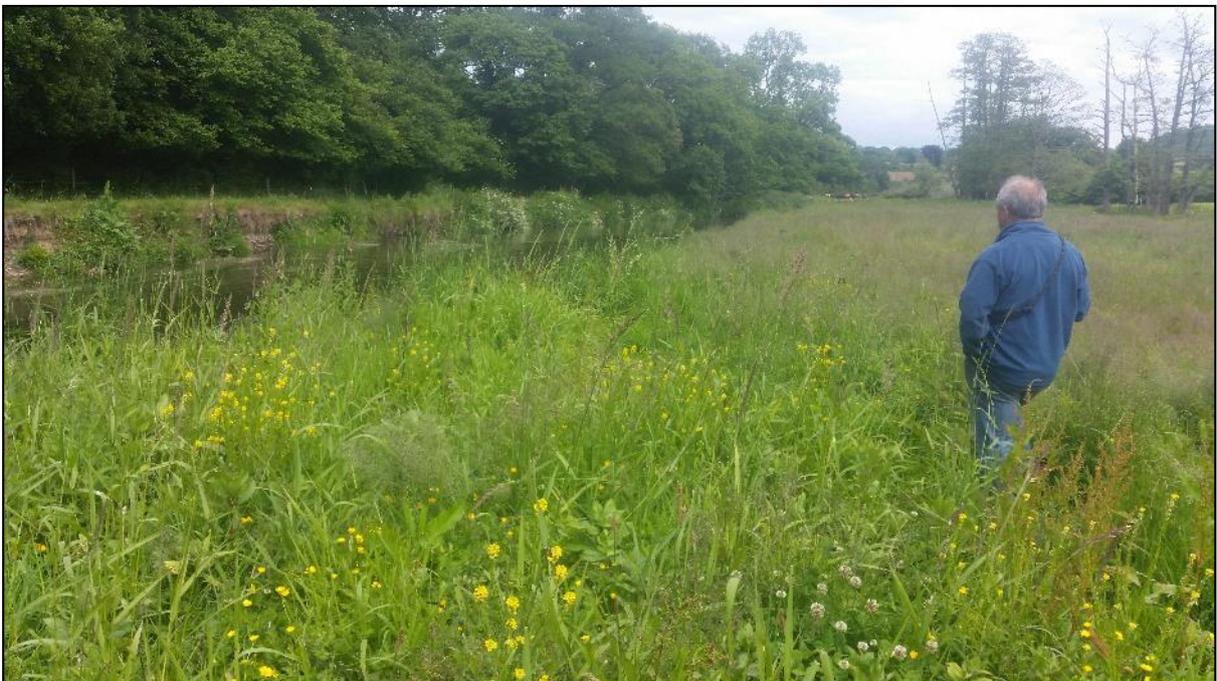
Throughout most of the Alfington reach, there was a general paucity of bankside trees. Some isolated sections of bank did have dense tree cover, but even these locations were lacking young saplings. The intensity of grazing through the reach varies significantly, with some sections very intensively grazed and fenced too close to the riverbank (Figure 4), and some sections appearing not have been grazed for some time, allowing a diverse range of plants to grow in abundance (Figure 5).

Figure 5: Where grazing pressure is reduced, a diverse range of plants occupy the bank and reduce the rate of erosion.

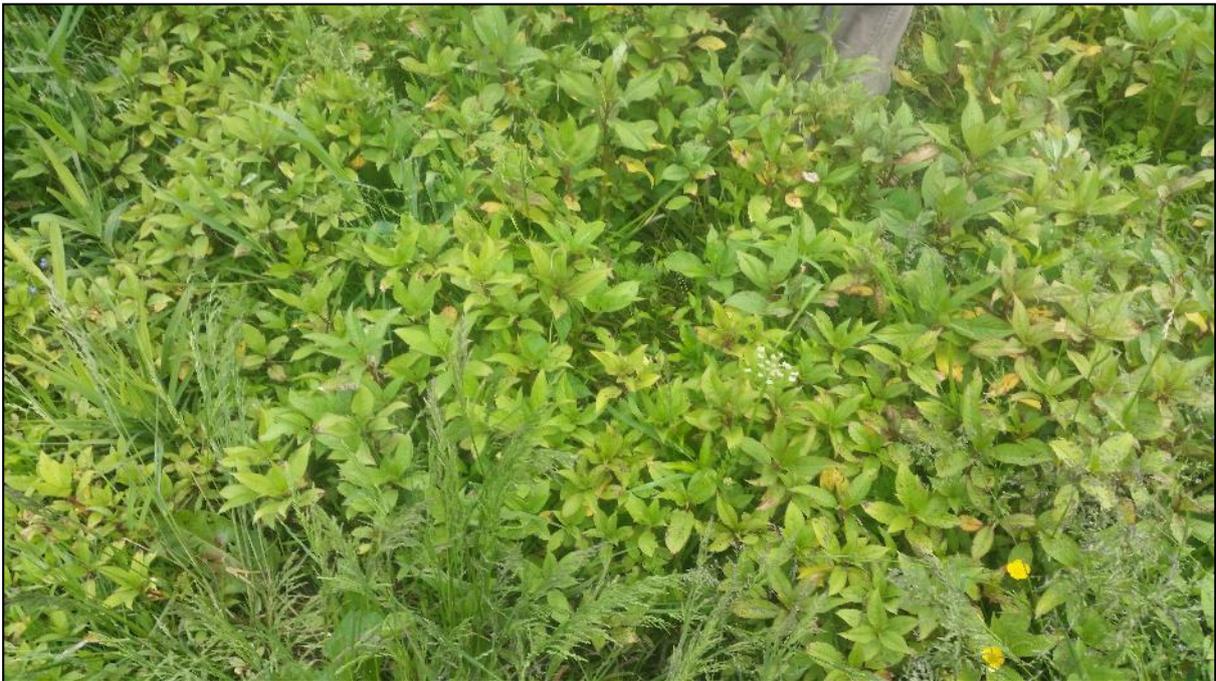
The alien invasive species Himalayan balsam (*Impatiens glandulifera*) was observed in various locations throughout this reach (Figure 6). Alien invasive plants such as Himalayan balsam or Japanese knotweed (*Fallopia japonica*) also weaken bank stability as they quickly out-compete and over-shade native species during summer months but die back to leave bare, exposed soil during the winter. This is often a significant factor in the rate of bank erosion and controlling these

species at the earliest opportunity is recommended. Himalyan balsam is very shallow rooted and can be pulled by hand or strimmed below the first (lowest) node early in the growing season before the plant flowers. Once balsam is in flower it can quickly go to seed and it is not recommended to attempt to remove balsam once the seed pods are ripe as they can burst on touch, propelling their seeds for several meters in any direction.

Figure 6: An infestation of Himalayan balsam. Eradicating this alien invasive species requires a source-to-sea approach. However, ongoing control of balsam at a local scale will at least help to limit the damage caused.

3. Take steps to control infestation of Himalayan balsam at the earliest possibility. Some angling clubs organise balsam pulling days, sometimes followed by a barbecue or other social activity in late spring/early summer to try and tackle infestations before the plants go to seed. It would be worthwhile contacting Devon Wildlife Trust and enquiring what balsam eradication programmes they may have already running and how the club could work within such a programme.

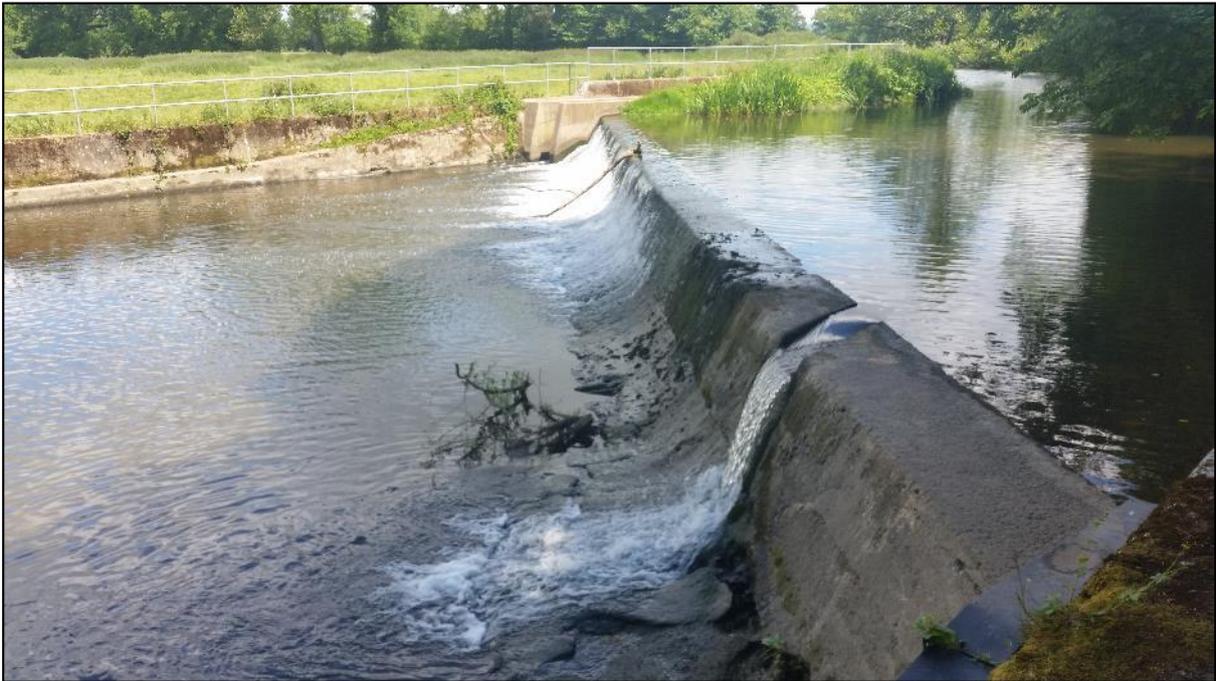
At Cadhey, the river is impounded by a weir at SY 09566 96211 (Figure 7). This weir holds up a head of water to feed a leat that flows alongside Fairmile Lane towards Otter St Mary where it falls through the Tumbling Weir; a rare circular weir constructed in the 1700s to power a textile factory and corn mill.

Even disregarding the impact of the weir on fish passage, the weir has other negative impacts on the ecology and morphology of the river. The impounding effect on flow upstream causes the river to be overly uniform, providing habitat for a reduced number of species compared to sections of un-impounded river.

Figure 7: The head weir at Cadhey

Although the Tumbling Weir in Ottery St Mary may have a perceived heritage value to local people, the ideal action in terms of fish passage and river ecology is to remove the head weir at Cadhey.

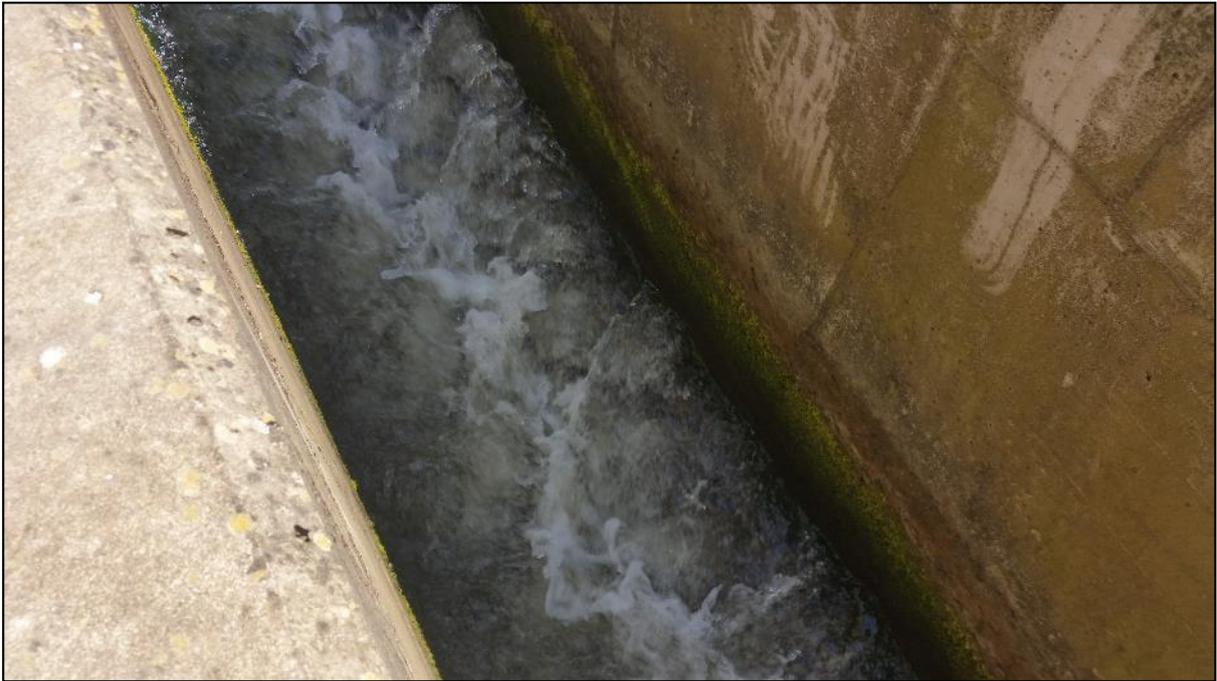
The Cadhey weir is made passable for fish by a technical fish pass on the RB (Figure 8) and an eel pass on the LB. Even if weirs are made passable for 90% of fish, the physical exertion required for a fish to traverse a fish pass has a cumulative effect for each pass ascended. The greater the number of obstacles to overcome, the lower the number of fish that will successfully reach habitat upstream. For rivers such as the Otter that support fish populations heavily reliant on anadromous behaviour (fish that run up from the sea to spawn), even apparently passable obstacles to fish passage can actually have a significant impact (Figure 9).

Figure 8: The fish pas on the right hand bank of the weir

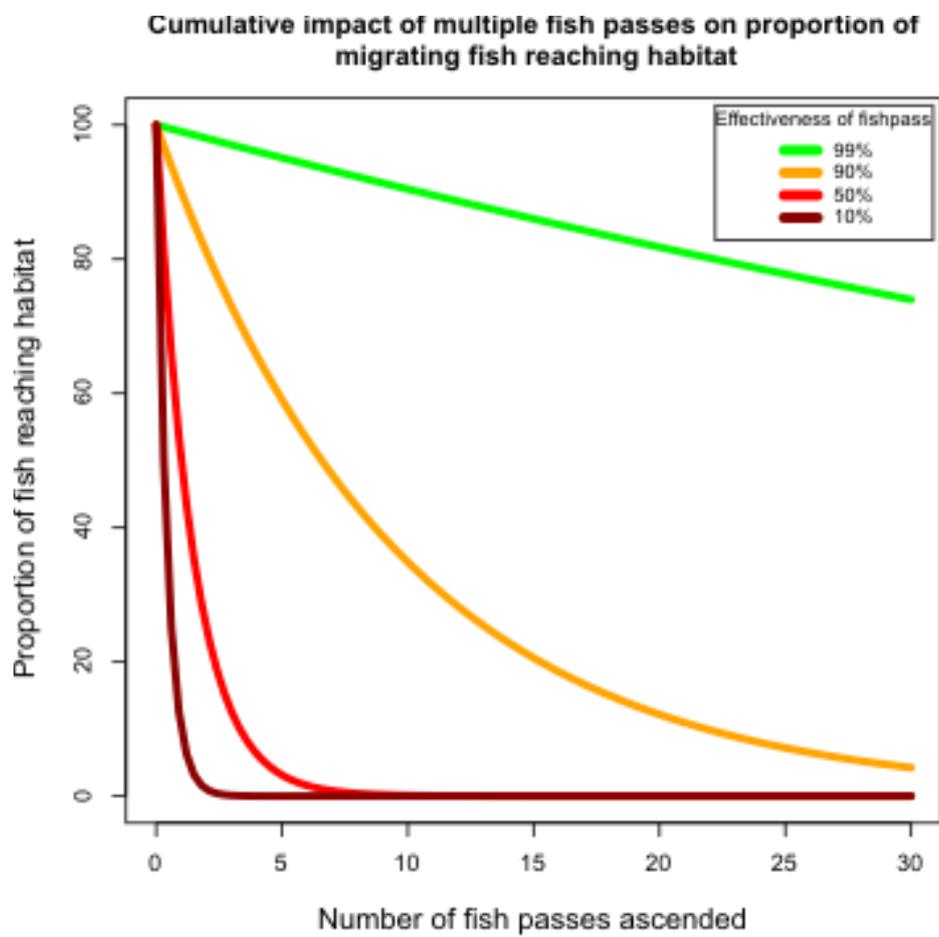
Figure 9: Graph showing the cumulative effect of multiple obstacles to fish passage on upstream migration (courtesy of Dr E Shaw, Catchment Science Centre, University of Sheffield).

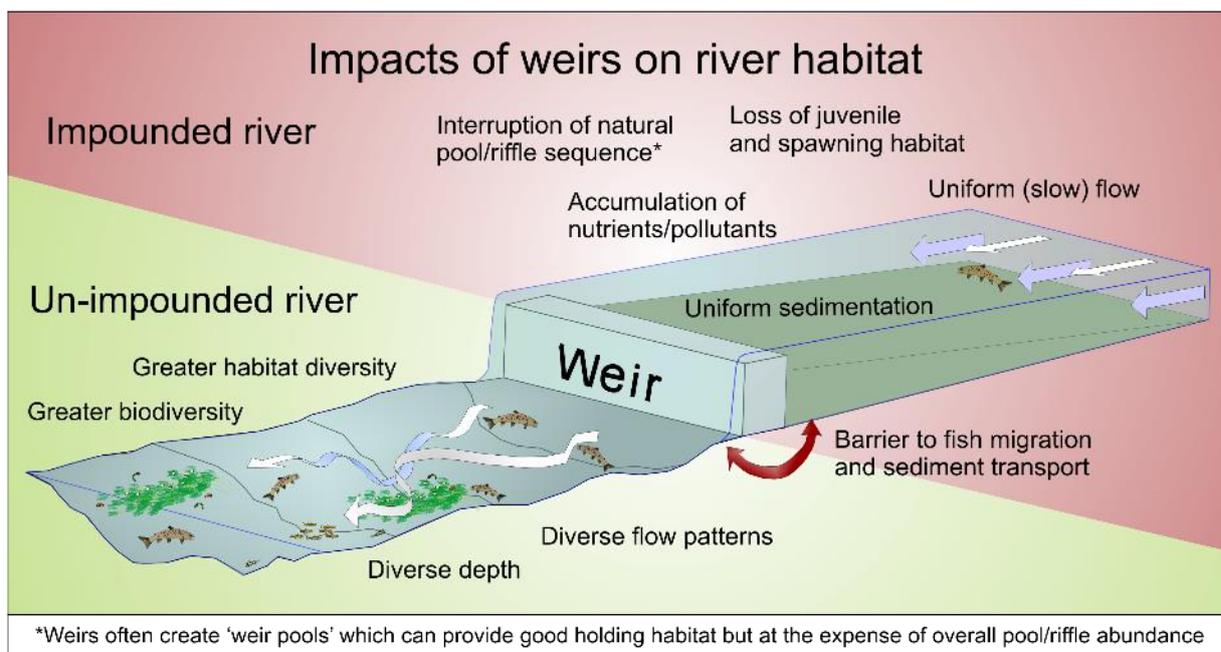
Figure 10: An illustration showing the impact of weirs on river habitat

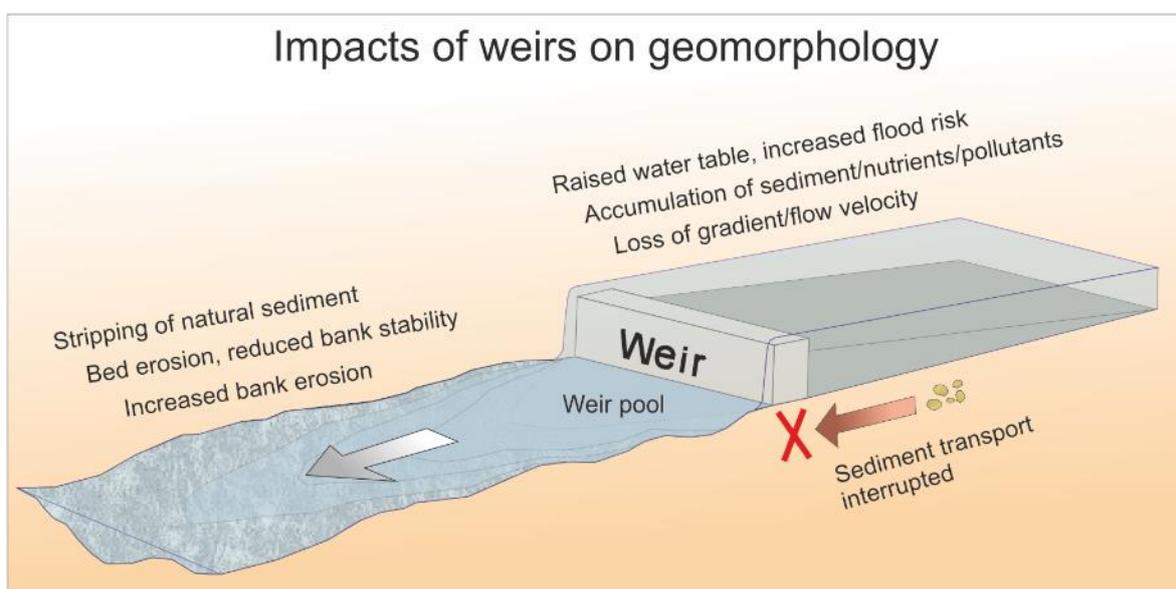
Weirs also interrupt the natural transport of river sediments. River gravels and cobbles are trapped upstream of weirs, reducing the supply of sediment downstream, this often leads to a net increase in bed and bank erosion downstream. Figures 10 and 11 illustrate these impacts, as does a video prepared by the Wild Trout Trust making use of the Severn Rivers Trust's EmRiver geomodel; a scale model used by scientists and researchers to demonstrate river processes.

Figure 11: An illustration showing the impact of weirs on river morphology

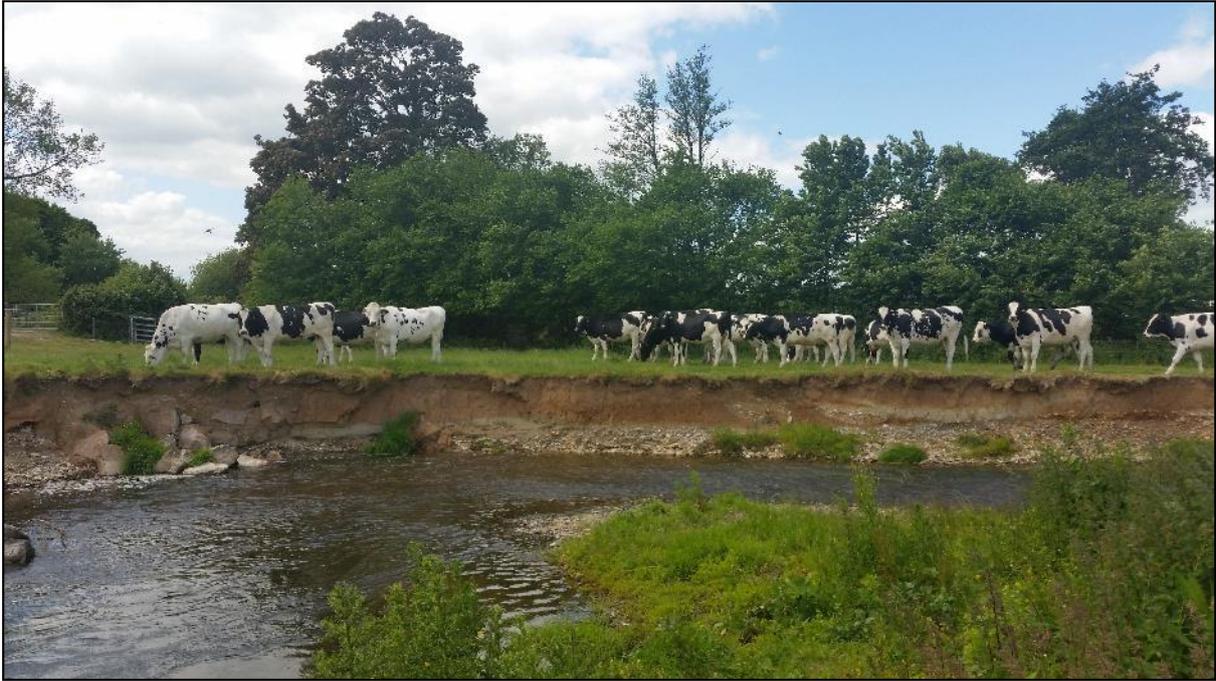
Downstream of the weir, towards the Fairmile Lane bridge, bank erosion is excessive and the impact of the weir on natural sediment transport is likely to be a significant contributing factor. Possibly of even greater significance is the

management of the riparian land through this reach. On the day of the visit, a herd of cattle were grazing the upper bank (Figure 12).

Figure 12: Cattle grazing the unprotected banks near Fairmile Lane Bridge

When riparian land is intensively grazed, grass is forced to divert energy to continuously growing new blades (leaves). This results in a shrinking of the roots and limits new growth of rhizomes and stolons (roots which creep outwards to produce new plants). The reduced length and abundance of roots results in a reduction in bank stability. In addition, intensive grazing also prevents other plant species from establishing, reducing bankside biodiversity which, in turn, reduces the diversity of food and habitat available for terrestrial invertebrates that often supplement the diet of salmonids.

1. Engage with land owners/tenant farmers throughout the club's waters and discuss the benefits of installing stock-exclusion fencing at least 3-5 metres back from the top of the bank. Alternative means of watering livestock are available which can eliminate the need for cattle to access the stream entirely. Pasture pumps (Figure 25), for example, do not require electricity as they are simply powered by the cattle themselves.

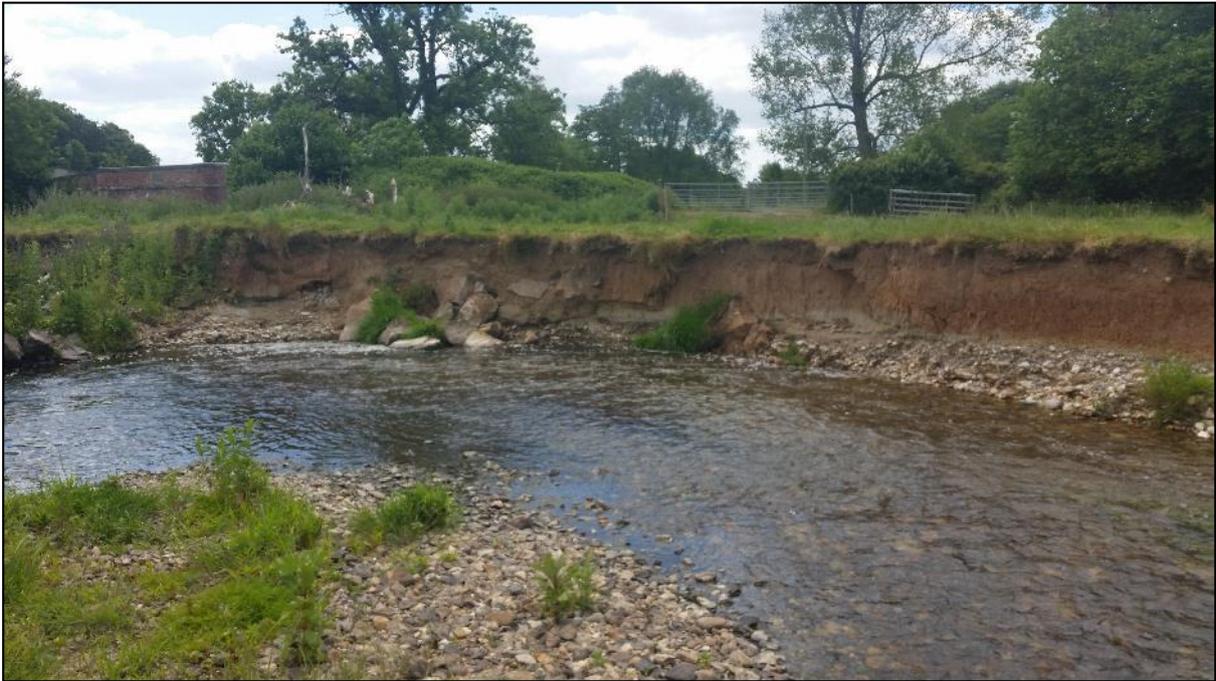
Attempts at bank protection using rip rap (large boulders) has failed to abate the rate of erosion; in fact, it is more likely that these attempts have actually exacerbated the problem. Hard-engineered revetments often protect the bank behind them at the expense of the bank at the edges of the revetment, or sometimes a section of bank downstream. At the interface between the hard surface of the rip rap and the soft, friable bank, erosive forces are concentrated, often causing erosion around the back of the revetment. A good alternative to hard revetments is to plant live willow into the bank. If undertaken during the winter or early spring when the willow is dormant, and driven down into the bank so that around two-thirds of the willow is underground and the very bottom is at or below summer water level, each stem should sprout in the spring and put out roots and leaves. Willow roots form a dense mat that gets denser and stronger with time. These also act to absorb energy and slow flows as opposed to simply diverting the energy as hard-engineered revetments do. Live willow revetments also have the advantage of being very cost-effective, often free to install. Whips (long sticks) can simply be cut from other bankside willows and driven into the bank by hand. Ideally, low-growing species such as goat willow (*Salix caprea*) should be used as these will require less frequent maintenance and provide good low cover for trout. It is worth emphasising that whilst living willow revetments can provide good protection for eroding banks, the requirement of annual maintenance as the revetment grows should factor into decision making.

Figure 13: Hard-engineered 'rip-rap' bank protections have failed to reduce the rate of bank erosion

4. Encourage land owners to protect excessively eroding banks with soft-engineered techniques such as live willow revetments. On sharp bends these structures should be installed to form as smooth a curve as possible so as to limit the occurrences of eddying flows and uneven friction. Live willow brushwood should be aligned in the same direction, ideally with the branched ends pointing downstream to reduce the risk of trapping debris that could pull the structure apart. Finally, the willow should be firmly secured and the upper bank fenced to protect new growth from browsing livestock.

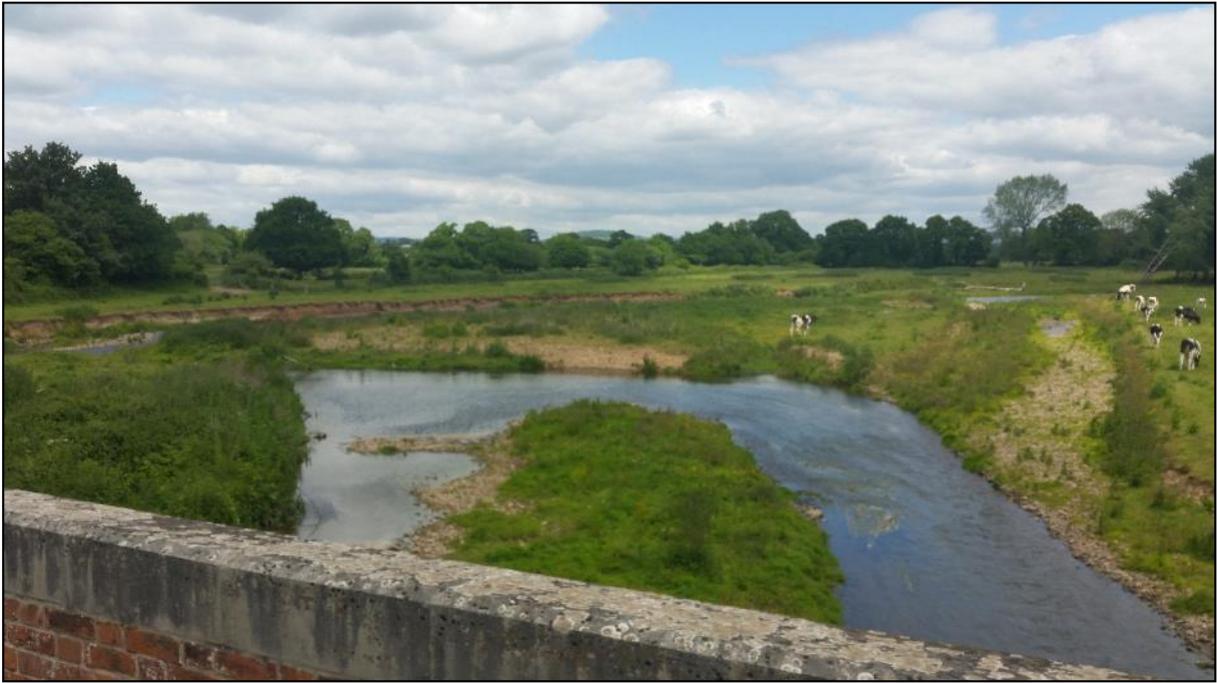
Figure 14: The view upstream from Fairmile Lane Bridge

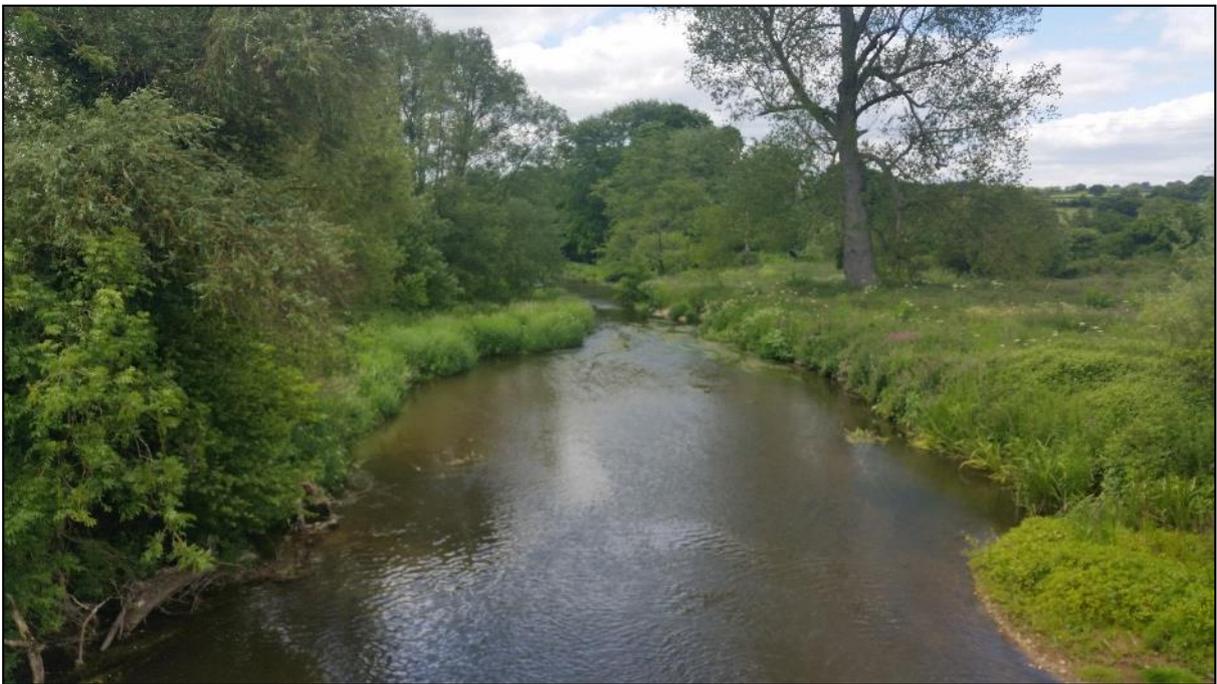
Downstream of the bridge, the land is not grazed and the banks are densely vegetated, providing much higher quality habitat for both aquatic and terrestrial wildlife. The rate of bank erosion is also substantially lower than upstream of the bridge, highlighting the important role of marginal and bankside vegetation in naturally protecting river banks.

Figure 15: The view downstream from the same bridge.

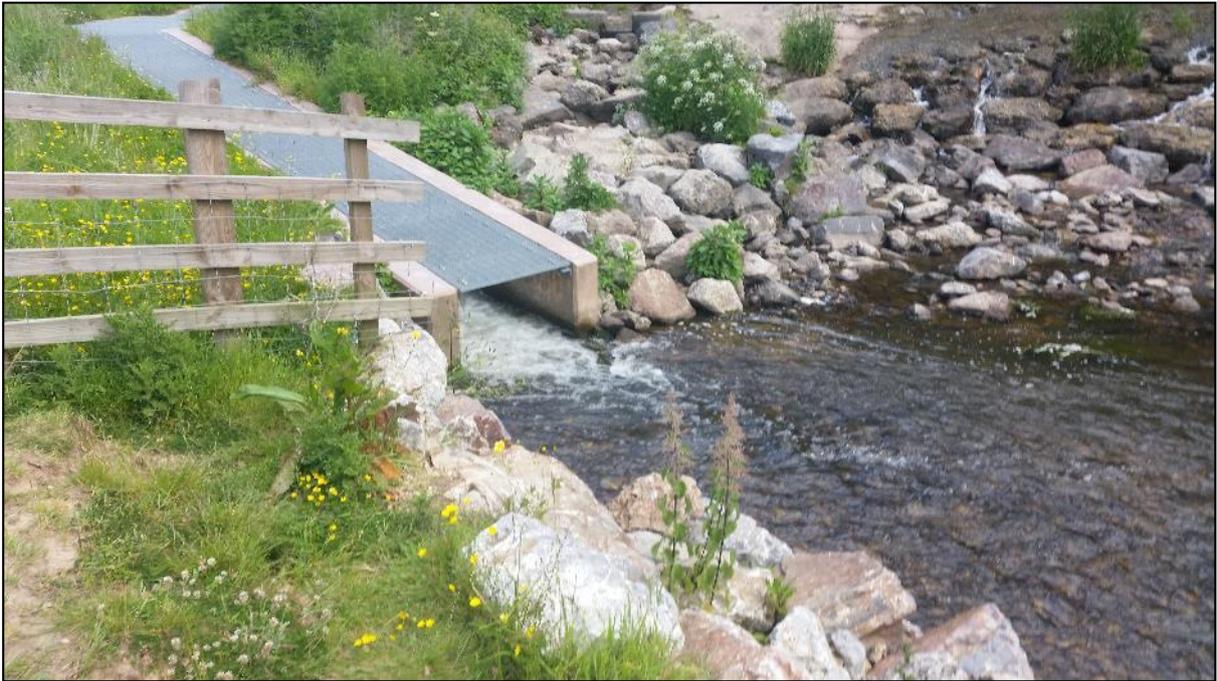
At Tiptop St John another weir was visited at SY 09142 92634 (Figure 16). Here the weir was also originally installed to divert water to a nearby mill.

Figure 16: The new technical fish pass at Tipton St John has significantly improved fish passage. More recently, a hydro power turbine has been installed downstream between the leat and the main river (Figure 17).

The previous fish passage easement on the weir consisted of a pool and traverse pass which, unfortunately, was not efficient. The newer pass, although less aesthetically pleasing to some people, is a much more effective solution that provides a better attraction flow to encourage fish up through the pass. Attraction flow is an important factor in fish passage as fish seeking to run upstream along the main stem of the river will follow the strongest flow. In a completely natural

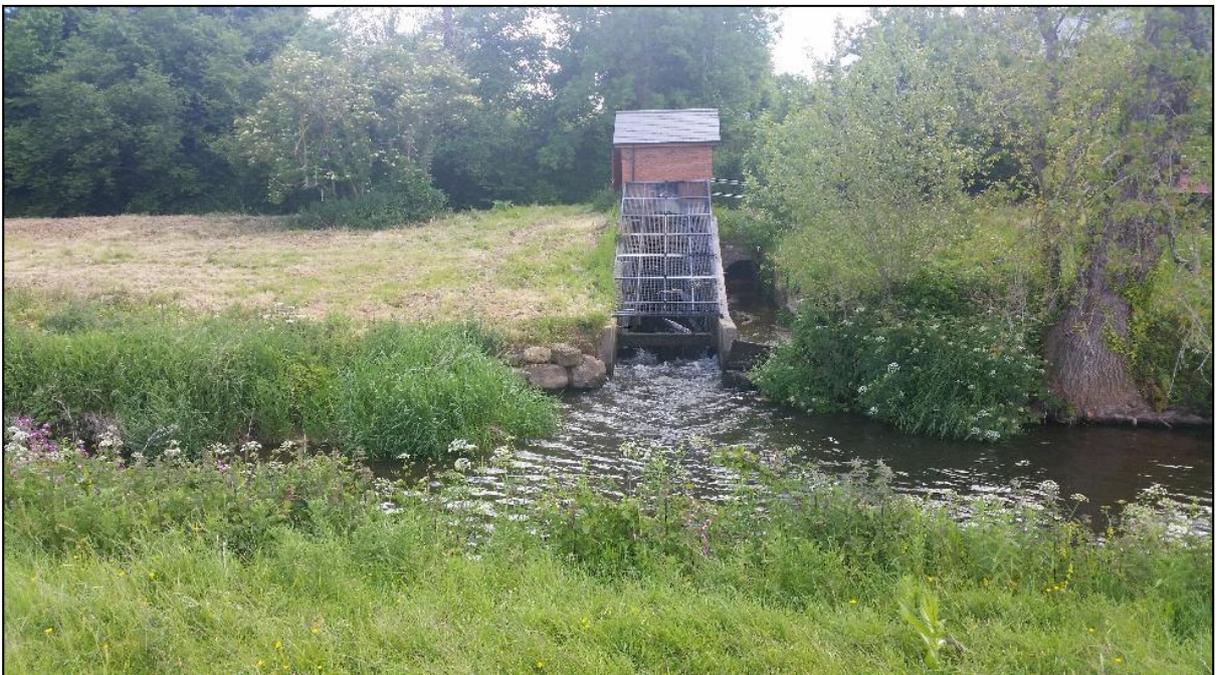
Figure 17: The 'Archimedes Screw' turbine a short distance downstream of the weir discharges flow from the old leat back into the main channel.

Some turbine designs, such as Kaplan turbines, can be extremely hazardous to fish. The Archimedes screw turbine at Tipton St John is one of the less harmful designs as the screw turns relatively slowly and is less likely to kill or seriously injure any fish that might come into contact with it.

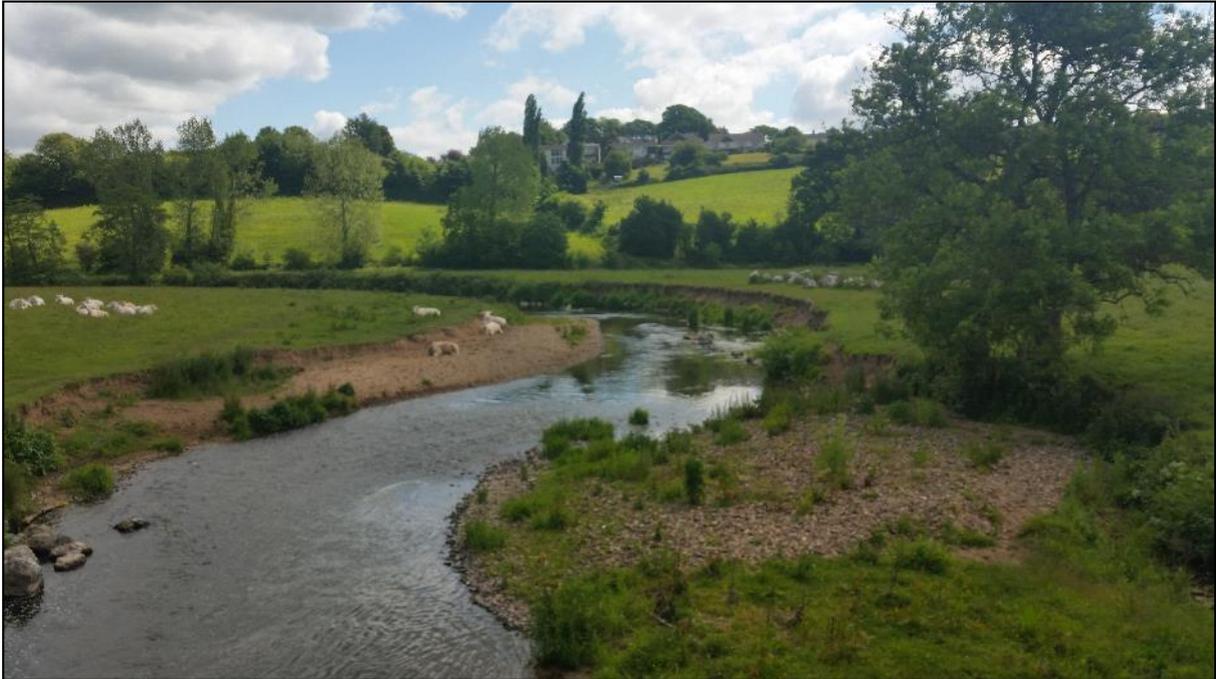
Downstream of the old mill, the Otter flows through open pasture land. As with the river at Cadhey, erosion is exacerbated by grazing on unprotected banks and attempts to protect the banks with riprap are unlikely to work long-term (Figure 18).

Figure 18: More erosion exacerbated by a complete lack of livestock exclusion from the bank

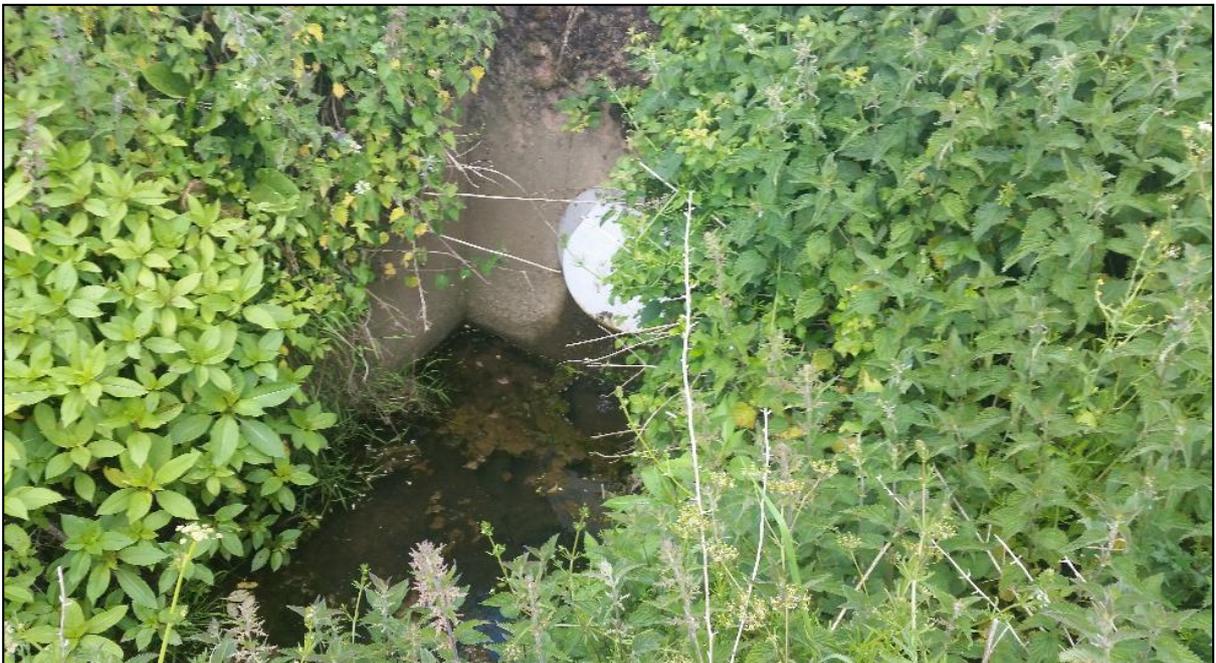
At SY 09038 92191 treated effluent from a nearby sewage treatment works discharges into the river. There were two outfalls at this location but only one was flowing on the day of the visit. No immediate signs of nutrient enrichment (such as algal blooms or sewage fungus) were observed around the flowing outlet but there was what appeared to be a small bloom of sewage fungus in the slack water around the non-flowing outfall (Figure 19). These outfalls should be closely

Figure 19: The outfalls at SY 09038 92191 should be monitored to assess water quality

monitored and a location a short distance downstream could be a good site to conduct regular invertebrate monitoring via the Riverfly Partnership in order to quickly identify and address any potential water quality issues related to the outfall.

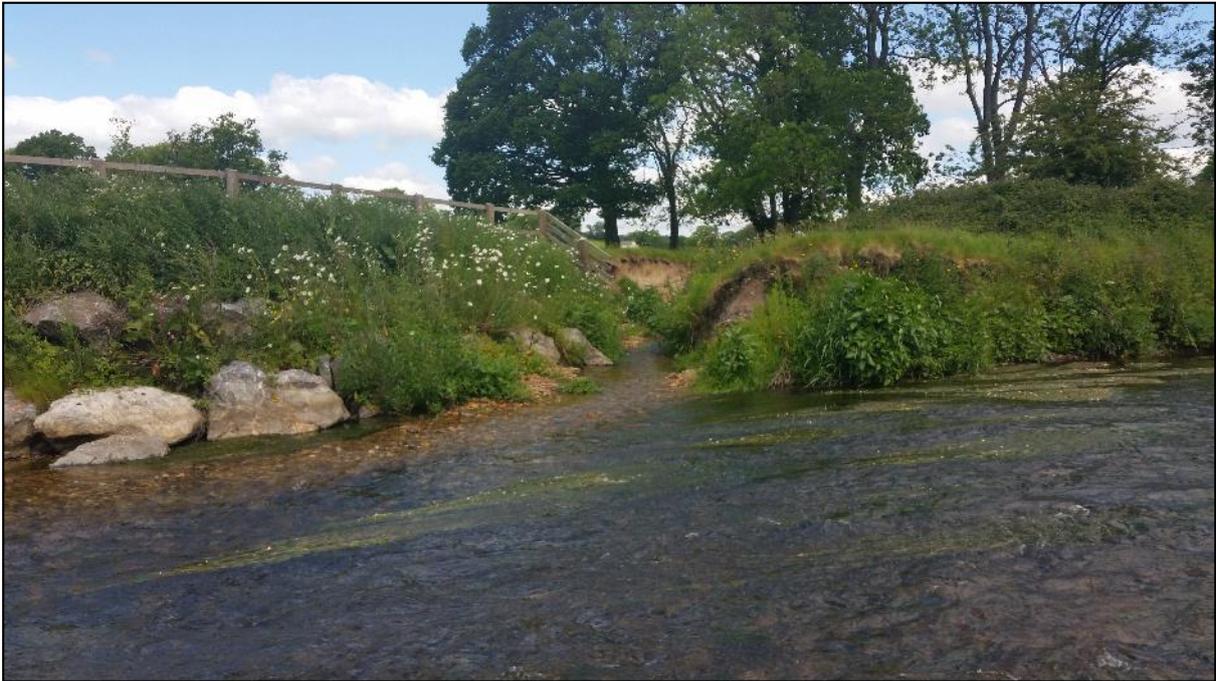
Around the next meander downstream, two small tributary streams draining from Broad Oak and Venn Ottery Common (Figure 20) join the river. These streams were not inspected on the day of the visit but could be important spawning and nursery habitats for wild trout.

Figure 20: The confluence of one of the small tributaries draining from the West

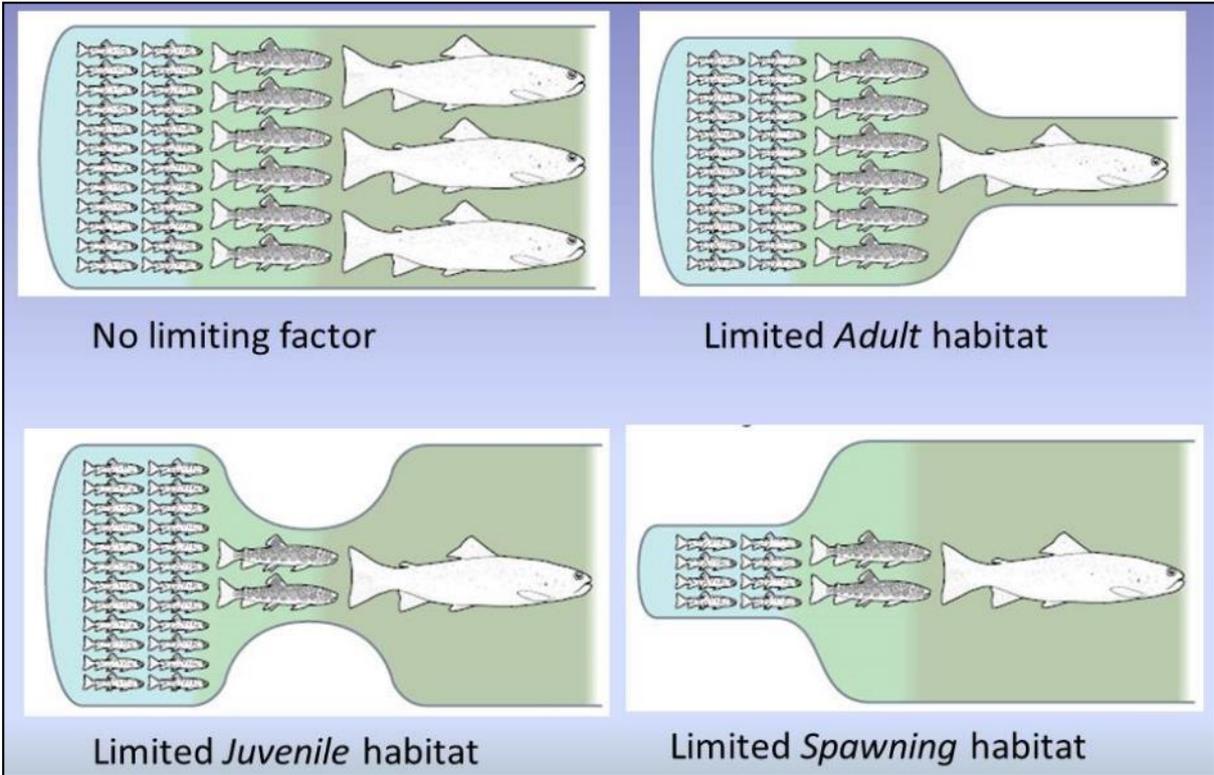
Figure 21: An illustration showing how ‘bottlenecks’ at a particular life-stage can impact on fish populations

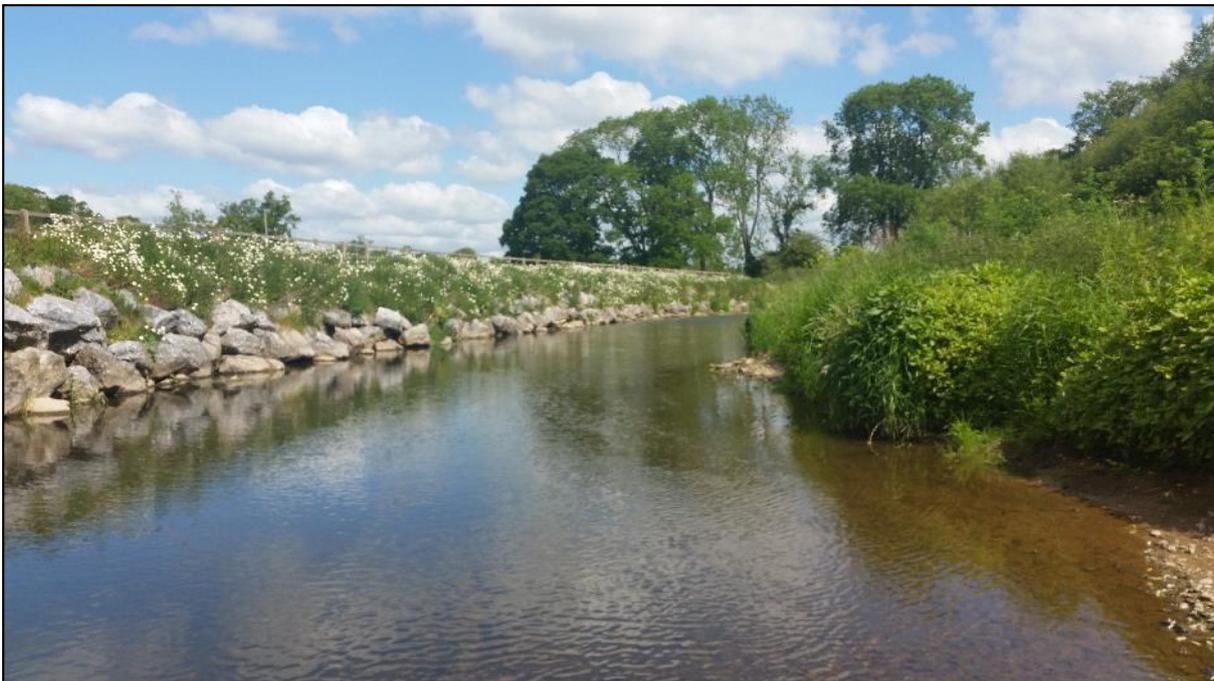
The remainder of the reach downstream is confined between extensive rip-rap revetments. The protection of nearby houses and infrastructure is probably the driver behind such aggressive engineering works but the result is that the river has become relatively barren of habitat features and there is a general lack of overhead cover and shade (Figure 22).

Figure 22: An upstream view of the large-scale rip rap bank revetments deprive the river of natural habitat features

The river here would benefit from tree planting along the relatively bare bank above the rip-rap to introduce a greater diversity of light conditions. Unfortunately, the height of the bank means that new trees (planted or naturally established) will not provide the low-lying and trailing cover that fish need to comfortably lie up and evade predators.

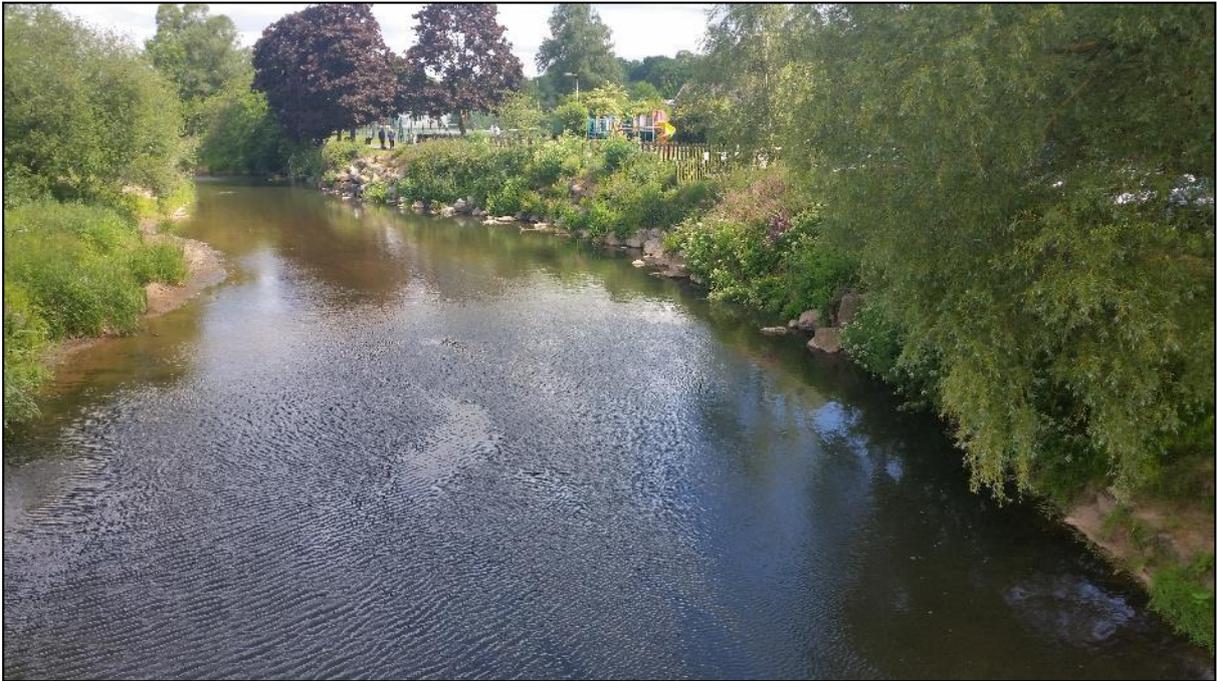
At the next meander downstream, the river bends to the right and then becomes straightened as it flows alongside a public park towards the A3052 road bridge. Here, yet another rip-rap bank revetment limits the abundance of marginal cover habitat (Figure 23). Fortunately, there are at least some trees on the opposite bank (RB) with low trailing branches (Figure 24). Being so close to the road bridge, it is unlikely that permission would be granted to introduce new habitat structure into the river at this location. It will therefore be important that as many of the naturally occurring low-lying branches be retained as possible.

Figure 23: More rip-rap limits the availability of marginal cover habitat
