River Otter, Tipton St John, Devon

An Advisory Visit by the Wild Trout Trust June 2015

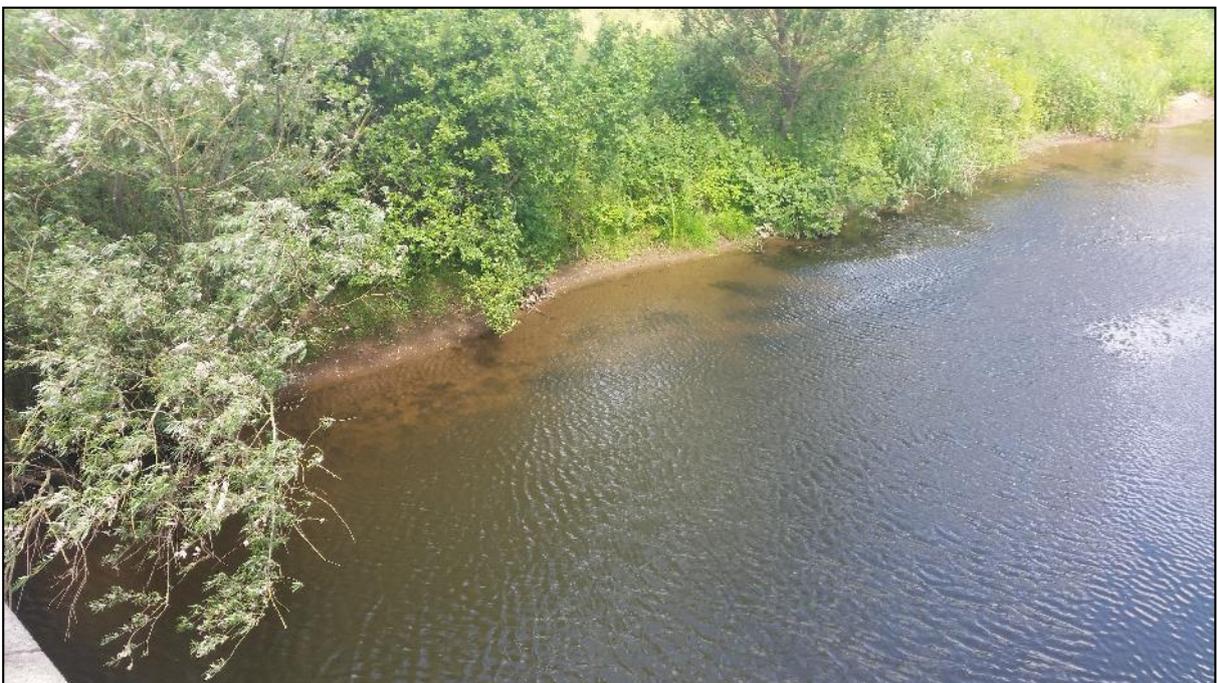
Figure 24: The few trailing branches present should be retained

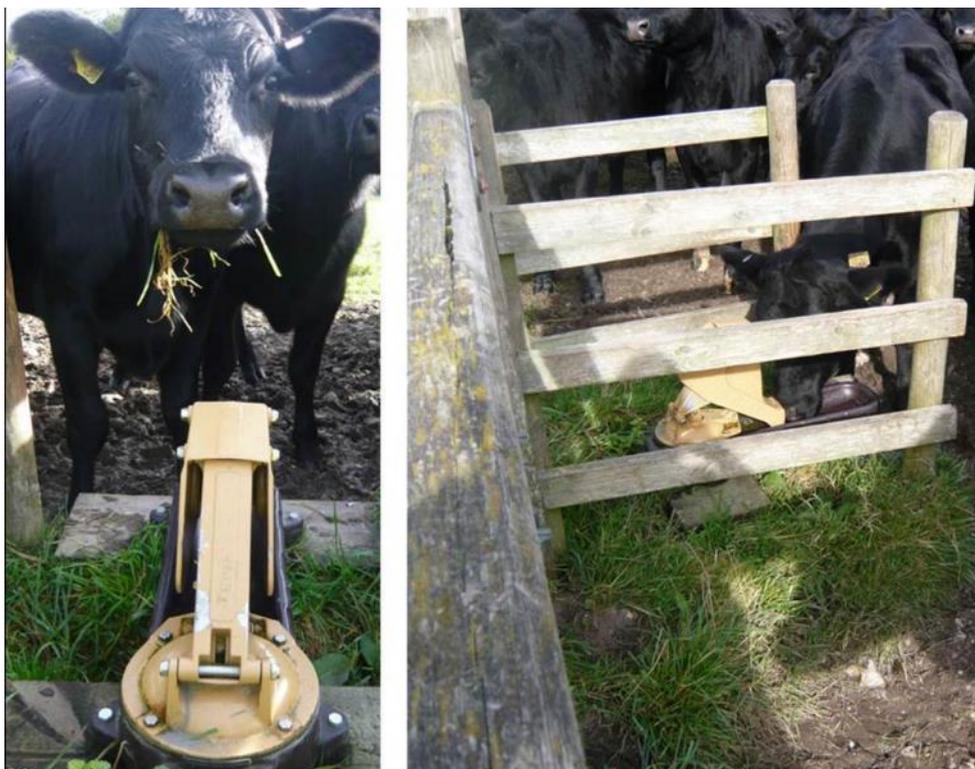
Figure 25: Pasture pumps are operated by cattle and do not require power

1. Engage with land owners/tenant farmers throughout the club's waters and discuss the benefits of installing stock-exclusion fencing at least 3-5 metres back from the top of the bank. Alternative means of watering livestock are available which can eliminate the need for cattle to access the stream entirely. Pasture pumps (Figure 25), for example, do not require electricity as they are simply powered by the cattle themselves.

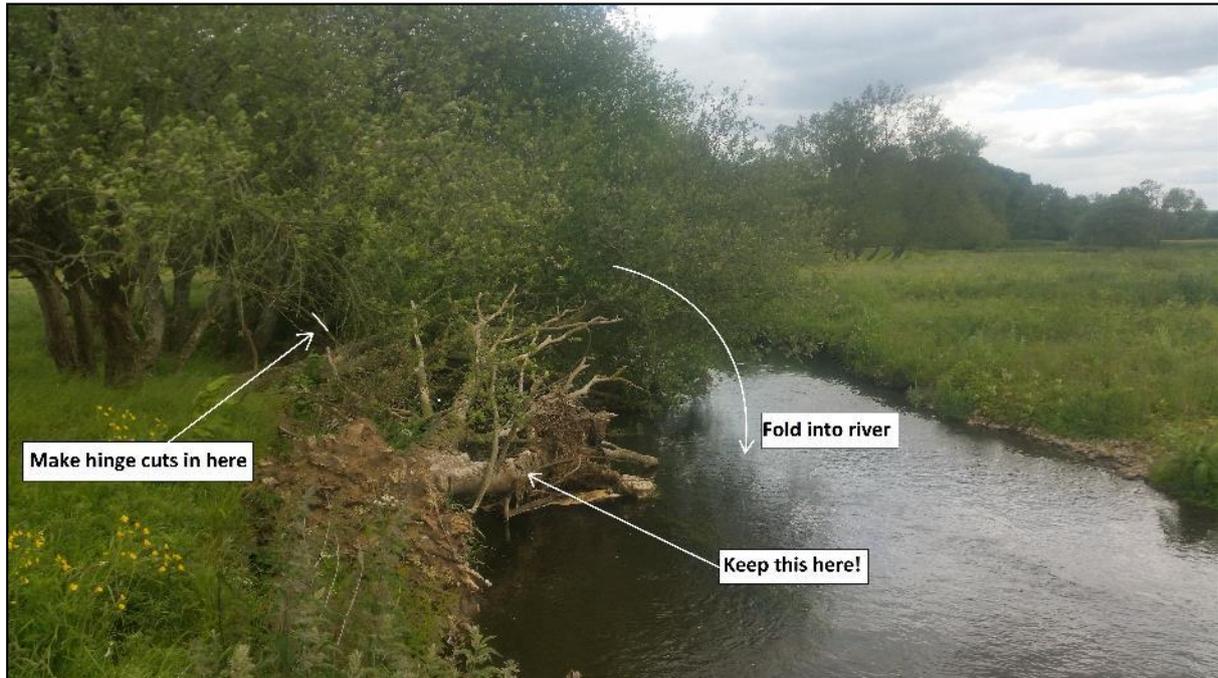
Figure 27: Suggested actions to enhance an existing woody habitat feature in the Alfington reach

5. Plan a series of woody habitat enhancements through the Alfington reach. Where possible, adapt existing habitat features to maximise their effectiveness. (Figures 27 – 29). Where woody habitat features are absent, introduce new features sourced from existing trees within the floodplain (Figures 30 and 31).

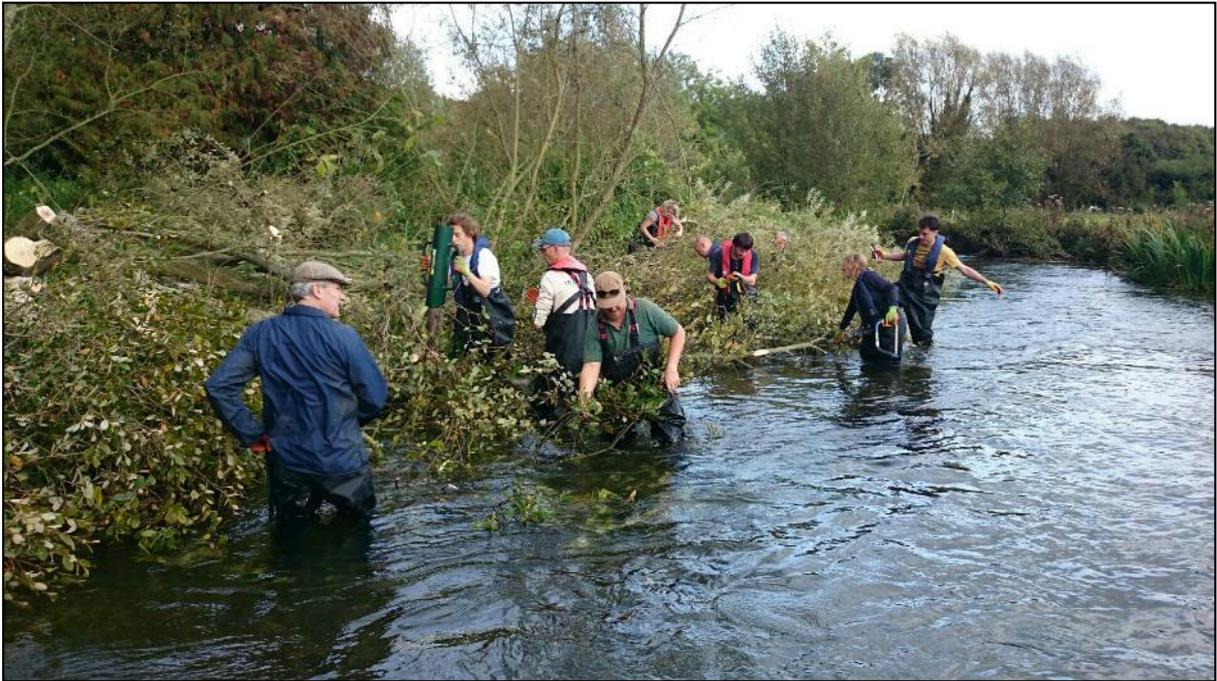
Figure 28: A work party hinged bankside willow limbs into the River Wylfe in Wiltshire

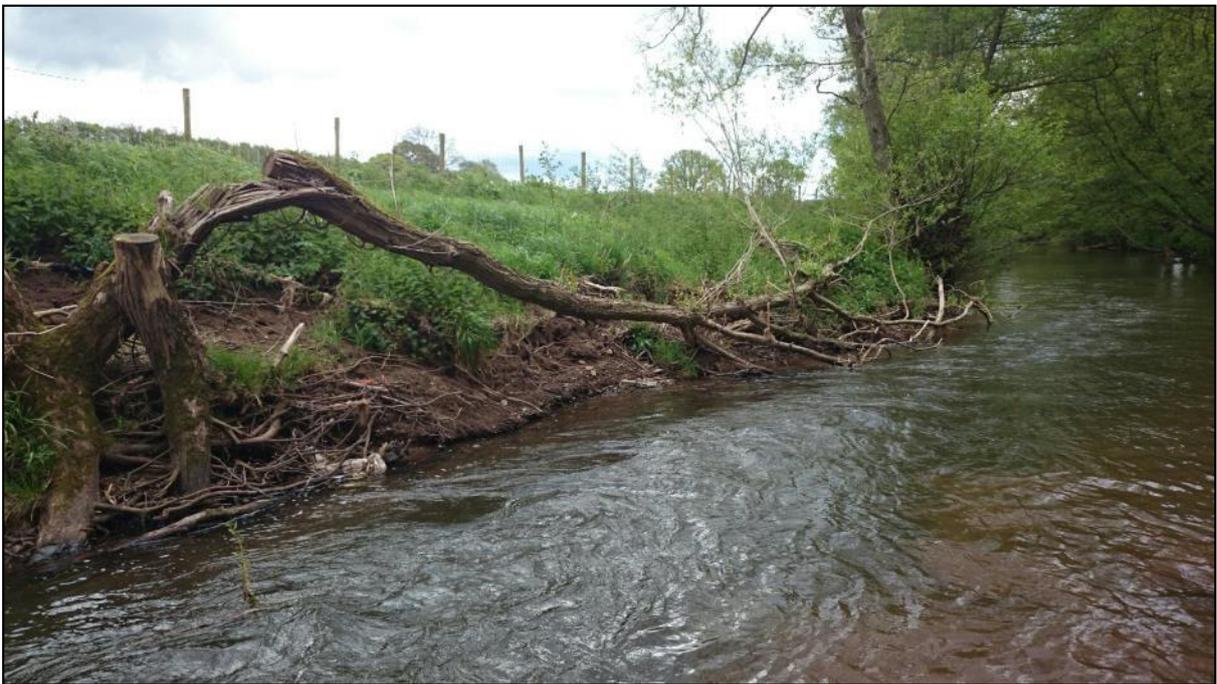
Figure 29: A hinged bankside willow provides good fish and invertebrate habitat and diversifies flow in a straightened reach of the River Monnow in Herefordshire.

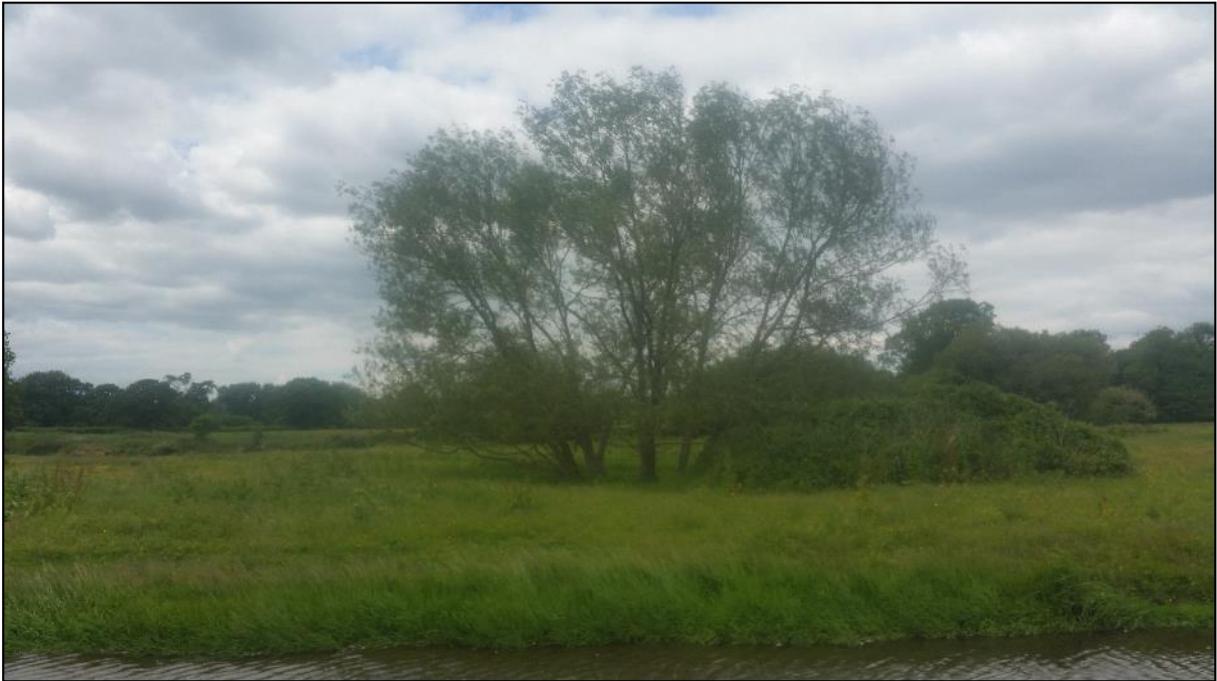
Figure 30: Additional woody habitat could be sourced from willows within the floodplain

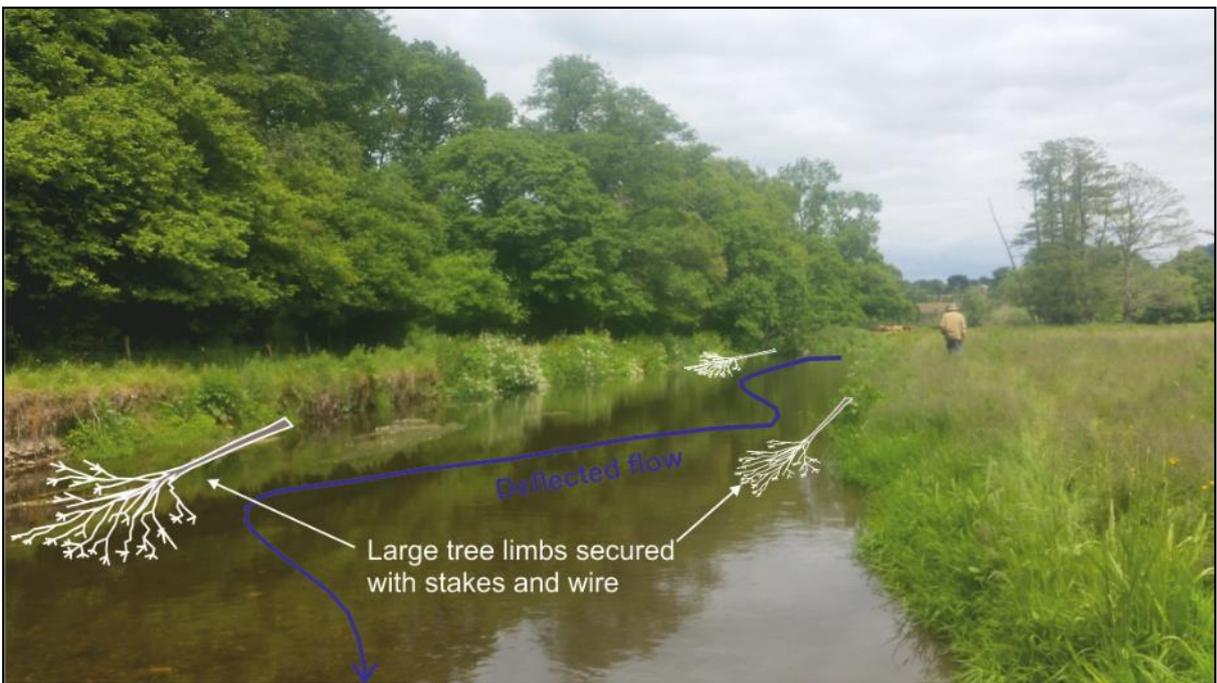
Figure 31: A suggested example of locations to introduce large tree limbs into the river to enhance habitat and diversify flow conditions. The blue illustrates how the trees might deflect flow and thus introduce habitat diversity in the river.
