River Ottery, Werrington, Cornwall

An Advisory Visit by the Wild Trout Trust, April 2014

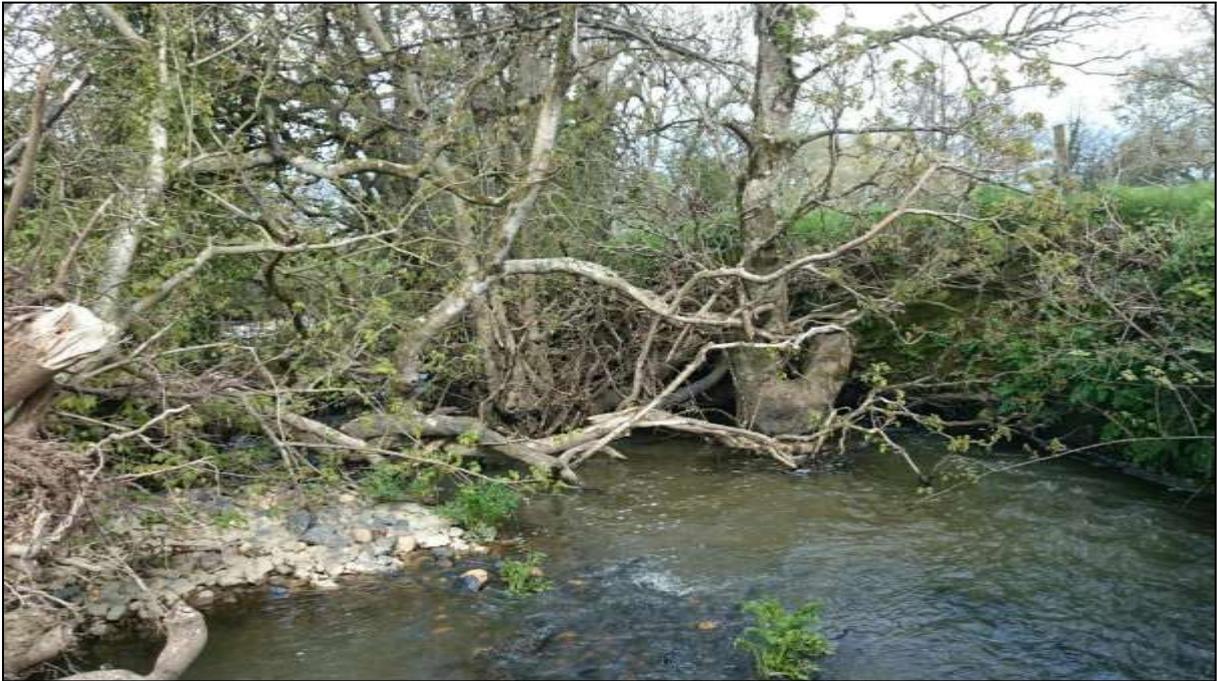
At the upstream extent of the reach, a large tree had fallen into the river and been carried a short distance downstream. Highly-energised flows during spate conditions have scoured deep runs around the tree (Figure 2) and created a deep pool beneath. Material scoured from the bed has been deposited a short distance downstream to form a riffle and coarse point bar (Figure 3). The resultant diversification of depth and flow conditions around the fallen tree, as well as the roots and branches of the tree itself has created a dense cluster of complex habitat features favoured by flow-loving fish. Overhead cover and pockets of slackened flow provide ideal opportunities for fish to conserve energy whilst darting in and out of faster flows to snap up passing food items. A good diversity of habitat features allows territorial fish such as wild trout to each hold up in a small micro-territory where they are less threatened by their neighbours. Dense brushwood in the form of roots and branches also provide excellent refuge from predators such as piscivorous birds.

Figure 2: Deep, fast-flowing runs have been scoured around the edges of the fallen tree

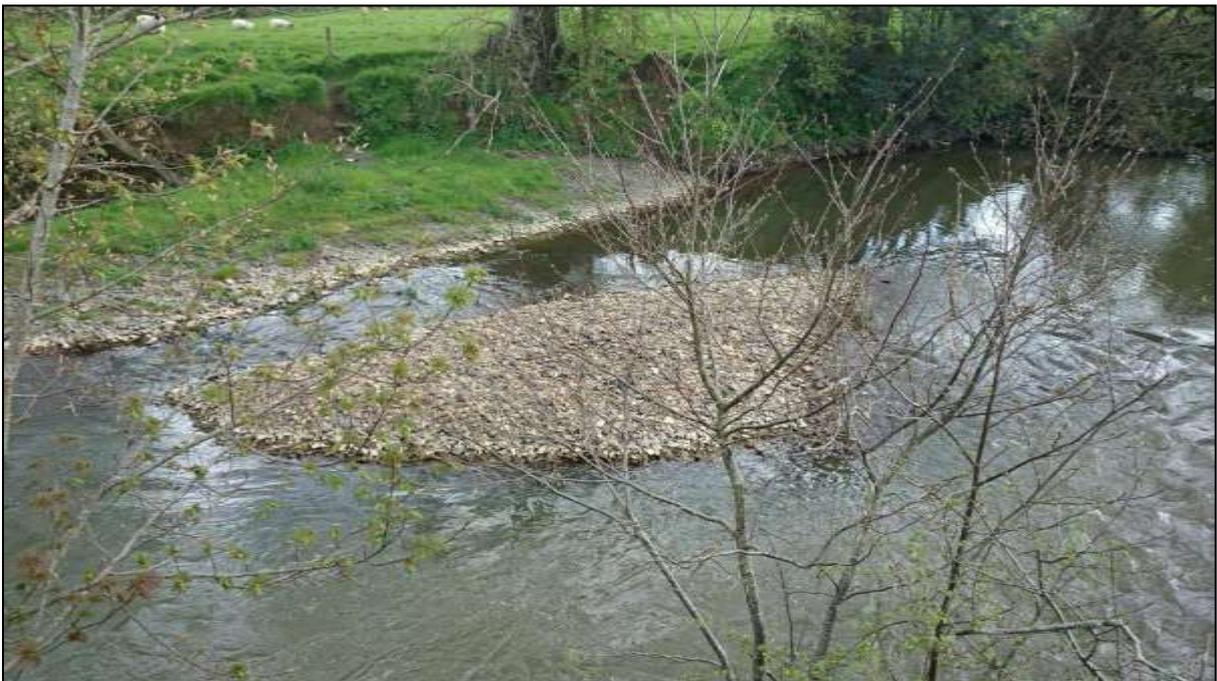
Material scoured out from the bed by flows deflected around and under the fallen tree will also be naturally 'sorted' by the flow. Fine sediment will be washed downstream and the bed material naturally graded by size as smaller (lighter) stones are carried further and larger (heavier) cobbles drop back to the bed sooner.

Figure 3: Material scoured out from the pool below the tree has formed a riffle and point bar downstream

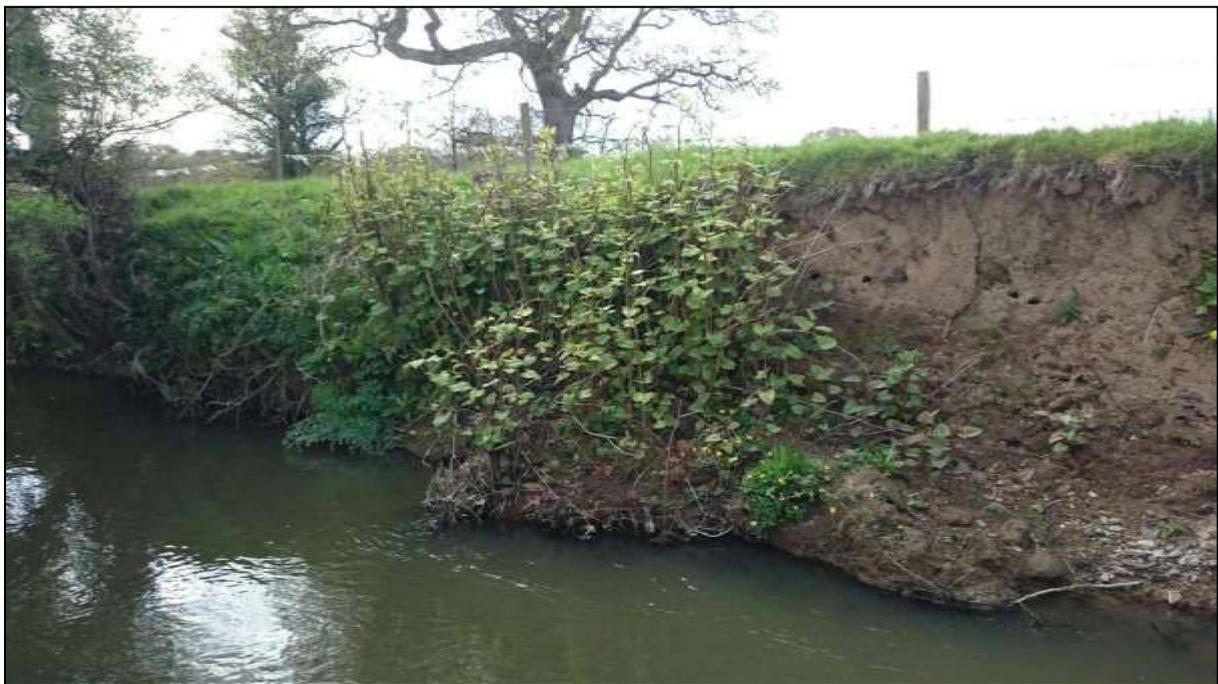
Alien invasive plants such as Japanese knotweed (*Fallopia japonica*) or Himalayan balsam (*Impatiens glandulifera*) also weaken bank stability as they quickly out-compete and overshadow native species during summer months but die back to leave bare, exposed soil during the winter. Unfortunately, examples of both poor bankside fencing and invasive plants were observed (Figures 4 and 5).

Figure 4: A stand of Japanese knotweed is weakening the bank. This will need to be addressed.

1. The stand of Japanese knotweed (JK) at SX 34323 86837 should be treated as a matter of priority. The best way to eradicate JK is by injecting the stem or spraying the underside of the leaves with the broad-spectrum systemic herbicide glyphosate. Glyphosate is relatively hydrolytic and therefore relatively safe to use near water. However, this should only be undertaken by a trained operative with an NTCP PA6 (W) qualification. Consent is also required from the Environment Agency to undertake any herbicide spraying within 1 metre of the river bank top.

Treatment of a JK stand will take a minimum of 3-5 years, with subsequent monitoring to ensure the plant has been completely eradicated. It is also imperative that you do not attempt to strim JK as even small pieces of the plant can take root and propagate into new plants.

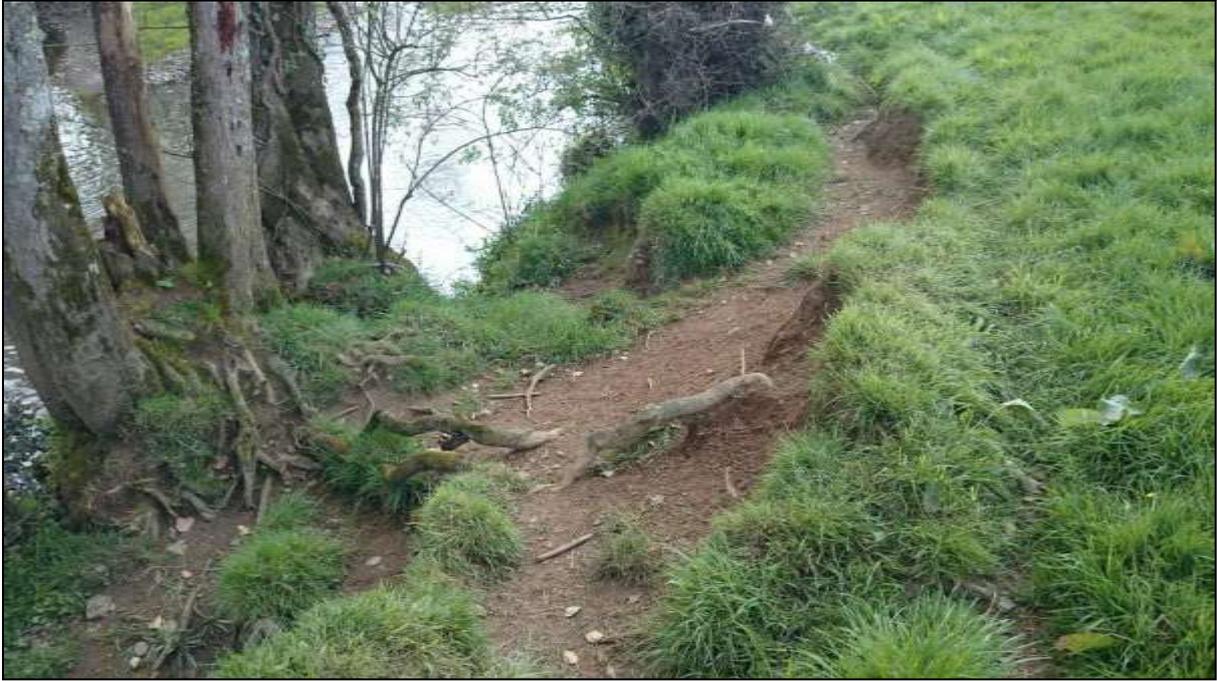
However, where the adjacent land is managed for intensive agriculture, banks are often weakened by reduced vegetation coverage. Fence lines too close to the bank result in too narrow a buffer between heavily grazed or cultivated land and the reduced root structure associated with such land uses places riverbanks at a greater risk of erosion.

Figure 5: Livestock-poached banks also weaken the bank and contribute towards excessive inputs of fine sediment.

2. Engage with riparian land owners/tenant farmers and Westcountry Rivers Trust explore options to improve fencing along the reach, ensuring that an adequate buffer margin of at least 3 metres is maintained between the top of bank and the fence line.

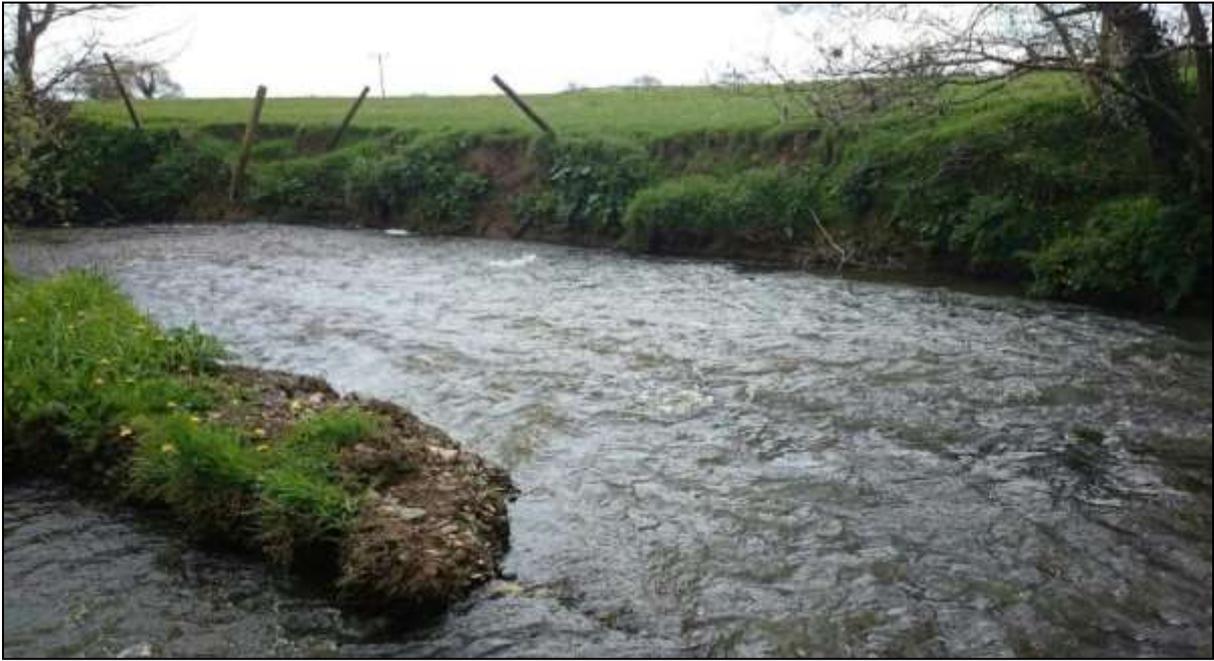
Approximately 50 metres downstream of Ham Mill Bridge, a point bar has formed at the head of a tight left hand bend in the river. The pinched channels either side of the point bar cause flows to accelerate into fast-flowing runs that are likely to be favoured feeding areas for trout. The pinched flow appears to have also accelerated the formation of a pool against the RB downstream. This, in combination with an ineffective buffer fence positioned too close to the bank edge may be causing excessive erosion (Figure 6).

Figure 6: Flow pinched around the point bar in combination with a fence line positioned too close to the RB appear to be contributing to a potentially excessive rate of erosion

6. In areas where excessive erosion is deemed to be a problem, brushwood won from on-site tree works could be used in combination with live willow to stabilise the bank (see example Figures 19 and 20). Densely-packed brushwood is very effective at absorbing energy from the flow and locally slowing water velocity. Live willow 'whips' (thin, straight sections) and live willow stakes driven into the bank will, if successfully planted, continue to grow and strengthen with time. Willow whips and stakes can probably be won from existing bankside willows.

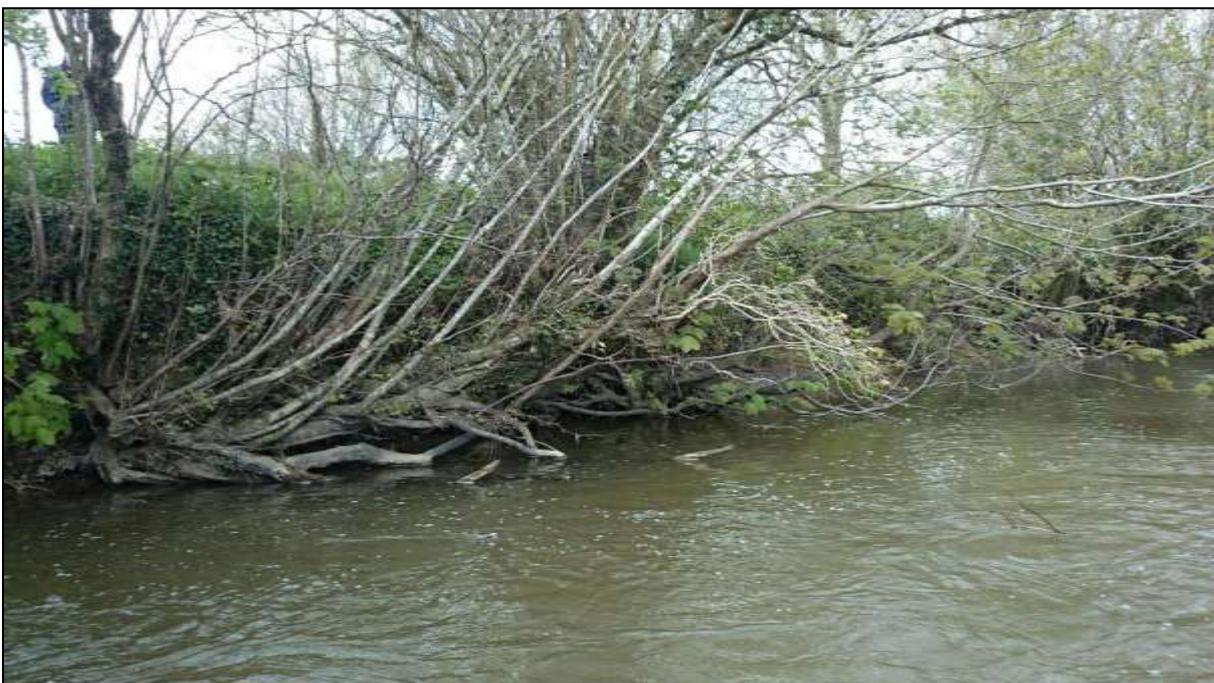
After the left-hand bend, both banks exhibit good examples of low-lying tree cover (Figures 7 and 8). Trailing branches and complex root systems in the margins of the channel will provide an important refuge for resident fish during spates. Sheltered pockets of slack water will provide somewhere for fish to hold up and wait out periods of turbulent flow.

Figure 7: Trailing bankside branches and roots provide excellent cover habitat

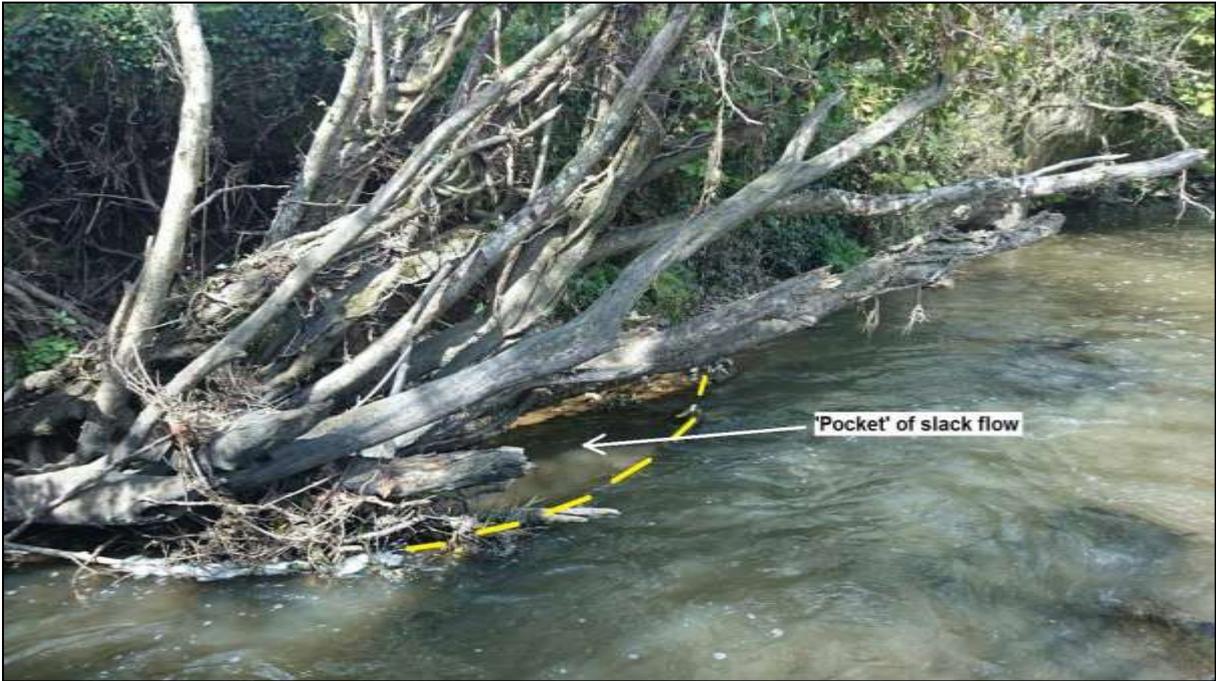
Figure 8: A 'pocket' of slack flow can be observed in the lee of a semi-submerged branch

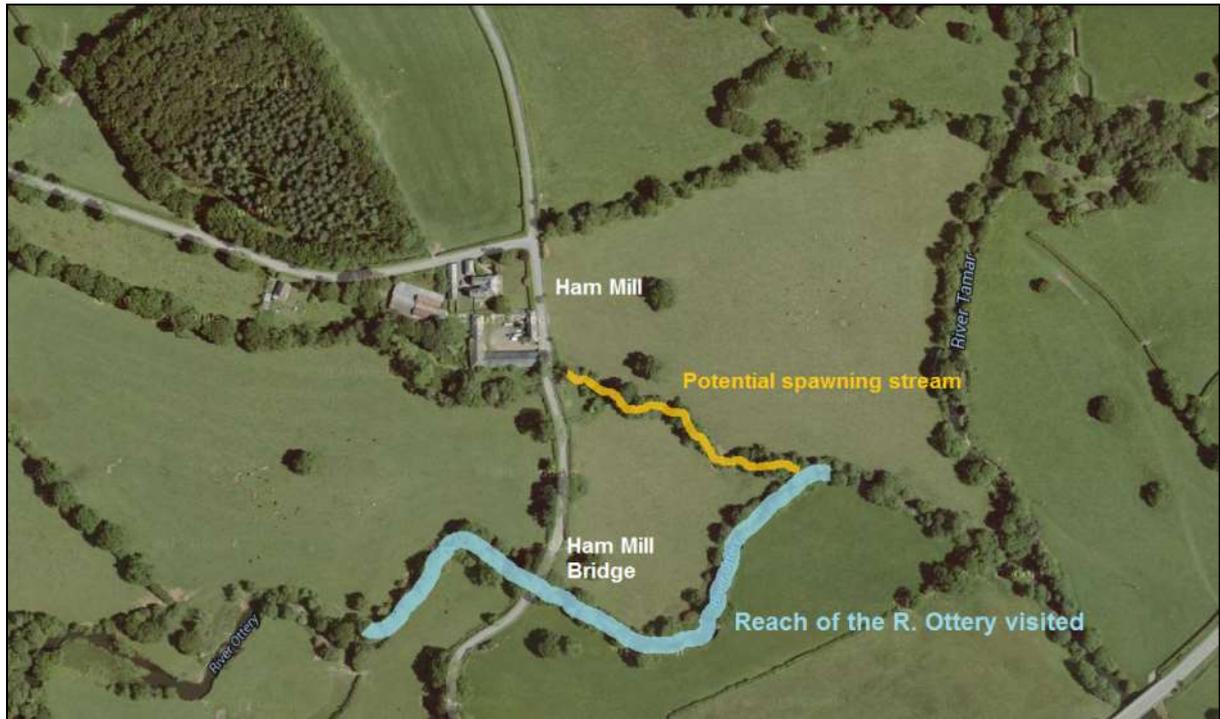
At the downstream extent of the reach visited a small stream joins the river. The 1884 map of this location (<http://www.old-maps.co.uk/index.html>) suggests the stream once carried flow from Ham Mill when there was a functioning mill at the site. This small stream has good potential as a spawning area for brown/sea trout, providing lower peak flows and a gravel substrate within the appropriate size range (10-50mm) for trout spawning. However, the stream is presently choked with fine sediment and heavily poached by livestock in places. Fencing the stream off from grazing livestock and occasional log deflectors to keep gravel scoured clean, could greatly improve the quality of the habitat. Unfortunately, due to technical issues, photographs of this reach were not available to include in the report. The reach is highlighted in the Google Earth image shown in Figure 9.

Figure 9: A Google Earth image showing the reach of the River Ottery visited and the location of the potential spawning stream

5. The small stream flowing from Ham Mill should be fenced off from livestock and allowed a sufficient marginal buffer of rough vegetation to limit the volume of fine sediment entering the watercourse. The stream should then be monitored to see how conditions improve and potentially explore options to improve gravel quality.

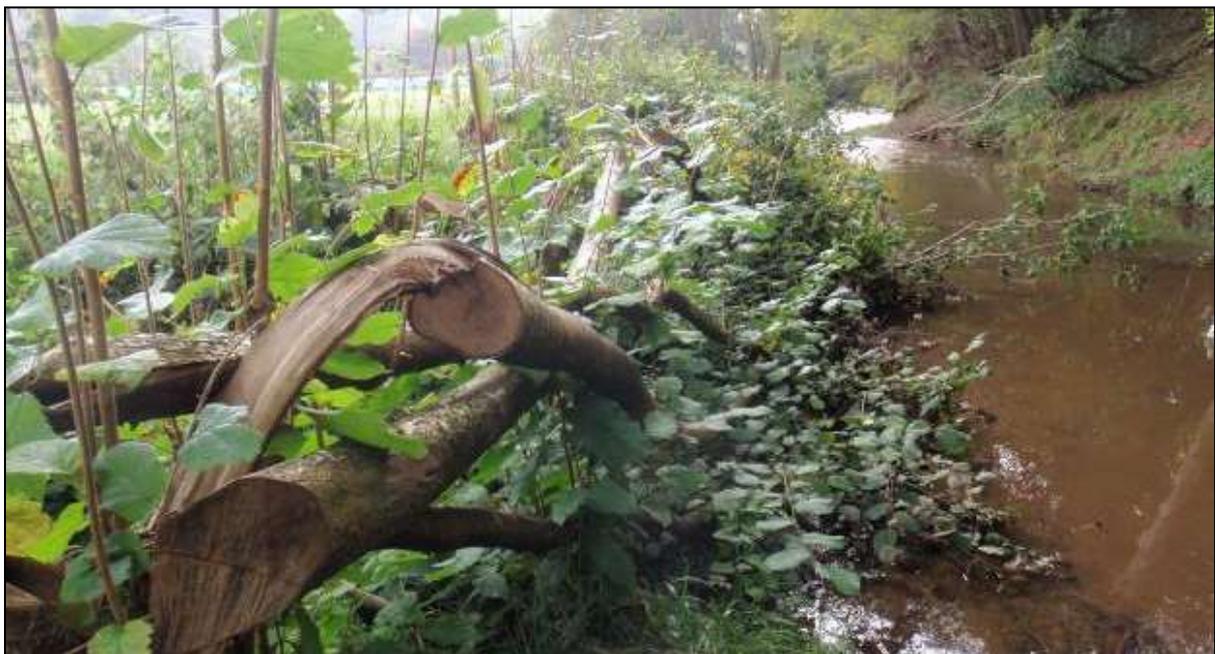
Figure 10: An example of a stand of hazel (*Corylus avellana*) hinged downstream to create marginal refuge habitat

3. Capitalise on opportunities to increase the abundance of trailing and submerged branches by 'hinging' accessible branches down into the water pointing downstream (see Figures 10, 11 and 12).

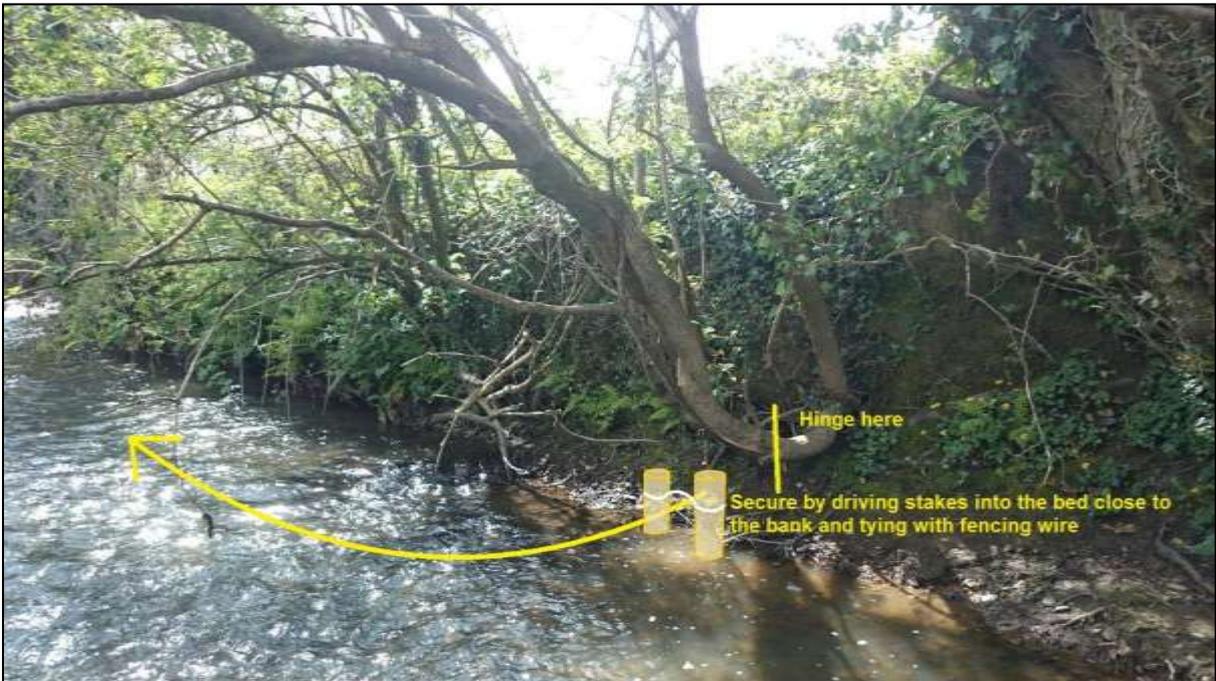
Figure 11: An example of an opportunity on the R. Ottery to introduce further woody habitat

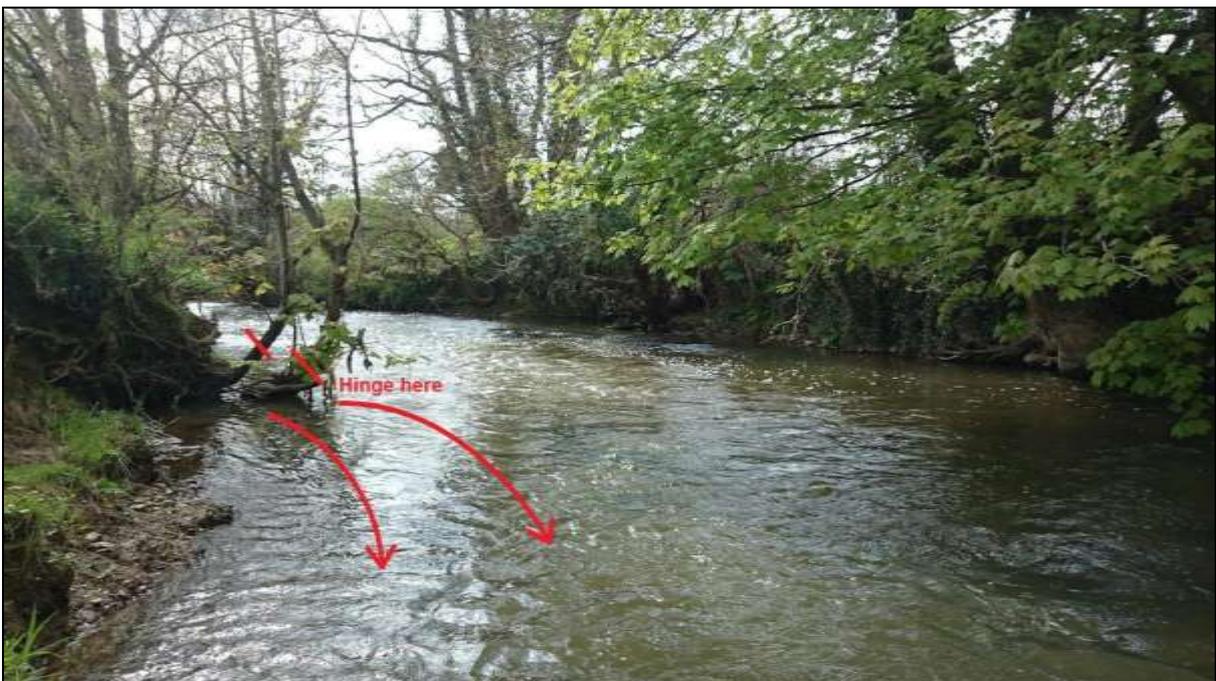
Figure 12: Another example on the Ottery where small limbs could be hinged into the river

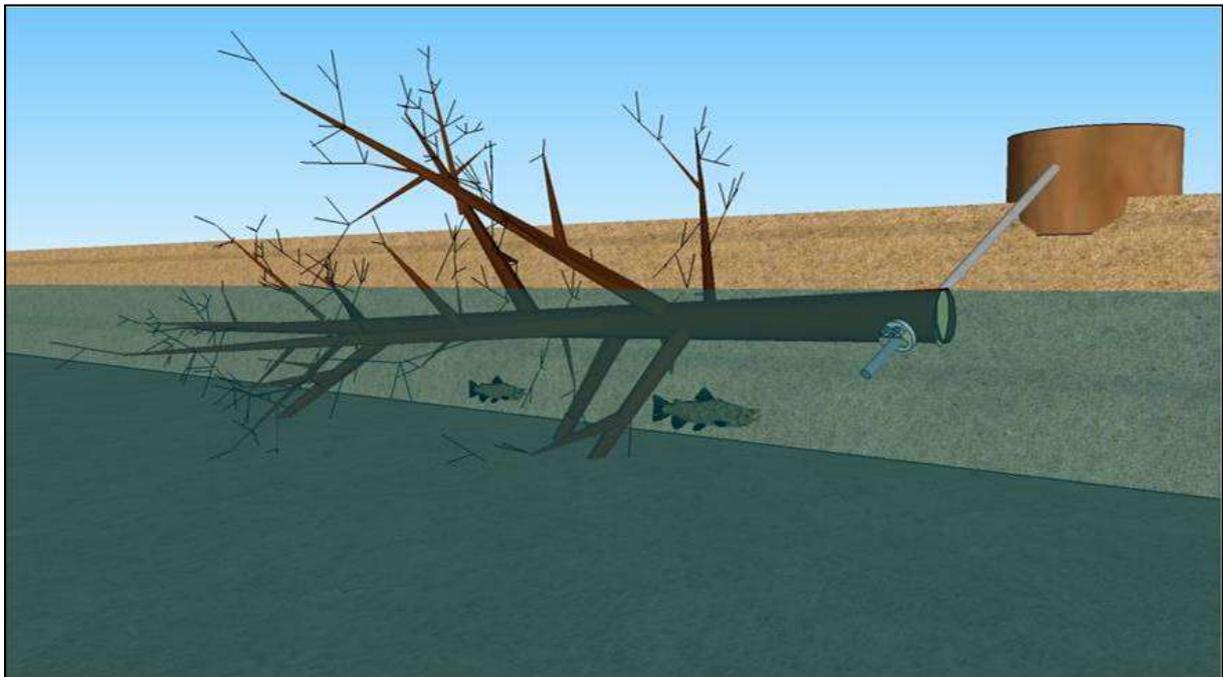
Figure 13: An illustration of a marginal kicker cabled to an existing tree stump

4. Another option for introducing additional woody habitat into the river is to create occasional 'kickers' (Figure 13). This technique involves cabling felled limbs or small trees back to their stumps so they can move slightly with the flow ([http://www.wildtrout.org/content/how-videos#tree kicker](http://www.wildtrout.org/content/how-videos#tree+kicker)).

A kicker will provide valuable cover for fish and food/habitat for freshwater invertebrates without increasing flood risk. During high flows the kicker will be swept against the bank and out of the strongest current. The cable also allows the wood to rise and fall with changing water levels.

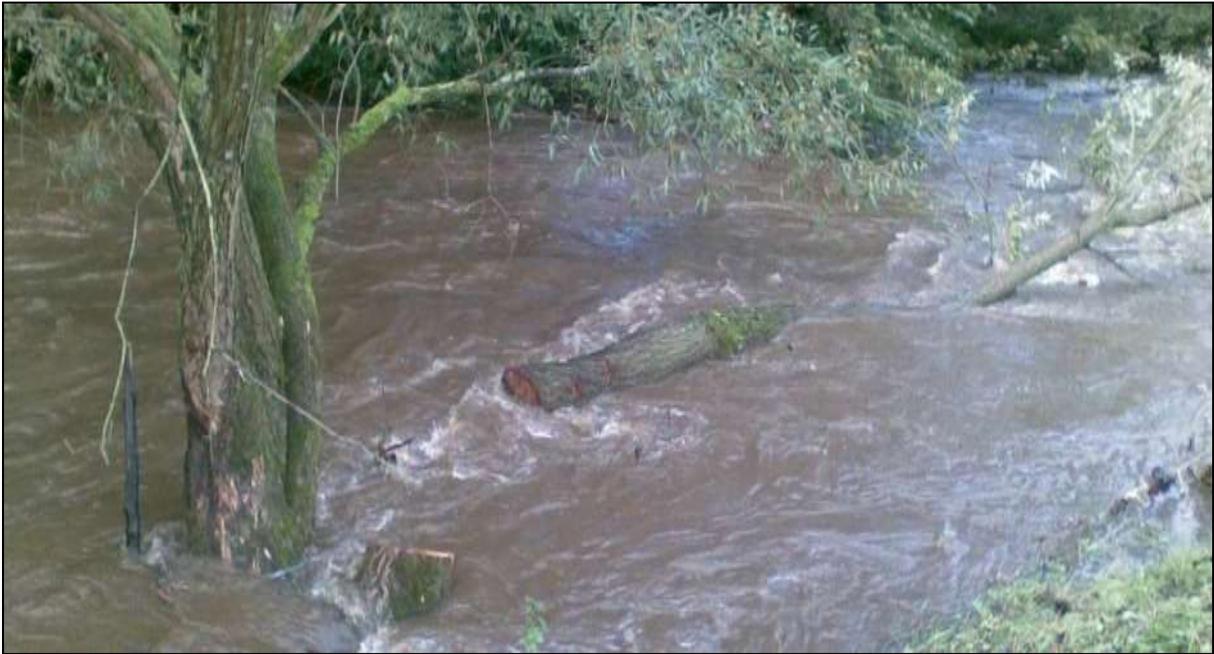
Figure 14: An example of a marginal kicker during high flows

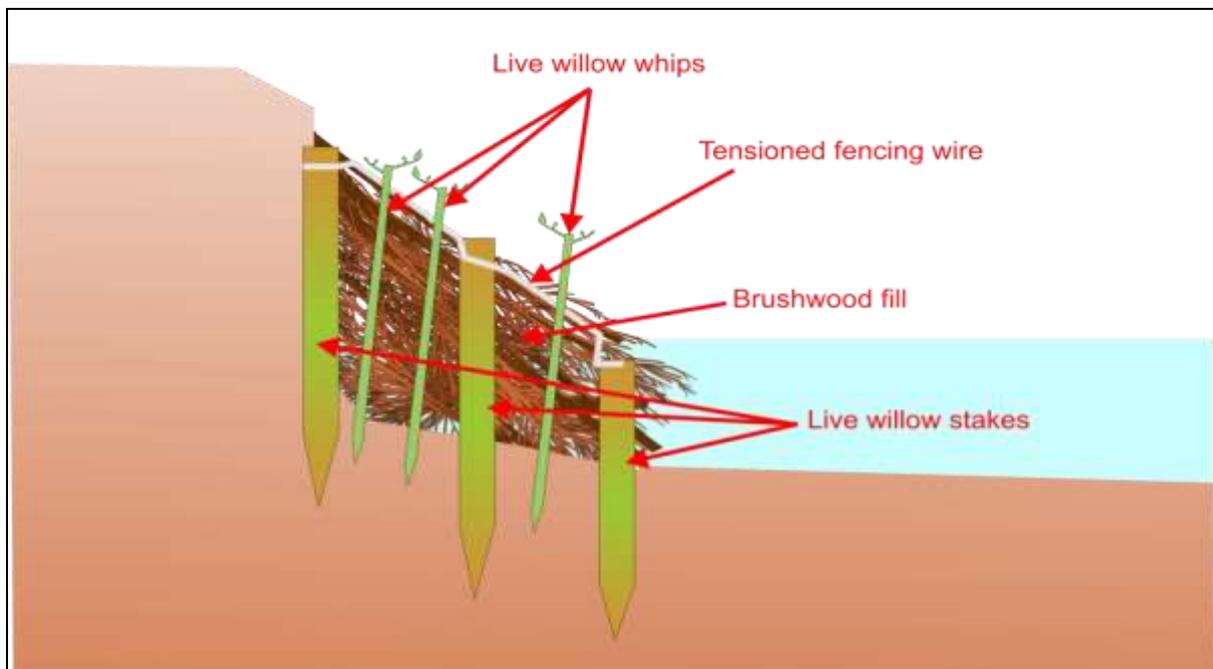
Figure 16: A cross section illustration of a brushwood erosion protection installation with live willow

Willow can be cut and planted at any time of year but the technique is most successful if undertaken in winter or early spring when the willow is still dormant.
