Habitat Advisory visit to the River Ounavarra, Co.  
Wexford, Eire.

Undertaken on behalf of the Ounavarra Angling  
Association (OAA) by Vaughan Lewis, Windrush AEC  
Ltd  
May 2013

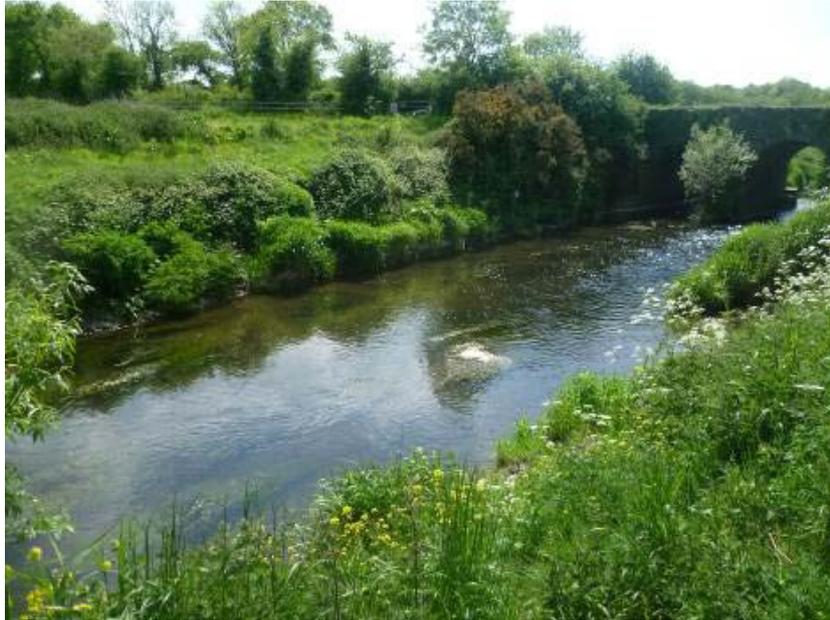
The upper reach of the fishery was moderately incised as a result of past dredging. It had a moderately well-developed riffle and (generally shallow) pool sequence, with some sections of good gravel and an associated growth of water crowfoot (Figure 1).

**Figure 1**  
**Riffle and shallow pool/deep glide habitat. Note stands of water crowfoot present**

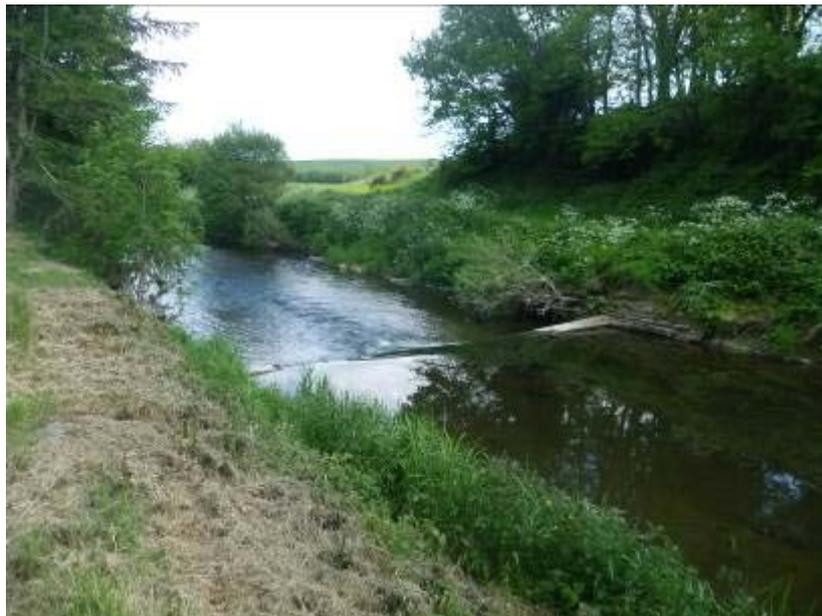
Further downstream, sections of the river were over-wide and over-deep as a result of dredging and the presence of a gauge weir (Figure 2). Flows are measured here regularly by the Office of Public Works. During an exceptional spate in the recent past, the hut adjoining the gauge weir was close to being submerged indicating how peaky the river flows can be.

**Figure 2**  
**Over-wide section of channel upstream of OPW gauge weir**

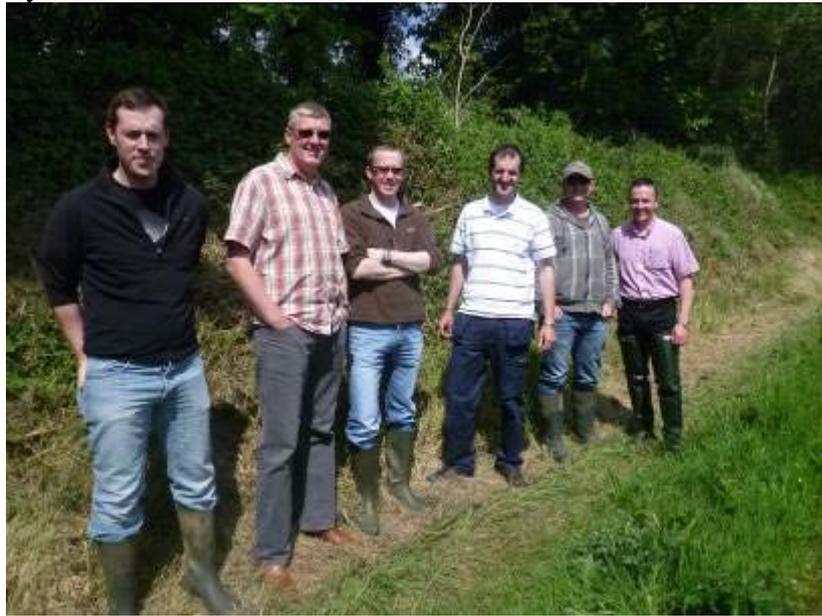
The extent of the past dredging could be gauged by the presence of large banks of spoil arranged along the LB of the river. Visual observation showed the high percentage of hard bed material (gravel, cobble and boulder) present within these piles (Figure 3).

**Figure 3.**  
**Ounavarra Angling Association members. They provide a scale to the large bank of dredged spoil deposited behind them**

- Subject to a suitable assessment of the flood risk, the stone previously dredged from the river and now stored on the LB, could be re-introduced to create series of pinch points, deflectors and rubble mats/riffles along the length of the fishery. By careful design, flow rates can be increased locally, without an associated large rise in water level. This would be of particular benefit in the Flats area where instream habitat was very uniform. Increasing the amount of gravel and stone in the river will provide more habitat for spawning and juvenile trout and salmon. The ideal size for trout spawning gravel is between 10mm-40mm diameter (optimum 20mm), with salmon and sea trout preferring larger gravel and cobbles up to the size of a small apple. There will also be a small but beneficial improvement in water quality caused by increased oxygenation of the water

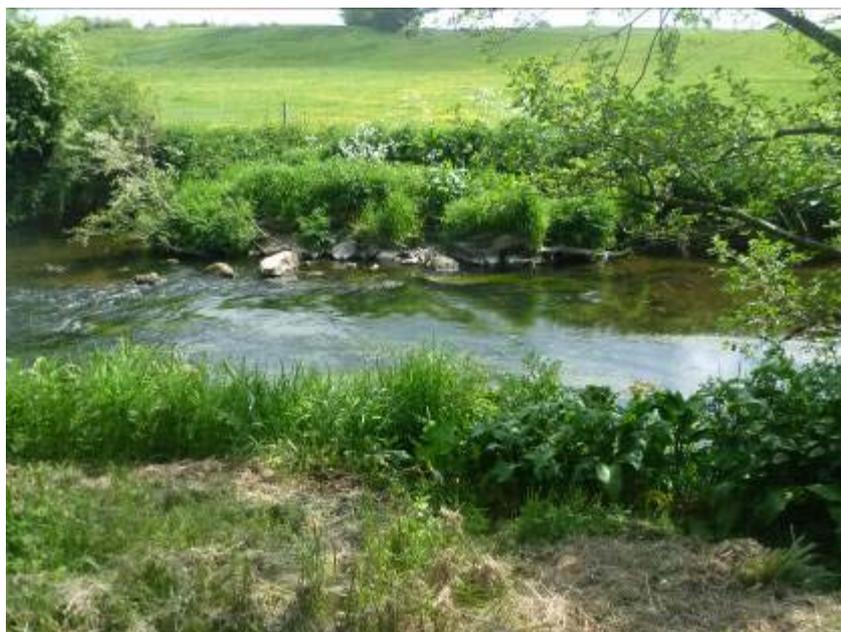
In an effort to compensate for the damage caused by the dredging, the club had previously installed a series of small deflectors/weirs with associated gravel riffles/rubble ramps. These had affected the local habitat in a variety of ways. The most successful structures were those that had tended to concentrate flow onto the gravel, causing downstream scour, without impounding the upstream water level(Figure 4).

**Figure 4**  
**Effective use of boulder and gravel to constrain flow and create scour without upstream impoundment**

- Whilst the previously installed boulder weirs/deflectors and rubble mats are generally working well, improvement could be made to those that are impounding water level upstream. Careful re-arrangement of the central boulders should take place to ensure that the structures constrain flow and increase downstream water velocity, but do not raised upstream water levels.

Care should be taken to direct flow into the centre of the channel, reducing the erosion risk to the banks. These simple changes have the potential to improve more than a hundred metres of habitat long the length of the fishery

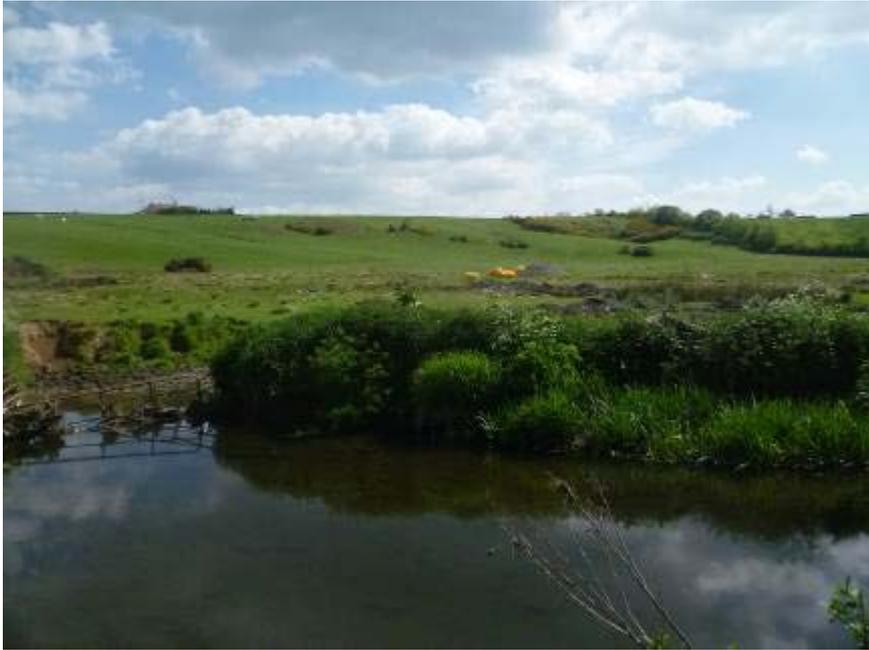
Most of the pasture land adjoining the river is well-fenced, with only two small sections of excess erosion due to stock access identified in the reach. These were at the location of poorly constructed cattle drinking areas. Less positively was the drainage of the surrounding fields in progress during the advisory visit. The loss of infiltration will lead to an increase in spate peaks and a reduction in infiltration of water, leading to lower flows during dry periods.

**Figure 5**  
**Drainage taking place in the RB fields**

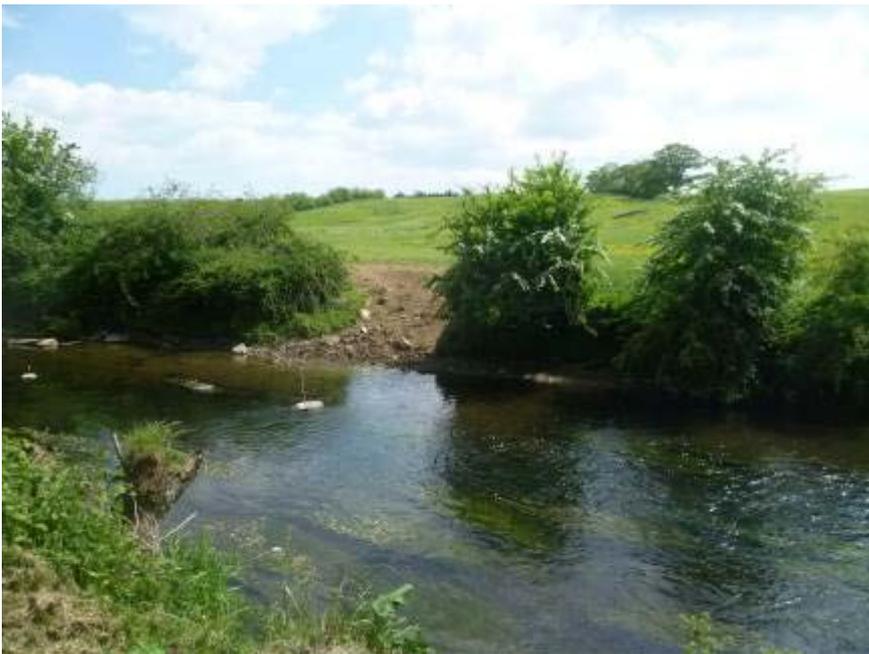
**Figure 7**  
**Small area of erosion due to poorly designed cattle drinker**

- Fencing should be maintained to exclude stock from the river banks. The maximum width possible (ideally in excess of 5m) should be isolated from the cattle, forming an un-grazed buffer strip of coarse vegetation that will reduce run-off of sediment from surrounding land, and allow the growth of fringing vegetation, valuable for the protection of juvenile fish. Where fencing is presently located very close to the bank top, it should ideally be moved back to create a wider buffer strip, helping to reduce bank erosion. There were two short sections where cattle had access directly to the river bank. Erosion of the bank was very evident at these locations. The construction of suitably designed cattle drink areas would reduce the input of sediment considerably and allow the banks to regenerate naturally

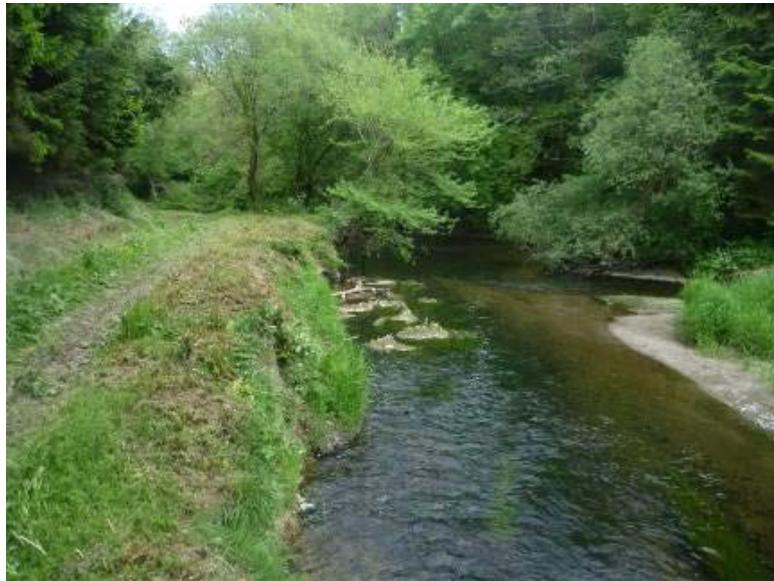
The upper section of the reach was moderately well shaded by riparian trees. There were also significant sections of Large Woody Debris (LWD) in the channel providing excellent cover for all life stages of fish. Further downstream, the river ran between an area of mixed woodland, which cast heavy shade over much of the river.

**Figure 8**  
**Heavily shaded lower section of the river**

- A mix of native deciduous trees should be planted along the more open sections of the reach to increase shading of the channel as they grow. There are increasing concerns that average water temperature is rising in small streams in the face of climate change, with maximum temperatures attained near to lethal levels for salmonids. Towards the bottom of the reach, sections of the channel were rather heavily shaded. Some coppicing and pollarding could be undertaken to reduce shading. Felling would also produce timber that could be utilised elsewhere as LWD in the channel

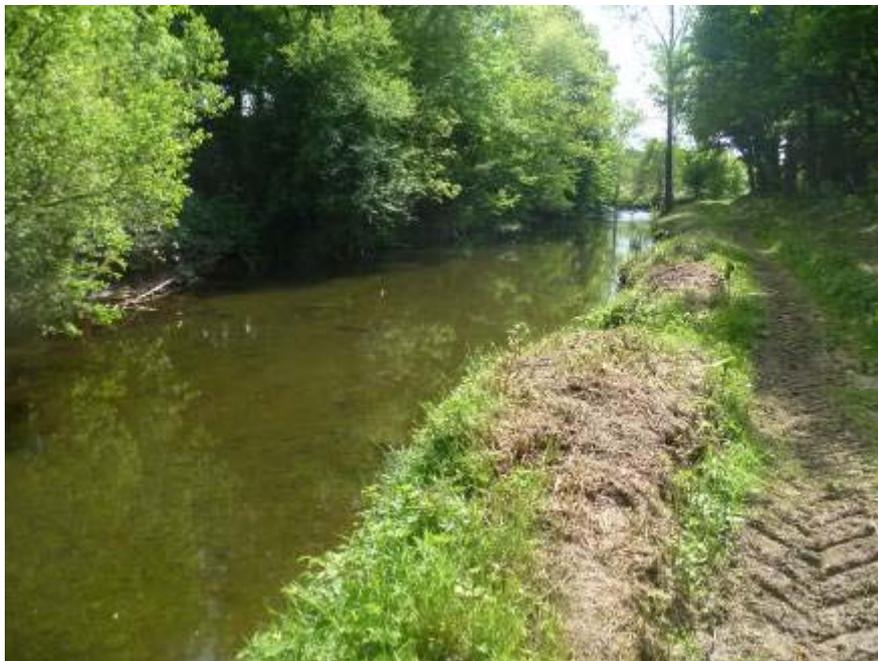
Partly as a consequence of the over-shading, the downstream section of the river was very over-wide and shallow, especially through well-named 'Flats' area, where there was little variation in depth and little instream or marginal cover.

**Figure 9**  
**The Flats**

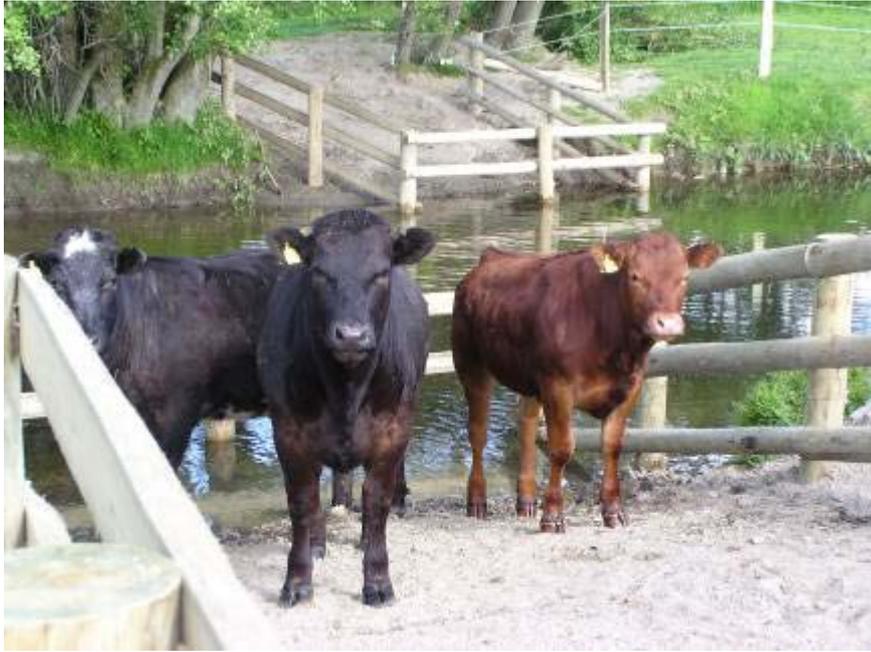
**Well-designed cattle drinking areas prevent damage to river banks and reduce silt input to the river**

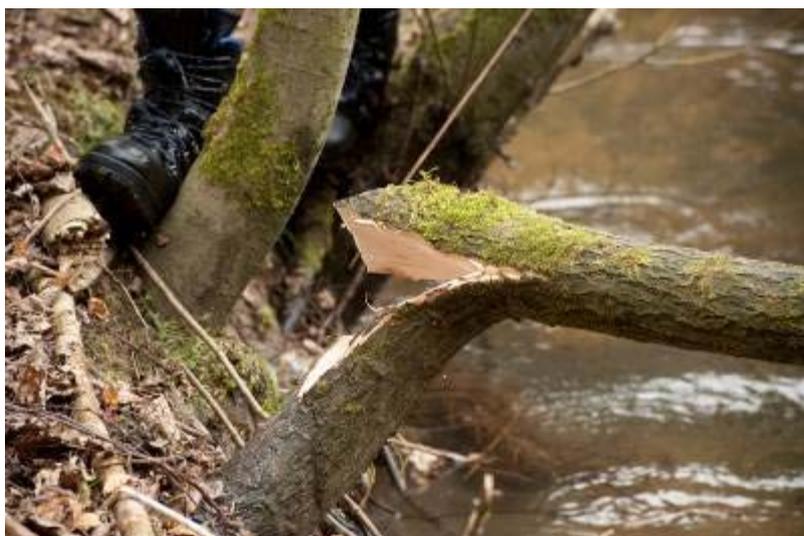
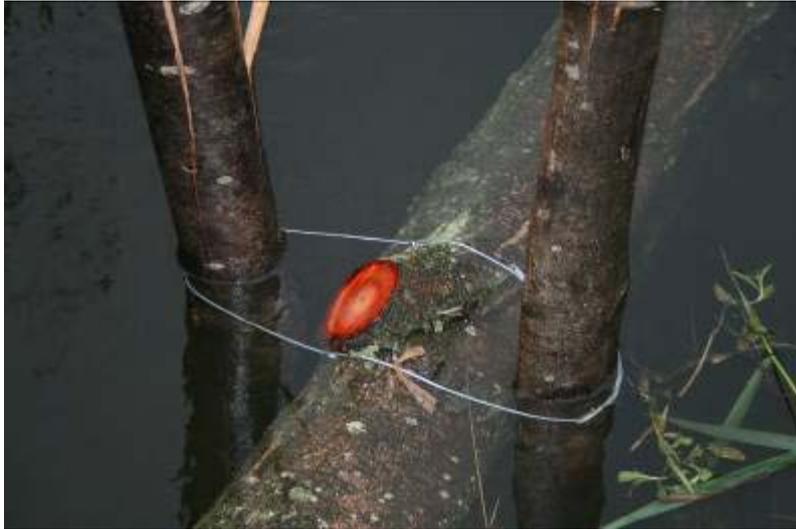
**Hinged timber .....**

.... And additional fixing using stakes and wire

- Large Woody Debris introduced to the channel is an excellent way of not only providing additional cover, but also of increasing bed scour, creating deeper pools and helping to sort the substrate. This is important as it will create short sections of silt free gravel at the tail of pools that is ideal for trout and salmon spawning. Ideally, LWD can be introduced by the partial cutting and hinging of bankside trees into the water. This has the advantage of maintaining a secure fixing to the bank and also keeping the hinged trunk alive. The LWD can be further secured using either wooden stakes driven into the bed and wired to the trunk, or by drilling the trunk and driving rebar through it into the riverbed (beware hidden utility service cables and pipes)

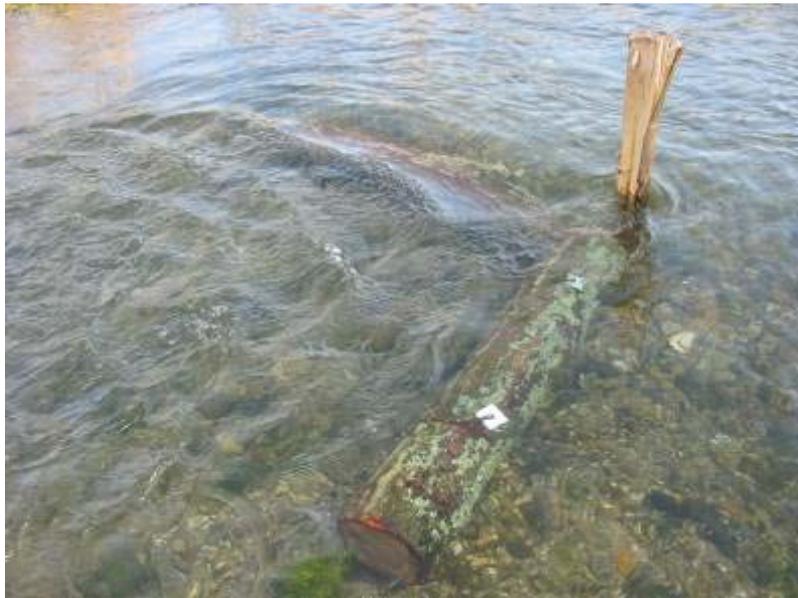
**Paired LWD limbs used to create a 'v' shaped deflector. Note rebar and steel washer fixing**

- Simple mid-stream deflectors can also be constructed using paired upstream facing timber limbs fixed in places with stakes or rebar. Arranged in this pattern, the LWD concentrates flow into the centre of the channel, scouring a small pool and downstream spawning riffle.

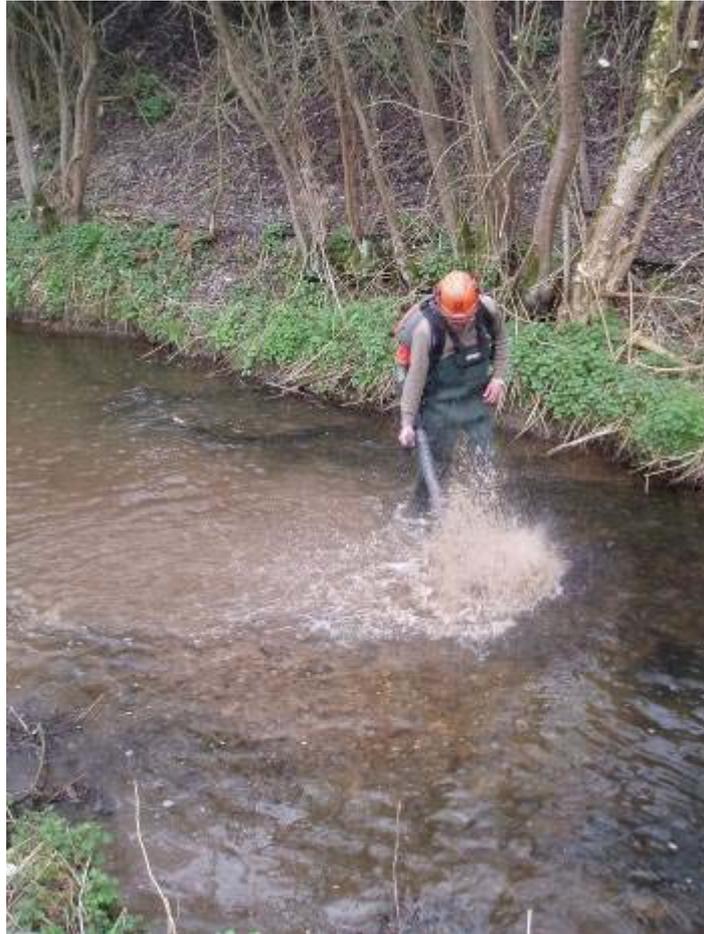
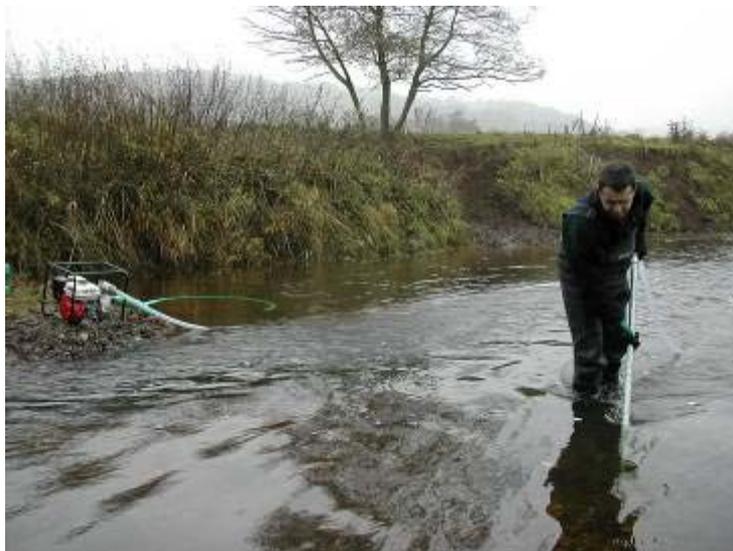
**Cleaning spawning gravel using a mechanical leaf blower.....**

**..... and a water pump**

- Cleaning sediment from gravel riffle areas prior to the spawning season can be beneficial. Not only does this maintenance reduce the silt burden within the gravel, it can also loosen concreted sections of the bed, making it easier for fish to excavate redds and deposit their eggs. Cleaning can be carried out manually using a fork, or mechanically with a high volume water pump, leaf blower and even the bucket of tracked excavator (take great care not to damage the bed structure). Whichever method is selected, work in a downstream direction during September or early October, and only clear relatively small sections of riffle at a time (the technique is temporarily damaging to invertebrate life)

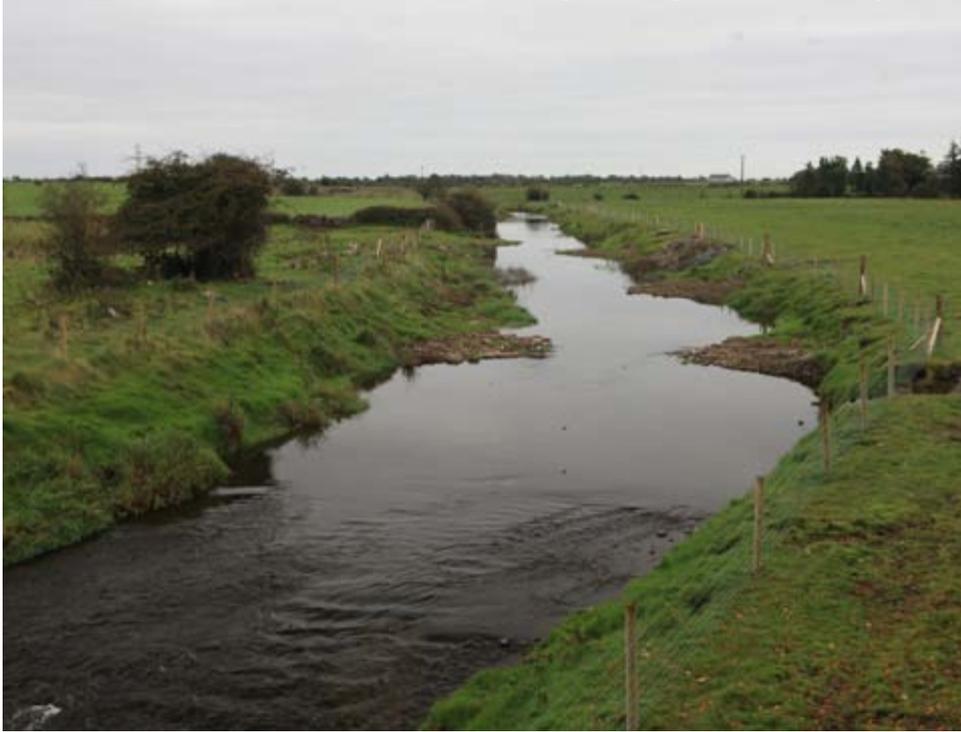
**Boulder deflector ‘pinch points’ with rubble mats installed by IFI on the River Robe**

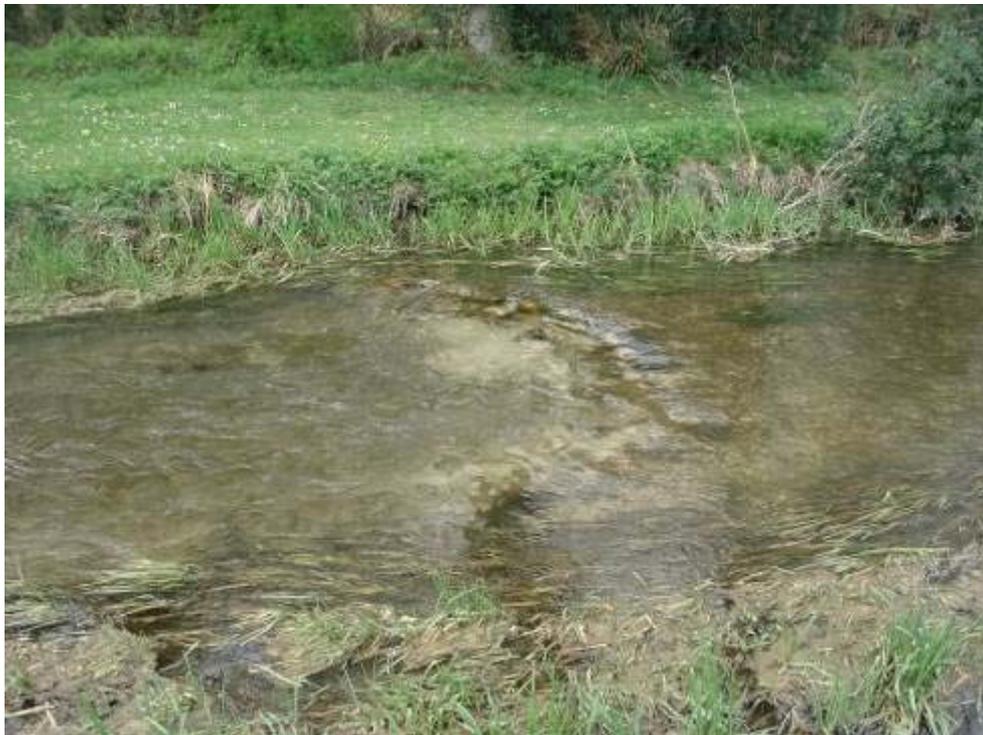
**A ‘D’ shaped deflector in a small limestone stream**
