Painswick Stream, Cranham, Gloucestershire

An Advisory Visit by the Wild Trout Trust, December 2012

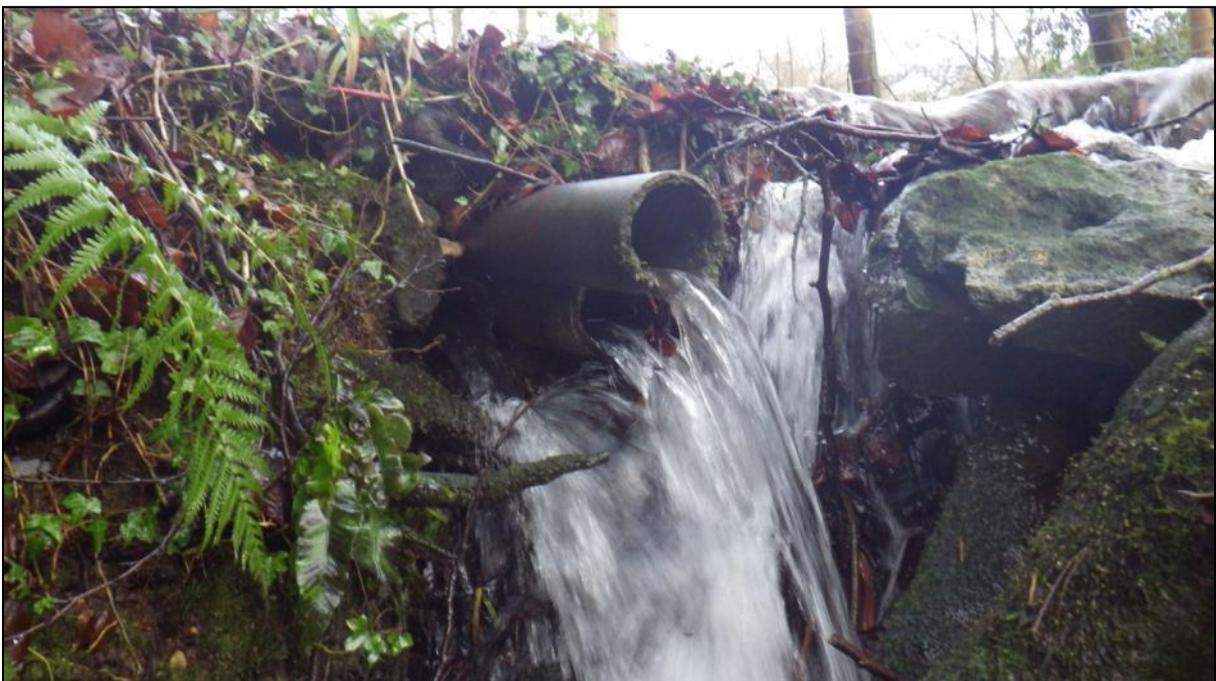
A short distance down from the spring at the source of the stream, at NGR SO903130, an online impoundment holds water in two ponds. On the day of the visit the impoundment, over which a footpath crosses, was overtopped by water flowing out of the smaller, lower pond. The structure may require inspection by a structural engineer to assess its condition as were the structure to breach and fail, the sudden input of fine sediment into the stream below could have a significant impact on habitat quality.

Figure 2: Water normally flows out from the pond through pipes but on the day of the visit water was flowing out over the path.

- The pond impoundment at NGR SO903130 should be monitored for signs of water seepage and if necessary may need to be assessed by a structural engineer.
- The outfall downstream of the impoundment could be a potential water quality issue. It is recommended that the owner of the outfall be engaged to discuss the quality of the discharged effluent and if necessary advice may need to be sought as to what alternatives may be available to ensure the water quality of the stream is protected.
- The culvert at NGR SO901129 should be replaced with a more fish friendly culvert to improve conveyance and habitat connectivity.

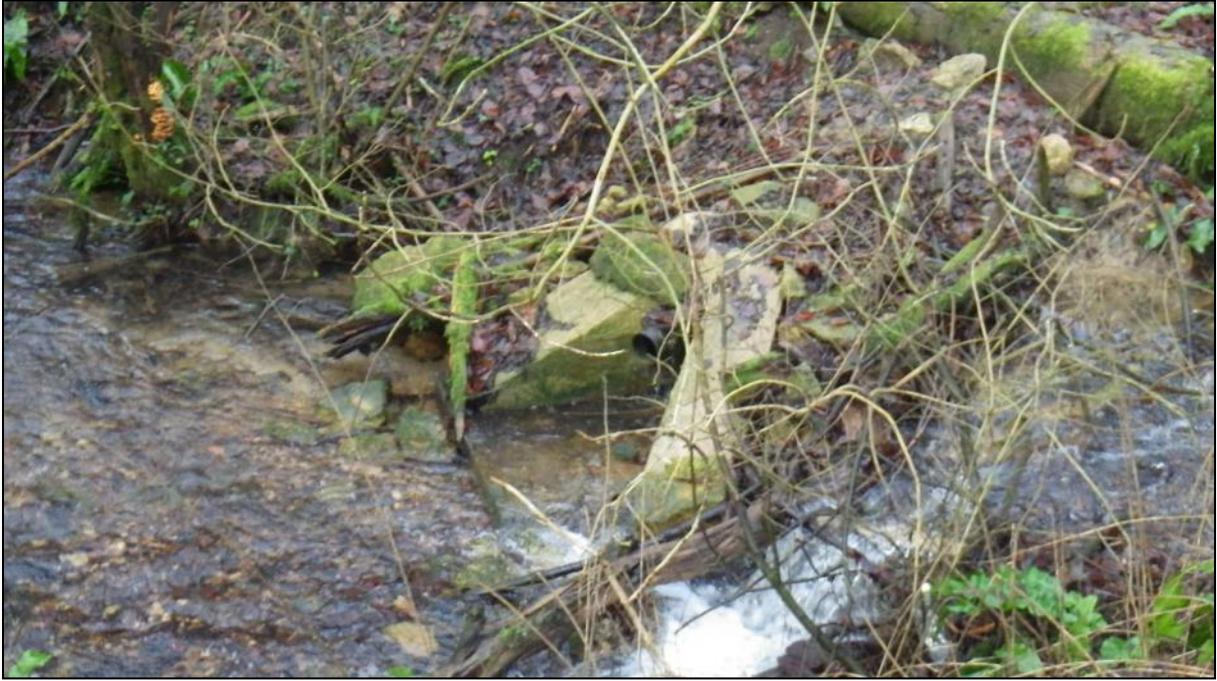
Near the head of the stream below the outfall of the pond, a small outfall structure appeared to be a drainage (and possibly a sewerage) outfall from a nearby property. Within a small watercourse such as Painswick Stream, with known isolated populations of sensitive endangered species, water quality is of the utmost concern. Misconnected sewerage could have damaging impacts on water quality in the stream. No obvious signs of enrichment were observed but further investigations may need to be carried out to ascertain the quality of water discharging from the outfall.

Figure 3: An outfall coming from a nearby property may need further investigation

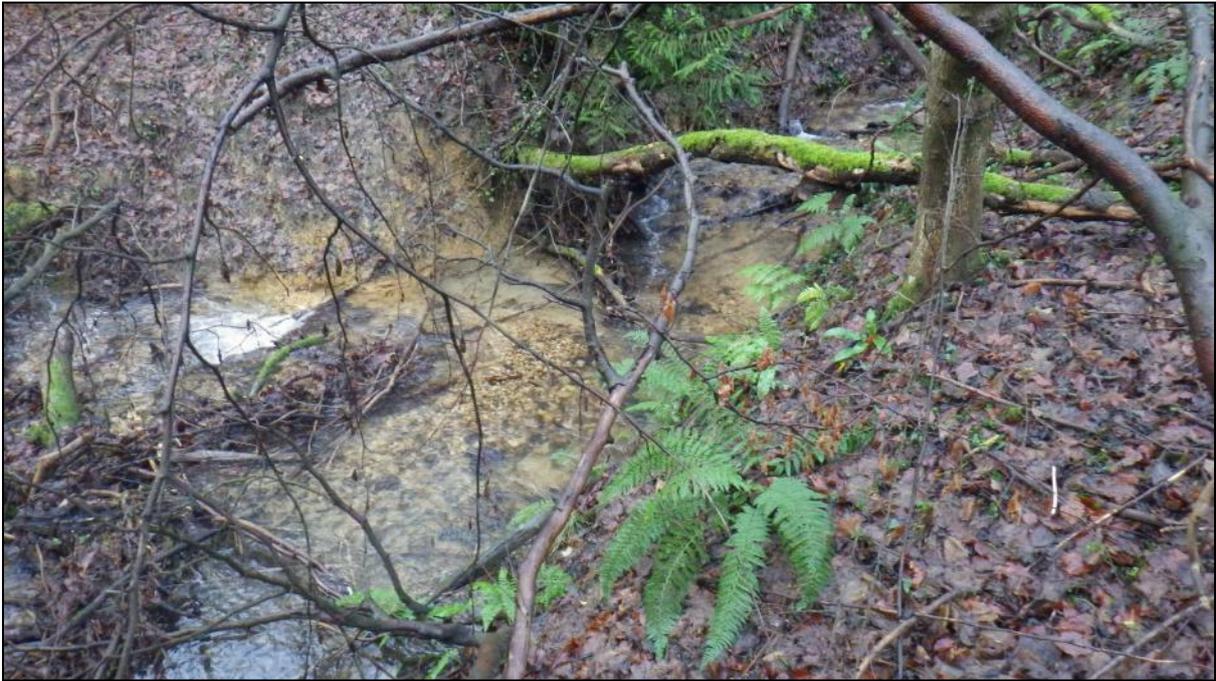
In addition to providing shade, the forest also provides an abundance of woody debris and leaf litter to the stream. Woody debris is an important component of the river ecosystem. It is an important food source for invertebrates, provides refuge for fish and crayfish, and diversifies flow patterns which in turn invigorate the geomorphology of the stream by scouring new pool and riffle features and increasing habitat diversity.

Figure 4: An abundance of woody debris helps to create a diverse and dynamic habitat

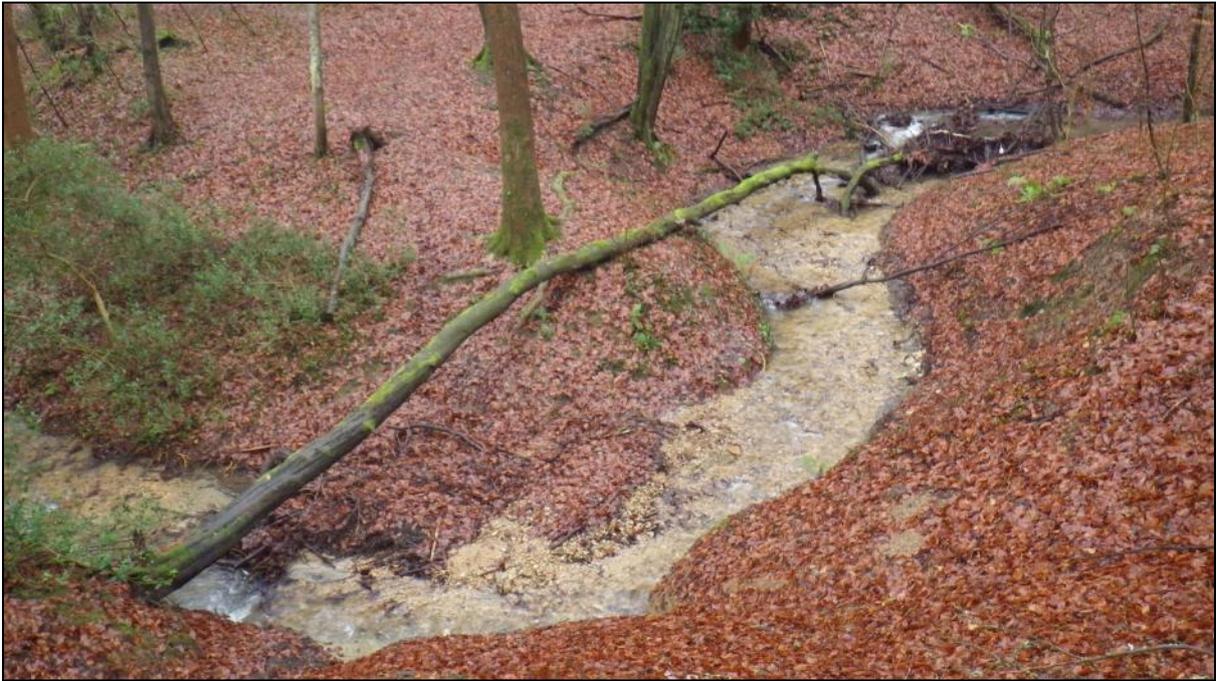
As flows are forced under pieces of large woody debris (LWD), gravels are scoured out from the bed to form a pool. Deeper pools are a holding habitat for trout and crayfish alike and can be vital refuges for a variety of species during low-flows. Gravel and fine sediment scoured out from pools is transported a short distance downstream. The finer material is transported the farthest whilst the largest stones settle closer to the pool. This 'sorting' of bed material is an essential process that ensures the gravel bed does not become overly compacted with fine sediment and makes it easier for gravel spawning fish species (such as trout) to shape the gravel to their individual spawning requirements.

Figure 5: LWD causing localised scour in the bed and diversifying the in-channel habitat

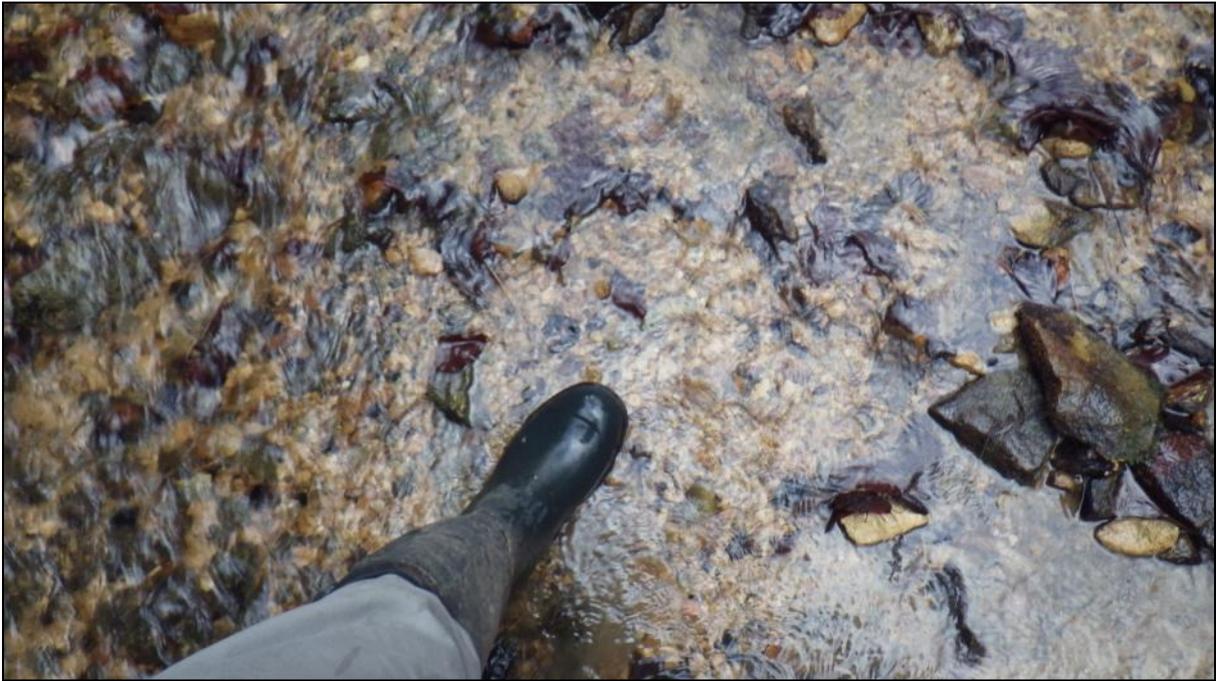
Although overall there is an abundance of woody debris in the stream, some sections of the river are deficient in larger woody debris and the bed is relatively flat and uniform. Sections of stream with a relatively uniform and flat bed can become desperately shallow during drought conditions, providing no deep pool refuges for aquatic fauna. Without pockets of localised scour, the bed substrate remains poorly sorted and can become compacted with fine sediment and precipitations of calcium carbonate.

Elevated levels of calcium carbonate leached from the limestone aquifer can be beneficial to the ecosystem as some invertebrates (such as crayfish) use the calcium to build their tough exoskeletons. However, the calcium carbonate can also precipitate out of the water and bind to river sediments. This build-up of calcium carbonate, known as 'tufa' can essentially glue pieces of gravel together and exacerbate the compaction of the bed.

Figure 6: Some sections of flat and compacted bed may become desperately shallow during low flows

- Tree works should be undertaken within the woodland to replace coniferous trees with native deciduous species and to create occasional pockets of direct sunlight over the banks.
- Pieces of LWD should be introduced to the more uniform and compacted sections of the stream in order to create more pools and loosen and sort compacted gravels. Where possible, small bankside trees should be hinged into the channel to provide anchored woody debris.

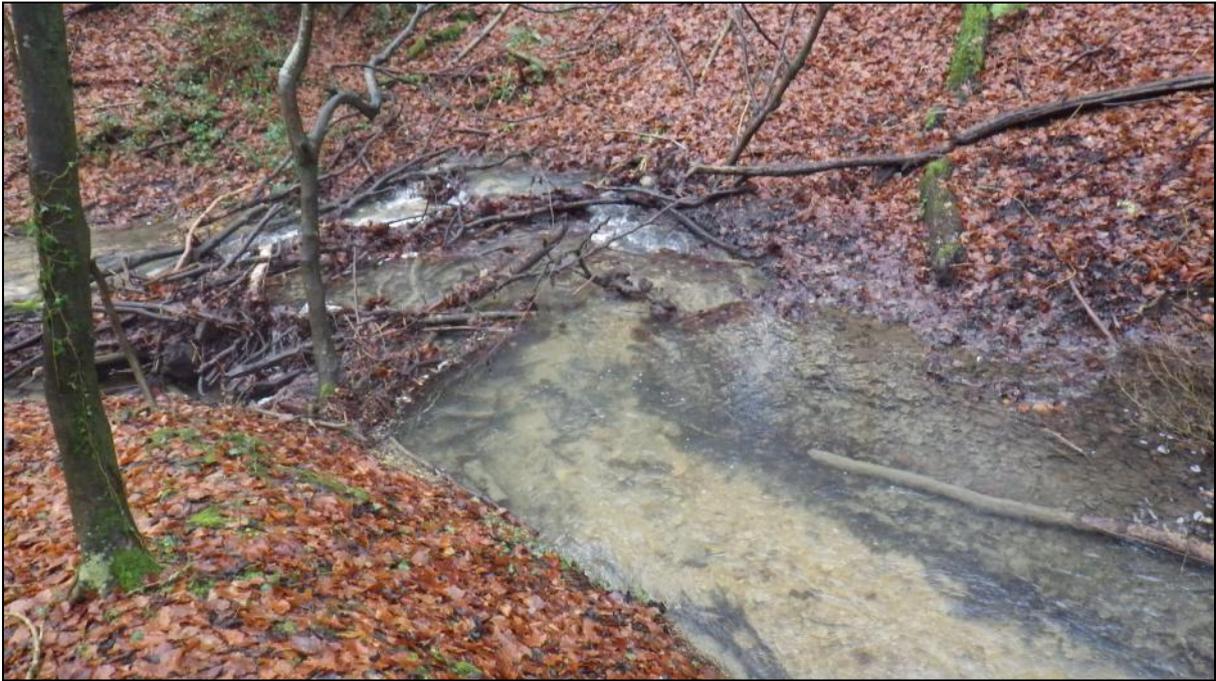
In addition to LWD, coarse woody debris (CWD) consisting of branches and brushwood can be equally as important to the health of the ecosystem. In upland rivers where in-stream macrophytes (river weeds) are less common, CWD and leaf litter provide the main source of nutrition for detritivores and shredding invertebrates and the main input of energy into the stream food-web. CWD can also become trapped at pinch points within the channel and form 'debris dams'. These accumulations of woody material locally impound flows and create small areas of deeper water upstream. The localised slowing of flows allows fine sediment to drop out of suspension and accumulate on the bed.

Figure 7: CWD debris dams provide small areas of deeper water and depositional habitat

Debris dams are a naturally occurring phenomenon common in heavily wooded areas that have a number of benefits to the stream ecosystem. However, large dams can be a barrier to fish passage and potentially prevent trout from accessing spawning gravels upstream.

An occasional sympathetic prodding of the woody material to ensure a solid flume of water is flowing through could help to keep the structures passable to trout. However, considering the reported presence of white-clawed crayfish and the apparent absence of brown trout, the debris dams may be best left undisturbed.

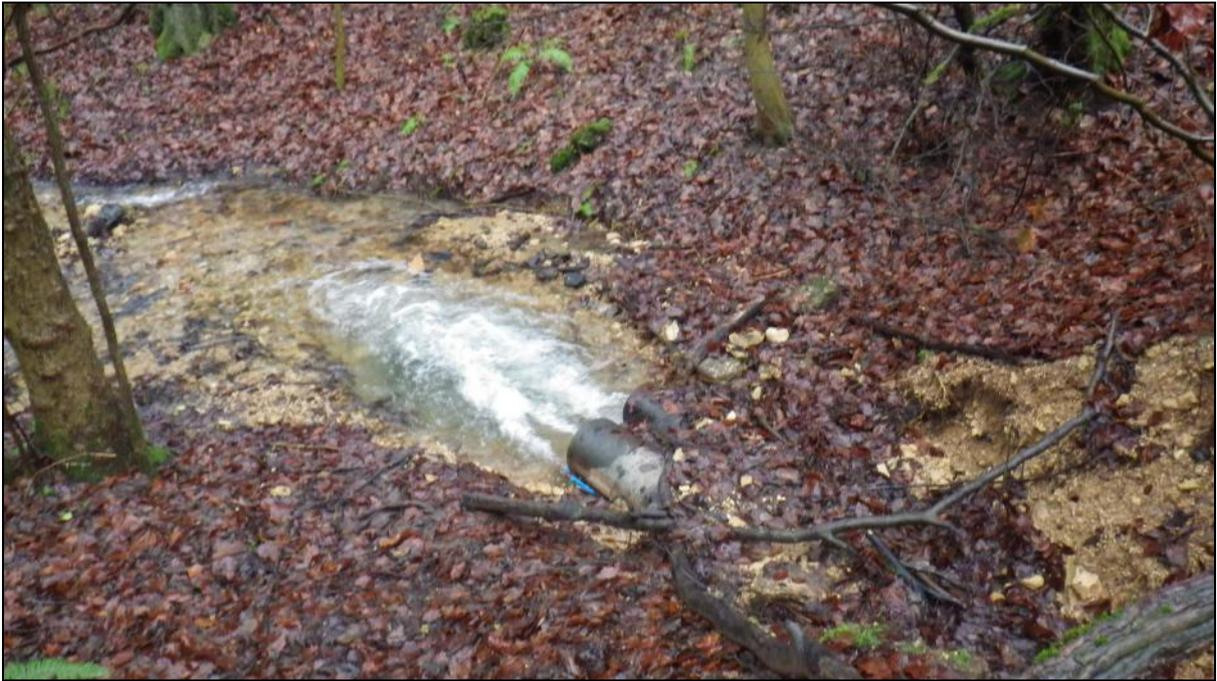
At NGR SO901129, the stream flows through two small culverts under a forest track. This is a barrier to fish passage that essentially cuts-off the upper reaches of the stream to any fish downstream. The track over the culverts was also heavily eroded at the time of the visit suggesting that the pipes are too narrow to convey a sufficient discharge during high flows and the track has over-topped and been partially washed away.

Figure 8: Narrow pipes used as a culvert under a forest track are fragmenting the stream habitat

The culverts should be replaced with a larger conduit or perhaps a culvert with a natural bed or a clear span bridge in order to improve habitat connectivity and control erosion.

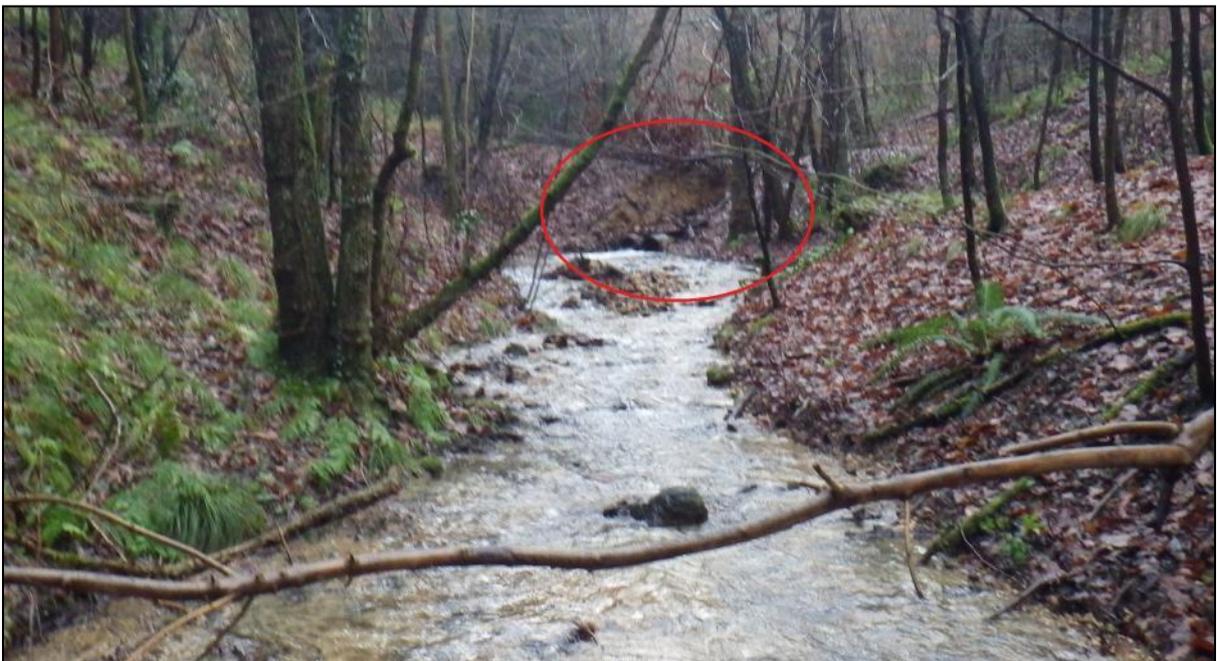
Figure 9: Erosion around the culvert suggest that conveyance is inadequate during high flows

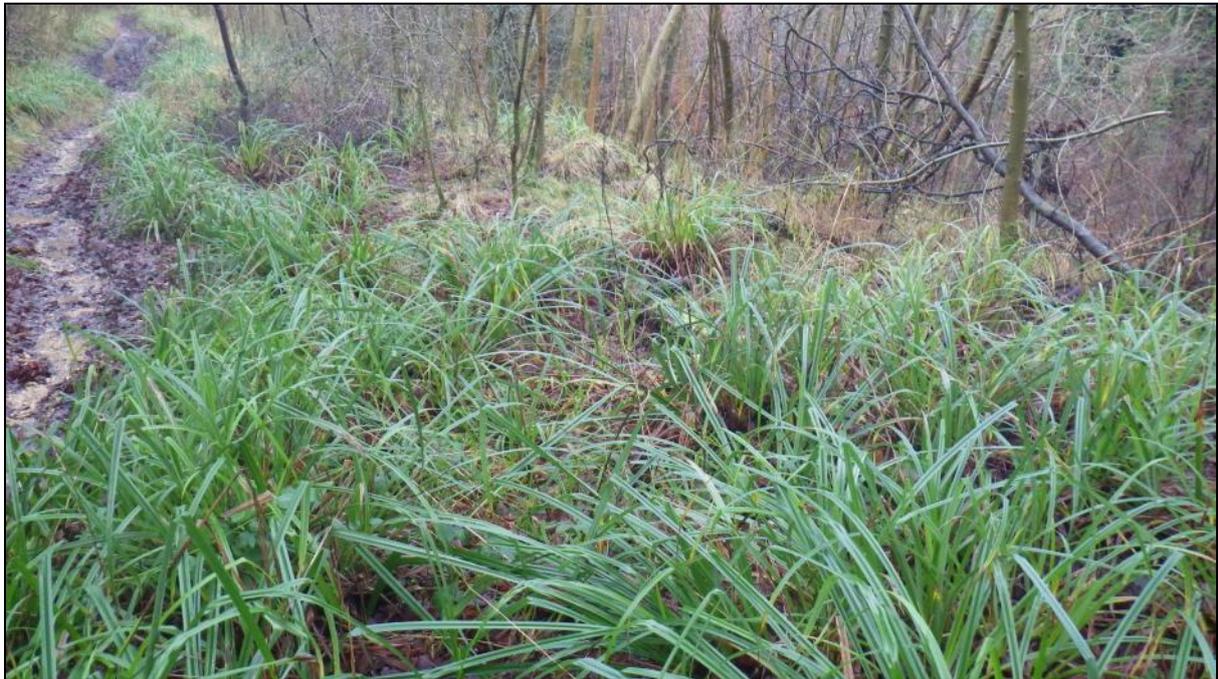
Occasionally on the banks of the stream and elsewhere within the woodland where small clearings allow direct sunlight onto the forest floor, less shade-tolerant species such as sedges (*Carex spp.*) have established. This

demonstrates the potential for a greater abundance of marginal plants to colonise the banks if and when light conditions allow.

Figure 10: Sedges growing in a clearing demonstrate the potential for marginal species to develop where sunlight reaches the forest floor and stream banks

Selective tree works to allow more light onto the river banks and bed would greatly benefit the biodiversity of the stream ecosystem. However, it is important to ensure that such works be planned with the objective of creating a diverse range of light conditions over the stream.
