Pen-Y-fan Pond, Pentwyn Crumlin, Caerphilly

An Advisory Visit by the Wild Trout Trust May 2015

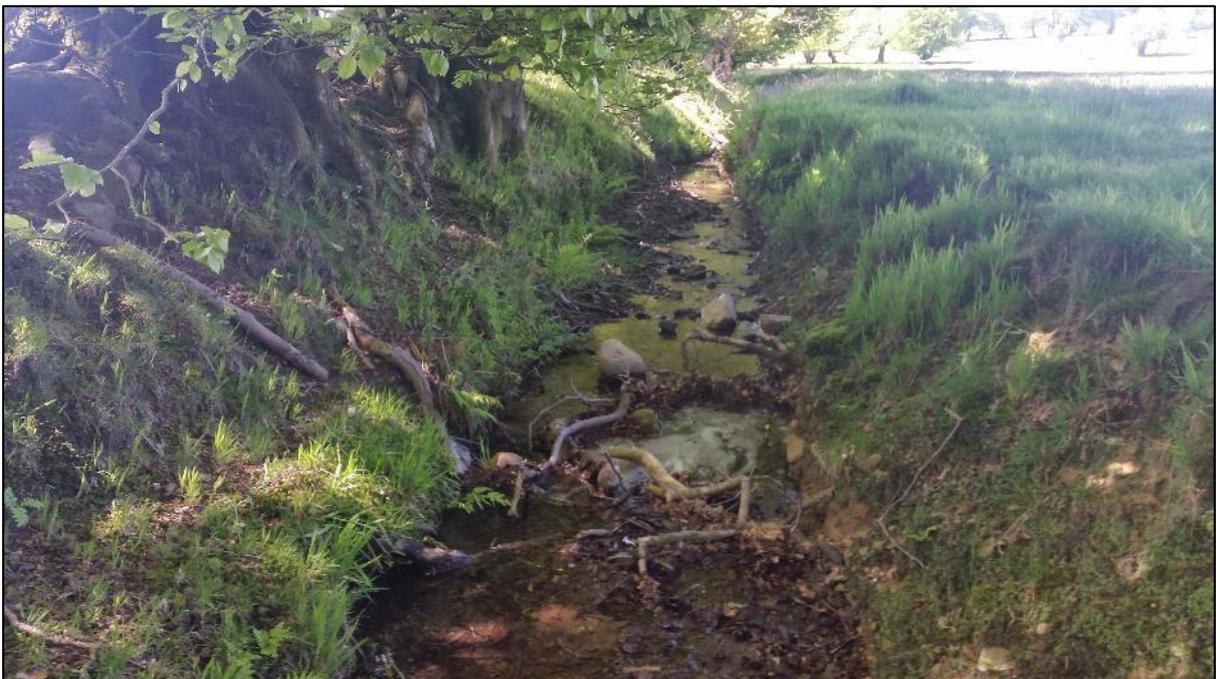
From here, the stream flows southwards through woodland, towards the lake, in a steep gully with a gravel and cobble bed (Figure 3). The channel has, at some point, been artificially straightened, leaving it uniformly trapezoidal in cross section. Fortunately, the steep gradient and an abundance of woody debris in the channel means that scouring flows act upon the stream bed during the wetter months of the year. This helps to retain a relatively uneven bed thus creating a moderately diverse habitat.

Figure 3: The stream is straightened and uniformly trapezoidal in cross section. It does however, retain a relatively diverse bed morphology.

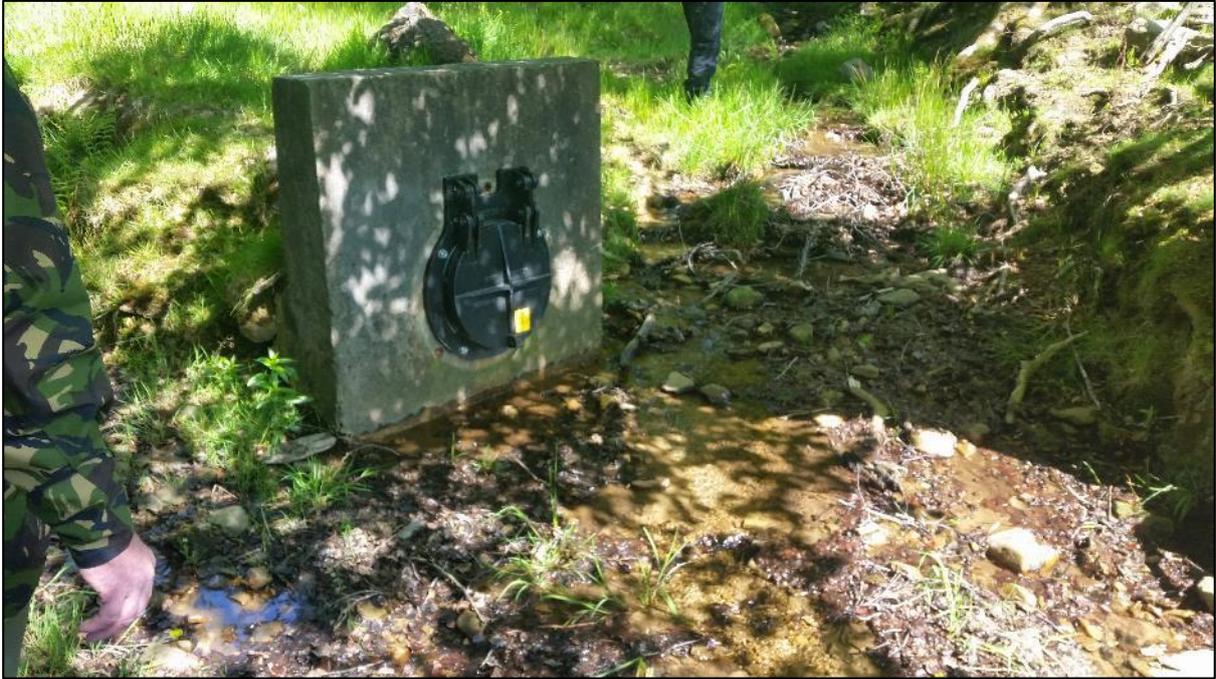
At NGR SO 19568 01197, an overflow outfall from nearby water storage tank was observed (Figure 4). No sign of nutrient enrichment were observed and other than possibly contributing to the flashiness of spate flows, the outfall does not appear to have any observable impact the stream.

Figure 4: The outfall pipe at SO 19568 01197 showed no signs of nutrient enrichment (pollution) such as algae or sewage fungus

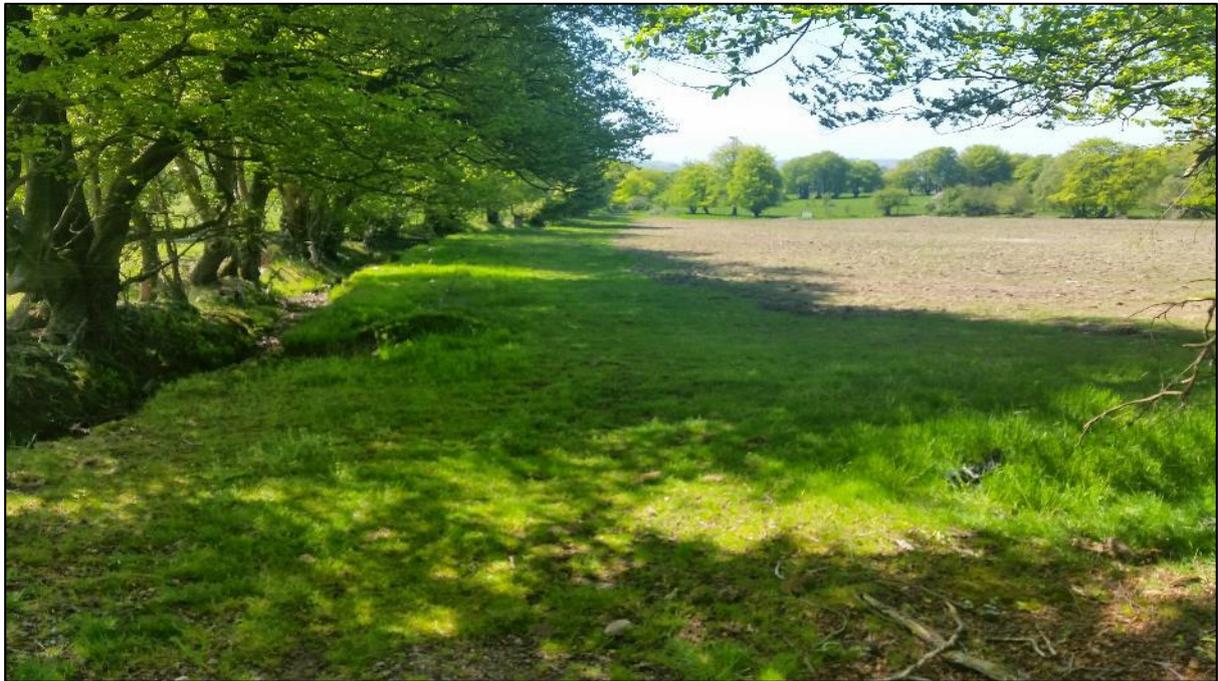
From the outfall downstream, the LB remains wooded but the RB opens out into an arable field (Figure 5). Intensive arable farmland is very often a diffuse source of excess fine sediment. Fortunately, there is a wide buffer strip of grass between the stream and the cultivated area of the field. This buffer will provide a certain degree of filtering of surface water run-off, helping reduce the fine sediment input to the stream.

Figure 5: The wide buffer between the stream and the land in arable cultivation may be helping to reduce the volume of fine sediment entering the stream

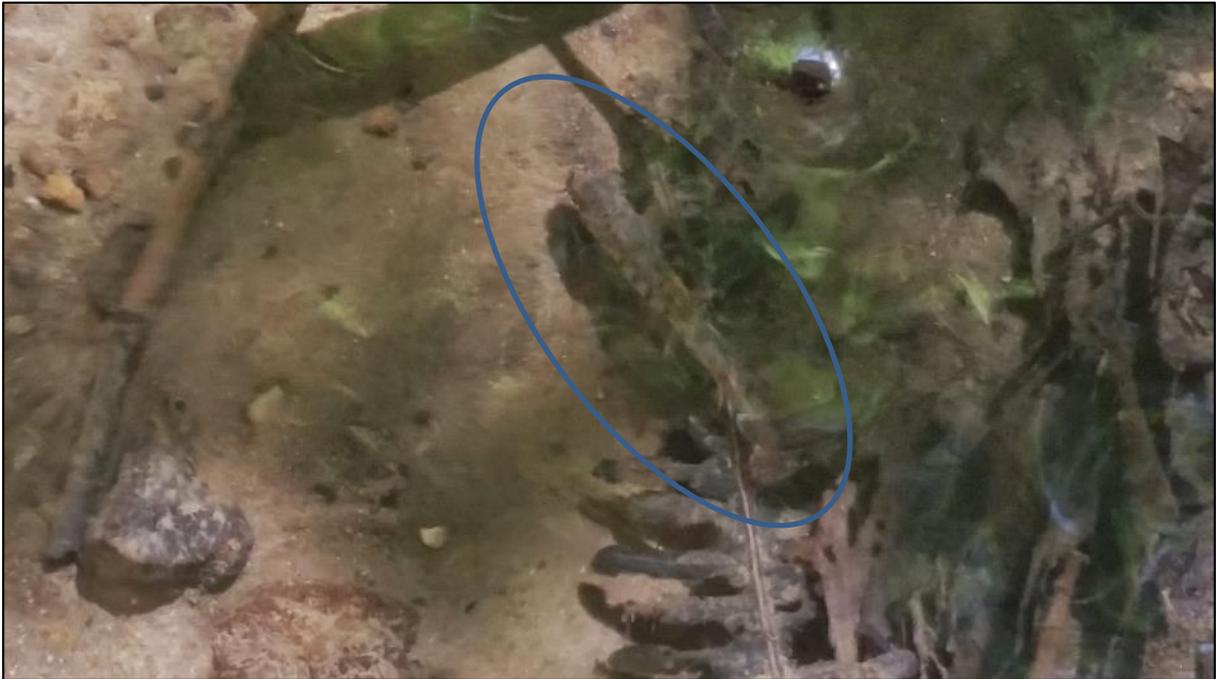
Along this reach a number of trout fry were observed darting amongst the submerged cover (Figure 6).

Figure 6: A trout fry (centre of image) camouflages well with its surrounding environment

The fry appeared to be in good condition and were present in surprisingly high numbers, especially where pockets of deeper water containing large cobbles, submerged woody debris and/or overhanging vegetation were present (Figure 7.)

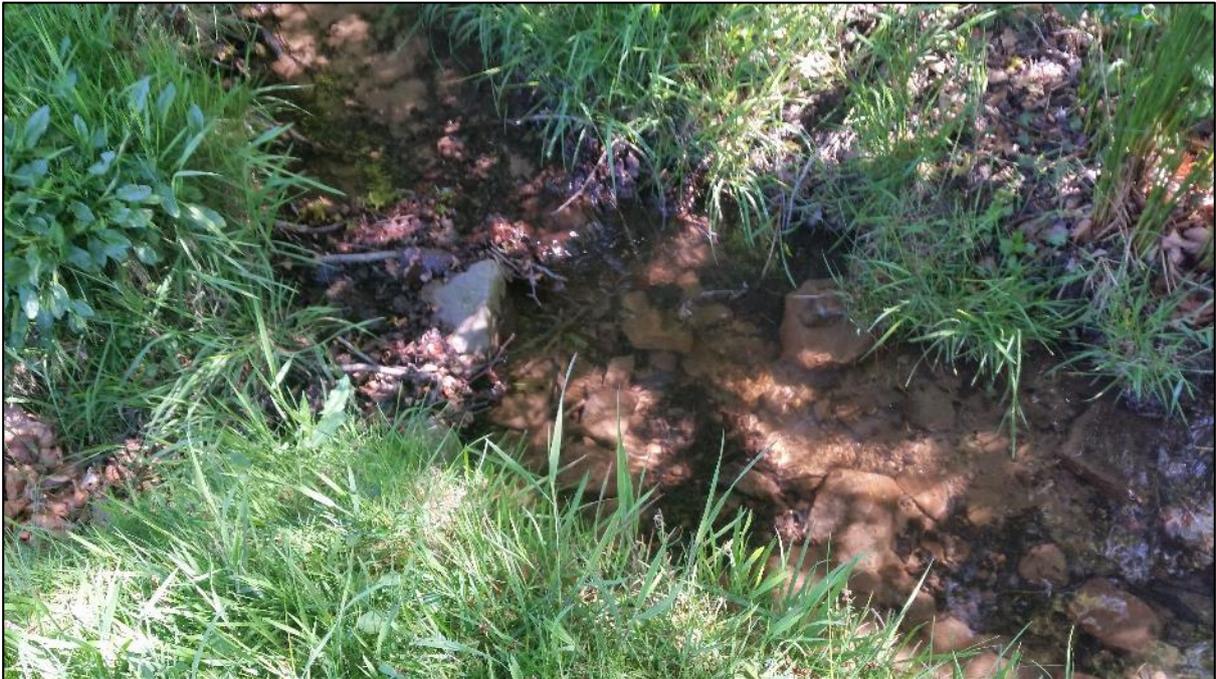
Figure 7: Large cobbles and woody debris help to create a mosaic of micro-habitats for trout fry

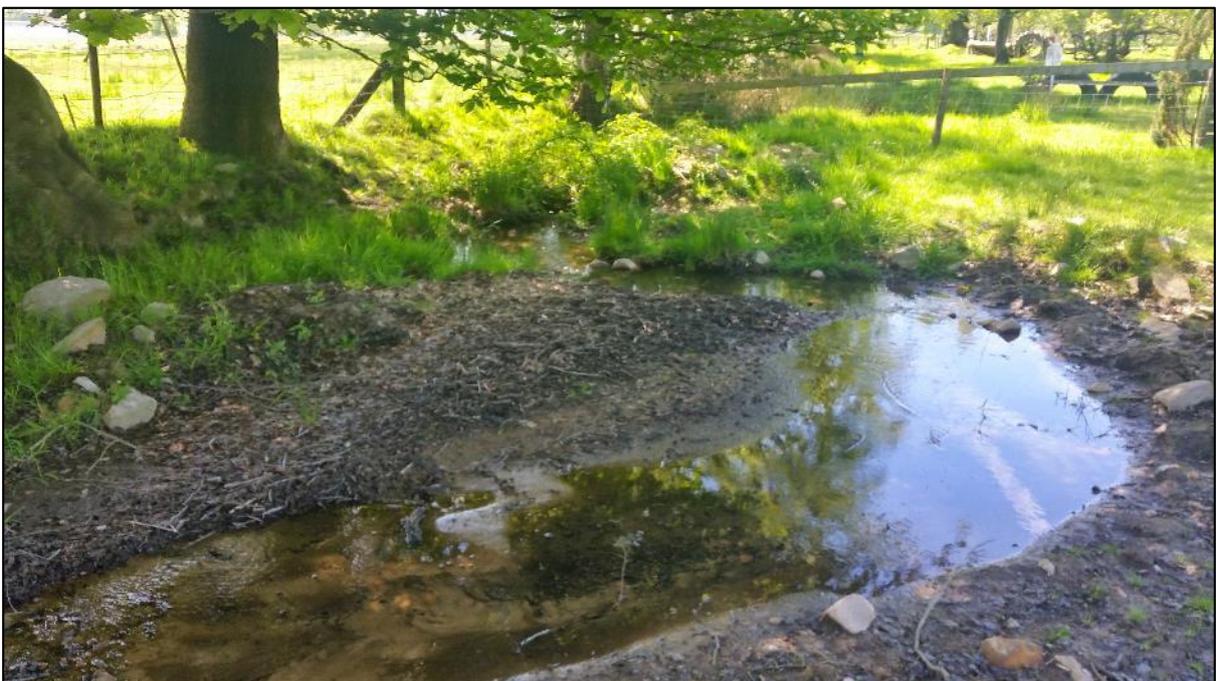
At the downstream extent of the arable field, an area of deposition, possibly correlating to a brief change in slope gradient, has smothered the stream bed in fine sediment. In this particular location, allowing more sunlight onto the stream could be beneficial. Encouraging plant growth here will help to stabilise the silty berm that has formed and will help to better define the channel and promote scour during sufficiently high flows.

Figure 8: A little more sunlight to promote plant growth could help consolidate fine sediment in this location

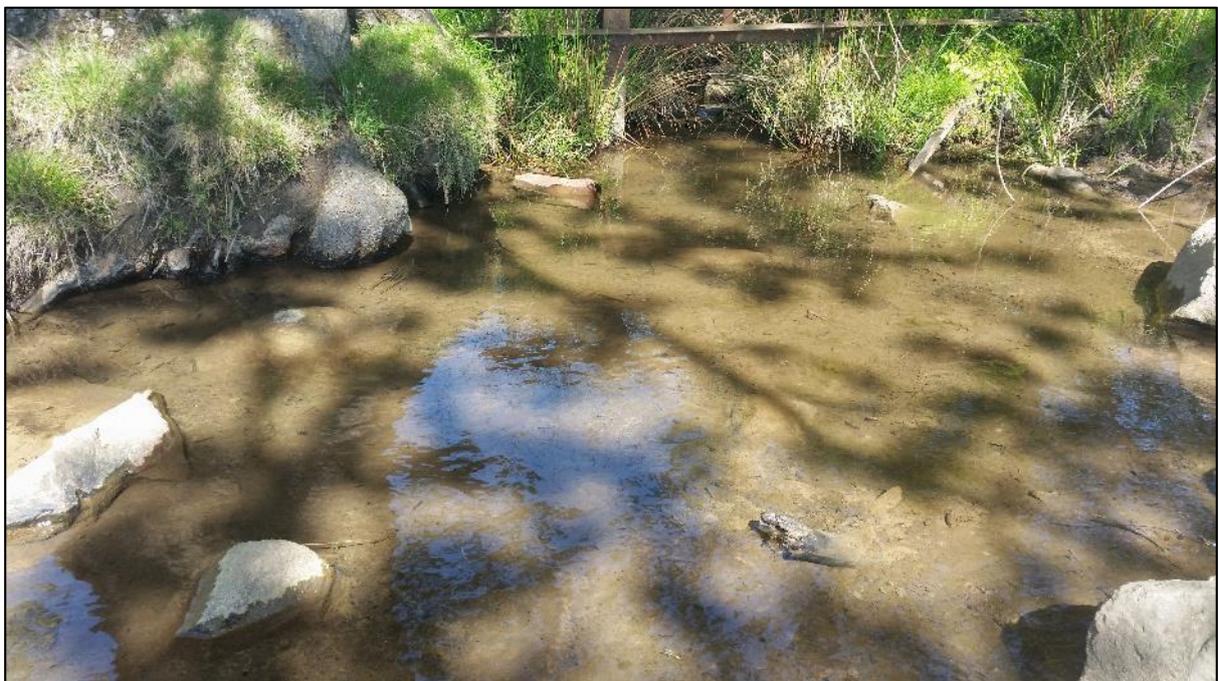
At the upstream boundary of the grazed field, a wide pool was found to be teeming with trout fry (Figure 9). This particular part of the field, having both shade and water, appeared to be also favoured by the cattle (Figure 10). Bank poaching can be extremely damaging to small streams and represents a significant point-source of excess fine sediment into the system. Grazing also reduces marginal biodiversity, resulting in a monoculture of shallow-rooted grass (which provides less underground structure for bank stability), and prevents the establishment of bankside saplings (which would provide essential instream cover).

Figure 9: A cattle-poached bay was teeming with trout fry

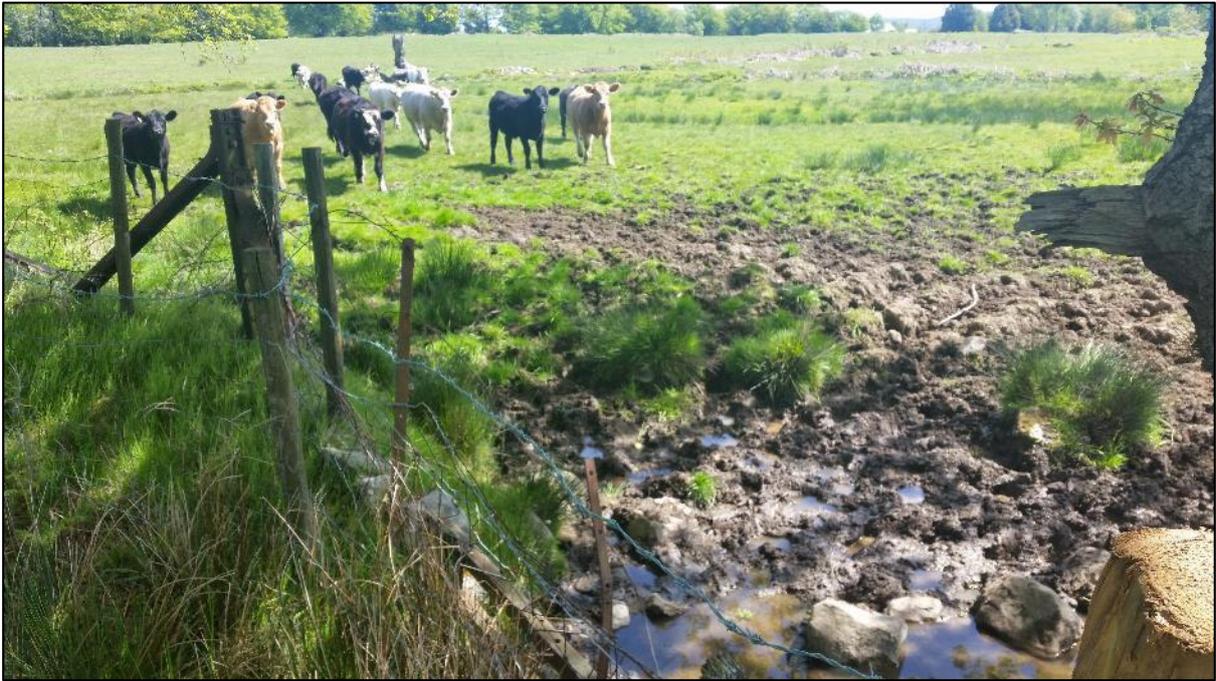
Figure 10: The combination of shade and water makes this a favoured congregation spot for cattle

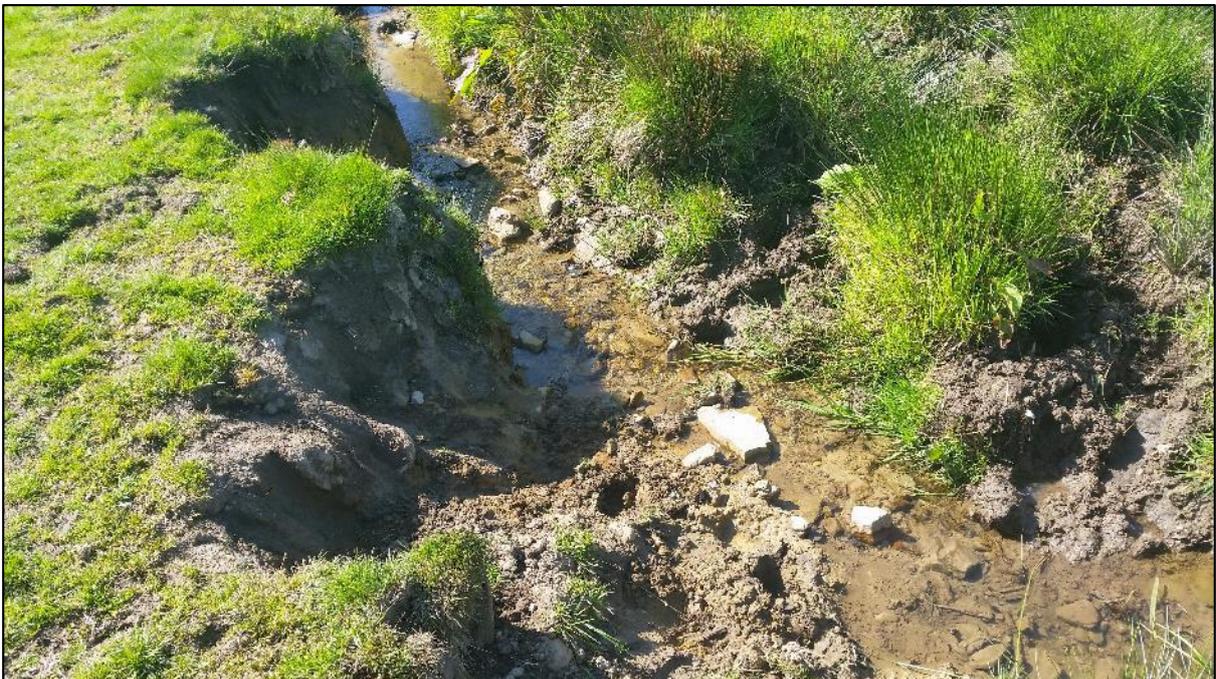
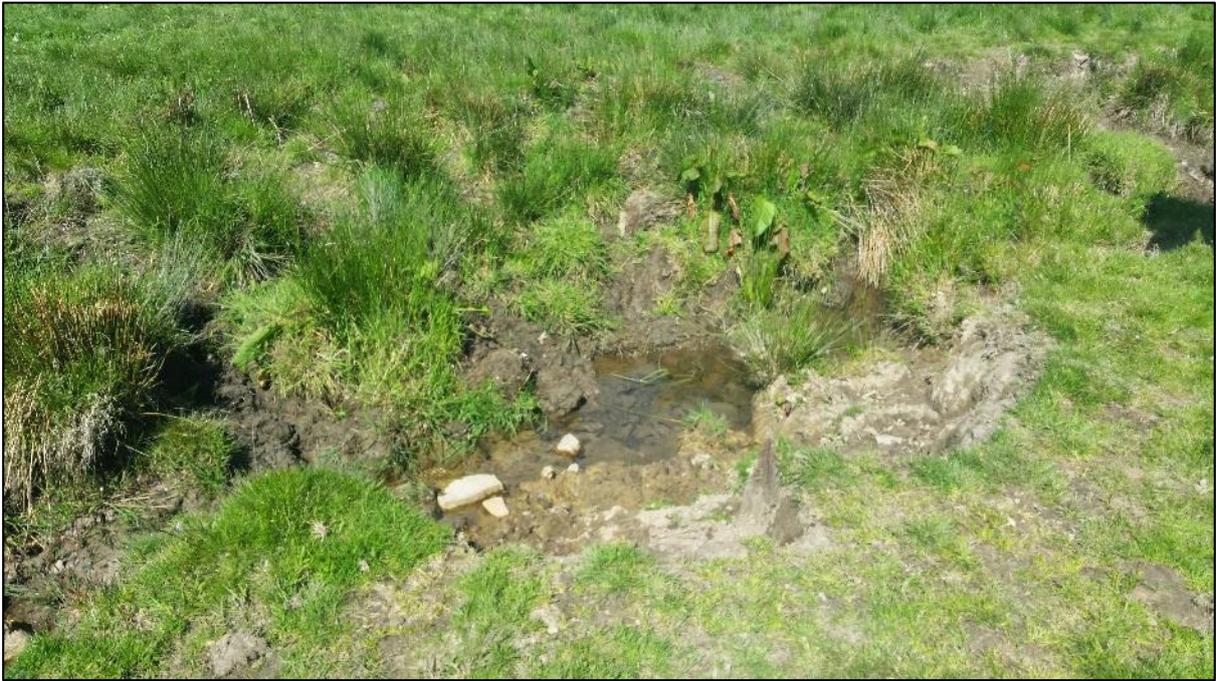
The section of the stream flowing through the grazed pasture has a gravel bed and could be a potential spawning habitat. However, soil and fine sediment from the trampled banks is smothering the bed. Fencing off the stream to provide an un-grazed buffer of at least 2 metres either side would substantially improve this reach. Alternative methods for watering livestock are discussed in the *Recommendations* section of this report. Figures 11 and 12 highlight the impact of cattle grazing.

Figure 11: The cattle poached (trampled) banks represent a significant point source of fine sediment.

Figure 12: Cattle poaching is seriously damaging a small and fragile spawning stream

1. Engage with the land owner (Llanover Estates) and the tenant farmer to explore options for fencing off the stream in the field presently being grazed by cattle. Alternative means of watering livestock are available which can eliminate the need for cattle to access the stream entirely. Pasture pumps (Figure 24), for example, do not require electricity as they are simply powered by the cattle themselves.

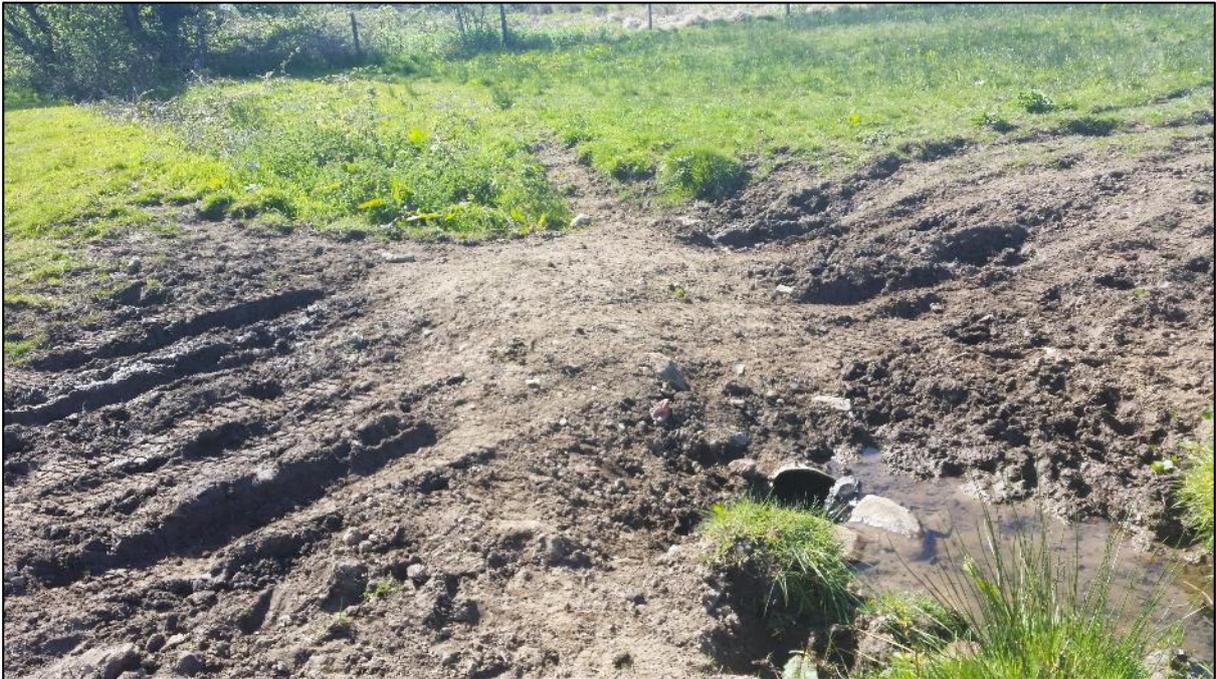
Along with the poor condition of the stream in this reach, the wild trout population has been put at further risk by the recent installation of a crossing in the form of an undersized culvert (Figure 13). The narrow aperture of the culvert means that, during higher flows, it will require a prolonged burst of considerable physical exertion from any fish attempting to pass through it upstream; the velocities and duration required may even be above the swimming capabilities of most trout. The narrow pipe is also at a substantial risk of becoming blocked which would result in the stream flowing over the crossing in a diffuse manner; this would further hinder upstream migration and cause erosion leading to more sediment ingress to the stream. The culvert should be removed and replaced with something more appropriate, such as a clear-span bridge or much larger, sunken culvert, as a matter of priority.

Figure 13: The culvert at this crossing is a significant obstacle to fish passage and should be replaced as a matter of urgency

Protecting the stream through the field will be critical for the conservation of the Pen-y-fan wild trout population. Of equal importance is the replacement of the culvert in the field (Figure 13) with a clear-span bridge or at least a larger culvert.

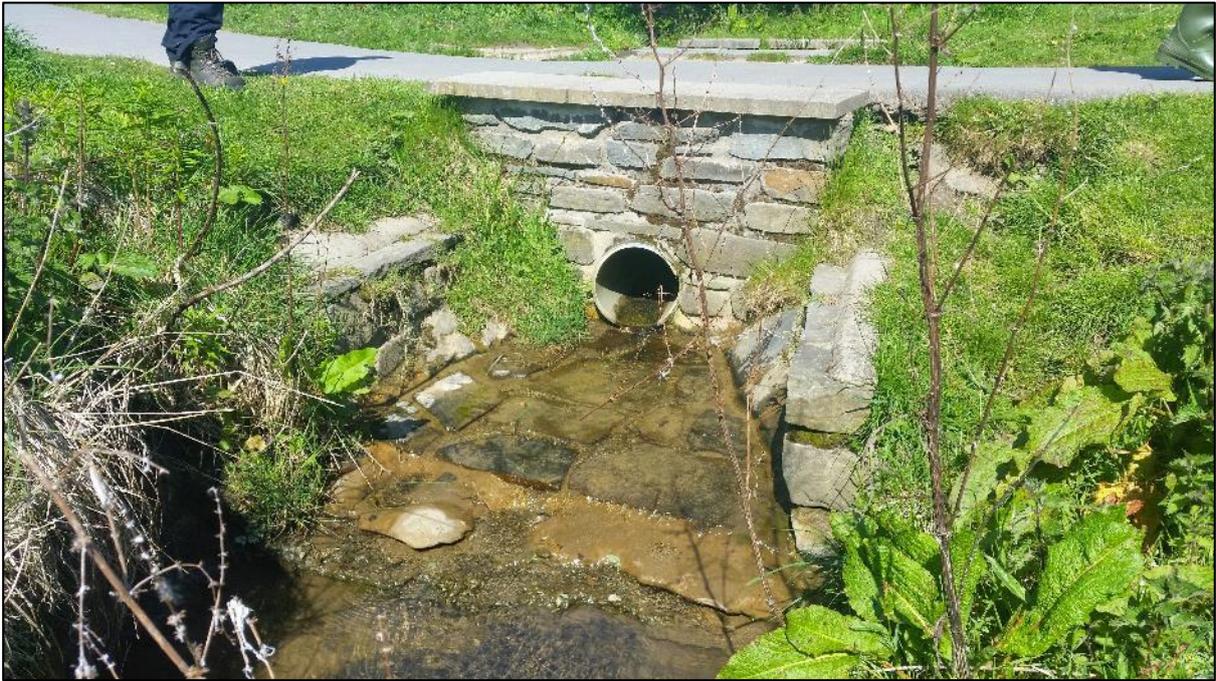
After a few more metres, the stream enters the grounds surrounding the lake. Almost immediately it is forced through another culvert below a surfaced footpath (Figure 14). This latter culvert appears to have been recently installed (or refurbished). As with the crossing upstream, the aperture of the pipe is less than ideal for fish passage. The narrow diameter also means the culvert risks becoming blocked and flooding the footpath. The pipe is also perched above the river bed and has a large flat apron (creating very shallow water), both of which further hinder fish passage. Ideally this should be replaced with a wider diameter culvert or clear-span bridge but it is understood that since the footpath has only recently been refurbished, other options may have to be explored in the short-medium term.

Figure 14: Another narrow culvert is another major obstacle

5. The culvert where the surfaced footpath crosses the stream (Figure 14) is also very narrow and perched, with a poorly passable shallow apron downstream. Although this has only recently been constructed, replacement with a clear-span bridge or larger culvert is a vital action to safeguard the future of fish stocks on the lake.

As a short-term solution, fish passage through the culvert might be eased via the installation of a timber baulk pre-barrage downstream of the culvert. This would slightly raise water level in the culvert and help to baffle flow (Figure 25). It should, however, be noted that raising water level in the culvert is not an ideal solution for fish passage and could also slightly increase the frequency of events where flows exceed the capacity of the culvert, possibly increasing the frequency of flows over-topping the footpath. Replacing the culvert would be a much better long-term solution.

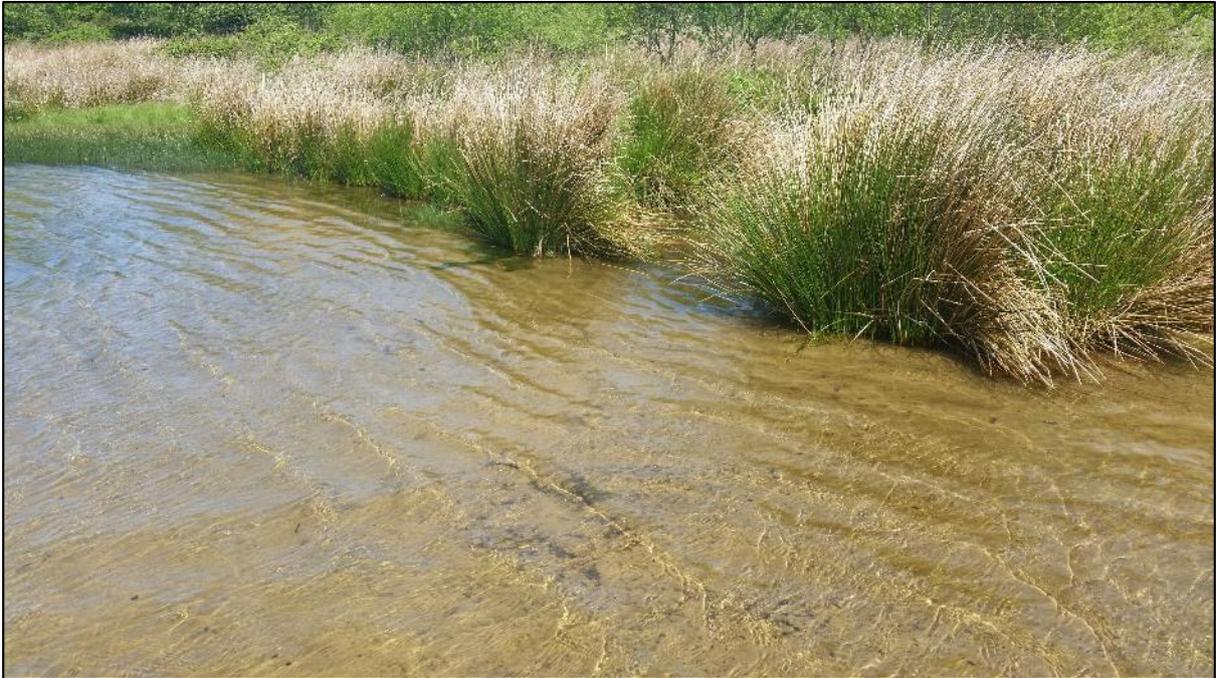
Figure 16: Fine sediment drops out of suspension and deposits on the bed of the lake near the stream mouth

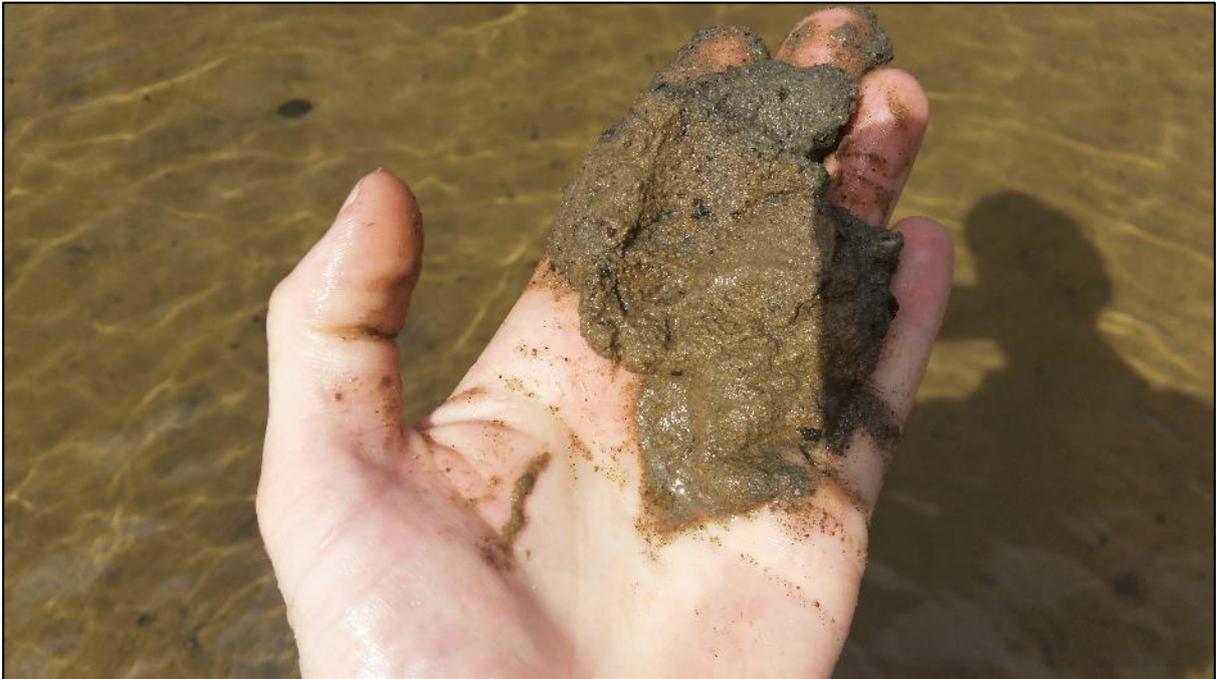
A cursory examination of the sediment accumulating around the stream mouth suggests that a large proportion of the sediment is inorganic (sand). It is therefore unlikely that silt treatments based upon stimulating bacterial decomposition, such as treating with porous calcium carbonate (Siltex), will have a significant effect. Mechanical removal such as via systems that pump silt/sand through large, permeable geotextile bags positioned on the upper bank will probably deliver the best results. These systems allow filtered water to drain back into the lake whilst the fine material trapped in the bags slowly dries. There are a number of specialist companies that provide this service and searching online for nearby contractors and inviting them to provide quotes will probably provide the best value for money. It should, however, be noted that the only sustainable, long-term solution is to reduce the sediment input from upstream.

Figure 17: The sediment has an organic component (darker material) but appears to be mostly inorganic, sandy material

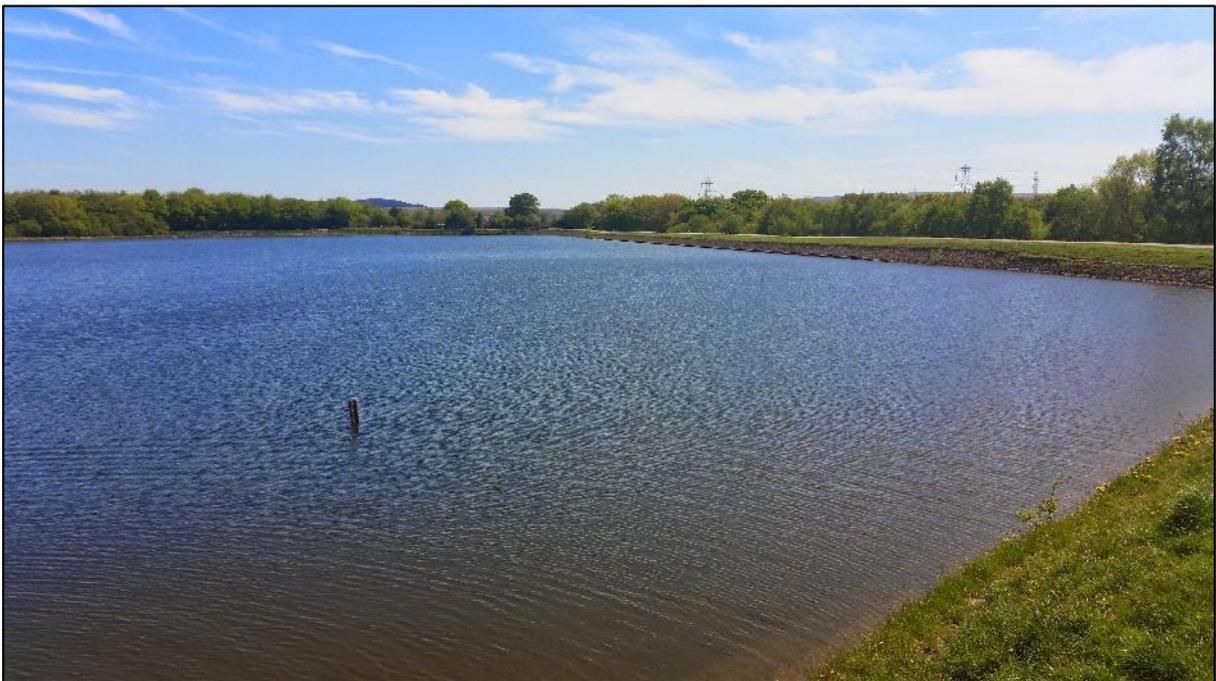
The opposite (southern) bank consists of a hard-engineered dam wall providing virtually no marginal habitat or cover (Figure 18). Whilst rainbow trout are often comfortable patrolling the open water at a relatively shallow depth, brown trout, especially wild fish, prefer the cover of the margins or deeper water.

Figure 18: The dam wall end of the lake presents a bare and uniform marginal habitat

3. The bare concrete of the dam wall side of the reservoir could be softened by the installation of some marginal brushwood shelves (Figure 26). Securing brushwood into the margins of the dam wall would provide some

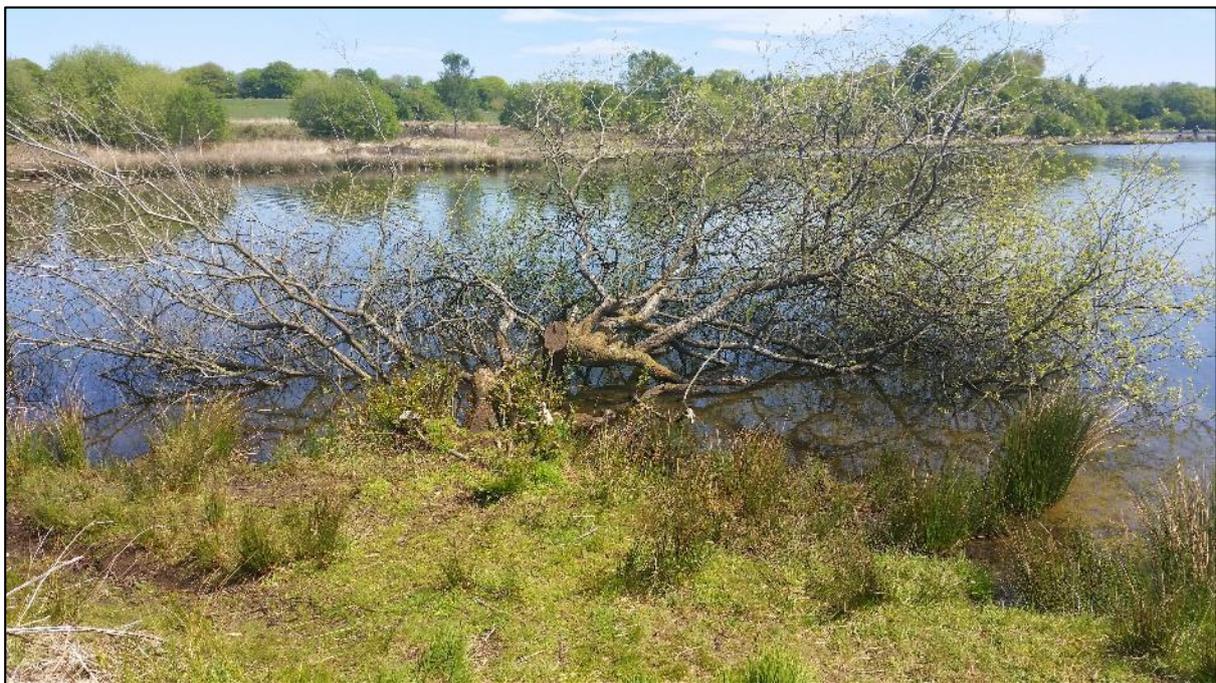
The barren southern bank is mitigated somewhat by the wetland along most of the northern bank but in general there is a paucity of bankside trees around the lake. Near the outflow of the lake however, one small bankside willow (*Salix* sp.) had been recently felled and was awaiting removal by the Park Rangers (Figure 19).

Figure 19: An excellent, if not necessarily deliberate example of marginal habitat enhancement

Removal should be discouraged as this is exactly the type of habitat that should be retained and increased around the lake. A balance will have to be struck between habitat, facilitating angling, and the public-perception, but any increase in the abundance of this type of habitat will be beneficial.

2. A greater abundance of submerged, coarse woody cover habitat (branches) such as shown in Figure 19 should be introduced into the margins of the lake to provide additional refuge and cover habitat. Again, planting the shrub willow species in the lake margin will greatly improve the shade and protection available for fish (once they begin to trail into the water). As much cover as possible should be introduced near to the stream mouth in order to maximise protection for small parr first entering the lake. Explaining the purpose of such features to the general public by, for example, erecting some information boards explaining their purpose, will help lake visitors understand that they are a deliberate feature and not just 'untidiness'.

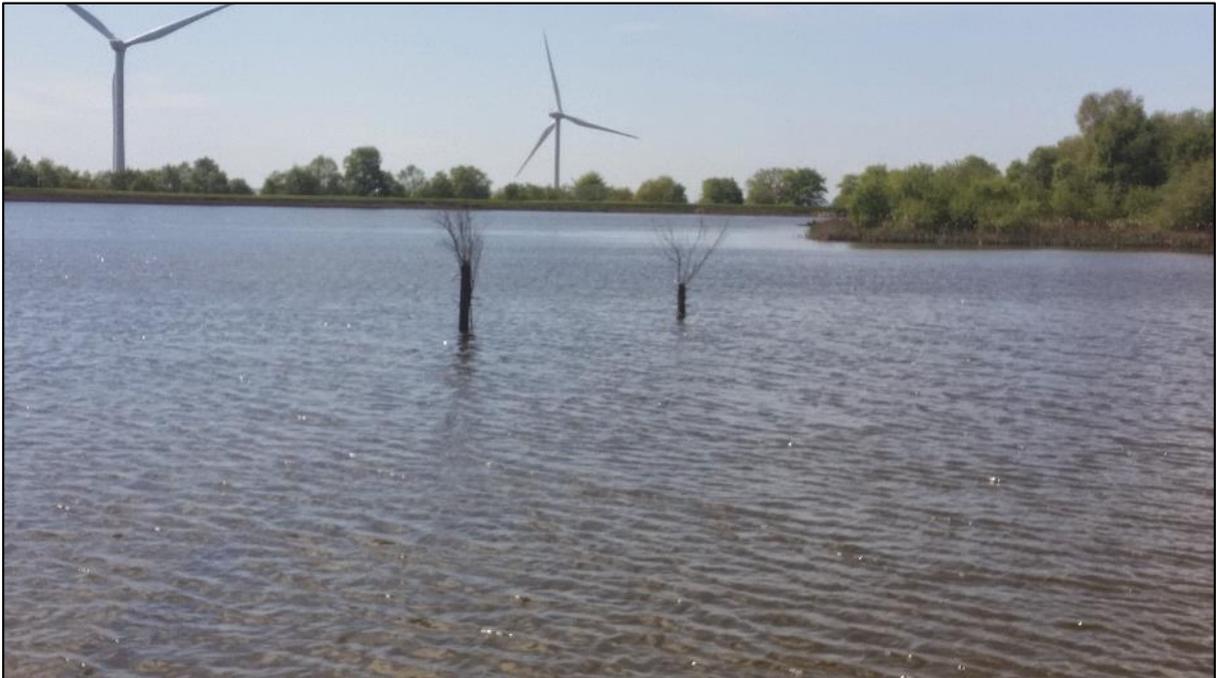
In a few locations around the lake, old redundant iron work structures protrude from the water, making convenient perches for cormorants. The fishing club has utilised an elegantly simple and effective solution to this problem consisting of branches tied to the iron work – and to any other would-be perches that prevent cormorants from landing on them (Figure 20). For cormorants, as with most predators, hunting efficiency in terms of energy exerted compared to calories gained, is of critical importance. Hence making fishing as difficult as possible for cormorants should encourage them to seek out easier meals elsewhere.

Figure 20: Simple branches tied to would-be cormorant perches act as excellent deterrents

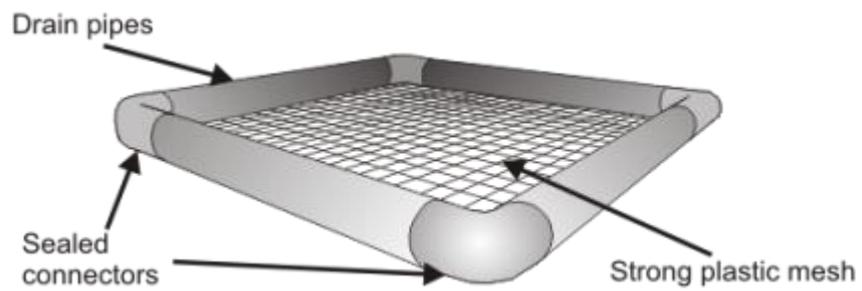
The basic design of a low-cost floating island is as follows:

Figure 21: A simple step-by-step example of a DIY floating island

4. Consider creating one or more floating islands on the lake. These would have a number of benefits including providing additional refuge habitat for trout and helping to regulate water quality. Once fully vegetated, they could also become attractive landscape features.

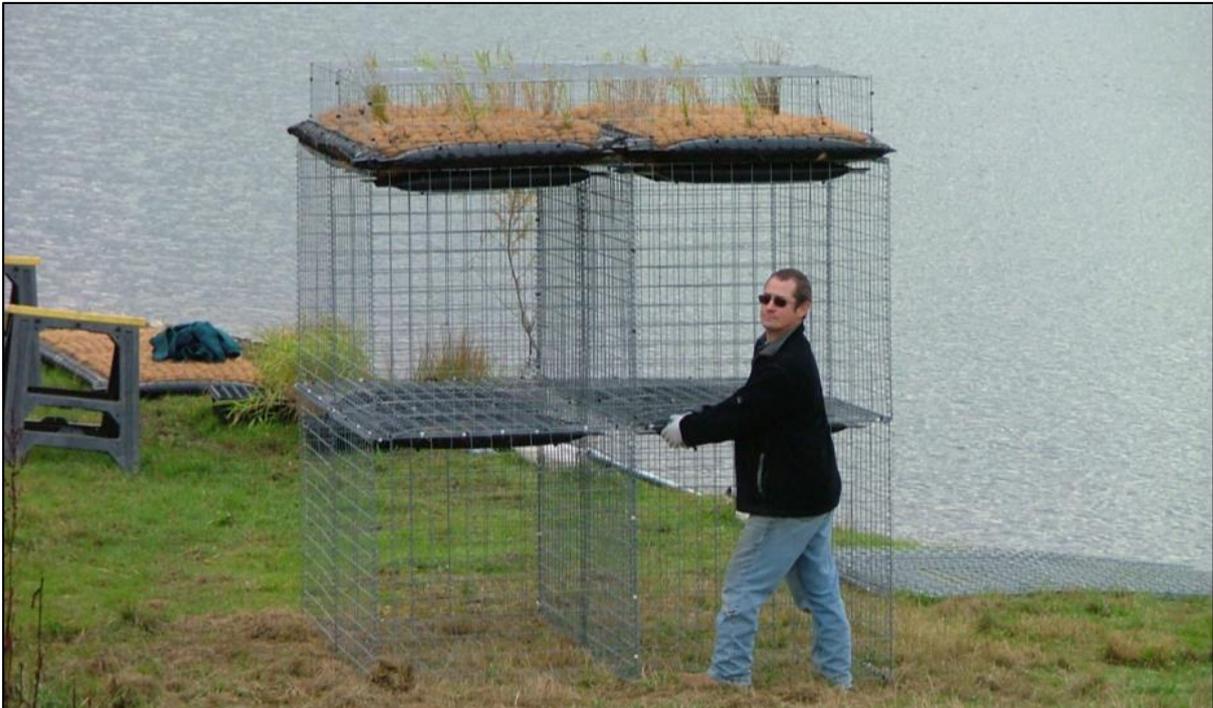
Floating islands can also be purchased equipped with suspended cages beneath them (Figure 22). These provide additional refuge from predation, further limiting the impact of cormorants, and larger predatory fish including cannibalistic trout.

Figure 22: Floating islands with suspended refuge cages

It is important to ensure that the islands are planted with species tolerant to the local conditions. Ideally, plants that are already present around the pond or lake in which they are installed.

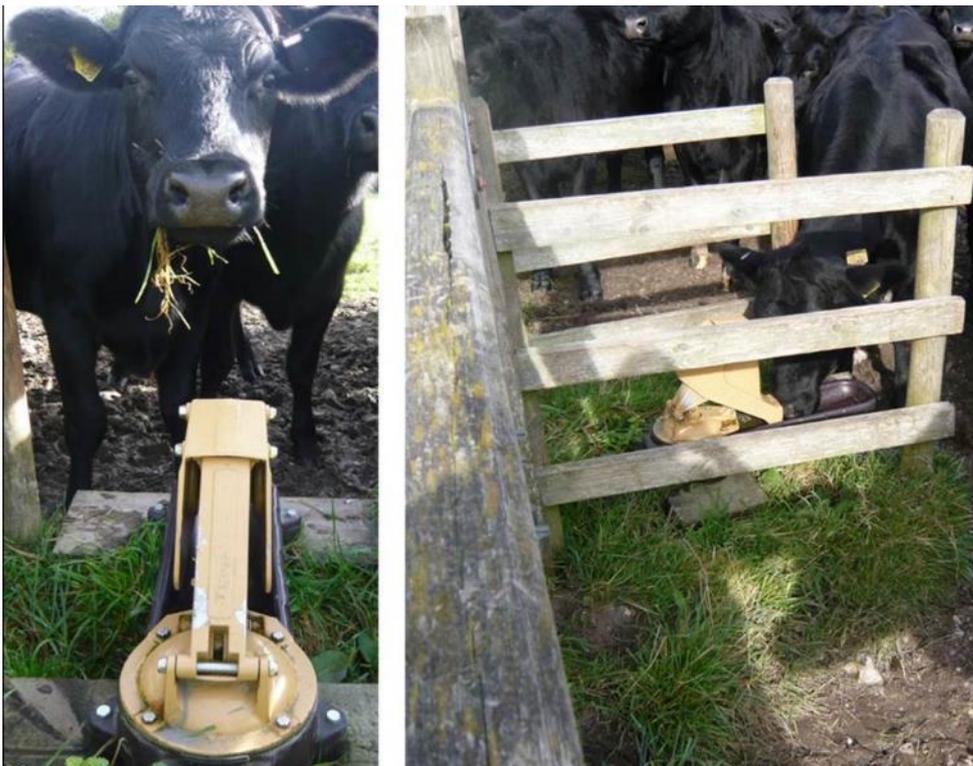
Figure 24: A cattle-powered pasture pump in action

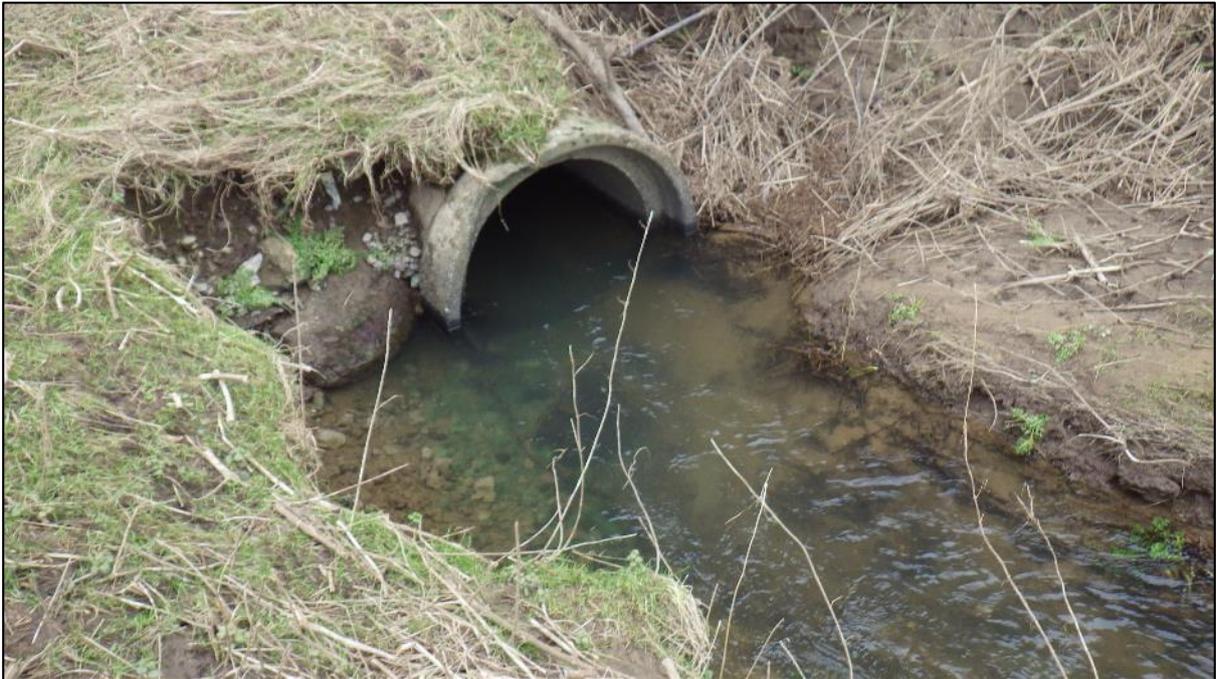
Figure 25: An example of an appropriately sized culvert sunken to facilitate fish passage and natural sediment transport

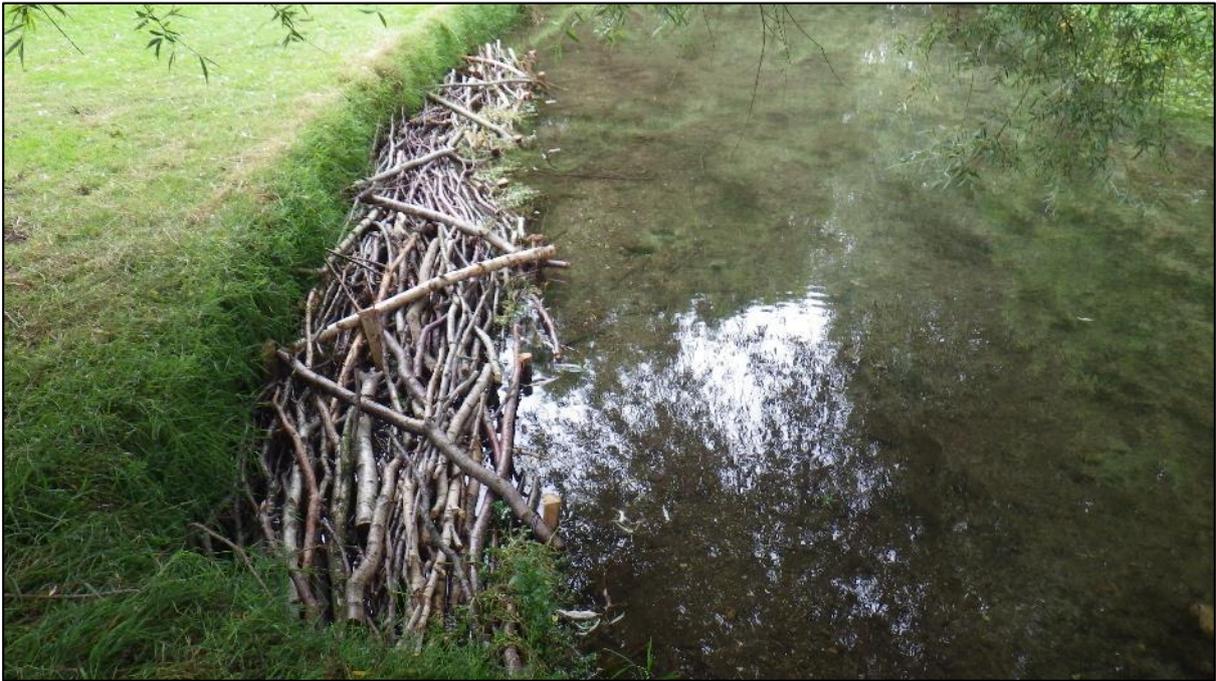
Figure 26: An example of a brushwood marginal shelf prior to planting. This was created by volunteers is just a few hours

shaggy marginal refuge habitat for juvenile trout as well as habitat for freshwater invertebrates and marginal plants. These structures can be constructed using site-won woody material from scheduled tree works etc. However, it may be prudent to limit the amount of willow used as it is highly likely to sprout new growth, which will require a certain amount of annual maintenance. If brushwood cannot be sourced from other on-site tree species, it may be advisable to import hazel faggot bundles to undertake such works.

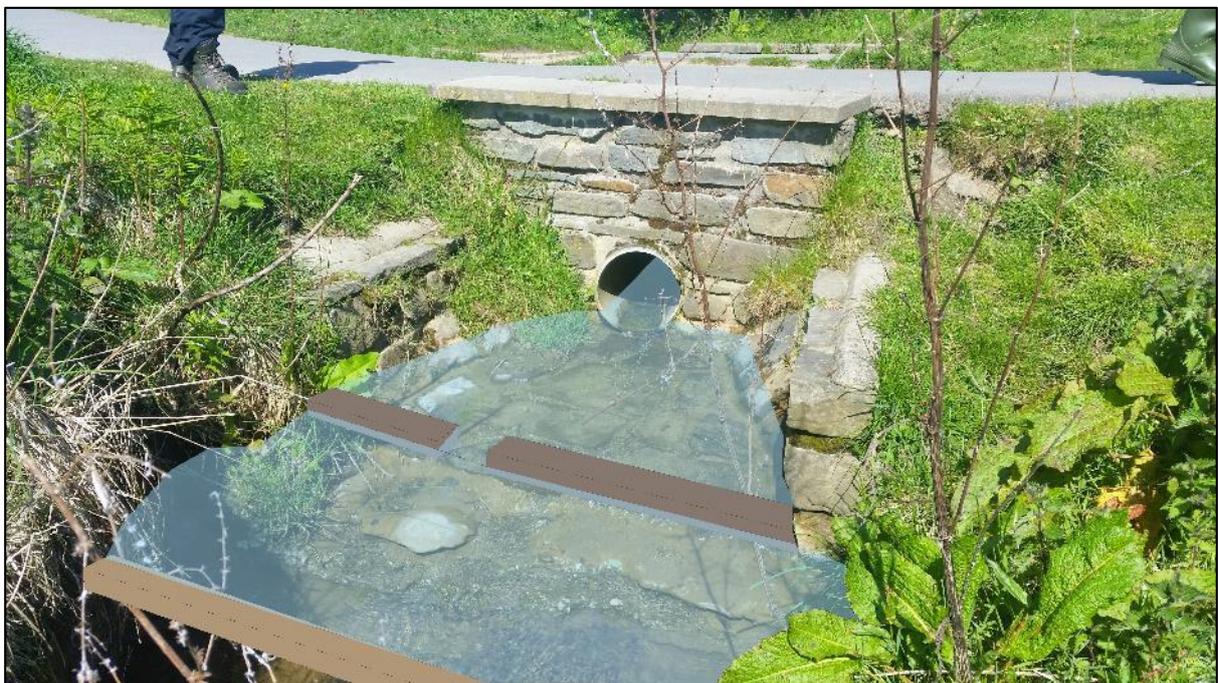
Figure 27: An illustration showing how a simple timber pre-barrage might look installed below the culvert outflow under the footpath
