**HABITAT ADVISORY VISIT TO RODBASTON
COLLEGE, STAFFORDSHIRE.
UNDERTAKEN BY VAUGHAN LEWIS,
WINDRUSH AEC LTD ON BEHALF OF
RODBASTON COLLEGE**

FEBRUARY 2008

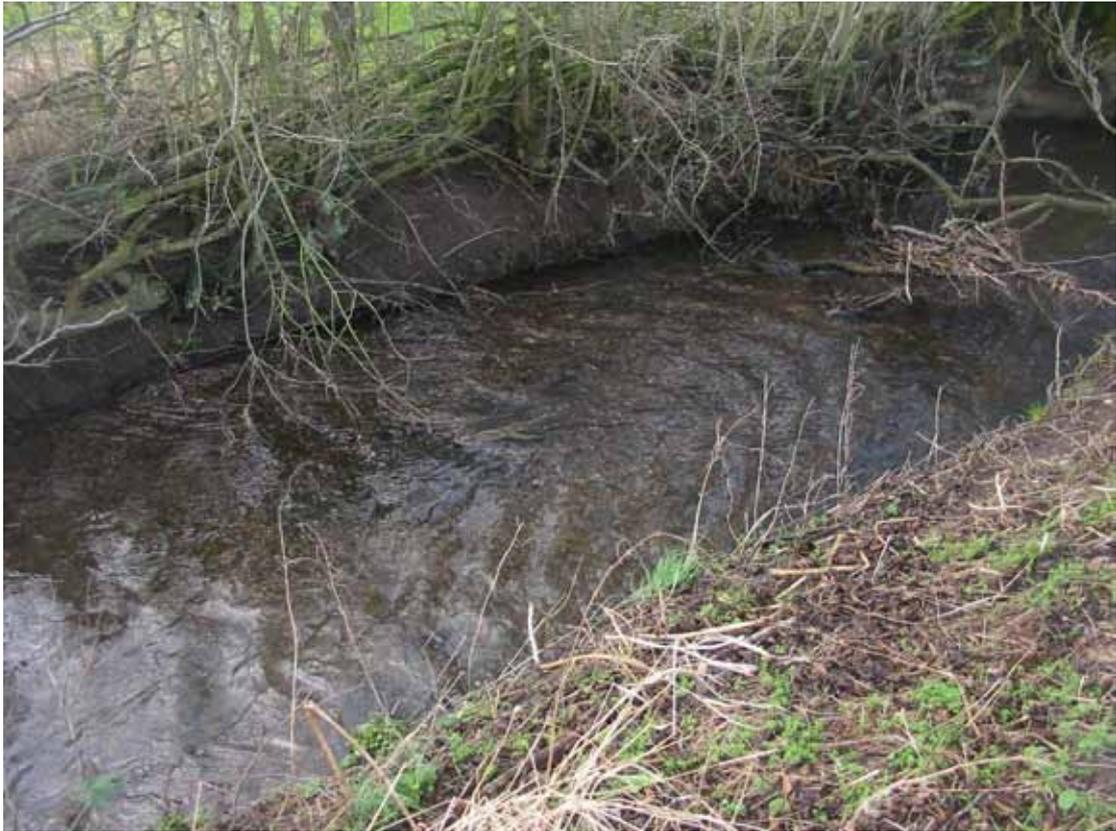
The upper length of the river had a much steeper gradient, with the bed dominated by gravel of a suitable size for spawning trout. This was however heavily imbedded (compacted), posing likely difficulties for trout with respect to excavating redds.

Steep gradient and gravel dominated substrate in the upper section of the fishery

- The gravel already present in the upper section of the fishery was heavily imbedded (compacted). In order to increase spawning success, it is important that the consolidated gravel 'pan' is broken up. This can be achieved by the use of LWD groynes (see above). Additional benefit can be obtained by utilising gravel washing using water pumps with a modified outlet. Starting at the upstream limit of the gravel riffles, the pressurised water jet is played over the gravel, loosening it and removing much of the silt trapped within it. This would make an ideal training exercise for students, perhaps as part of the WTT Practical Visit (see below) or in conjunction with the Environment Agency.

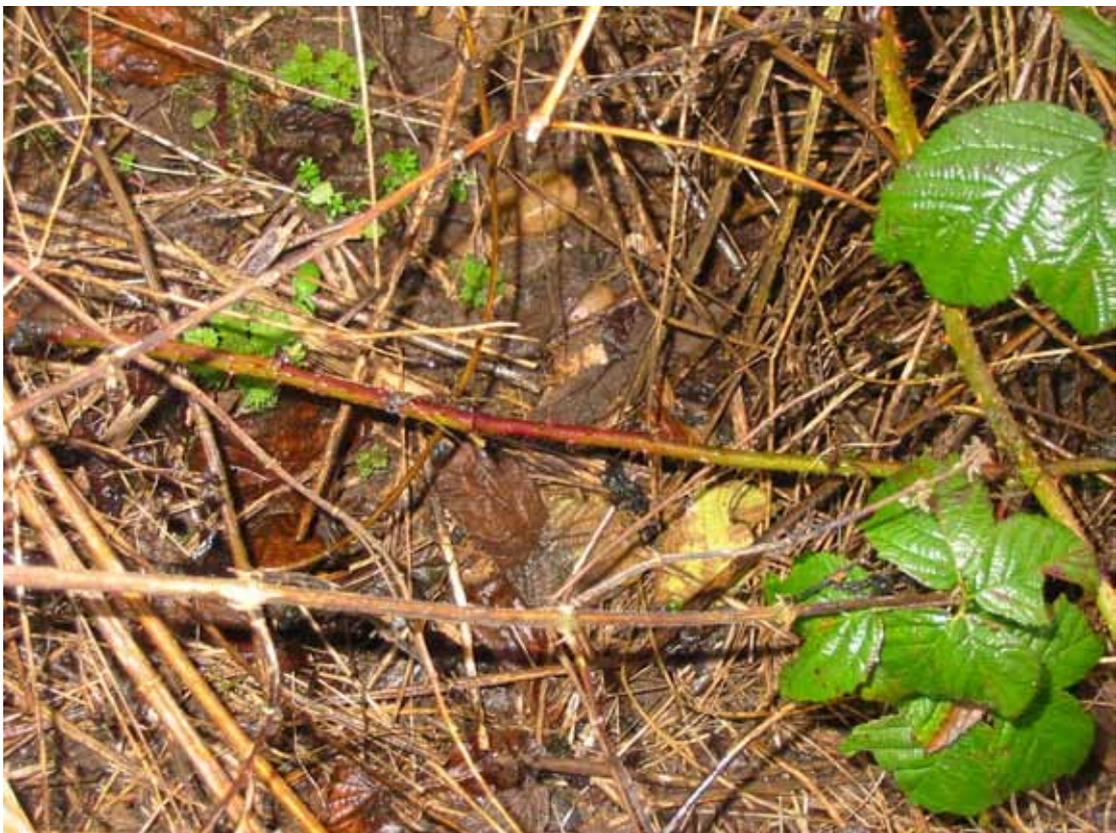
There was clear evidence of dredging having taken place in this reach in the past. There was a substantial bund of excavated material on the RB, which was, as a consequence, significantly elevated with respect to the LB. Excavation of the surface of this spoil revealed an amount of riverbed gravel, providing confirmation of its origin.

Excavated river bed gravel in deposits on RB of the brook

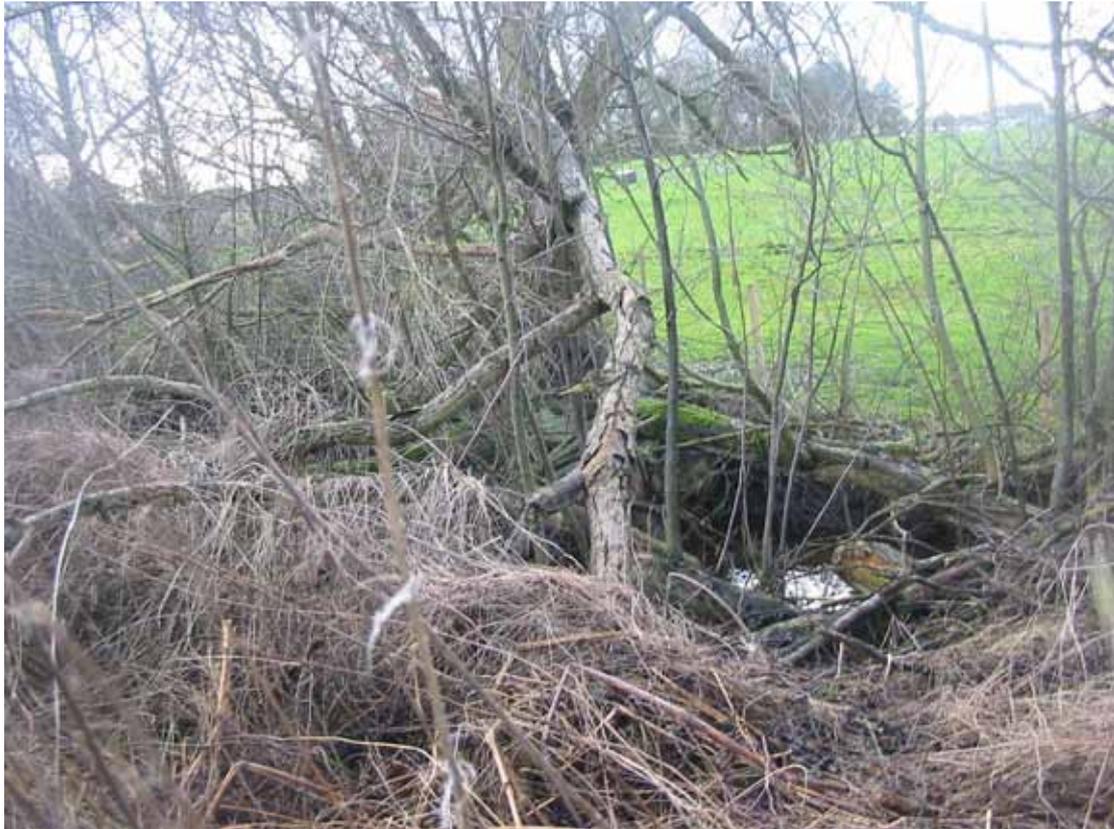
The channel was moderately shaded by a fringe of deciduous trees, dominated by alder *Alnus glutinosa*. Many of these appeared to have developed *Phytophthora* infection, and were dying. As a consequence, there was a substantial amount of Large Woody Debris (LWD) present in the channel. In places, this had accumulated to form stable woody debris dams, which were actively shaping the downstream river morphology. In conjunction with the tree- root system of the alders, this provided a high degree of instream cover.

Stable LWD dam

- The large amount of LWD present was of great benefit to the stream. It provided excellent cover for a range of species, including fish. It concentrated flow, thus helping to shape the river's morphology, by scouring and sorting the substrate, and causing differential deposition of sediment. The stable LWD dams also act to detain leaf litter that is the basic foodstuff of many 'shredding' species of macroinvertebrates. There should thus be a general policy of retaining LWD in the channel, except where it poses an unacceptable flood risk or prevents access along the channel for migrating fish. LWD should be stabilised within the channel by the use of stakes and wire if necessary. Trimming of branches and local realignment of LWD can be usefully undertaken, in order to optimise its beneficial impact on river processes. This can include scouring out of new pools or maintaining the depth of existing pools. LWD can also be of great benefit in cleaning silt from, and sorting sediment sizes in gravel dominated riffles, used by spawning trout and rheophilic coarse fish species. Upstream facing LWD groynes can be used to direct flow into the centre of the channel, encouraging scouring here and deposition of fine sediment in marginal areas. Upstream facing groynes staggered along opposing banks can be used to create a longer section of fast, scouring flow along the central part of the channel. Further details are shown in the 'Wild Trout Survival Guide'.

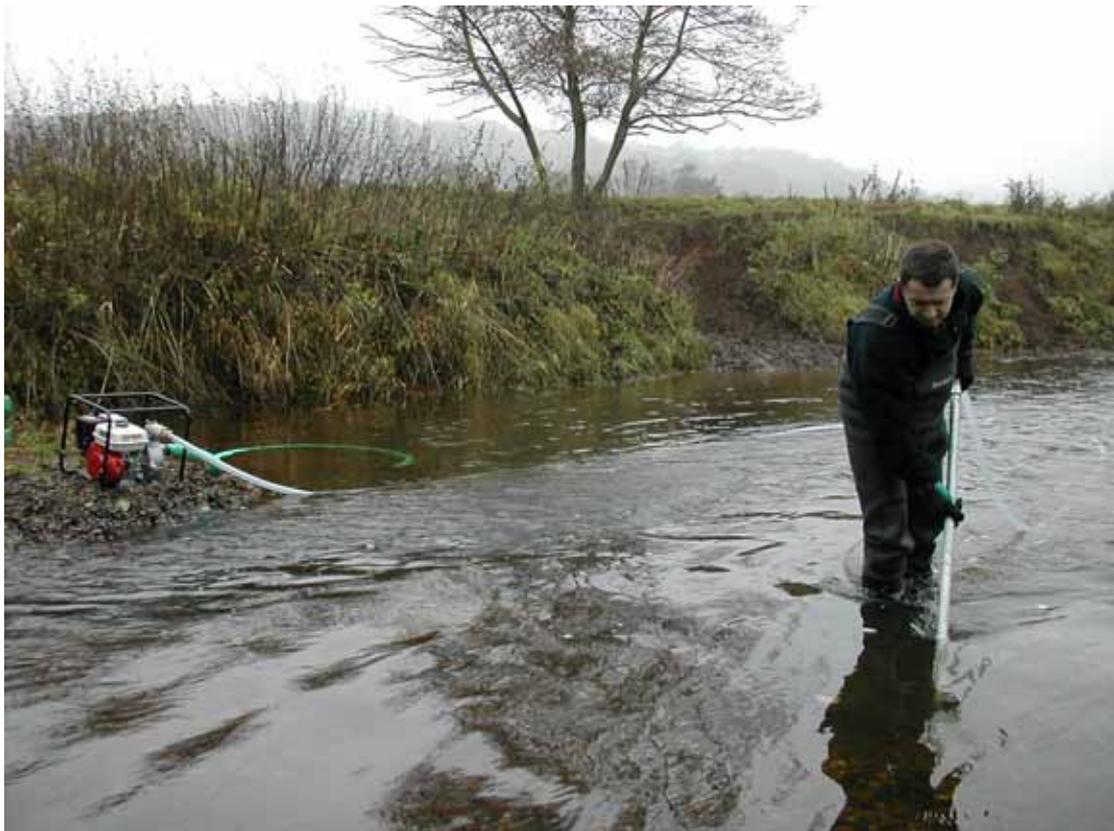
Gravel cleaning

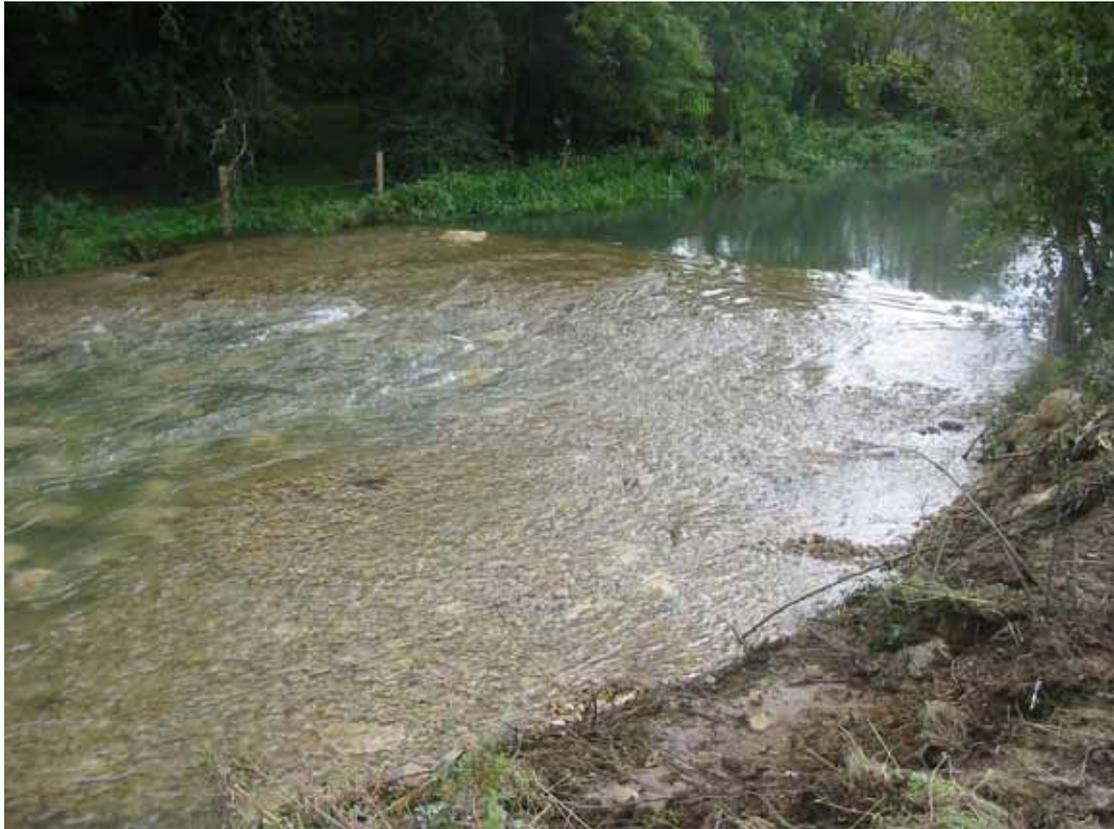
Partially constructed riffle showing stone base covered with finer gravel

- There was a limited amount of gravel present within the stream, particularly in the middle and downstream sections. This is likely to be limiting both spawning and subsequent survival of brown trout. In order to address this limiting factor, it would be beneficial to construct a series of shallow, gravel dominated spawning riffles. These could be simply constructed by importing gravel to the site and introducing it to the brook. Ideally, larger 'reject gravel' (mixed materials generally >75mm in diameter) or sandstone derived from locations within the college, should be used to construct a stable base to the riffle. This should be covered with a layer of finer gravel (ideally 10-40mm diameter) ideally at least 30cm deep, in order to create a final water depth of between 20cm-50cm. Water velocity over the gravel should be in

excess of 25cm sec^{-1} , with deeper areas left intermittently along the margins in order to provide cover for spawning trout. Sections of LWD should be introduced and secured onto the riffle in order to scour fine sediment and create a more diverse depth profile.

Each riffle should be at least 10m in length, with construction of riffles started at the downstream end of the fishery, progressing upstream, in order to avoid drowning out of each riffle by the construction of additional ones. Typically, a 10m riffle would require around 35 tonnes of stone to construct, at a price of £18/tonne (+ VAT) delivered to site.
