Upper Penk, Wolverhampton: Advisory Visit & Small Project Proposal

**Report and Proposal by the Wild Trout Trust – Following a Site Visit on
27/10/2015**

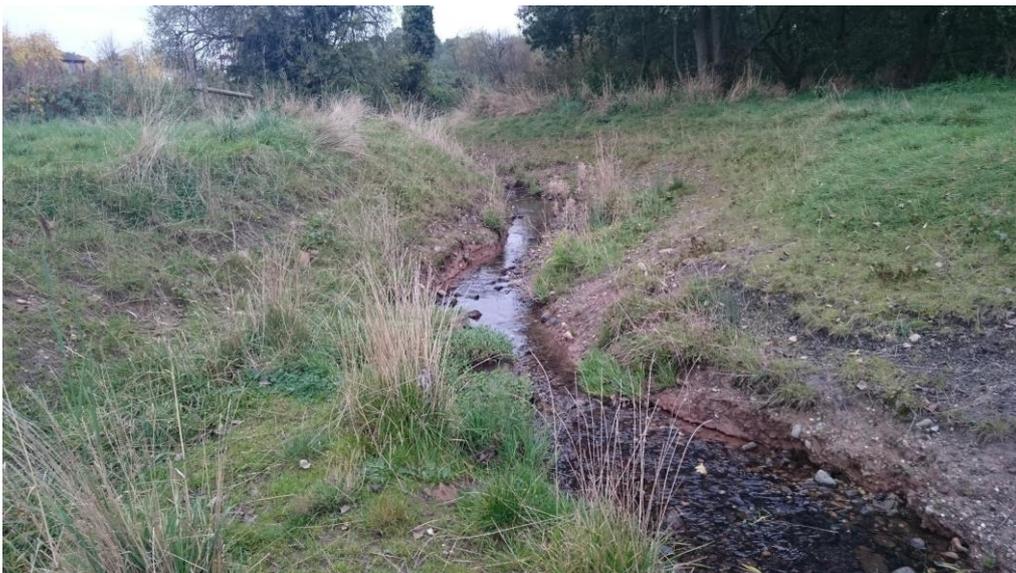
The upstream limit of visited locations was at SO 87500 89661. Here, a de-culverting project has reinstated the Penk as a surface watercourse. Encouraging signs of natural geomorphological processes (gravel exposed in the banks due to lateral erosion) were noted in the new, meandering channel that has been created (Figs. 1 and 2).

Figure 1: New channel created for a previously-culverted watercourse. A varied substrate with inputs of gravels and finer particulate material arising from natural erosion.

The new channel would benefit from a more structurally-diverse riparian vegetation (although apparently un-mown within the “bank-full” channel, the surrounding land management is unclear). It may be appropriate to consider some supportive planting and/or seeding of native river corridor species to increase floral and faunal diversity, using plants of local provenance.

The most achievable opportunity for improvements to the degraded habitat of the upper Penk probably lies in riparian vegetation enhancements at the de-culverted section around SO87500 89661 and also the trapezoidal section at SO86917 99725. This latter site could also be earmarked for a much larger project of radical re-profiling (perhaps as part of a flood-water storage creation scheme). Such a large-scale project would require its own, detailed and dedicated project proposal that incorporated relevant expertise in geomorphological channel design. Such a project would also provide an opportunity to break up the armoured channel-bed and restore processes of erosion and deposition within a more meandering planform.

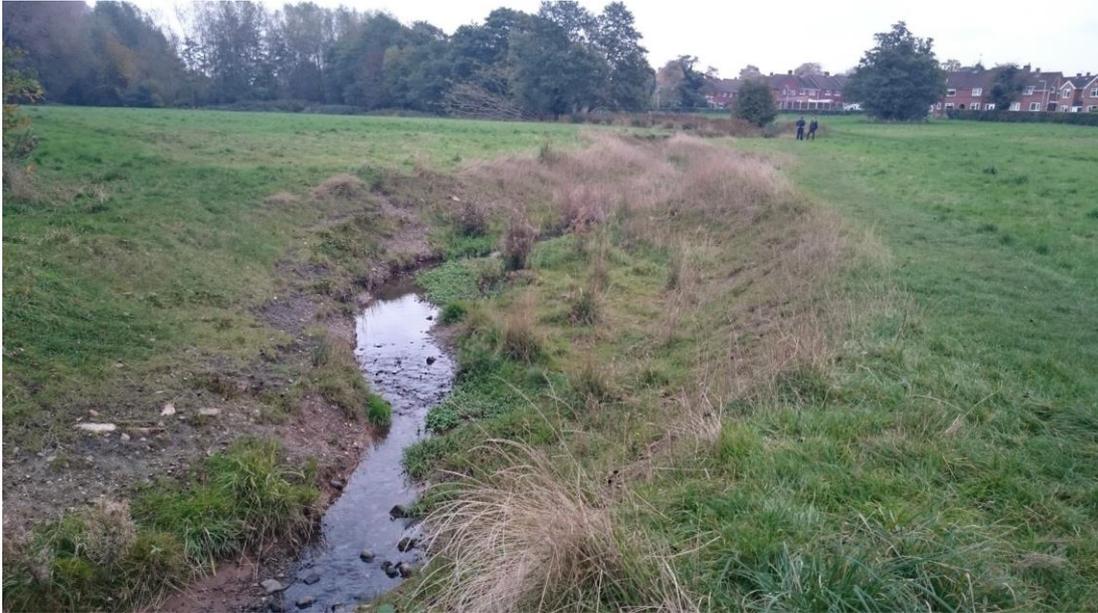
Figure 2: Deculverting project photographed from the same point as Fig. 1 (this view is facing upstream)

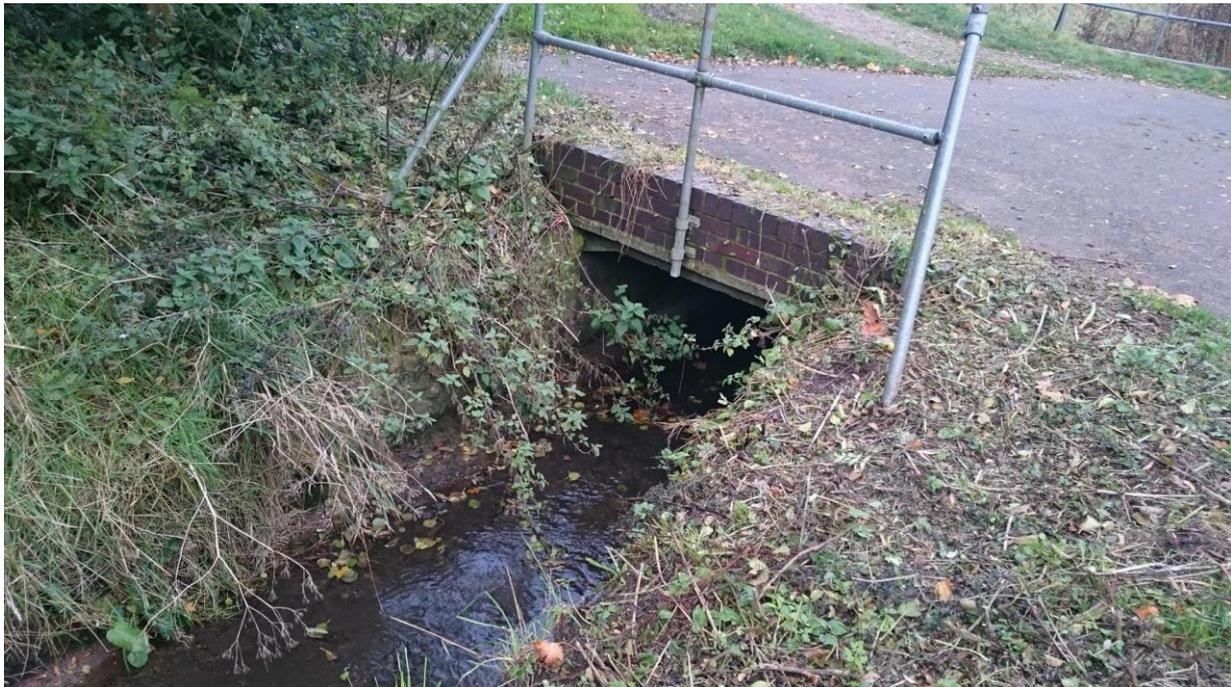
An example of a lower-impact option for bridge culverting is shown at SO 87135 99727 (Fig. 4). This illustrates the benefits to fish passage and downstream river-bed substrate transport processes when square-section culverts are used in preference to circular pipes. Benefits are maximised when square culverting is sunk far enough into the riverbed to allow a natural riverbed (of the same character as directly up and downstream) to persist within the base of the culvert.

Figure 4: Square-section culvert - a good option to minimise impacts on habitat and biota.

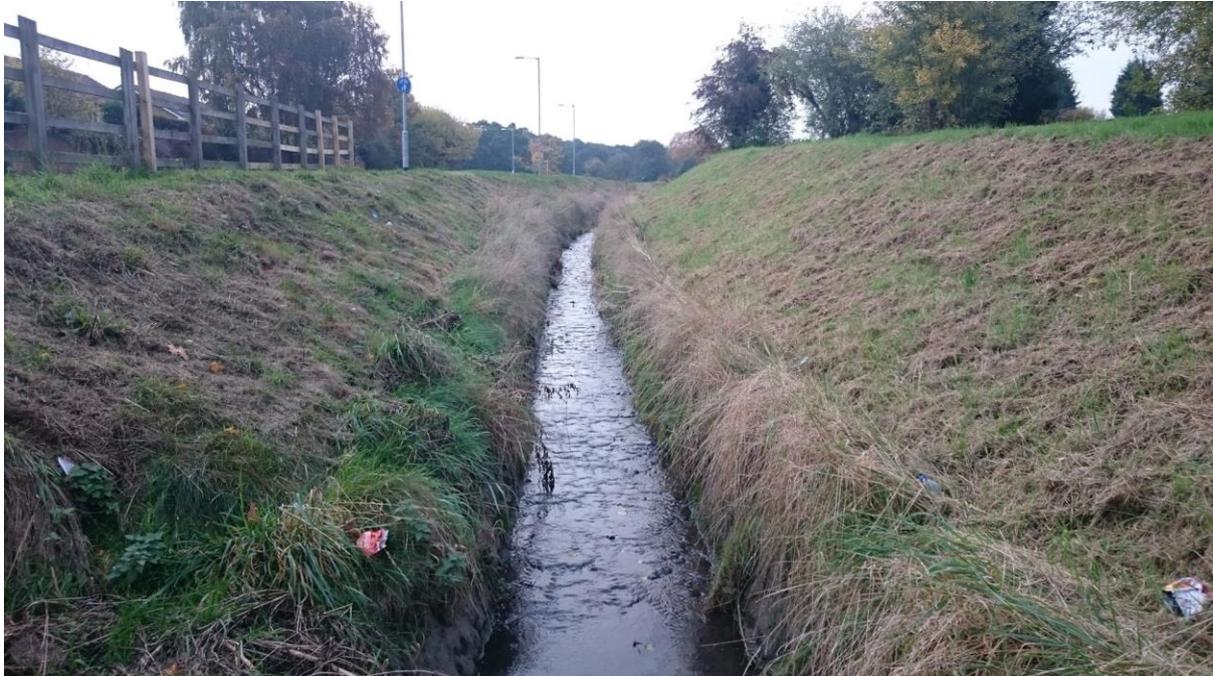
Unfortunately, the straightening and extensive modification of the channel itself degrades the biological quality of this section. Figure 5 shows a heavily engineered section of channel that has an armoured riverbed and uniform, trapezoidal cross-section – essentially devoid of natural geomorphological processes. Compounding this poor channel habitat is the lack of any diversity in the riparian vegetation. The channel modifications and the way that the vegetation is managed as a lawn have severely degraded the ecological status/biological function of this section of stream. The shallow root system and compounding effect of road and pavement drainage will also make the runoff profile extremely “flashy”. In other words, there is little or no opportunity for buffering of heavy rainfall via soak-away before it enters the stream. Instead, the flow in the stream channel will increase almost immediately in response to rainfall on the surrounding land – potentially elevating flood risk in the downstream catchment.

Figure 5: Trapezoidal channel at SO 8691799725 with armoured channel-bed. Very poor habitat in a channel that has little opportunity to buffer heavy rainfall on the surrounding land

Depending on available funding and regional priorities, it may be possible to combine a flood-water storage scheme with greatly improved in-channel habitat

and ecological status. As a minimum, there will be benefits in improving the riparian corridor vegetation (which would also increase its attractiveness and could potentially act as a valuable resource for pollinating insects away from intensive agriculture). Potential project work options are suggested in the "Recommendations" section.

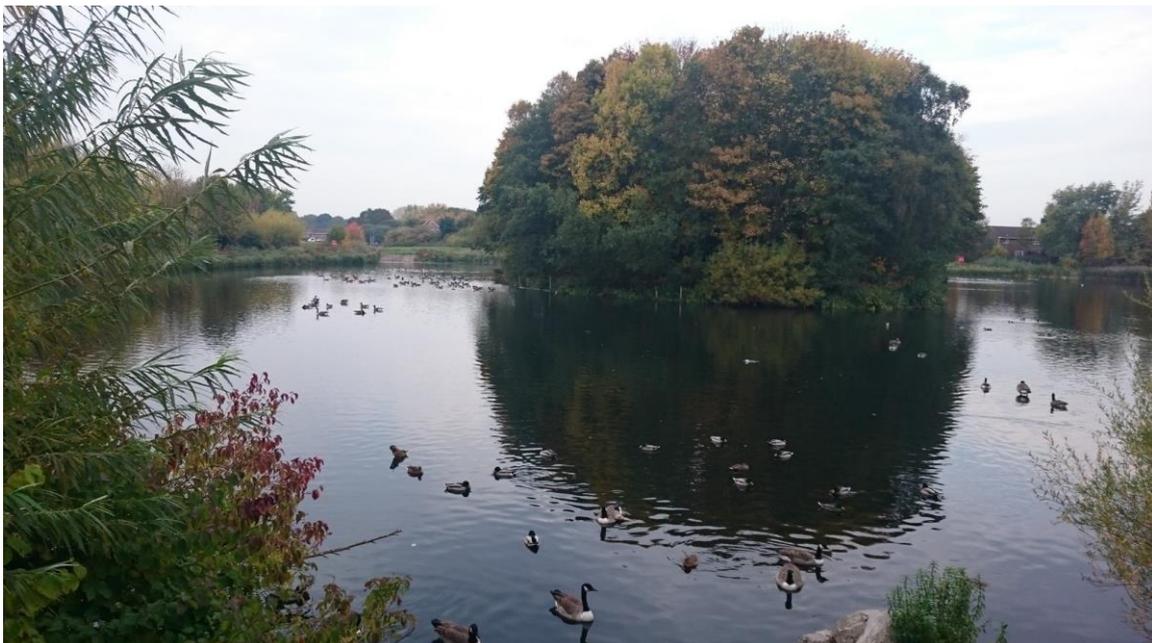
Figure 6: The Penk enters this on-stream lake at this point via a culvert at SO 86233 99732. The lake has had extensive planting for the benefit of wildlife both around the outer margins and also those of the island

These represent something of a trade-off as the one pictured in Fig. 6 provides good habitat for lentic (stillwater) species whilst also interrupting the transport of stream substrate and acting as a barrier to migration for rheophilic (flow-loving) fish. In order to produce these lake habitats (and to control water within a developed landscape), the stream channel is entirely artificial in significant proportions of the visited reaches (e.g. concrete channel at SO 86087 99852; Fig. 7). There are also multiple barriers to substrate transport and fish migration such as weirs (e.g. SO 86032 99915; Fig. 8) and culverts (e.g. SO 859939956; Fig.9).

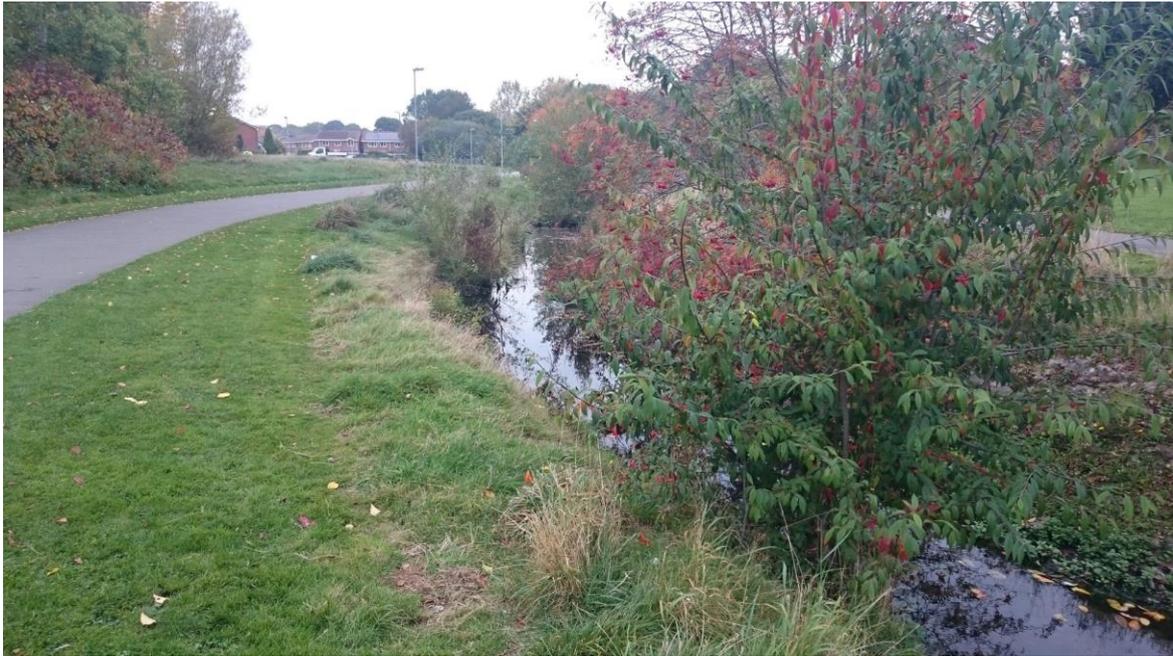
Figure 7: Artificial channel with water-level maintained by weirs

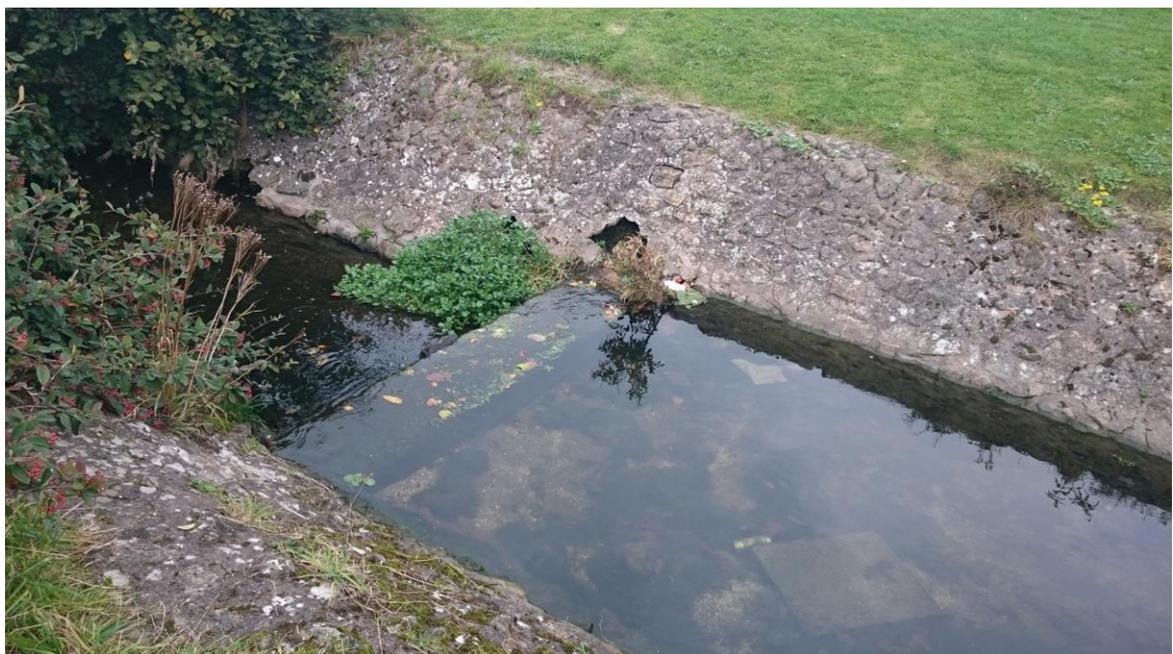
Figure 8: Example of weir impounding water to maintain a particular depth/width of water within the artificial channel (presumed to be for aesthetic reasons)

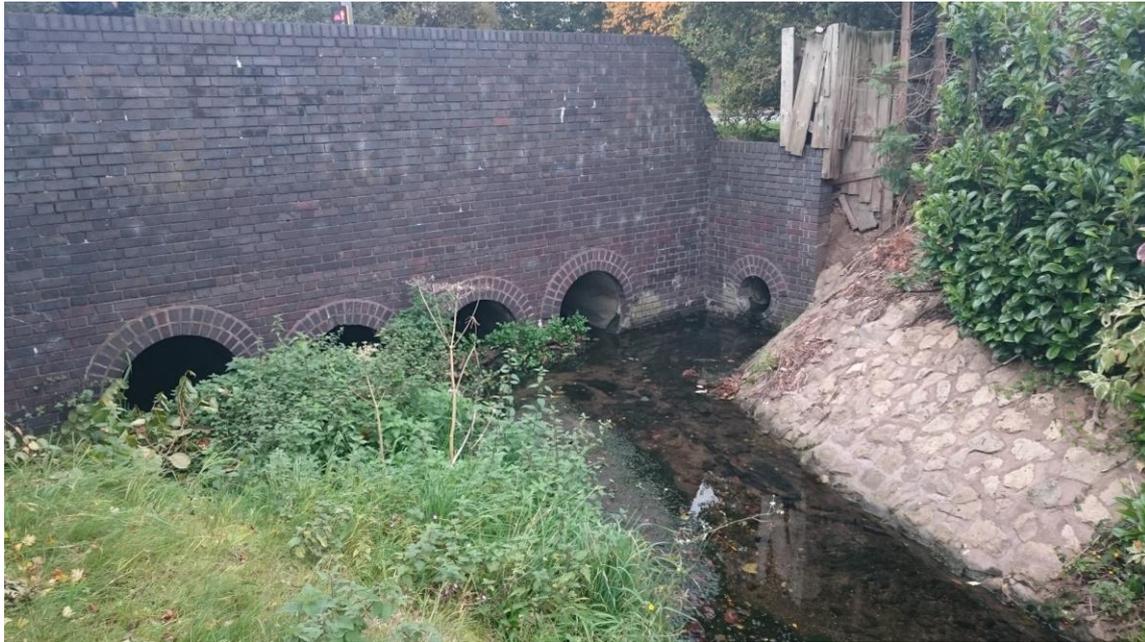
Figure 9: Circular-section culverting causing a barrier to fish migration as well as river-bed substrate

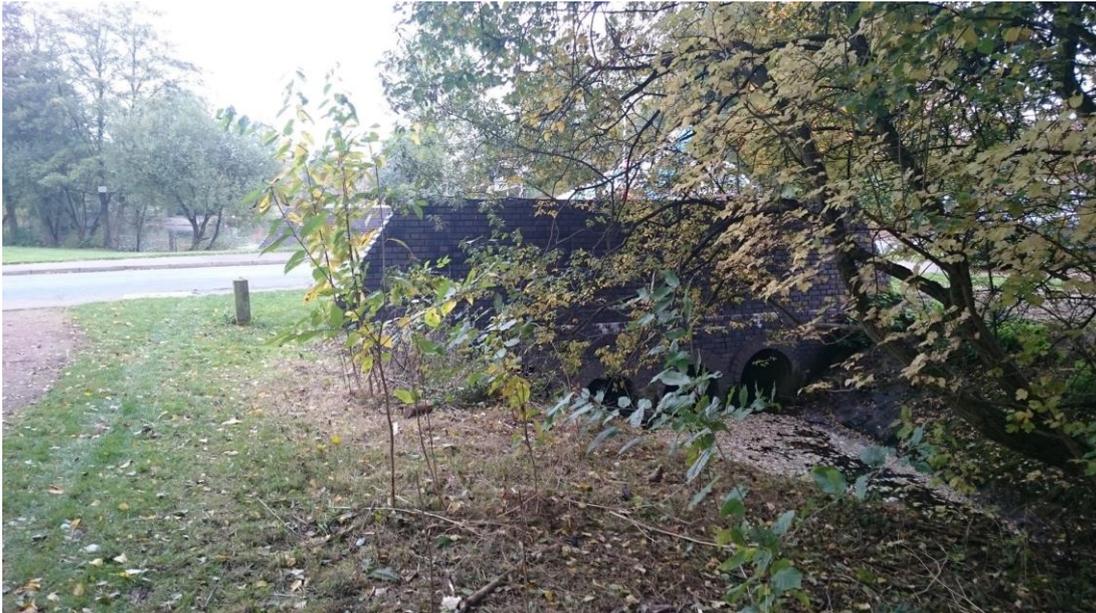
Further barriers in the form of another on-stream lake and the culverts connecting that lake to the stream channel were noted around SJ 85941 00235 (Fig. 11). The bottom of the visited reach was defined by a trash screen on a culvert that takes the stream below ground at SO 85985 00471 (Fig. 12).

Figure 11: Bridge/culvert at the upstream end of another on-stream lake, thought to have been constructed at the same time as the adjacent housing development
