Upper Penk, Wolverhampton: Advisory Visit

Upper Penk (Visit II): Pear & Partridge to culvert under Wrottesley Park House footpath
River	Penk
Waterbody Name	River Penk from source to the Saredon Brook
Waterbody ID	GB104028046680
Management Catchment	Trent Valley Staffordshire
River Basin District	Humber
Current Ecological Quality	Poor
U/S Grid Ref inspected	SJ8603200506
D/S Grid Ref inspected	SJ8647400966
Length of river inspected	0.8 km

Wild Trout Trust Report – Following a Site Visit on 29/08/2017

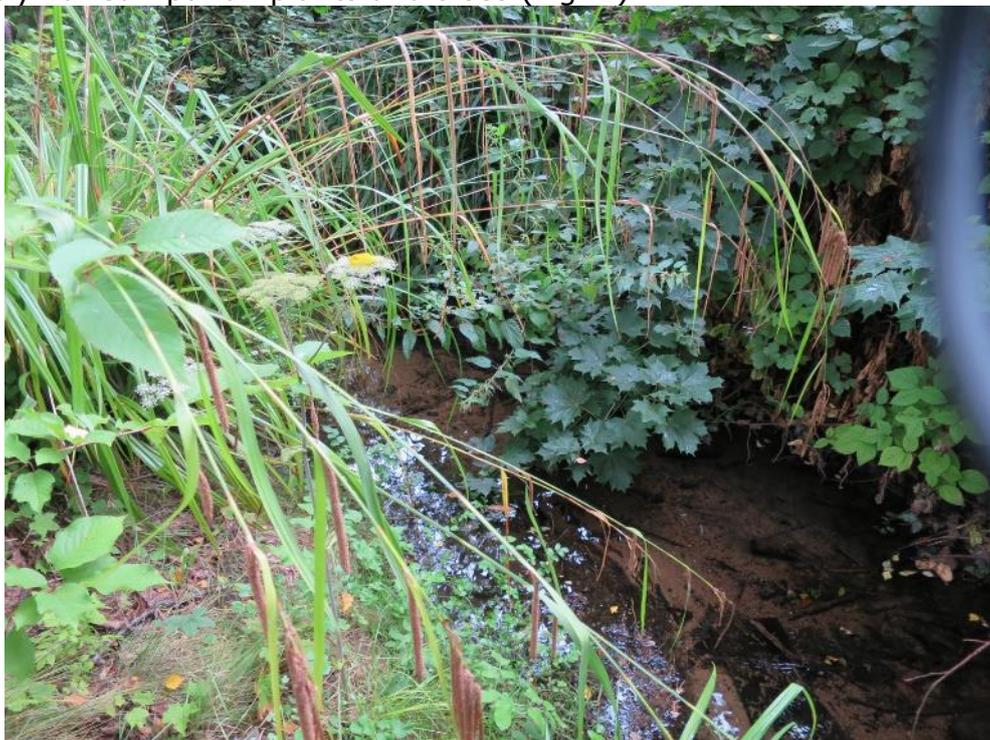
At the upstream limit of this visit, a small, sandy channel was visible with relatively varied riparian plants and trees (Fig. 1).

Figure 1: Native understory plant species associated with varied tree canopy at SJ 86032 00506.

Although the channel has been artificially straightened, the development of surrounding woodland canopy and bankside understory vegetation provides ecological value. The channel has narrowed to a more natural width (appropriate to its rate of discharge and bed-slope) and a range of species have recolonised following historic channel realignment. However, the sandy nature of the catchment and the straightened planform of the channel result in very limited structural variety within the substrate. This, coupled with the apparently poor water quality results for phosphate and dissolved oxygen, will significantly limit the diversity of aquatic species.

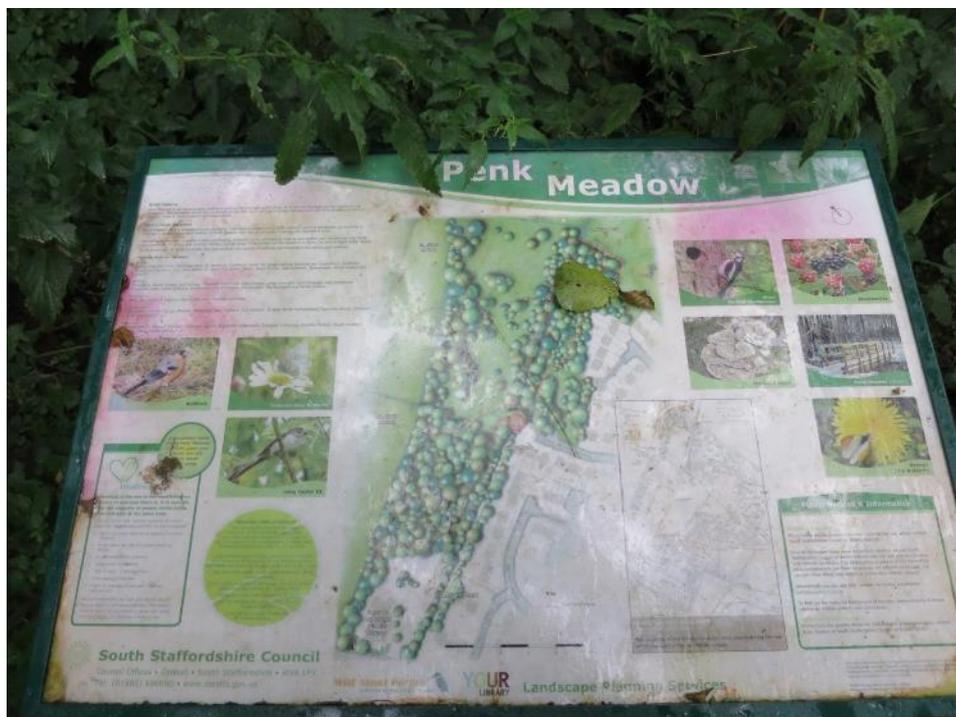
Just downstream, a section of the Penk runs through Penk Meadow. This is a diverse area of grassland managed by South Staffordshire Council and Wild About Perton. Managed rides are regularly cut along designated paths, whereas the surrounding vegetation is mown annually to promote maximum diversity – in combination with the surrounding woodland of Smiths Rough (Fig. 2).

Figure 2: Interpretive signage detailing the management and notable species of Penk Meadow.

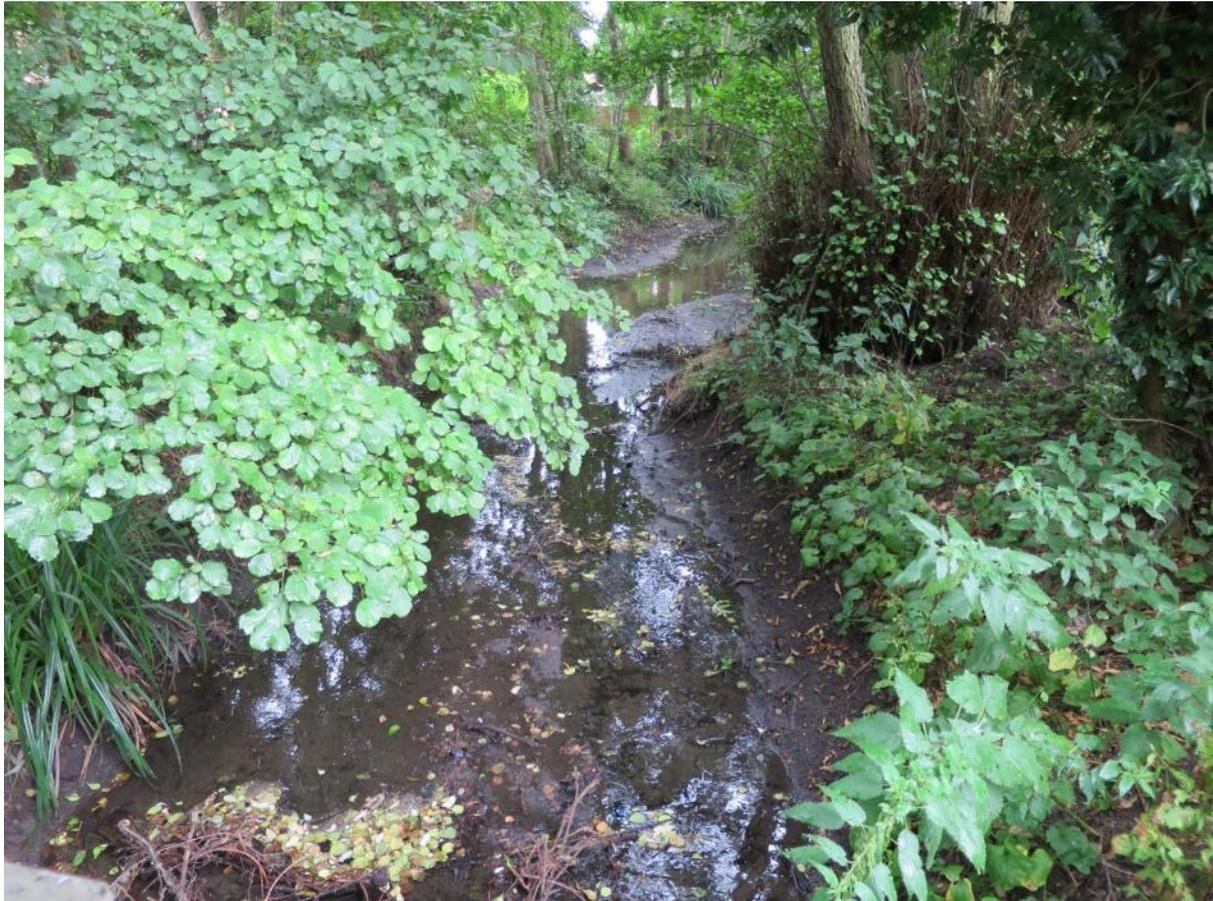
The single line of trees associated with both banks of the Penk in this area (Fig. 3) could provide additional benefit through light rotational coppicing. This would generate greater variety in the light/shade regime experienced in the channel and understory vegetation. The bank-side trees are regenerating some sinuosity in the channel (Fig. 3) – and are consequently valuable. However, the relatively uniform shade throughout the reach is likely to constrain species diversity. Allowing the coppiced trees to re-grow in a more staggered fashion will create valuable low-level cover, more varied (dappled) light. The staggered regrowth, combined with remaining veteran trees, will ensure the continued valuable input of nutrients from falling leaves each autumn. Given the straightened nature of the channel, it will be important to allow some in-channel roughness to develop through a combination of coarse and large woody material. In the absence of such roughness (particularly in association with straightened channels) leaf litter will not be retained within the reach during high flows. The loss of that material limits those

Figure 3: Dense stands of similar-sized/aged trees produce quite uniform, dense shade. At the same time, their value in regenerating greater structural diversity in the channel is apparent - as is the essential trapping of leaf litter by coarse woody material.

- Investigate the potential to remove the culvert under the Wrottesley Park House footpath and replace with bridge (preferably) or ford
- Undertake light, rotational coppice work (aim to preserve around 60% of the canopy cover): <http://www.shropshirehillsaonb.co.uk/wp-content/uploads/2010/10/Management-of-Riverside-Trees-Feb-2013.pdf>

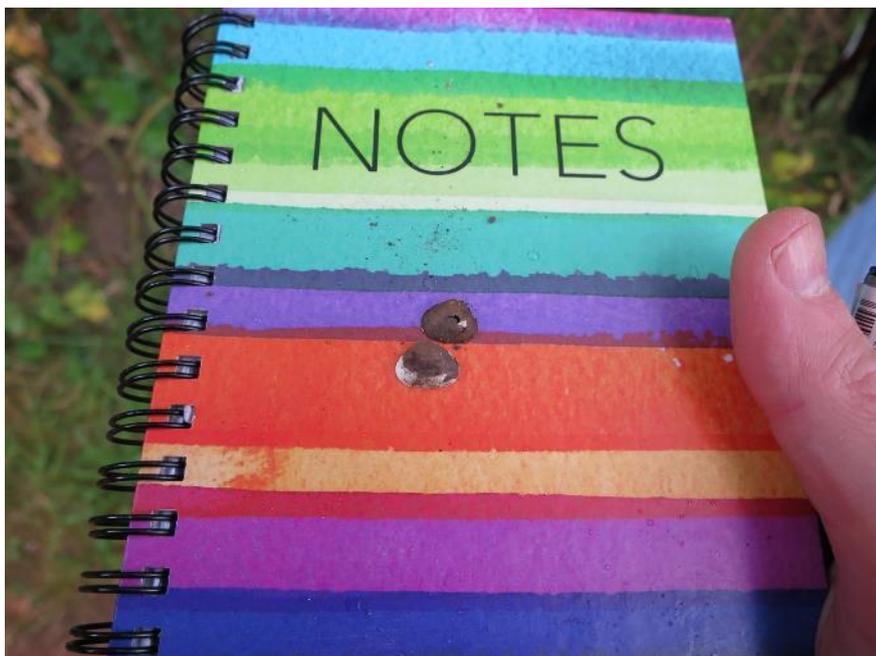
Figure 5: Two halves of a pea mussel shell - taken from the tens (or hundreds) of thousands present in the dredging spoil.

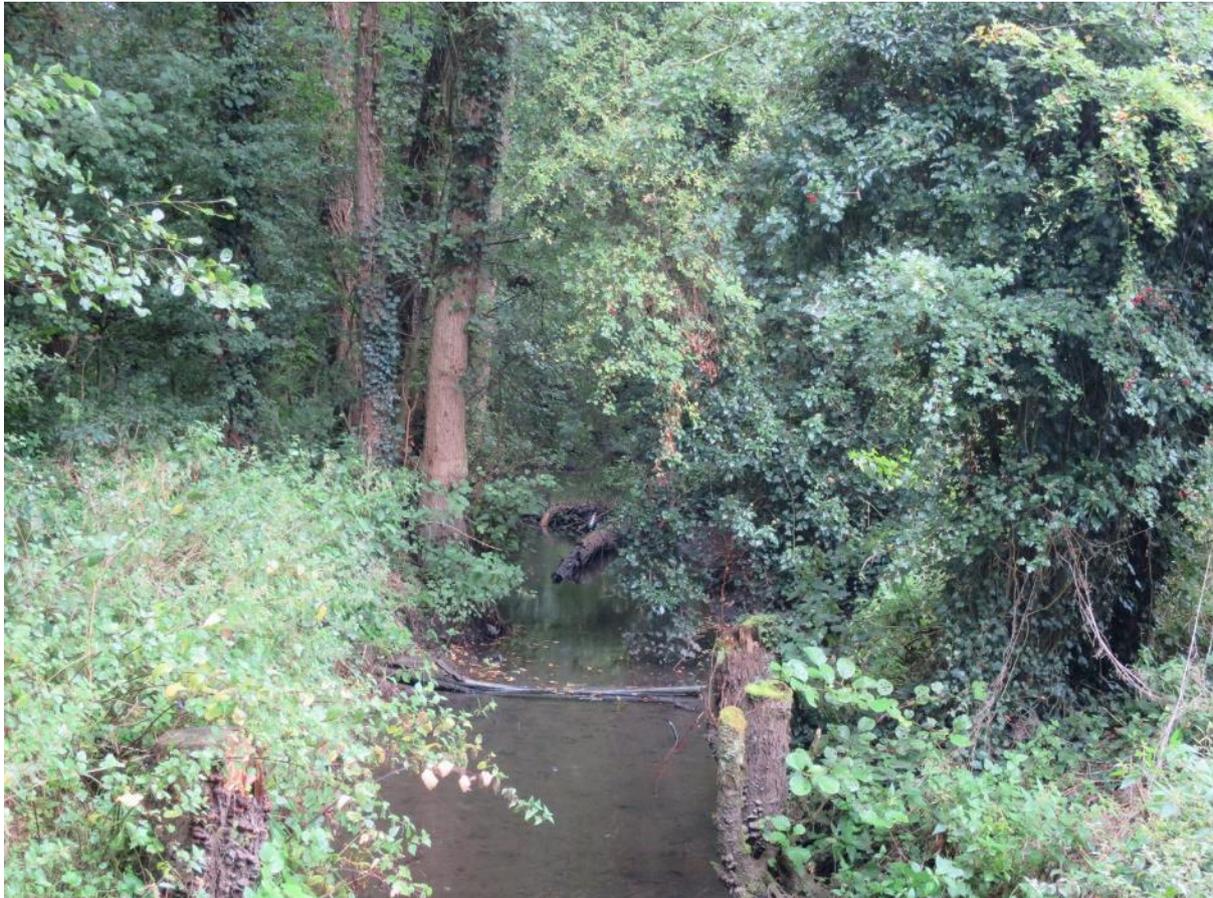
In contrast to the damaging management practices, there were some good examples of in-channel structure generated by natural deadfall of woody material (e.g. Fig. 6). This provides more diverse niche opportunities (structural) as well as vital nutrient resources (energetic) benefits.

Figure 6: Fallen wood creating more diverse habitat, providing additional substrate and roughness (as well as being a source of nutrients in itself). Note that the deep, uniform shade is still evident here.

Again, in common with the whole reach falling within Penk Meadow, the tree canopy structure produces a dense and fairly uniform shade (Figs. 6 and 7). As already highlighted, a very light rotational coppice (whereby a small percentage – e.g. 5 to 10% of trees are cut each year and then allowed to regrow) would promote a more biodiverse river corridor. Furthermore, the woody material that arises from coppicing can be used to produce habitat features both within and adjacent to the channel. Wood habitat piles or beetle-banks can be created in the terrestrial habitat, while nature-mimicking woody material within the channel can generate localised bed (or even bank) scour to produce greater in-stream structural variety. Coarse and large woody material introduced (and securely anchored) will also increase channel roughness to aid retention of nutrients. . It is, though, important to always retain some areas of dense shade to protect watercourses from low flow/high summer temperature events. See “Recommendations” for further details.

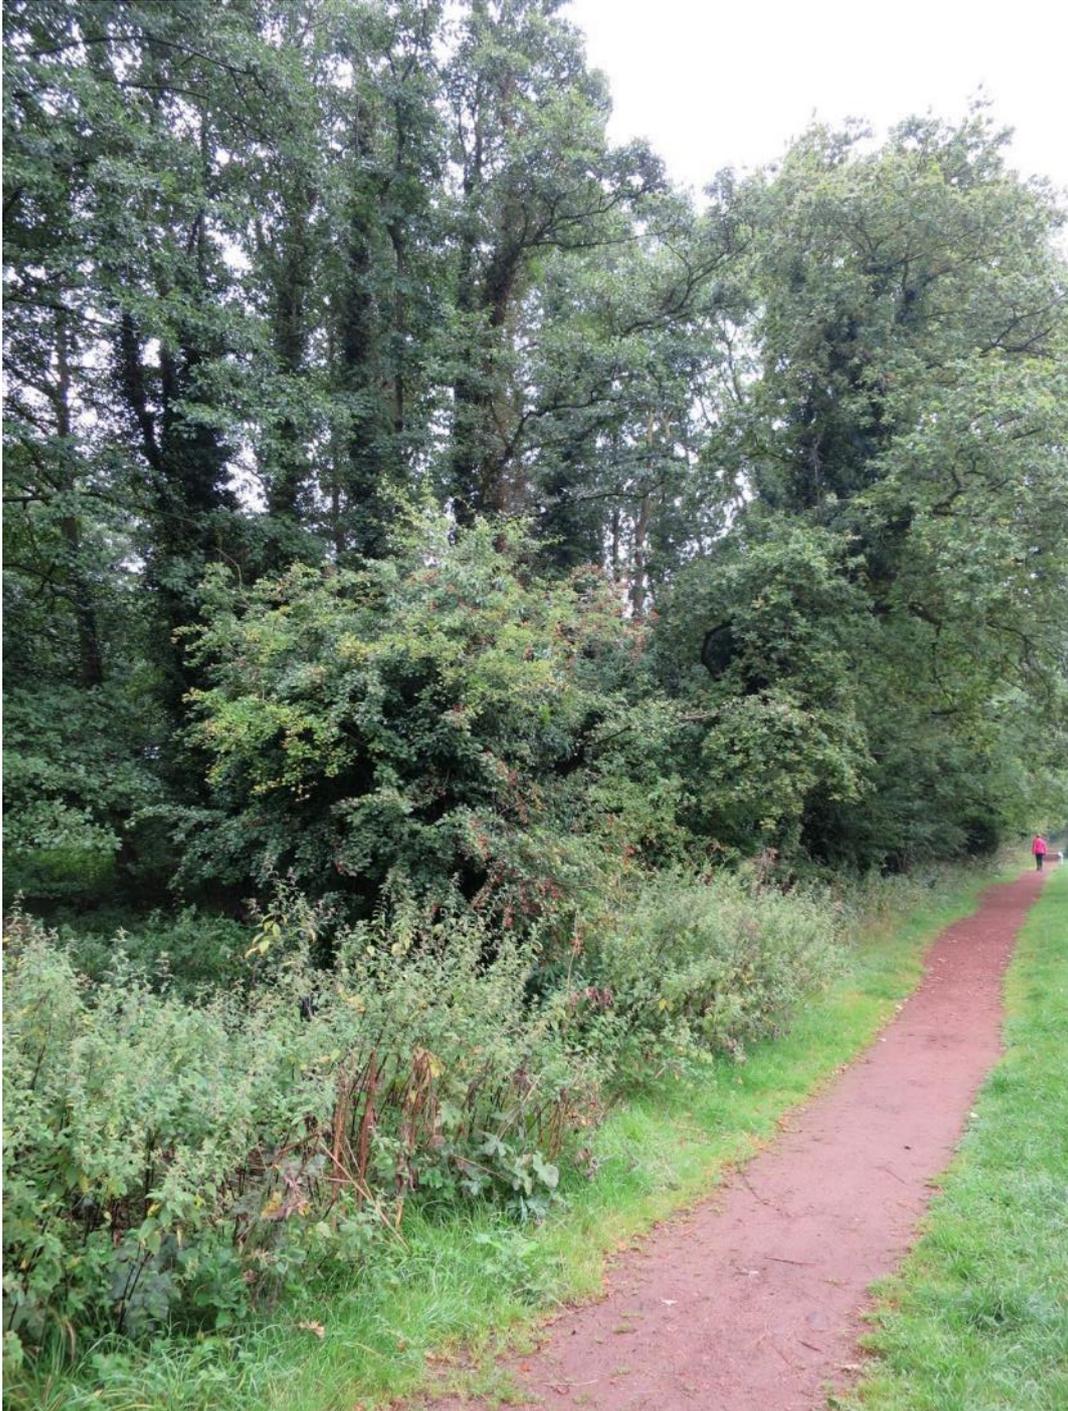
Figure 7: River (left of frame) adjacent to footpath - showing the straightness of the channel as well as the dense, uniform shade.

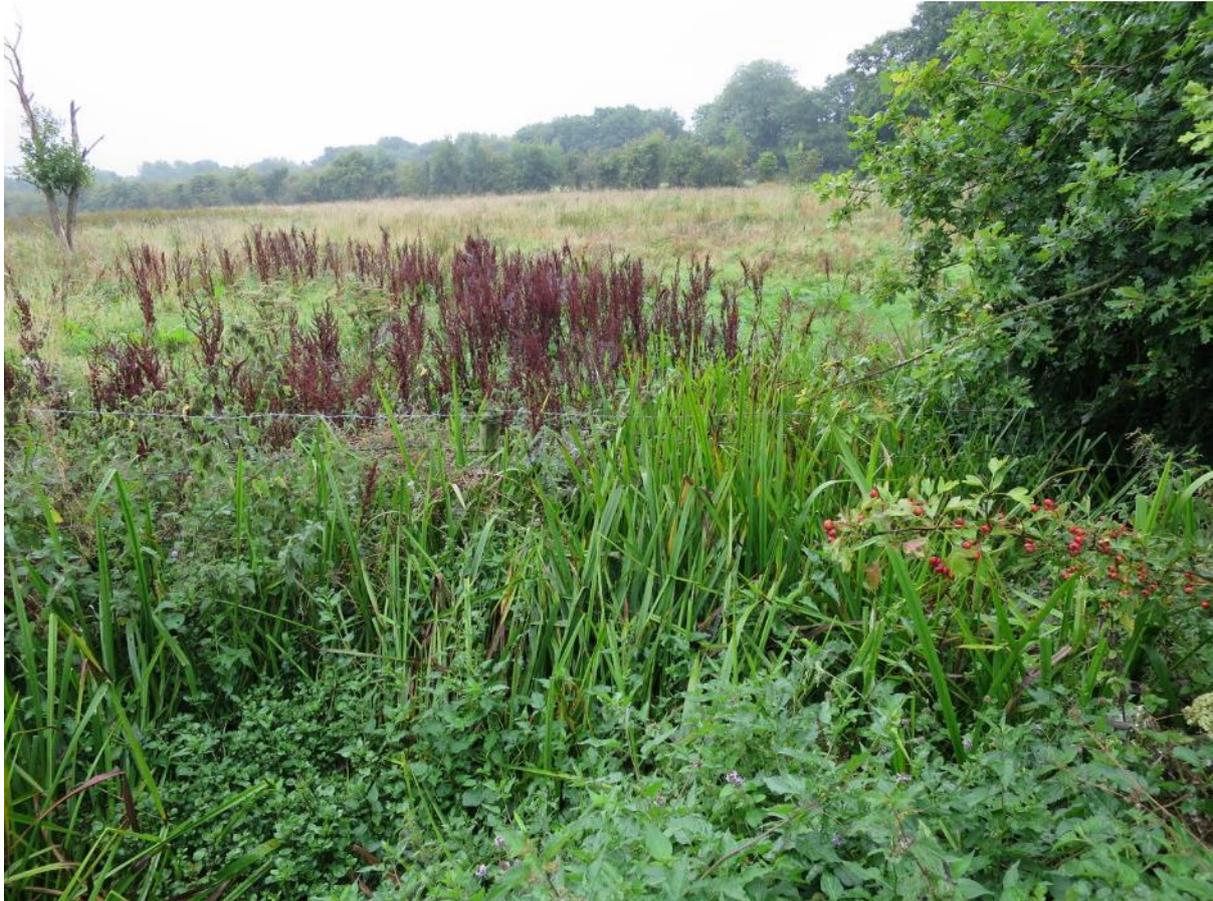
The importance of varied light and shade is evident in the land that falls outside the woodland (e.g. Fig. 8 at SJ 86355 00875). Where agriculture or other land-management practices remove most or all of the shading to a small river, there is a strong tendency for the channel to become completely choked with vegetation. This is particularly the case when channel modifications produce very slow flows.

Figure 8: Where tree canopy is completely removed, the soft nutrient-rich riverbed and shallow, slow-flowing water quickly becomes choked with emergent vegetation.

- Create log-pile habitat in Penk Meadow:
<https://www.buglife.org.uk/activities-for-you/wildlife-gardening/create-your-own-dead-wood-habitats>
- Introduce securely-anchored woody material to the stream in the form of small tree "kickers":
<https://vimeo.com/72720550>
- Lay, wedge and securely anchor larger trunks/limbs across the channel in the open-canopy areas to create low shade and structural diversity (Figs. 10 & 11)

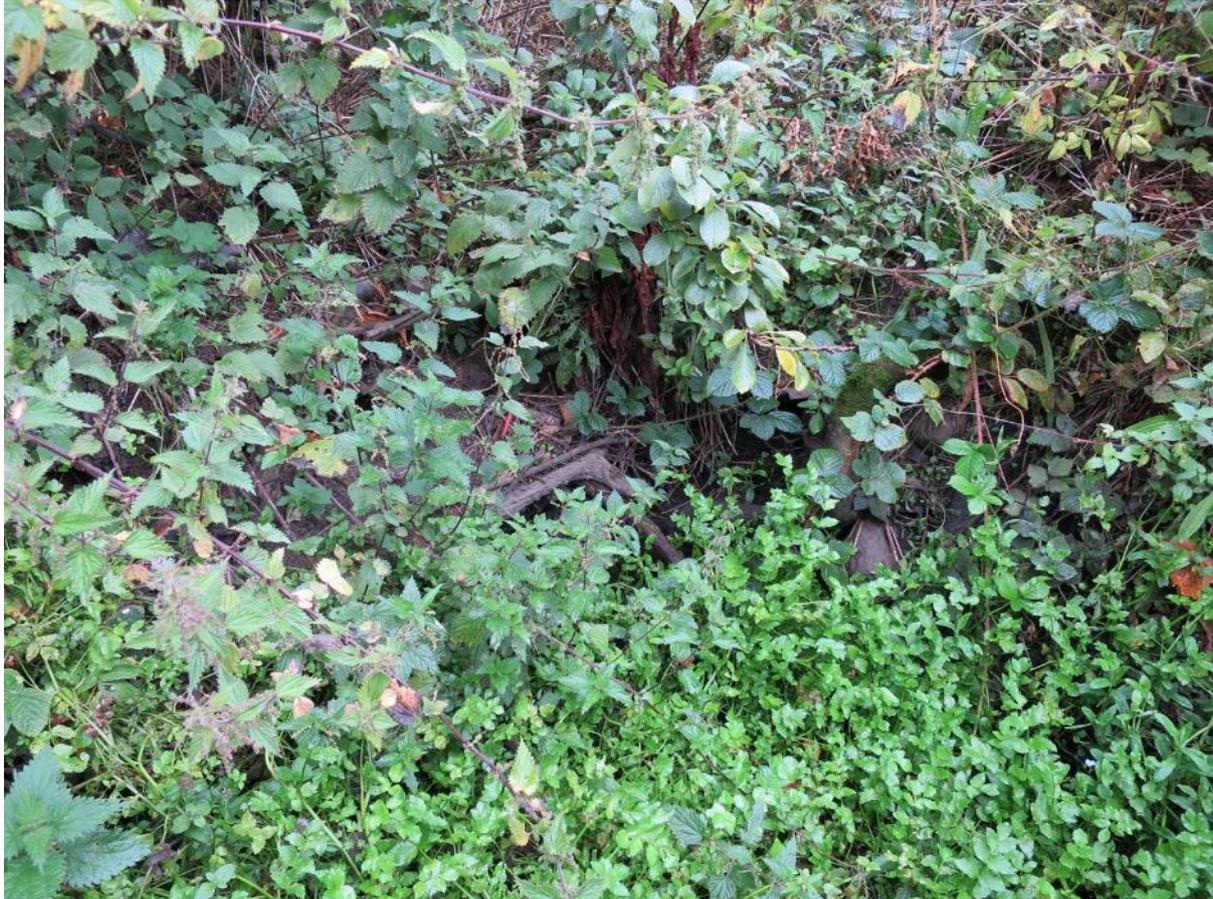
The choked channel condition is uniformly evident between SJ 86355 00875 and a largely blocked culvert entrance at SJ 86474 00966 (Fig. 9) and, while this marshy vegetation will provide habitat for some species, there is very limited value for fish.

This condition also highlights the futility of dredging activities in the adjoining upstream section. Increasing the supply of water (in terms of both volume and rate) to this section by increasing channel capacity upstream will not result in increased conveyance during spate conditions. There is a naturally, very low, limit to the rate at which water can escape the vegetation-choked channel and culvert.

Figure 9: Culvert entrance partially blocked by plant growth.

In terms of potential habitat improvements in this lower section, the historic importance of the culvert which takes the Penk under the footpath from Wrottesley Park House should be investigated. The culvert and path seem to be associated with an original gated access point for the estate. However, if it were possible, the removal of that culvert may enable the river to be returned to a more natural planform and capacity. In the process of producing that, unblocked, channel, it may be possible to speed the flows to avoid the complete domination of the wetted channel by vegetation. In support of that, a channel of natural (i.e. relatively narrow) width could be augmented by installing a series of felled trees (or material arising from the same). The timber should be anchored in such a way to mimic

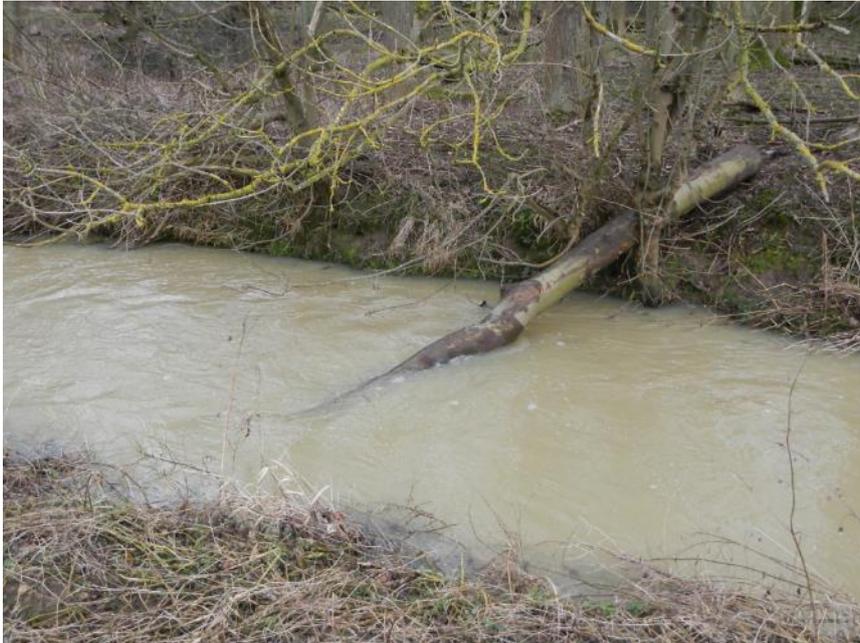
Figure 10: Cross-channel log under "bank full" spate conditions

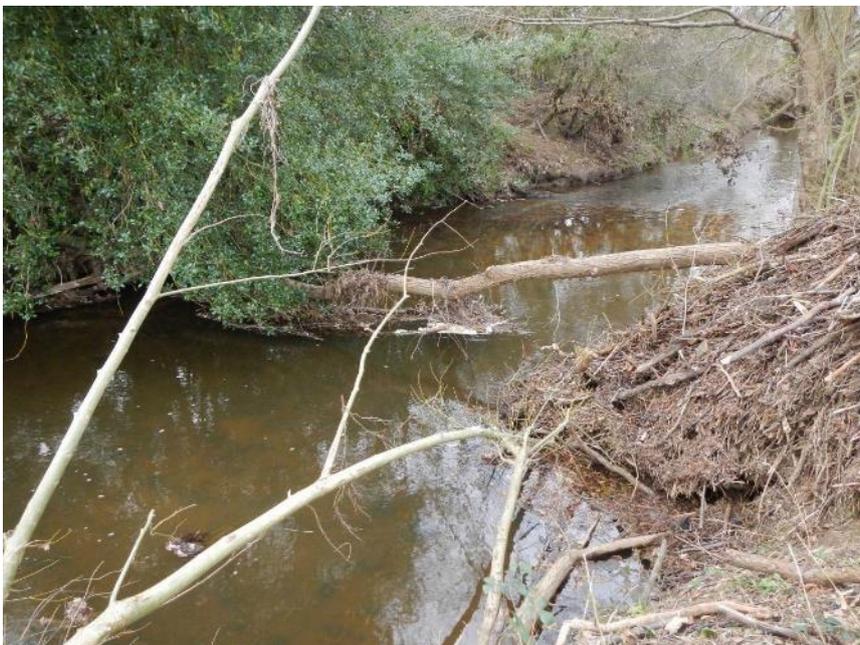
Figure 11: Cross-channel log example in normal flows
