Advisory Visit

River Perry, Whittington, Shropshire

2nd November, 2010

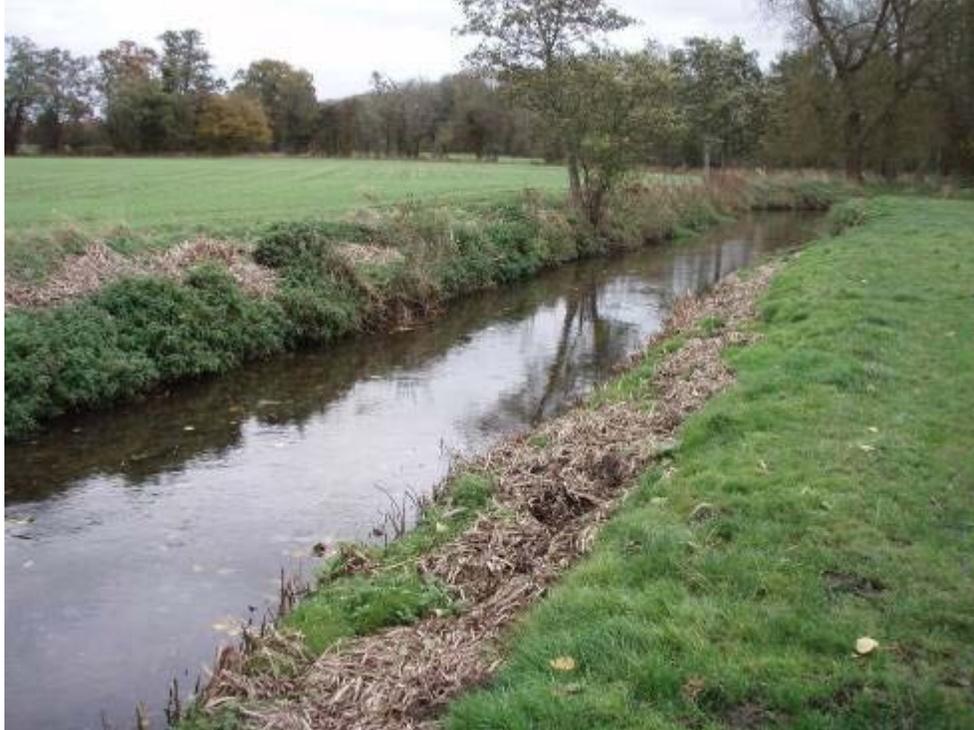
This section of the Perry has been previously modified for land drainage and unfortunately now lacks most of the requirements to sustain a wild trout population. The channel has a trapezoidal cross-section, is over-wide, uniformly shallow and has a bed consisting primarily of fine sediment. The over-wide nature of the channel promotes the deposition of fine sediment and the colonisation of emergent plants like rushes; the latter are removed on an annual basis by the Environment Agency river maintenance team (Photo 1).

Photo 1 Showing straightened, trapezoidal cross-section, shallow channel. No buffer zone is present between agricultural land and the river. Emergent vegetation is removed annually and can be seen deposited on the near bank.

In places arable farming and grazing is taking place immediately adjacent to the river (Photo 1). This has an impact on the riparian zone, that is the habitat alongside the river, which has an important influence on the overall habitat quality of the river. An uncultivated and ungrazed margin between field and river is desirable and this can often be incorporated into agri-environment schemes such as Entry Level Stewardship, Higher Level Stewardship and Countryside Stewardship (www.defra.gov.uk/rural/rdpe/erdp/schemes/index.htm). The protection afforded by these strips alongside the river allows excellent marginal habitat to develop, providing good habitat for fish (in the form of trees, shrubs and overhanging vegetation), largely stable banks with little erosion, shading of the channel (which helps control weed growth) and good habitat for wildlife, including otter and kingfisher. It is important that a marginal fringe of vegetation is retained when creating access for angling, and preferably access and egress points are created, between which the river is fished by wading.

A buffer zone should be created alongside the river to reduce the impact of agriculture on habitat and water quality in the river; options are available under various agri-environment schemes. Livestock should be fenced out of

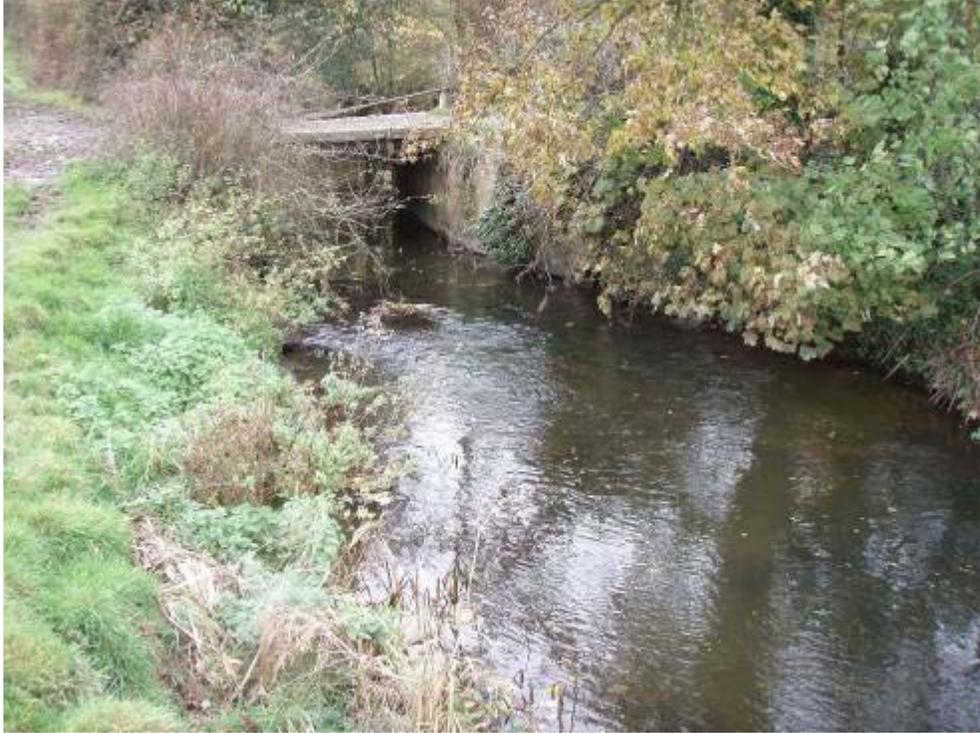
Photo 2 Deeper scour pool downstream of farm bridge

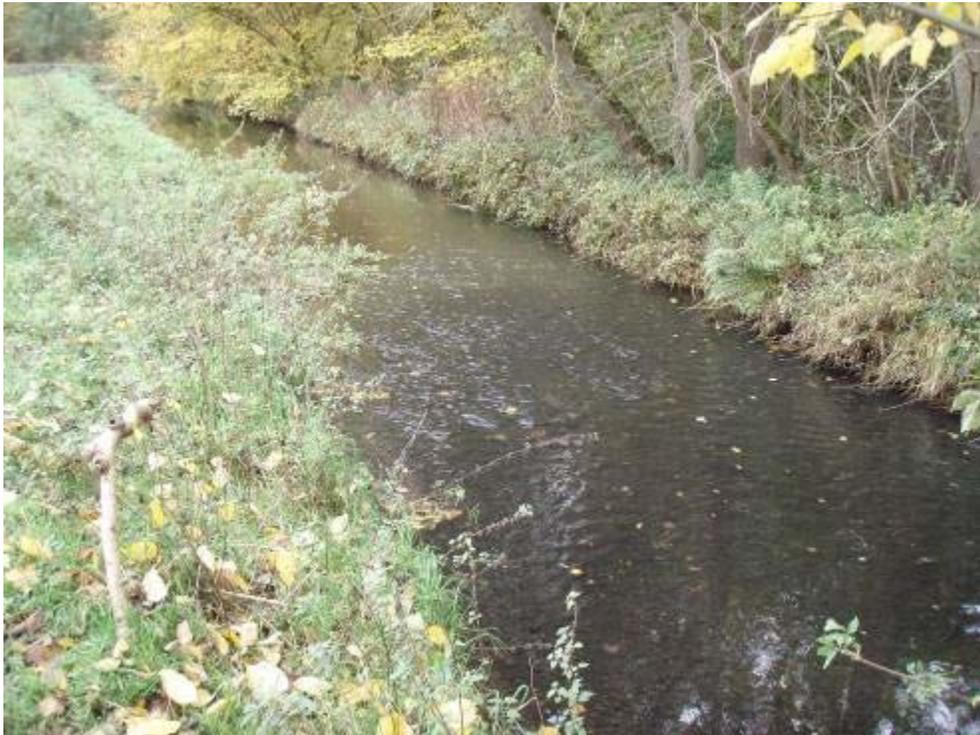
Photo 3 Gravel riffle area with deeper scour pool downstream

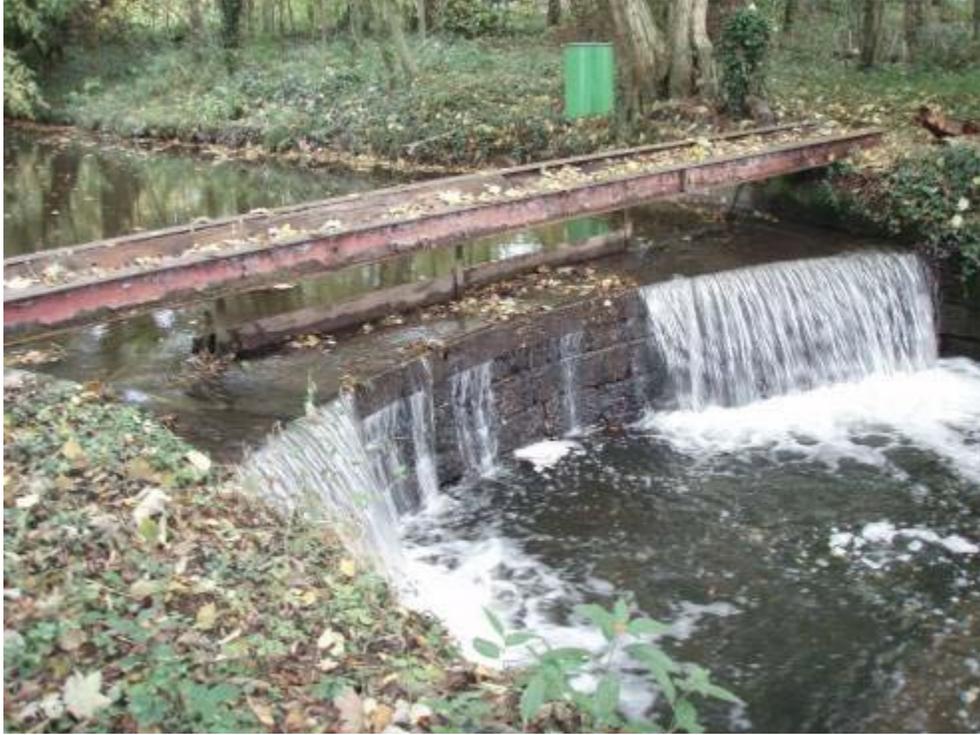
Photo 4 Horseshoe weir

The horseshoe weir and piling weir are both barriers to the free movement of fish within the river. This is significant because most fish species migrate to some degree during their life-cycle, for example for spawning, feeding or to fulfil seasonal or daily habitat requirements (e.g. reaching refuge areas). Barriers which prevent or delay such migrations lead to impoverished fish populations. Barrier removal or the installation of fish passes or easements improve this situation.

The weirs shown in Photos 4 and 5 should be modified to improve access for fish across them. Installing engineered fish passes is expensive, but easements such as pre-barrages are a cheaper solution. Pre-barrages are installed to break up the head difference across a barrier into manageable portions for fish to be able to cross. The principle is illustrated in Figure 4 and Photo 15.

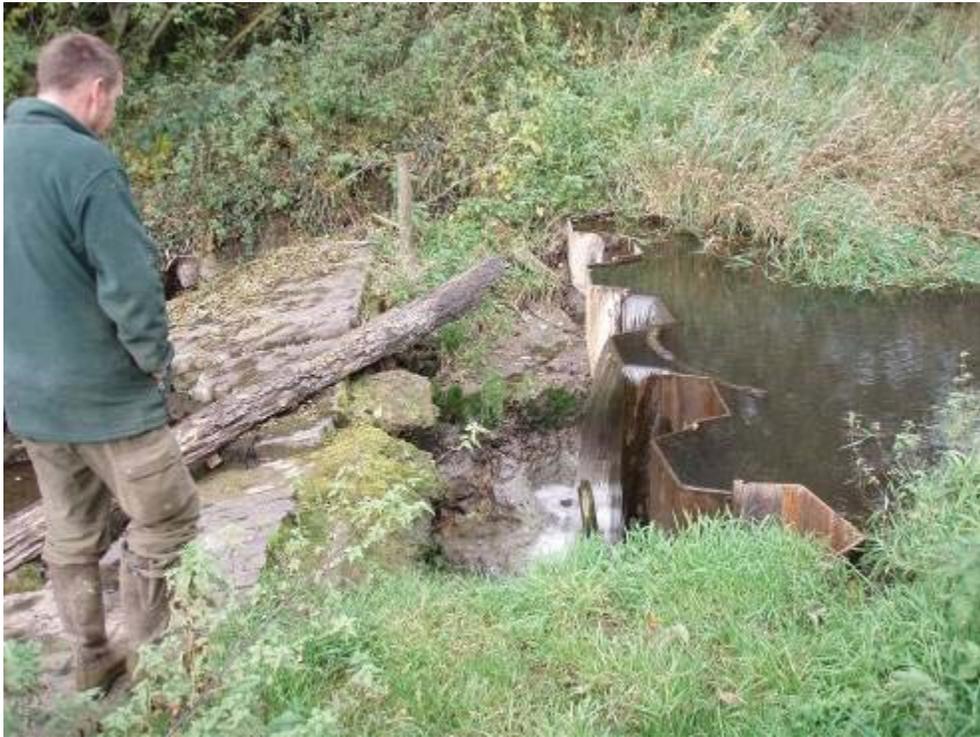
Photo 5 Piling weir replacing the broken-down brick structure

The back river is a small channel which begins at the smaller outlet from the lake below Noddy's Bridge. The old brick weir at this outlet collapsed in summer of this year and was replaced by steel pilings (Photo 5); since then the flow in the upper end of the back river has been reduced, possibly because the crest of the pilings is higher than the previous weir level. The back river also receives the outfalls from the other two lakes on the estate (Figure 3).

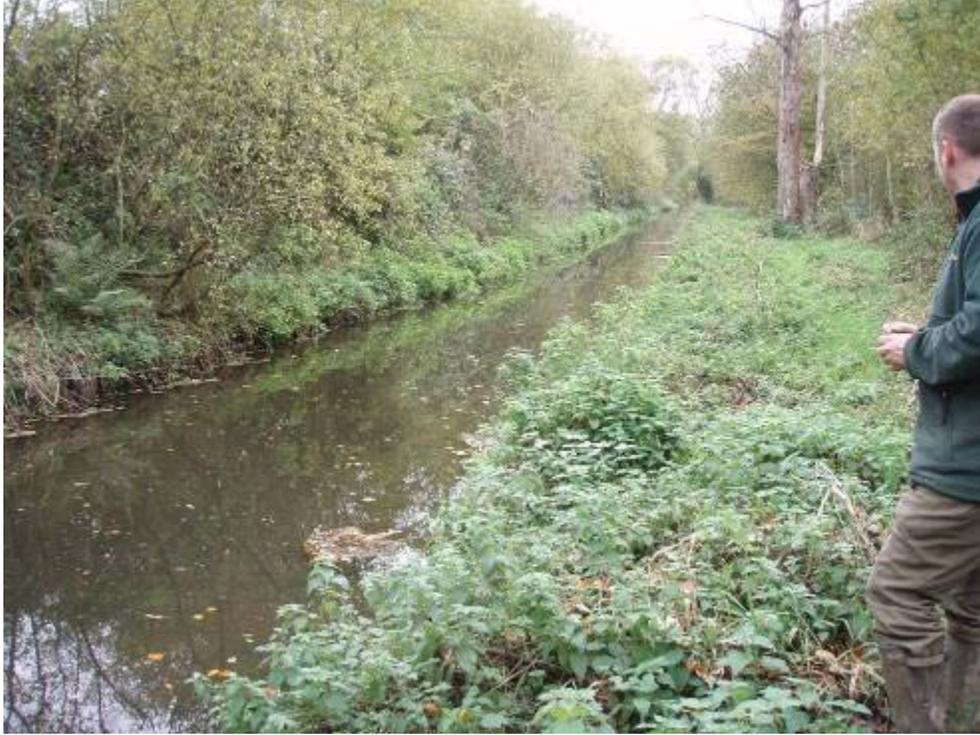
Downstream of the horseshoe weir the river has been straightened resulting in a canal-like section with slow flows and a bed comprising fine sediments (Photo 6). The gradient of the river here appears to be very shallow and this limits the opportunities for improving habitats. However with progress downstream, the gradient steepens and there is more potential for the installation of flow deflectors, etc. (see recommendations). Some areas of gravel are evident although again these are relatively thin deposits with lots of fine sediment entrained.

Photo 6 Long, straight, low-gradient section below the horseshoe weir

It would be worthwhile cleaning suitable areas of gravel by raking or jetting to break up the crust and dislodge fine sediments. See Appendix for gravel cleaning advice.

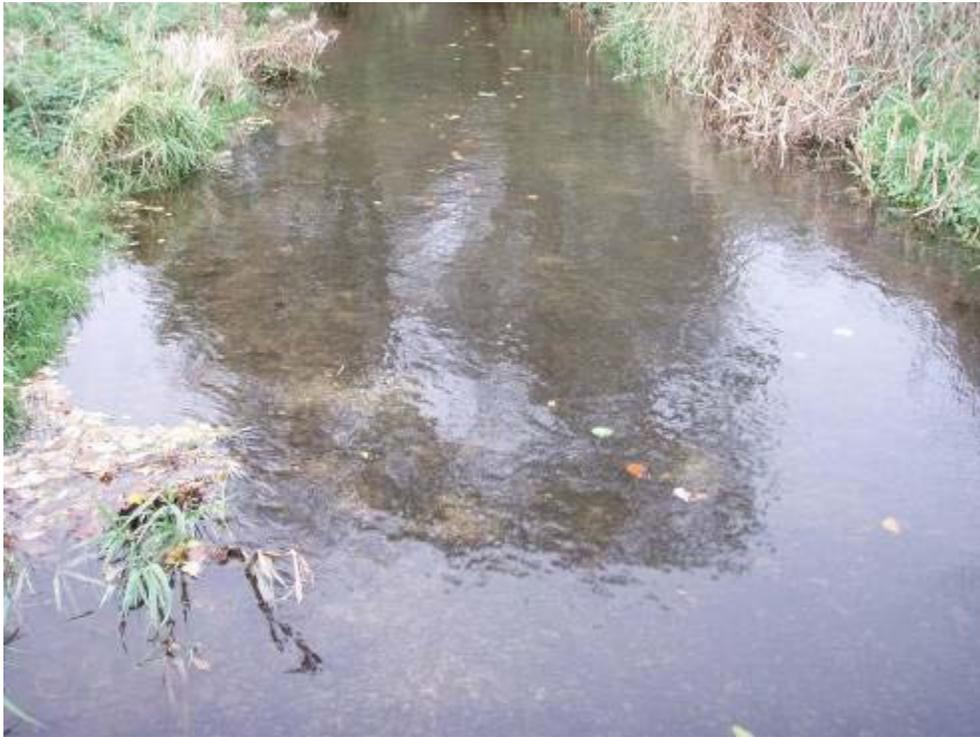
It appears that there may have been some initial "testing" by trout of the suitability of the gravel for spawning as there were a number of cleaner patches of gravel (Photo 7). Female fish often try out areas of gravel before selecting a suitable site to cut a redd (excavate a "nest" in the river bed by wafting away gravel with her tail) in late autumn.

Photo 7 Lighter patches on the gravel may be where trout have tested it for spawning suitability

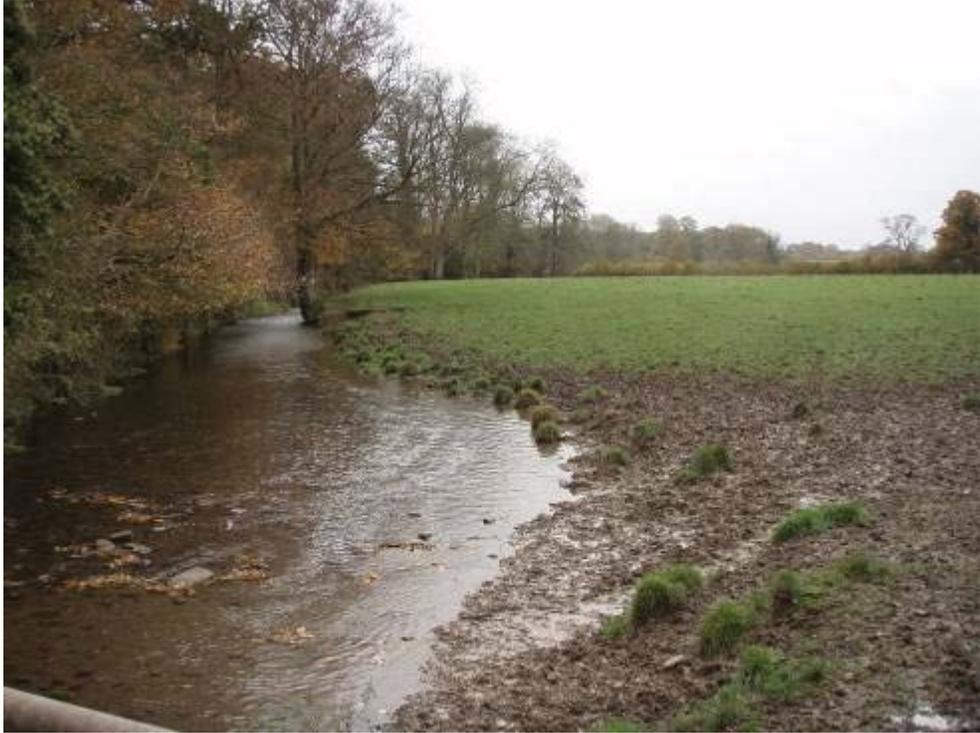
Downstream of the track bridge there are three fields on the right bank which are under separate land ownership. The fields are used for grazing livestock which have free access to the river; this has resulted in some severe poaching of the banks and widening of the river channel (Photo 8). Large amounts of fine sediment are entering the river from these areas and deposits of this are evident in slower parts of the river throughout the rest of the section. The left bank is wooded opposite these fields, then the river enters a wood on both banks.

Photo 8 Poached banks leading to over-widening of the river and excessive sediment input

the watercourse and the provided with drinking troughs, pasture pumps or dedicated watering points. (see Upland Habitat Manual for details).

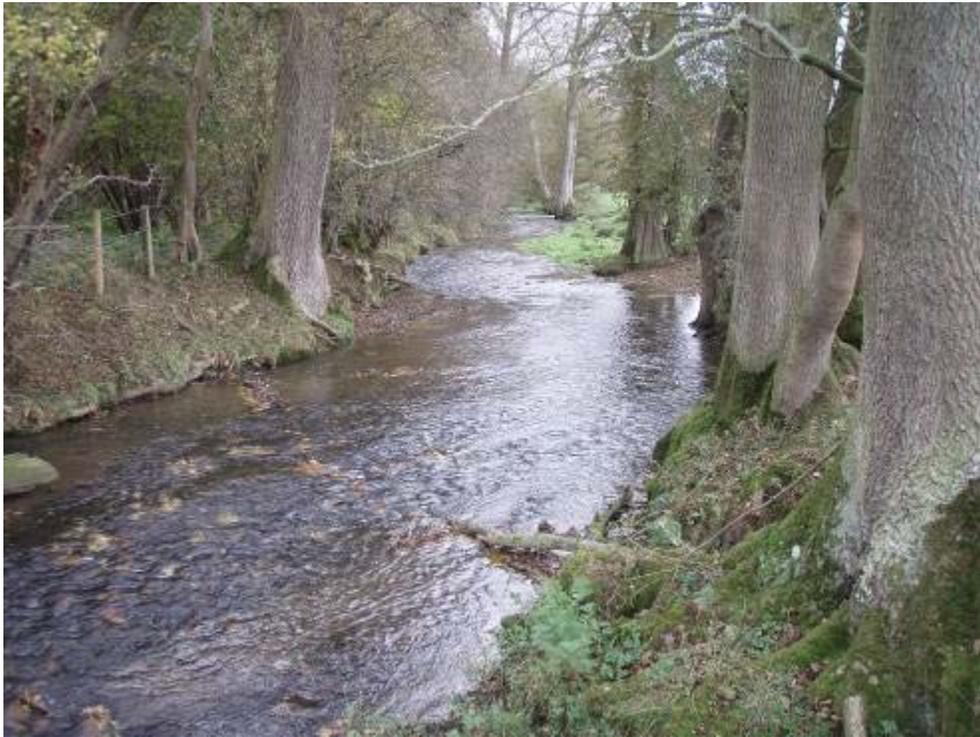
The character of the river changes markedly in this section and there is a more natural appearance to the river. The river is more connected to its floodplain and the river bed substrate is predominantly gravel. The channel is still relatively straight compared with an un-modified river, but there is a pool-riffle sequence and much better in-stream habitat than the rest of the river (Photo 9 and 10). There is however still a lack of deeper pool areas and this could be improved by introducing large woody debris (LWD).

Photo 9 More natural channel features exist in the downstream section of the main river.

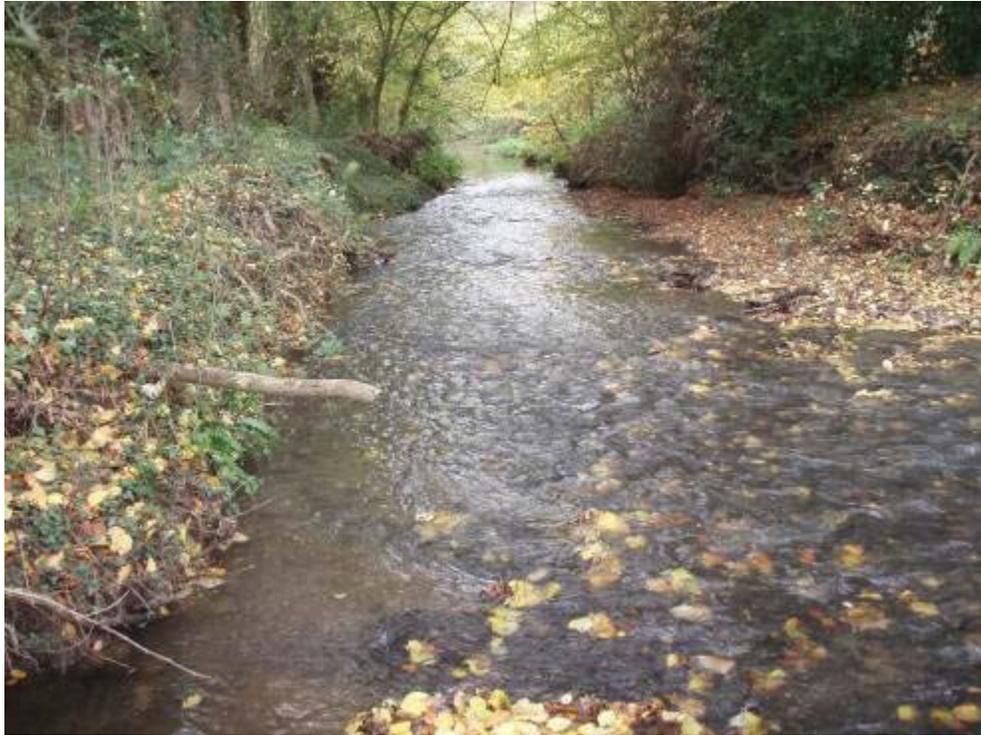
Photo 10 In the wooded section

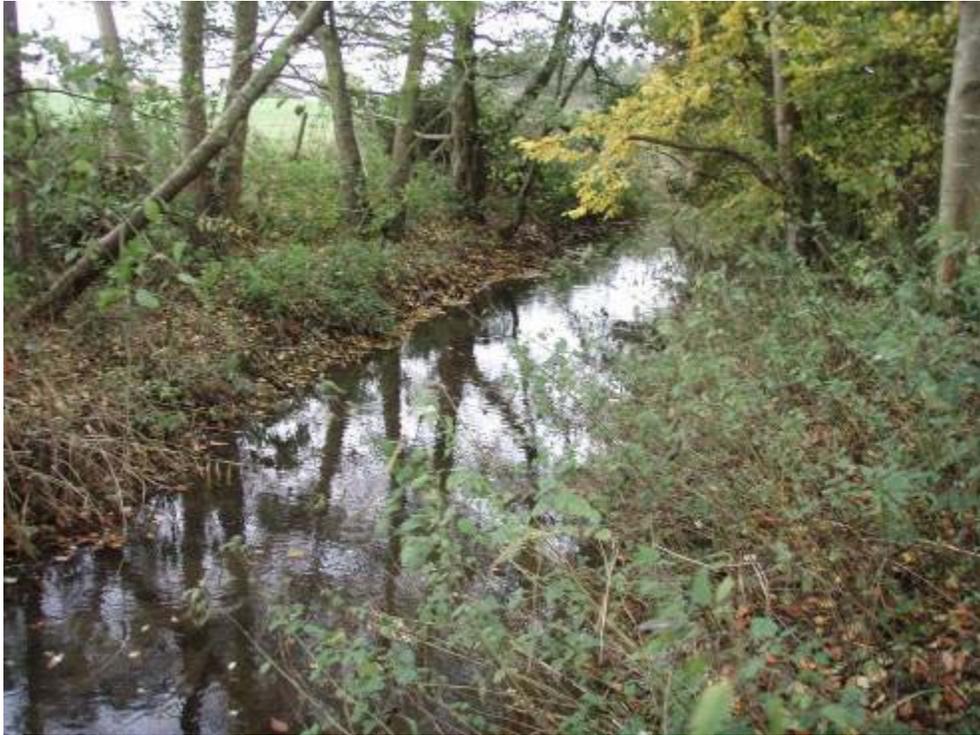
Photo 11

The channel is narrow and straight and flows through open fields before entering the wood and re-joining the main river. The open section has a dense growth of low vegetation fringing the channel (Photo 12) which contrasts with the shady, wooded section where there is far less cover (Photo 11). Trout are known to inhabit the back river and have been caught here and observed in the deeper pool area below a pipe culvert where the track crosses (Photo 13).

The presence of trout indicates that there is sufficient habitat in the back river to sustain a small population. However this is likely to be heavily dependent upon the small areas of gravel suitable for spawning and the good cover afforded by the shaggy marginal vegetation. There is certainly scope for improving trout habitat by creating deeper pool areas and more spawning gravel whilst retaining the good marginal cover.

On the back river, it is recommended that some pool areas are created by using logs to construct low weir structures. It is important to stress that these structures should be designed **not** to impound water upstream, but to focus flows downstream of the structure creating scour and maintaining depth. There are various designs which can be used (e.g. Figures 5-7), but in such a small channel, simply experimenting with fixing logs at an angle across the channel (bearing in mind the downstream scour principle) should

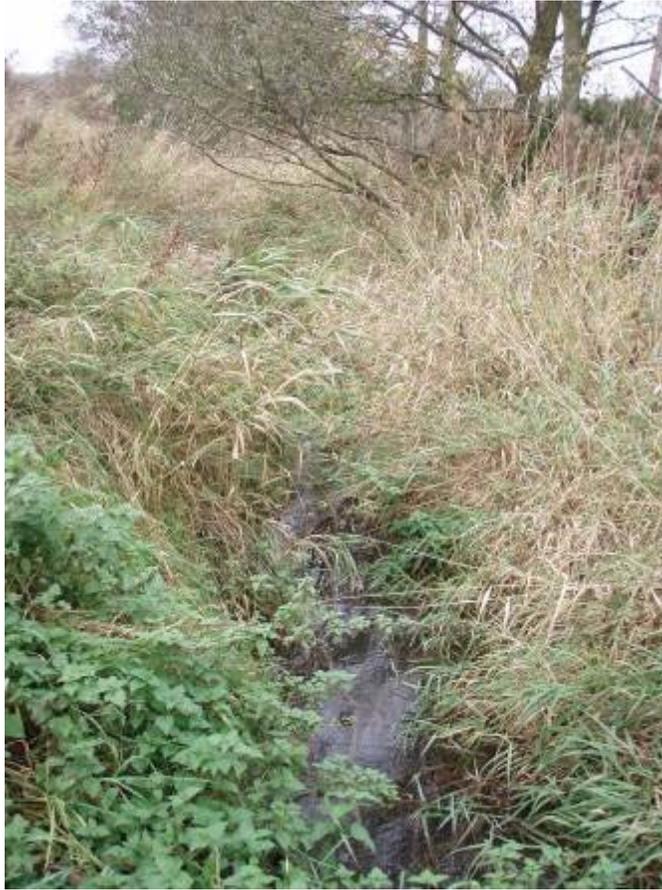
Photo 12 On the open section of the back river shaggy marginal vegetation provides excellent cover for fish

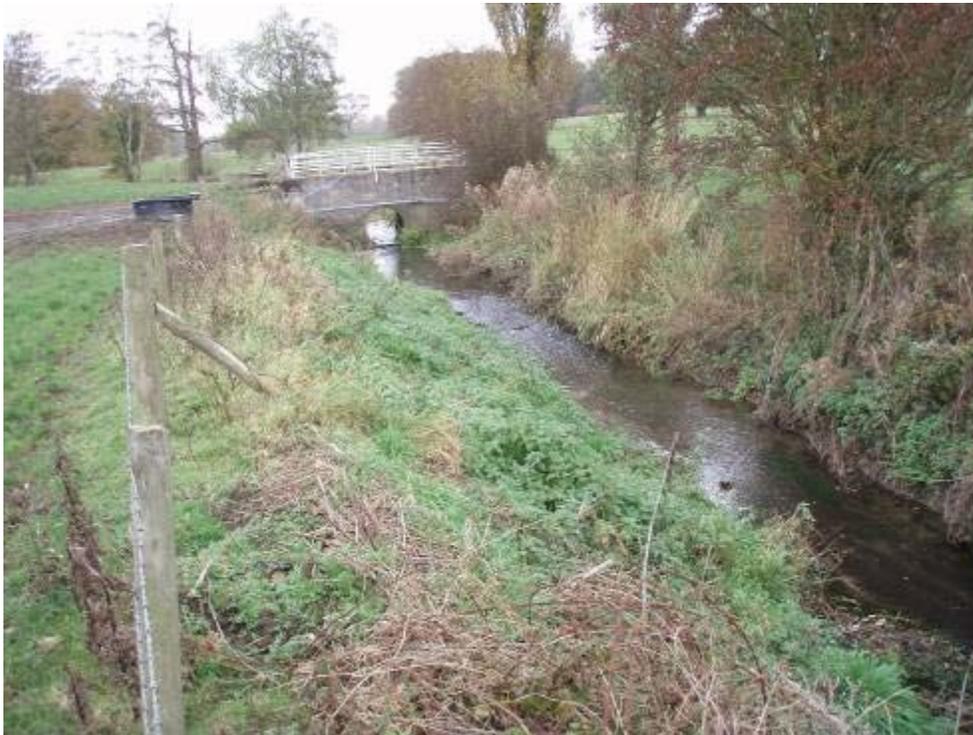
Photo 13 Pool below the bridge culvert on the back river which holds trout. (The cattle drinker on the left of the bridge would be better positioned away from the watercourse to prevent silt from the muddy ground washing into the watercourse).

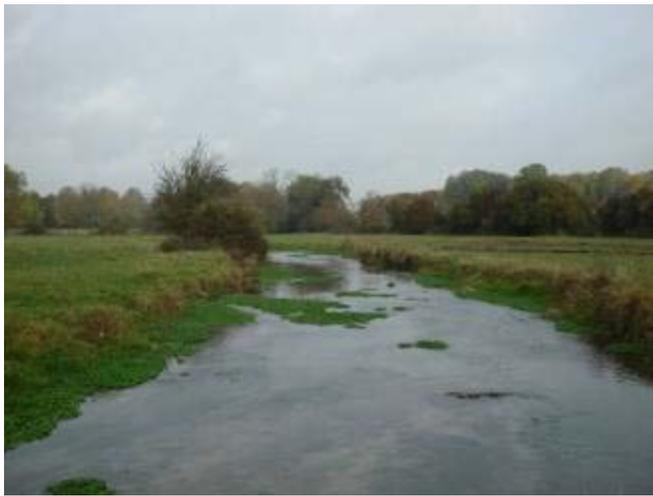
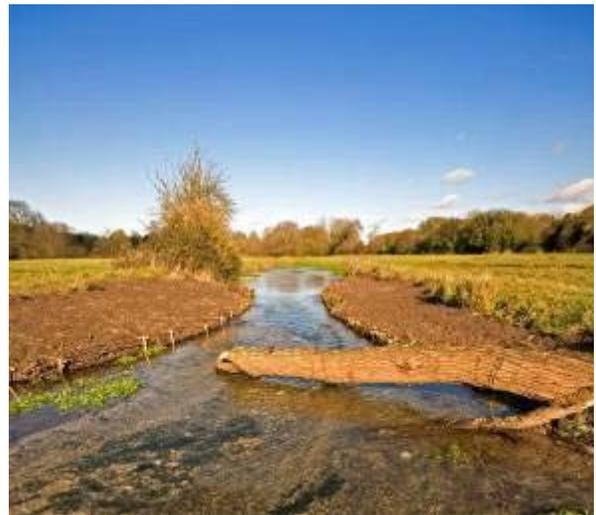
Before (above left) and after shots of narrowing a section of over-wide channel. Immediately after completion (top right); One year later (bottom left). An undershot flow deflector has also been installed.

The upstream section above the main road should have the channel narrowed to re-create a more natural base width to the river and gravel and large woody debris introduced. Various techniques can be used and these are detailed in the manuals supplied on the visit: the Wild Trout Survival Guide (p 40-45) and particularly the Chalkstream Habitat Manual.

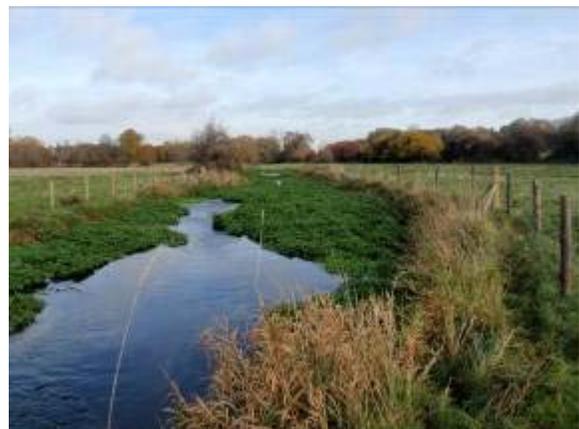
Flow deflectors, groynes and large woody debris could be installed along the uniform sections of river. The effects of positioning such structures are shown below; they are generally best positioned pointing upstream to avoid bank erosion.

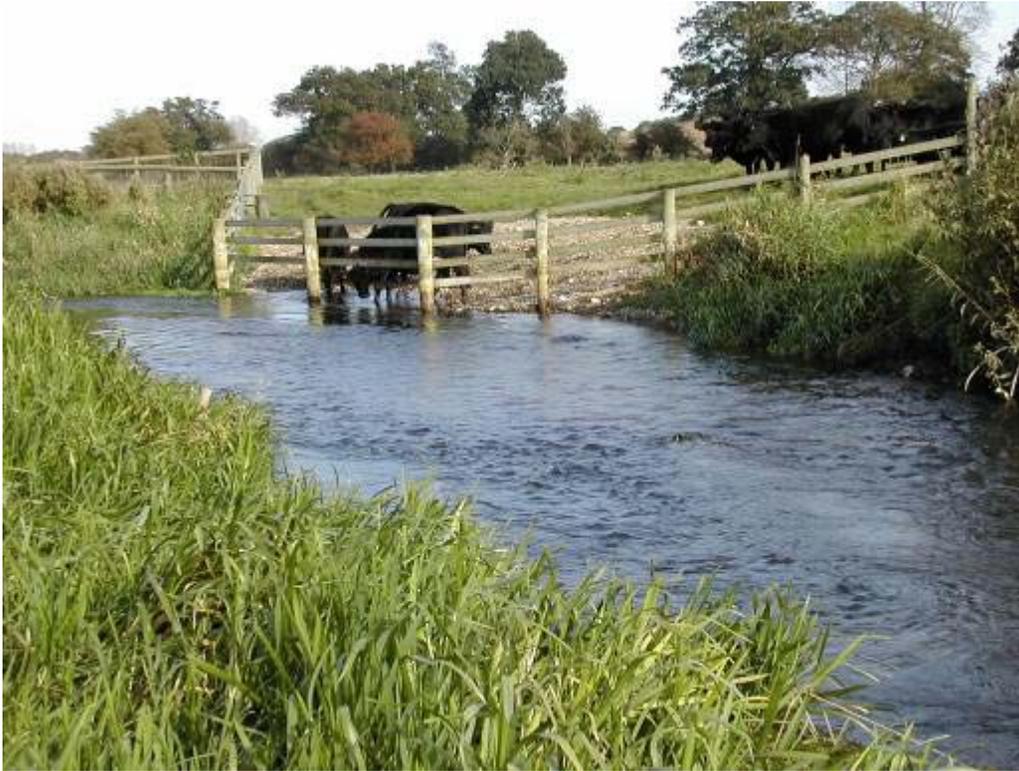
Photo 14 Example of a cattle drink with hard standing area.

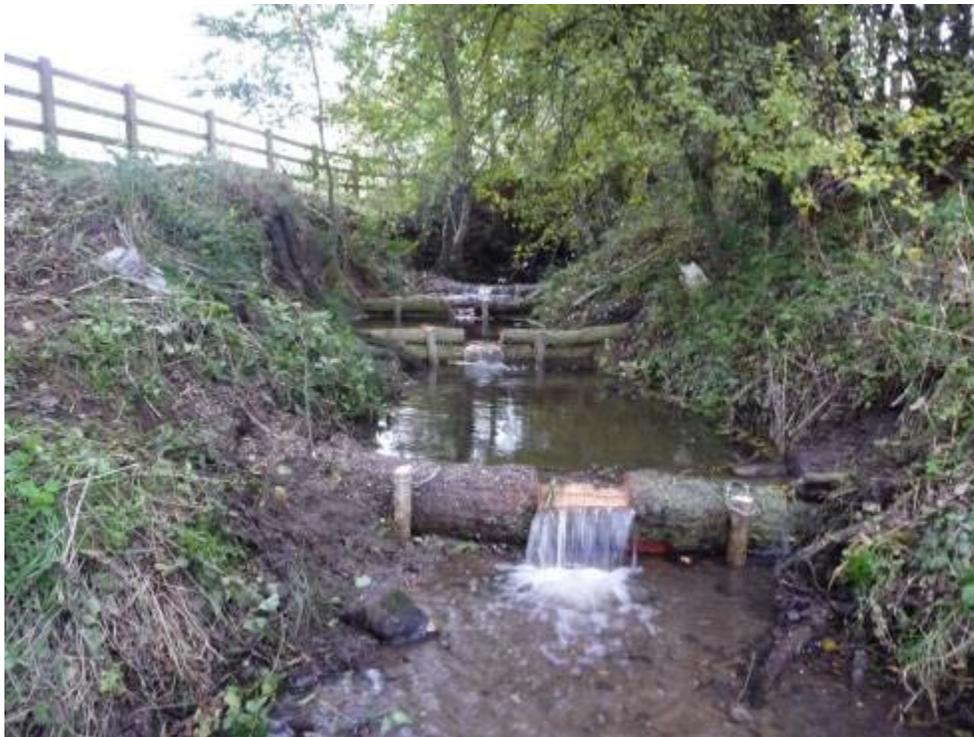
Photo 15 Pre-barrages can be installed in series to overcome the head difference at a barrier

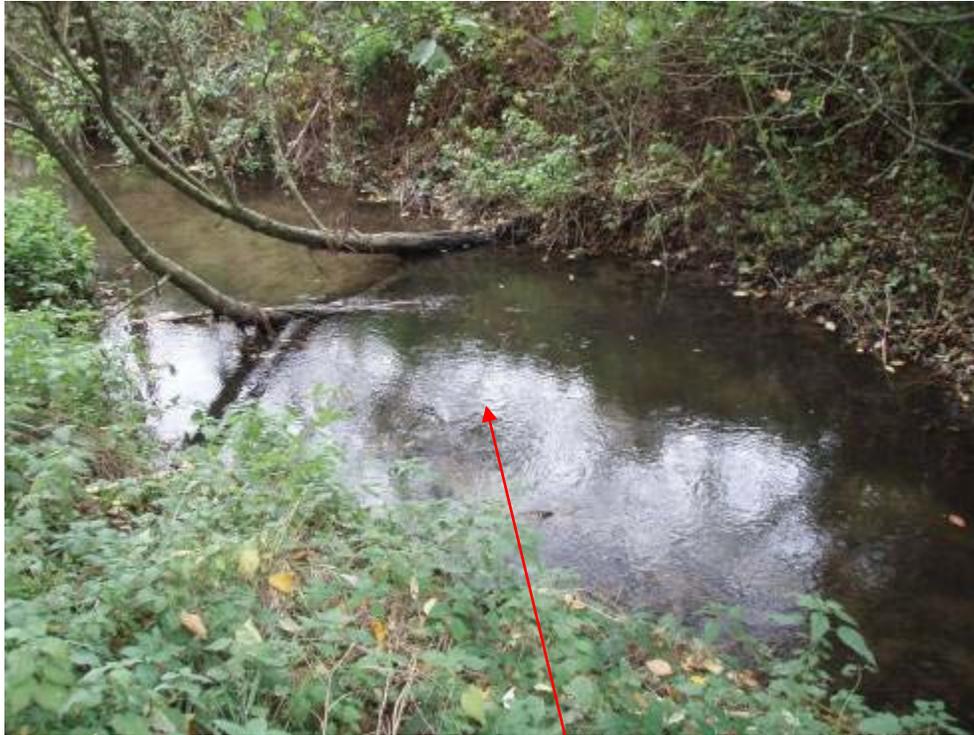
Photo 16 Example of woody debris enhancing habitat. A scour pool has formed downstream of these leaning trees on the back river, providing valuable fish habitat.

In addition to introducing structures, it is important to make the most of those that occur naturally, such as woody debris which has fallen into the channel. Woody debris promotes the development of a range of habitats including localised scour which keeps patches of gravel clean and sediment free; these will be actively sought out by spawning fish (Photo 11). Adopt a policy of retaining it in the river channel wherever possible. The West Country Rivers Trust provides a useful guide to the management of natural woody debris:

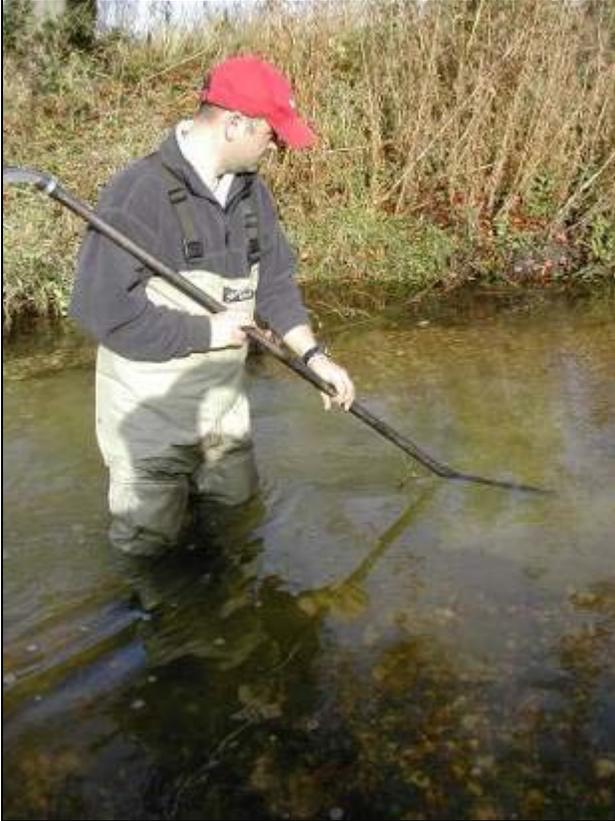
Jetting riffles

3). Gravels need to be cleaned in September / October, prior to spawning (Nov-Jan) to an approximate depth of 20-30cm; on no account do it later than this or you may be causing more damage than you are trying to rectify. Concreted gravels need to be broken up, by bashing away at them with the steel lance (or a crow bar), they do break up to leave loose gravel, it's just hard work! Work in a downstream direction to avoid mobilising silt into areas already cleaned.
