Advisory Visit
River Perry, Shropshire
June 2019

1.0 Introduction

This report is the output of a site visit undertaken by Tim Jacklin of the Wild Trout Trust to the River Perry at Yeaton Pevere Estate, Shropshire, on 10th June 2019. Comments in this report are based on observations during the site visit and discussions with Jack Cooper of Balfours, the agent for the owners of the fishery.

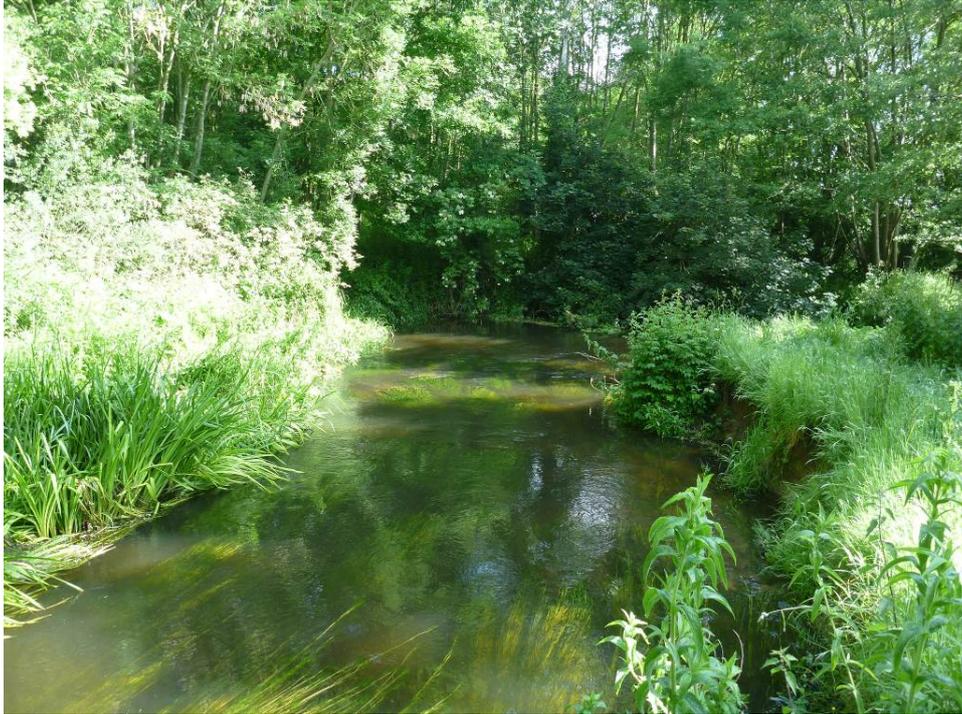
Photo 1 Good river habitat provided by a meandering plan-form, variety of depths, dappled shade and a healthy riparian zone.

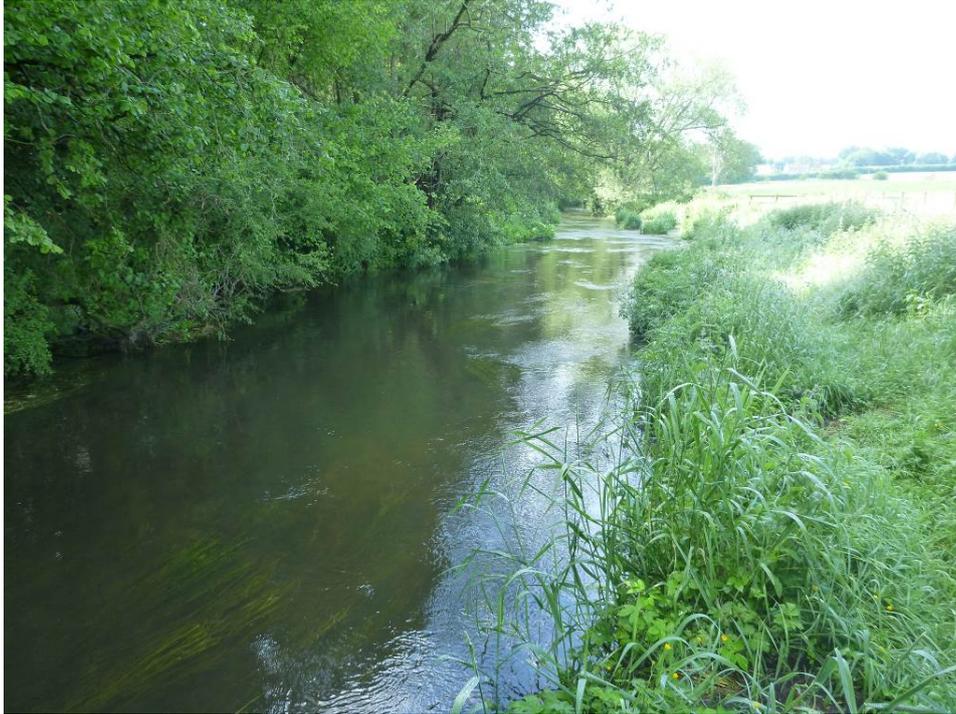
Photo 2 A more uniform section of the river which has probably been straightened in the past. Good marginal habitat and cover are present, but the channel would benefit from some woody material to promote bed scour and depth variation.

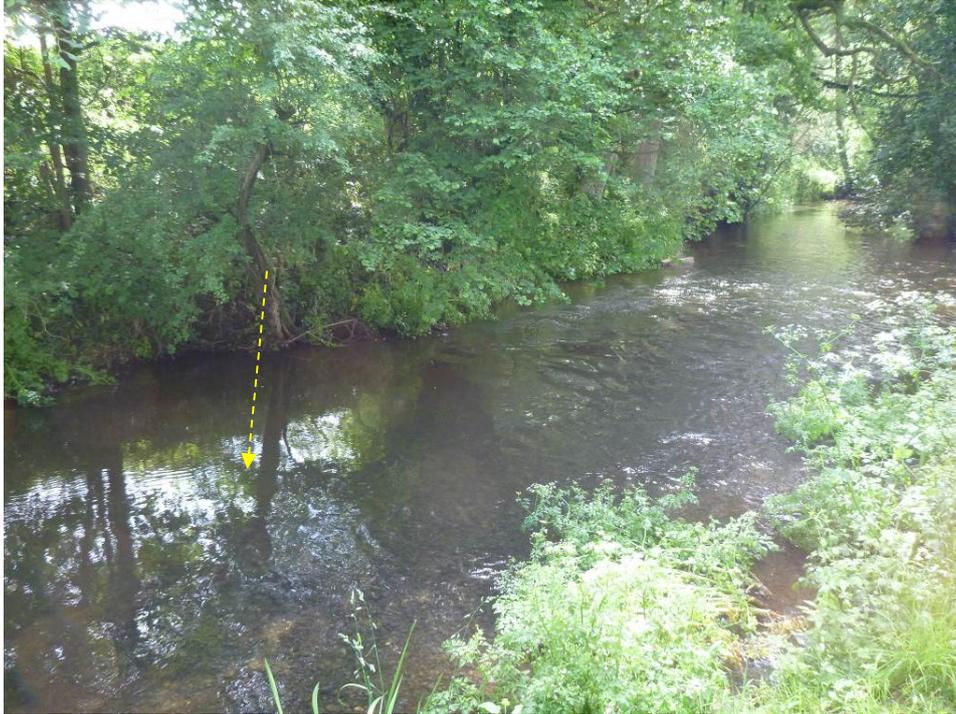
The shallow, faster, gravel-bottomed sections of water (riffles) are where most river fish species choose to spawn, including trout and salmon. Loose, un-compacted gravel containing a low proportion of fine (<2 mm) sediments is very important for the survival of incubating trout and salmon eggs and alevins, which spend several weeks buried in gravel nests (redds) cut into the gravel by the adult female fish. The riffle areas on this part of the Perry contained a high proportion of fine sediment and were compacted; this is very likely to compromise the survival of trout and salmon eggs and alevins and represents a bottleneck in the lifecycle of these fish. The problem of fine sediment and compacted gravels remains. In 2009 the recommendation was to carry out gravel jetting as a temporary fix, but there are problems with this approach including identifying the specific areas where fish will choose to spawn. Additionally, fine sediment inputs could occur soon after gravel jetting, rapidly undoing the benefits. A better approach is to introduce flow deflectors made from large woody material to create localised scour and well-sorted gravel which will remain free of fine sediment and allow fish a range of options for preferred spawning areas (Photo 3).

Photo 3 Introducing woody structures to riffles and pool tails where gravel is present will create localised scour to winnow out fine sediment and improve spawning conditions. In this example, the tree indicated could be hinged over.

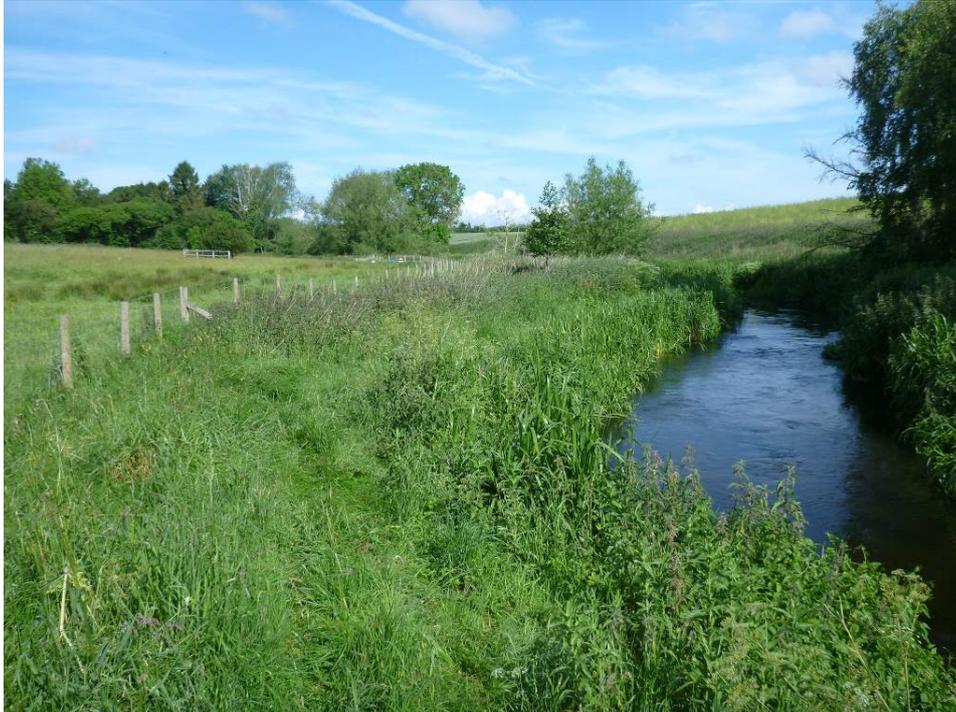
The majority of the banks are fenced and have a generous margin between cultivated land and the river. The protection afforded by these strips alongside the river has allowed excellent marginal habitat to develop, providing good habitat for fish (in the form of trees, shrubs and overhanging vegetation), largely stable banks with little erosion, and good habitat for wildlife, including otter and kingfisher. It is important that the marginal fringe of vegetation is retained when creating access for angling, and preferably access and egress points are created, between which the river is fished by wading. The management of the riverside habitat at Yeaton Pevereley is exemplary and continues to provide the abovementioned benefits (Photo 4), along with excellent habitat for riverflies to complete their lifecycle (e.g. shaggy vegetation where mayflies can moult before mating and egg-laying). There is a short section of the river on the LHB which is in different ownership and has reduced quality marginal habitat due to livestock access (Photo 5). Access for angling from the bank (rather than by wading) was discussed – the management of the riverbank for this can reduce habitat quality because of the desire to remove obstacles to casting, with knock-on impacts upon the amount of cover for fish or shading for the river. The

Photo 4 A wide margin between the field and river, along with light-touch management for angling access provides excellent riparian habitat along the majority of the fishery.

negative impacts can be minimised by restricting bank fishing access to certain beats and to only one bank (usually the RHB to favour right-handed casting). Strimming a path back from the river's edge and leaving a shaggy vegetated margin is also good practice.

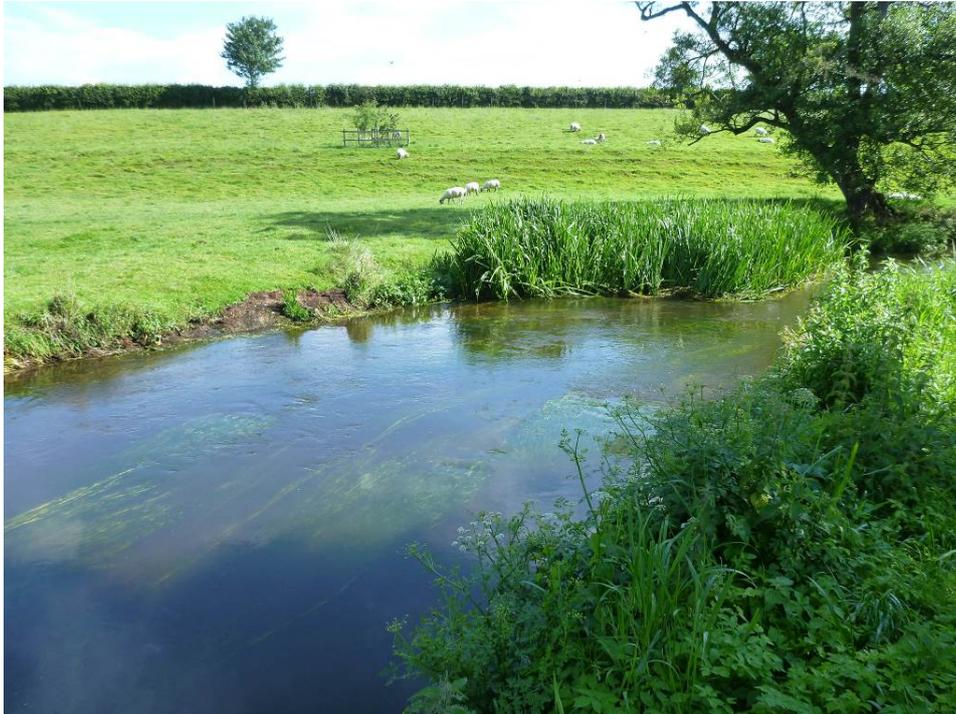
Photo 5 Livestock access on the LHB reduces the habitat quality by grazing off marginal plants, leading to a wider and shallower channel with reduced cover for fish. Ideally this section should be managed in a similar way to the rest of the fishery.

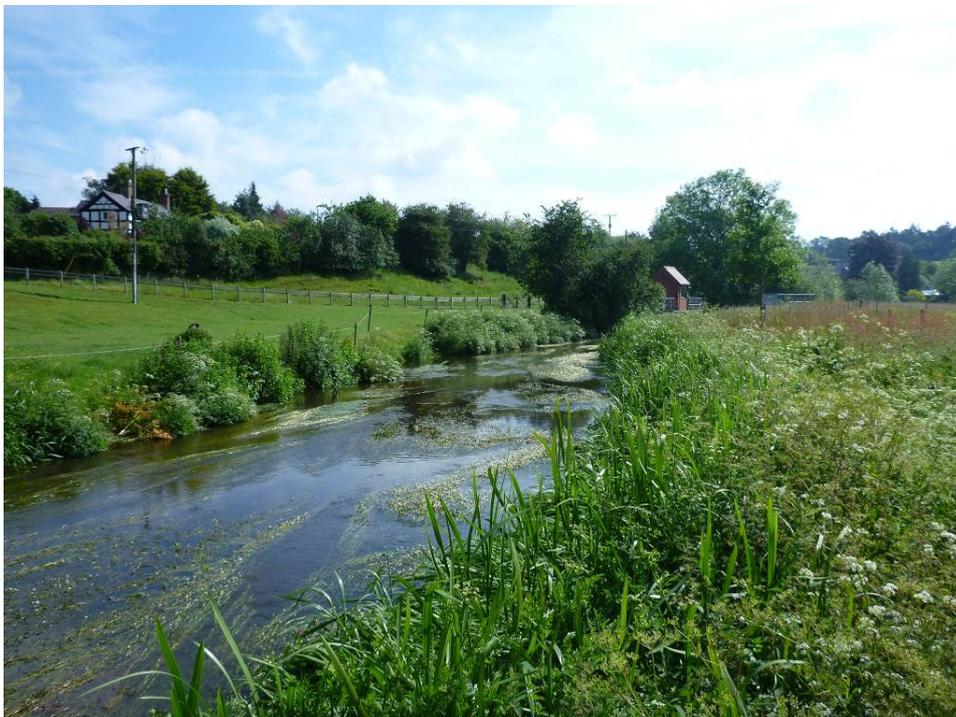
The full extent of aquatic weed growth was evident during this visit, with prolific stands of water crowfoot present in less-shaded areas (Photo 6); the crowfoot was coming into flower, which is approaching the point it reaches its maximum biomass during the year. The annual weed cut (by hand) was being carried out at the time of the visit, later in the year than the usual timing of April/early May. Weed cutting in spring and summer tends to stimulate the growth of water crowfoot leading to a higher overall biomass than in streams that are left uncut in the long term. Cutting weed in the autumn tends to suppress growth the following spring but can have negative

Photo 6 Prolific growth of water crowfoot in an open section of the river (upstream of the EA gauging station). Establishing more tree shade on the southern bank in areas such as this may reduce the need for weed cutting in the longer term.

Shading of the river channel plays an important role in regulating weed growth and the difference in the amount of submerged weed between open reaches and those with tree shading is easy to see. In the longer term, establishing trees and bushes on the southern bank in the more open reaches will provide a natural brake on weed growth.

- Establish trees on the southern bank in areas where aquatic weed growth is very prolific, in order to provide more shading in the long term.
- Review weed cutting practice with reference to the WTT guide here https://www.wildtrout.org/assets/files/library/Manage_Riparian.pdf. Continuing the annual spring cut probably strikes the best compromise between river ecology and fishing access, but a trial of different weed-cutting regimes on different sections of the river could be considered. For example, leaving a section uncut for several seasons may see a natural reduction in weed biomass. Cautious and limited (in extent) autumn cutting could be trialled in particularly densely weeded areas to see if this controlled growth the following spring; note however the potential negative impacts on over-winter cover – this should not be a blanket policy of autumn cutting, but very selectively targeted. Marginal vegetation (emergents like reeds, rushes, etc.) should not be cut back.

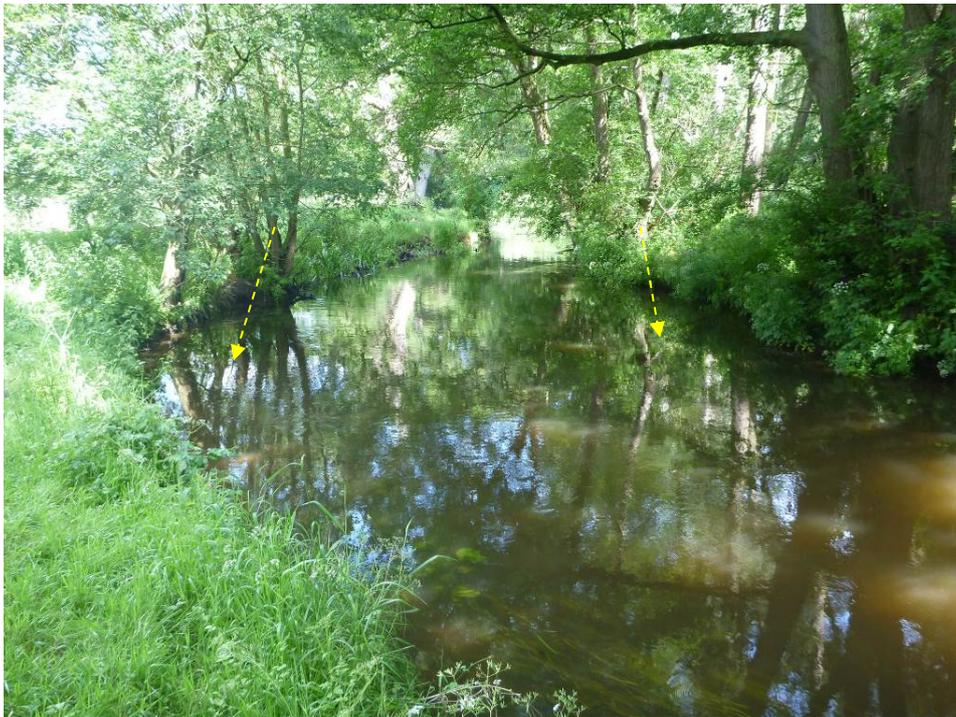
Not many examples of large woody material (fallen trees, branches) were observed during the visit. As noted above, these structures help to naturally engineer good habitat through localised scour, as well as providing good

Photo 7 Opportunities for introducing large woody structures.

cover and habitat niches for invertebrates upon which trout feed. It is recommended that naturally occurring tree falls are left *in situ* unless there is an overriding need to remove them. There are numerous opportunities to introduce such structures throughout the fishery, where suitable trees occur along the river bank (Photo 7).

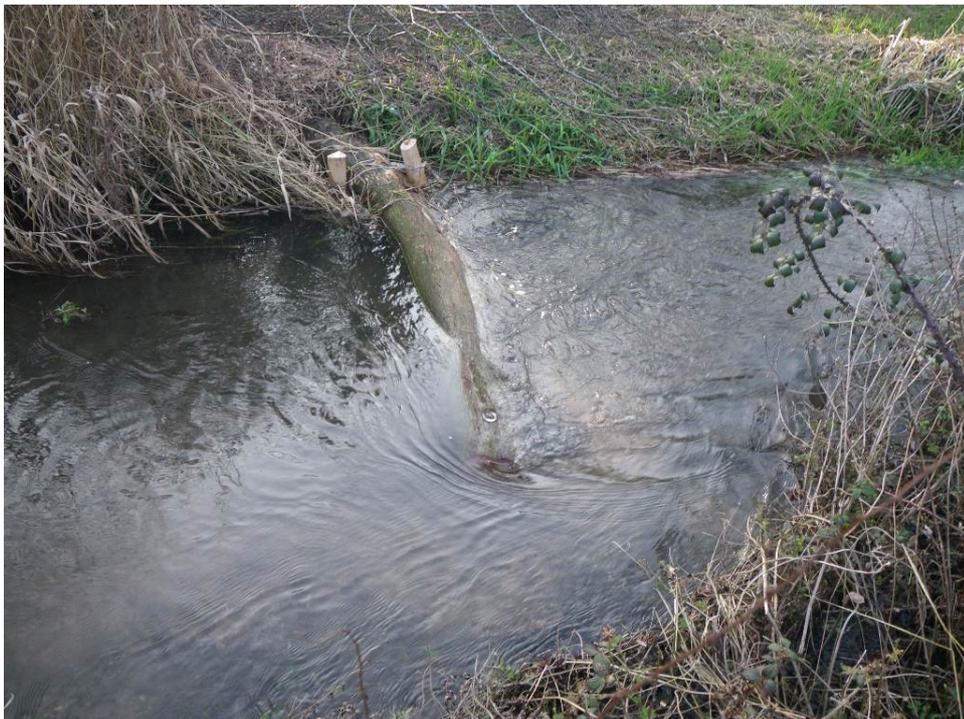
Photo 8 A log flow deflector creating flow variation and scour.

- Retain naturally occurring fallen woody material within the channel wherever possible.
- Introduce in-stream woody structures in uniform, shallow straights and in areas where gravel occurs (Photo 8 and Photo 9). Areas most likely to benefit would be between the EA gauging weir and the sewage works (Beat B) and the upper part of Beat C (above Fitz Mill Farm).

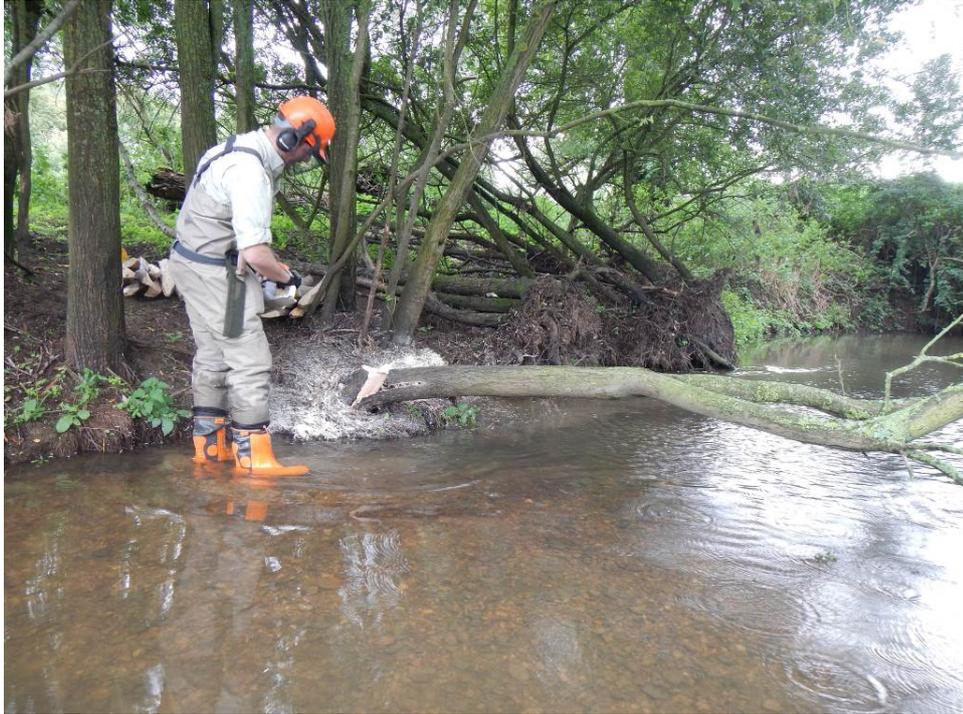
Photo 9 Partially cutting and laying a live tree to create in-stream structure.
