**Advisory Visit**

**River Petteril, Cumbria**

**8<sup>th</sup> February, 2010**

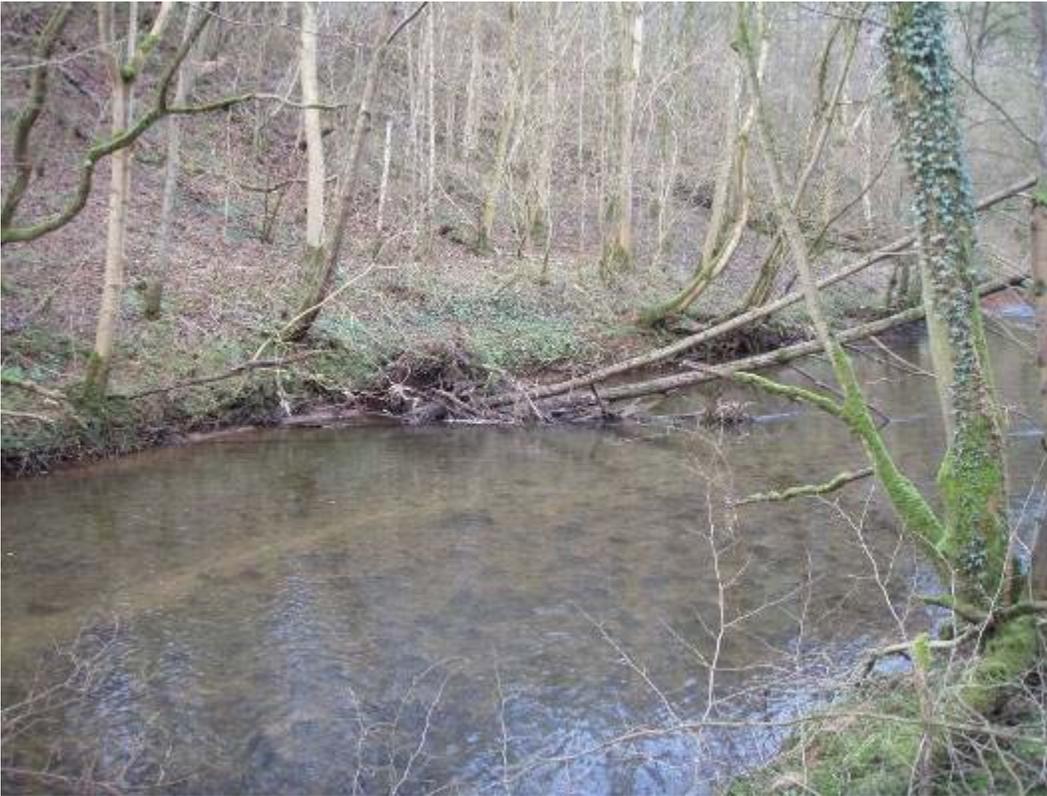
There is a very sandy, friable soil here which is not particularly resistant to erosion, a fact exacerbated by the absence of dense low bankside vegetation at this shaded site. These factors have created a river channel which is generally wide and shallow, dominated by riffle and shallow glide habitats, with few deeper pools which provide good habitat for adult fish (Photos 1, 2). The river bed substrate is poorly sorted and contains a high proportion of fine particles (sand), which mitigates against successful salmonid spawning (Photo 1).

**Photo 1 Wide, shallow river channel with a high proportion of fine sediment in the bed substrate**

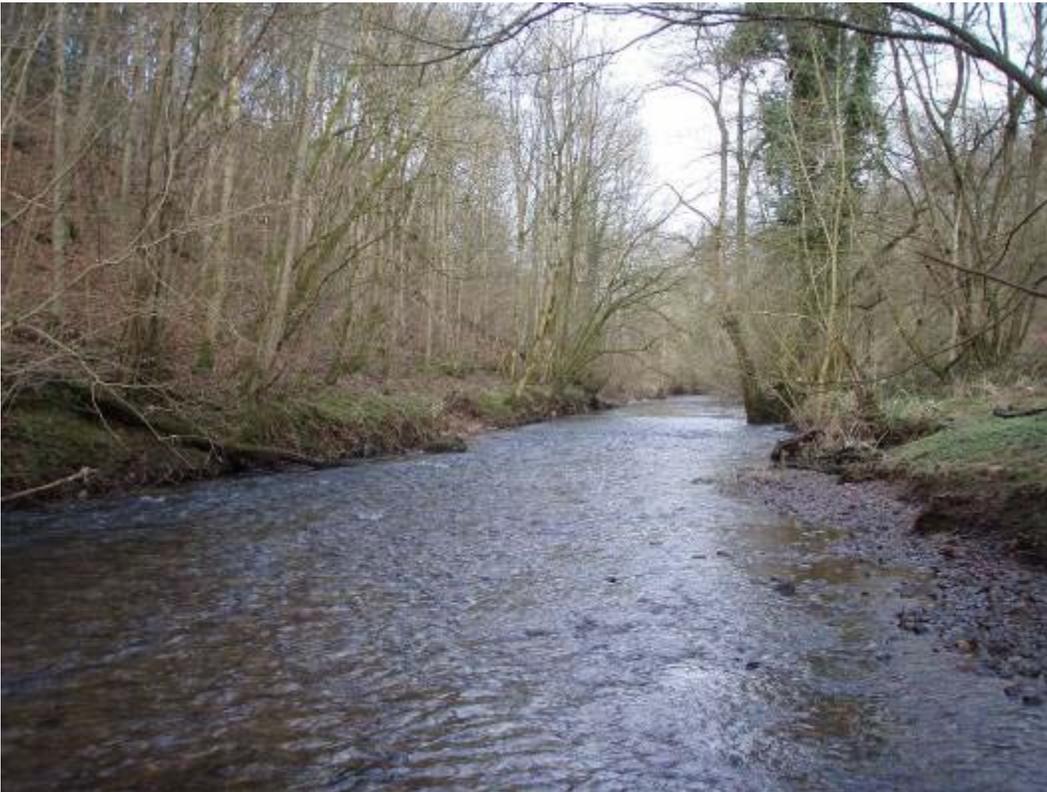
**Photo 2 The reach is dominated by shallow riffle and glide habitat**

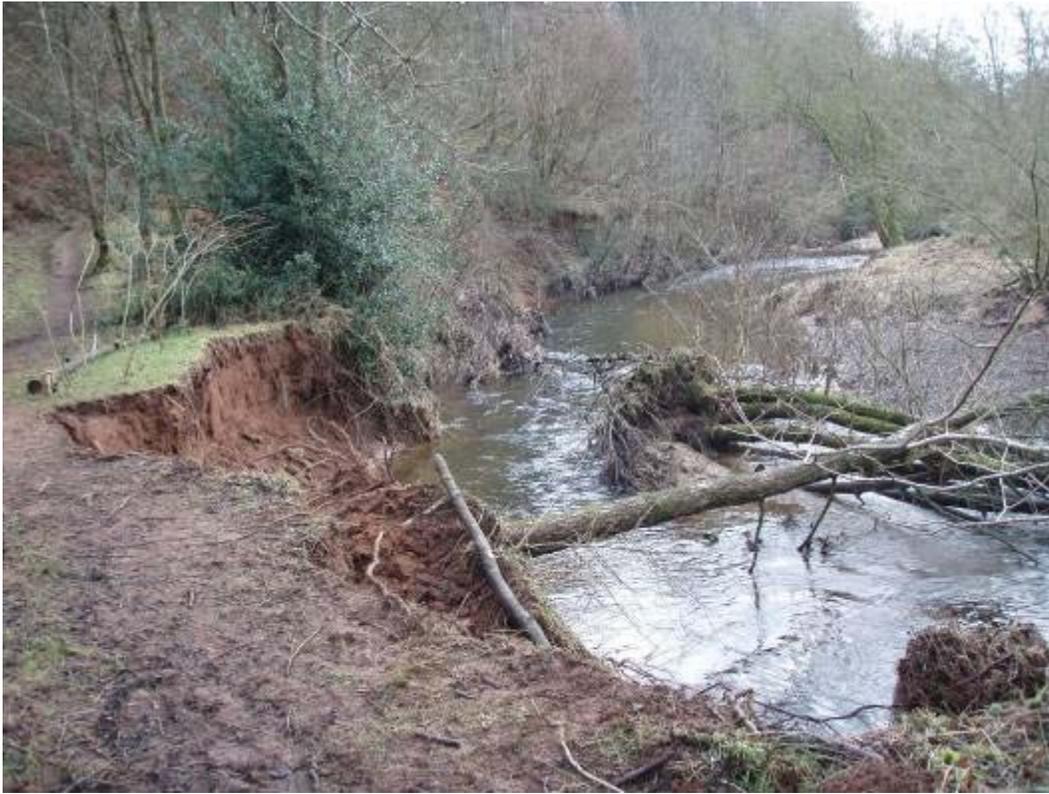
The erosion resulting from the friable soils, tree shading and flashy flow of the river means there is an active recruitment of large woody debris (LWD) to the river (Photo 3). Any wood that falls into the river is left *in situ* by CWT, and as a result there are some very good examples of natural LWD (Photo 4). The presence of LWD within rivers has been shown to be important for a number of reasons, including:

**Photo 3 LWD is being actively recruited to the river channel within this reach**

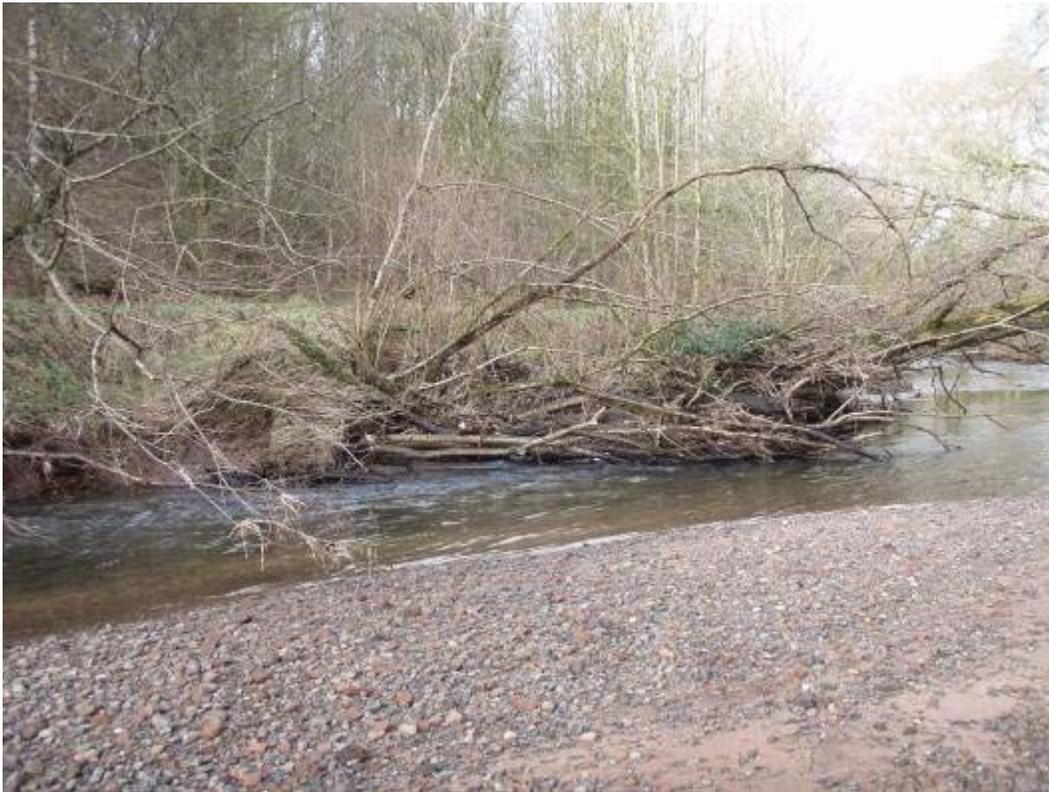
**Photo 4 There are some good examples of mature LWD illustrating the effects on channel shape, dimensions and bed load sorting**

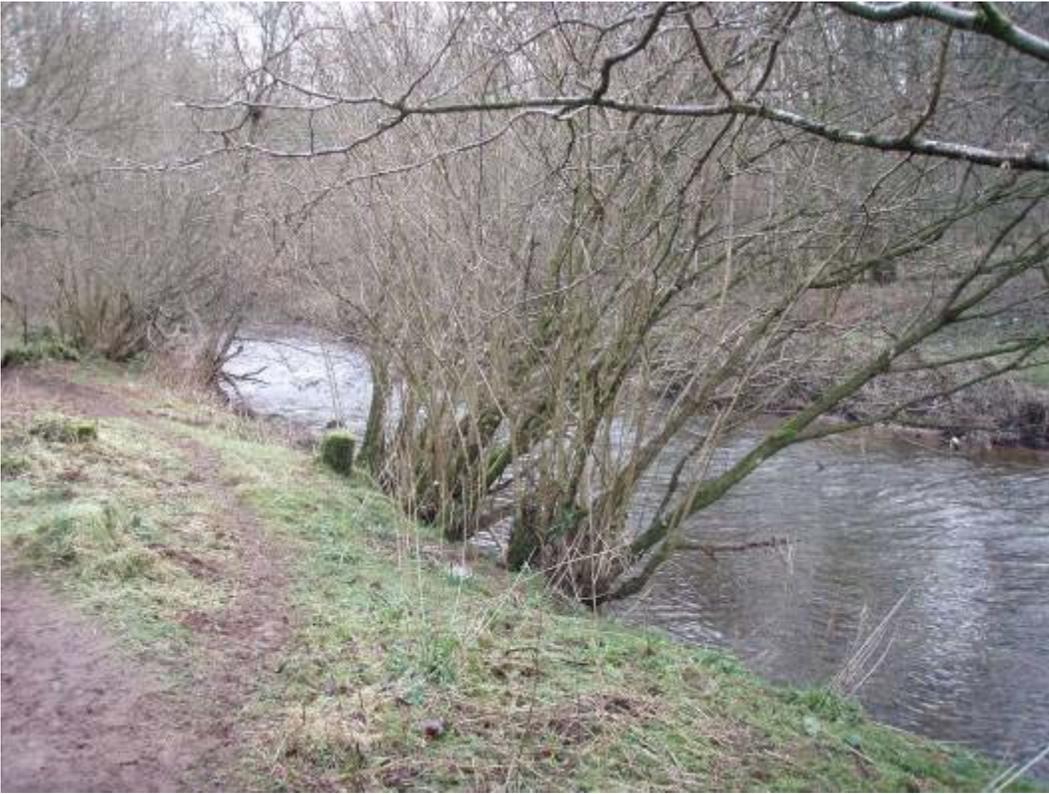
**Photo 5** There are ample opportunities in this reach for 'hinging' smaller trees....

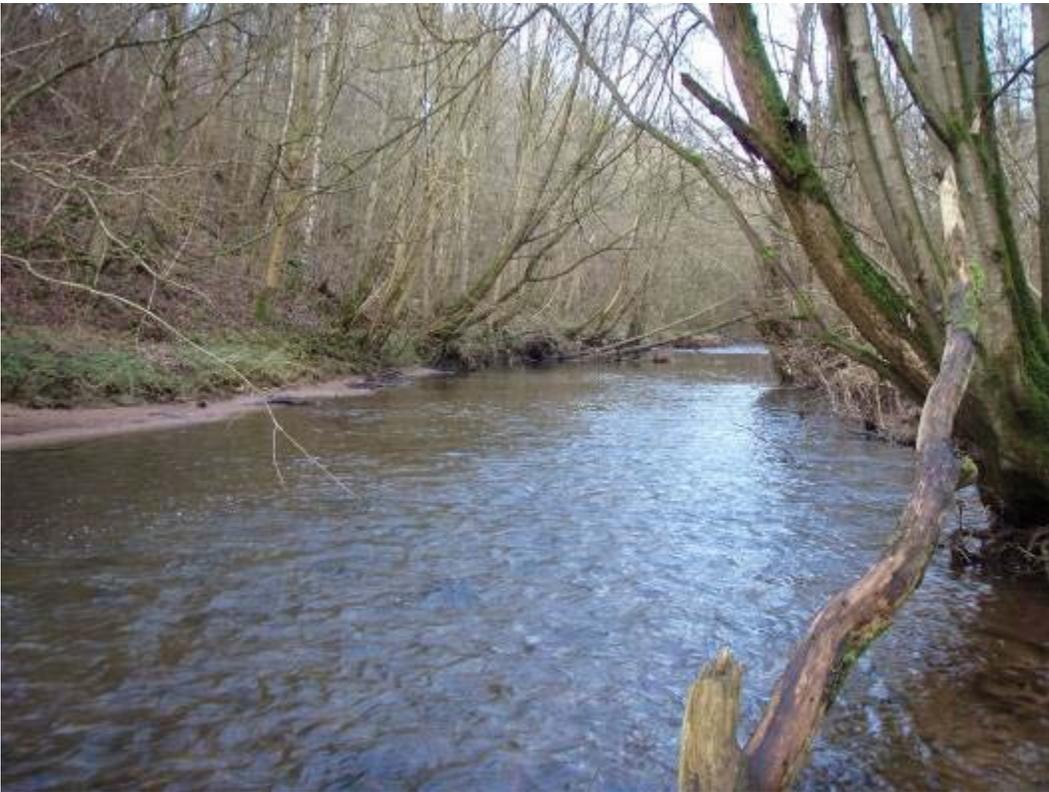
**Photo 6** ....and fixing larger trees into the channel.

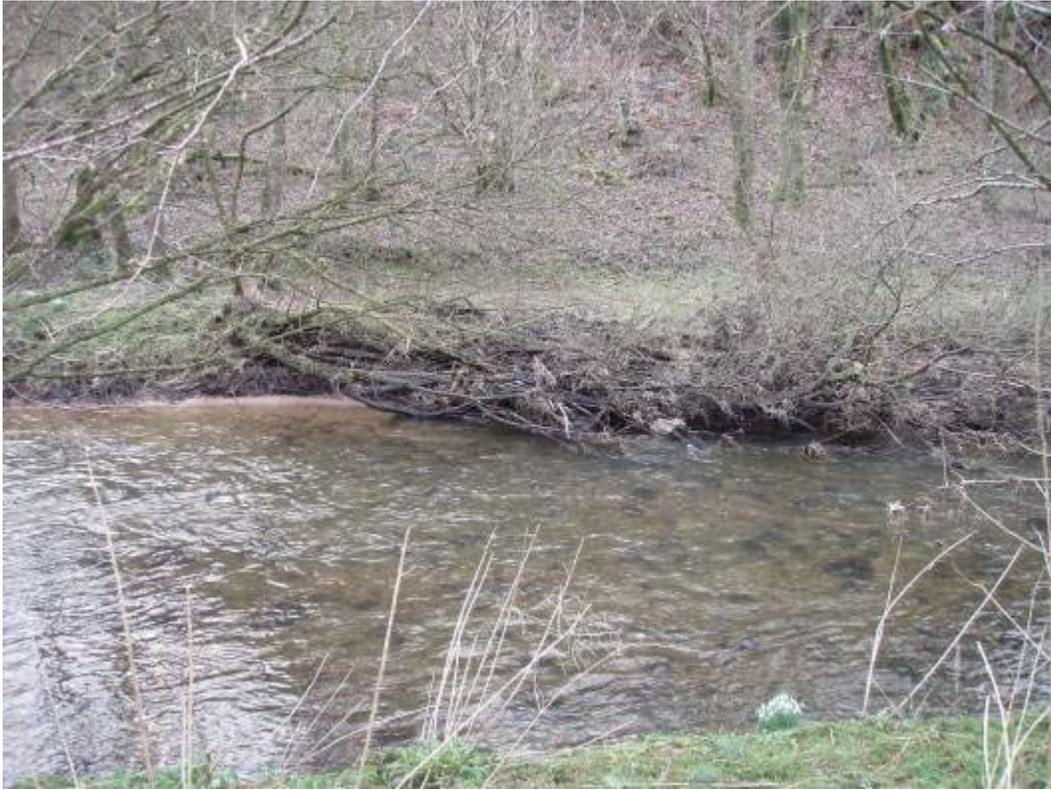
**Photo 7 Low marginal cover – great for juvenile trout**

There are ample opportunities for easily introducing LWD in this section of the Petteril. There are numerous hazel trees which could be nicked and hinged into the river to provide low marginal cover for juvenile trout, mimicking similar natural structures (Photo 7). Larger LWD structures could be introduced using tree trunks and rootballs, with various methods of anchoring (see recommendations section).

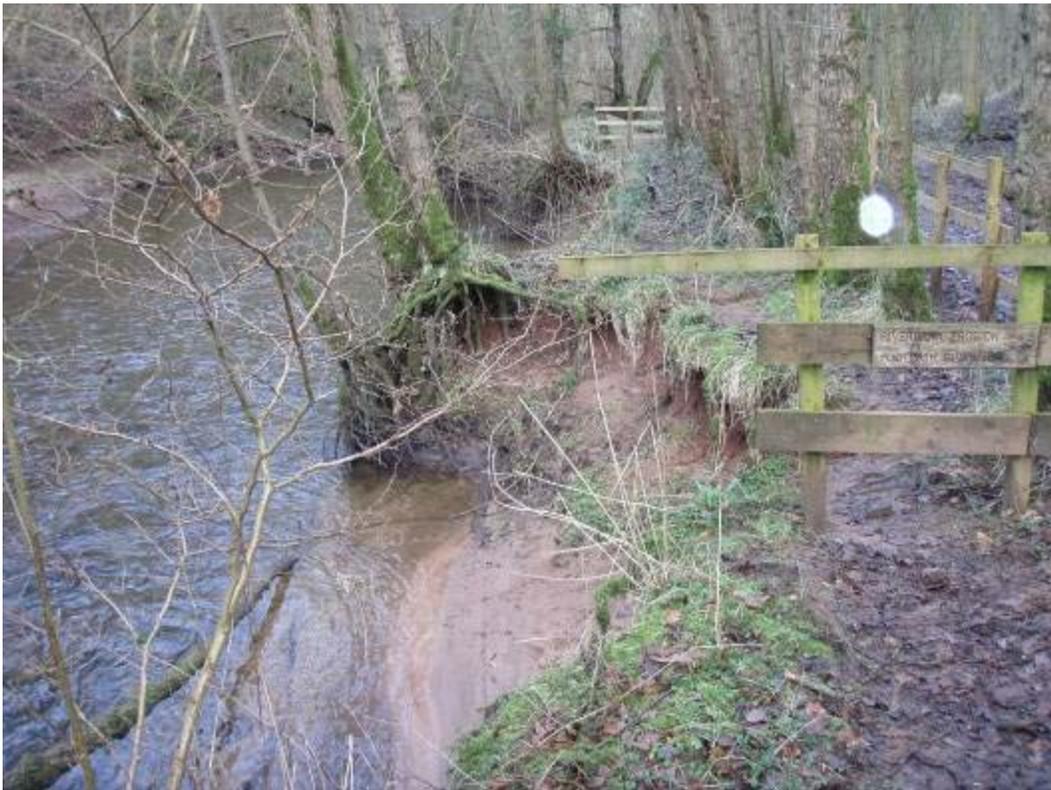
**Photo 8 Bank erosion affecting the route of the footpath**

During the visit the feasibility of positioning LWD to protect eroding banks was discussed. There were two areas where erosion was threatening the route of the existing footpath. One area (Photo 8) could be tackled by packing brushwood into the scalloped areas between trees, and would slow the rate of erosion here; however, it is unlikely that the bank would consolidate and vegetate because of the shading of the woodland. The second area is an earth cliff where trees have recently fallen into the river (Photo 3). It is unlikely that attempting to protect this bank would be successful or worth the considerable effort involved, as floods will undoubtedly continue to erode the outside of this bend. Whilst such erosion is inconvenient in that it affects the footpath, it is not a 'bad thing' for the river ecology in this context. It could be argued that the erosion is of greater severity through more frequent and larger spates because of upstream land use and drainage, but tackling the causes rather than the symptoms would be the way forward here.

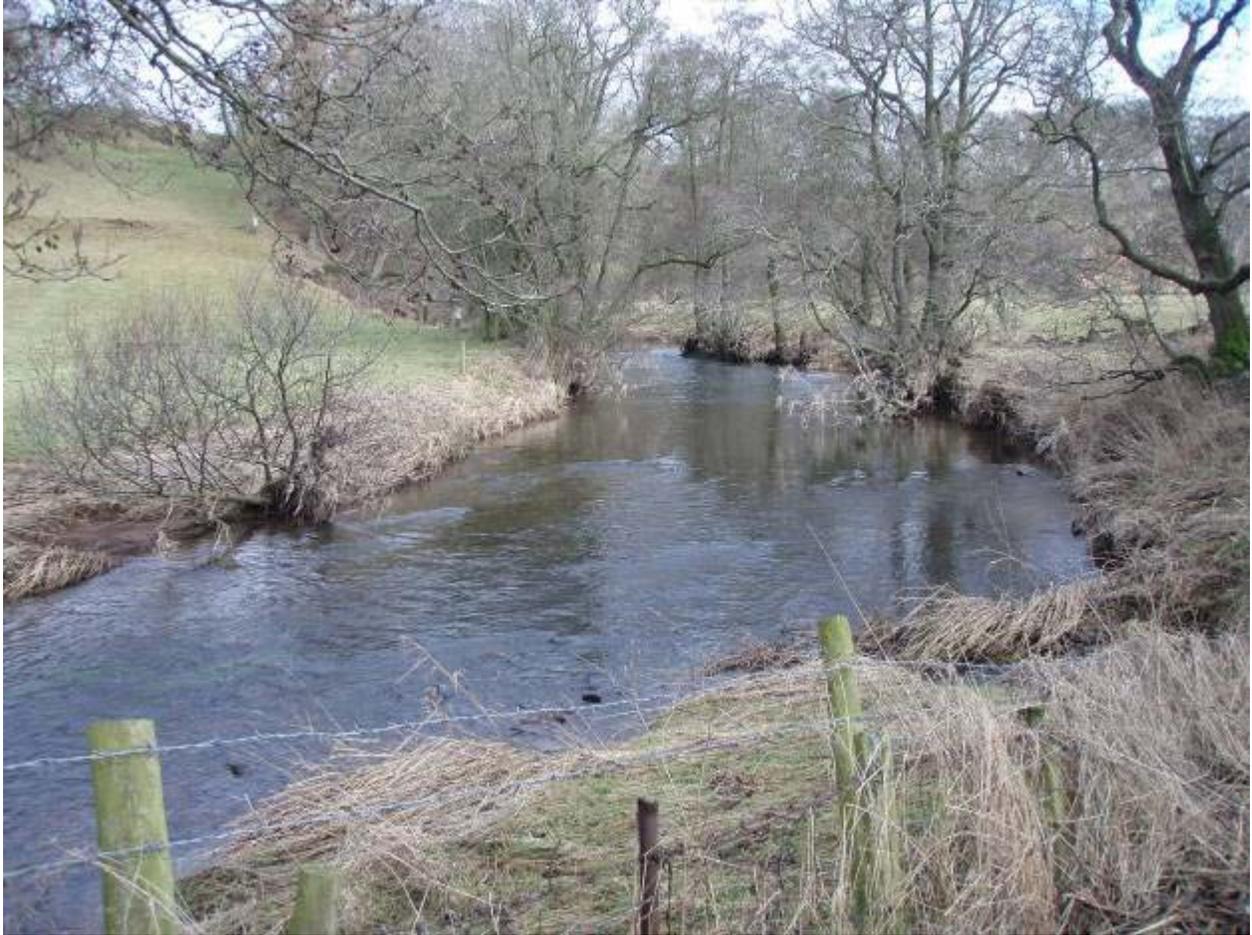
**Photo 9 River Petteril at Petterilside Farm**

The presence of a road bridge at the downstream end of this reach means it would be advisable to make LWD structures from pieces of timber which

would not block the bridge in the event of them coming loose in floods. Alternatively a failsafe anchor needs to be used to ensure the LWD does not move out of position; this could be a deadman anchor fixed into the bank, or to a tree stump (see Recommendations section).

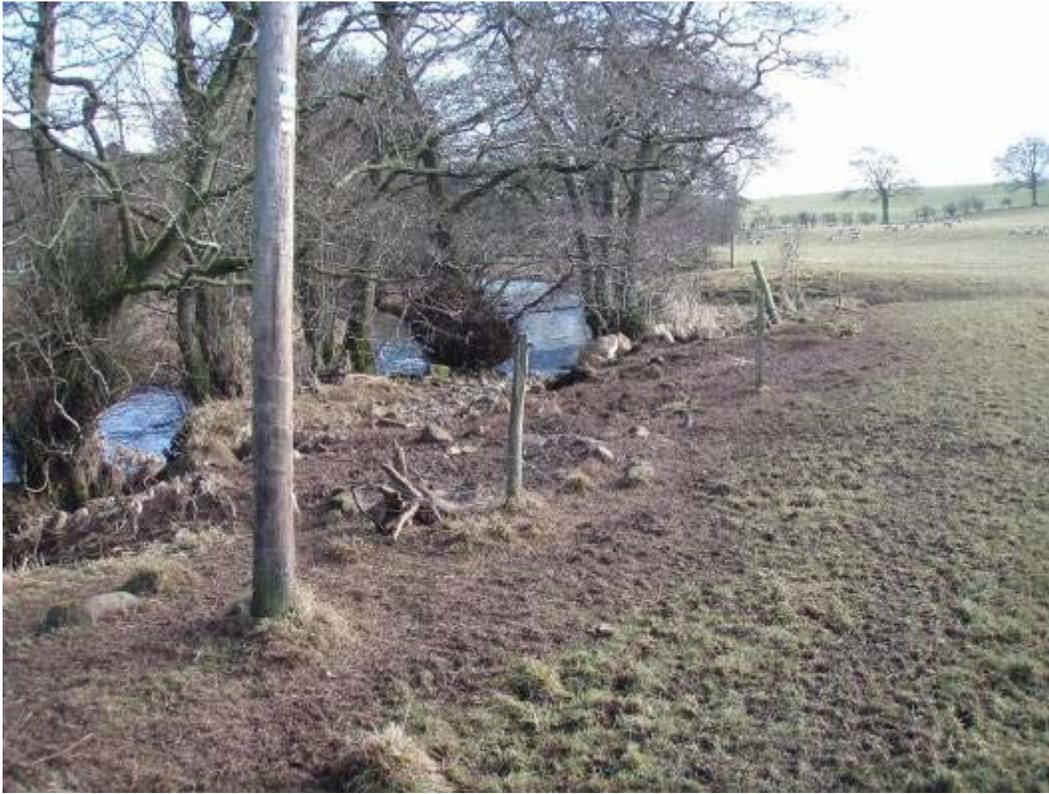
The river here has a good pool and riffle structure. There are a moderate number of trees alongside the river, chiefly on the right bank which is steep and wooded in the middle of the section. Shading by trees is relatively light along this reach, and stands of water crowfoot (*Ranunculus* sp.) are present in shallow, faster-flowing areas. The left bank is lightly grazed although limited areas show signs of poaching where livestock are congregating.

**Photo 10 Localised bank poaching by livestock**

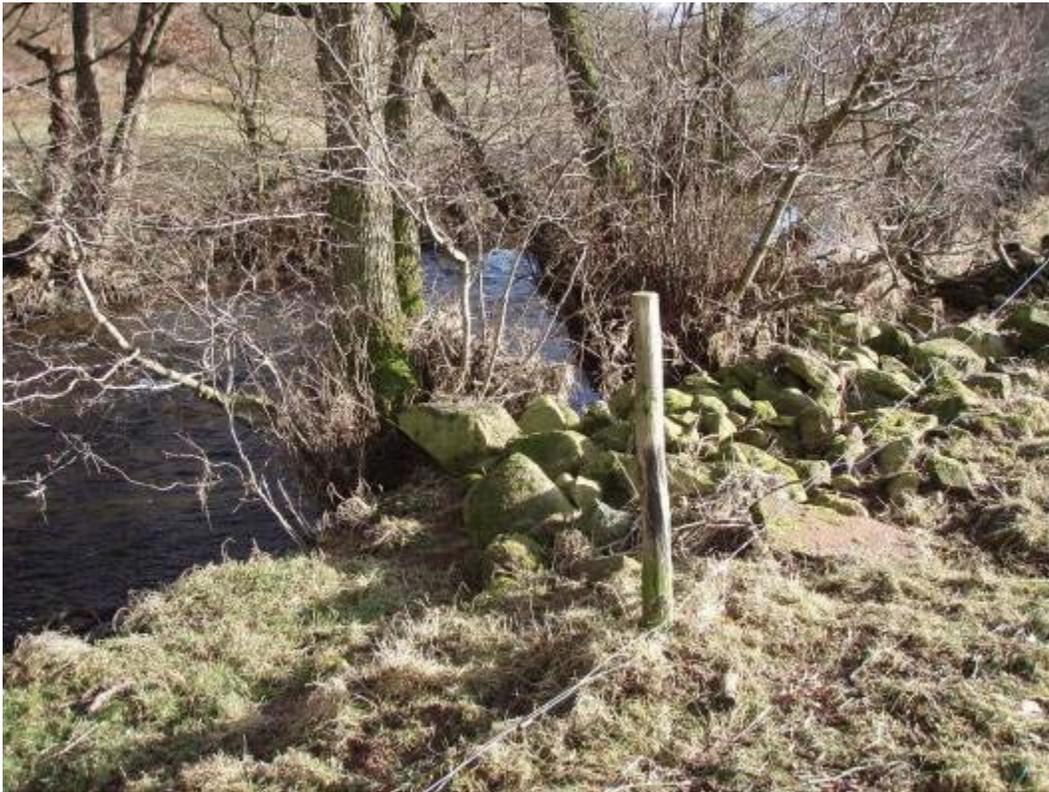
**Photo 11 Boulders reinforced banks – perhaps some of these could be used within the channel once the banks are fenced?**

Some areas of the bank have been reinforced with boulders, which may have been sourced from the river channel (Photo 11). It would be beneficial to place some of these in shallow glide habitats downstream of riffles to provide shelter for juvenile trout and help increase the river's carrying capacity for this life stage.

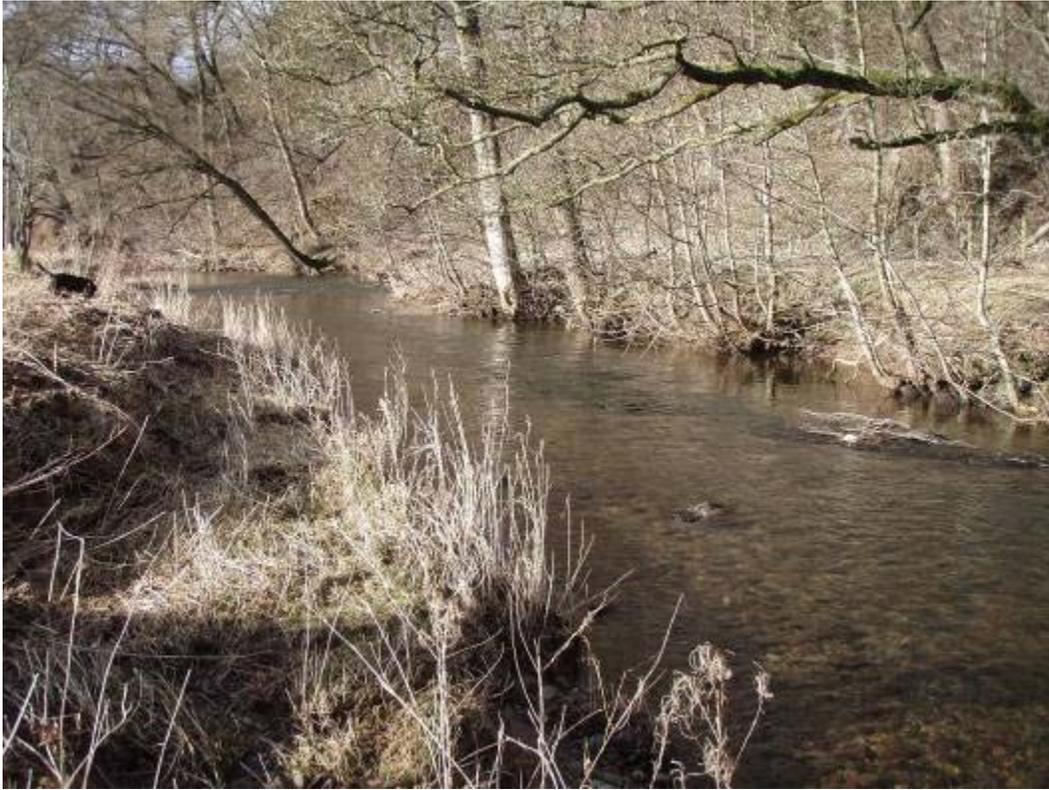
**Photo 12** Small trees on the far bank could be partially cut and hinged over to provide low cover

- hinging smaller trees over into the river to provide marginal cover for juveniles (Photo 12)
- hinging well-placed larger trees to create larger LWD structures that will promote scour, depth variation and sorting of the bed substrate (Photo 13)
- Fixing tree trunks arising from coppicing to the river bed to form flow deflectors/groynes. Tree root balls with some trunk still attached would be even better for this purpose but would likely have to be imported to the site.

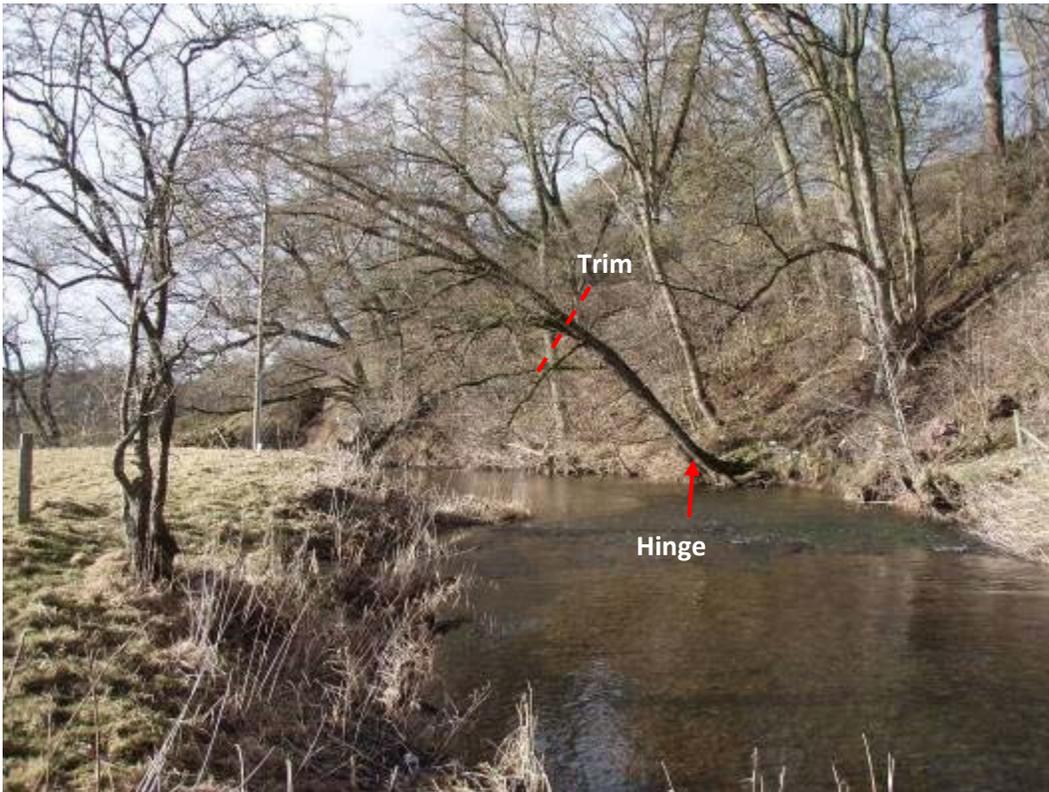
**Photo 13** Leaning trees like this could be hinged and trimmed to create stable LWD structures; this would also preserve the root ball within the bank.

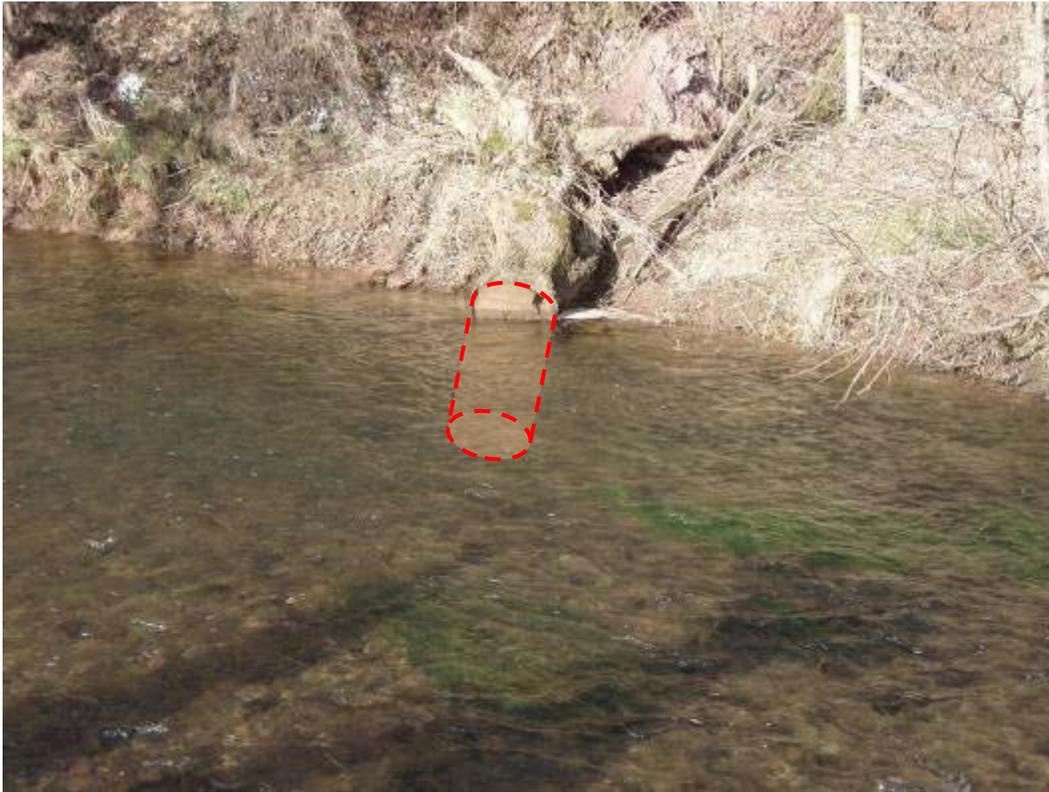
Some fallen trees have previously been removed from this section which could have been managed to create beneficial LWD structure (Photo 14).

**Photo 14** Leaving more of the trunk on this fallen tree could have created a good LWD structure on this riffle

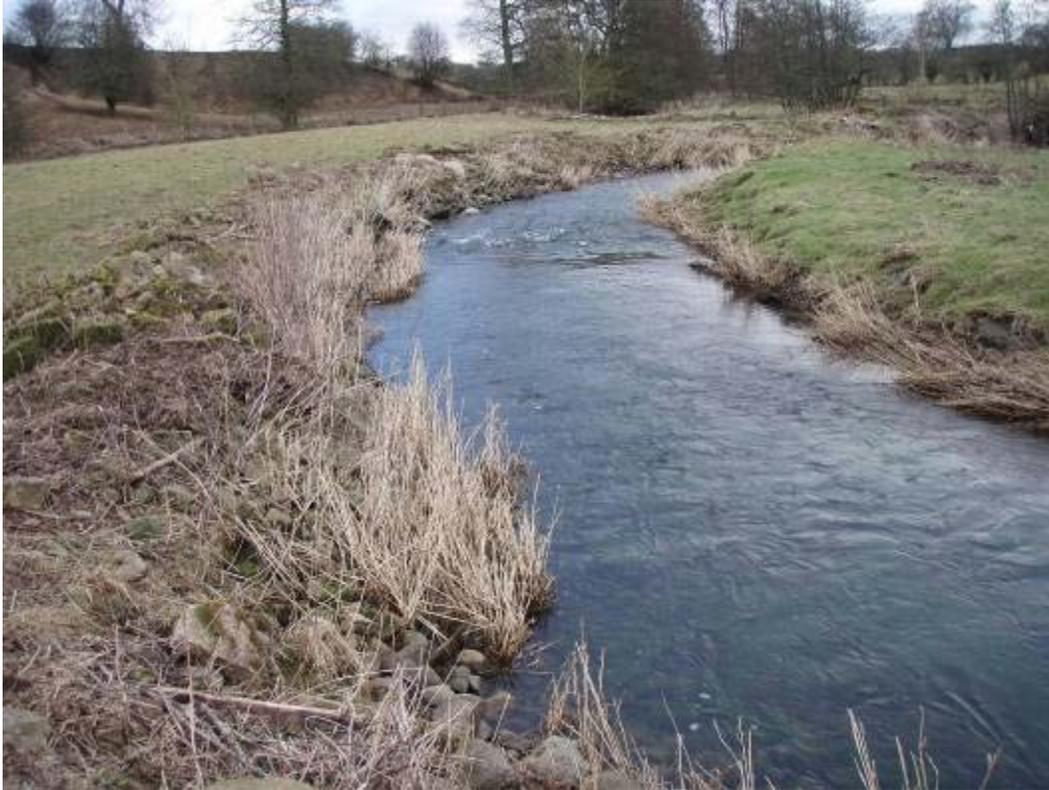
**Photo 15 Open banks heavily reinforced with rip-rap**

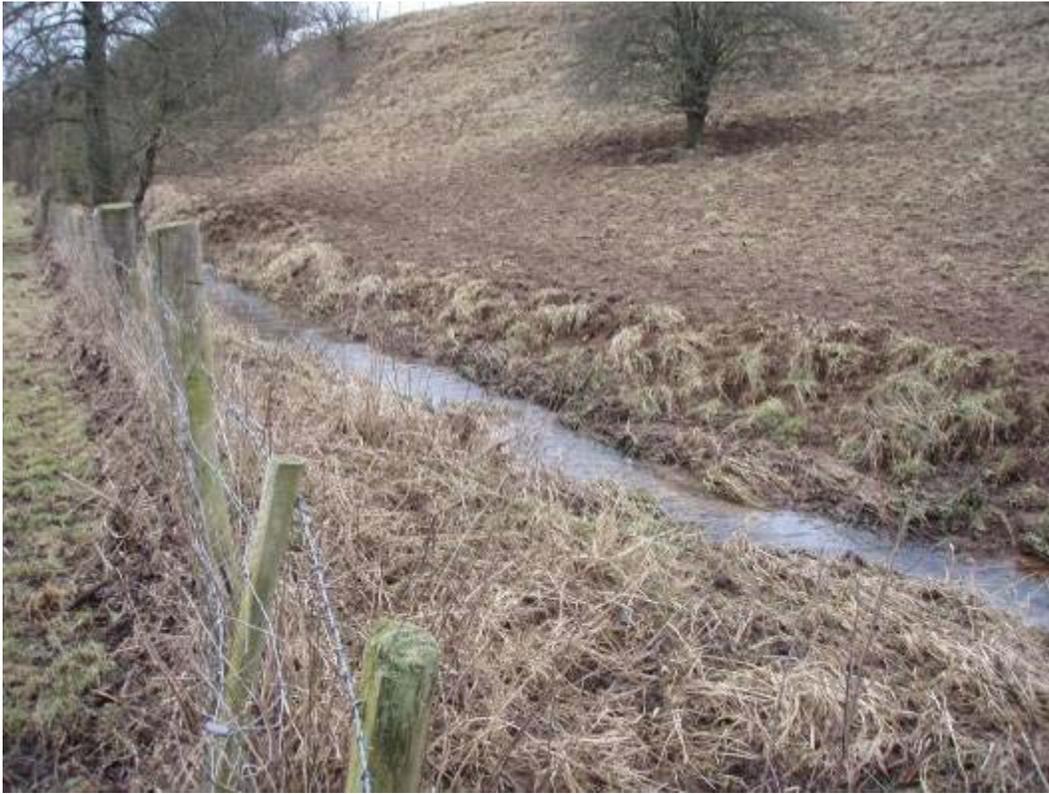
This site is located between the above villages at approximate grid references NY 46965 32770 and NY 47685 32025. The site is not fished, although it would make a good addition to the ERT Go Wild fishing passport scheme. In the field at the upstream end of the reach, the river channel was open and treeless, and the banks had been extensively reinforced with rip-rap consisting of stone and building waste (Photo 15). A small tributary on the LHB was suffering from excessive bank poaching and is a source of fine sediment entering the river (Photo 16).

**Photo 16 Heavy poaching alongside the small tributary on the LHB**

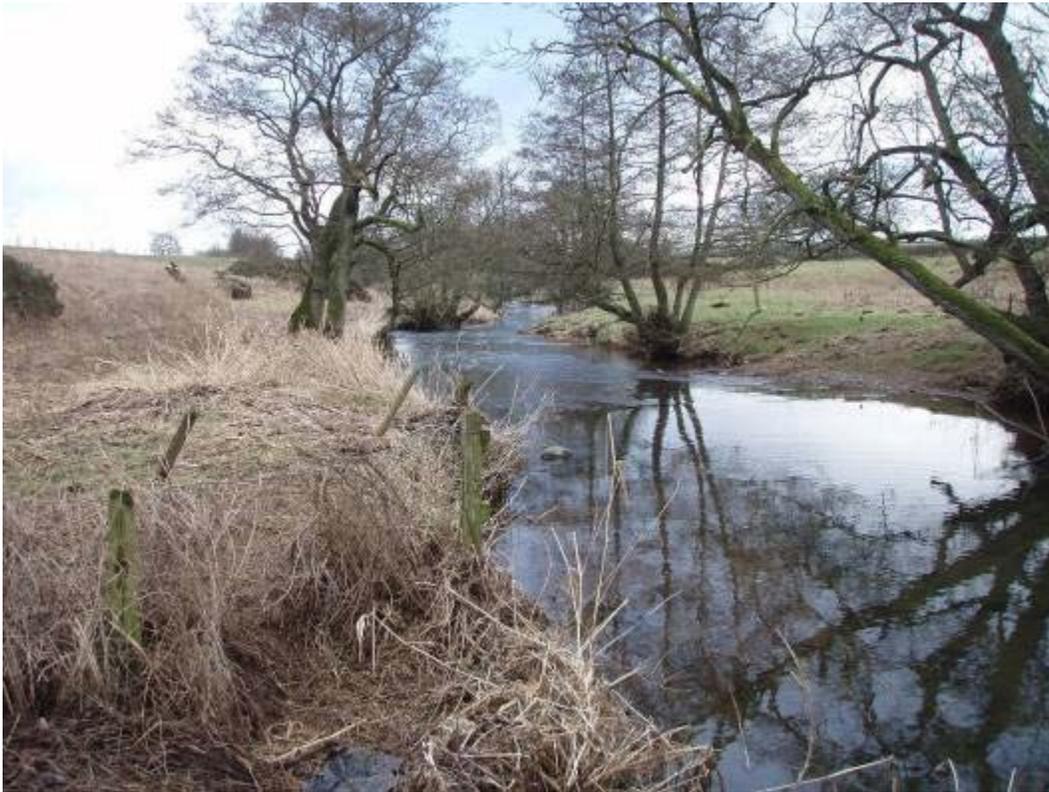
Further downstream the land use is less intensive, particularly on the LHB where there is a wide zone of lightly-grazed, wet ground (Photo 17). Riparian trees are more prolific, the majority being alders. The right bank is grazed (by alpacas at the time of the visit!) and is not fenced; the grazing is relatively light although there are one or two areas of light poaching where stock drink or cross the river.

**Photo 17 Low intensity land use on the LHB on the middle section**

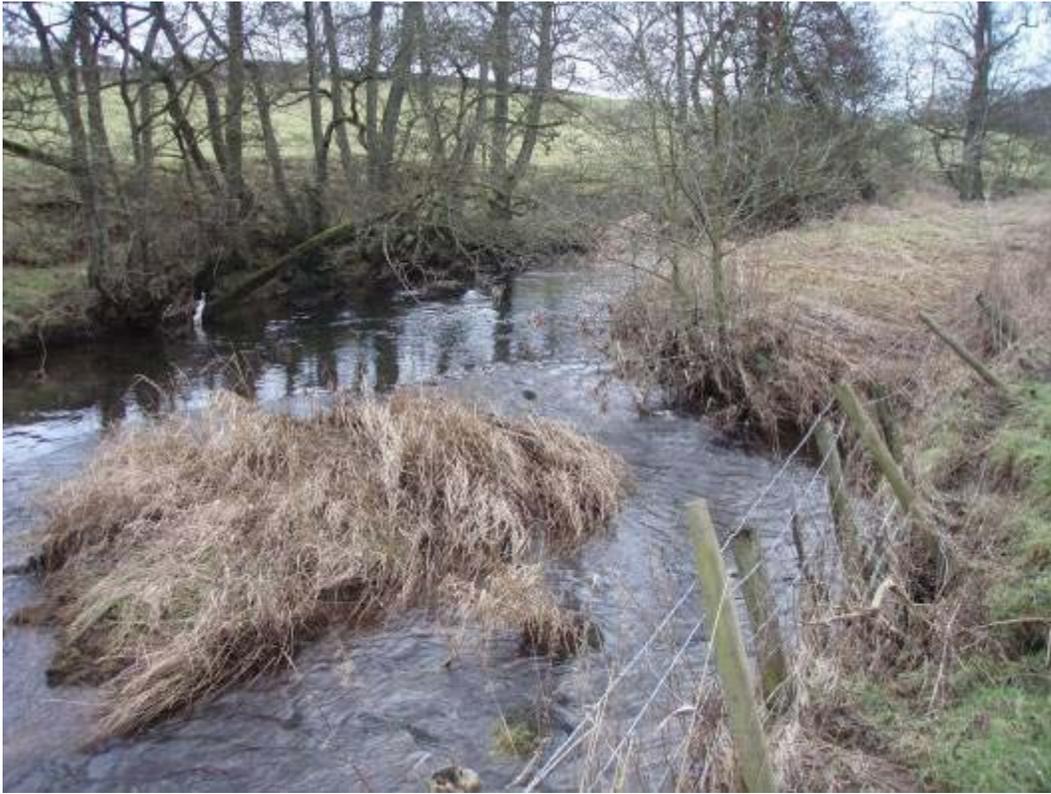
The in-stream habitat on this reach is good, with a well-developed pool and riffle sequence, shingle point bars and mid-channel shoals (Photo 18), a good balance of light and shade, the presence of water crowfoot and some good examples of LWD (Photo 19).

**Photo 18 Mid-channel shoals**

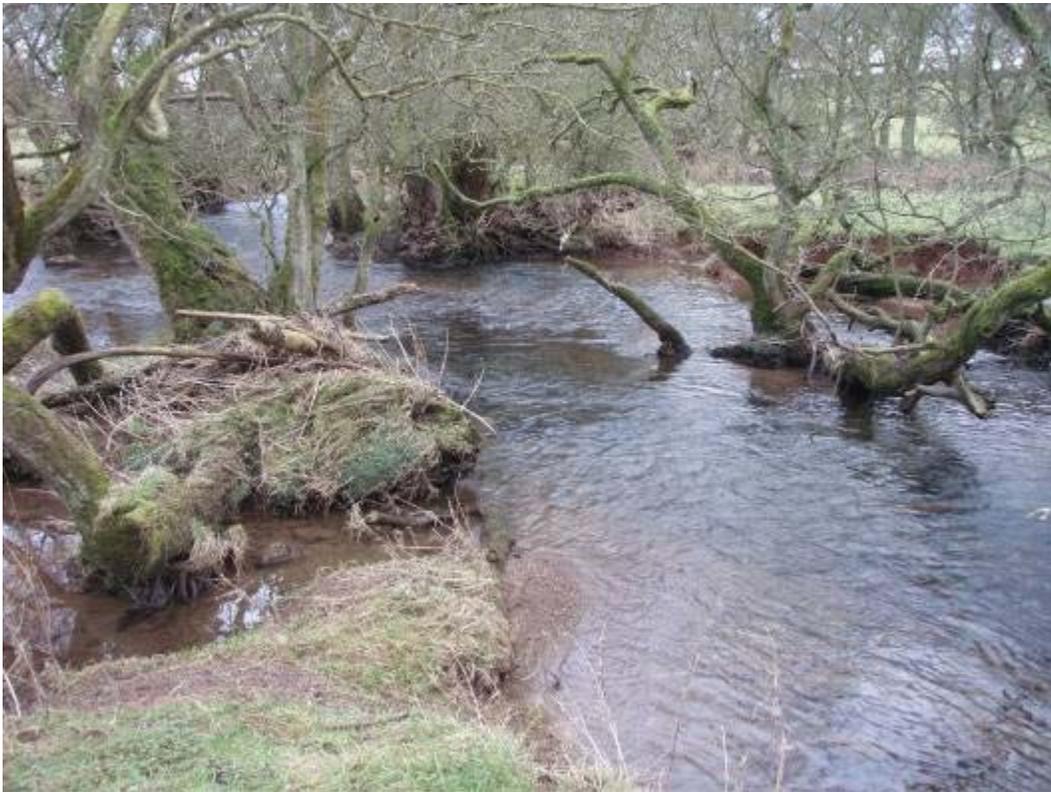
**Photo 19 Natural LWD**

Further LWD structures could easily be introduced to this reach by hinging selected trees and/or pinning logs to the river bed. This could be achieved by a two-person team in a day, although the effort may be better targeted at other stretches of the Petteril given the relatively good habitat at this site.

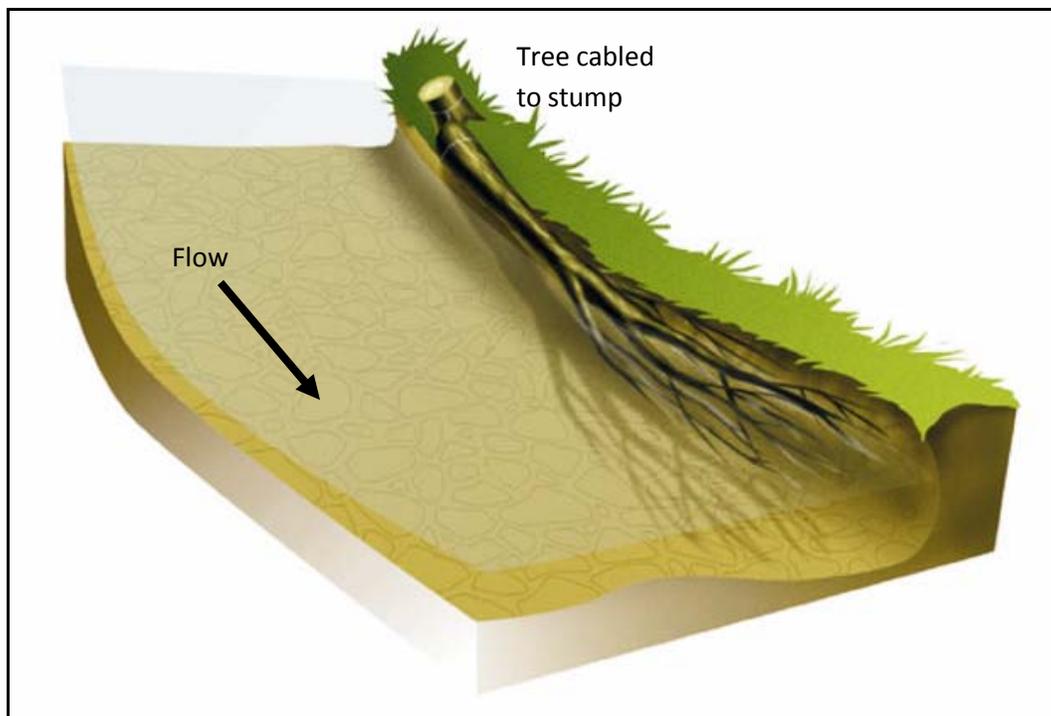
**Figure 1** Tree sweeper or kicker

These are generally larger trees with a dense branch network which are positioned parallel to the bank and provide excellent cover for invertebrates and fish (Figure 1). They can be created by hinging larger trees which are in a suitable position, or by cutting trees and cabling them to their stumps, or by felling trees some distance from the river so they fall with their crowns hanging into the water.

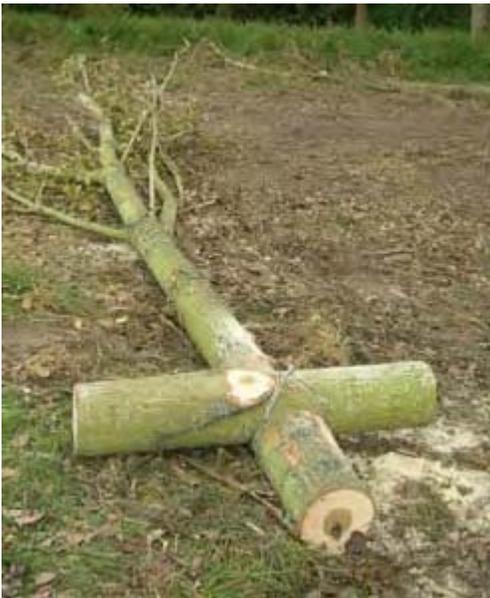
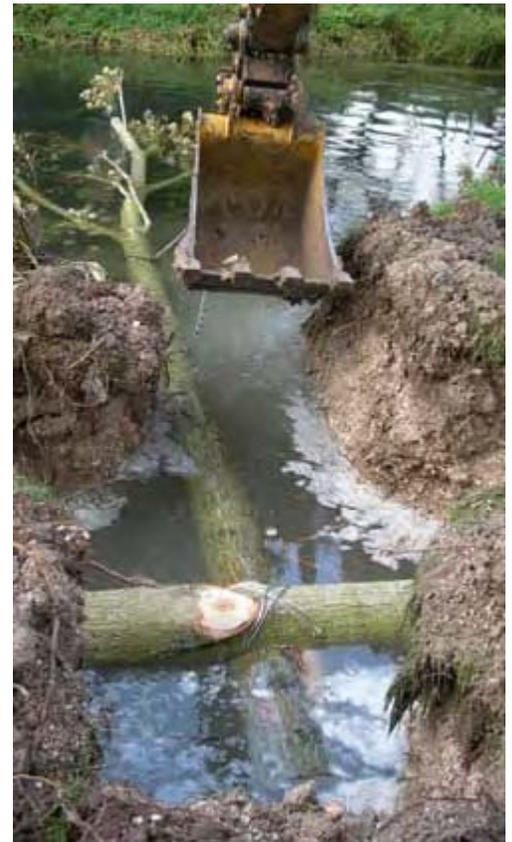
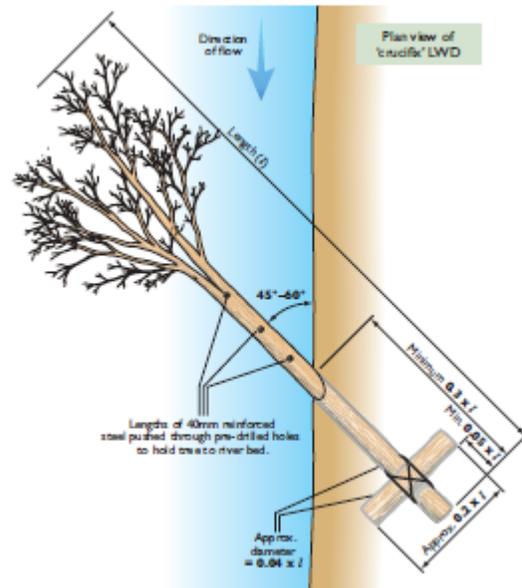
General principles of fixing upstream pointing deflector. Main piece of LWD can be a tree (as shown), tree trunk, or root wad with trunk attached (From STREAM project, [www.streamlife.org.uk](http://www.streamlife.org.uk)).

These structures need to be very firmly fixed. Leaving trees hinged or cabled to their stumps is a possibility on steeper banks (Figure 3). Embedding a good proportion of the LWD into the bank, and / or using a deadman anchor would be necessary on lower gradient banks – heavy machinery would be required for this (Figure 4).

These structures would be suited to the Wreay Woods site and the Petterilside Farm site. At the former site, the fixing shown in Figure 3 would have to be used because of limited access for heavy machinery. At the latter site, structures similar to those in Figure 4 are possible, positioned on the LHB nearer the upstream end of the site, where excavation and machinery access is possible.
