Advisory Visit

Pickering Beck, North Yorkshire

24th October, 2009

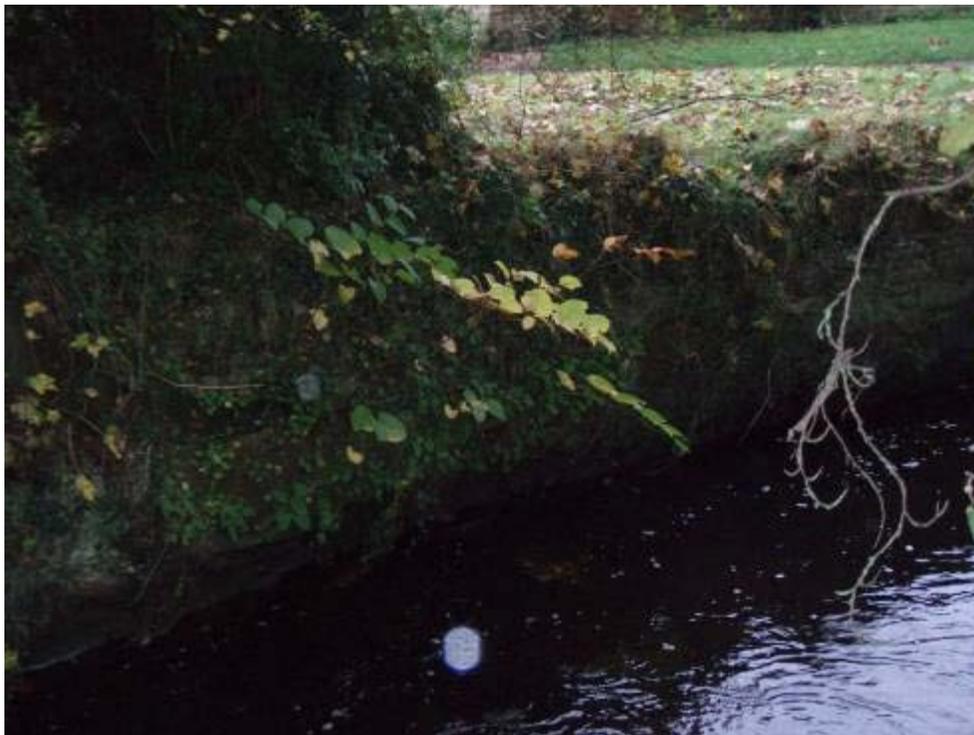
The river channel here is largely confined between stone walls, and there is little variation in width. Mature trees are abundant on both banks, and some Japanese knotweed was observed growing from niches within the wall (Photo 1); this is an undesirable, invasive, non-native species and should be eradicated before it spreads.

Photo 1 Japanese knotweed growing from the RHB upstream of the old railway bridge

- Tackle the growth of invasive plant species. Himalayan balsam should be hand pulled before it flowers. The small stand of Japanese

knotweed should be cut back and the regrowth sprayed with successive treatments of glyphosate. Be sure to dispose of the cut material carefully to prevent spread of the plant (off-ground drying then burning).

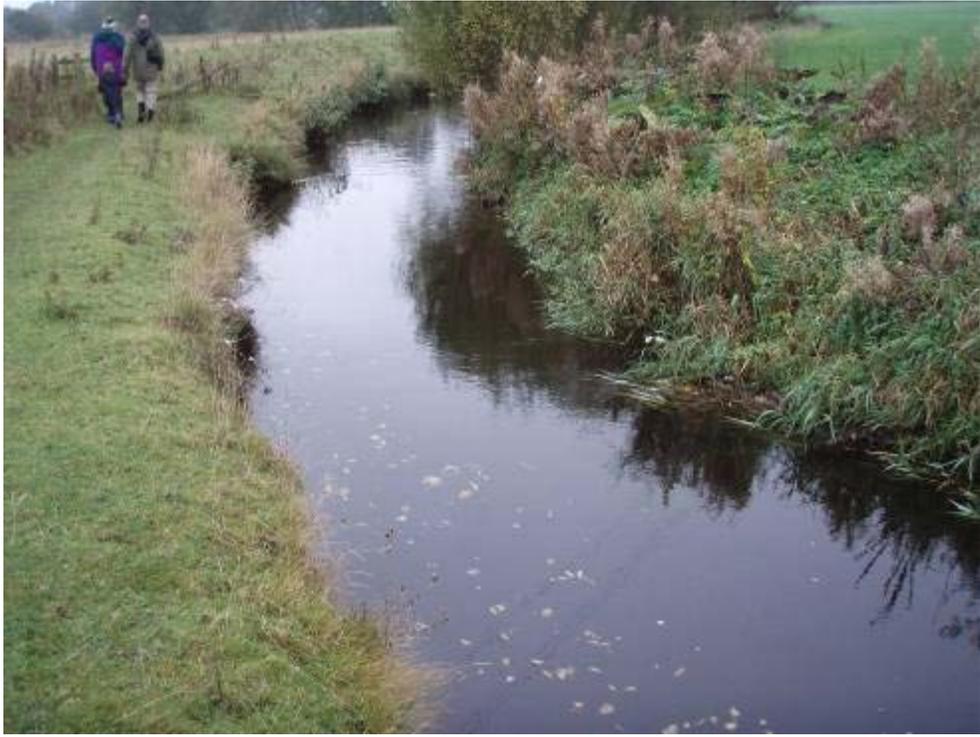
Below the mill in the Sheep Field (LHB), there is a bund on the LB forming a flood bank. The LB is grazed right up to the river edge and there are no trees or bushes on this bank; this is in contrast to the RB which has a shaggy fringe of vegetation overhanging the river, interspersed with trees and bushes, giving way to arable fields behind (Photos 2, 3). The trees include alder (*Alnus glutinosa*), willow and sallows (*Salix cinerea*, *S. caprea*).

Photo 2 Sheep Field - contrast between grazed LHB and shaggy, overhanging margin on RHB

- Use stock fencing to encourage the development of a shaggy marginal fringe and low, bushy tree growth (sallows) in areas which are currently grazed (e.g. sheep field, field on RHB upstream of Low Mill, and PFA-owned field).

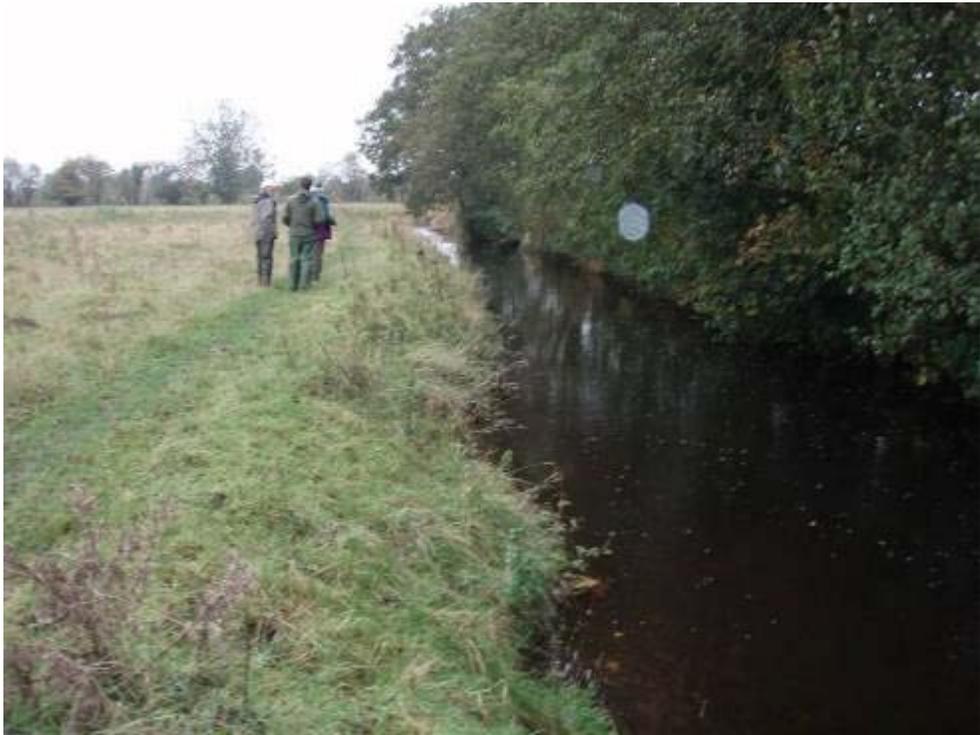
The river channel is relatively uniform in dimensions with little variation in width, although there was a reasonable degree of depth variation with deeper pools on the outside of meanders, and shallower water in between. Some beds of water crowfoot (*Ranunculus* sp.) were evident in shallower water and, according to club members, growth can be extensive in summer. There are opportunities to improve habitat within this section by introducing some flow variation using log groynes, replacing low stone weirs with log groynes, and protecting some eroding banks with brushwood mattresses (Photos 3 – 5).

Photo 3 There are some uniform lengths of the upper section of river that would benefit from flow variation provided by groynes and large woody debris

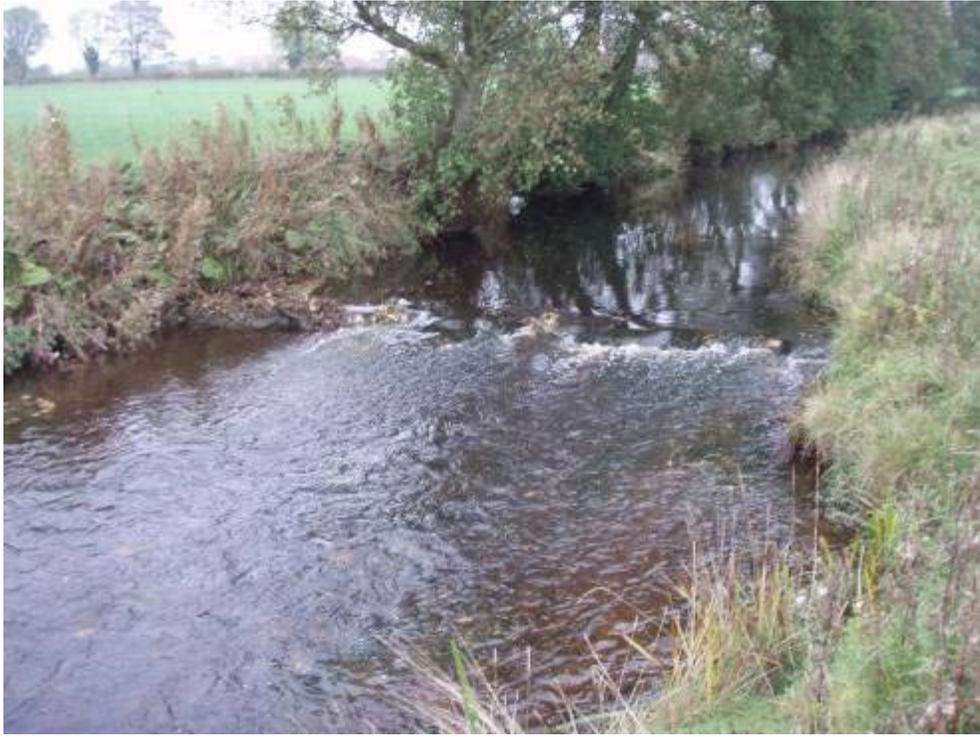
Photo 4 Low stone weir on upper river section. Replacing such structures with groynes would reduce water impoundment and improve in stream habitats.

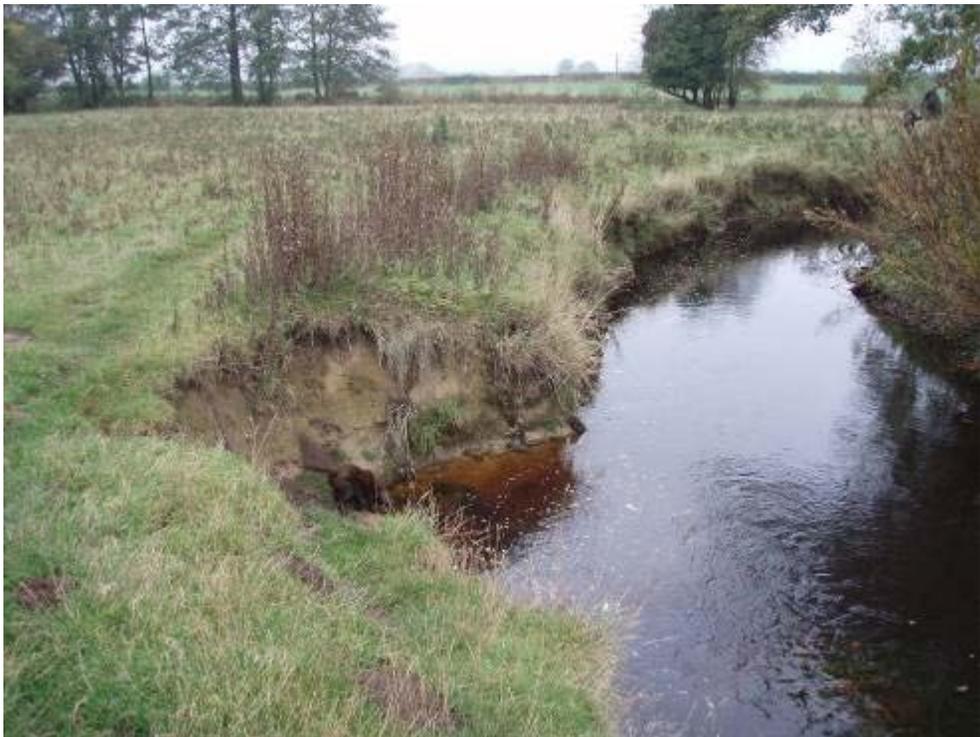
Photo 5 Limited areas of bank erosion on the upper river section. These could be protected with brushwood mattresses.

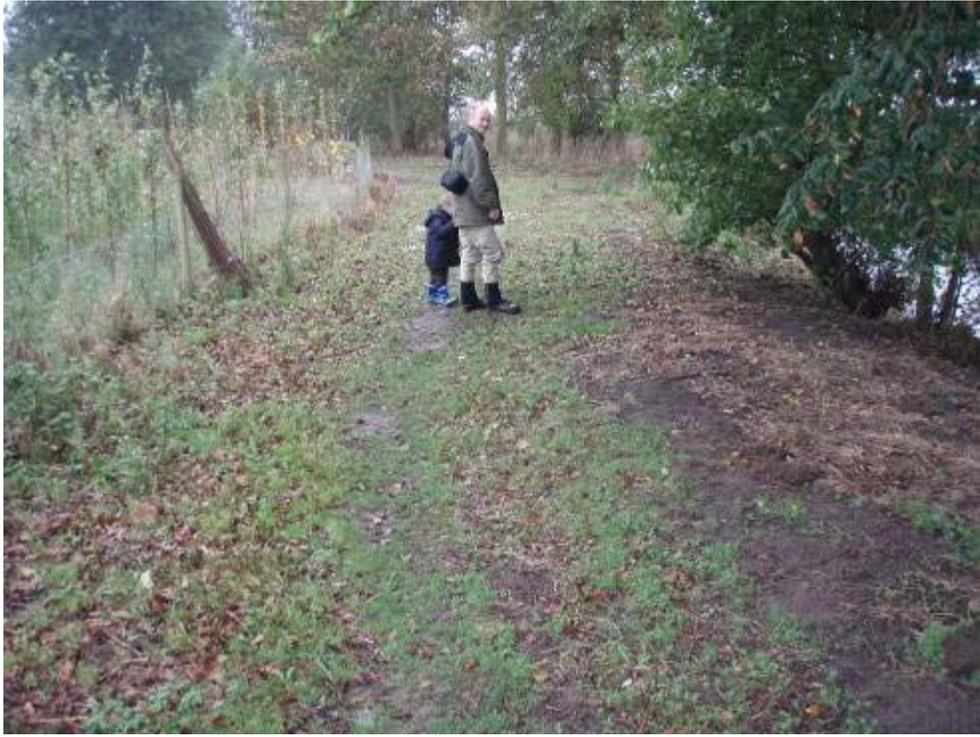
In the next field downstream, the LHB is bordered by mature alder trees, then a headland up to a fence alongside a field of young trees and shrubs being grown for a plant nursery (Photo 6). There is very little ground vegetation on the headland and under the alders suggesting it may have been treated with herbicide; there were a few Himalayan balsam plants here, which is an undesirable invasive non-native species (perhaps why spraying has been used).

Photo 6 Bare banks alongside the nursery field – possibly where Himalayan balsam has been sprayed with herbicide

Himalayan balsam can dominate local flora then die back in winter (it is an annual) to leave bare soil vulnerable to erosion by flood flows, hence it should be kept under control. Spraying (with the appropriate consent from the Environment Agency) is one method of control, but the herbicides permitted for use alongside watercourses are non-specific and hence affect all vegetation; glyphosate wiping can be more specific. A better method of control is hand pulling before the balsam flowers in late June. Further information on invasive plant species and their control can be found at [http://www.environment-agency.gov.uk/static/documents/Leisure/GEHO0307BLZO-e-e\(1\).pdf](http://www.environment-agency.gov.uk/static/documents/Leisure/GEHO0307BLZO-e-e(1).pdf) .

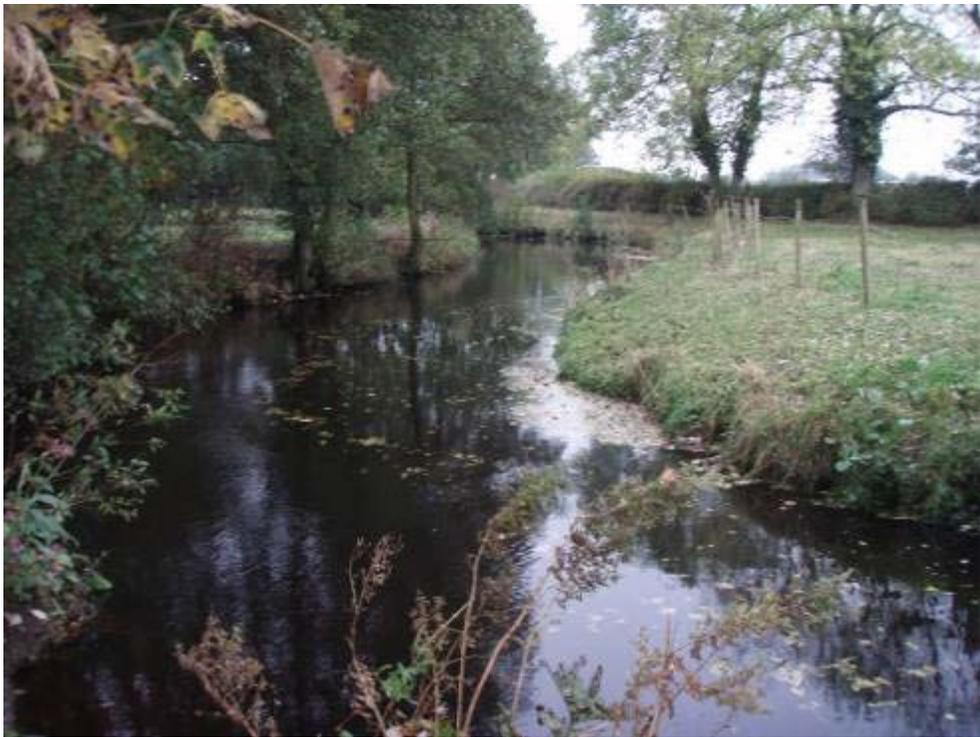
Photo 7 Slow-flowing, impounded section above Low Mill.

The river is impounded through this section by a weir at Low Mill; this structure has a head difference of approximately 2 metres, with a sloping face, and a lip at the crest. There is a sluice gate on the right side which was closed at the time of the visit. The weir impounds water upstream creating a slow-flowing, deep section which will encourage the deposition of fine sediment; this is not good habitat for trout or grayling, although it may hold a few larger fish and some stocked trout.

Large weirs like this impede or prevent fish movement, hence preventing them from using the range of habitats necessary throughout their life cycle; for example, the seasonal upstream movement of adults to spawning habitat, dispersal of juveniles, daily movements between feeding and refuge habitat, etc. This structure appears to be impassable to fish in an upstream direction because the lip at the crest prevents fish swimming directly over at low flows, and when flows are sufficiently high to drown the lip, water velocities on the face are likely to exceed maximum swimming speeds.

- Continue the instream works started with Bishop Burton college in the lower field, and consider extending these to other parts of the fishery; the upstream end (Sheep field) would be an ideal area (above the impounding effect of the weir, or ideally in combination with its removal).
- Open up a dialogue with the owner and/or Environment Agency over operation and purpose of the large weir at Low Mill. Removal of the structure, or fully opening the sluice would lower upstream water levels and improve the habitat of a considerable length of river which is currently impounded. Fish passage improvements and habitat reconnection would also result from weir removal or modification.

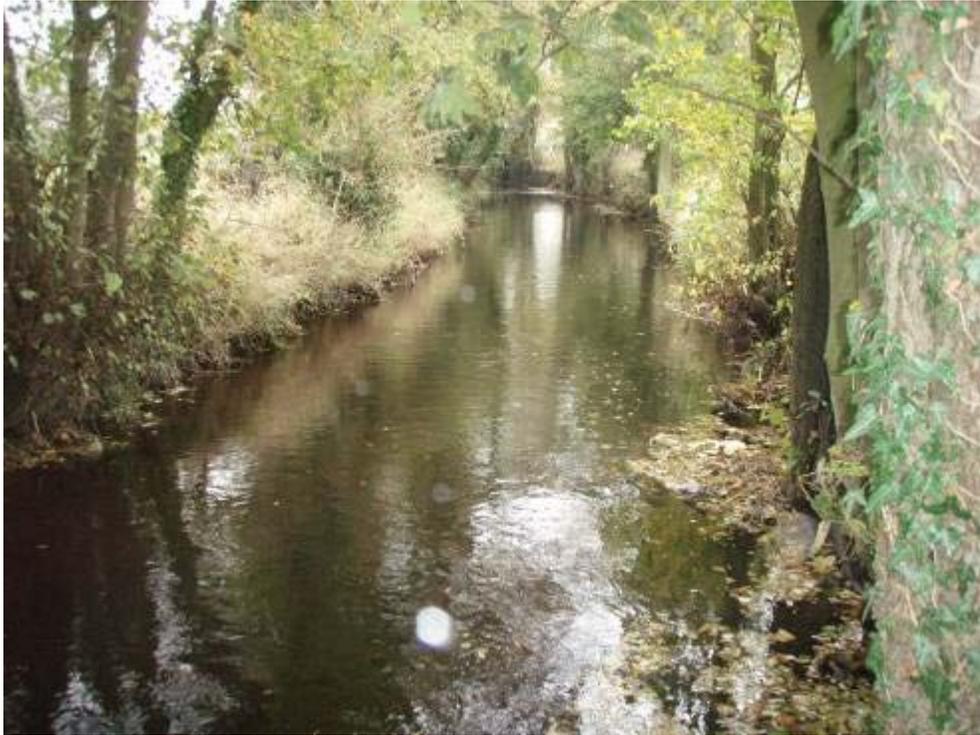
Downstream of Low Mill is where most angling takes place. Here the water is generally shallow, with rapid riffles and smooth glides (cover photo, Photo 9) and the occasional deeper pool such as "Cox's Hole", a favoured angling spot for dace, grayling, trout and the odd pike and chub. A minor road runs along the RHB here, and the bank in places comprises gabion baskets and a stone wall. A fresh trout redd was present against the LHB here (Photo 10), and there is a shallow area where grayling are known to spawn.

Photo 9 Downstream of Low Mill

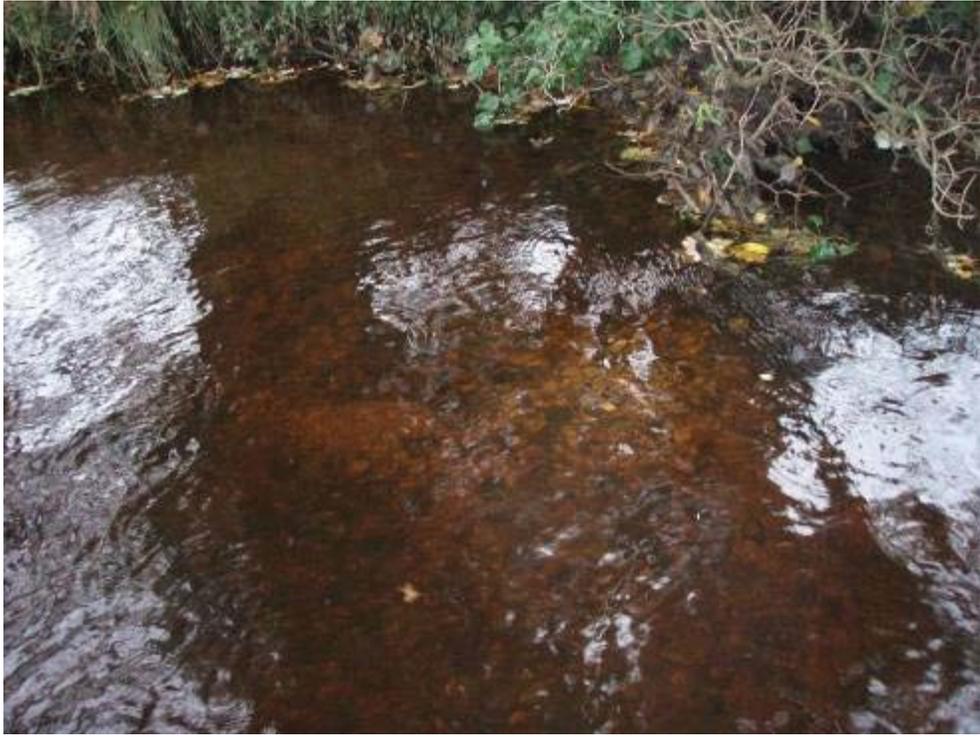
Photo 10 Recently cut trout redd

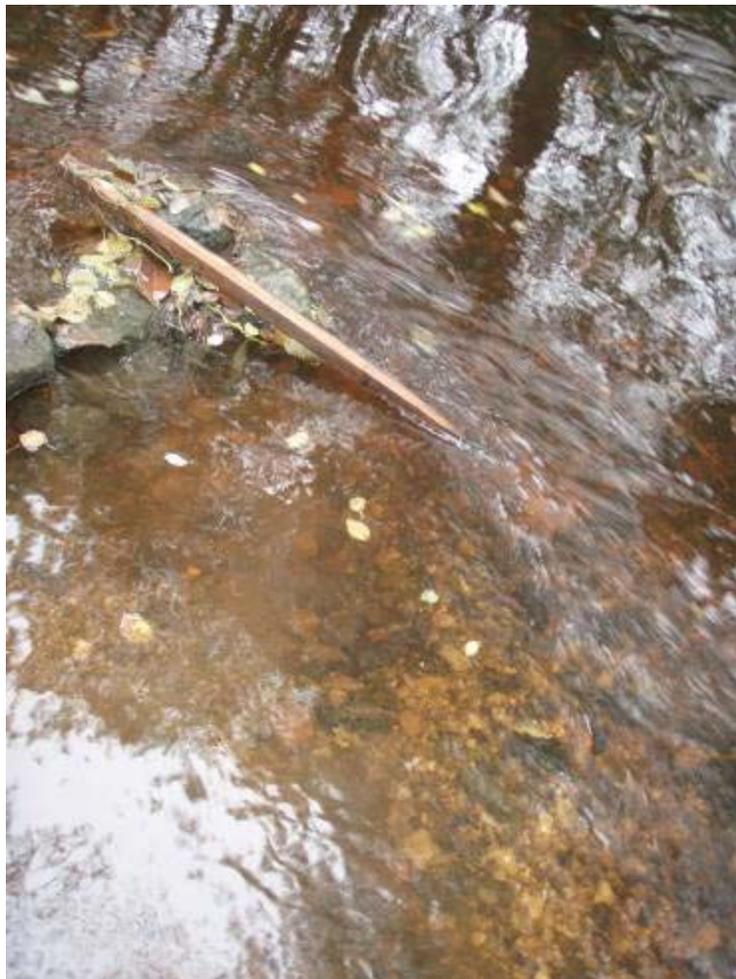
Near Willow Cottage there is a long, shallow riffle with clumps of water crowfoot (*Ranunculus sp.*); the bed substrate here is a suitable size for trout and grayling spawning, but relatively unsorted. Throughout the section below Low Mill, the substrate could be improved by installing small groynes and flow deflectors to promote localised scour and better spawning conditions.

Photo 11 Stub groynes can clean and sort gravel and improve spawning success

- Short 'stub' groynes and mini-flow deflectors should be installed on areas of suitable trout and grayling spawning gravel to promote localised scour and sorting of the river bed substrate. Suitable areas are the shallow glides and riffles between Low Mill and Ings Bridge. There should be no issues in gaining consent for these as long as the individual structures are small enough to pass through downstream bridge arches if they break free.

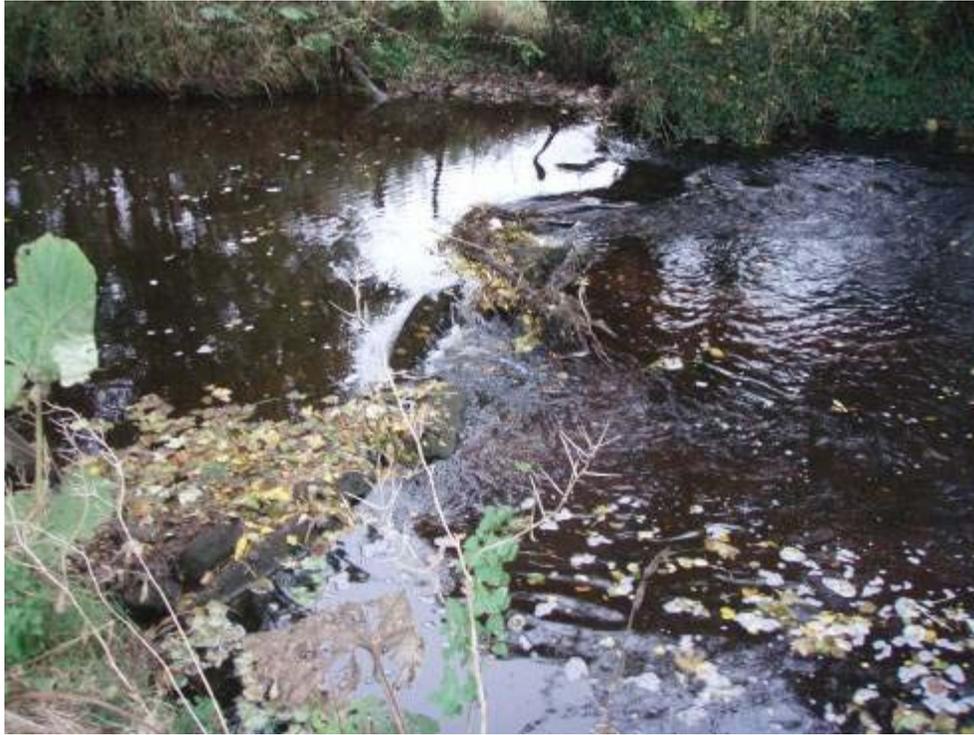
In the fishing hut field, the river is slower and deeper, and there are some low weirs constructed from stone. These were presumably installed to hold up water levels upstream, but unfortunately this tends to slow down water velocities and encouraged sediments to settle in the reach above. A good compromise would be to remove the central third of the structures, which will still promote an interesting flume but not significantly impound the water above.

Photo 12 Low stone weir in the fishing hut field – replacement with a series of log groynes would reduce impoundment and provide a more varied habitat

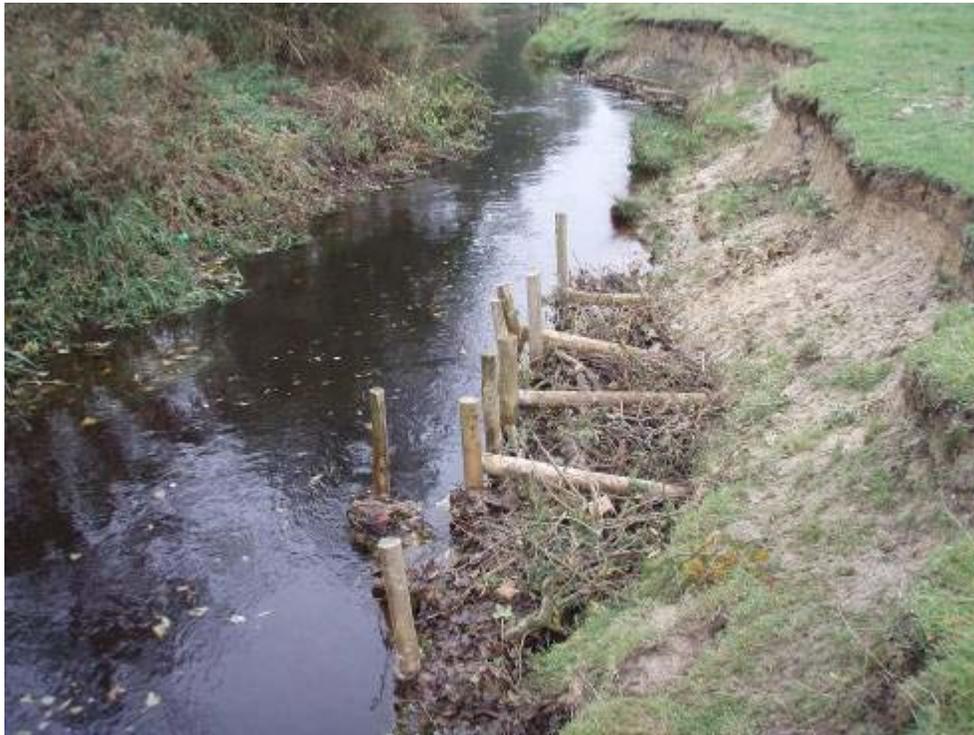
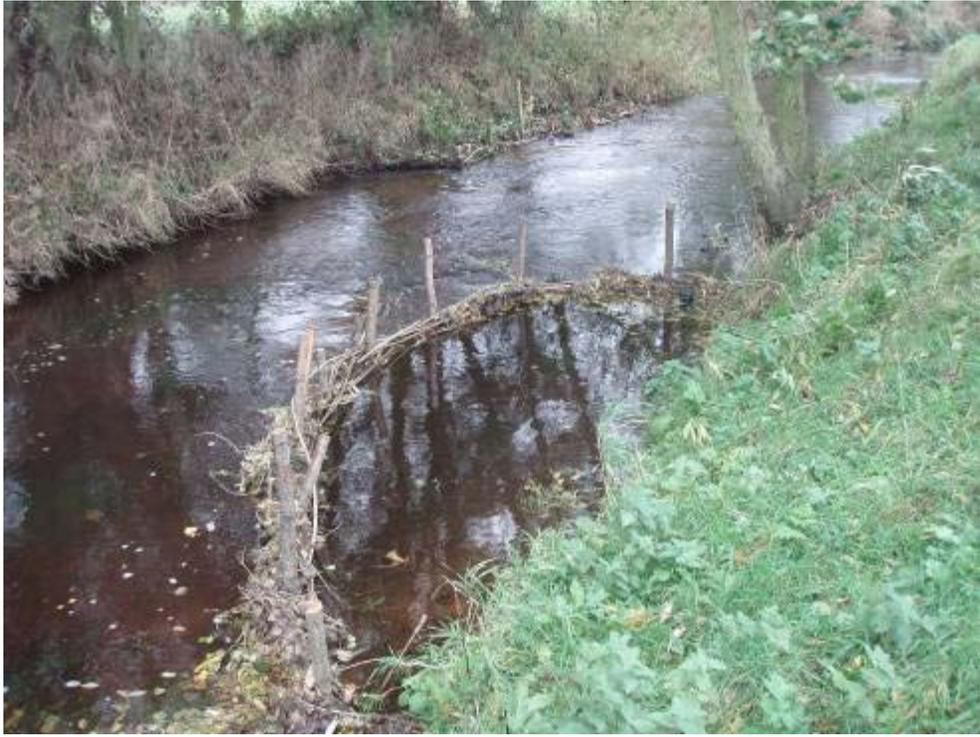
Within this lower field some habitat improvement works have been carried out in conjunction with Bishop Burton College fisheries department, following land drainage consent applications by PFA. This work includes bank revetment with brushwood, channel narrowing with D-shaped groynes and

brushwood mattresses, wooden groynes and submerged cover logs (Photos 13-15). This work has been well-executed, and will create some nice habitat as it matures. One or two of the flow deflecting groynes are almost perpendicular to the bank, and have caused some bank erosion; normally these would be positioned at a greater upstream angle to prevent this, but it is not a major problem given that PFA own the bank affected.

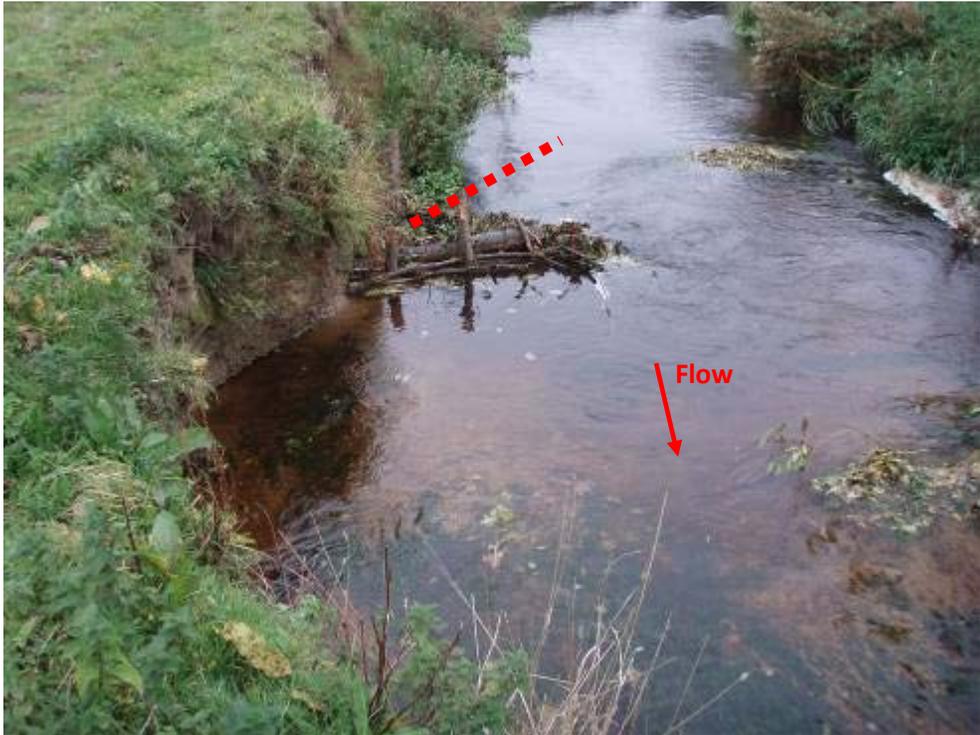
Photo 15 Repositioning this flow deflector to point more upstream will avoid the bank erosion currently occurring.

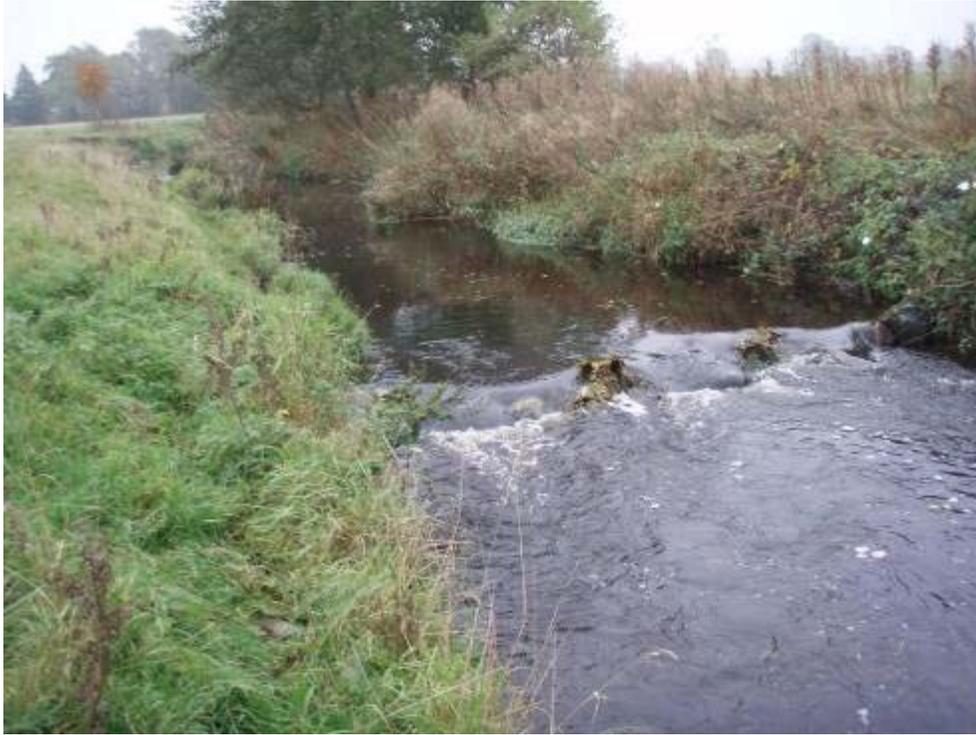
There are one or two stone groynes and low weirs in this section, the latter impounding water upstream (Photo 16). It would be beneficial to breach the middle of these weirs to create a flume, or to replace the structure with paired upstream pointing groynes.

Photo 16 Low weir on the lower section
