Advisory Visit

Pickering Beck – Duchy Water

30-08-2011

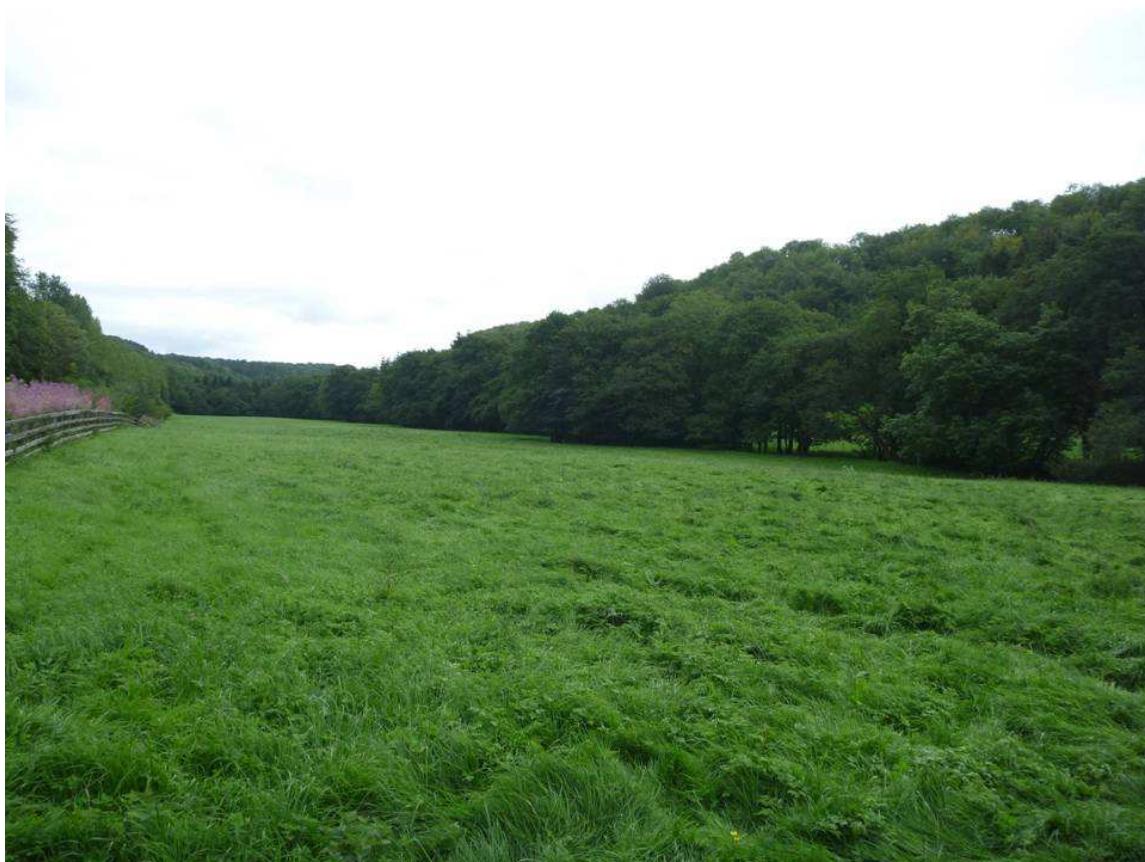
Starting at the lower limit of the inspected reach at SE 81385 85737 (national grid reference), the only example of grazed pasture is pictured (Fig.1). This is proposed to be the site of a future floodwater storage scheme with increased connectivity of the river to its floodplain and inclusion of floodwater retaining bunds in the surrounding pasture.

Figure 1: Pasture scheduled for floodplain floodwater storage scheme. The river follows the treeline to the right of frame. The border between trees in the background and the grass represents the upstream limit of grazing pasture on this reach.

It might be desirable to either “hinge” or cut through and cable some of the bankside trees such that their crowns lay in the river channel margins, parallel to the flow direction. This would provide a little variety in the surrounding tree canopy, but also be a simple way of improving in-stream cover for fish (as well as hydrological roughness). Such cover is lacking to a degree in this section (due to the grazing regime). Depending on future plans for livestock presence/absence or overall densities in the surrounding pasture, it may be desirable to exclude grazing of a marginal “buffer strip” of vegetation. However, any fencing design would need to be compatible with floodwater storage schemes and the attendant inundation regime of the flood plain. For example, top-hung panels or batons threaded onto tensioned wires between fence posts (or sacrificial panels separated by “water break points” – Appendix 1) could be used in strategic locations to minimise flood damage to fencing. The fencing design should be explicitly incorporated in the floodwater storage scheme. Contacting the managers of this scheme to

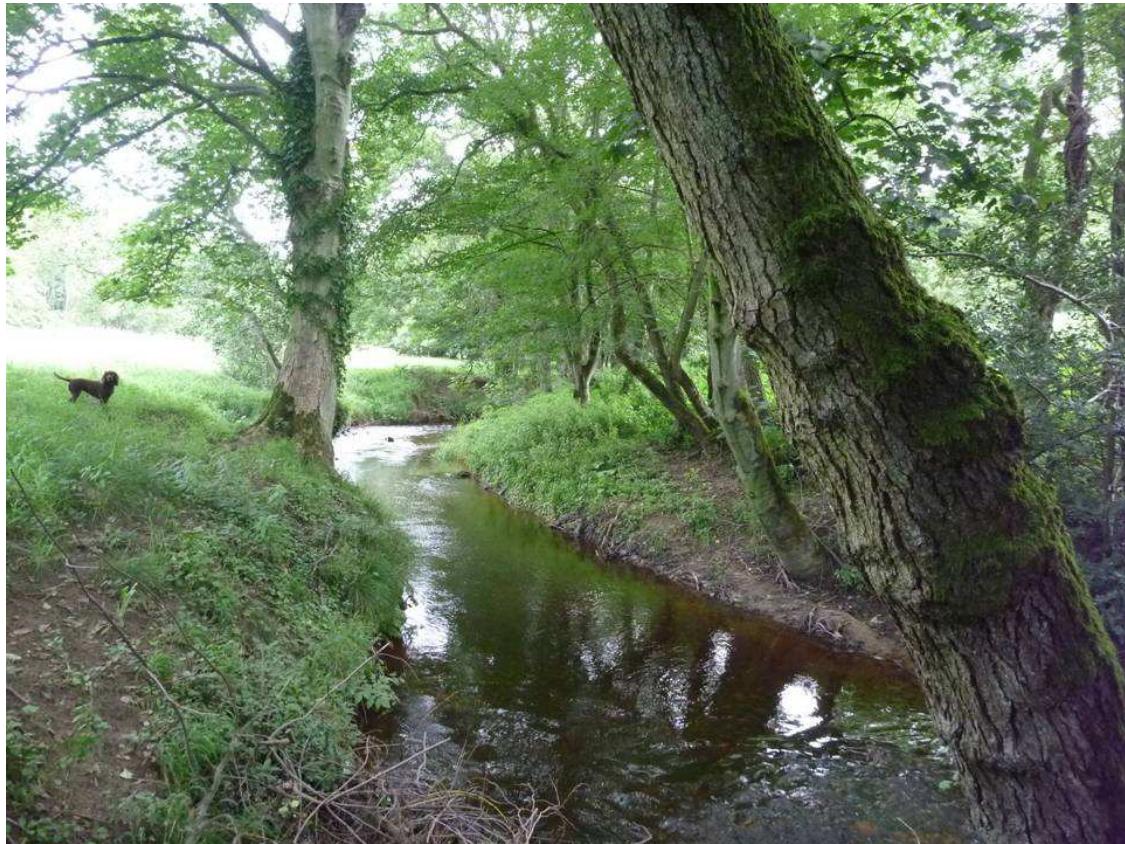
A single line of trees provides a nice mixture of light and shade along both banks, but could possibly benefit from a little variation in the height of the

canopy. The presence of grazing is also likely to prevent succession of tree seedlings at the current time (Fig. 2).

Figure 2: Single line of trees bordering both banks of the river in the pasture reach

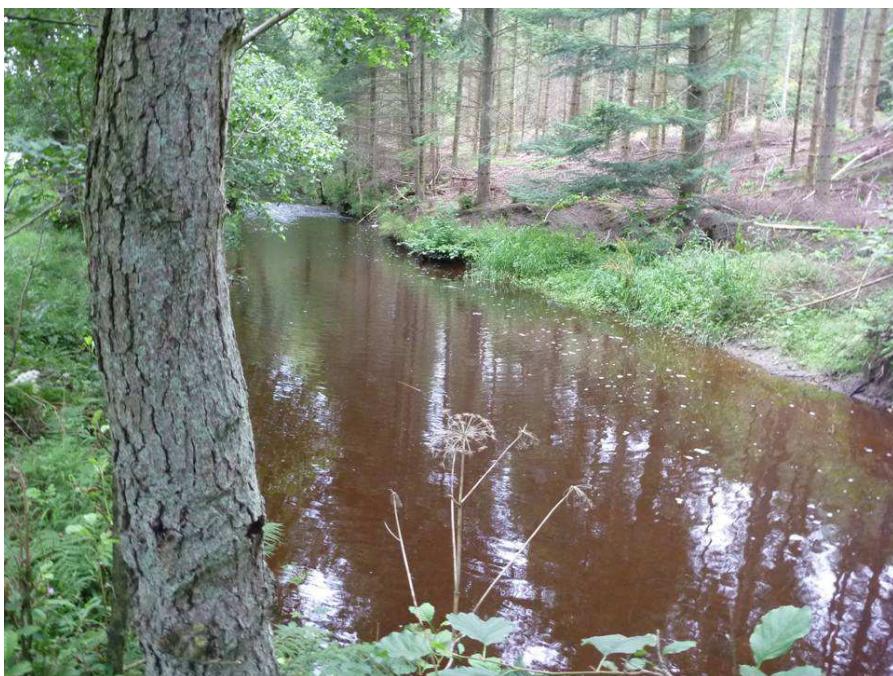
Figure 3: Root wad cover pinned into the riverbed in a scattered arrangement would help to increase the adult fish holding capacity of this reach. Forestry on the LHB could provide a ready supply of raw material

- Scattered root wad pinning into glide and pool habitat
- Scattered log pinning into pool tail habitat
- Tree hinging or felling and cabling to provide more substantial overhead cover and erosion control benefits (as well as juvenile fish shelter and fine sediment “filtering” and accumulation)
- Grazing exclusion (if relevant) via fencing that is compatible with future floodplain connectivity and floodwater storage schemes

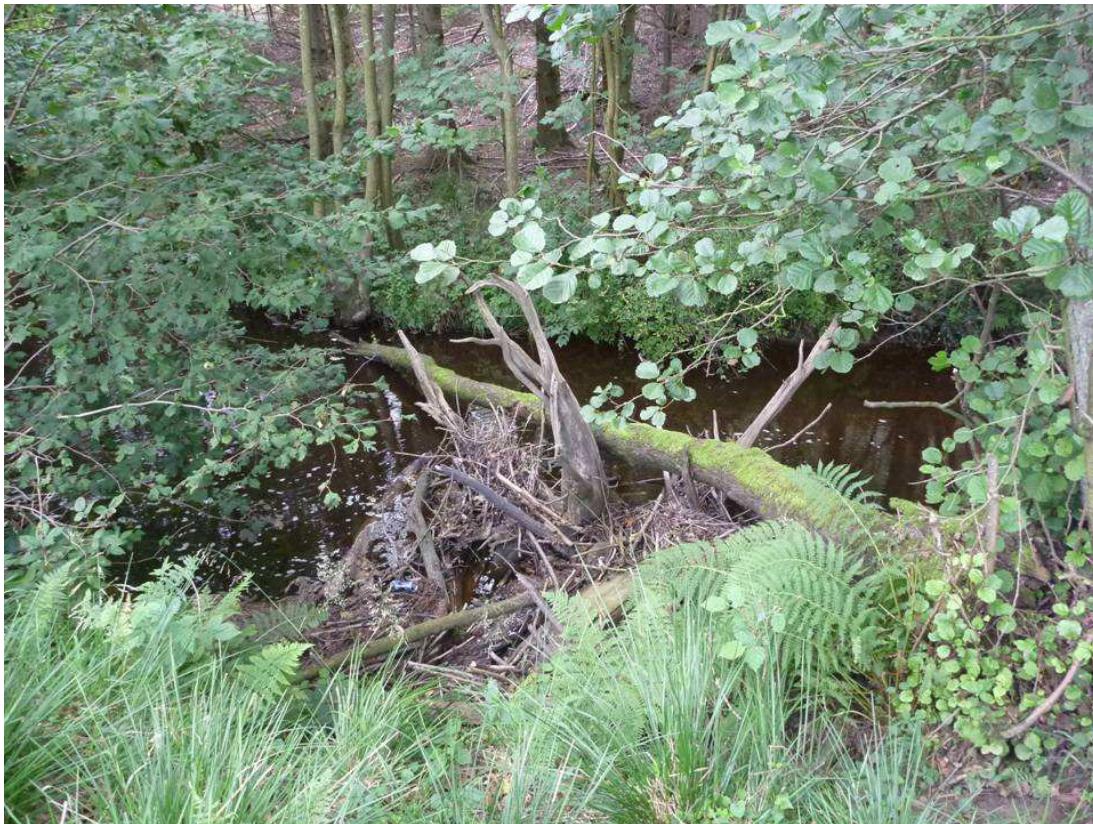
Figure 4: Natural debris accumulation - great habitat for the bugs that trout feed on and excellent cover for fish. Pool habitat creation is also promoted by the bed scour generated by cross-channel logs/attendant debris accumulation.

- Installation of a number of artificial log jams and/or upstream facing “v” flow deflectors are appropriate
- Resist the temptation to remove natural, fallen woody debris in the channel unless it is clearly either highly dangerous or highly unstable (either leave it in place if stable, or safely move and secure it if unstable)

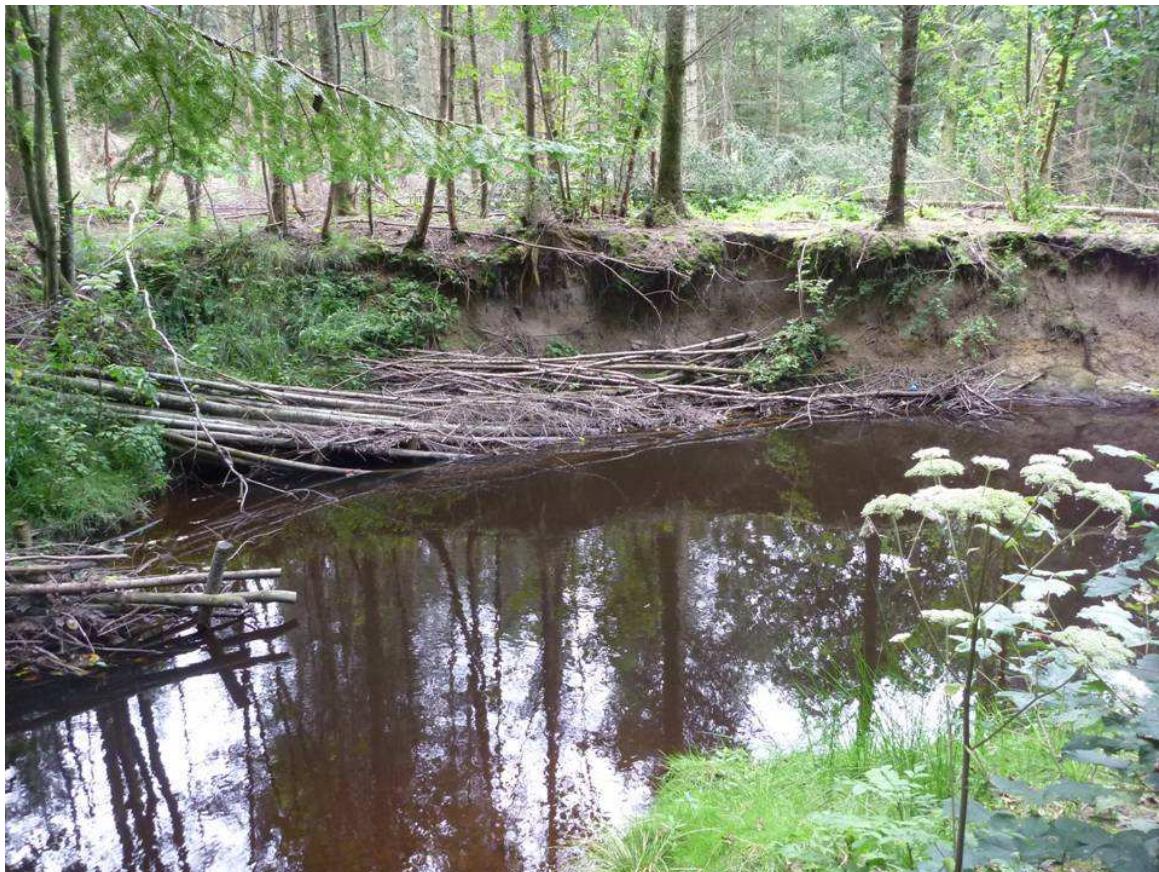
Figure 5: Parallel placement of marginal brashy material installed by Pickering Fishery Association is a great "soft engineering" technique to slow erosion as well as brake the downstream progress of floodwater. It also provides excellent cover for juvenile fish and a range of invertebrates.

The first recommendation probably counts as more of a commendation – and that is to continue the excellent programme of sensitive and effective existing works. The marginal brashy cover installation is providing excellent habitat as well as flow-regime and erosion control benefits. However, there are opportunities to produce additional adult scour pool habitat (with concomitant improvements to condition of spawning gravels). To this end:

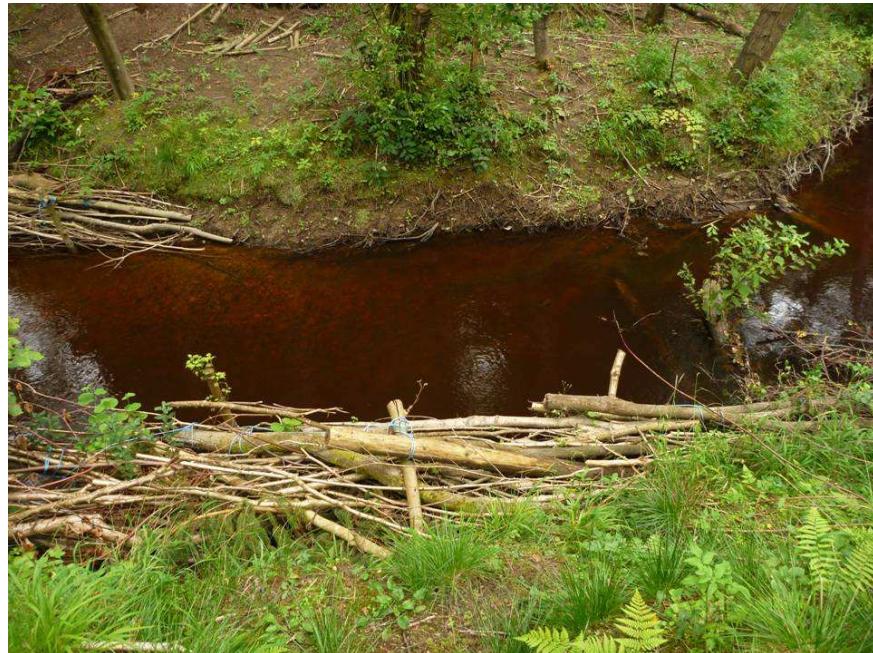
Figure 6: Great marginal habitat created by working party efforts

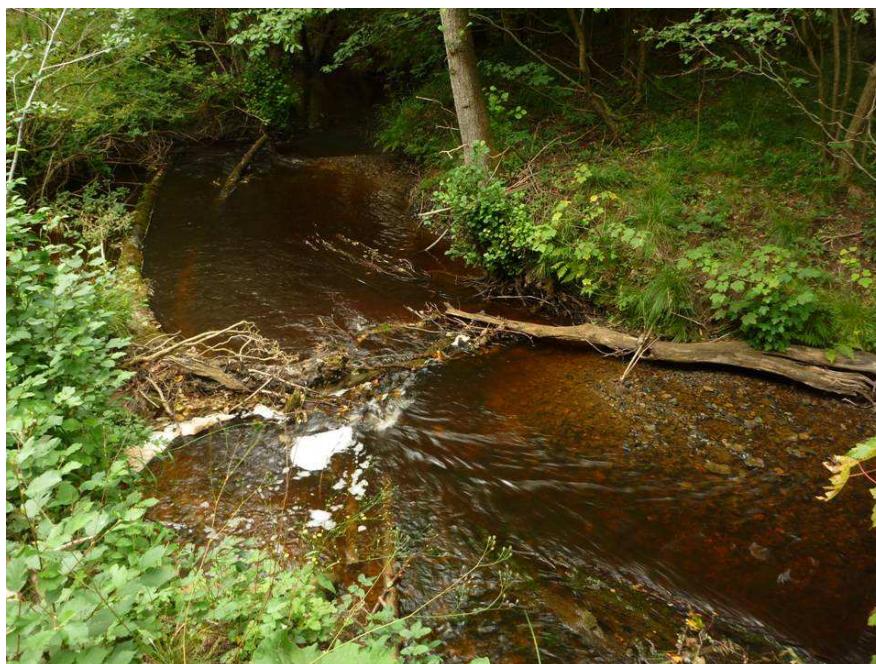
Currently, the club is limited by physical capacity to both the volume of work and the size of woody materials that are feasible to tackle. Furthermore, the considerable depth of water within some sections of this reach makes manual work within the channel impossible. However, the clear benefits of the excellent existing works (Fig. 6) and naturally occurring debris (Fig. 7) show the great potential of pursuing all safe and feasible opportunities. In fact, the location pictured in Figure 7 is probably the best overall example of high quality habitat encountered during the site visit.

Figure 7: Fantastic habitat created by combined deposition, erosion, and cover effects of natural woody debris.
The best habitat encountered during the whole visit. The fallen trees have also provided the right balance of light and shade.

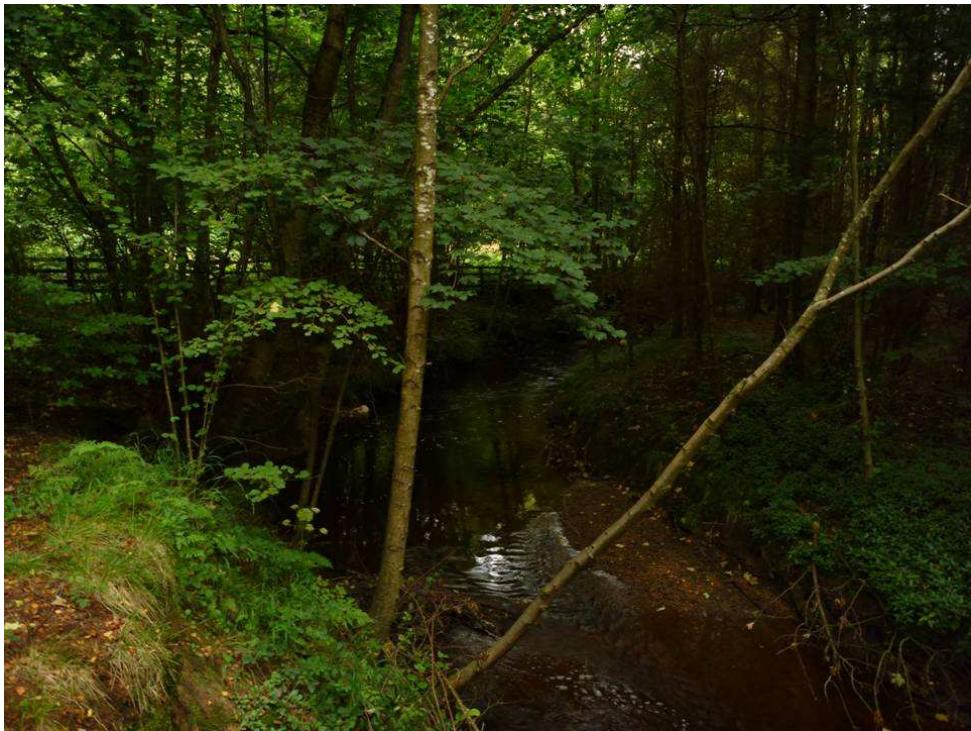
The other feature common throughout much of the river upstream of the lower pasture is very dense mature tree cover (Fig. 8). This extends right up the valley sides on both river banks in places and provides mostly a uniform, dense shade. Ideally a programme of rotational coppicing (using the arising

Figure 8: Dense, uniform shading that extends for the majority of the forested reaches

material for in-stream habitat structures) would be undertaken to introduce a more staggered age structure, canopy density and height distribution of trees. Something closer to the density illustrated in Figure 9 would be a reasonable benchmark to aim for.

- A programme of light rotational coppicing (potentially incorporating tree hinging as required) is recommended. Ideally, softwood species would be clear felled and replaced by planting suitable hardwood species. Selected hardwood trees could then be coppiced on a rotational basis to maintain diversity in canopy height and density. It is worth investigating whether any local financial incentives exist for changing from softwood to hardwood forestry (particularly given SSSI status and existing adjacent ancient woodland).

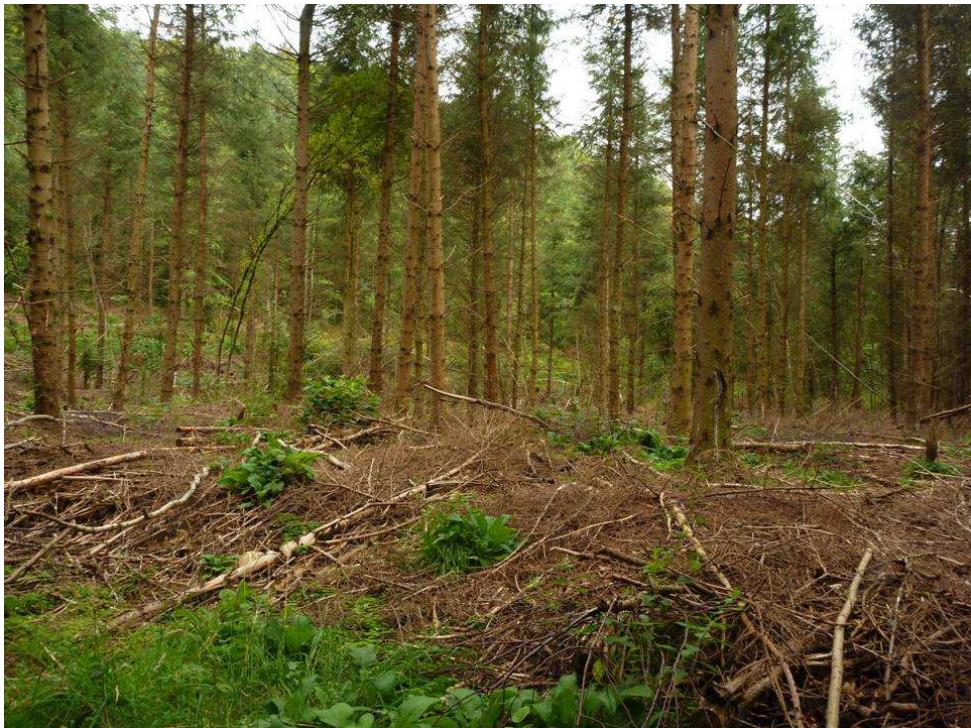
Figure 9: Some recent felling work indicates a fair benchmark for the appropriate extent of coppicing

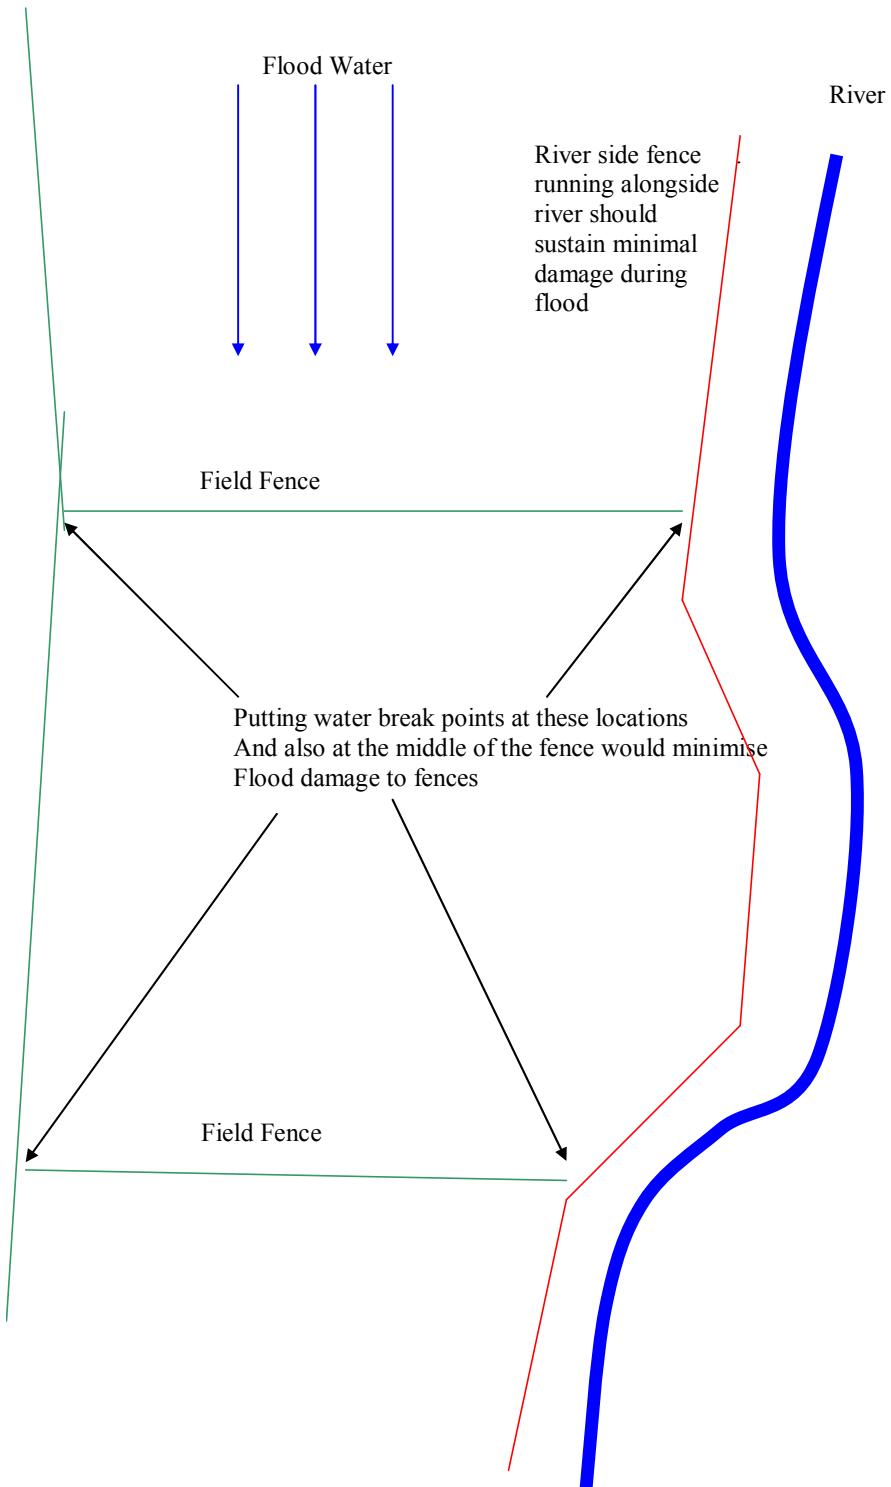
Details for setting up water break points to separate one fence into two

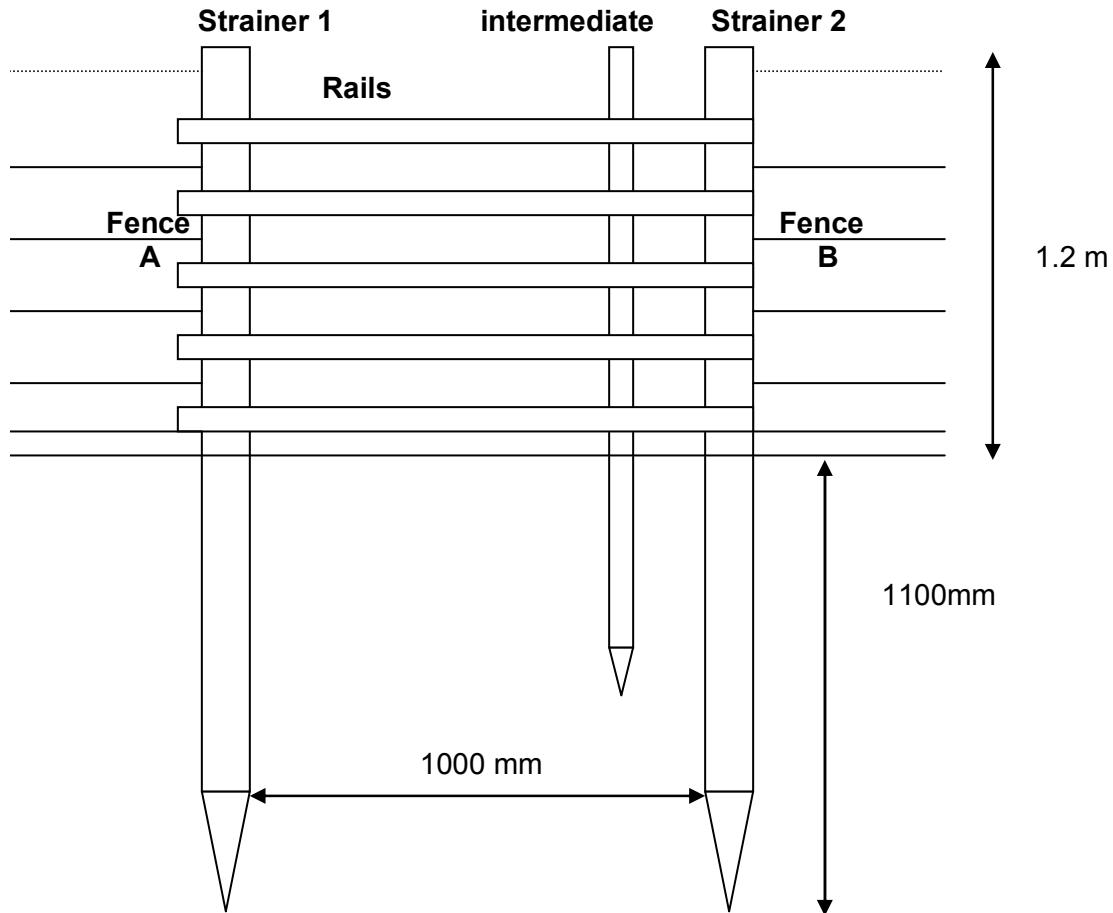
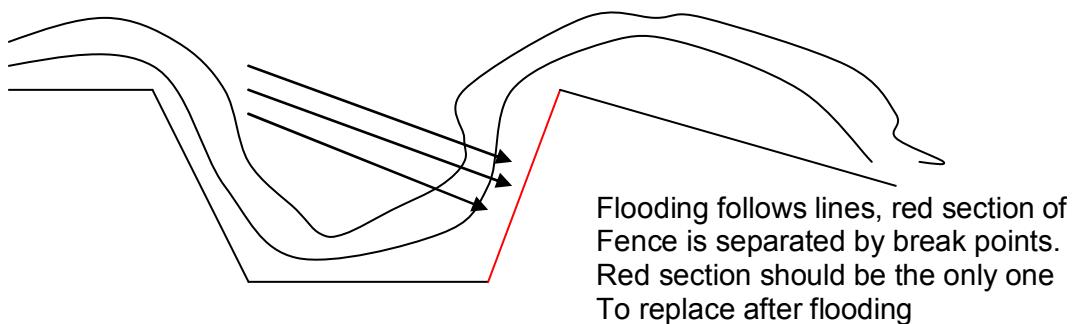
Water Break Point:

- Straining posts 1 and 2 set at approx 1m apart
- Intermediate post set 200mm of strainer 2
- Rails are nailed to strainer 1 and intermediate post
- Rails sit flush to strainer 2 but not attached to it
