Pillhill Brook, Monxton, Hampshire

An Advisory Visit by the Wild Trout Trust, March 2014

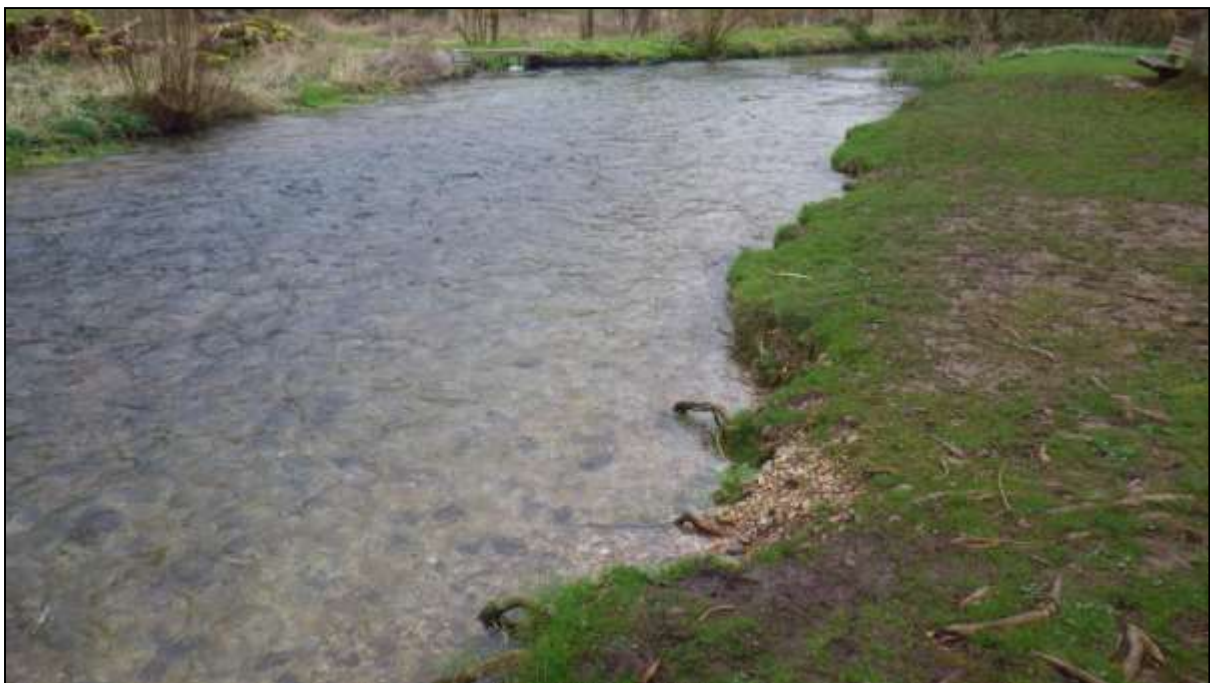
At the upstream boundary of Mr Corroon's water, the Brook flows out from under a clear-span road bridge. On the RB a small green is used as a community recreation area. A combination of lawn mowing right up to the bank edge and the footfall of people, dogs and probably waterfowl accessing the river have severely eroded the bank. This has inhibited the establishment of marginal and bankside plants and caused the channel to widen.

True marginal species are an important component of the river ecosystem and provide food and shelter for a range of invertebrates, small mammals and birds. A 'shaggy' bank margin also provides important refuge habitat for juvenile trout. The widening of the river has caused a reduction in flow speed which has resulted in a uniformly flat channel profile. This leaves the channel vulnerable to becoming over-shallow during periods of low flow.

Figure 3: Bank erosion on the RB has reduced habitat quality and the ability of the channel to adapt to low flows

6. The eroded area at the upstream boundary of the reach could be repaired by installing low-lying brushwood shelves as prescribed above. However as the bank is regularly accessed it would be wise to include some formalised gravel access ramps where people and dogs could access the river without trampling the brushwood or causing further erosion. Dogs will generally favour accessing the river via the gravel ramps and should avoid the brushwood.

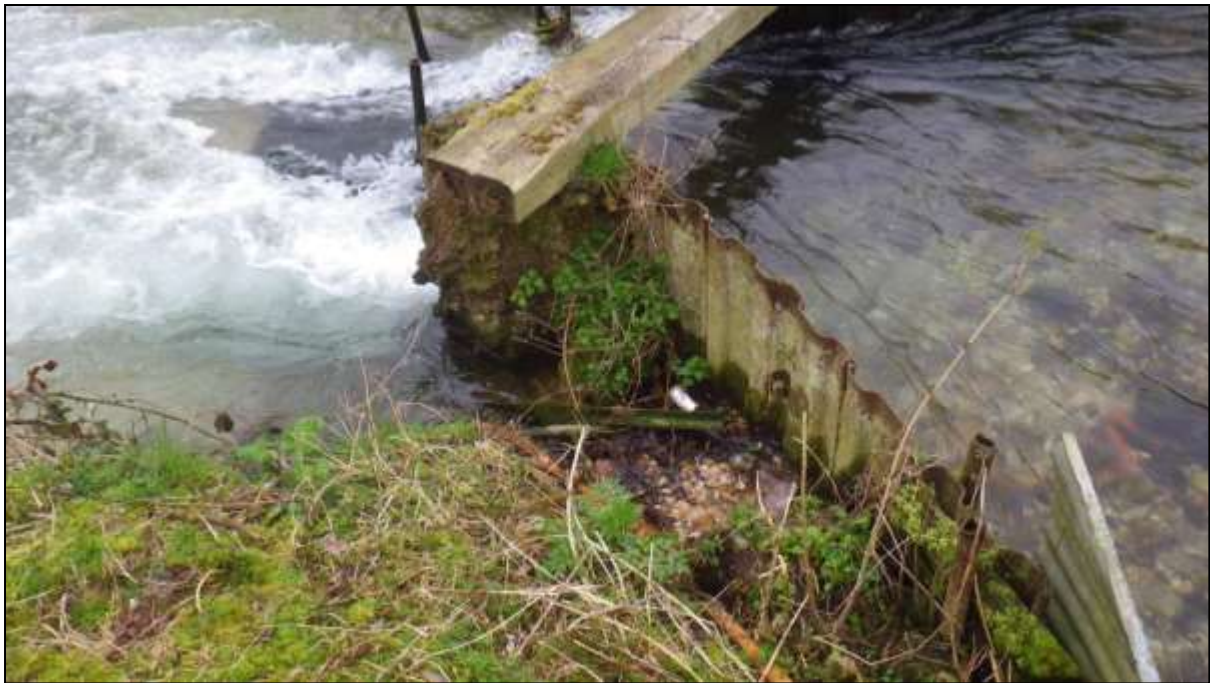
A few metres downstream the flow is divided between the natural river and a wide mill leat. Holding up a head of water to supply the old leat is a small stop-log weir. Under the flow conditions observed on the day of the visit, the weir was passable to trout but under low-flow conditions the weir becomes an impassable barrier (Pers. Comm. Hugh Corroon). The weir is in a state of dilapidation and the river is cutting its way around the structure (Figure 4).

Figure 4: The weir is in poor condition and the river is cutting around the sides

In terms of habitat, the best outcome for trout and biodiversity in general would be if the weir were to be completely removed. This would help ensure the reach below the weir (which has a far greater habitat value) does not become depleted of flow during dry periods and would facilitate both fish passage and the natural transport of river sediments. However, the leat flows along a number of neighbouring properties including the beer garden of The Black Swan pub and is undoubtedly an important feature to the riparian residents. A potential solution to the weir is proposed in the *Recommendations* section.

1. The weir shown in Figure 4 should be replaced with a stepped series of bowl-shaped retained gravel reject riffles. This technique has been successfully used to improve fish passage on other rivers.

The technique involves driving a series of lines of sweet chestnut stakes across the river at roughly 100mm centres and stacking large flint cobbles (Figure 10) behind each line. Each line can then be back-filled with flint gravel rejects to form a step. The head loss over the existing structure should be spread out over a series of small steps with a head loss of

approximately 100mm. The retaining wall at each step should be lowest at the centre sloping up towards each bank. This will ensure that a smooth flume of water flows over the centre of each step allowing for easy upstream passage (Figure 11).

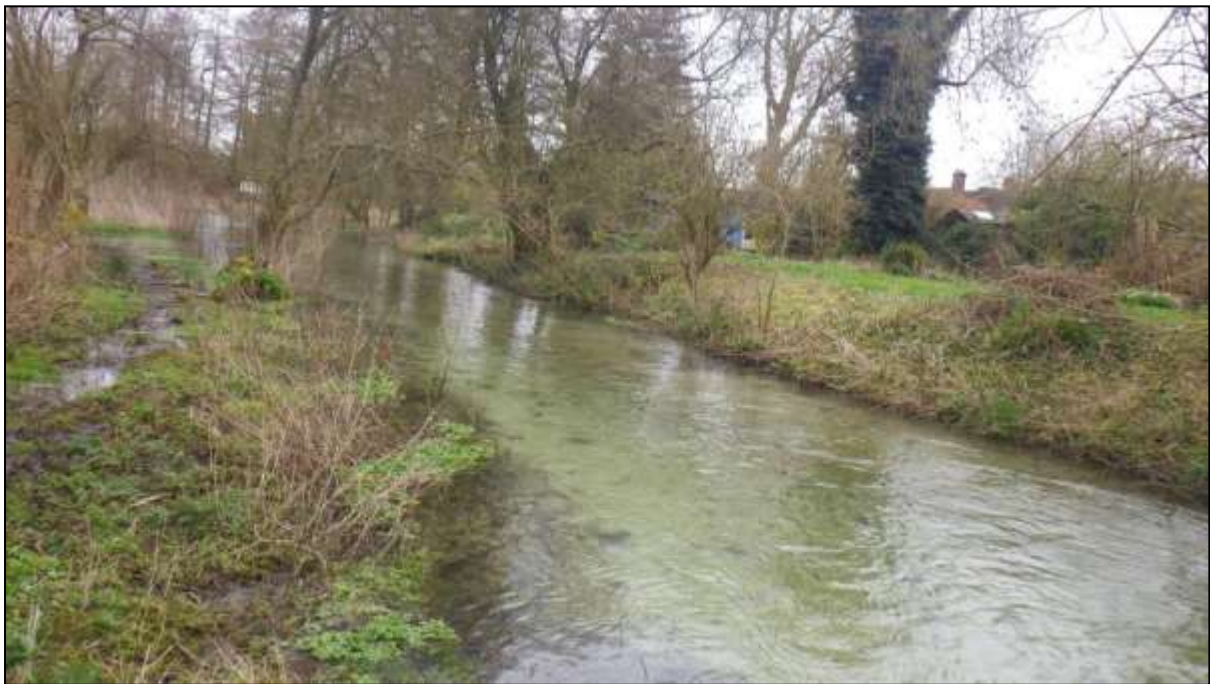
Downstream of the weir the channel bends sharply to the right and is then artificially straight and relatively uniform in width. The uniformity of the channel plan form (bird's eye view) contributes to a relatively uniform cross section. The bed is relatively flat and flows are uniformly laminar. The reach lacks distinct pool and riffles and consists almost entirely of shallow 'glide' habitat. Under the flow conditions observed during the visit, fine sediment was being swept out of the centre of the channel and deposited in the margins. This is a beneficial process which ensures that a gradient of different habitat conditions is maintained. Certain animal species (such as mayfly (*Ephemera danica*) and brook lamprey (*Lampetra planeri*)) prefer silty conditions, whilst others (such as Yellow May Dun, *Heptagenia sulphurea* and bullhead, *Cottus gobio*) prefer clean gravels. Ensuring that a good diversity of conditions is present will also ensure

However, it should be noted that the visit followed the wettest winter on record and flows were uncharacteristically elevated. It is reasonable to infer that under average flows the physical uniformity of the channel will result in more uniform distribution of fine sediment. This will limit biodiversity and may also impact on the quality of potential spawning habitat.

Figure 5: The channel below of the weir is straightened and lacks physical diversity

2. The channel below the weir should be narrowed and greater sinuosity introduced. This can be achieved by laying site-won brushwood into the channel margins to create a series of 'D-shaped' (roughly semi-circular) brushwood shelves.

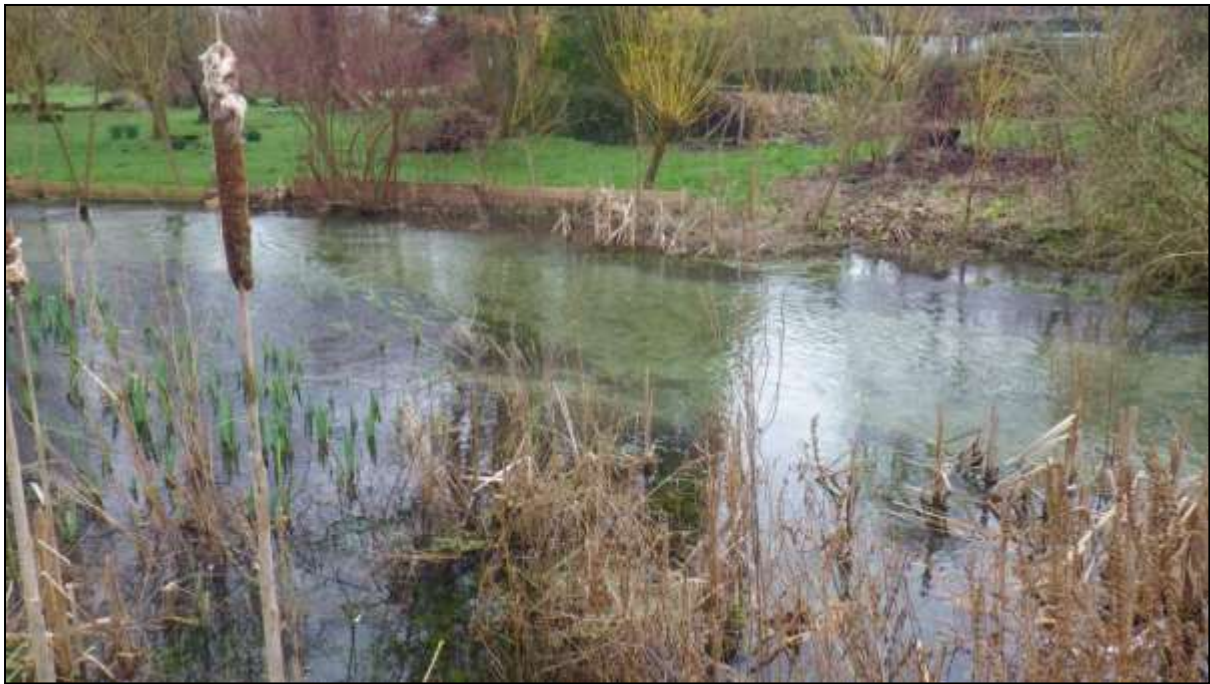
Although the bank gradient is generally good, some properties on the RB have installed toe boards and have mowed lawns right up to the bank edge. This is locally diminishing marginal habitat quality and biodiversity and the practice

should be dissuaded if possible (Figure 6). The shallow root structure of a grass monoculture can also leave banks vulnerable to erosion as boards rot away.

Figure 6: Mown lawns and toe boards reduce marginal biodiversity and can leave banks vulnerable to erosion.

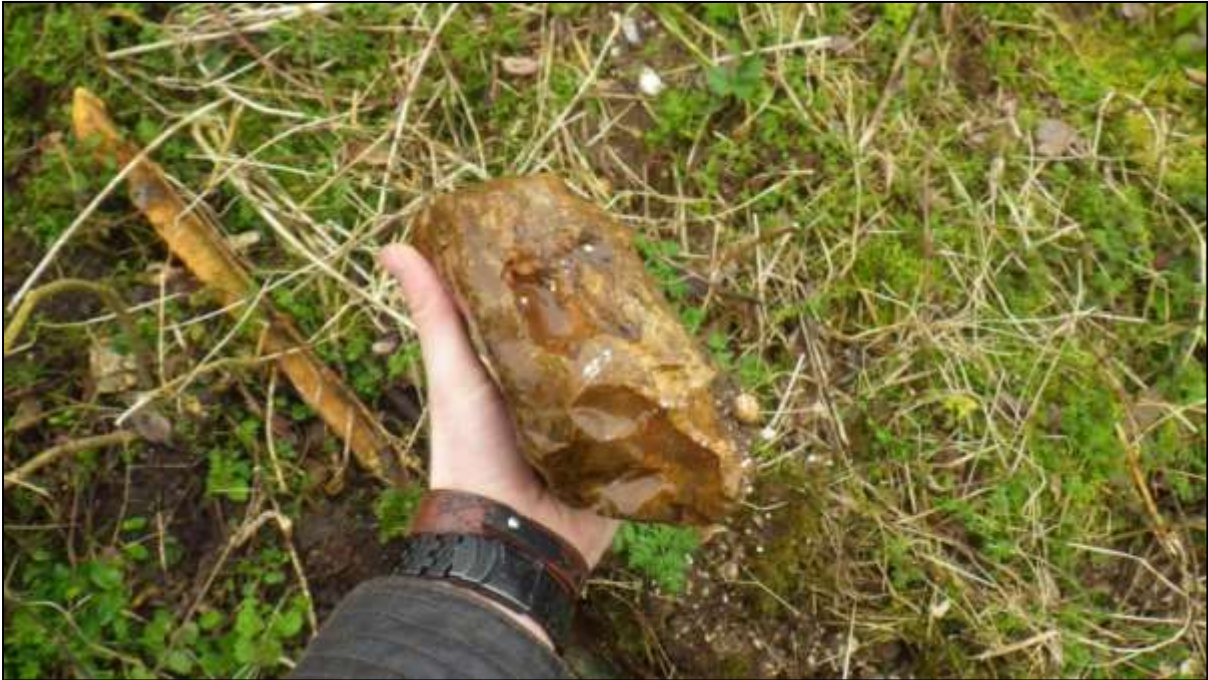
Figure 10: A large flint cobble (picked out of the river near the existing stop-log weir).

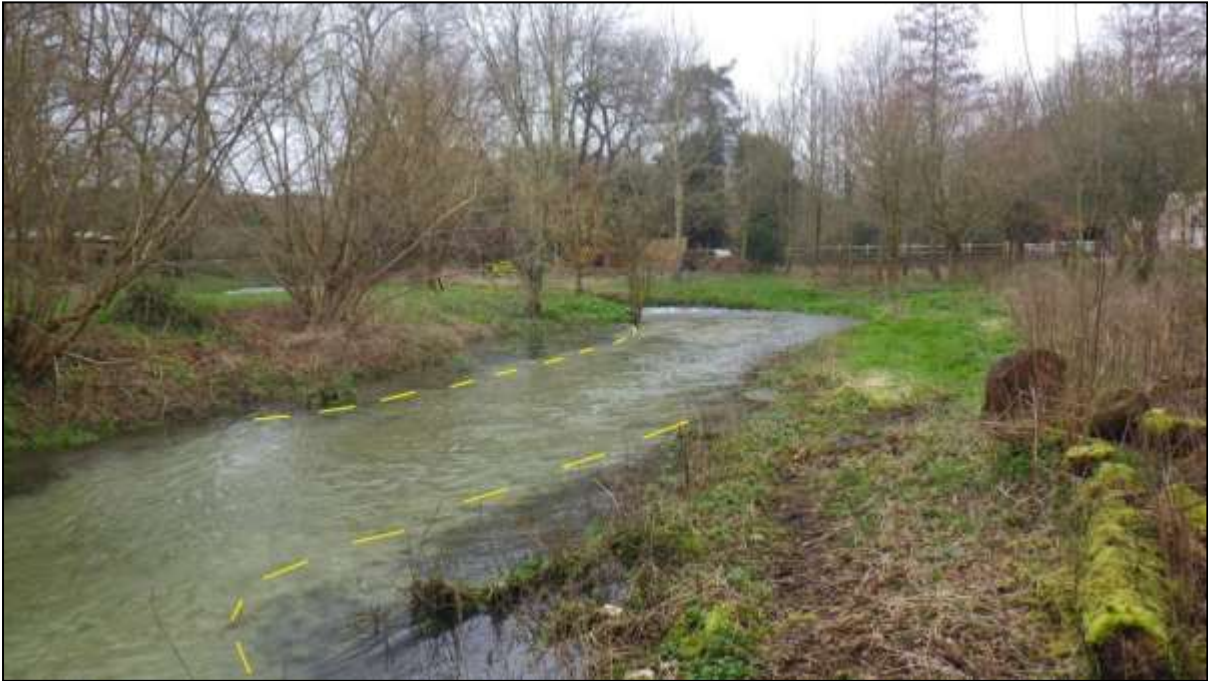
Figure 12: Brushwood shelves should be installed in existing areas of deposition (outlined with yellow dashes)

The outline of each shelf can be simply marked out with sweet chestnut stakes following the areas of existing deposition (Figure 12). This will ensure that the new structures work with the existing river processes, quickly consolidating fine sediment. The lifespan of each shelf should then be sufficient for colonising plants to replace the brushwood and form more permanent marginal beds. Brushwood structures installed in erosive conditions will not last more than two or three years.

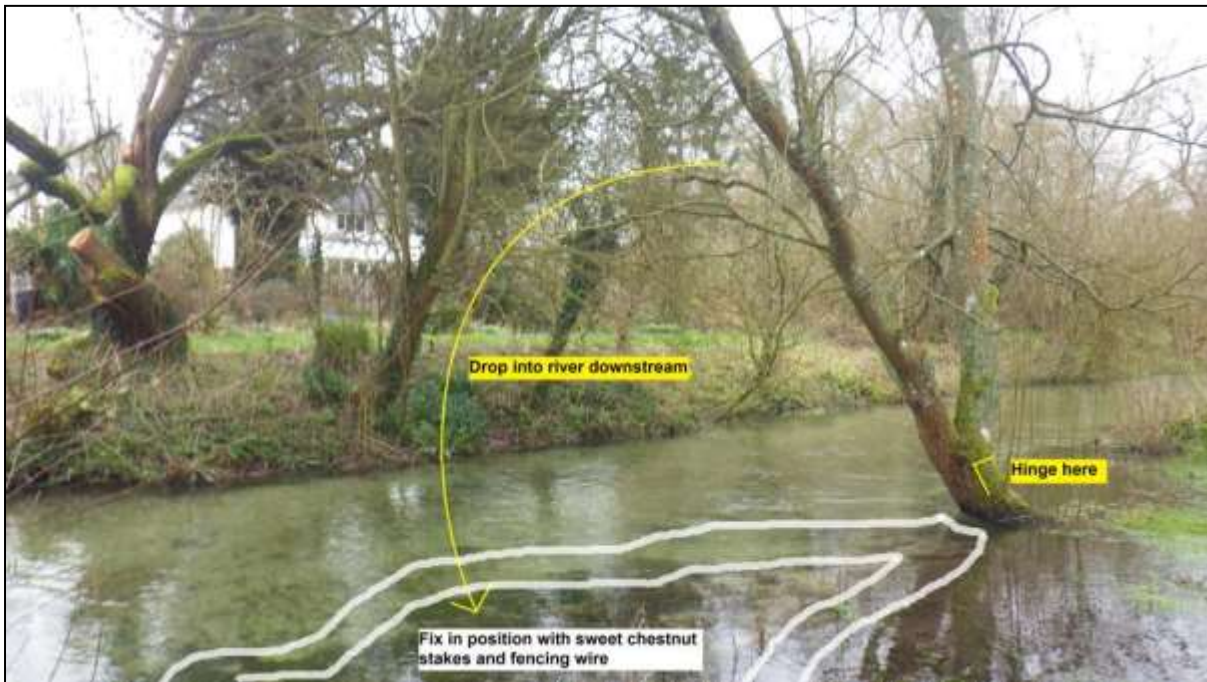
Figure 15: An example of an existing tree that could be hinged into the river.

3. Opportunities should be sought to 'hinge' bankside trees into the river to both act as flow deflectors and to form more sparse brushwood cover in areas of deposition. By mimicking how a tree might naturally topple into the stream, LWD/CWD habitat can be introduced in a fashion that wild trout are perfectly evolved to exploit. By leaving the tree attached at the base it should survive and will require very little securing, though it will require some ongoing maintenance. The tree in Figure 15 is an example such an opportunity.

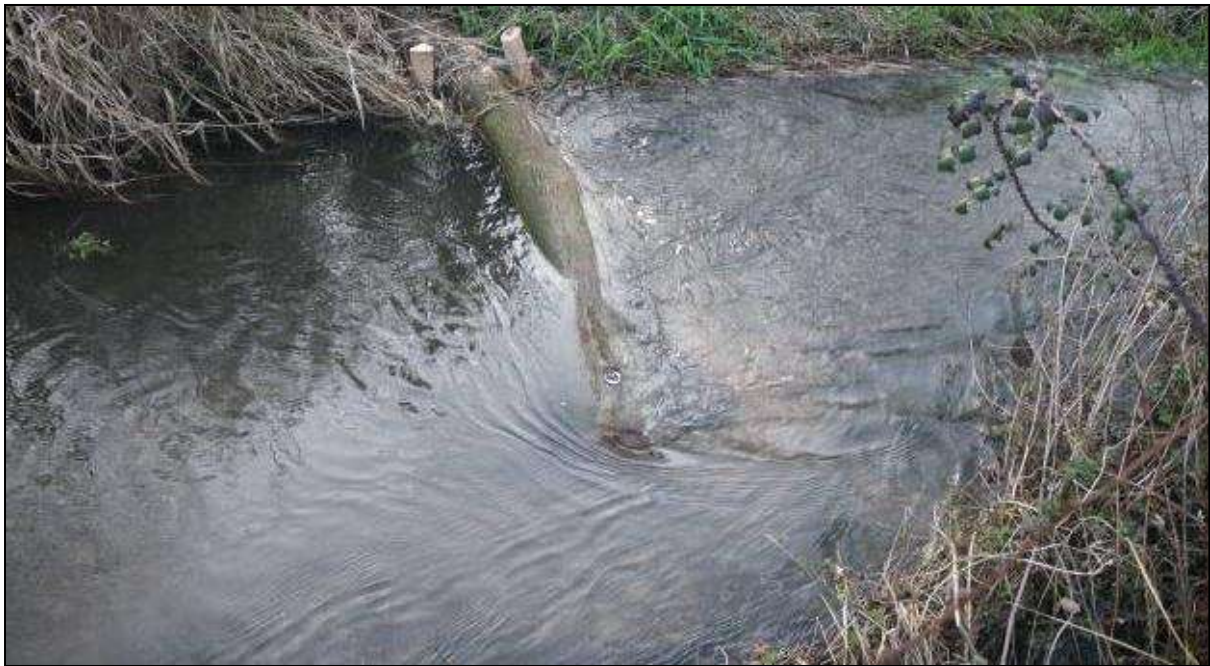
Figure 16: An example of a simple log deflector. Note the bankside edge is keyed into the bank and the log slopes down into the river. The stream flows from left to right in this picture.

4. LWD should also be introduced to act as flow deflectors to kick flow left and right across the channel and increase scour through the thalweg. Simple log deflectors (as pictured in Figure 16) alternating from bank to bank will work but ideally, more complex-shaped pieces of LWD should be used to maximise flow diversity.

To fix LWD into the river, drive sweet chestnut stakes in pairs at both ends of the log. Wire between the stakes across the width of the log and then drive the stakes in further to secure the LWD in place.

Water flowing over a log will be deflected at 90° from the angle of the log across the channel. For this reason, deflectors should be positioned

pointing slightly upstream so that flows are deflected into the centre of the channel as opposed to the bank.

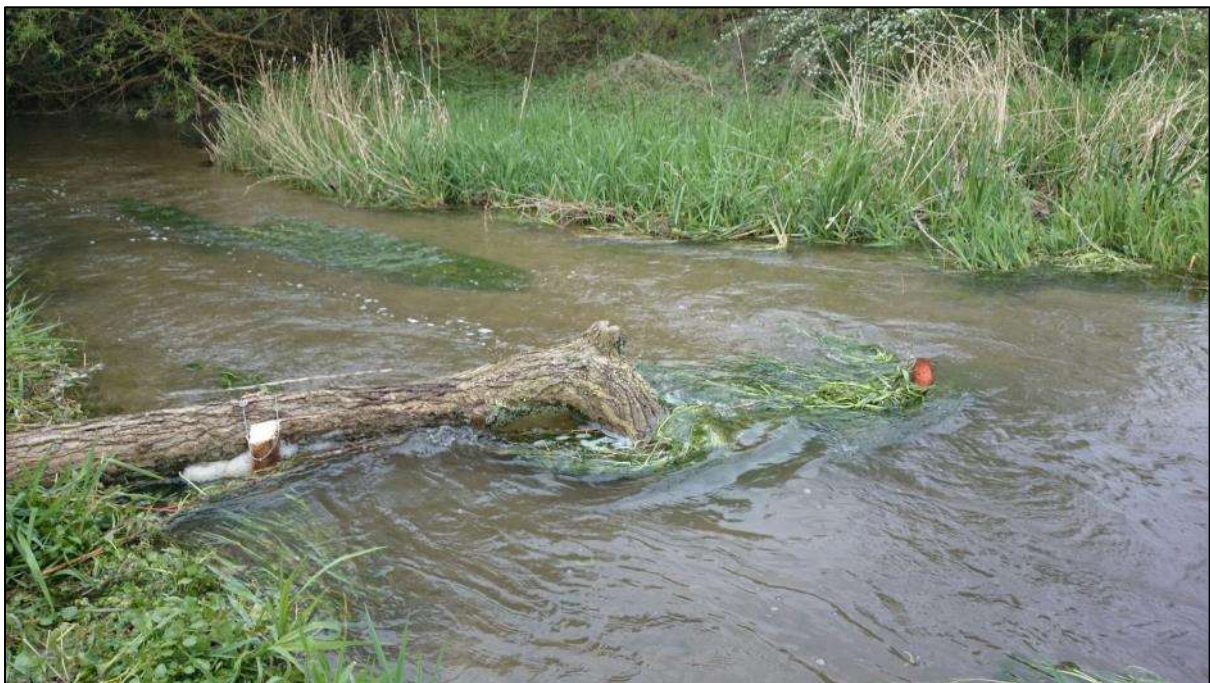
Figure 17: Complex woody debris deflecting flow across the channel but also providing both overshoot and undershot scour.

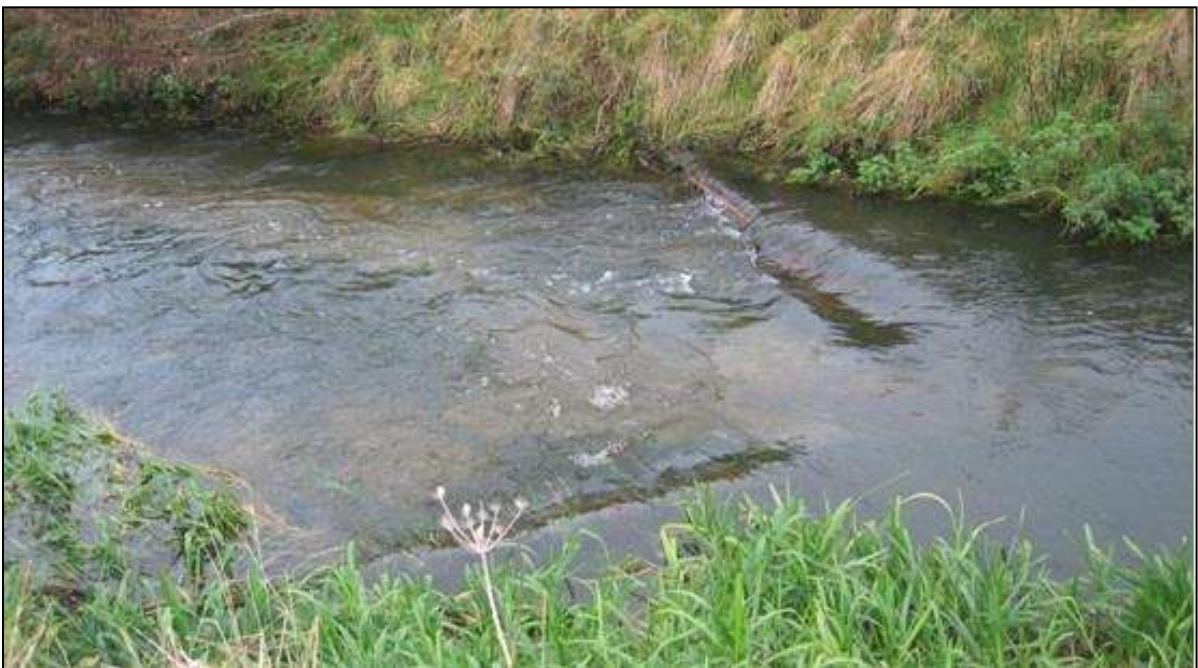
Figure 19: An example of a pair of deflectors in an upstream-facing V formation

5. In order to further drought-proof the reach, occasional deep pools could be encouraged to form by the introduction of one or two pairs of deflectors positioned in a 'V-shaped' formation with a small gap between them (Figure 19). The size of the gap can be determined by eye. The deflector pair should pinch flow through the gap without impounding the flow upstream.

This formation will focus scour into the bed at the centre of the channel and gradually shape a pool with potentially good spawning habitat at its tail.
