Pillhill Brook, Monxton, Hampshire

An Advisory Visit by the Wild Trout Trust, March 2014

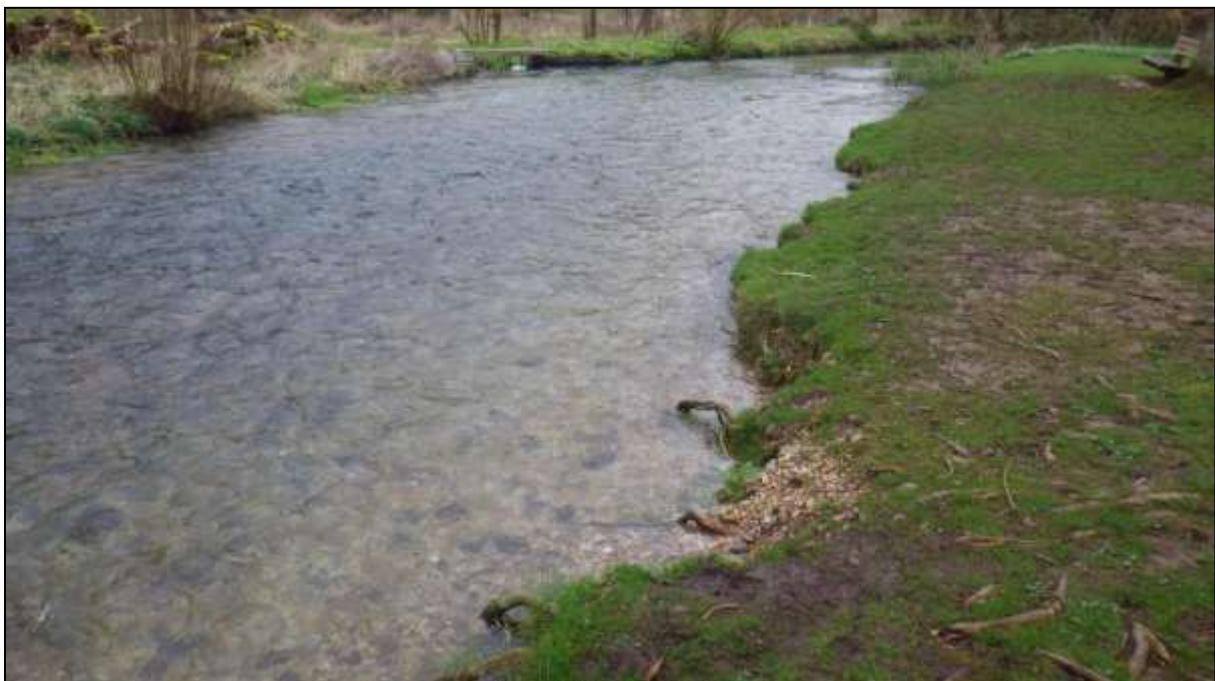
At the upstream boundary of Mr Corroon's water, the Brook flows out from under a clear-span road bridge. On the RB a small green is used as a community recreation area. A combination of lawn mowing right up to the bank edge and the footfall of people, dogs and probably waterfowl accessing the river have severely eroded the bank. This has inhibited the establishment of marginal and bankside plants and caused the channel to widen.

True marginal species are an important component of the river ecosystem and provide food and shelter for a range of invertebrates, small mammals and birds. A 'shaggy' bank margin also provides important refuge habitat for juvenile trout. The widening of the river has caused a reduction in flow speed which has resulted in a uniformly flat channel profile. This leaves the channel vulnerable to becoming over-shallow during periods of low flow.

Figure 3: Bank erosion on the RB has reduced habitat quality and the ability of the channel to adapt to low flows

6. The eroded area at the upstream boundary of the reach could be repaired by installing low-lying brushwood shelves as prescribed above. However as the bank is regularly accessed it would be wise to include some formalised gravel access ramps where people and dogs could access the river without trampling the brushwood or causing further erosion. Dogs will generally favour accessing the river via the gravel ramps and should avoid the brushwood.

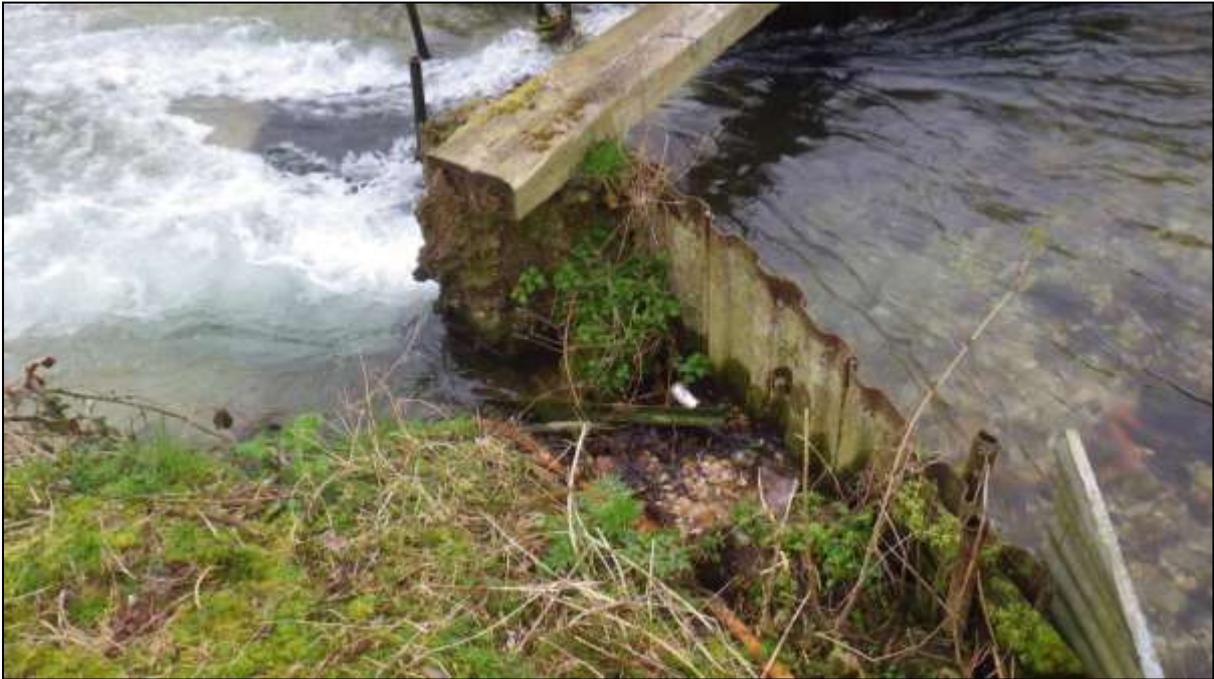
A few metres downstream the flow is divided between the natural river and a wide mill leat. Holding up a head of water to supply the old leat is a small stop-log weir. Under the flow conditions observed on the day of the visit, the weir was passable to trout but under low-flow conditions the weir becomes an impassable barrier (Pers. Comm. Hugh Corroon). The weir is in a state of dilapidation and the river is cutting its way around the structure (Figure 4).

Figure 4: The weir is in poor condition and the river is cutting around the sides

In terms of habitat, the best outcome for trout and biodiversity in general would be if the weir were to be completely removed. This would help ensure the reach below the weir (which has a far greater habitat value) does not become depleted of flow during dry periods and would facilitate both fish passage and the natural transport of river sediments. However, the leat flows along a number of neighbouring properties including the beer garden of The Black Swan pub and is undoubtedly an important feature to the riparian residents. A potential solution to the weir is proposed in the *Recommendations* section.

1. The weir shown in Figure 4 should be replaced with a stepped series of bowl-shaped retained gravel reject riffles. This technique has been successfully used to improve fish passage on other rivers.

The technique involves driving a series of lines of sweet chestnut stakes across the river at roughly 100mm centres and stacking large flint cobbles (Figure 10) behind each line. Each line can then be back-filled with flint gravel rejects to form a step. The head loss over the existing structure should be spread out over a series of small steps with a head loss of

approximately 100mm. The retaining wall at each step should be lowest at the centre sloping up towards each bank. This will ensure that a smooth flume of water flows over the centre of each step allowing for easy upstream passage (Figure 11).

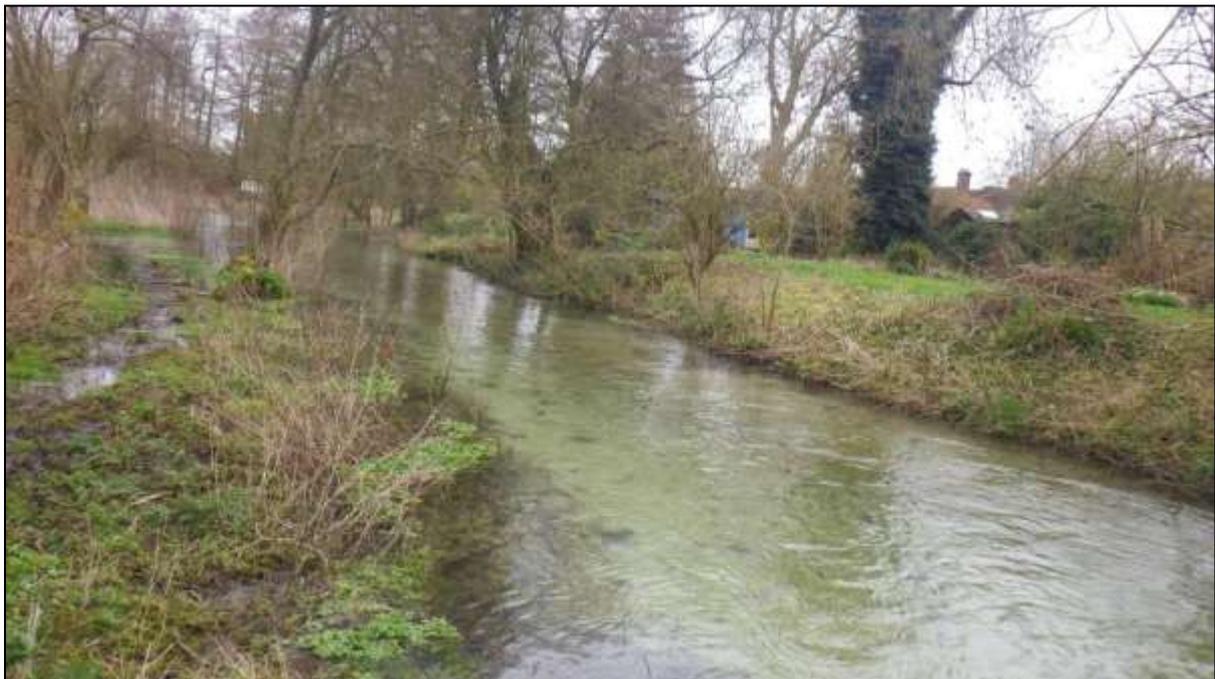
Downstream of the weir the channel bends sharply to the right and is then artificially straight and relatively uniform in width. The uniformity of the channel plan form (bird's eye view) contributes to a relatively uniform cross section. The bed is relatively flat and flows are uniformly laminar. The reach lacks distinct pool and riffles and consists almost entirely of shallow 'glide' habitat. Under the flow conditions observed during the visit, fine sediment was being swept out of the centre of the channel and deposited in the margins. This is a beneficial process which ensures that a gradient of different habitat conditions is maintained. Certain animal species (such as mayfly (*Ephemera danica*) and brook lamprey (*Lampetra planeri*)) prefer silty conditions, whilst others (such as Yellow May Dun, *Heptagenia sulphurea* and bullhead, *Cottus gobio*) prefer clean gravels. Ensuring that a good diversity of conditions is present will also ensure

However, it should be noted that the visit followed the wettest winter on record and flows were uncharacteristically elevated. It is reasonable to infer that under average flows the physical uniformity of the channel will result in more uniform distribution of fine sediment. This will limit biodiversity and may also impact on the quality of potential spawning habitat.

Figure 5: The channel below of the weir is straightened and lacks physical diversity

2. The channel below the weir should be narrowed and greater sinuosity introduced. This can be achieved by laying site-won brushwood into the channel margins to create a series of 'D-shaped' (roughly semi-circular) brushwood shelves.

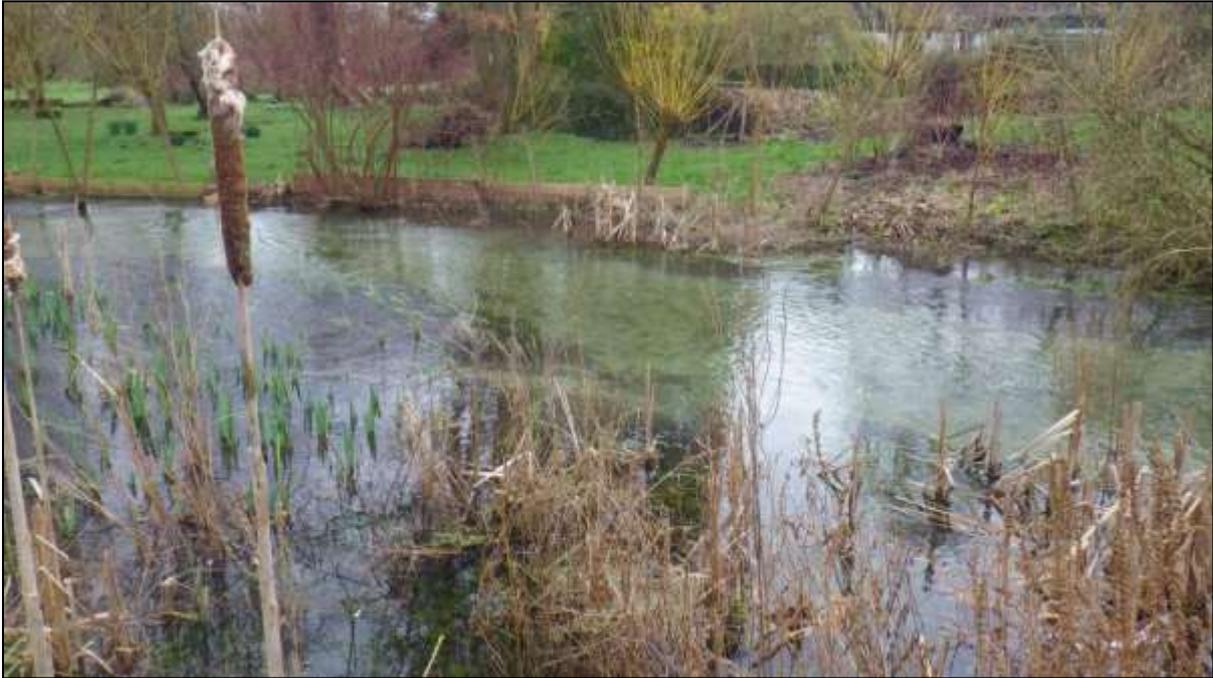
Although the bank gradient is generally good, some properties on the RB have installed toe boards and have mowed lawns right up to the bank edge. This is locally diminishing marginal habitat quality and biodiversity and the practice

should be dissuaded if possible (Figure 6). The shallow root structure of a grass monoculture can also leave banks vulnerable to erosion as boards rot away.

Figure 6: Mown lawns and toe boards reduce marginal biodiversity and can leave banks vulnerable to erosion.

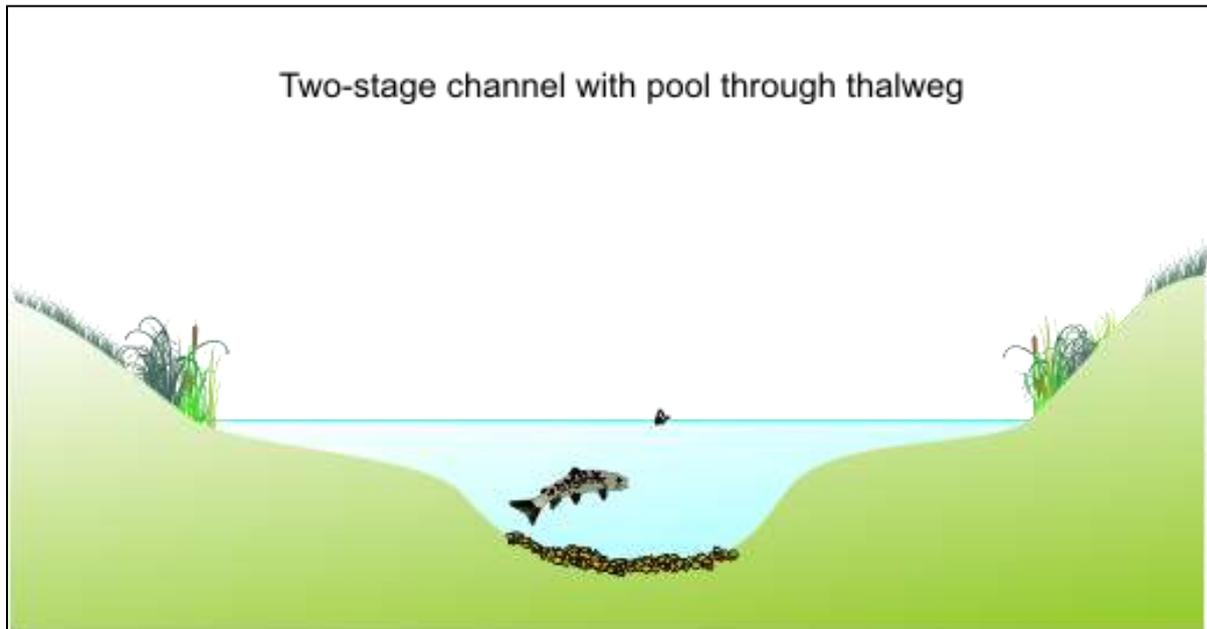
The scouring effect of in-channel LWD and CWD helps to create a sinuous flume of fast-flowing water that meanders through the channel. This eventually scours a relatively deep trench in the bed which becomes the very bottom of the valley known as the 'thalweg'. This trench acts as a low-flow channel which allows the river to naturally self-narrow during low flows and retain both depth and water velocity (Figure 8). A river with a well-pronounced thalweg is said to have a 'two stage' channel.

Figure 9: An illustration of a two stage channel cross section with a deeper 'low-flow' channel holding trout during low flows.

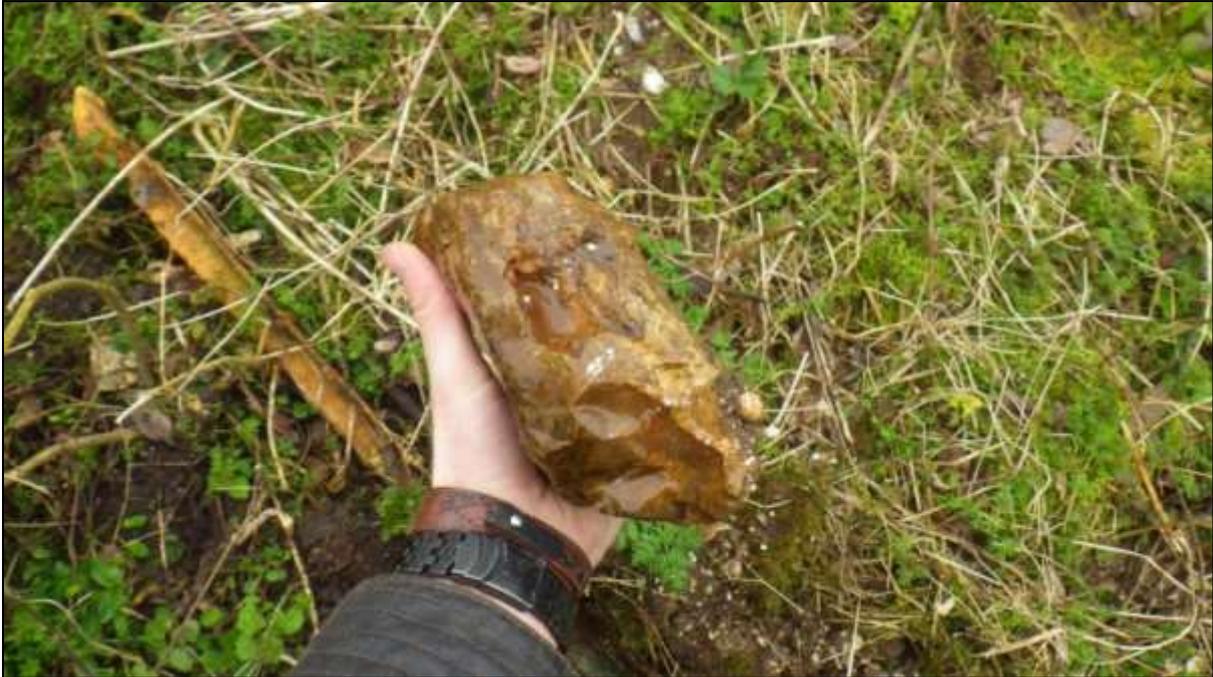
Figure 10: A large flint cobble (picked out of the river near the existing stop-log weir).

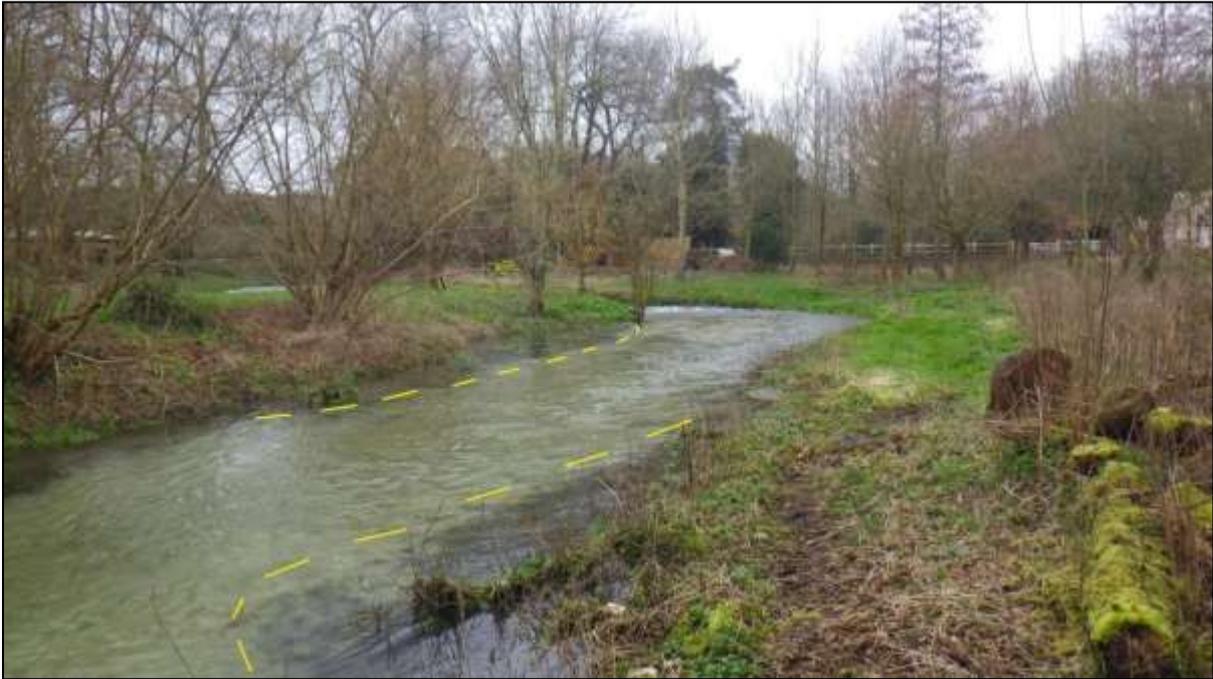
Figure 12: Brushwood shelves should be installed in existing areas of deposition (outlined with yellow dashes)

The outline of each shelf can be simply marked out with sweet chestnut stakes following the areas of existing deposition (Figure 12). This will ensure that the new structures work with the existing river processes, quickly consolidating fine sediment. The lifespan of each shelf should then be sufficient for colonising plants to replace the brushwood and form more permanent marginal beds. Brushwood structures installed in erosive conditions will not last more than two or three years.

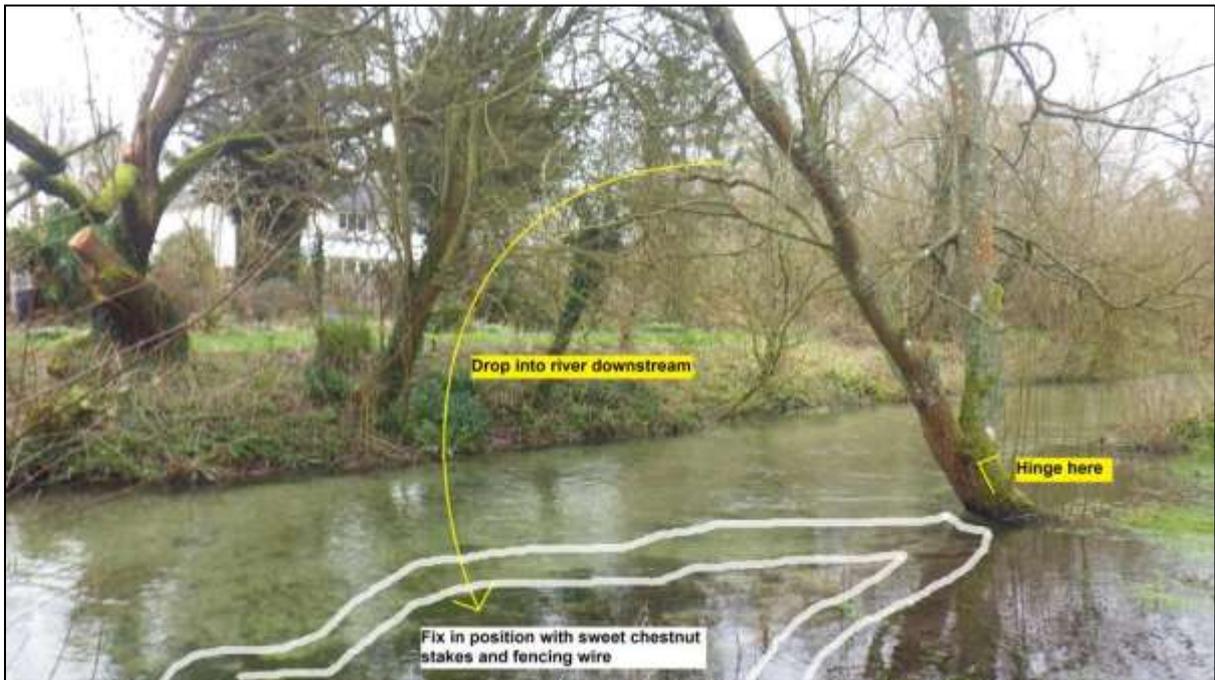
Figure 15: An example of an existing tree that could be hinged into the river.

3. Opportunities should be sought to 'hinge' bankside trees into the river to both act as flow deflectors and to form more sparse brushwood cover in areas of deposition. By mimicking how a tree might naturally topple into the stream, LWD/CWD habitat can be introduced in a fashion that wild trout are perfectly evolved to exploit. By leaving the tree attached at the base it should survive and will require very little securing, though it will require some ongoing maintenance. The tree in Figure 15 is an example such an opportunity.

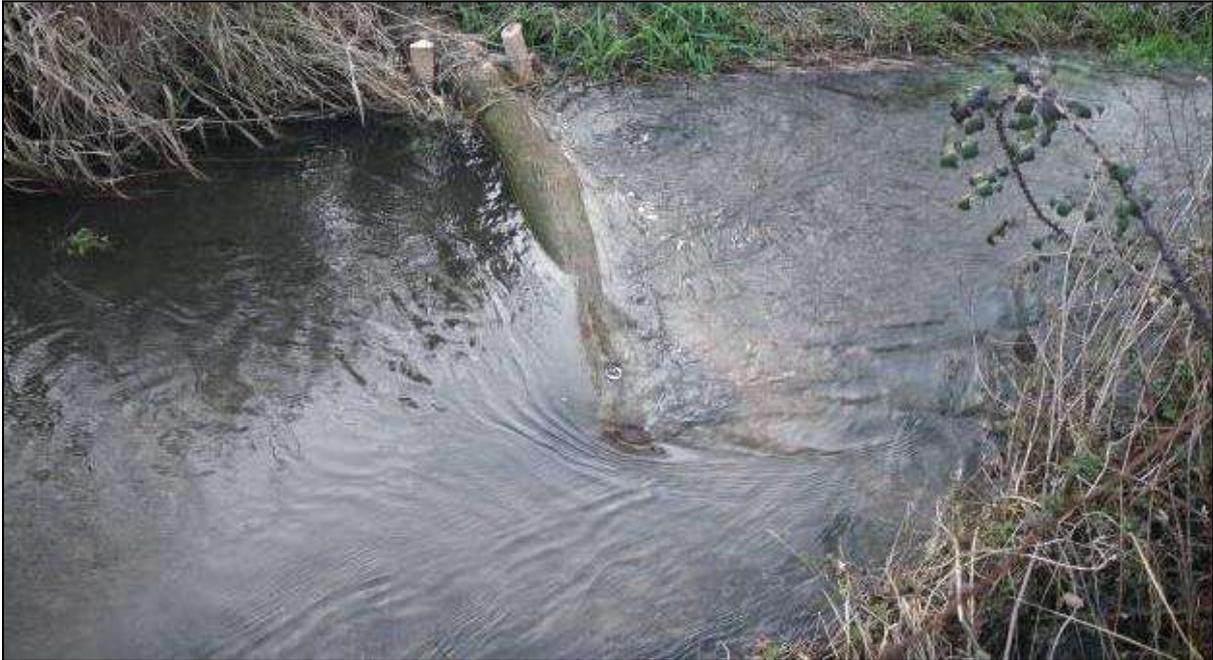
Figure 16: An example of a simple log deflector. Note the bankside edge is keyed into the bank and the log slopes down into the river. The stream flows from left to right in this picture.

4. LWD should also be introduced to act as flow deflectors to kick flow left and right across the channel and increase scour through the thalweg. Simple log deflectors (as pictured in Figure 16) alternating from bank to bank will work but ideally, more complex-shaped pieces of LWD should be used to maximise flow diversity.

To fix LWD into the river, drive sweet chestnut stakes in pairs at both ends of the log. Wire between the stakes across the width of the log and then drive the stakes in further to secure the LWD in place.

Water flowing over a log will be deflected at 90° from the angle of the log across the channel. For this reason, deflectors should be positioned

pointing slightly upstream so that flows are deflected into the centre of the channel as opposed to the bank.

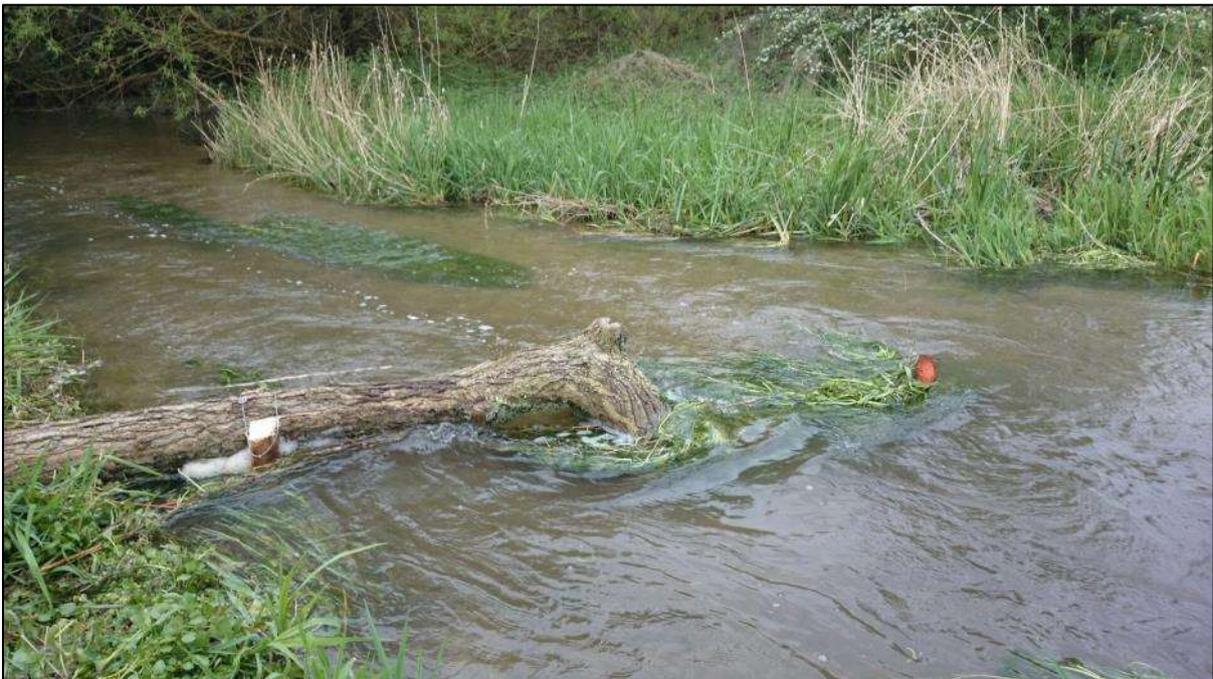
Figure 17: Complex woody debris deflecting flow across the channel but also providing both overshot and undershot scour.

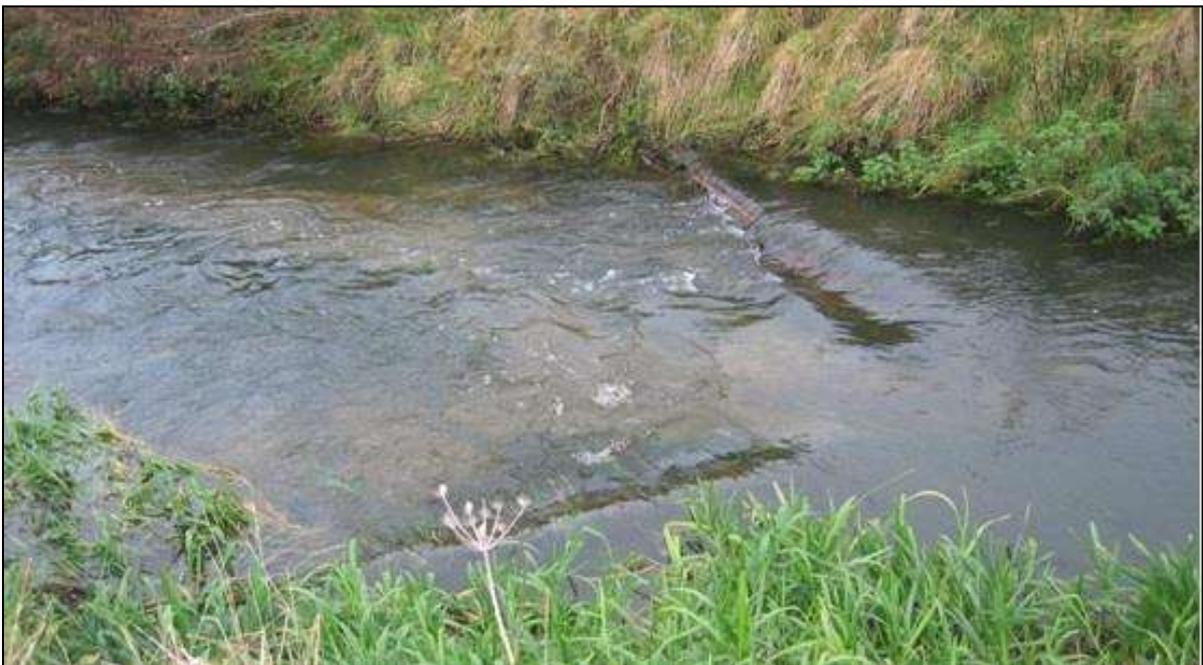
Figure 19: An example of a pair of deflectors in an upstream-facing V formation

5. In order to further drought-proof the reach, occasional deep pools could be encouraged to form by the introduction of one or two pairs of deflectors positioned in a 'V-shaped' formation with a small gap between them (Figure 19). The size of the gap can be determined by eye. The deflector pair should pinch flow through the gap without impounding the flow upstream.

This formation will focus scour into the bed at the centre of the channel and gradually shape a pool with potentially good spawning habitat at its tail.
