Pillhill Brook – Little Ann

Advisory Visit October 2018

Key Findings

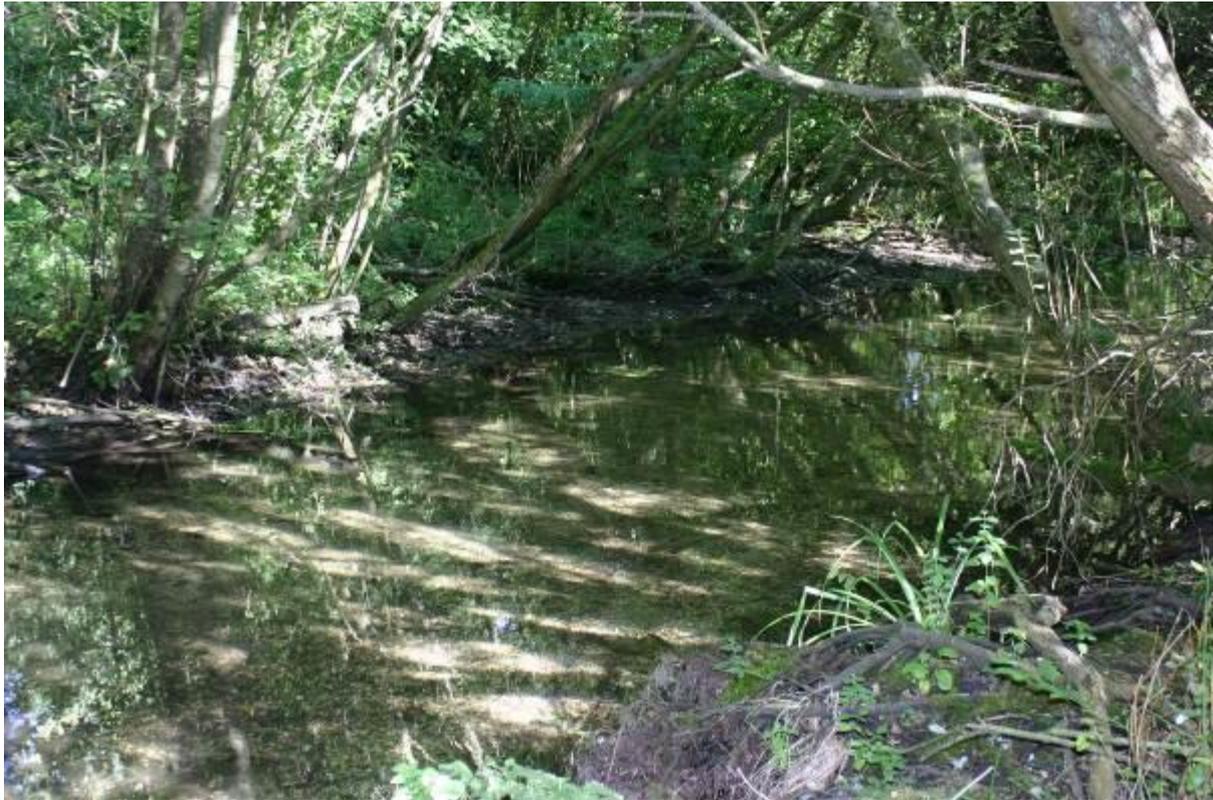
The lower section of the river is heavily shaded mainly by willow trees (photo 1). There is a plantation of mature poplar trees in the meadow adjacent to the LB, which casts additional shade from mid-afternoon onwards, but the bulk of the shading comes from trees in the immediate riparian zone. Mr. Griffiths is in the process of thinning the plantation using a local contractor.

Photo 1. Typical section of lower channel, shallow and wide with a heavily silt laden bed below a thick canopy of riparian trees.

In the heavily shaded reaches, punching the odd hole in the tree canopy to create a dappled light & shade regime is recommended. Using some of the woody material to create cover logs and a loose matrix of brushings in the margins will also provide additional cover in shaded sections, where weed growth is compromised and cover limited.

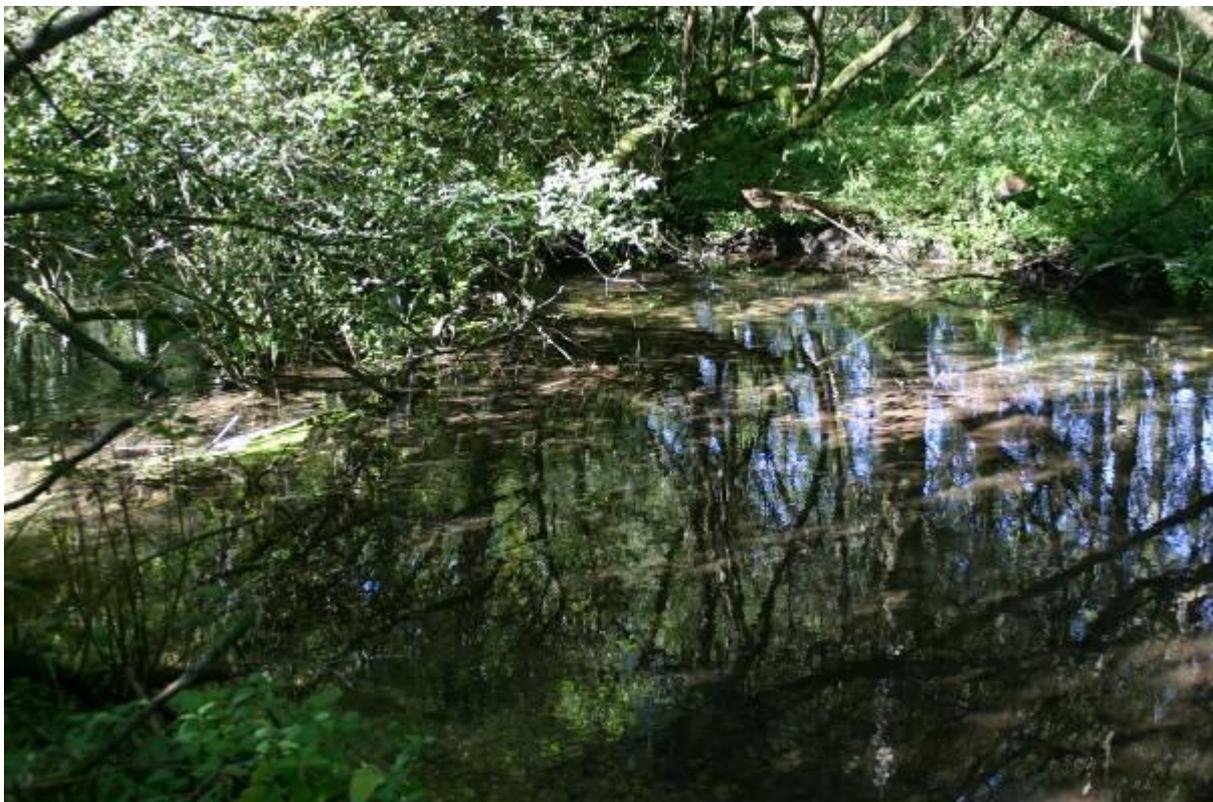
The extensive shade cast by the willow at the bottom end of the fishery has restricted both in-channel submerged weed beds and also marginal emergent plants. As a direct result, the channel width through this section is comparatively wide (photo 2) for the given average flow discharge, resulting in considerable deposition of soft sediments in marginal zones.

Photo 2. This shaded reach has restricted the success of aquatic plants and enabled an exceptionally wide channel to form, resulting in low flow velocities and fine sediment deposition.

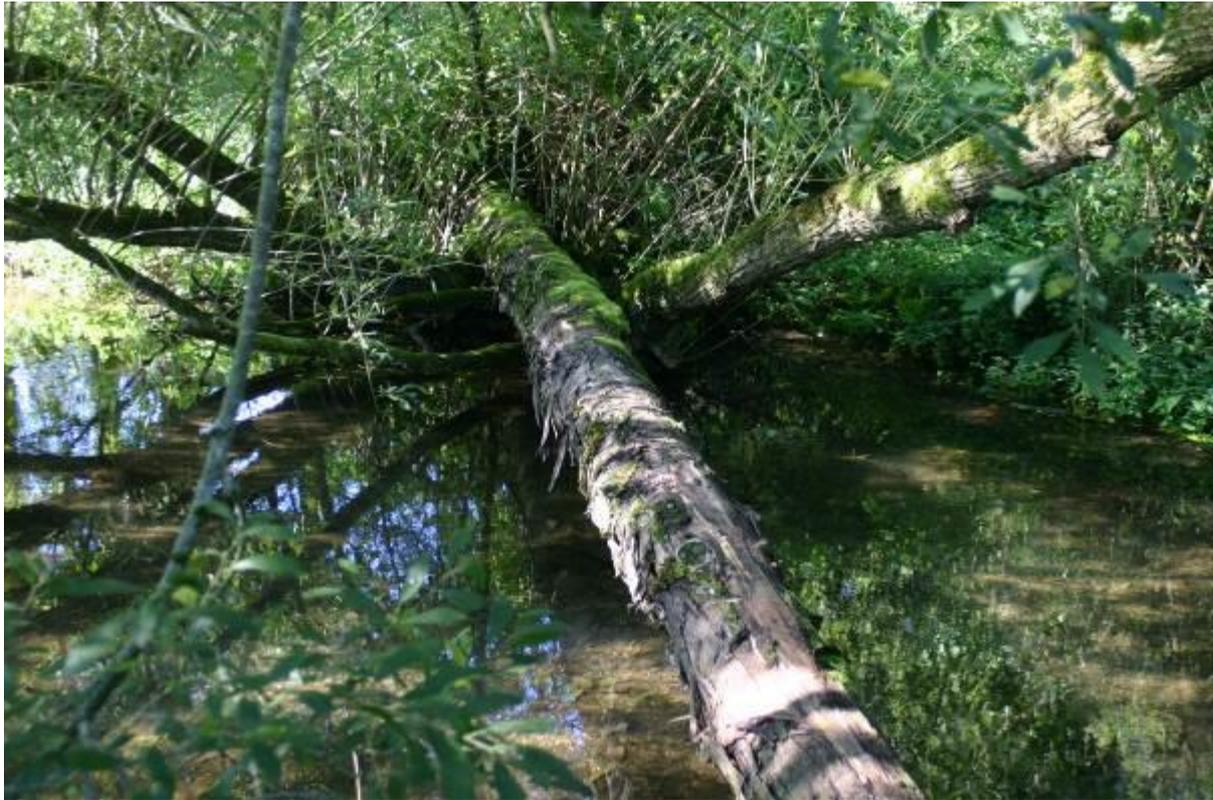
At the time of the inspection in late September, following a long dry summer, the flows were low and the bulk of the river comparatively shallow. Several small trout were observed in this section, utilising mainly fallen woody material (photo 3) as cover; however, holding opportunities for large adult trout were at a premium due to the very shallow nature of the reach.

Photo 3. Fallen trees can provide valuable “low-level” cover for trout and when in contact with the water also promote bed scour.

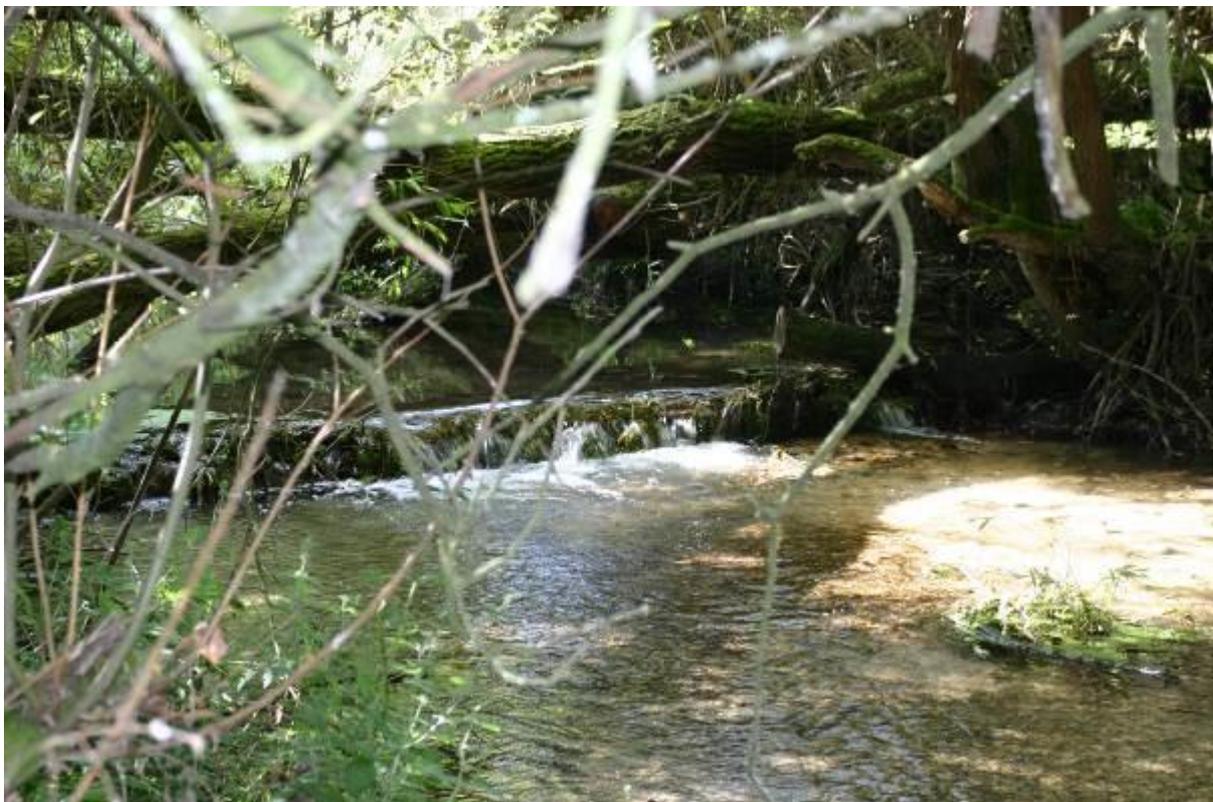
In one location there is a small impounding structure (photo 4). It wasn't entirely clear as to whether the impoundment had been constructed from stones, or has been naturally formed by fallen woody material, which has

completely blocked the channel. Water usually manages to scour beneath naturally fallen woody material, often providing valuable adult trout holding lies. In situations where the river becomes completely blocked and a full channel-width impoundment is formed, bed sediments will deposit in the reach immediately above the structure, sometimes leading to a substantial difference in river bed height below and above the dam. In these circumstances, it is advisable to either move or cut the trunk to create a gap for water to pass through at bed level. This will allow sediment transport to be maintained and avoid excessive deposition in the reach above the debris dam.

Photo 4. A full channel-width impoundment has formed from what appears to be a fallen trunk. This should be “notched” to bed level to reduce deposition pressure upstream and promote bed scour below.

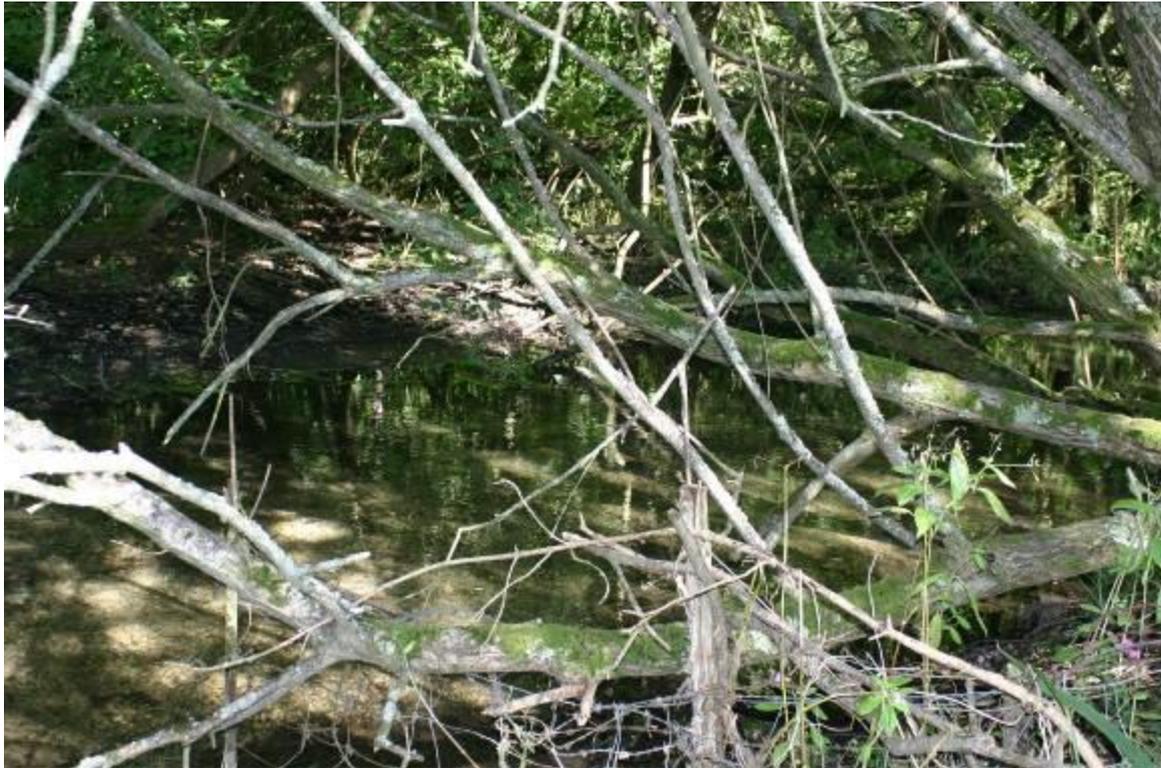
In a few other areas, there are the beginnings of what could potentially become further debris dams (photo 5). In such circumstances, it is better to intervene at an early stage, utilising the fallen trunks and branches to create cover and promote bed scour and sediment sorting, rather than wait until a blockage completely occludes the river.

Photo 5. A fallen tree facing upstream is likely to trap lots of debris, especially when it completely falls, leading to what could be a serious debris dam. Lowering selected trunks into the water, securing and snedding off excess limbs can result in the creation of valuable habitat, as well as reducing the risks of blockage.

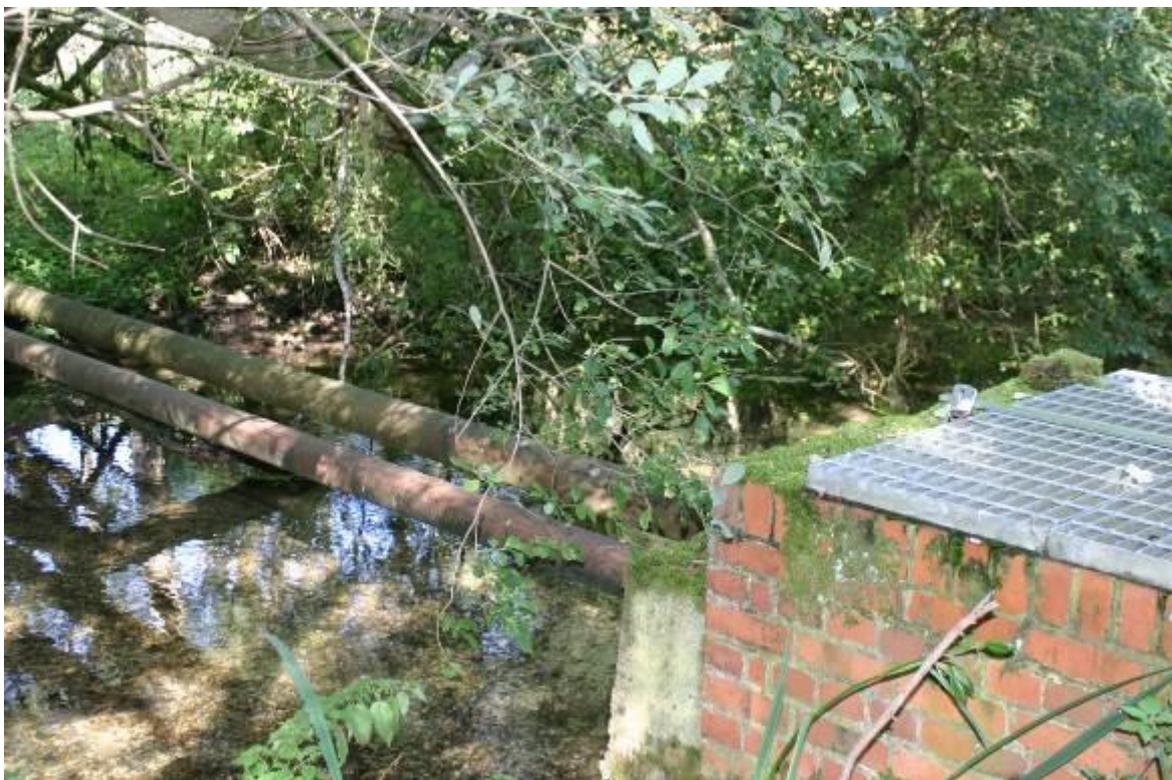
An overhead river pipeline was noted (photo 6). These overhead pipelines always ring slight alarm bells in such locations and could potentially pose a hazard for the fishery, depending on what they carry. If these pipes are used for pumping raw sewage, the local water company should be reminded to inspect them regularly, as well as local trees that could fall and perhaps result in a pipeline failure, potentially resulting in a serious pollution incident. Having some reassurance that these pipes are regularly monitored and maintained should provide some peace of mind.

Photo 6. Pipelines that carry waste water need to be regularly inspected and vulnerable trees that might cause failure regularly managed.

- Make sure the water company responsible for the pipe crossing makes regular safety inspections.
- Approach the Hampshire and Isle of Wight Wildlife Trust to see if they would be interested in driving through improvements to the walled margins at the top of the beat via their Watercress and Winterbournes initiative.
- Monitor fishery performance via one or two trusted rods providing you with an annual catch return. Keep fishing visits low key and relatively infrequent to maintain a high-quality wild fishery and insist on catch and return of all wild fish captured.
- Note that before undertaking works, Environmental Permits may be required from the Environment Agency.

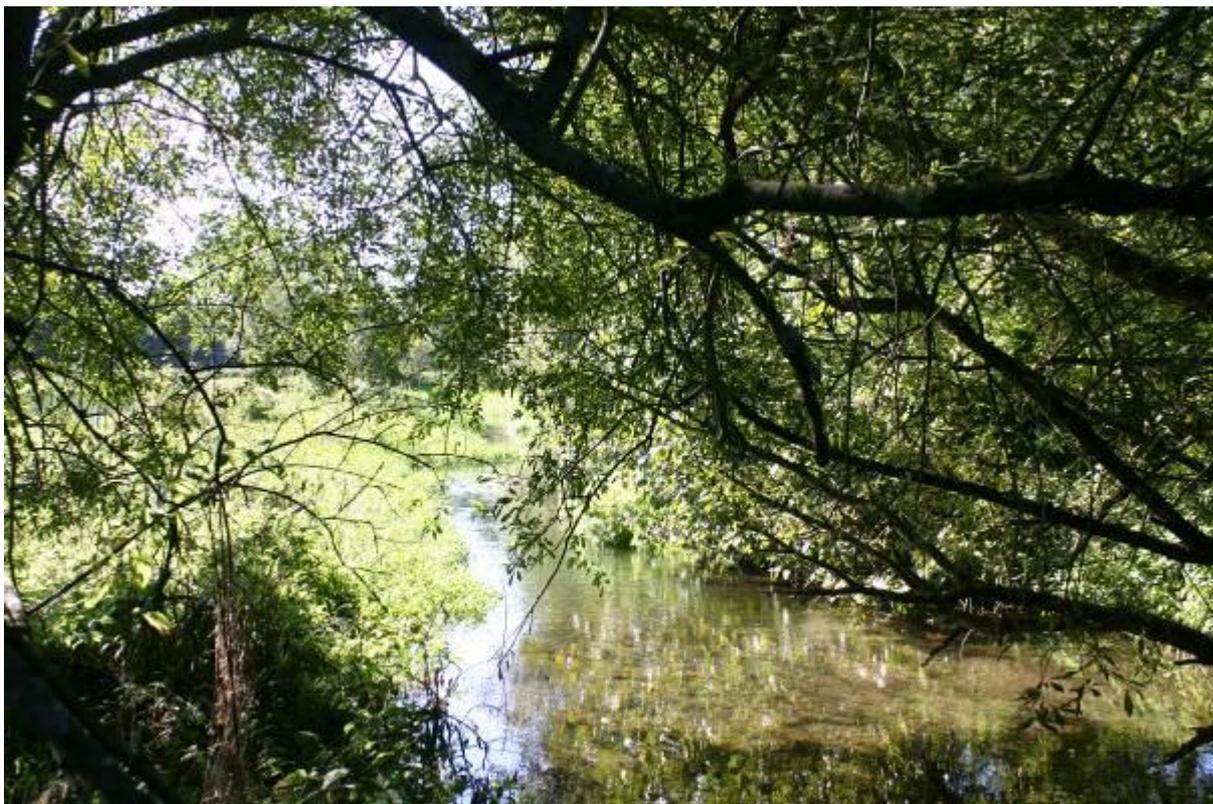
A short distance upstream, in the central section of the beat, the tree canopy opens up on the true RB (photo 7), which has enabled sufficient light penetration to promote a well-established fringe of emergent aquatic plants. The combination of a slightly squeezed channel width has enabled fine sediments to be swept from the underlying gravel bed and in turn provided an ideal environment for valuable submerged plants such as water crowfoot *Ranunculus* sp. (photo 8) and starwort *Callitriche* sp. This section, right up to the hatch pool, supports classic small chalkstream habitats of soft, luxuriant margins and bright, energetic flows over a mainly clean gravel river bed. Again, the odd small trout was seen here, this time utilizing the submerged weed beds as cover.

Photo 7. The shaded canopy gives way to an open meadow reach where the river width has been naturally narrowed by the encroachment of emergent plants.

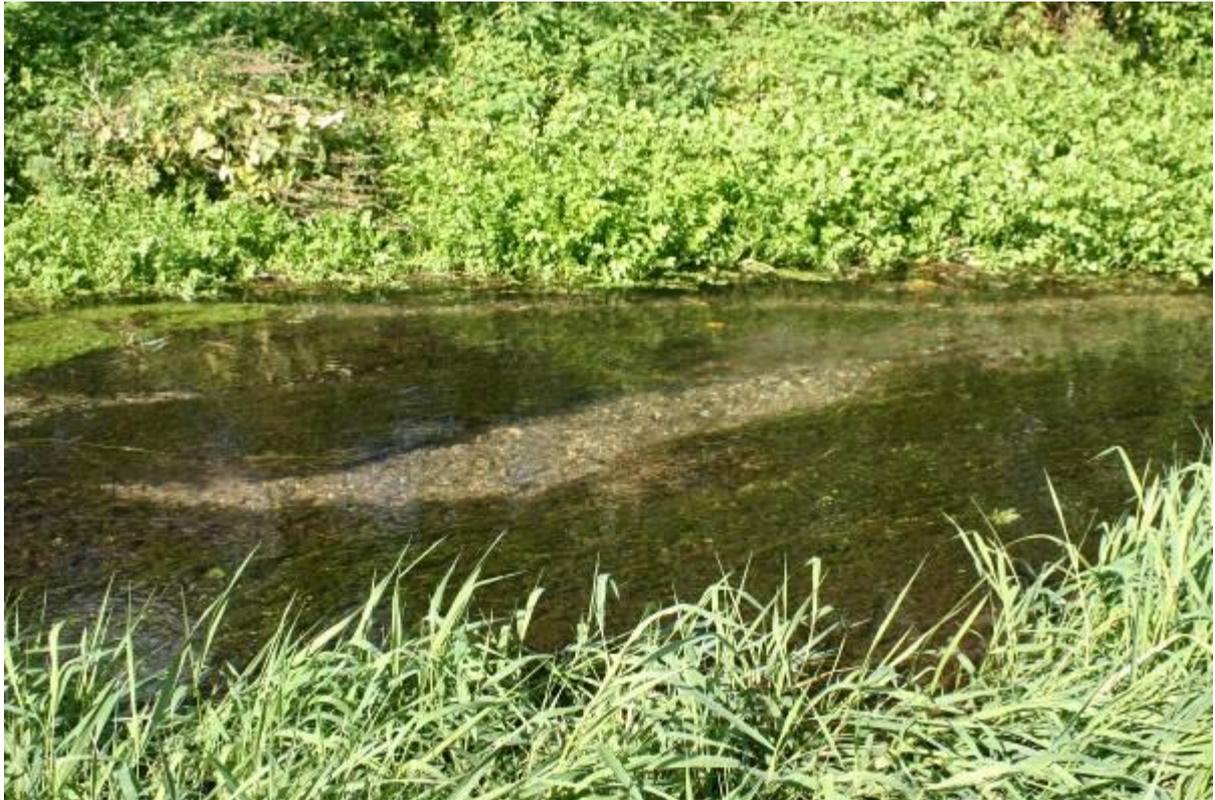
Photo 8. Classic chalkstream habitat: soft luxuriant fringe and thick beds of water crowfoot funnelling clear water over bright strips of gravels.

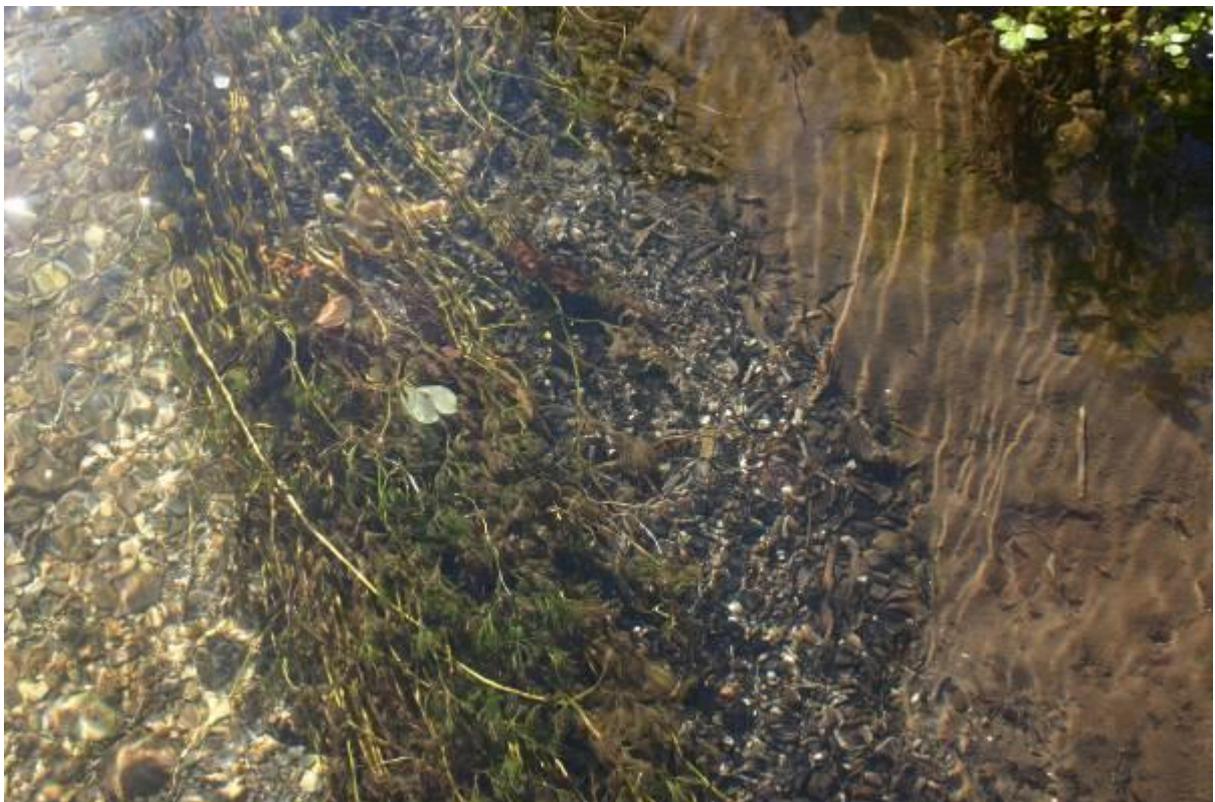
It was noticeable in this reach that the reduced channel width, sometimes coupled with a piece of fallen woody material, was helping to sort bed sediments (photo 9) and thus create a variety of habitat favoured by a range of invertebrate species. The weed itself is favoured by certain olive species, particularly the blue winged olive *Serratella ignita* and the larvae of black gnats *Simulium* sp. The layer of woody detritus will be favoured by shredding invertebrates such as shrimp *Gammarus* sp., whilst the inside line of finest settled material will be favoured by burrowing mayfly nymphs. A cursory inspection of a few large stones in the main body of flow also identified good numbers of caddis larvae (photo 10).

Photo 9. A few square foot of river bed supporting four distinct habitats which are all maintained by a gradient in flow velocities.

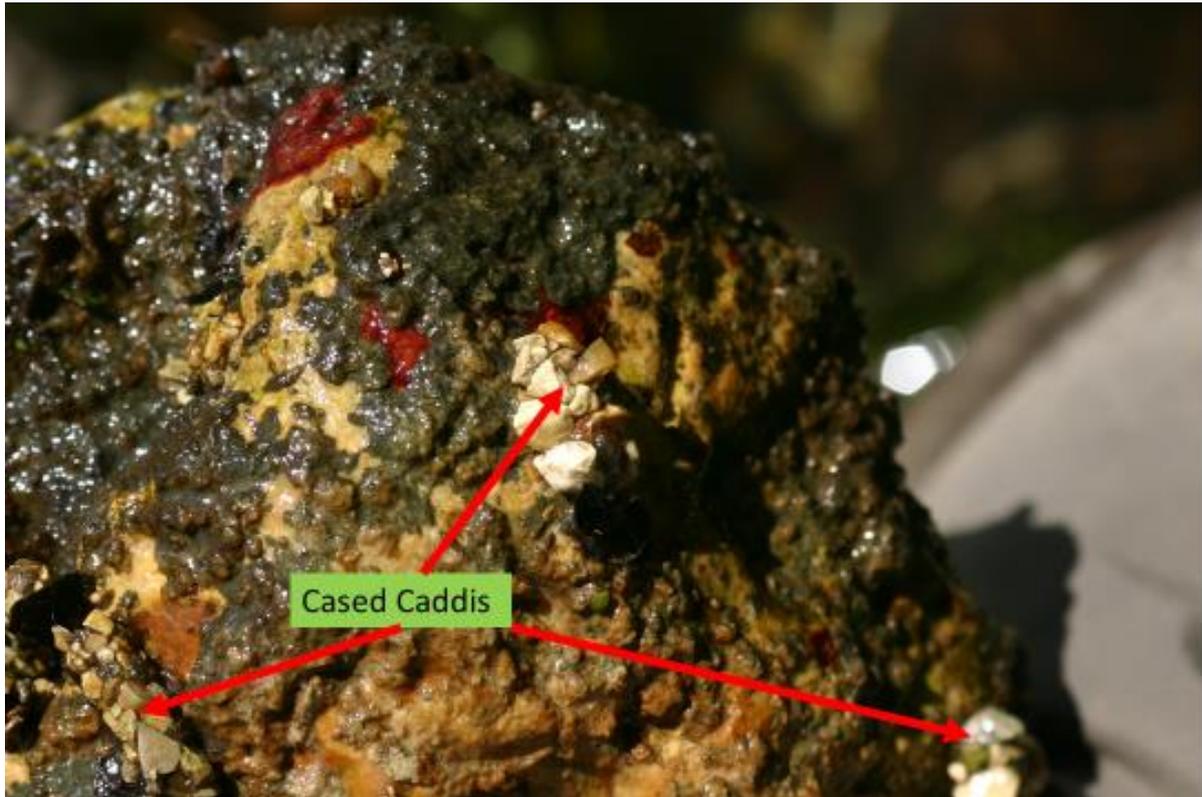
Photo 10. Large stones supporting lots of potential trout food.

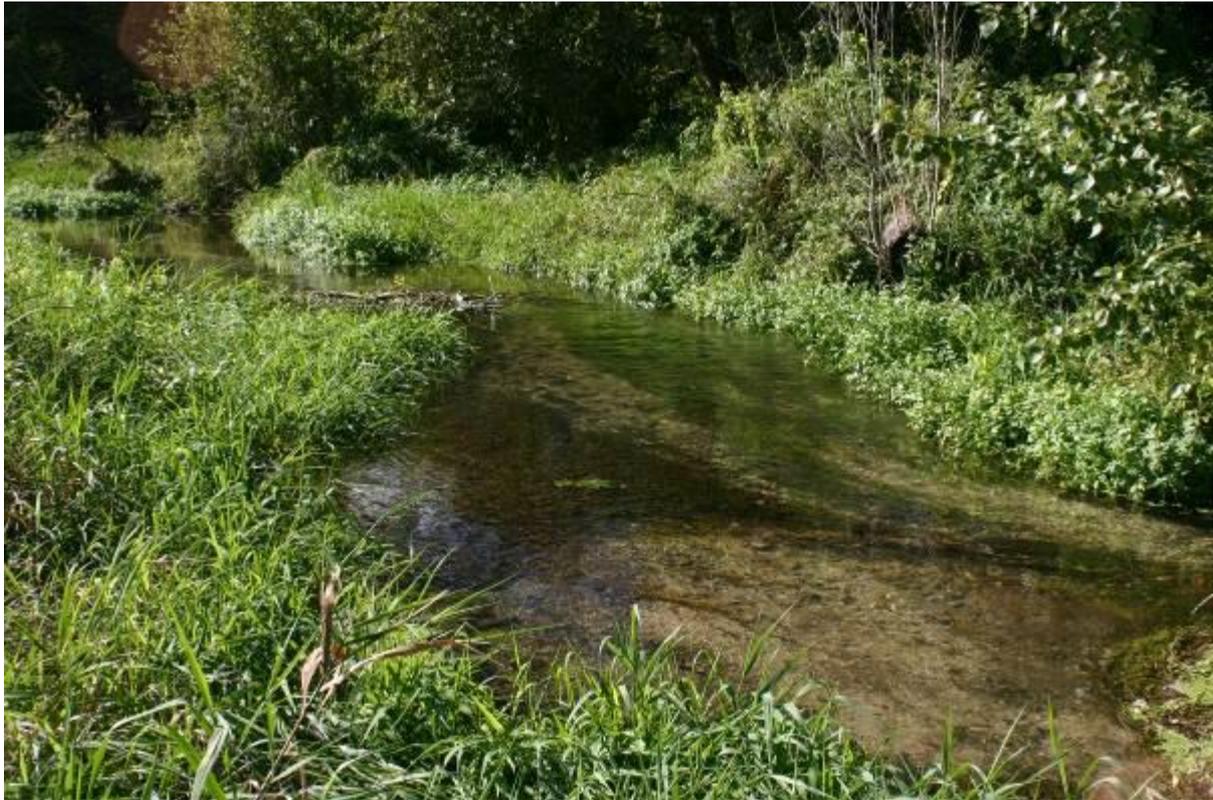
There were some good examples of high-quality habitats being maintained by the odd piece of woody material (photo 11). In this example, a modest sized tree branch has squeezed the channel width and promoted a sinuous flow pattern in what would otherwise be a straight, uniform section of river. In doing so, it has enabled the marginal fringe of emergent plants to safely encroach, as well as promote elevated flow velocities through the narrowed section, sweeping away fine sediments and providing an ideal environment where water crowfoot can flourish and small trout can feel comfortable with suitable cover.

Photo 11. Woody material encroaching from the RB promoting a valuable sinuous flow pattern.

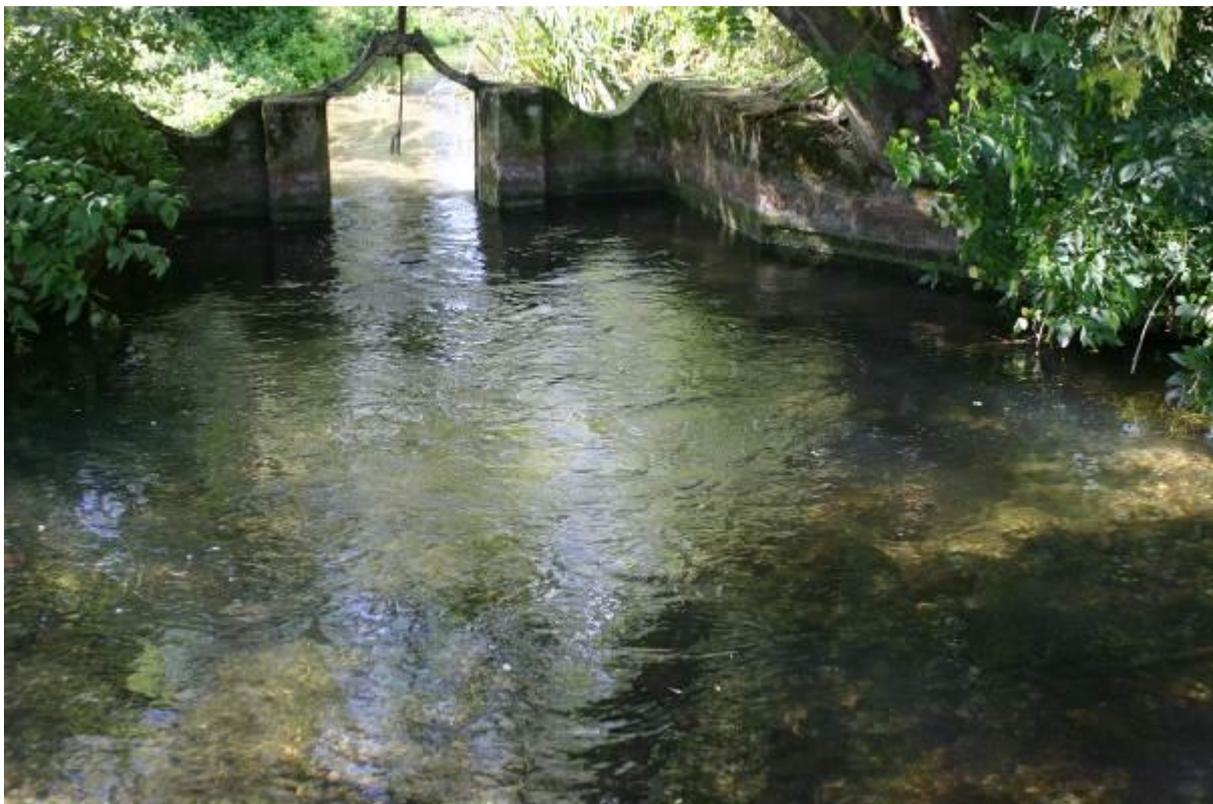
The only deeper "pool" habitat was found immediately downstream of the old water meadow hatch (photo 12). The structure would have originally been used for drowning the adjacent ridge and furrow water meadow but is now derelict. The fact that the hatch gate is no longer in place is good for the ecology of the river, especially for the reach above. The flume of pacey water squeezing through the supporting walls of the structure have created a very attractive pool, which is bound to be good for both large adult trout and grayling. The low-level overhanging cover in each margin immediately below the hatch makes this an even more valuable holding pool.

Photo 12. The old water meadow hatch has promoted years of bed scour to form a high quality pool below. Replacing the gate would not be in the best interests of in-river habitat quality.

The structure itself is a very important piece of agricultural heritage and the narrow flume creates wonderful downstream adult trout habitat, but it is recommended that any moves to reinstate a working hatch gate are resisted.

The hatch pool is a lovely feature but replacing, or restoring the hatch gate is not desirable, at least not in terms of in-channel habitat quality.

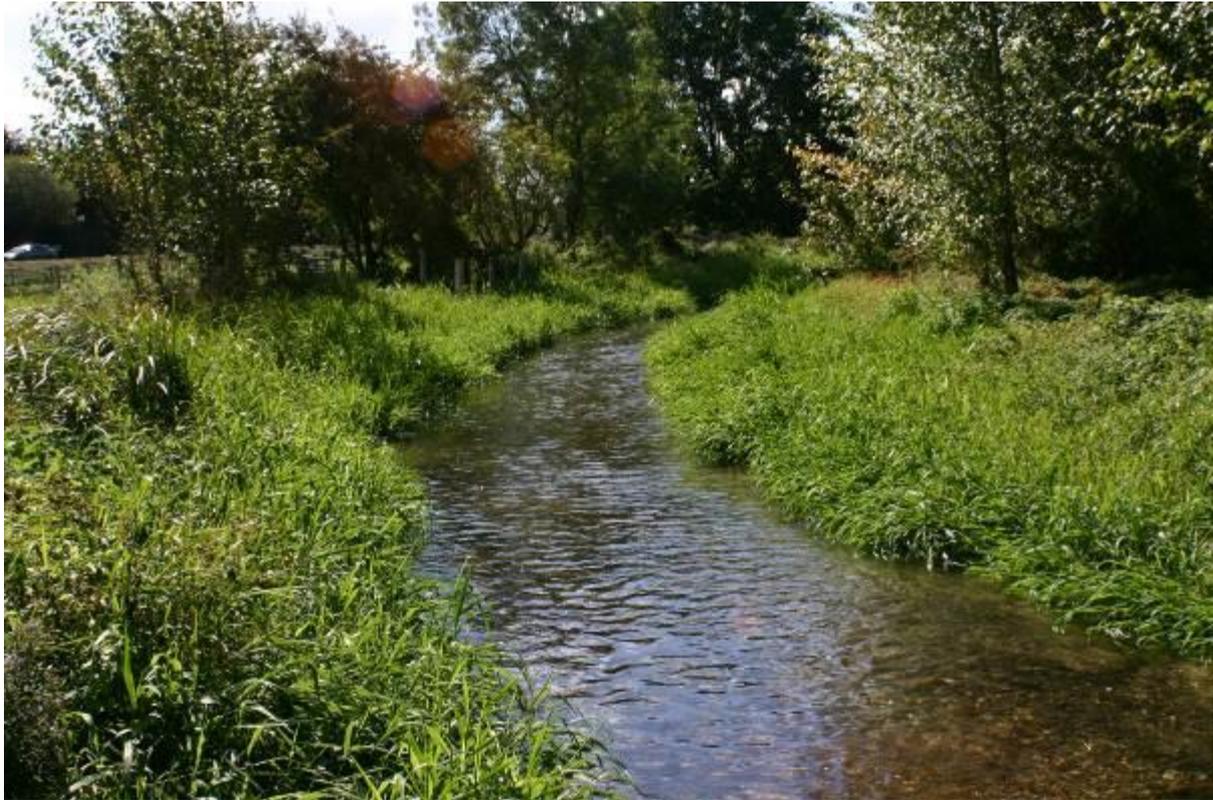
Where there was good light penetration to the river, there are examples of ideal summer habitat for trout fry and parr, with plenty of available marginal cover from trailing marginal beds of reed sweet grass (*Glyceria maxima*) and reed canary grass (*Phalaris* sp., photo 13). Following early winter frosts, the amount of available cover will be reduced in sections like this. The introduction of woody brushings into the margins to provide additional cover through the winter will help to offset reduced natural cover.

Photo 13. A shallow run with well covered margins provides habitat for small fish but may prove to be too exposed during the winter months.

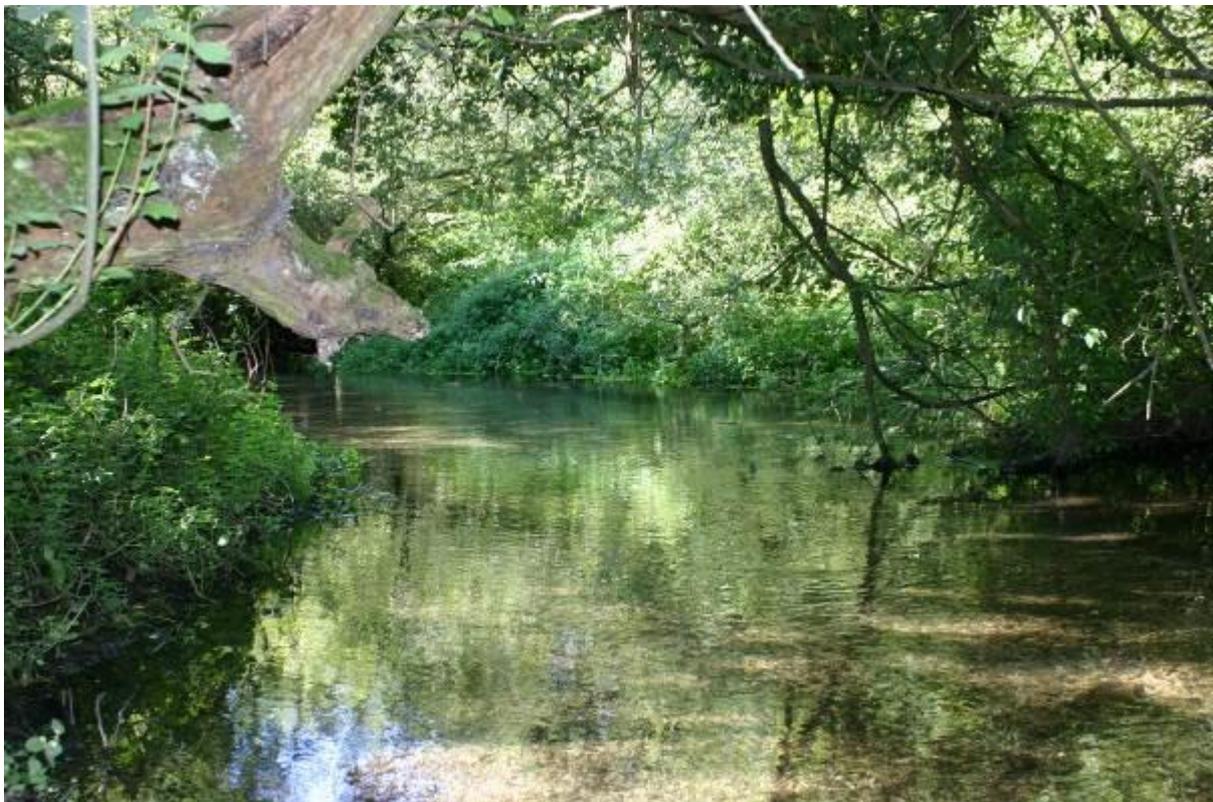
In some of the more heavily shaded sections towards the lower half of the beat, it was again evident how flat and uniform much of the river bed is (photo 14). Shaded sections are considered to be valuable, even in chalk streams where light usually promotes intense weed growth but without a fringe of vegetation to squeeze the channel width, the river loses energy and the ability to scour fine sediment. It is suggested that some of these more heavily shaded reaches would benefit from having more woody material in the channel to promote locally elevated flow velocities and therefore improved bed scour and cover.

Photo 14. Another heavily shaded reach of a wide shallow glide. Pieces of woody material pegged in the river bed here could promote scour and provide additional cover.

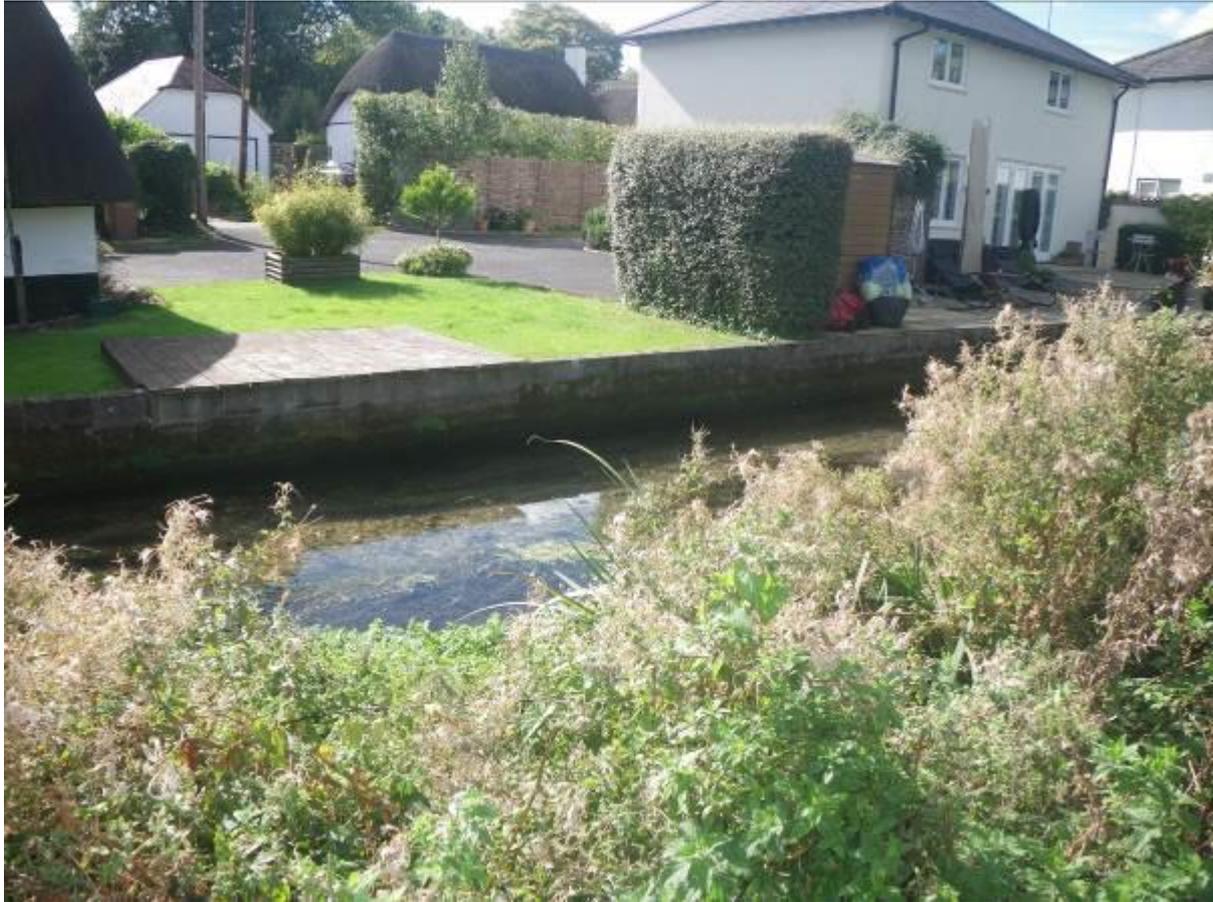
At the very bottom of the beat, the owner reverts to single RB ownership. The true LB has several houses that back onto the river and as so often happens, the owners have resorted to defend their properties with wholly inappropriate bank defences, in this case vertical block walling (photo 15). River margins are usually the most biologically rich zone of the river. When banks are vertically revetted, these areas are often sterile in comparison to soft, natural margins, as well as being an eye sore. It is possible to mitigate against the impacts of the wall by creating a new low-level bank toe immediately in front of the existing wall and planting it up with suitable emergent plants. This might be a candidate project that could be tackled under the new Watercress and Winterbournes project, hosted by the Hampshire and Isle of Wight Wildlife Trust.

Photo 15. The walled margins on the RB at the top of the beat are inappropriate for a chalk stream margin. A new toe to the bank could be installed to support a soft, green margin and help provide long-term protection for the footings of the wall.

The area of hard, vertical block wall adjacent to the properties at the top end of the beat provides very little habitat for plants, invertebrates, fish or mammals. Provided the landowners were in favour, it would be possible to build a new narrow toe to the bank to support a soft green fringe that would add biological value to the reach as a whole. This might be an appropriate project as part of the "Watercress and Winterbournes" initiative.
