THE PILTANTON BURN

**WILD TROUT TRUST ADVISORY VISIT
PREPARED FOR DUNRAGIT ANGLING CLUB BY**

JUNE 2007

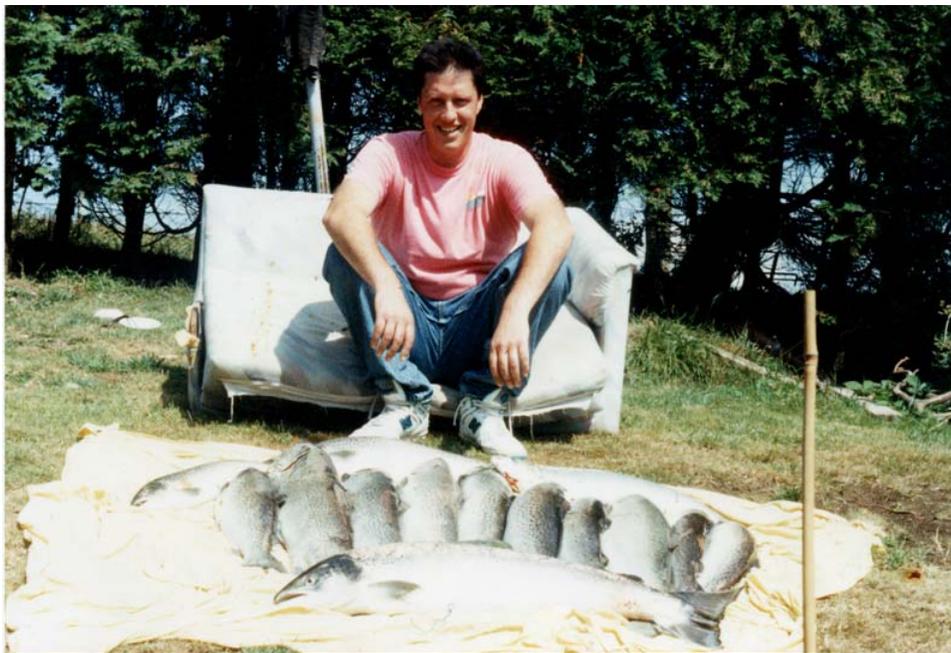
Figure 3.4.1: Some of the sea trout removed from the burn following the 1990 pollution incident

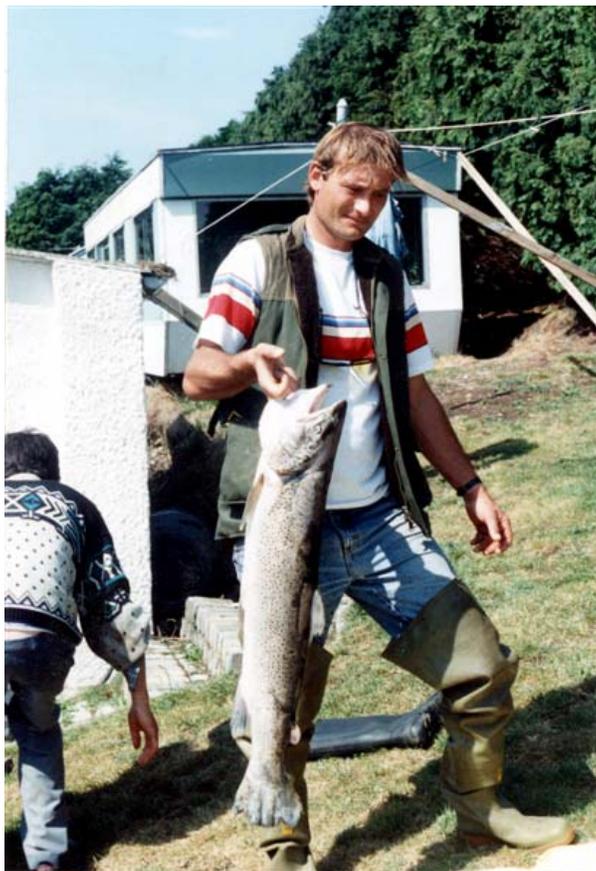
Figure 3.4.2: A large sea trout removed from burn following 1990 pollution

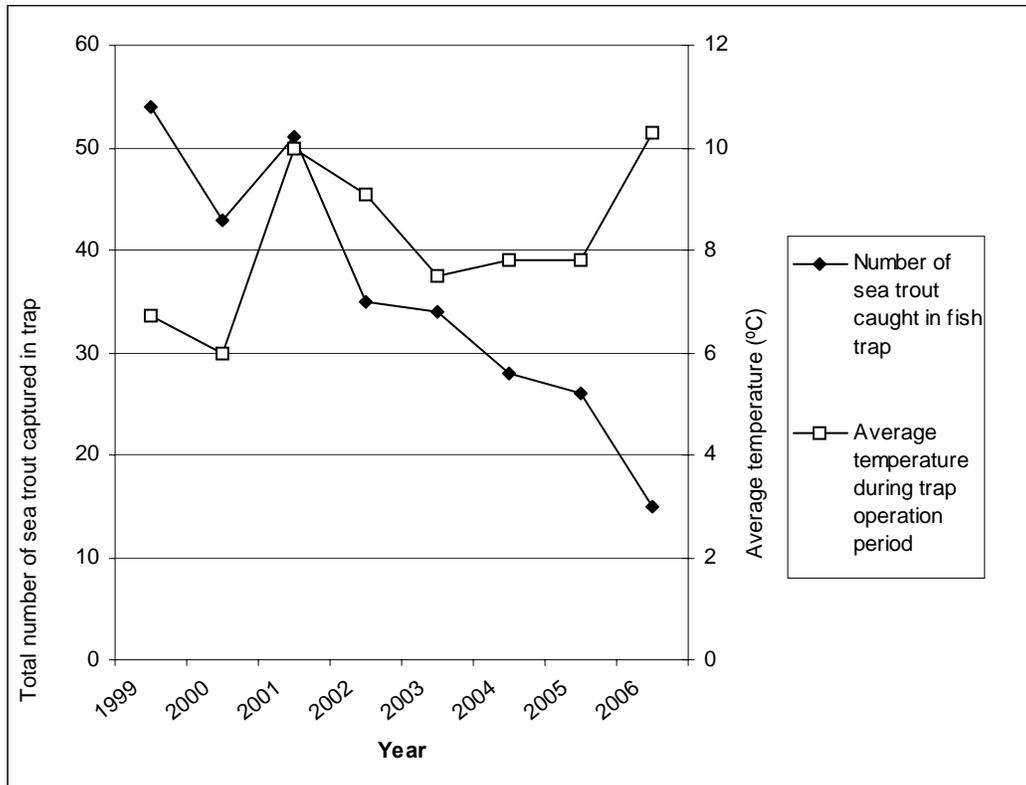
To investigate the potential role of temperature in affecting the numbers of sea trout caught in the trap, the number of sea trout captured was plotted against the average temperature during the trapping period (*Figure 3.5.2*). Although no temperature data were available for the Piltanton Burn, data are available for Torhouse Trout Farm which is situated approximately 15 miles to the west of the Piltanton Burn. The trap was not operated during the same time period during the 10 year period for which data are available, with the trap being fished earlier in recent years. This was undertaken to ensure that sufficient fish were captured as broodstock. This variation in trapping time is likely to have caused some temperature increase over the time that the trap has been

Figure 3.5.2: A graph showing the number of sea trout caught in the Chlenry Burn fish trap and the average water temperature during trap operation time

The earlier trapping periods in recent years in comparison to earlier years are likely to partially explain the increased average temperature profile over time. However in 2004, during the earliest trapping period, the average temperature rose only slightly and did not exhibit the large change that might be expected from initiating the trapping operation almost one month earlier than the previous year. However, 2004's trapping period was also significantly shorter than the other trapping periods and this may mean that the average temperature for this trapping period is less comparable. The average temperature during the trapping period in 2006 was the highest during the period for which data is available but the total number of sea trout caught was only 60% of the previous year. In recent years trapping has commenced earlier but fewer fish have been captured. This strongly suggests that less fish are available for trapping within the system for some reason. It is widely believed that increases in temperature may have contributed to the current decline in sea trout numbers in the Solway. Possible mechanisms by which temperature increases could affect sea trout include changing food webs within the estuary, or increased stress (due to increased temperature) which may lead to increased susceptibility to disease. However, further research is required before conclusions can be made.

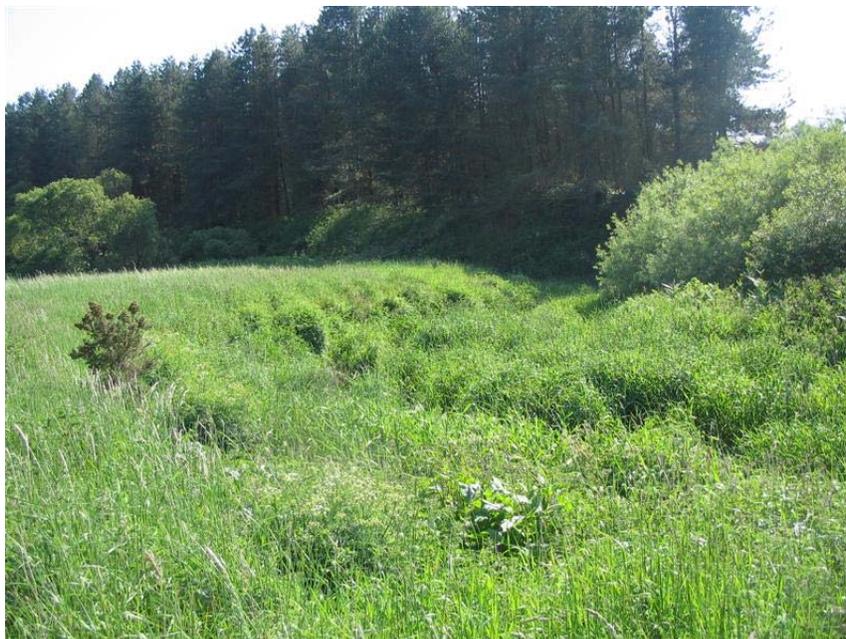
Mr M^cCreadie stated that the DAC had interest in investigating whether works could be undertaken on a section of the lower burn. The area in question (NX 215300 556400) used to be part of the main channel of the burn but a diversion had been created around ten years ago. The burn was diverted as the original channel meandered through a field, effectively dividing the field and reducing its farming potential. The farmer infilled a section of burn at the start of the meander and then created a new channel to join the two closest points of the meander. The downstream section of the meander was blocked with boulders but on a spring tide, the water rises above the height of the boulders and floods part of the old channel. It was anticipated by DAC that the old channel would be infilled to allow the land to be used for farming. However, Scottish Natural Heritage (SNH) objected to the development and the old channel remains in place. The DAC would like to investigate whether it would be possible to reinstate the original channel. This would involve removing the earth infill in the old channel, infilling the newly created diversion section and then diverting the water back into the old channel.

Figure 4.1.1: Upstream section of meander

To investigate whether there is a possibility of undertaking remedial works on this section of the burn, a variety of different parties would need to be consulted. Firstly the landowner would need to be amenable to repairing the work. As the field is currently not used for crop or livestock and is filled with tall vegetation, it is possible that the landowner would be amenable to undertaking some works in this area. It may be possible to suggest a reinstatement solution which would also provide some benefit to the farmer in terms of providing some land adjacent to the burn for farming activities. However, it is important to ensure that reinstatement works aim to provide the highest possible quality habitat and the burn must be protected from activities that may detrimentally affect it (such as grazing of the riparian zone). SEPA and SNH would also need to be consulted regarding this proposal. SEPA may decide that the potential environmental effects of removing the earth infill from the old channel and infilling the new channel outweigh the benefits of reinstating approximately 80m of original channel. Certainly the mobilisation of sands and silts could cause siltation downstream and

Careful engineering considerations would be needed in ensuring that the infilled area within the new channel is stable enough to persuade the burn to follow its previous route. SNH may also have concerns regarding possible reinstatement works both from an environmental damage perspective and a biodiversity perspective. Whilst the old channel is not currently useful as fish habitat, the wetland area and natural stands of vegetation that have developed are important in supporting other flora and fauna. There may be a possible reduction in biodiversity if the old channel area was to become inundated with water again and this would also need careful consideration in any reinstatement proposal.

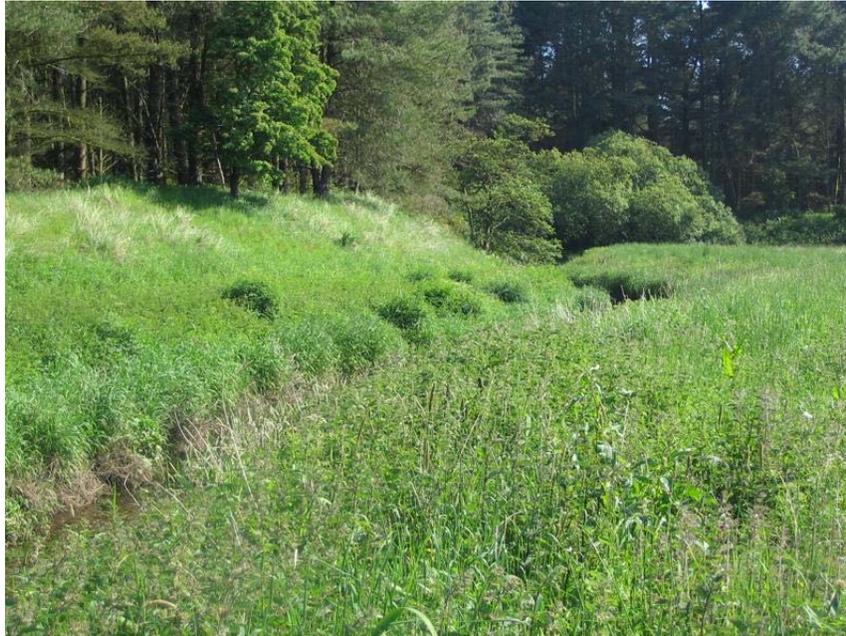
Figure 4.1.2: Downstream section of meander

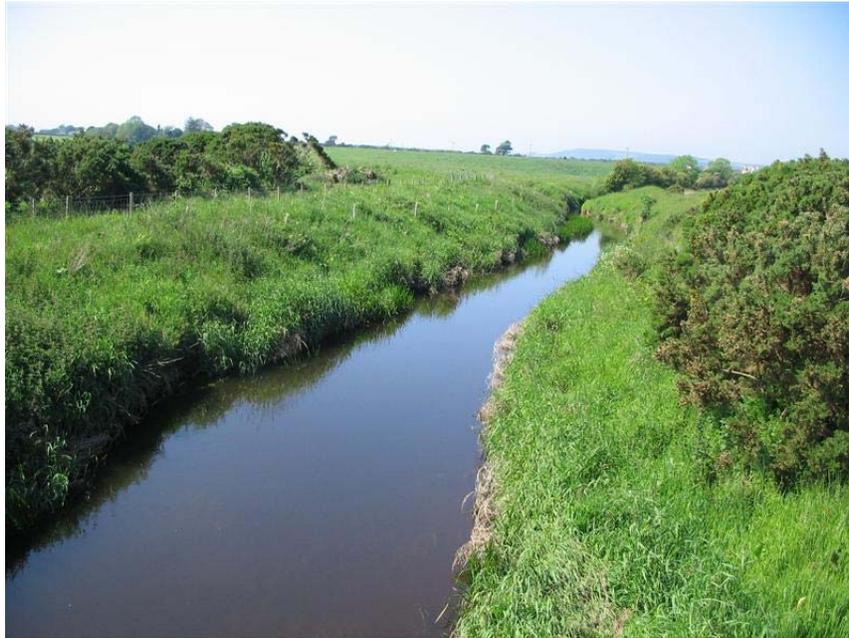
Upon visiting the area, it became clear that fencing had greatly improved the riparian zone. A range of grasses and understorey plants are now present, with some shrubs also becoming established. Grasses now provide bankside cover for trout. The broadleaved trees that were planted have flourished. The benefit of this improved buffer zone to the burn cannot be overemphasised enough. Whereas previously, the riparian zone consisted almost entirely of bare earth, which did little to disrupt the path of runoff into the burn, there is now an established area of complex vegetation to remove any nutrients that may be present.

Figure 4.2.1: Fencing and tree planting

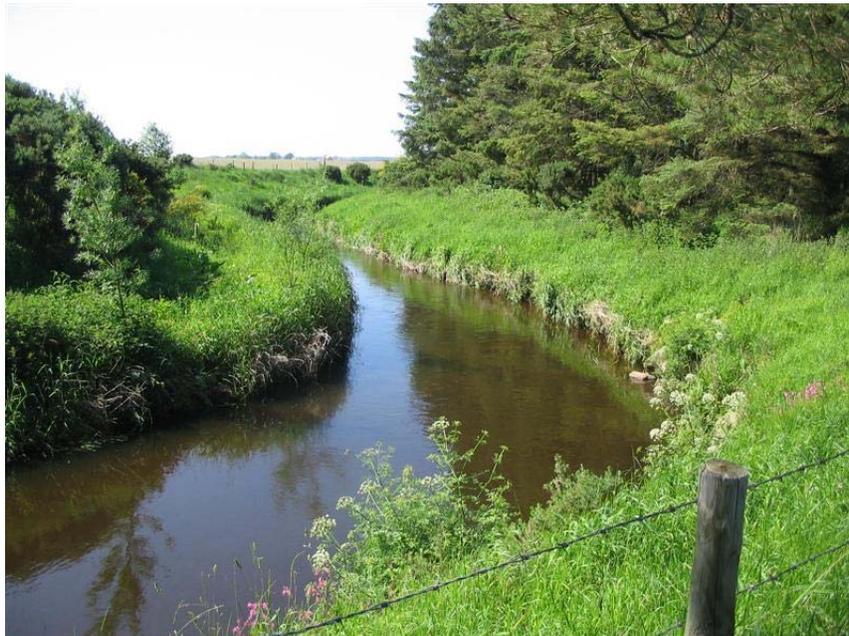
Figure 4.2.2: Fencing and tree planting upstream of Forestry Pool

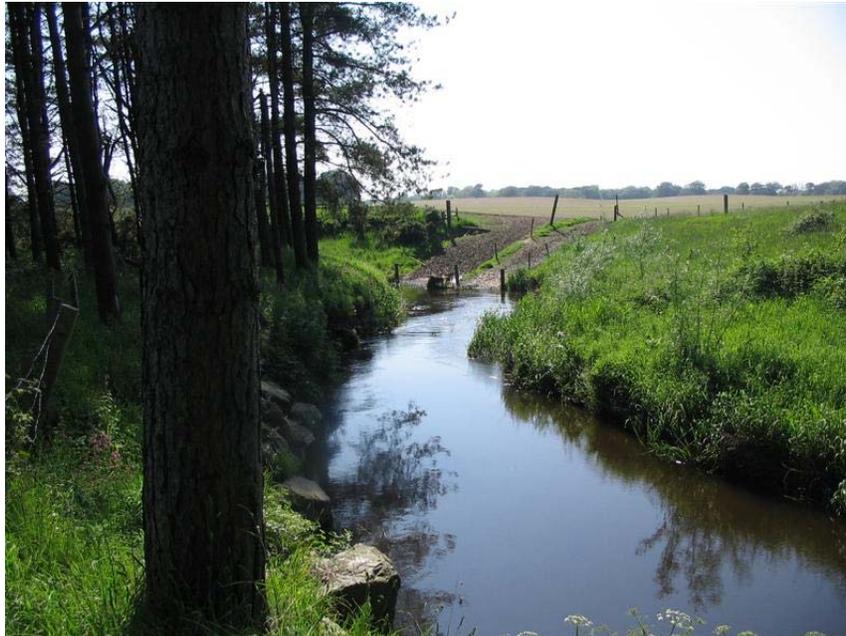
Just downstream of Forestry Pool, cattle have access to the water. The geology in the Piltanton catchment is dominated by sand and therefore water is not retained particularly well. Watering holes, that use the burn as a source of water, are often the only way to water livestock in this area. There are obvious environmental benefits in preventing cattle from accessing the water but where there is no alternative, farmers currently have little choice. Recent figures suggest that up to 1400 cattle are present in fields adjacent to the lower burn, all of whom require water. Finding a low cost, environmentally

Figure 4.2.3: Watering hole downstream of the Forestry Pool

beneficial solution to the stock watering issue in the Piltanton catchment could have a huge impact on the biology of the system. In developing a solution, it is of critical importance to ensure that landowners are supportive of the scheme and are engaged in the consultation process. Historically, a range of different stock watering techniques have been attempted in the catchment, some being more successful than others. Developing a watering solution that would reduce the need for cattle to enter the burn at all would seem to be the best option. GFT are presently investigating possible solutions in a separate report.

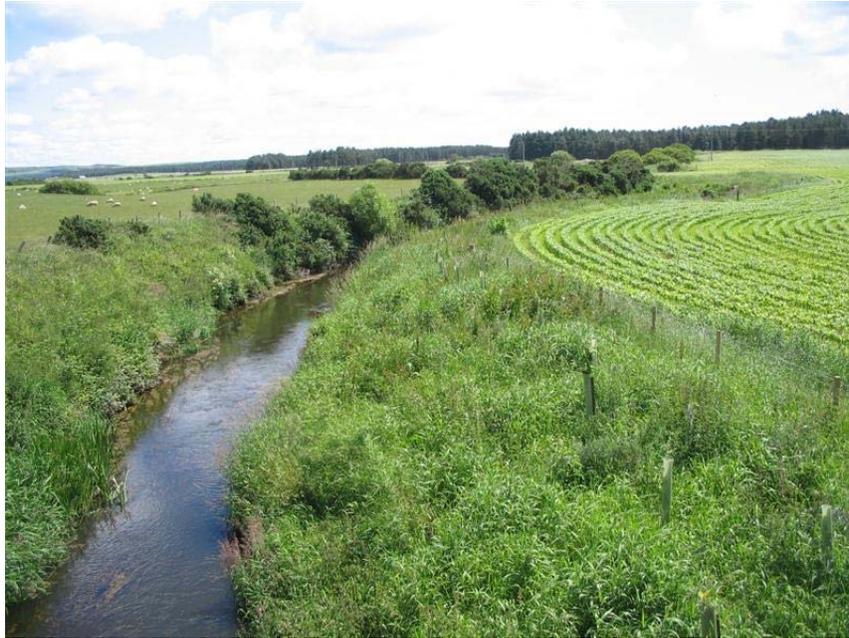
A further site visit was undertaken downstream of Drochduil. Fencing had been erected in this area in 2005, again to reduce the impact of cattle grazing banksides. From the site visit, it was observed that fencing had greatly improved the riparian zone in this area, with tall herbs and grasses having become established. At the current time, the field is being used to grow maize and therefore livestock pressure is currently not an issue. However, the legacy left by previous livestock is still evident (*Figure 4.2.5*) in an area where cattle have previously accessed the burn for water. The burn has become shallow at this point, due to the area having been repeatedly trampled and silt having entered the watercourse. The riparian zone is becoming more established but is clearly not as stable as other parts of the burn that have not historically had this pressure.

Figure 4.2.4: Downstream of Drochduil bridge, where fencing was erected in 2005

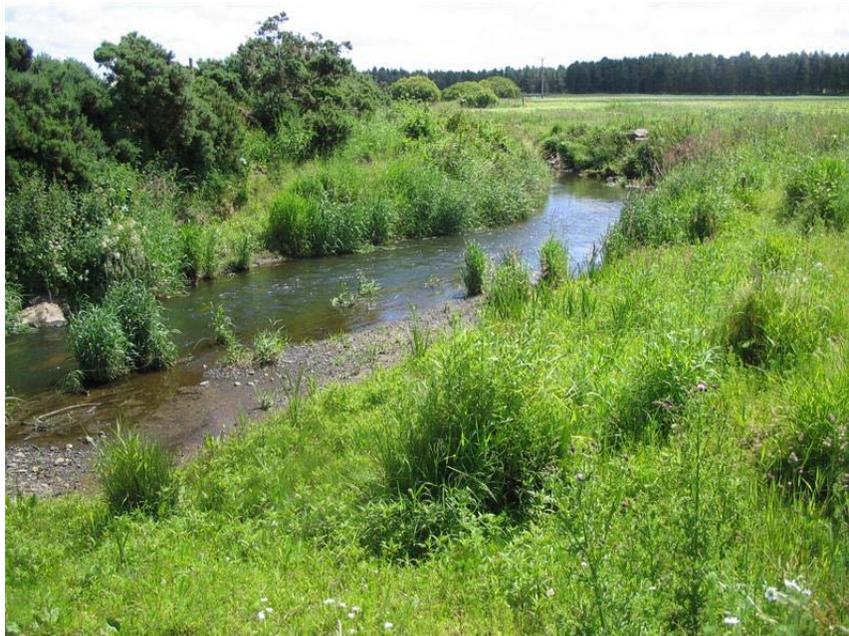
Figure 4.2.5: Newly fenced area where livestock have historically accessed burn

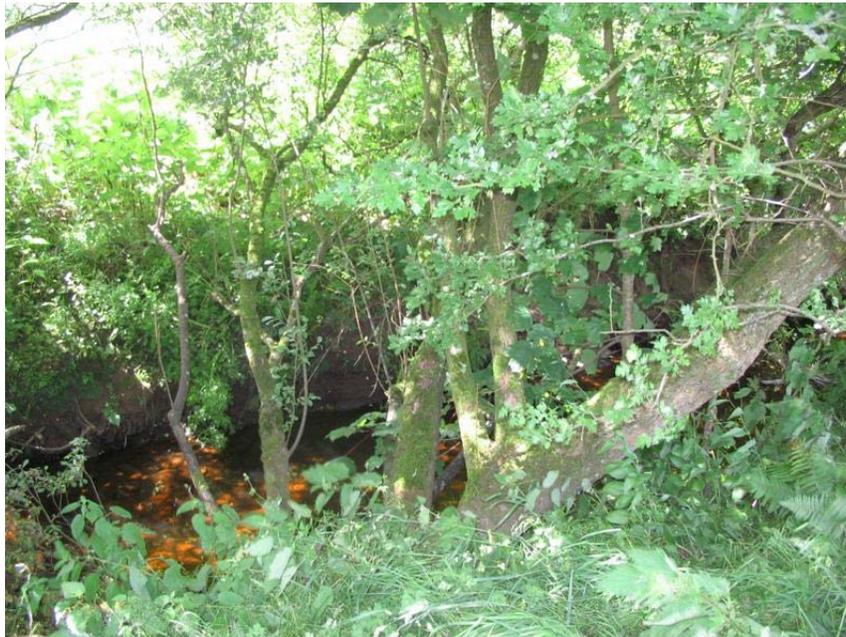
The lower reaches of the Chlenry Burn were visited, adjacent to Drumflower Farm. The burn was judged to have a predominantly sandy substrate, with some areas of gravel. Woody debris was recorded instream. Bankside vegetation consisted of tall herbs and grasses on the right bank (when facing downstream). A house and gardens were present on the right bank and a pipe was seen to be discharging from this area. On the left bank, bankside vegetation was dominated by hawthorn bushes and broadleaved trees (sycamore) were present on the bank top. The combination of bushes and trees led to the burn being classed as overshadowed and some selective removal of branches overhanging the burn may be beneficial. The field adjacent to the burn contained horses and the fence in this area was in disrepair. It may also be beneficial to repair this fence.

Figure 4.3.1: Lower reaches of the Chlenry Burn, showing overshadowing

It appeared from the site visit that the burn may become less overshadowed upstream. It is recommended that a habitat survey of this burn is undertaken to determine the current habitat quality.

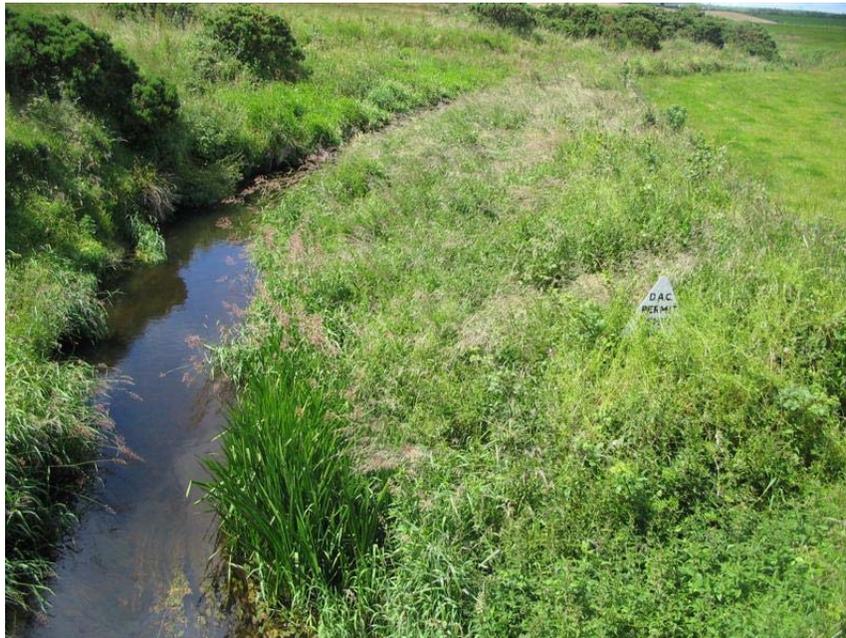
The area of the burn around Barnultoch Bridge was visited as this part of the catchment is believed to be one of the main spawning areas in the main Piltanton Burn. The water was deep in this area, as evidenced by the fact that DAC fish this part of the burn. The area visited was most suited to adult trout and there were some good holding areas. Instream vegetation was present within the burn (mainly broadleaved pondweed, *Potamogeton natans*) and this is likely to be important as fish cover within the central

part of the channel, given the depth of the site. Both sides of the burn were fenced. Dense vegetative cover was present on both banksides, with tall herbs being abundant and a smaller amount of low level shrubs. This bankside vegetation provided draped cover for fish over the majority of the area visited.

Figure 4.3.2.1: Upstream of Barnultoch Bridge

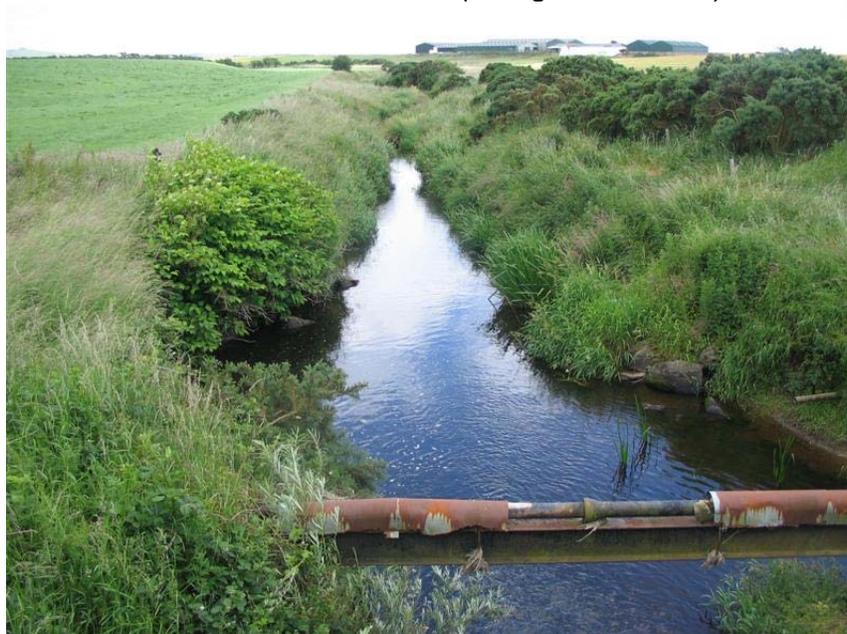
Downstream of the bridge, SEPA have a water quality monitoring station. Japanese knotweed (*Fallopia japonica*) was recorded downstream of the bridge and it is suggested that an appropriate control programme is initiated to prevent this invasive plant from spreading further downstream.

Japanese knotweed is known to affect river banksides in a number of ways. Firstly, it reduces the diversity of the banksides by outcompeting native plants, due to the fact that it can develop dense stands very quickly once it becomes established. Furthermore, the stands that are formed offer a poor habitat for native insects, birds and mammals. In the riverine corridor, it is particularly harmful as the foliage dies back on a seasonal basis reducing the 'anchoring' and stabilising role that bankside vegetation performs. That this happens during the winter months when flood events are more prevalent causes further environmental degradation as erosion increases.

Figure 4.3.2.2: Downstream of Barnultoch Bridge. A stand of Japanese Knotweed can be seen on the left bank (facing downstream)

The plant is very easily spread, with new stands developing from tiny fragments of the original plants. It is vital that the plant is controlled as soon as a stand becomes established.

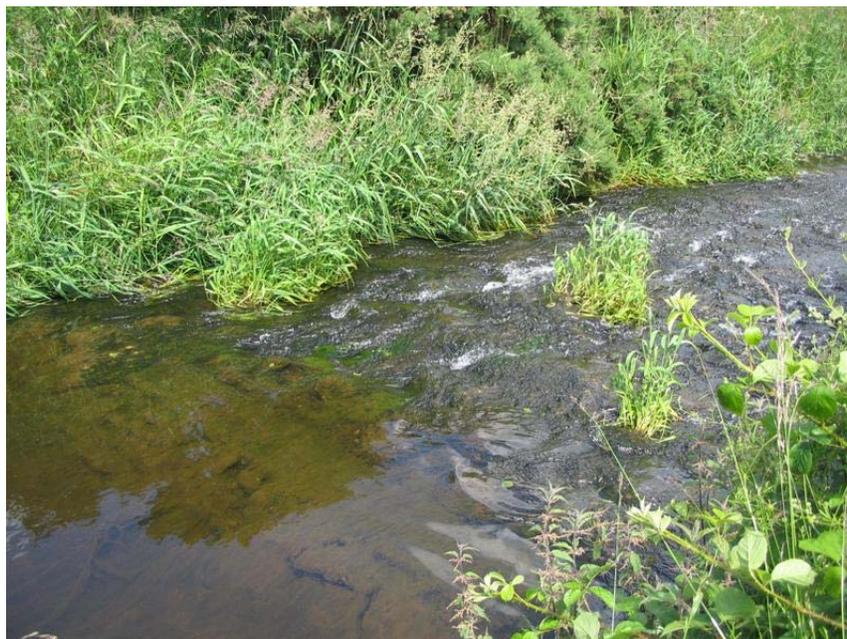
The burn is generally slow and deep throughout the section visited and is probably important as a holding area for adult trout. At NX 208200 556700 a small weir (which appeared to have been constructed of wood and stone) had been placed across the river. The structure then sloped downstream and over this section the flow was faster. It is not clear what was the purpose of this structure. At the time of the site visit, water was slightly above normal summer levels following rain the previous day. It did not appear that this weir would present a problem to migrating adults.

Figure 4.3.3: Weir downstream of Bridgebank

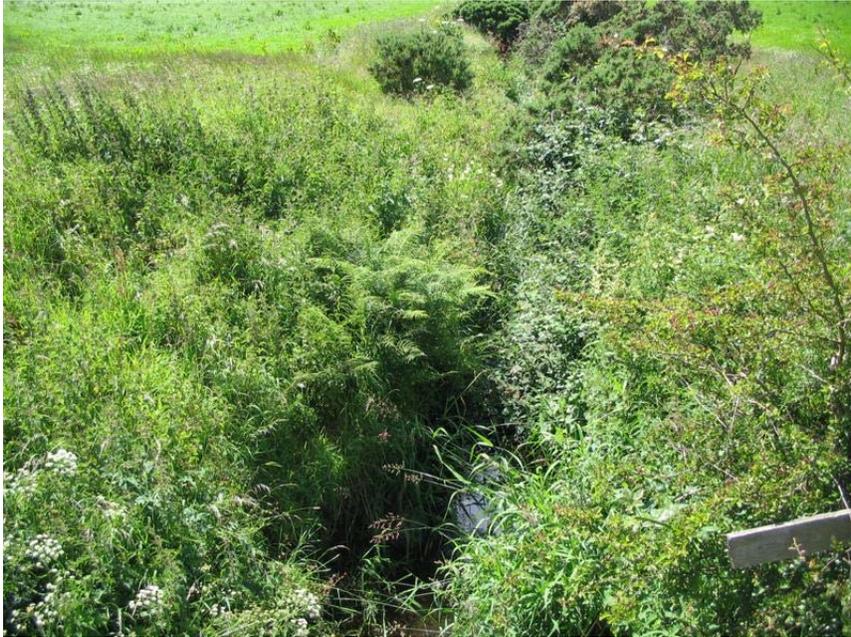
The bankside vegetation of the burn was well established, with draped vegetation being present. Tall herbs and grasses dominated the banksides and due to the seasonal nature of these plants, it is likely that bankside cover is greatly reduced at this site during the winter months. In some places, the vegetation provides complete cover over the water which is related to the burn's narrow width. The encroachment of vegetation could restrict light penetration to the burn. It may be useful to manage the bankside vegetation selectively on this burn and it may be worth considering planting a low density of native broadleaved trees, which will eventually assist with vegetation control by shading. Neither bankside was fenced, but it appeared that the fields adjacent to the burn were not actively being farmed.

Figure 4.3.4.1: Upstream of the bridge on the Garthland Burn

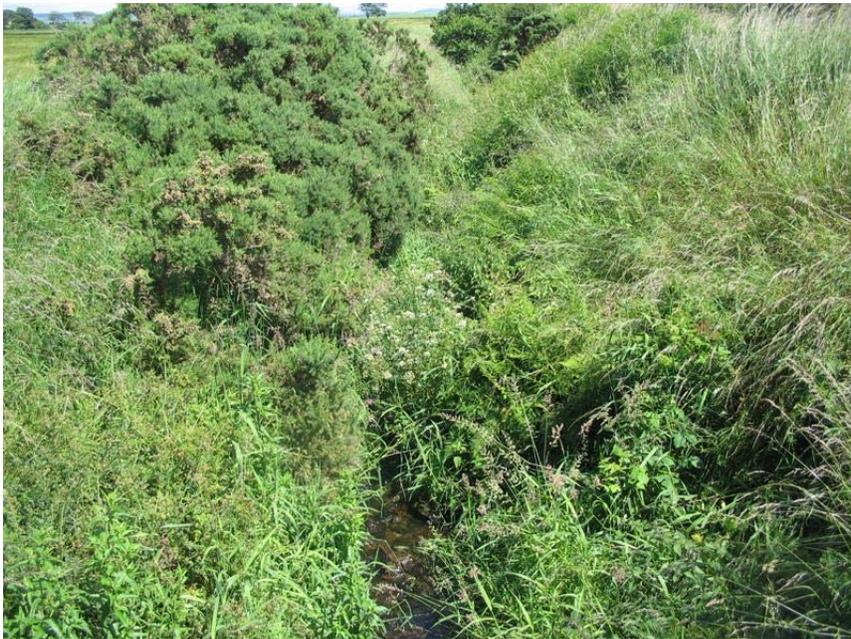
Figure 4.3.4.2: Downstream of the bridge on the Garthland Burn

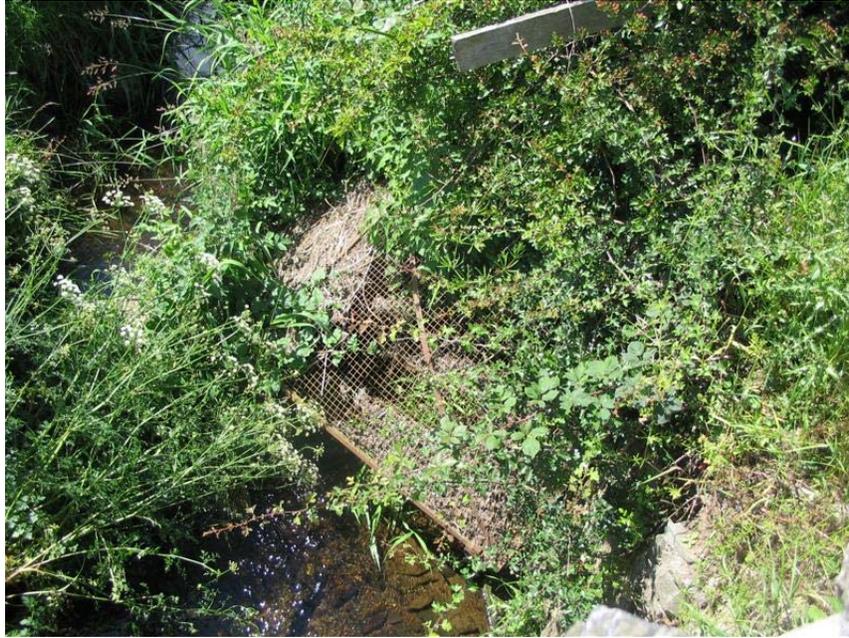
Figure 4.3.4.3: Metal screen upstream of bridge

Upstream of the bridge a metal screen was partially blocking the burn. It is suggested that this screen is removed as it will undoubtedly act as an attachment area for waterborne debris.

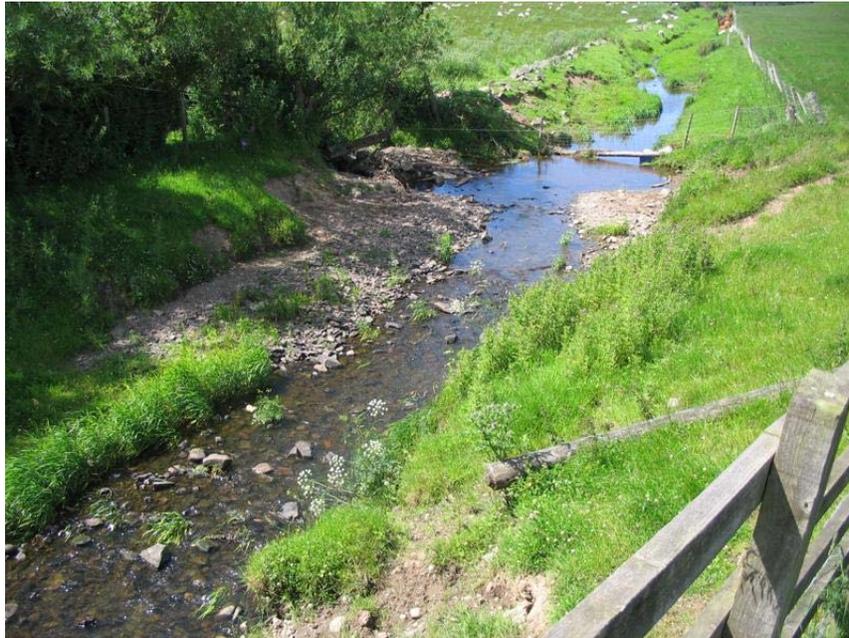
At the time of the site visit, it was evident that livestock in the field adjacent to the left bank (when facing downstream) had been using the area nearest the road as a watering hole (*Figure 4.3.5.1*). The burn was shallow in this area and erosion was clearly occurring. The burn is not fenced at this point and therefore livestock are able to access the burn without issue (*Figure 4.3.5.2*). This is another area where a stock watering solution is required.

Figure 4.3.5.1: Watering hole

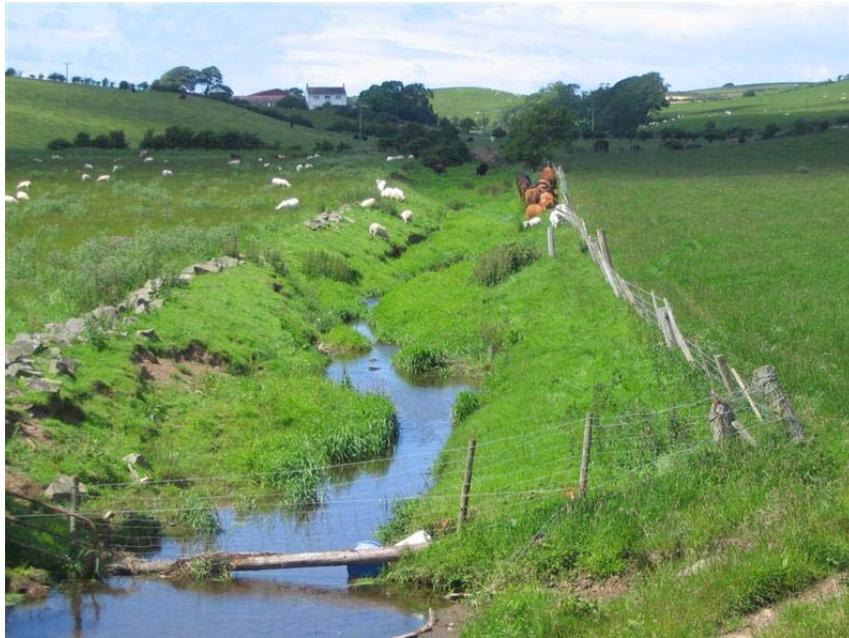
Further upstream, livestock from the field on the right bank of the burn were grazing in the bankside margins of the burn. Both cattle and sheep were seen to be grazing in this area. It is strongly suggested that this area is fenced and an alternative means of watering the stock is considered in this area. It may be useful to fence this area to exclude cattle but allow sheep to access the burn margins. This is suggested as the burn is quite narrow at this point and its productivity may be reduced by allowing tall herbs and other vegetation to encroach across the burn. By excluding the cattle but not sheep, some low understorey vegetation will become established whilst the lower grazing pressure of the sheep will prevent taller vegetation from becoming established and blocking out light.

Figure 4.3.5.2: Livestock grazing burn margins

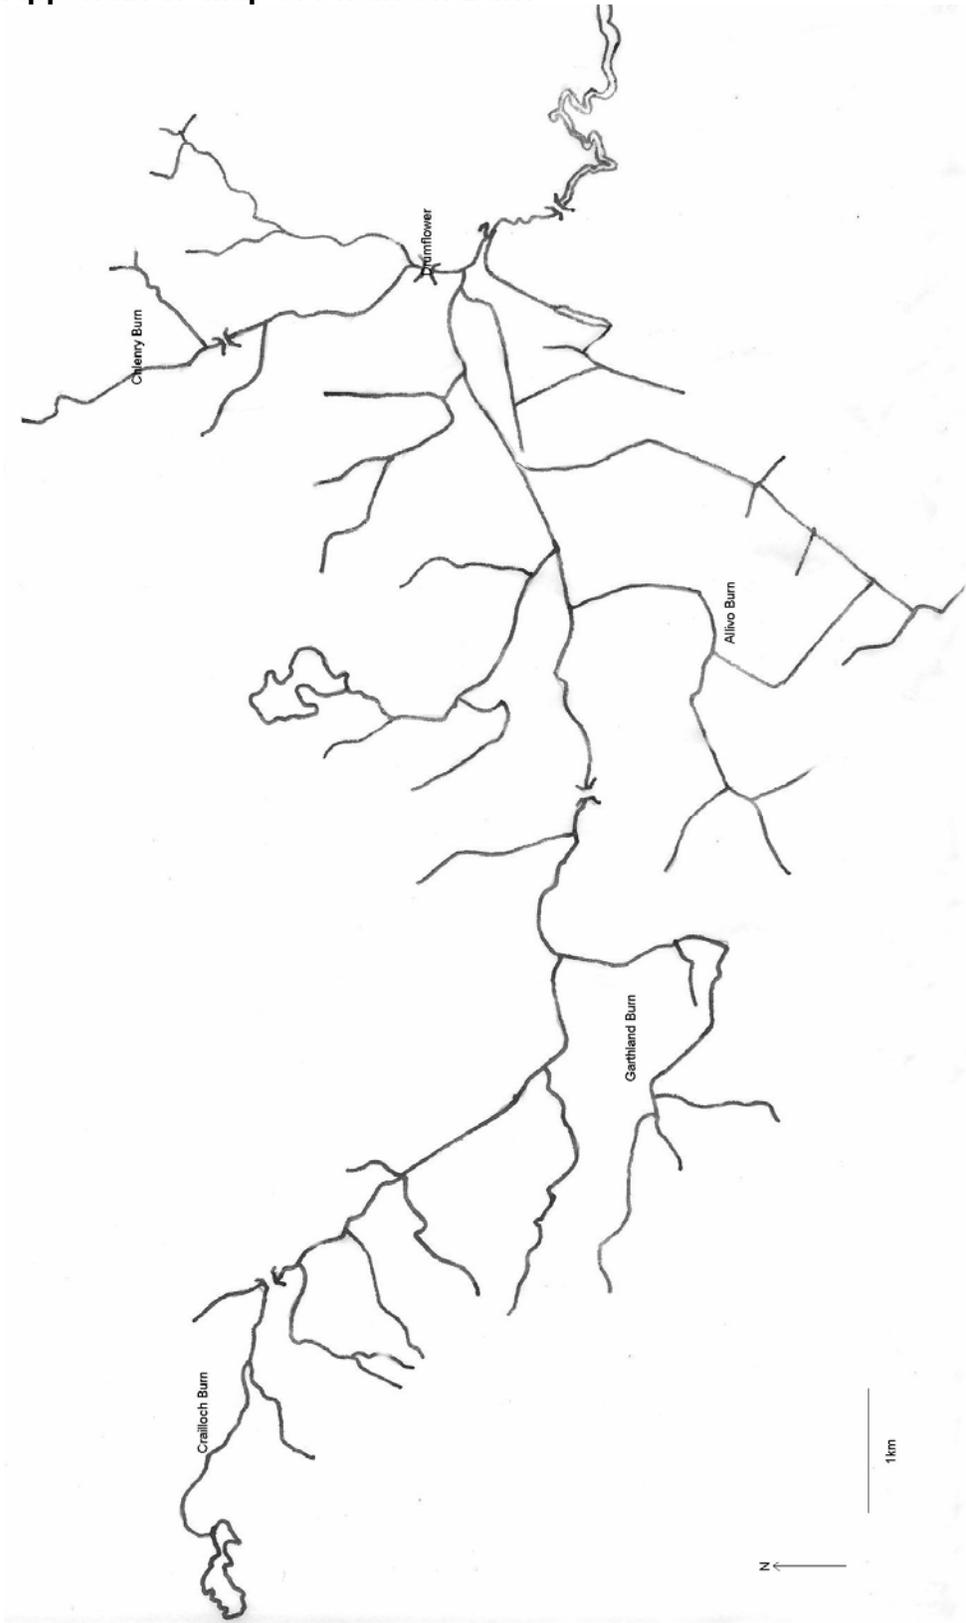
Appendix 1: Map of Piltanton Burn

The Piltanton Burn is a small watercourse situated near Stranraer in South West Scotland. The burn rises to the west of Stranraer and flows east until it enters Luce Bay near Dunragit. The burn is tidal in its lower reaches (see **Appendix 1** for map).
