Advisory Visit

Porter Brook, South Yorkshire

13/09/11

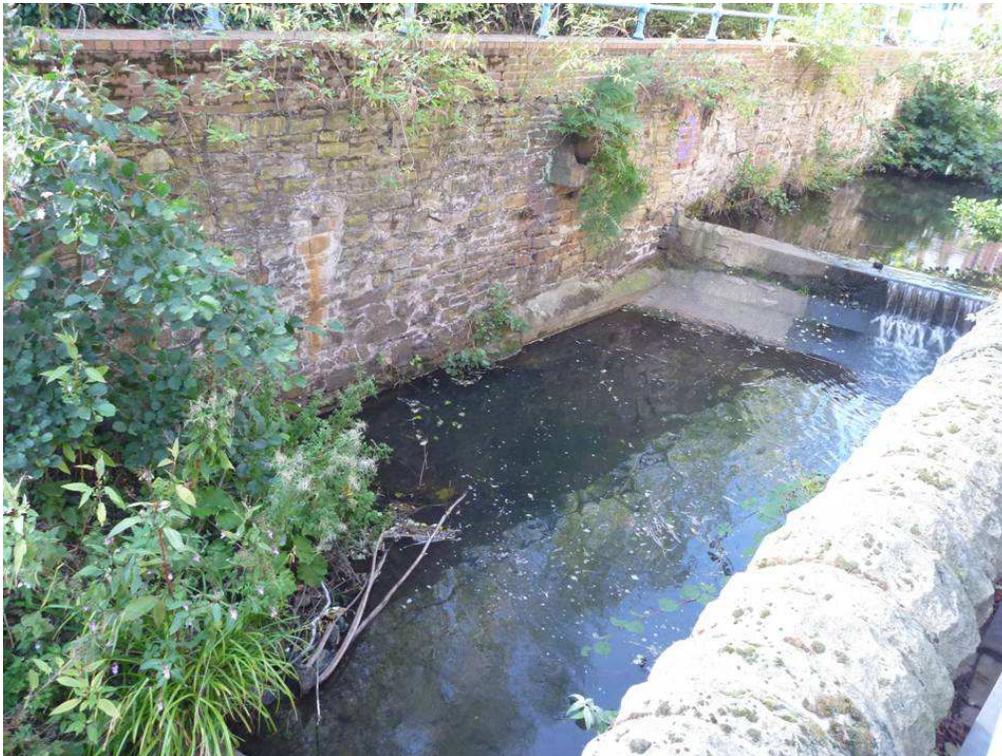
The first feature visited at the downstream limit (indicated in Fig. 1) showed an example of the multiple barriers to fish movement on the Porter Brook (Fig. 2). However, the pool habitat downstream of this weir had some excellent and varied submerged stone structure as well as varied native riparian (river-bank) vegetation. A number of adult fish were observed making use of this habitat during the visit. In addition to the native vegetation, the invasive non-native Himalayan balsam (*Impatiens glandulifera*) was also present. Over time, balsam is likely to come to

Figure 2: Pool habitat below weir with good native flora and good submerged structural shelter for fish and a range of invertebrates. A few Himalayan balsam plants were evident here – and it would be a shame to lose the currently good native plant diversity evident on the RHB.

dominate the river corridor flora and reduce the diversity of both the native plants and their dependent fauna. For this reason, a programme of removal is highly recommended. Eradication efforts must begin by identifying the upstream limit of this invasive species. Once the source stand of balsam is located, removal (via hand pulling of plants just prior to seed setting - usually in June) should proceed in a downstream direction. This is because seeds are washed downstream from source populations – so eradication success will be limited until such upstream sources are removed. Seeds of Himalayan balsam are known to remain viable for only ~3 years (compared to the many decades of native flora). This means that control can be established within only a few years following the above protocol.

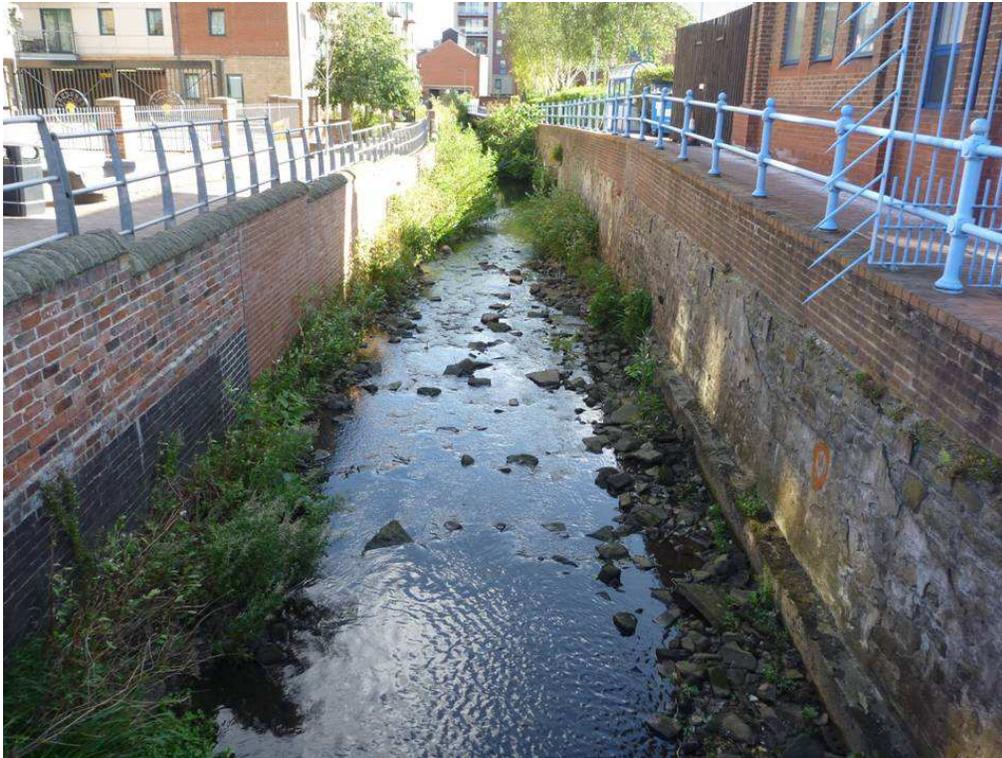
Surprisingly, the impounding effect on the water upstream of this weir is relatively limited. This is due, no doubt, to the steep gradient of the Porter Brook and its resultant capacity to mobilise stream bed material. As a consequence the watercourse has been able to reproduce some natural features of a meandering channel - even within the confines of the retaining walls (Fig. 3). Although undoubtedly still following a straighter path than

would be the case in a completely unmodified system, the formation of marginal berms of gravel and cobble provides a nice variety of microhabitats for plants, invertebrates and some life-stages of flow-loving fish like trout.

Figure 3: Reformation of a slightly meandering path via deposition of stream bed material transported from upstream reaches during spate flows. The valuable presence of marginal vegetation also owes its existence to this process. It is unusual to find this type of briskly flowing watercourse immediately upstream of a weir – and is a product of the steep gradient and relatively narrow confines of the channel.

The cobble and small boulder-strewn run shown in Figure 3 is a high quality nursery area for trout. A relatively shallow average depth, presence of flow-disrupting rocks, low overhanging vegetation and stems of emergent aquatic plants are ideal for young fish. However, opportunities for both spawning and holding areas for adult fish are very limited. This highlights one of the primary problems facing the Porter Brook more generally (as well as specifically on this reach): the obstructions to fish passage. In order for the adult fish below the weir to reach upstream spawning habitat, and subsequently for their offspring to thrive in the nursery areas (typified by Fig.3), the multiple barriers to fish passage must be tackled. Solutions to this problem need not always consist of very formal “fish ladder” installations. Some suggestions are provided in the “Recommendations” section of this report.

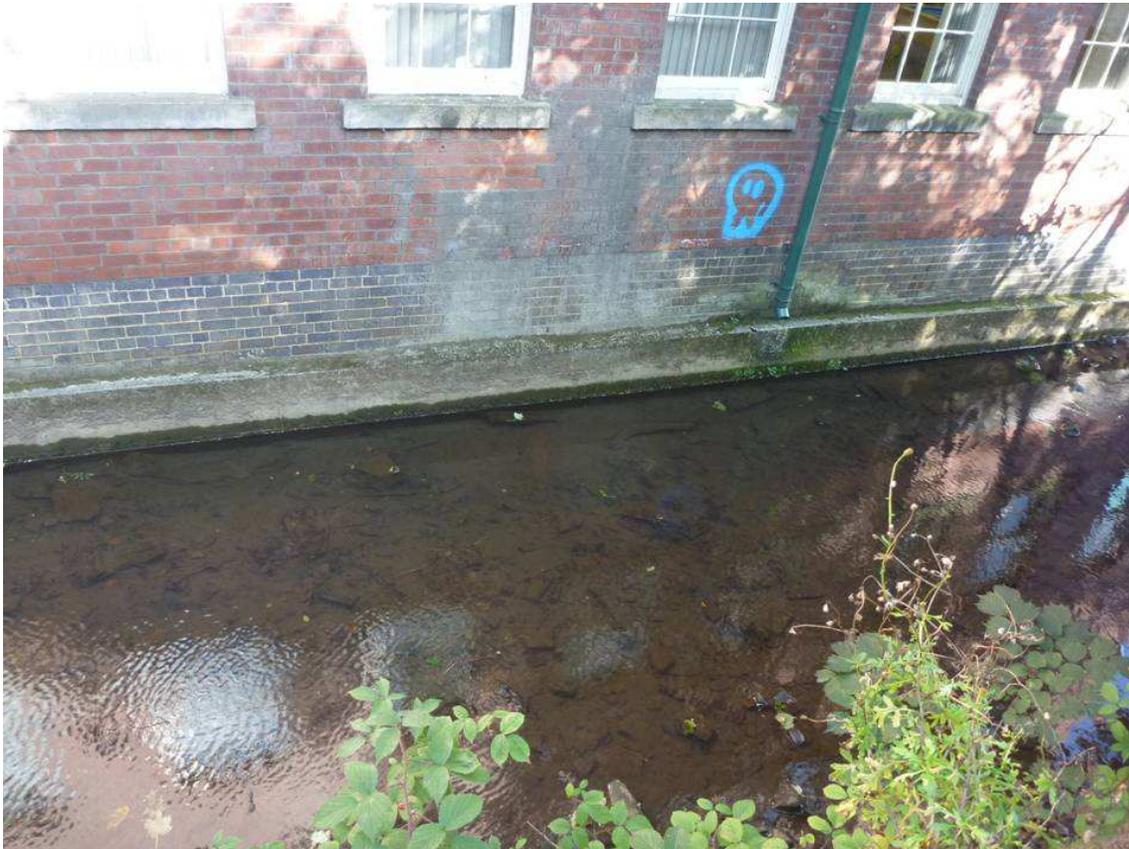
In contrast to the good quality nursery habitat that has arisen in the relatively steep and narrow sections of the brook, some sections are both too wide and of insufficient gradient to recover from being straightened (Fig. 4)

Figure 4: Overwide straightened section. There is a severe lack of overhead cover from predation here - along with a lack of deeper pool habitat. Both features would be required by adult fish. Deposition of fine sediments is also favoured from bank to bank. Such uniform deposition tends to reduce the variety of available microhabitats for both flora and fauna (although the presence of a variety of larger rocks is a valuable mitigating feature).

Overwide and straightened sections of rivers lack variety in depth and flow velocity and also tend to lack pool habitat (due to the flow being too diffuse to produce the necessary bed-scour). The overwide and straightened sections of the Porter Brook also lacked vegetation, cover from predation and gravel spawning substrate (Fig. 4). Desirable priority actions in such reaches are the provision of low overhanging cover (i.e. <30cm above water surface at normal flow) and creation of variety in depth and flow velocity. If opportunities to improve fish passage are limited (or only viable over a long timescale), it may be appropriate to import and stabilise gravel spawning substrate. Possible means of generating the above three characteristics are given in the Recommendations section.

For the section of the Porter Brook pictured in Fig.4, it would be very valuable to incorporate some securely anchored (using steel expansion bolts) brush bundle cover at the base of the concrete retaining wall on the

LHB. This should be installed approximately 25cm above the stream bed so as to provide a dense matrix refuge for small fish during spate flows – as well as providing overhead cover from predation during normal flow conditions for all age-classes of fish. Clearly, this should be only undertaken between berms – where the base of the retaining wall is exposed to the normally wetted portion of the channel (e.g. Fig. 10).

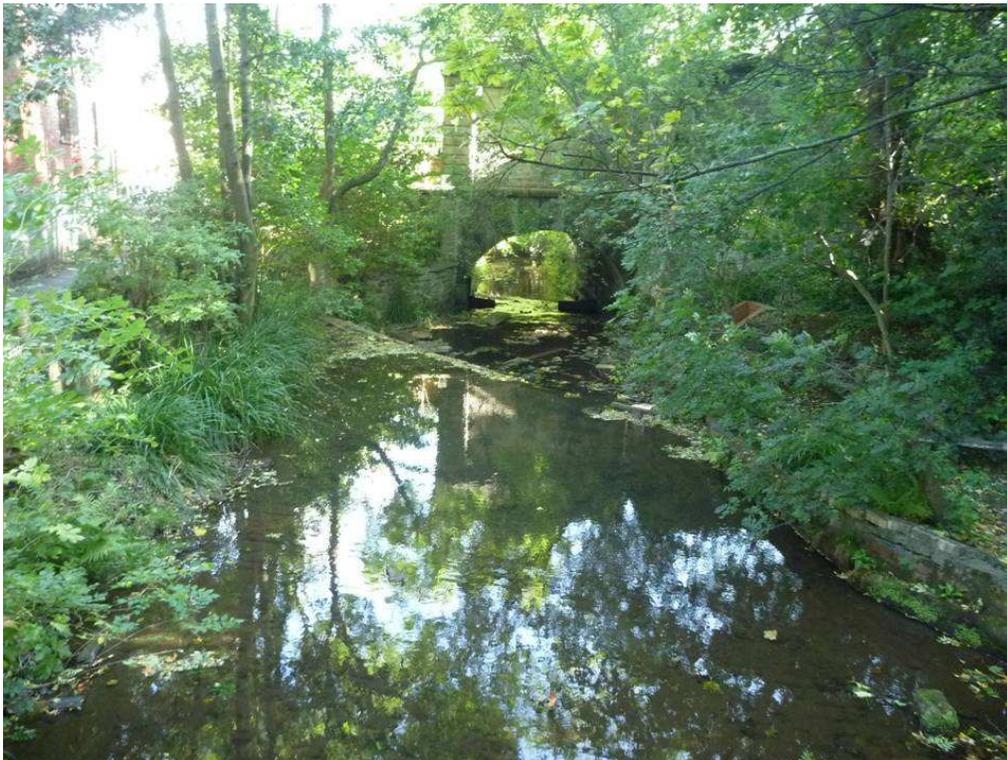
A pair of weirs (one mid-frame and one beneath the arch; Fig 5) again exemplify the issue of blockages to accessing the varied habitat components that trout require to complete their lifecycle. In addition, the more typical impoundment effect of a weir (cf. Fig. 1) is clearly visible in figure 5. The obstruction produces a pond-like character of nearly static water that tends to produce a uniform habitat. However, the riparian vegetation is nicely varied and appears to lack significant incursions of invasive, non-native species.

Figure 5: Facing downstream towards a pair of weirs installed within a short reach. Opportunities exist to improve the in-channel conditions that are currently impacted by the impounding effect of the weir. Conversely, the good quality of the riparian vegetation is notable here – especially along the LHB

There may be opportunities to improve the variety of microhabitats in this reach via introducing a small notch in the weir towards the RHB (Fig. 5). This should be combined with redistribution of stream bed material to create additional variety (see Recommendations).

Finally, in combination with pursuing suitable fish passage easement measures, the habitat upstream of the larger weir pictured in figure 5 could be improved by:

- Notching the weir (subject to suitable permissions from the structure owner and also subject to E.A. approval and lack of risk to underground services such as sewers, gas mains, electricity cables etc.)

- Side casting the stream bed material to produce a deeper slot towards the RHB and a shallower sloping berm at the LHB

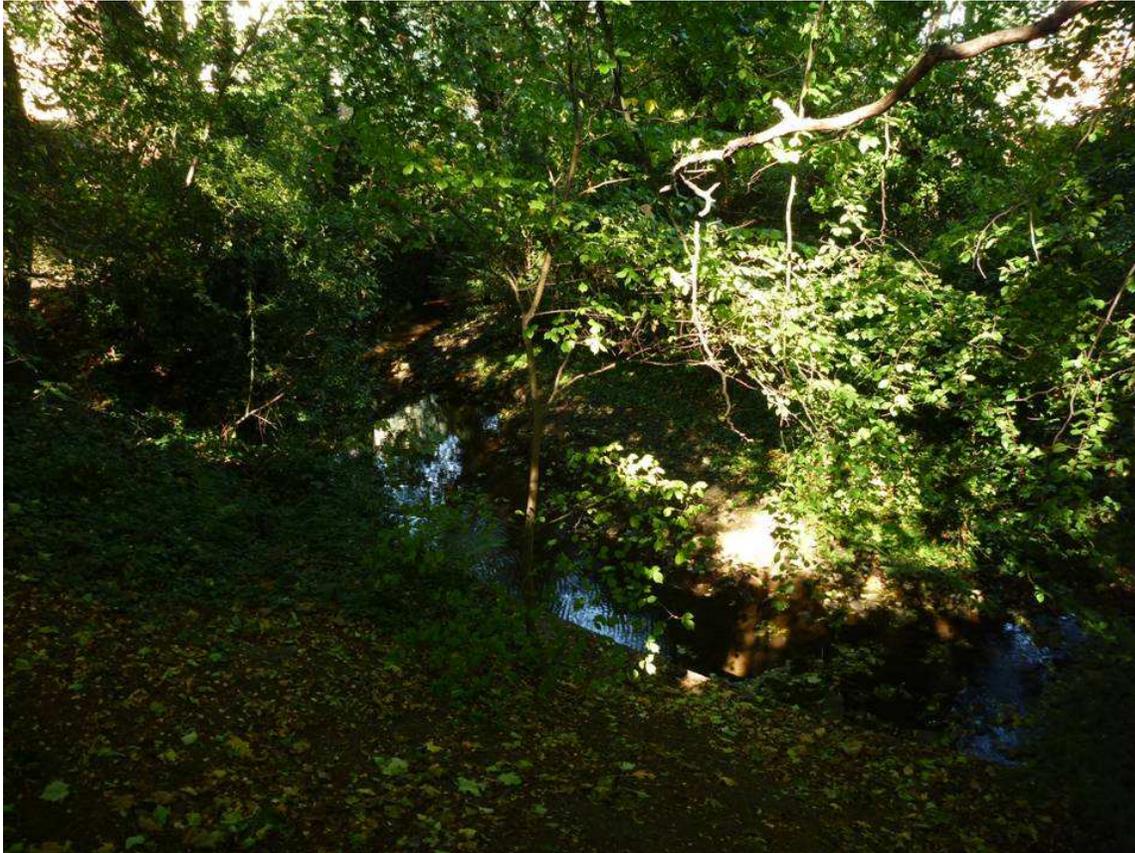
The final feature visited during the visit was the bend pool that marks the upstream limit of this reach (yellow circle; Fig. 1). Here the presence of a bend in the river has promoted the formation of a fantastic lateral scour pool

(Fig. 6). In other words, the outer edge of the bend has been deepened by the faster flow, whilst a “point bar” of stream bed material has been deposited by the slower flows at the inside of the bend – great habitat for a range of species. There is also quite an extensive riverside corridor of mature woodland vegetation. In this instance, the slight shading effect of

Figure 6: Fantastic lateral scour pool and mature woodland habitat at the upstream limit of the inspected reach

the short section of woodland will provide a crucial refuge from high summer temperature/low flow conditions. Brown trout, for instance, find water temperatures sub-optimal above around 19°C, with a lethal range of around 24°C to 29°C. This temperature refuge is especially important given the relatively un-shaded conditions in the adjacent sections of river (and will also provide a valuable passive cooling effect for surrounding human populations). Efforts to preserve the riparian vegetation here are well worthwhile and tree management should only be undertaken when there is a clear threat of damage to surrounding property by falling timber.

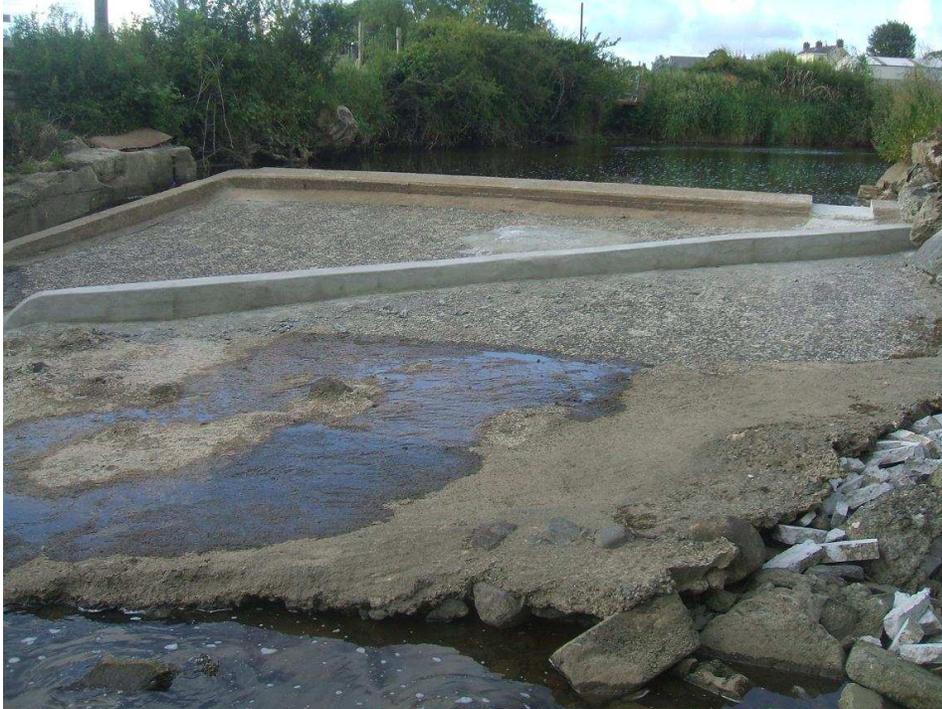
Figure 8: Diagonal baulk fitted to a sloping-faced (crump) weir. Structure is pictured in the dry with flow passing down an existing bypass channel to the left of frame. Could also be constructed using bolted wooden sleepers (cost - cement and metal pins)

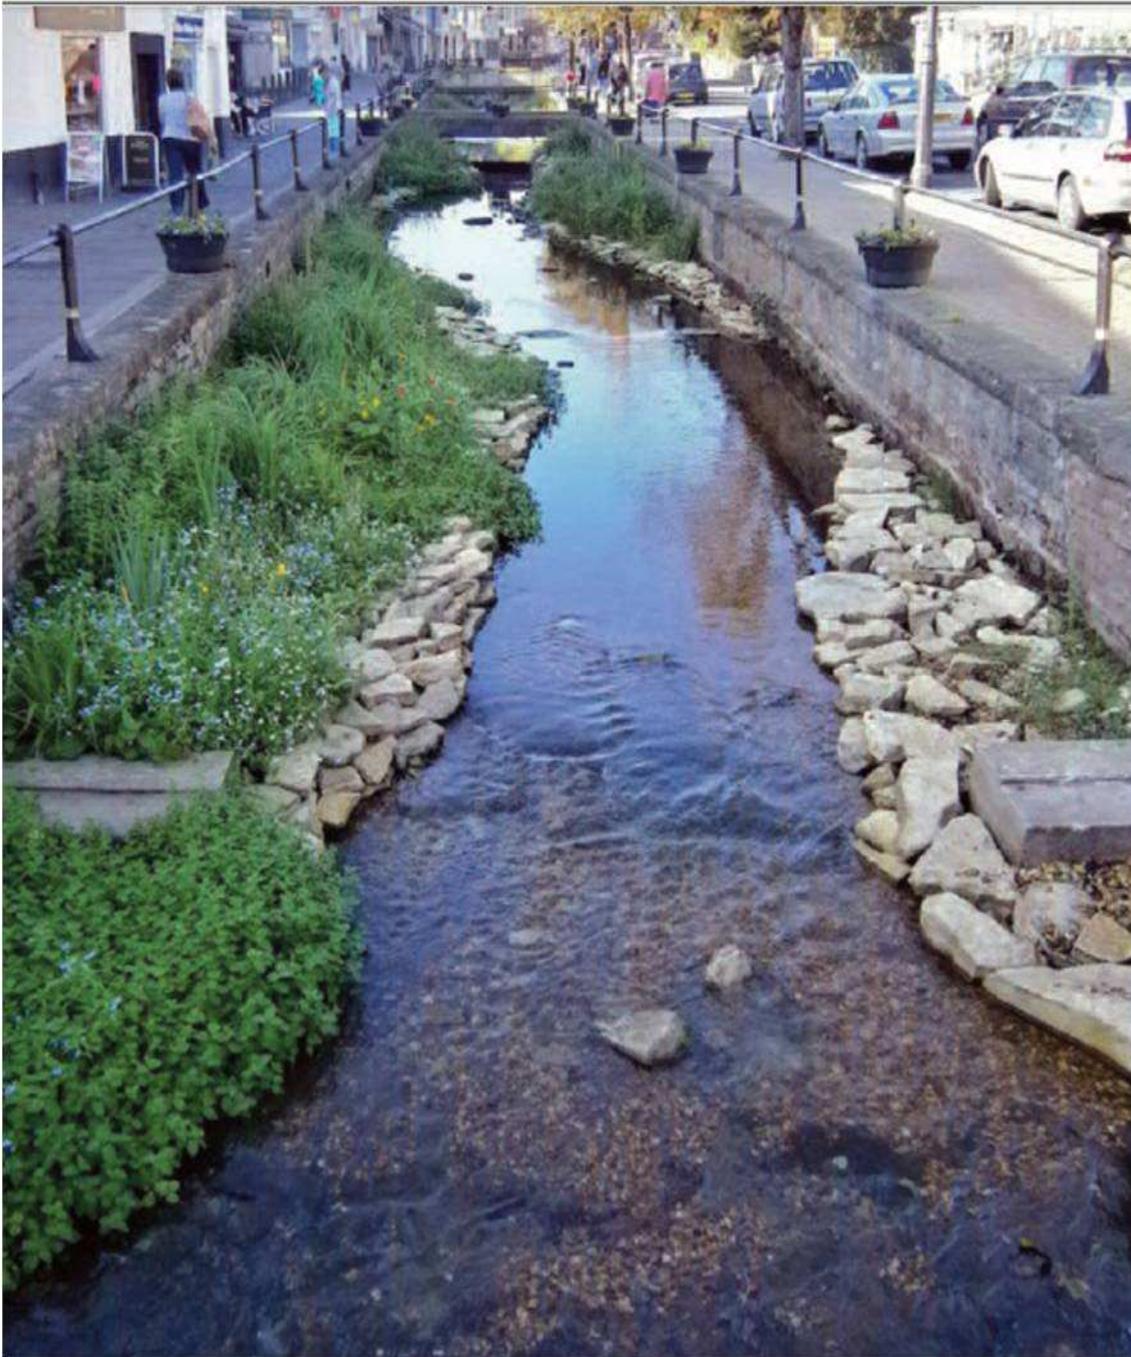
Figure 9: Meandering planform, aquatic plant establishment and introduced gravels/cobble substrate within retaining walls of an engineered channel.

For overwide, straightened sections it would be ideal to use a combination of suitable imported stone and re-distributed stream bed material to produce a staggered series of alternating side-berms. In this way a meandering planform of the river flow could be created within the river channel. It is important to make the bank-side edges of such berms the highest point – with the lowest points occurring in the river channel. If this guideline is not observed, the water tends to cut behind such installed berms during spate flows and erode the banks. The berms should also be planted up with suitable wetland plant species seed (consider also installing mature sedge grasses grown for at least 6-months to 1 year in flat coir pallets - not rolls; see Appendix 1 for selecting appropriate materials). An example of berm creation within an engineered/straightened channel is given over (Fig. 9). Note the size of stone selected and also the gentle, vertically sloping nature of the berms towards the centre of the channel. It may also be possible and desirable to introduce spawning substrate (gravels in the 20 – 40-mm diameter size range). The existing presence of large boulders, as well as the introduced berm features would be valuable in grading and retaining such

spawning gravels during the natural processes of remobilisation and deposition during spate flows.

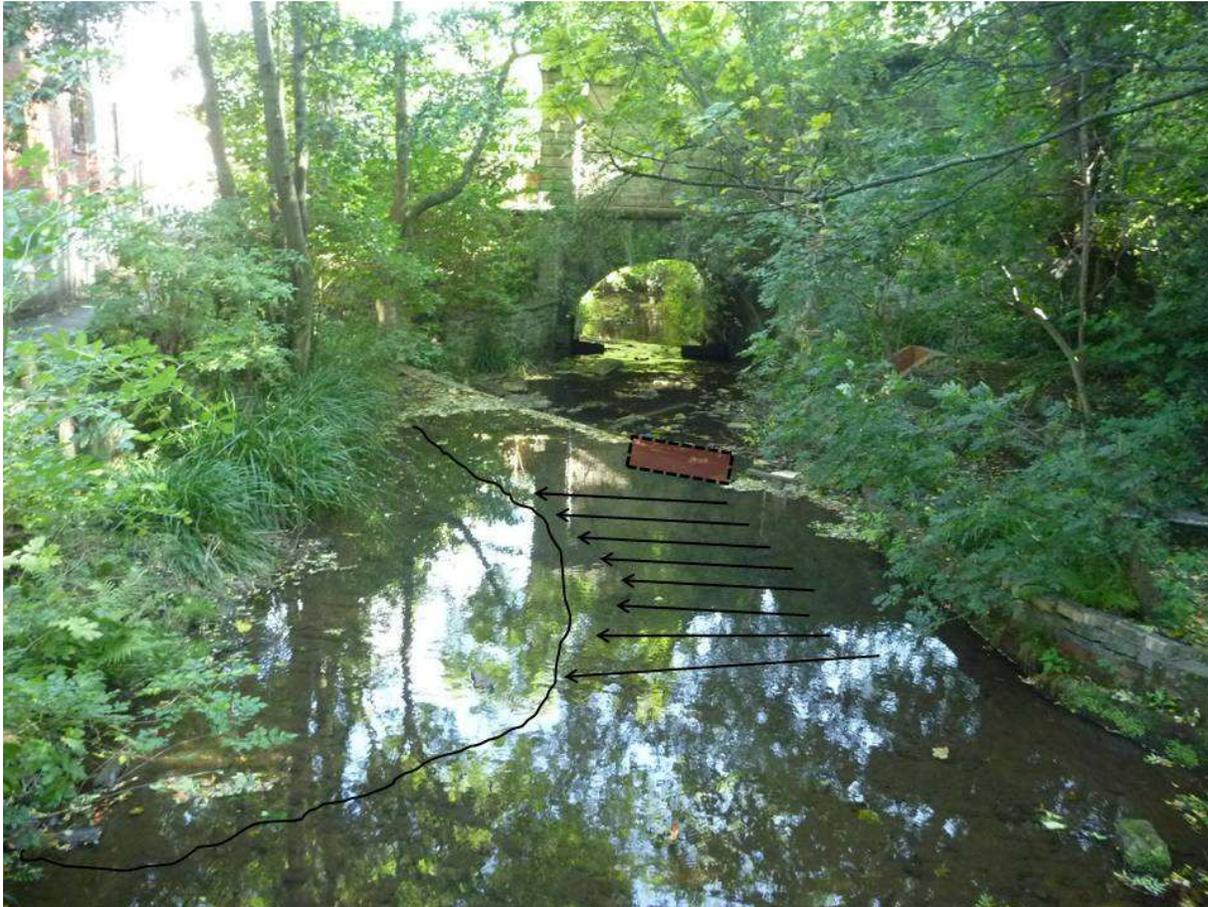
Figure 11: Cutting a small notch (red shaded box/dotted line) and redistributing the stream bed material according to the arrows would promote the existence of a deeper channel on the RHB and the formation of a shallow sloping berm on the LHB (outlined). The notch would aid fish passage measures below the weir as well as help to preserve the existence of cross-sectional depth variation created upstream of the weir

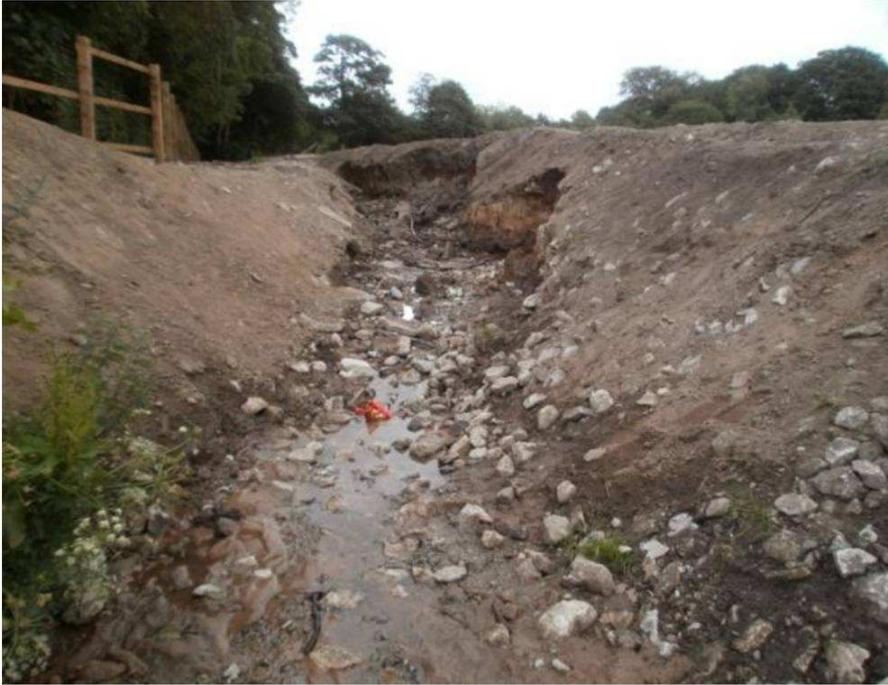
Photo 1: Before - Eroded channel before

Following works within Worden Park to remove a culverted section of Cricket Field Brook that was the cause of flooding to neighbouring residential properties, a long term solution was required to re-landscape and stabilise the channel and establish new vegetation in the watercourse. The solution had to address rapid bank erosion as a result of a very high sand content of the subsoil. This was further compounded by very high flow rates following heavy rain events as a result of development within the watercourse's catchment area upstream. There was a desire to provide a watercourse that would positively contribute to the landscape of the park and also provide a range of wildlife habitats. The works to the watercourse were completed within two weeks of starting on site and, despite a number of prolonged heavy rain events both during and after the works, the mature pre-established coir rolls and pallets all began putting on new growth within a matter of days providing the watercourse with instant channel vegetation and protection to the toe of the banks. A coir blanket was installed to stabilise the banks has also prevented any erosion to the sandy soil beneath

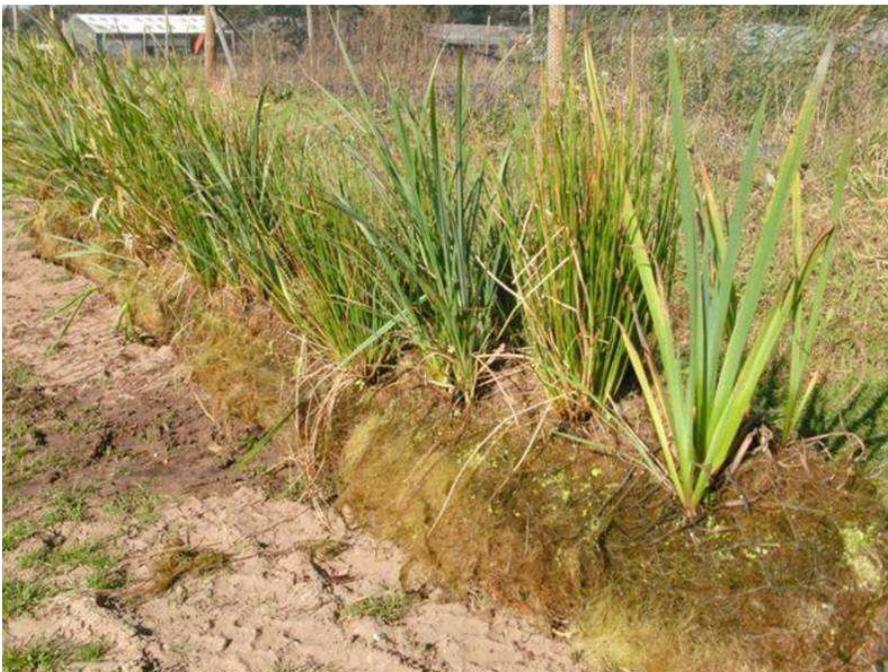
Photo 2: A mature pre-established coir roll ready to install

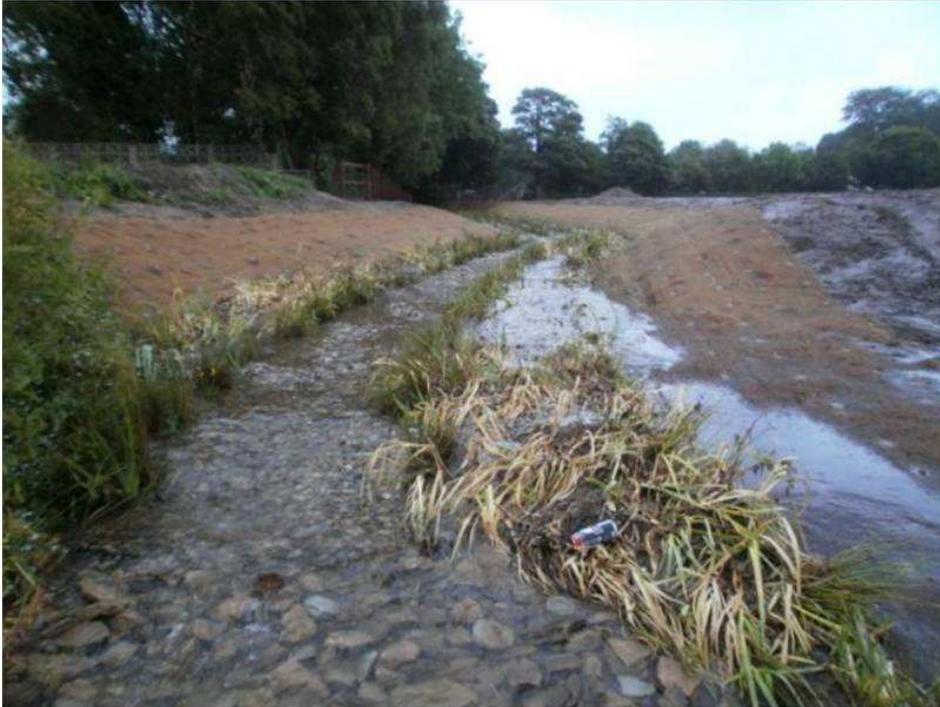
Photo 3: Installation - Mid July 2011

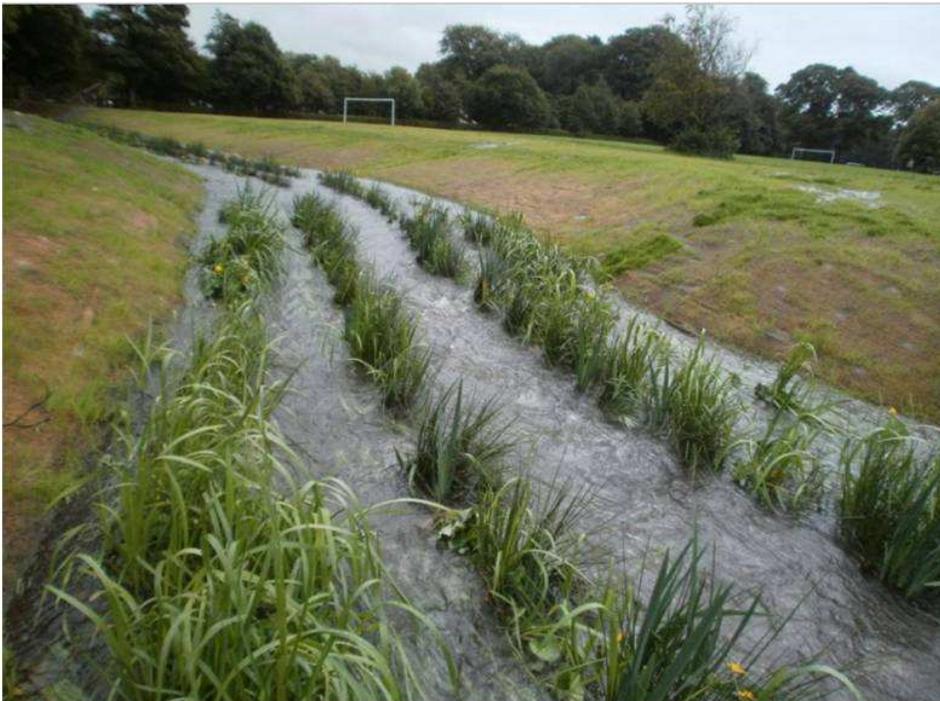
Photo 4: Post - The start of a flood event that eventually reached bankfull. Note the maturity of the vegetation installed just 6 weeks before. Immature coir rolls and pallets would have failed here.

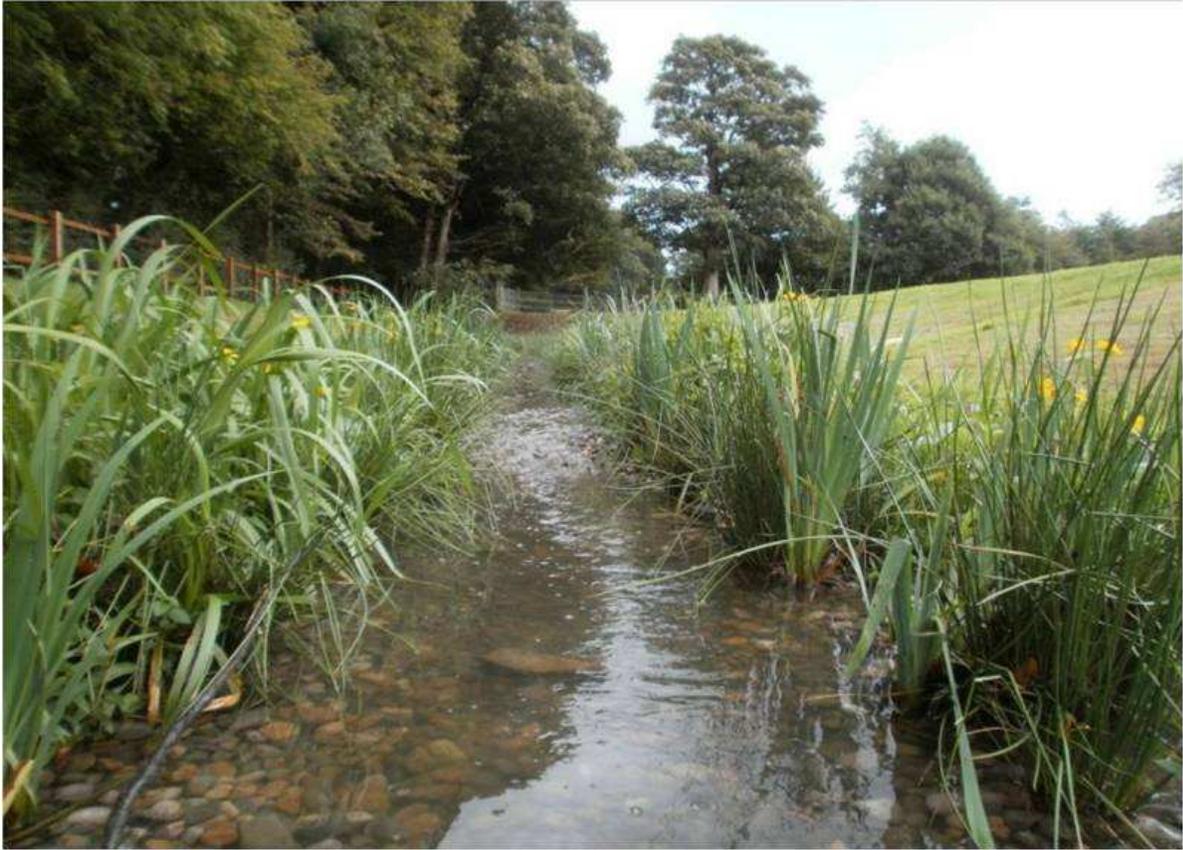
Photo 5: Post - The channel immediately after the flood event after only 6 weeks after installation
