Prior Park Stream, Bath

A Project Proposal by the Wild Trout Trust August 2014

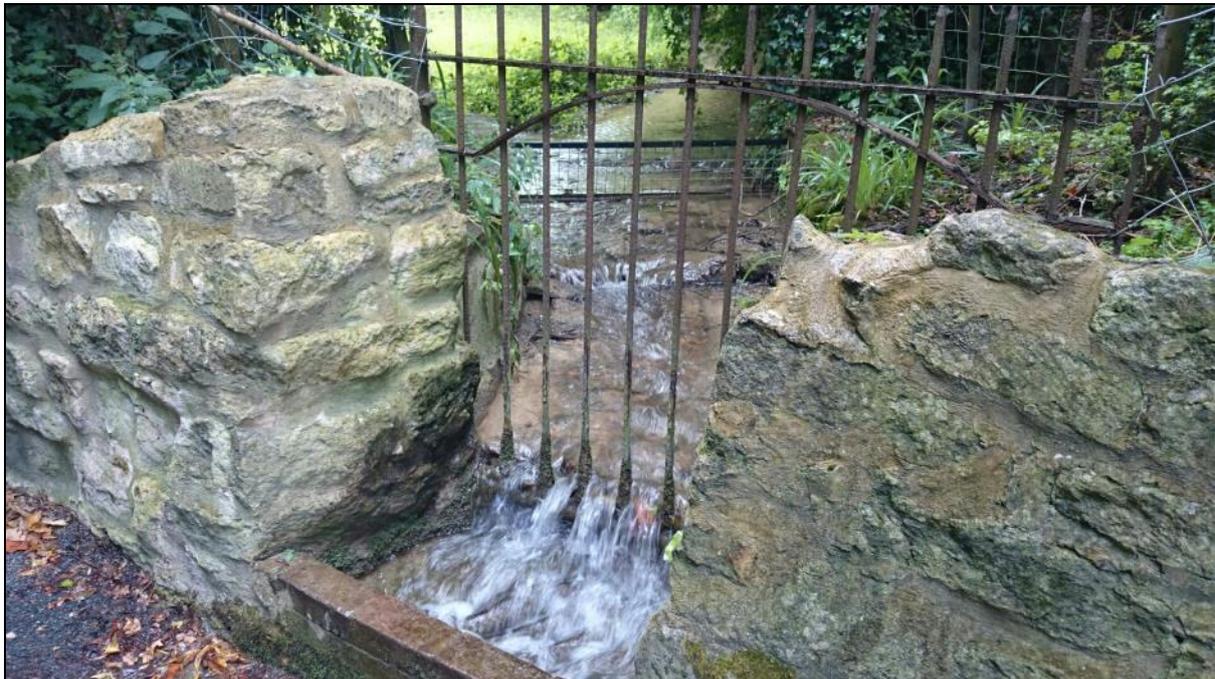
Near the upstream boundary of the reach visited, the stream flows down from Prior Park and enters a culvert through a drain cover at Church Street, NGR: ST 75930 63736 (Figure 2). The culvert is completely impassable for upstream migration but it is possible that small and juvenile fish could drop down from the fishing lakes and pass downstream. The river re-emerges on private property immediately upstream of Prior Park Garden Centre and the exit of the culvert was not inspected during the visit.

Figure 2: The entrance to the culvert at Church Street. Whilst it is almost certainly impossible for fish to pass upstream through the culvert, it might be possible that juvenile fish can drop through it downstream.

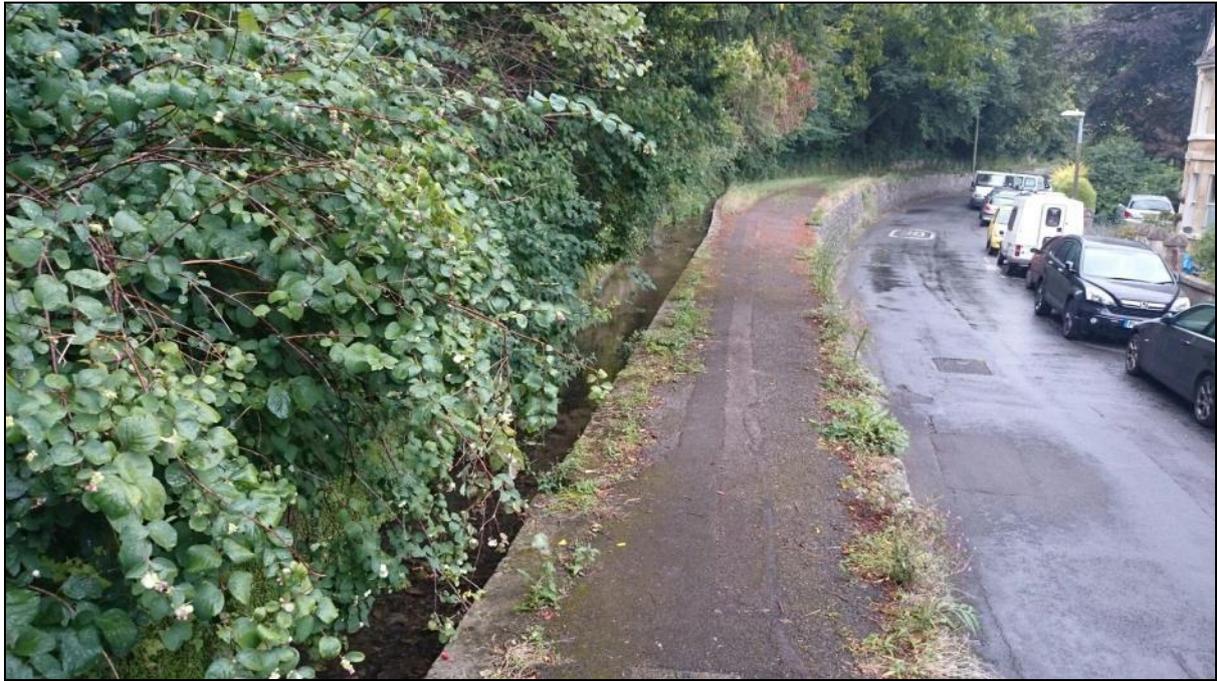
Nearby Lynn Brook flows through Lyncombe Vale via an artificial perched channel (Figure 3). The brook enters a culvert at Bagatelle House, at the Junction of Lyncombe Vale and Ralph Allen Drive and flows underground past the garden centre and Prior Park Buildings, which may explain why there has been some confusion between the two streams. At the garden centre, there is also an offtake for excess spate flow from Prior Park Stream, diverting it into the Lynn Brook culvert.

Figure 3: Lynn Brook flows through a perched channel above Lyncombe Vale

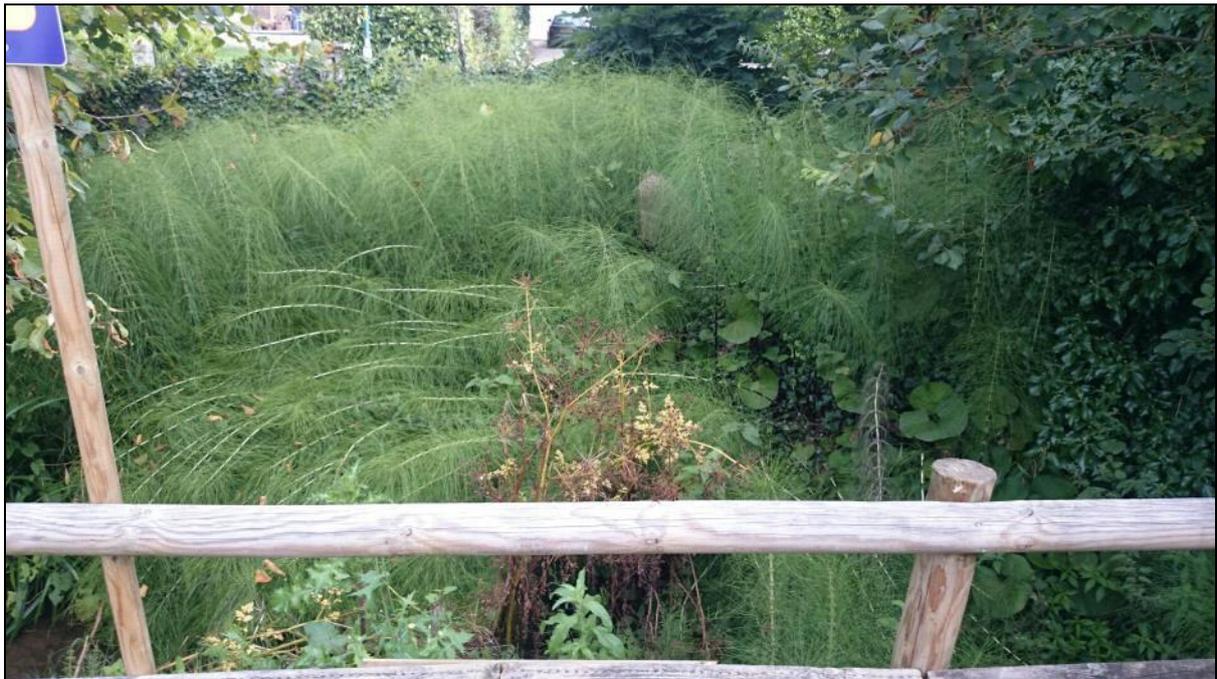
At the upstream boundary of the garden centre the riverbank is densely populated by horsetail (*Equisetum* sp., Figure 4). Horsetail is a living fossil; the last remaining genus of the Equisetaceae family which for a hundred million years dominated the understory of the late Paleozoic forests.

Figure 4: Horsetail dominates the bank at the upstream extent of Prior Park Garden Centre

Reproducing with spores and arising from deep roots, *Equisetum* species can be invasive and difficult to control. Nonetheless some control of this plant may be required in order to maintain biodiversity.

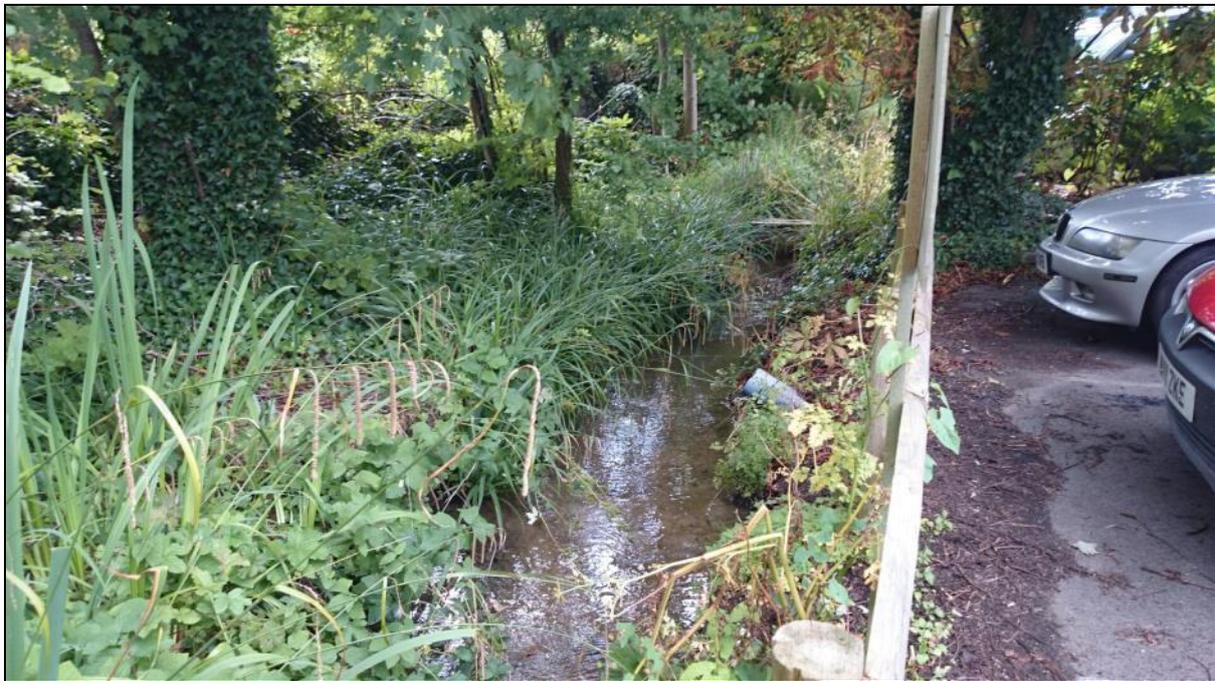
Alongside the remaining length of the garden centre car park, the stream flows through a straightened but naturalised channel with a bed comprising sand, gravel and tufa (a granular substance formed by the precipitation of carbonate minerals). A variety of true marginal plant species are present including sedges (*Carex* sp.), meadowsweet (*Filipendula ulmaria*), willow herb (*Epilobium* sp.) and water dropwort (*Oenanthe* sp.).

Figure 5: Prior Park Stream along the garden centre car park

In places the bed is smothered with a layer of fine sediment and the stream would benefit from some in-channel structure to deflect flow and scour fine sediment from the bed.

The land between the stream and the road (the Right Bank) is neglected and obstructs the stream from view from the road. Some clearance work along this strip of land, in combination with the introduction of a few small in-stream flow deflectors would deliver habitat enhancement benefits and significant aesthetic improvements. Making the stream a prominent landscape feature of the garden centre car park would help highlight the importance of the stream within the local community and could help ensure that any future water quality or habitat problems are quickly identified and tackled.

- a. At Prior Park Garden Centre, efforts should focus on improving the diversity of wetland and marginal plant species and keeping the channel clear of fine sediment. The latter task can be achieved by the simple installation of some occasional 'pinch points' and flow deflectors to accelerate flow where sedimentation is excessive. Pinch points could be created by importing some small-sized flint or limestone gravel, perhaps stabilised with some larger cobbles. This could also provide some potential spawning habitat for minnows. Flow deflectors could be constructed from short logs approximately 100mm in diameter.

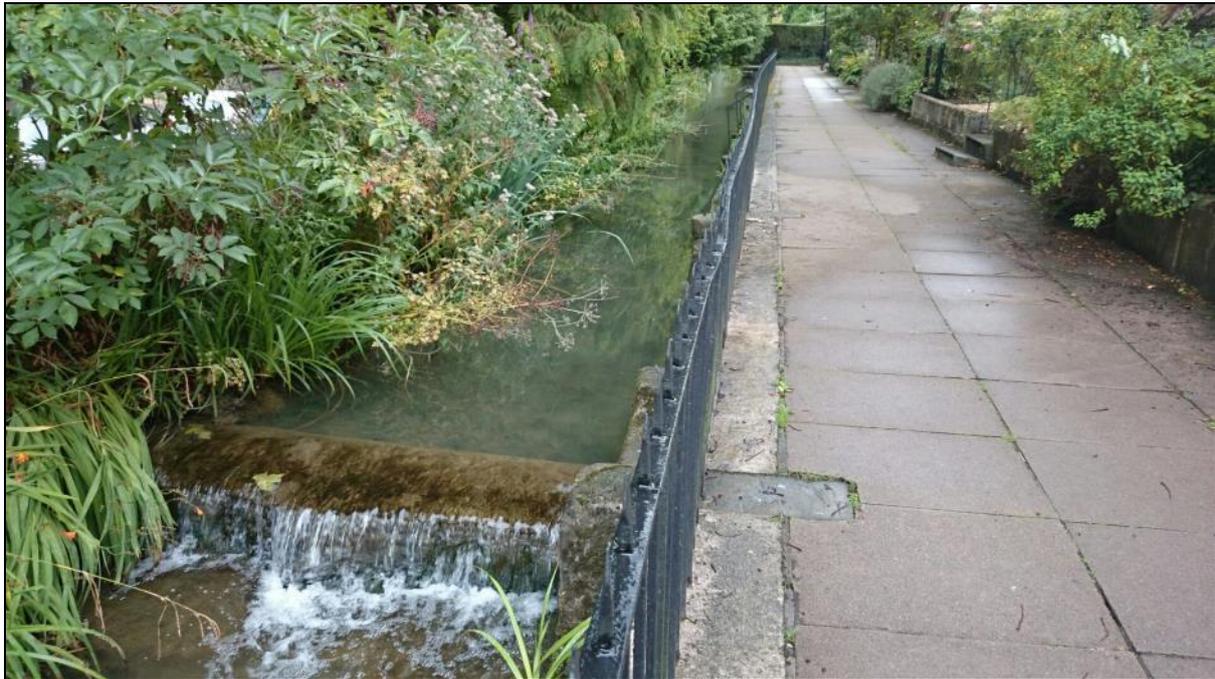
over-wide and heavily impounded (Figure 6). The result is that flow is uniformly sluggish and laminar, allowing fine sediment to drop out of suspension and blanket the bed.

Figure 6: Prior Park Stream along the front of Prior Park Buildings

Whilst the LB is a vertical face of stone blockwork, the RB has been softened by the installation of some marginal brushwood faggot bundles. Where the introduced soft margin receives sufficient sunlight, marginal plants have flourished. However, under the shade of bankside trees, the brushwood remains un-vegetated. Shade from bankside trees help to keep rivers cool during summer months, helping maintain appropriate water temperature for fish and invertebrate species sensitive to low levels of dissolved oxygen. However, sunlight is also vital for marginal and submerged plants. The Environment Agency's *Keeping Rivers Cool* guide (available from the WTT website at:

Many of the shrubs and plants growing on the RB are ornamental cultivars with little habitat value for the stream. Removing these shrubs and replacing them with small, native trees such as elder (*Sambucus nigra*) hawthorn (*Crataegus monogyna*) or goat willow (*Salix caprea*) would be beneficial for the ecology of the stream. Willows and hawthorn in particular are associated with a high

- b. At Prior Park Buildings, non-native shrubs should be replaced with small, low-growing native trees such as elder, hawthorn and goat willow. Ideally, the large conifers should also be replaced but this

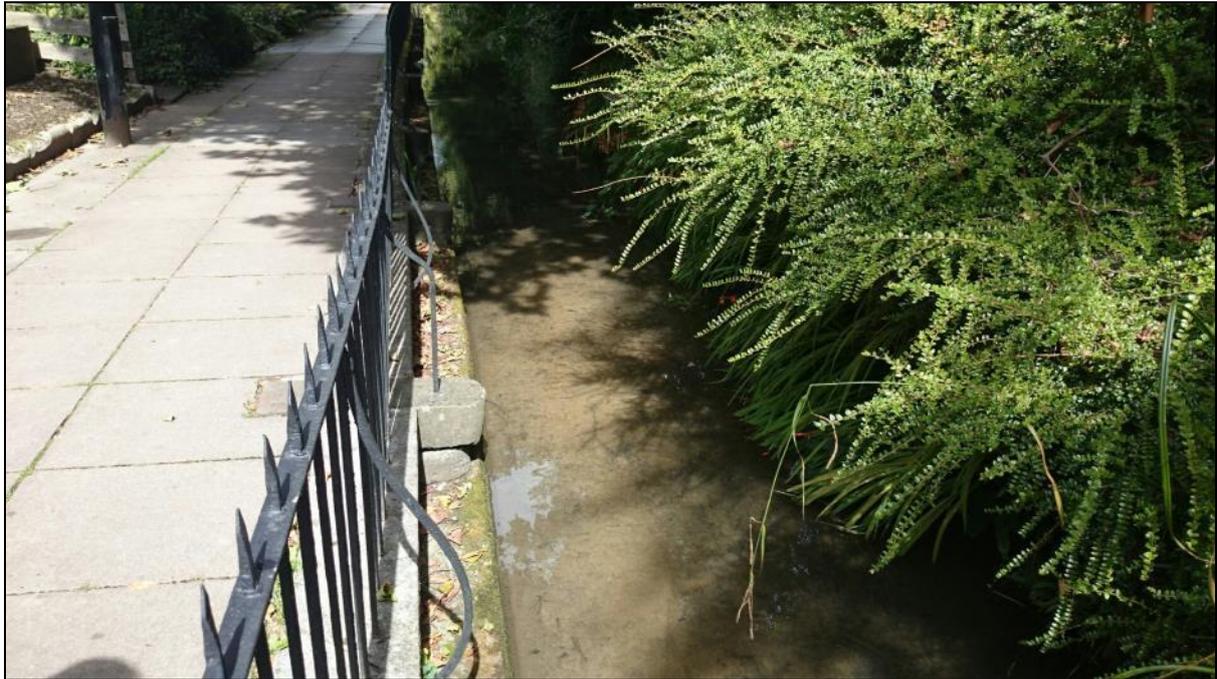
The channel in front of the terrace can be divided into two sections upstream and downstream of a weir situated approximately halfway along the terrace. Upstream of the weir the stream is generally shallower, particularly towards the upstream extent of the terrace (Figure 7). Below the weir the channel is deeper

Figure 7: The stream upstream of the weir at Prior Park Buildings

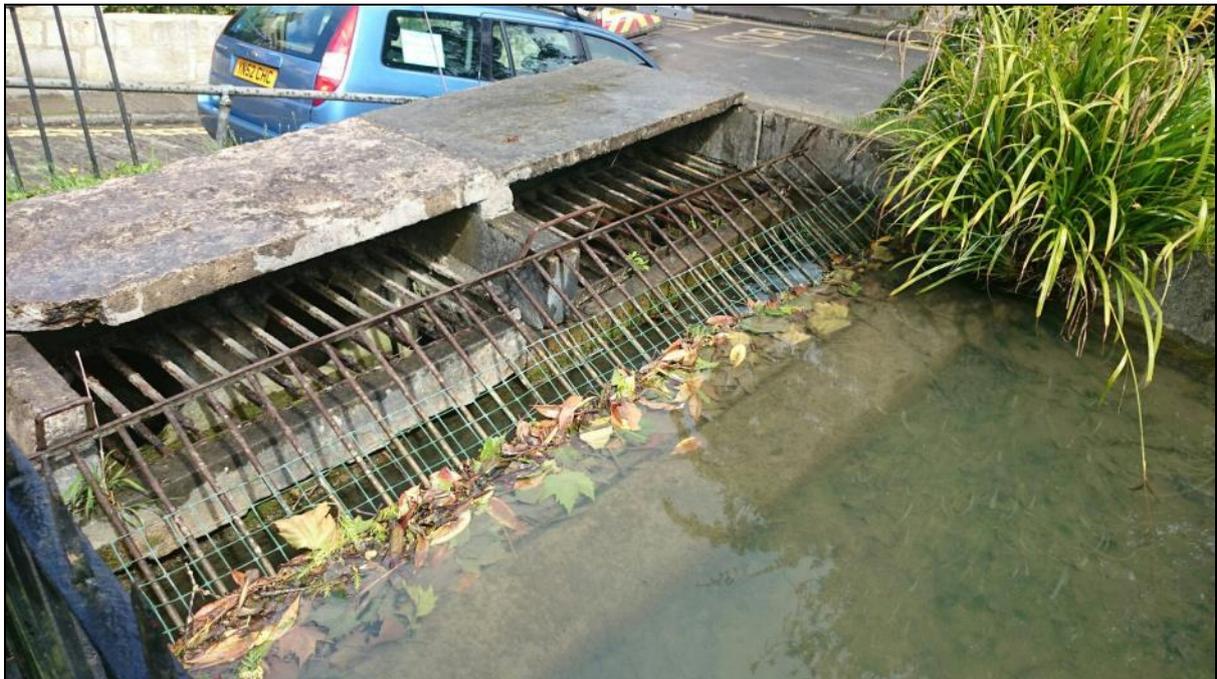
and further impounded by the structure at the downstream extent of the terrace where the stream drops into another culvert (Figure 8).

Figure 8: The entrance to the culvert at the downstream extent of the Prior Park Buildings reach.

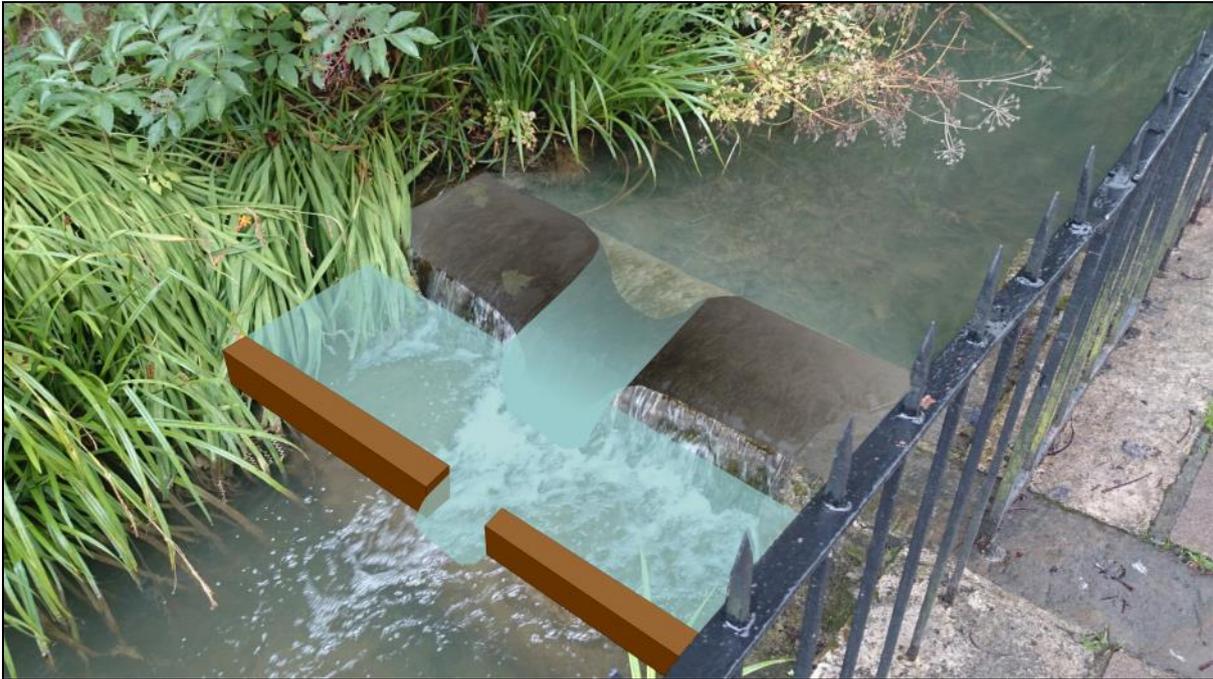
Figure 9: An illustration of how a notching a section of the weir could be combined with a timber balk pre-barrage to ease fish passage.

2. Engage with the residents of the terrace to discuss the possibility of removing the weir half way along the terrace in order to reduce the impounding effect and improve flow speed. If fully removing the weir is deemed to be unfeasible, options to lower a small section of the weir to facilitate fish passage should be explored. At the very least, fish passage over the weir should be improved via the installation of a low-cost fish passage easement (Figure 9).

Better connecting the canalised reach at the terrace to the more-natural habitat at the garden centre could for example, facilitate minnow reproduction, possibly leading to a self-sustaining population.

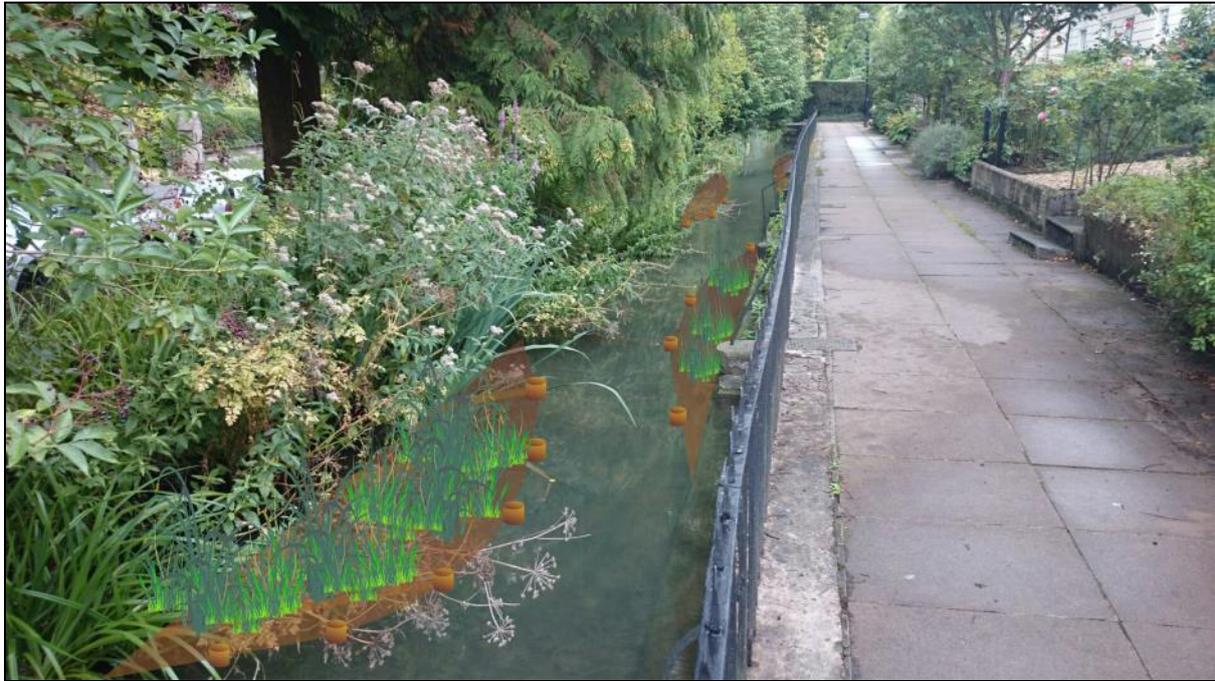
Figure 10: An illustration of how alternating brushwood berms could introduce marginal habitat and also increase sinuosity

- c. A lack of both in-stream sinuosity and marginal habitat can be addressed by installing some coarse brushwood habitat similar to that previously installed along the RB. However, instead of laying brushwood bundles in a straight line along the bank, the opportunity should be taken to introduce sinuosity by creating a series of alternating brushwood berms along the length of the channel (Figures 10 and 11).

This would also narrow the channel and increase the flow speed, helping to mobilise fine sediment and reduce the rate of sedimentation.

Particular care should be taken to ensure that the berms are positioned under direct sunlight so that the berms can be colonised by marginal and emergent plant species.

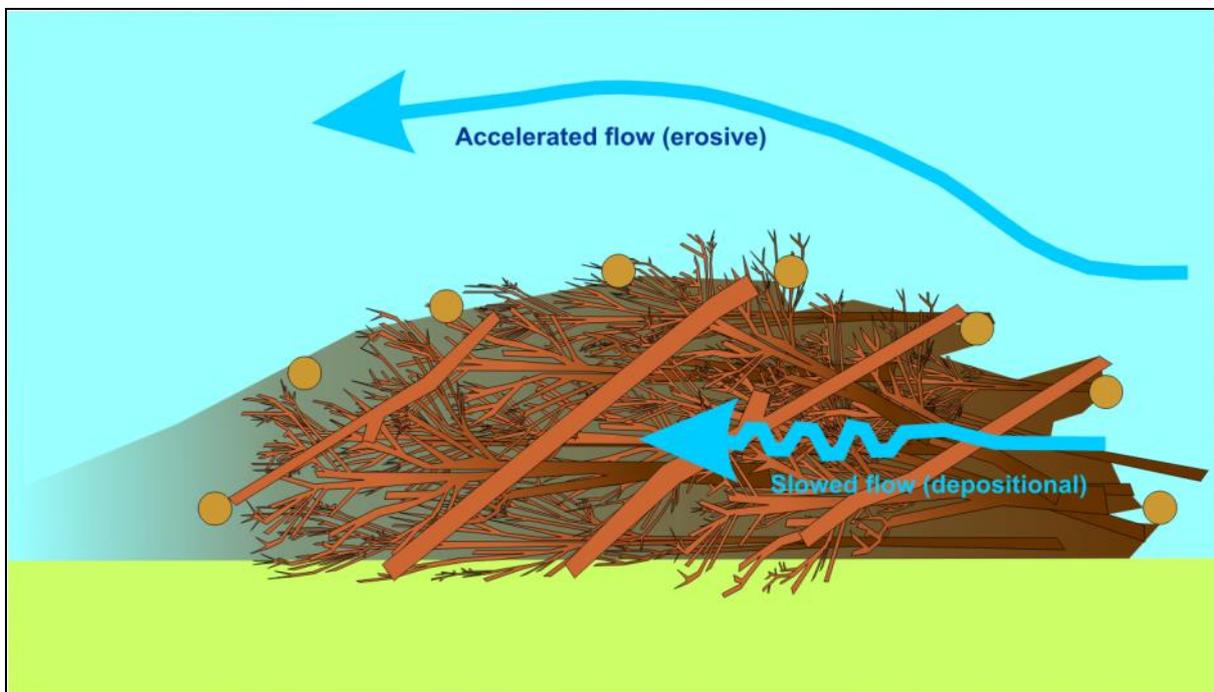
Figure 11: An illustration of how brushwood berm structures can help manage in-stream fine sediment
