Advisory Visit
River Rea, Shropshire
February 2015

1.0 Introduction

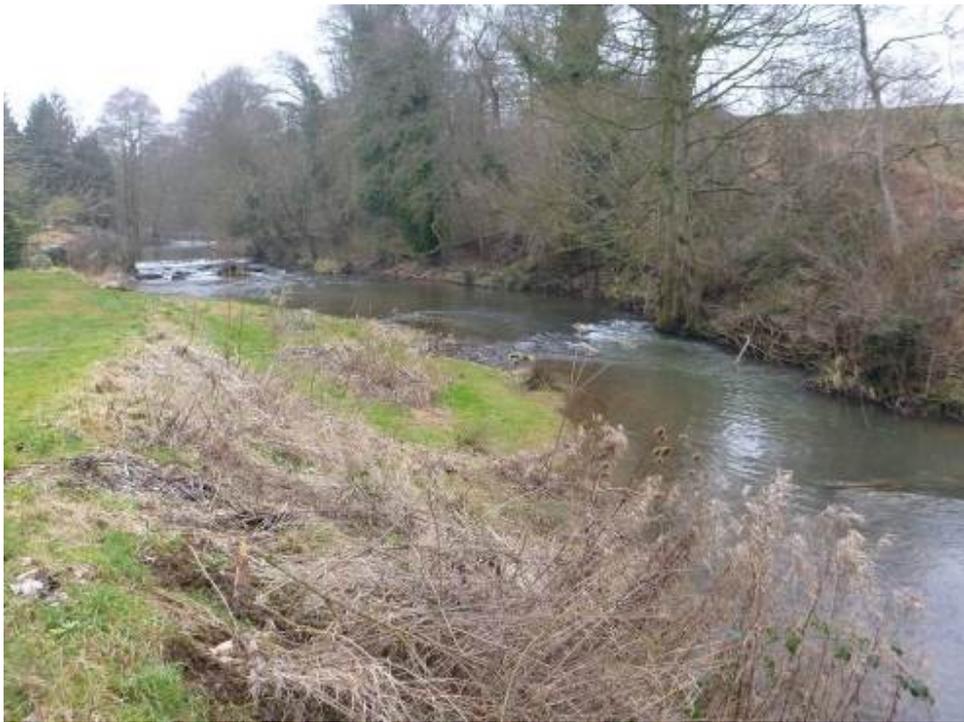
Photo 1 Pinkham Mill area.

The weir at Pinkham Mill is much reduced in height from historic levels, now around being around 40cm (Photo 1). This represents a barrier to the migration of smaller trout and other species; although it is likely to be quickly drowned out at higher water, lowering the central portion of the weir crest would increase the opportunity for free fish passage. There is minimal impoundment upstream of the weir given the relatively steep gradient of the Rea. The weir is recognised as an obstacle to migration by SRT which is currently focussing on higher priority barriers downstream, such as Lower Forge weir.

- Notch the weir at Pinkham Mill and consider altering the fishing weirs along this beat to reduce the upstream impounding effects.
- Control Himalayan balsam by hand-pulling prior to flowering in early summer

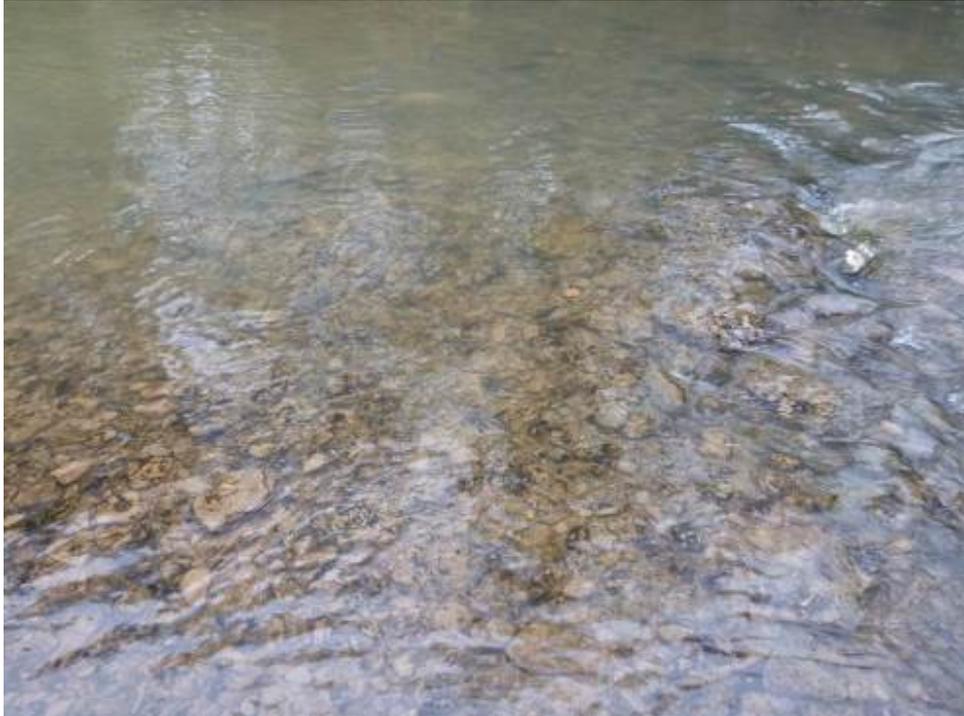
Photo 2 Fine sediment accumulation amongst the larger gravel and stones.

It is evident throughout the reaches inspected that fine sediment ingress and accumulation is a problem on the Rea (Photo 2 and other pictures), as recognised in the Water Framework Classification noted above. High levels of fine sediment reduces the survival of trout eggs which spend the winter buried in gravel 'nests' (redds). If the gaps between the gravel particles are

filled with fine sediment, the flow of fresh water over the eggs is reduced and they can suffocate. Increased levels of fine sediment can also impact upon invertebrate diversity. The high levels of fine sediment are associated with the geology of the area (sandstone) and intensive farming. This is recognised with the wider Teme catchment being a priority under the Catchment Sensitive Farming Delivery Initiative and the work being done by SRT with farmers.

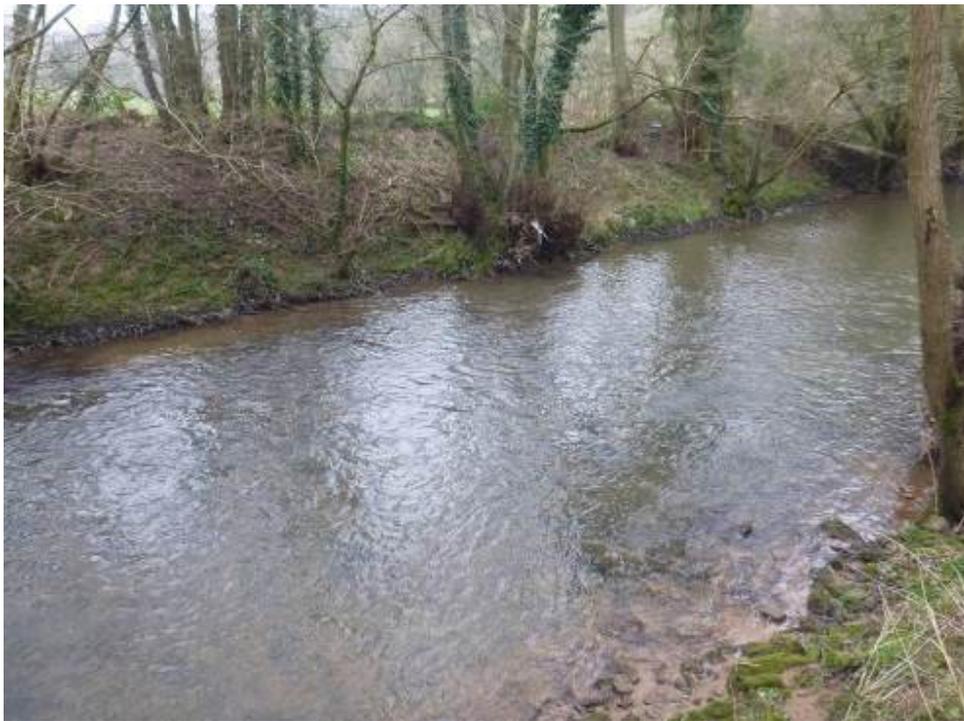
Photo 3 Just downstream of Pinkham Mill – a good area for hinging some trees to create marginal cover

and there is ample opportunity for hinging and laying smaller trees into the margins of the river to provide valuable cover for juvenile trout; this has been shown to greatly increase juvenile survival rates. Areas where such as Photo 3 where there is little marginal cover are ideal for this. See Recommendations for more details.

- Continue with the riverfly monitoring – support and advice is available at www.riverflies.org
- Hinge trees into the margins of the river to provide valuable cover for juvenile trout and greatly increase their survival chances (Photos 16, 17). This technique is the same as hedge-laying, using trees up to about 15cm diameter; species such as alder, hazel and willow are ideal and it can be easily carried out on working parties. The ideal locations are shallow (ankle to mid-thigh depth) marginal areas where there is a constant flow at all water levels.

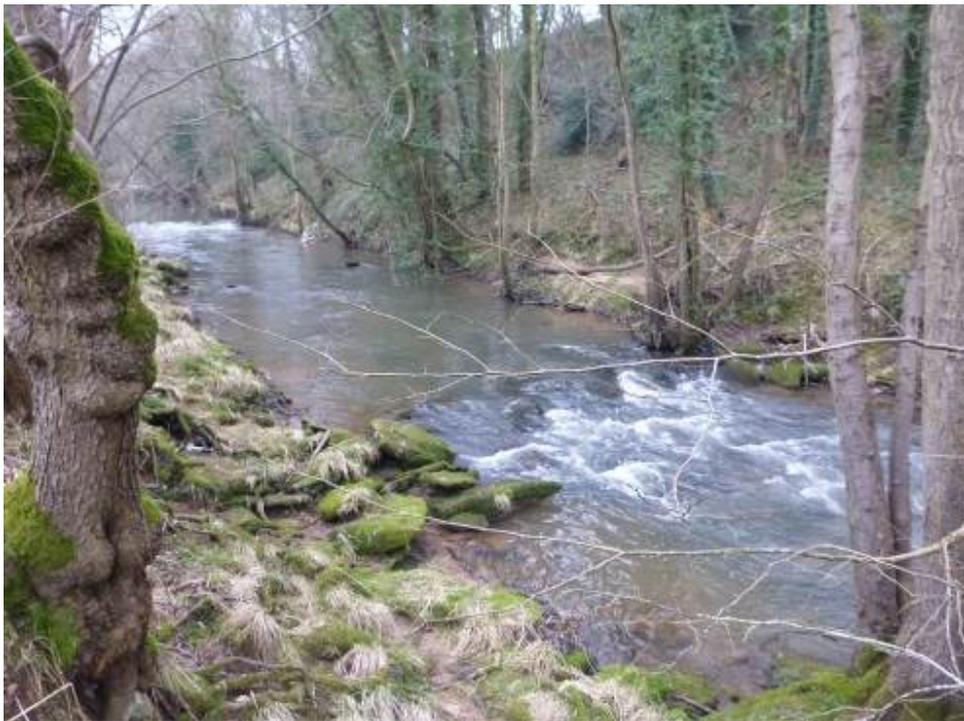
Photo 5 Fishing weirs

There are a number of low fishing weirs along this beat which were constructed by the club shortly after the water was acquired in 1979 (Photo 5). The weirs were made with large rocks from the river bed rather than imported material. The construction of such weirs is not recommended because they impound water upstream and can lead to the accumulation of coarse sediment (gravel, cobbles), negating the increase depth gained in the short-term by building the weir. In this case, the impounding effect is minor because of the steep gradient of the channel, but re-arranging some of the stones to reduce the impoundment is recommended.

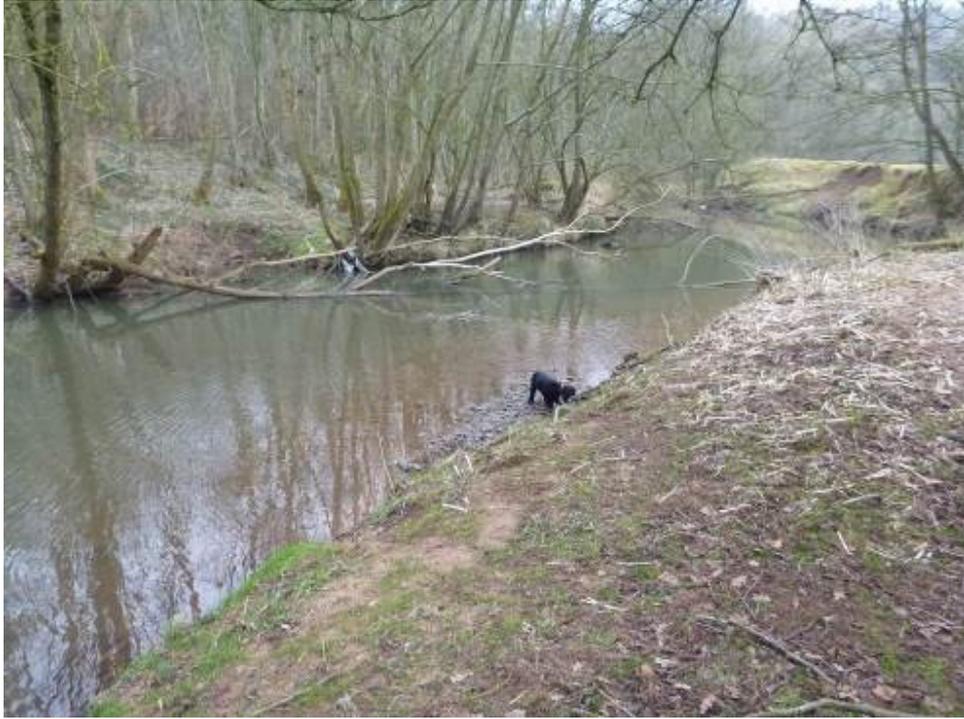
Photo 6 Slower flowing section

A much greater impounding effect is evident at the lower end of the beat where the character of the river changes markedly, becoming much slower flowing (Photo 6). This is because of what appears to be a natural bedrock outcrop just beyond the lower boundary of the beat. There is evidence of historic, man-made modification to this impoundment but this does not appear to have raised the height of the natural feature.

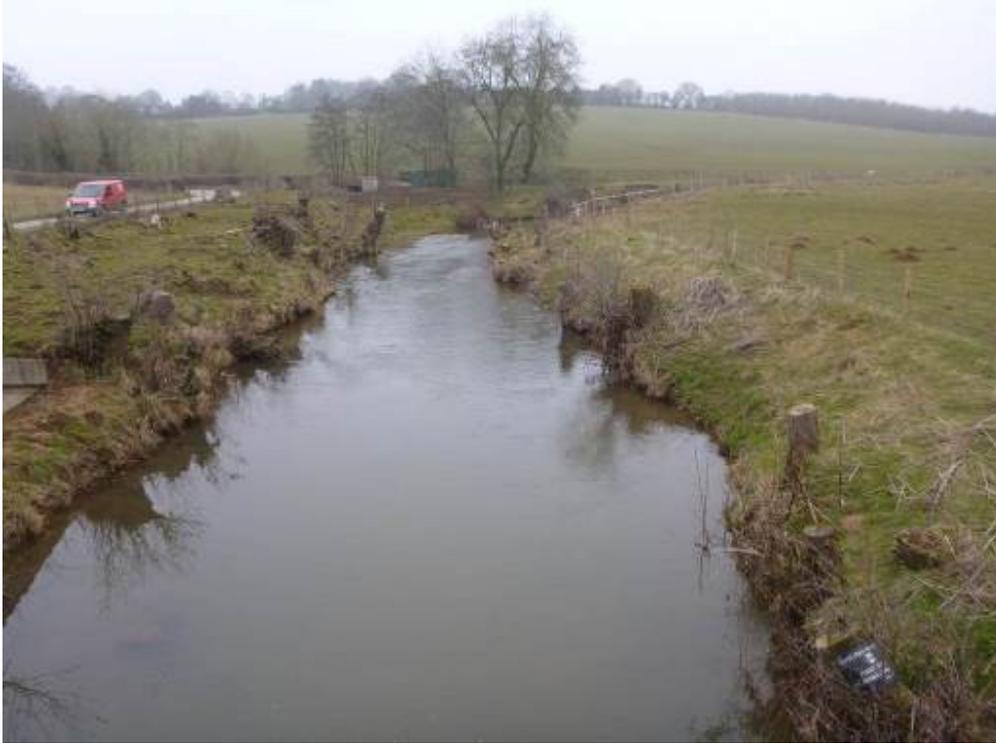
The Detton beat is about 5km upstream of the Pinkham Mill beat. Upstream of the road bridge at Detton the riparian tree cover was completely coppiced by the landowner the previous year (Photo 9). Coppicing riverside trees can be a useful technique for prolonging the life of ageing trees and retaining rootmass and bank stability. However, rather than cutting down all the trees in one go, a better approach is to employ a rotational coppice taking down between one-in-five and one-in-ten trees each year. The re-growth will then provide a range of different tree heights and valuable diversity of habitats, such as low cover over the water and higher shading from the canopy. Leaving any dead wood standing is also good practice for providing a diversity of invertebrates for woodpeckers and other birds. The coppiced trees need to be fenced from grazing to allow re-growth (which appears to be the case here).

Photo 8 Upstream of Detton Bridge, where trees have been coppiced

- Liaise with the relevant landowner over adopting best practice in coppicing of trees. A guide is provided in the Appendix.
- Support catchment-wide initiatives such as Catchment Sensitive Farming and Severn Rivers Trust work to reduce the impact of diffuse-source pollution on the river.

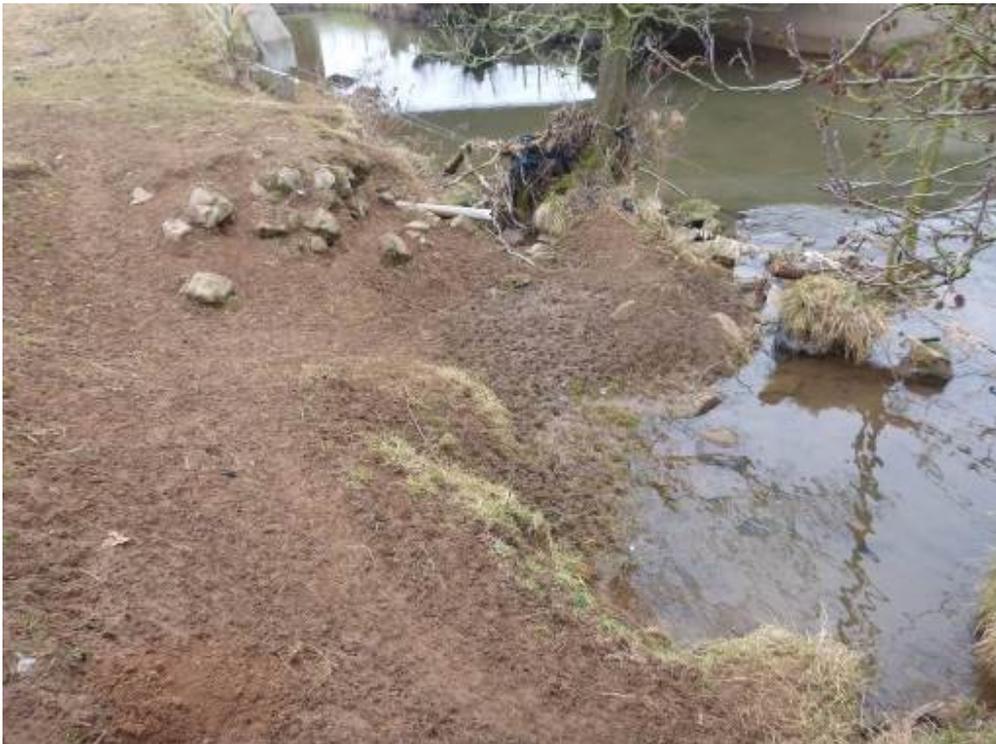
Just downstream of the bridge on the right bank, there is an access point to the river for sheep in the adjacent field which has become severely poached and a source of fine sediment input to the river (Photo 10). Ideally a hard-standing drinking area or fencing and an alternative water source should be provided here (possibly with help from the Catchment Sensitive Farming Initiative).

Photo 9 Drinking point for sheep in the field adjacent to Detton Bridge is a source of fine sediment pollution.

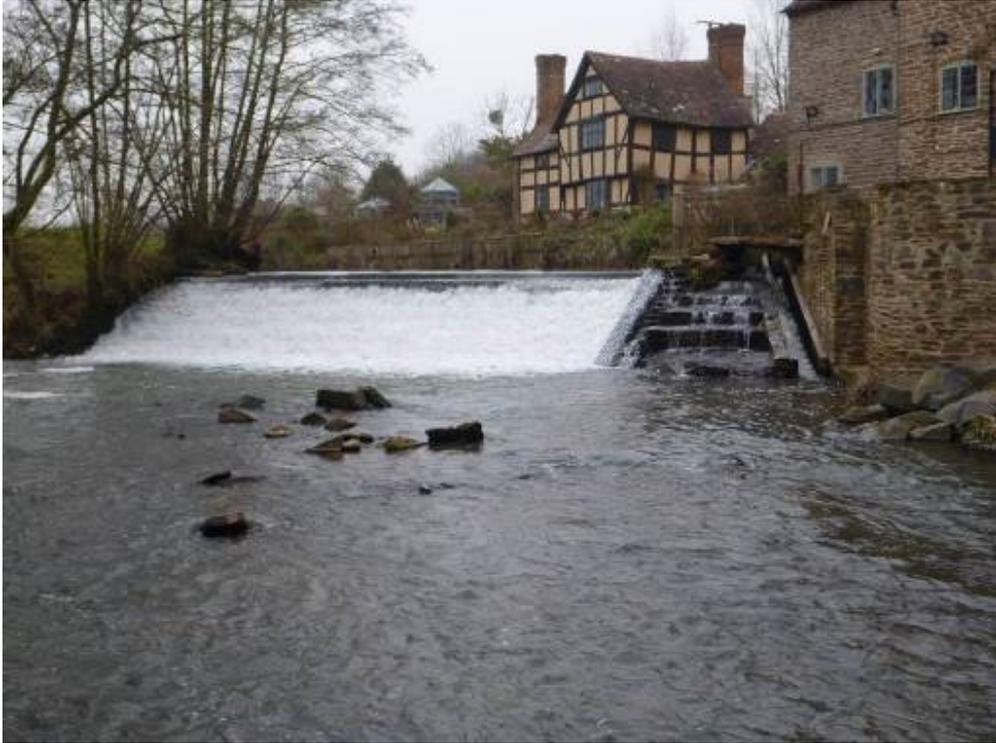
A short distance downstream of the bridge, the river is impounded above Detton Mill weir. The mill is no longer in operation and is a private residence and the weir has a head loss of about 2 metres (Photo 11). Severn Rivers Trust built a fish and eel pass here recently, the fish pass being an Alaskan steep-pass located against the left bank and the eel pass being stippled plastic tiles on the face of the weir. At the time of the visit, the flow through the fish pass was low, providing poor attraction to the downstream entrance. This may have been due to partial blockage by debris, but the reason should be investigated and addressed to ensure efficient attraction flow at all times.

Photo 10 Detton Mill weir with an Alaskan fish pass (right of picture) and eel pass (right of white water). There was very little attraction flow from the fish pass at the time of the visit.

- Investigate the fish pass at Detton Mill to check for a blockage and whether there is enough flow to provide sufficient attraction for migrating fish. If a blockage is the cause, make sure an effective maintenance regime is in place.

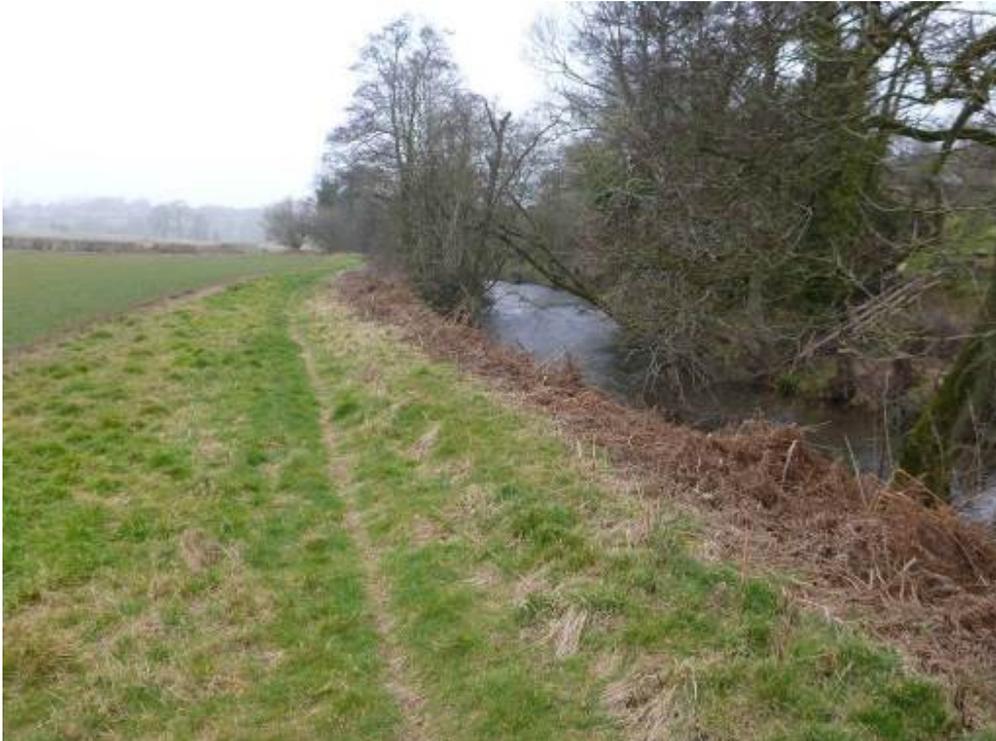
Photo 11 A wide buffer strip between the river and fields downstream of Detton Mill – good practice reflecting the Higher Level Stewardship agreement on this land.

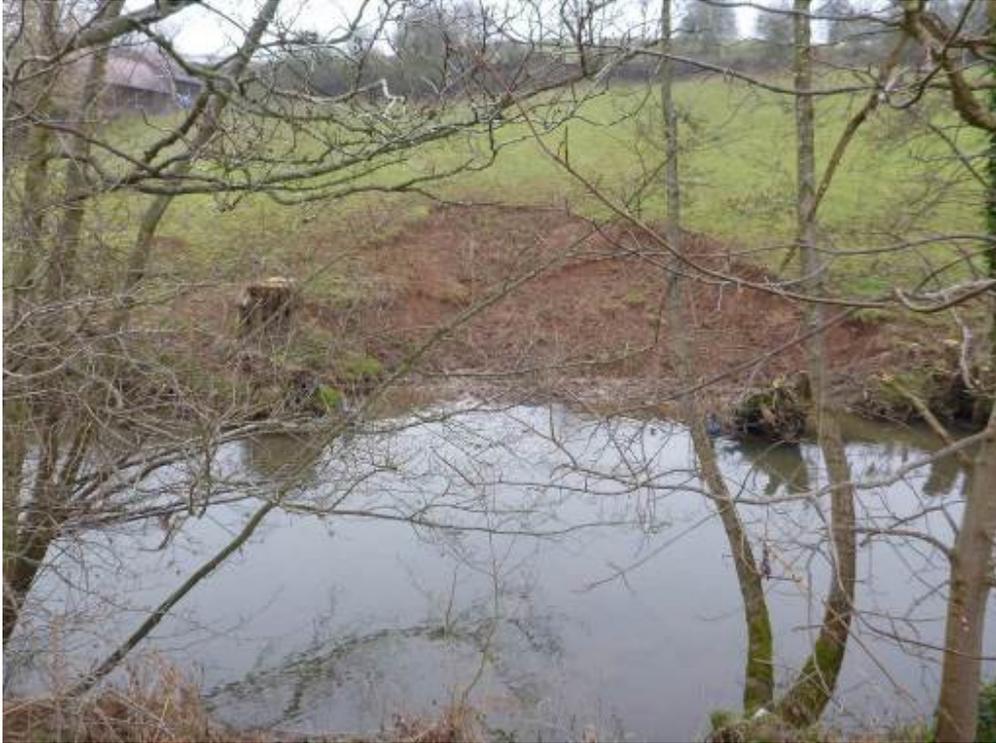
Photo 12 In contrast on the opposite bank, tree removal and heavy livestock trampling causing excessive fine sediment ingress.

Downstream of Detton Mill, there is some good in-stream habitat (Photos 12, 14) with varied depths, flow patterns and sediment sizes, good tree cover and stable banks. Riparian land use is buffered from the river by wide grass margins and wooded river banks. One area of concern was a left-bank field where riverside trees had all been coppiced and livestock access was causing a fine sediment input (Photo 13). A little further downstream towards Tittford Bridge, the field margins on the right bank were much narrower (Photo 15) and soil erosion and runoff was evident.

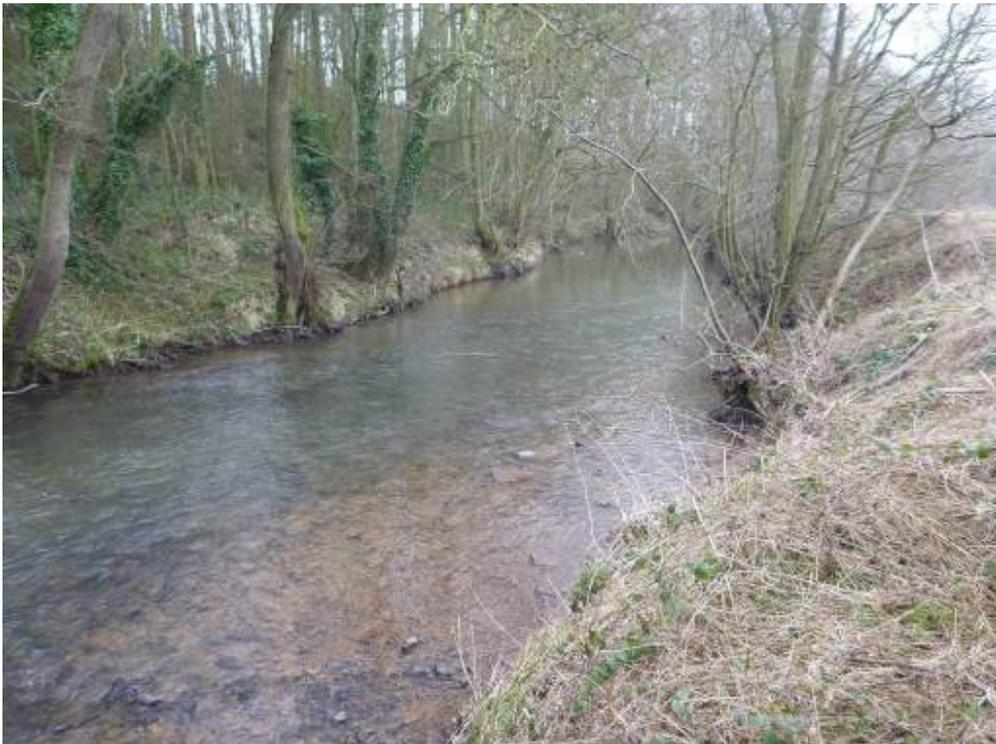
Photo 13 Typical section of the Rea downstream of Detton Mill – good habitat.

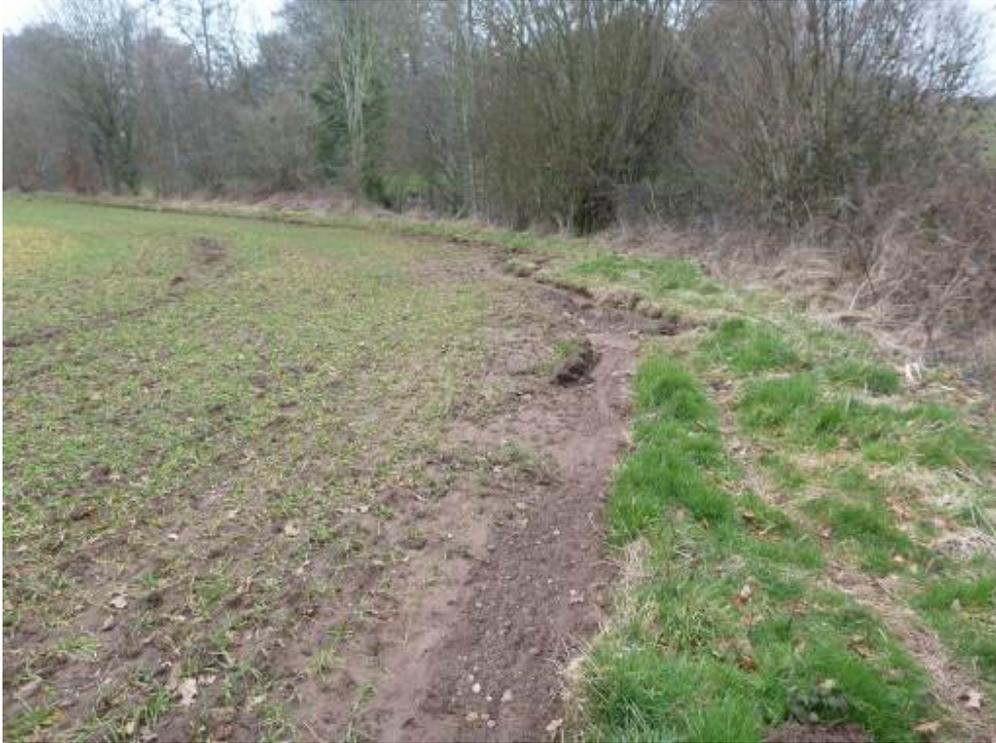
Photo 14 Near Titford Bridge, the buffer between fields and river is much smaller with run-off pathways for fine sediment evident.

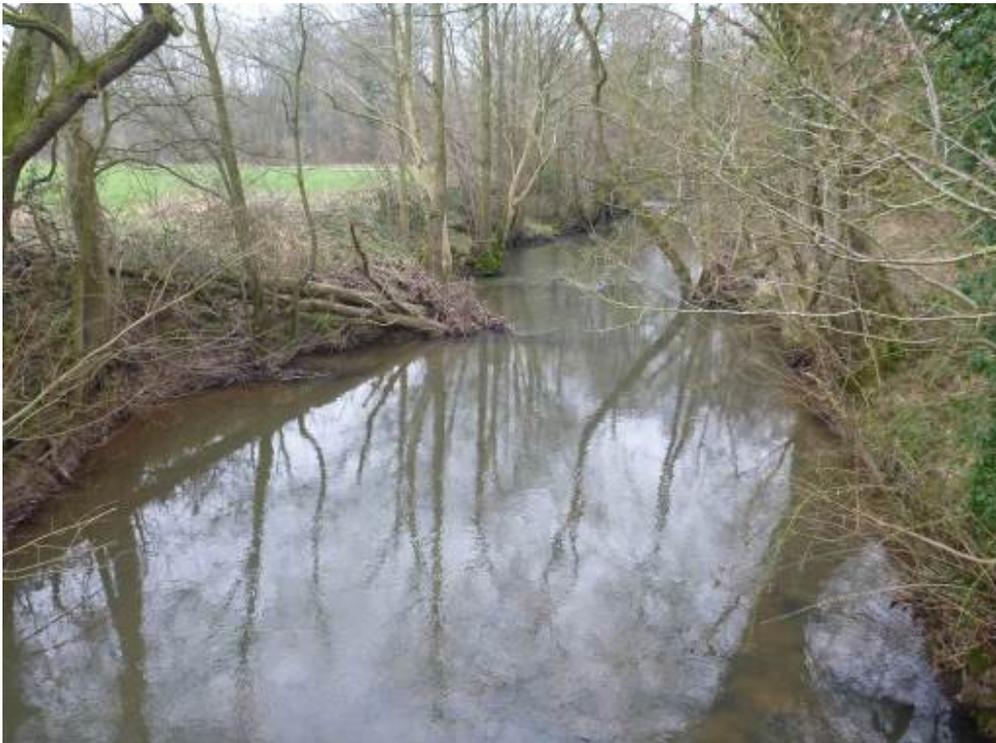
Photo 15 Large woody debris provides good in-stream habitat and should be retained.

Fallen trees in the river were present in a number of locations (Photo 16). As noted above, these are beneficial for river habitat and should be retained wherever possible. There are many areas where trees could be hinged and laid into the river to provide valuable low-level cover (see Recommendations).

- Retain large woody debris (LWD) in the river channel wherever possible. To achieve this liaison with landowners and the Environment Agency internal workforce may be required (if either of these routinely remove fallen timber). A useful guide for managing LWD can be found here:
http://www.wildtrout.org/sites/default/files/library/Woody_Debris_Apr_2012_WEB.pdf

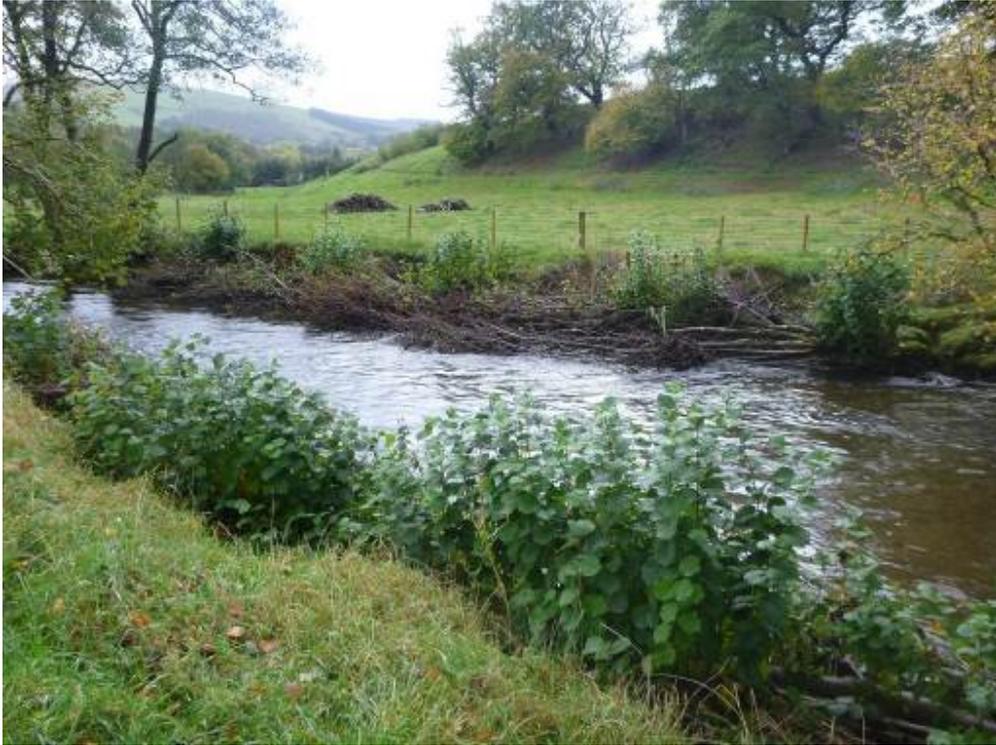
Photo 16 Young alders partially cut and laid into the margins to provide fantastic juvenile trout habitat

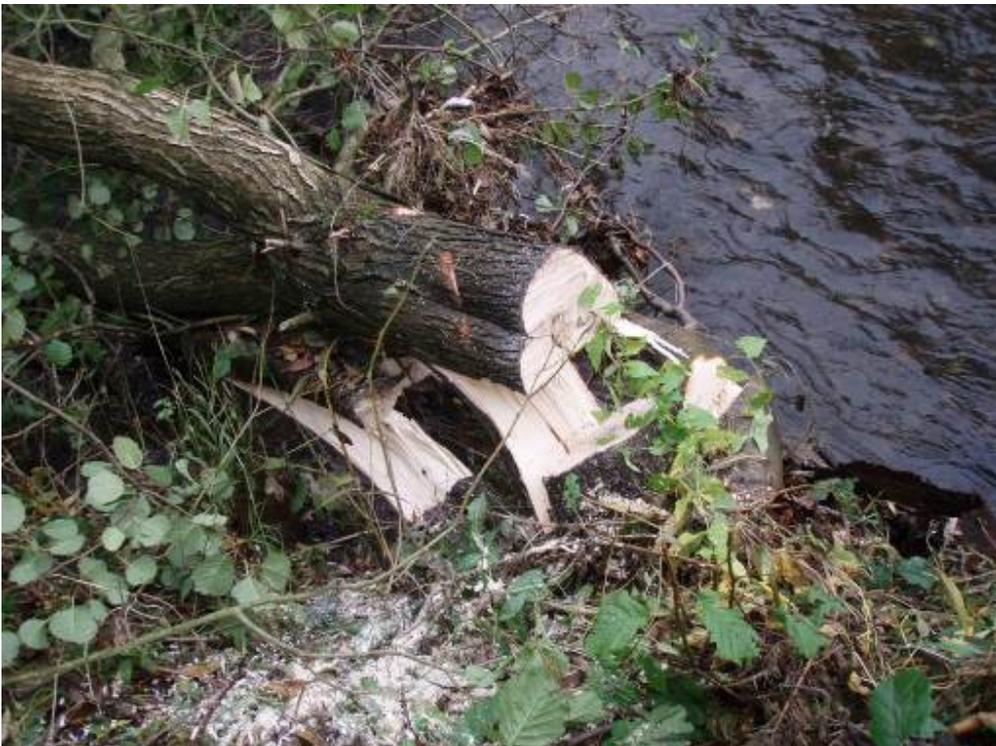
Photo 17 Partial cut and laying technique detail
