**Advisory Visit for Lancashire Fly Fishing Association**

**Rivers Ribble and Hodder**

**April 16<sup>th</sup> 2013**

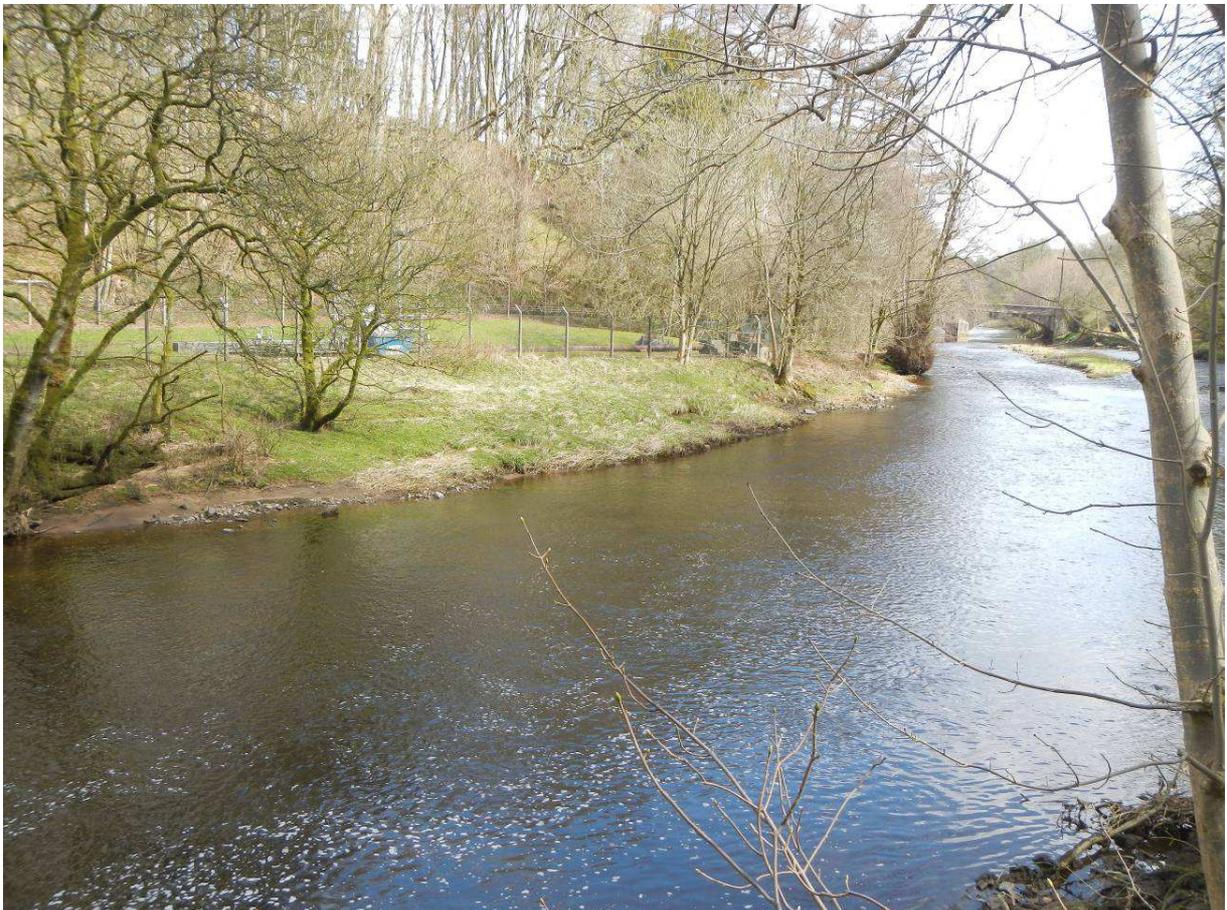
The Ribble around Gisburn is a medium sized (c.15-20m wide) river, flowing within a steep gradient valley and narrow floodplain. This generates high flow velocities and results in a relatively straight watercourse, generally lacking in sharp meander bends (Figure 1). This results in an elongated pool and riffle sequence, typical of many upland rivers, characterised by long straight pools, of a much shallower depth in relation to river size than more sharply meandering, low gradient watercourses. This is due to flows being more evenly distributed across the channel width, rather than focused in specific areas where localised scouring would create deeper pools (e.g. deeper outside of bends).

**Figure 1. Gradually meandering river course, typical of many higher gradient upland rivers.**

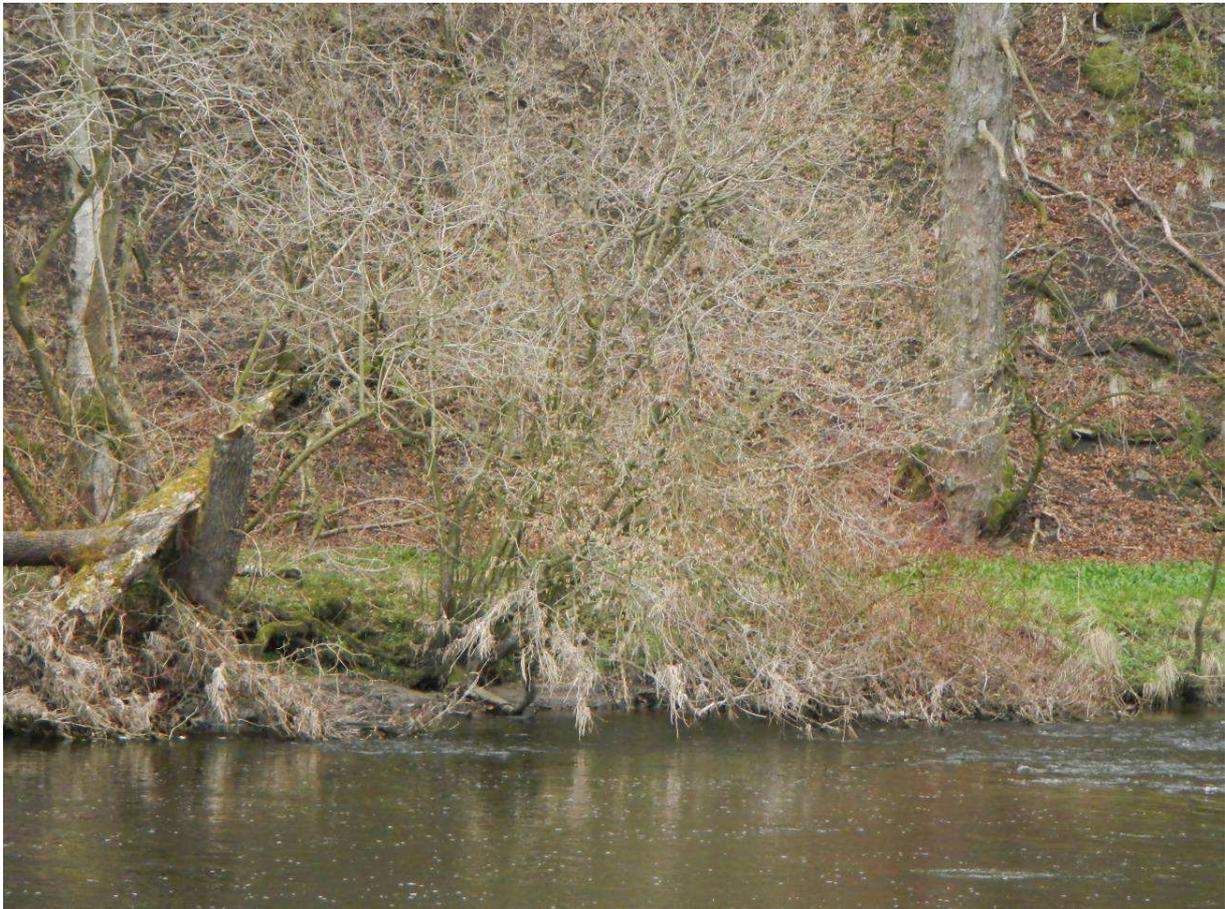
and trailing into the watercourse, as Figure 2) are vital for enhancing trout habitat and it is imperative that they be retained to optimise the carrying capacity of the river (number of fish the river can support).

**Figure 2. Valuable low-level and trailing cover. Over deeper water this greatly enhanced the ability of areas to hold adult fish and over shallow areas it can provide protection from flows and predation for juveniles. The value of this type of cover can be improved further by laying some branches into the water.**

It would be highly beneficial to encourage more low-level growth of this type by selective coppicing of suitable bank side trees (willows *Salix spp*, alder *Alnus glutinosa*, hazel *Corylus avellana*, elm *Ulmus minor* and sycamore *Acer pseudoplatanus*), along with laying (as you would lay hawthorn for a hedge) willow, hazel and elm down into the channel, to encourage low level growth (particularly where the canopy has been lifted through pruning).

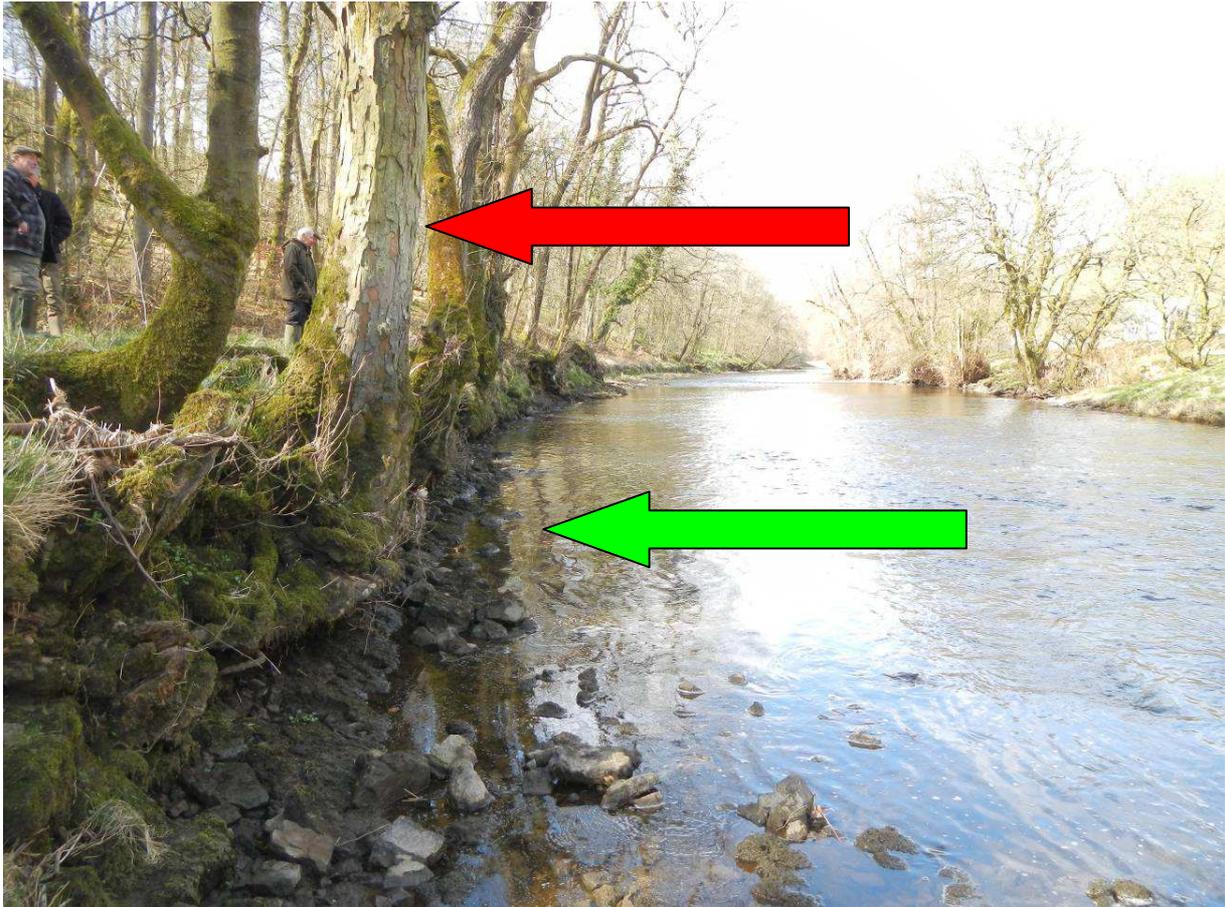
Pruning of riverside trees and removal of trailing and fallen trees/branches is often undertaken on fisheries with the best of intentions, particularly where easy casting access is wanted for salmon and sea trout fishing (Figure 3). However, removal of these features is ultimately detrimental to angling. It reduces the number of fish that the river can support, making trout more heavily reliant upon other in-channel features, and potentially even putting them into more direct competition with salmon (particularly juveniles) for the remaining habitat. As such, it is strongly recommended that pruning of low level and trailing tree branches on club waters ceases.

**Figure 3. Lower level branches have been removed (red arrow), leaving a complete lack of low level or trailing cover in the vital area (green arrow). This was the case in many areas. To an extent, this also occurs naturally, as lower branches are broken during floods or sloughed in favour of higher branches, which makes it even more vital to retain and enhance low cover habitat.**

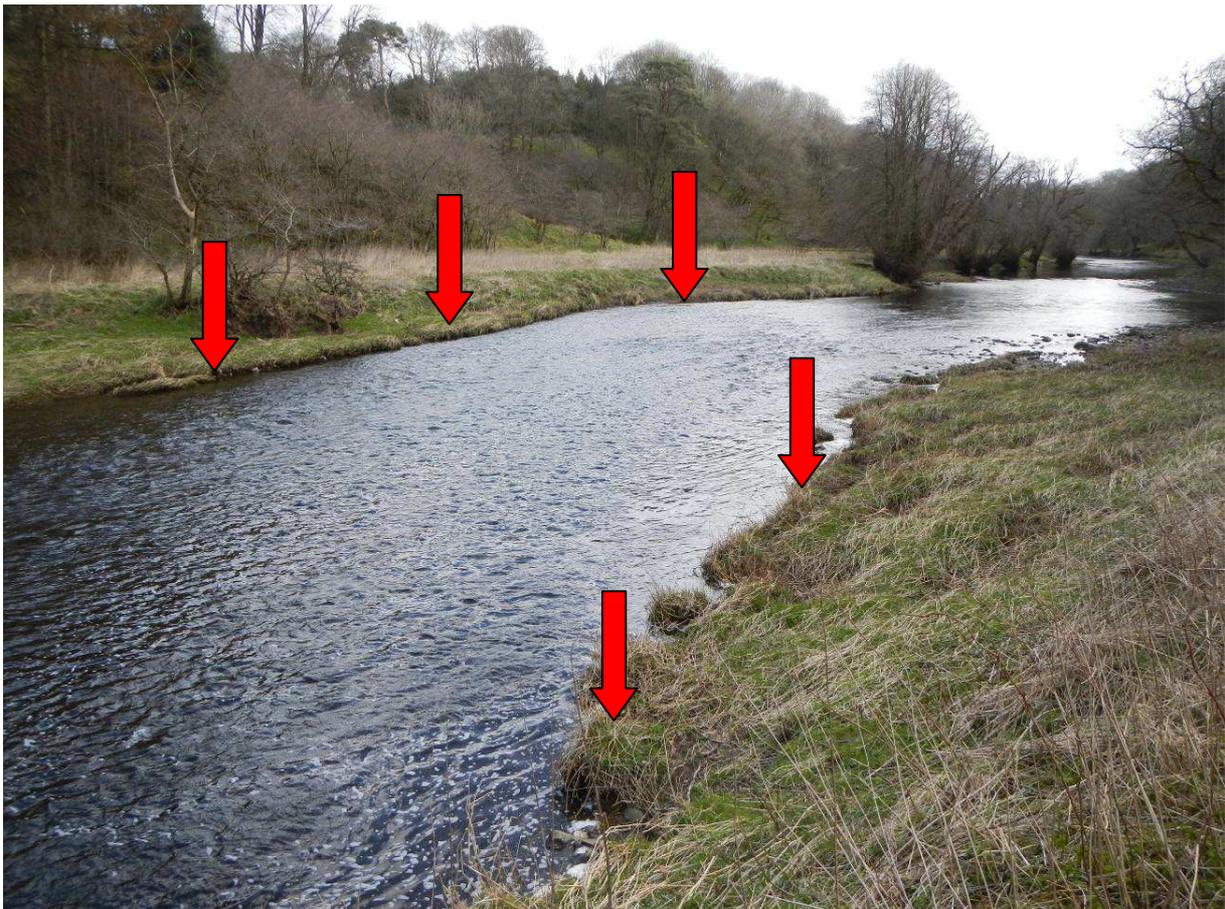
**Figure 4. Open river banks where planting of trees, or more easily, willow whips and bundles could offer greatly enhanced habitat quality and fish holding potential. Potential planting locations indicated in red. These would ideally be small clumps of two or tree whips planted at uneven intervals.**

Wherever stock are excluded from the river bank, planting of trees/shrubs to increase the availability of cover would be highly beneficial. Planting of saplings at low level along the bank, or planting of willow whips at the average water line presents a great way of rapidly increasing cover while protecting the river bank (Figure 4; also see recommendations for further locations). Equally, bundles of living willow brash can be staked along the water line, ideally partially submerged. These methods would be beneficial in any areas lacking cover and particularly where willow is used, can provide trees to lay over into the channel once they become established.

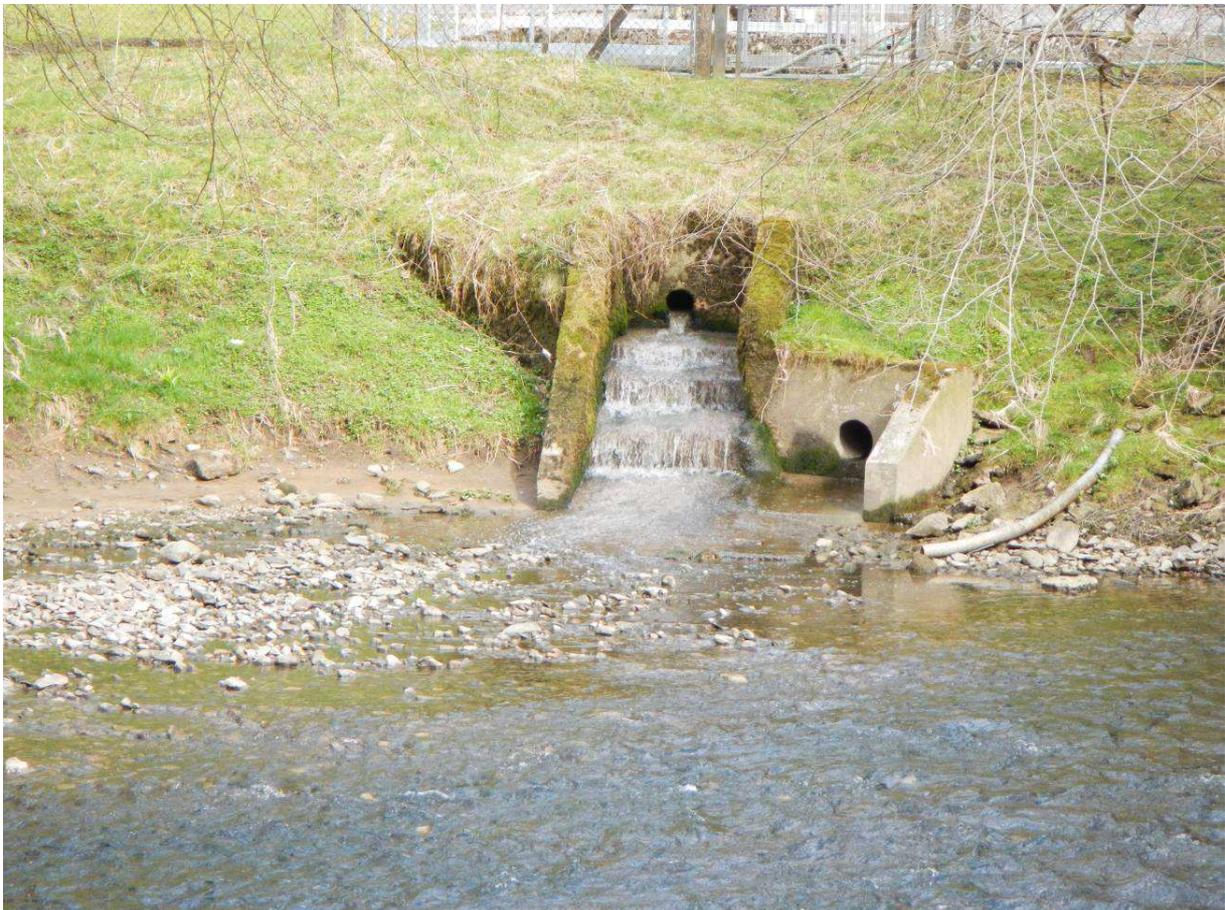
Two potential water quality issues were observed within this section; the first was Stock Beck, which has been identified by the EA as having issues with phosphate and having poorer invertebrate and fish communities than would be expected. The second issue was the discharge from the sewage works (Figure 5), which by its grey colouration and presence of sewage fungus, appeared to still contain a high nutrient level. Any issue created by this discharge is likely to be exacerbated by the fact it is discharging into slack water along the LB margin, where there is little mixing and dilution from main river flow. The effect of this discharge is visible for some distance downstream and has the potential for a significant negative impact upon water quality (esp. oxygen content), particularly in warm dry periods.

**Figure 5. Sewage works discharge. Note the grey discharge water and sewage fungus on the cascade.**

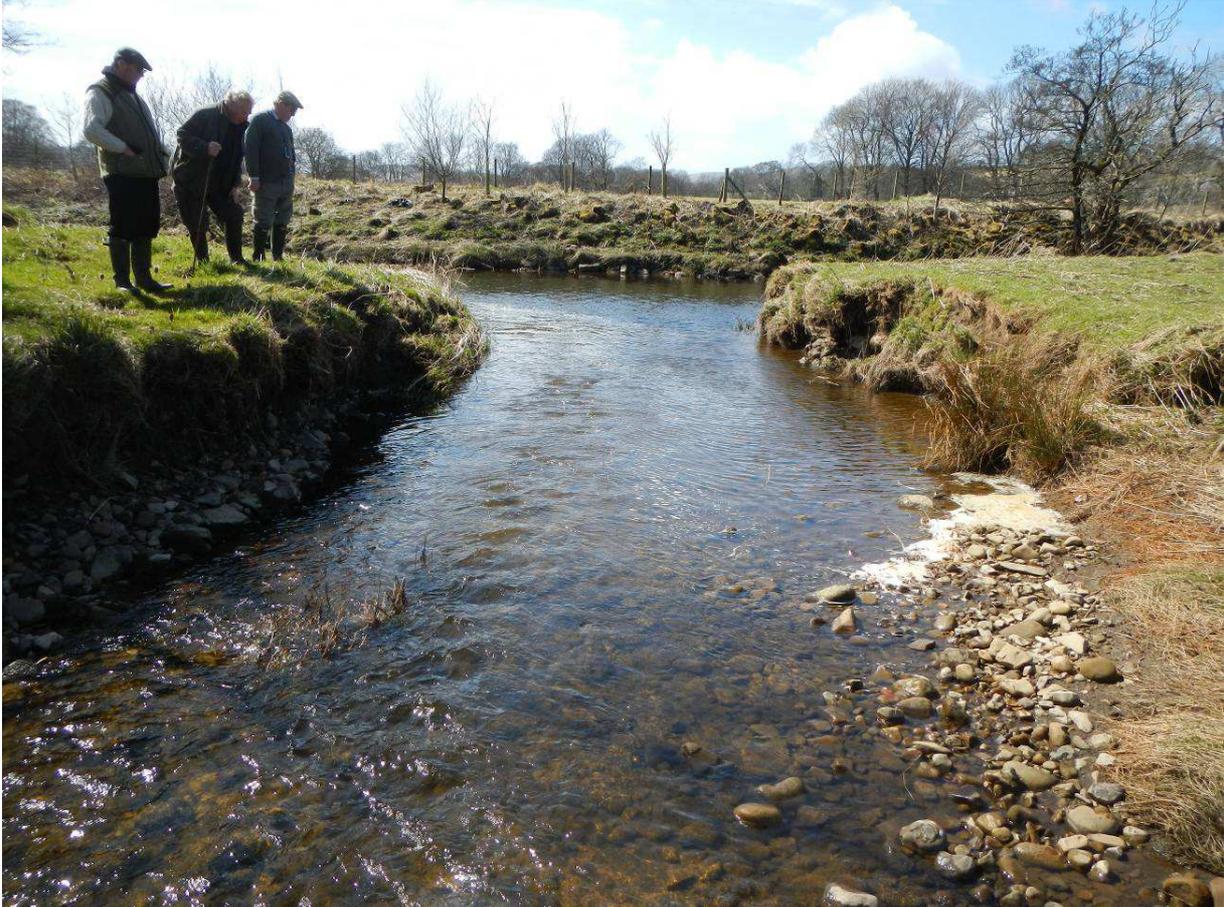
**Figure 6. Confluence of the Easington Brook and River Hodder. Planting of bank side trees here, to trail into the water and provide cover and structure in the channel is likely to increase the survival of juvenile fish emigrating from the brook.**

The Ribble Rivers Trust has also undertaken work to improve habitat on the Easington Brook. Again, any support possible from the club should be offered to such initiatives, now and in the future, to optimise the environmental gains that can be achieved. To complement the work on this tributary, planting of willow around the confluence of the Brook and the River Hodder (Figure 6) would increase the cover and protection from predation for fry and juvenile fish as they leave the brook. This will in turn increase their chances of survival, optimising the Brook's contribution to fish stocks, and would therefore be a particularly beneficial action for the club to take.

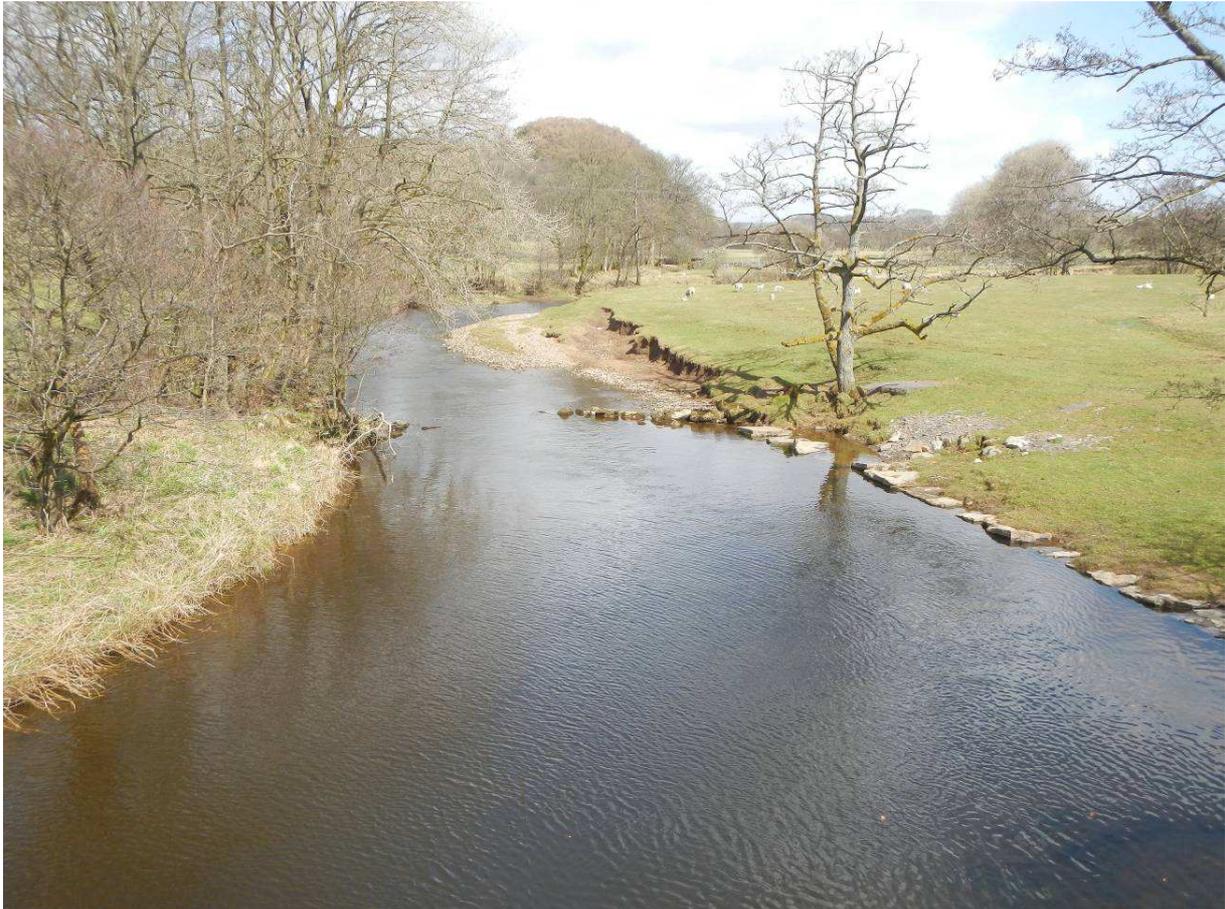
In stark contrast to the Ribble, there was a significant issue with overgrazing by sheep on the Hodder (Figure 7), starting in the field above Newton Bridge and continuing downstream. The grass has been grazed almost to bare earth in many places and although it has been a slow start to the spring, which will have limited the availability of grass this year, the significant scarring to the river banks, lack of herbaceous vegetation and shrubs and excessive erosion, even on the inside of bends and straight sections of river bank indicates a history of overgrazing.

**Figure 7. Obvious signs of overgrazing in the field upstream of Newton Bridge, as shown by lack of grass and trees, and erosion, even on the inside of a bend.**

not only to river habitats and fisheries, but also to landowners and farmers, as retention of trees and vegetation protects riverbanks, greatly reducing the rate erosion and loss of land. It is therefore highly recommended that discussions are held with the landowner/farmer to convey these issues, with a strong drive towards obtaining permission that buffer fencing be allowed. If possible, this would also allow planting of additional trees to stabilise the riverbank and provide cover, away from livestock. The Ribble Rivers Trust may also be able to provide support and assistance with the task.

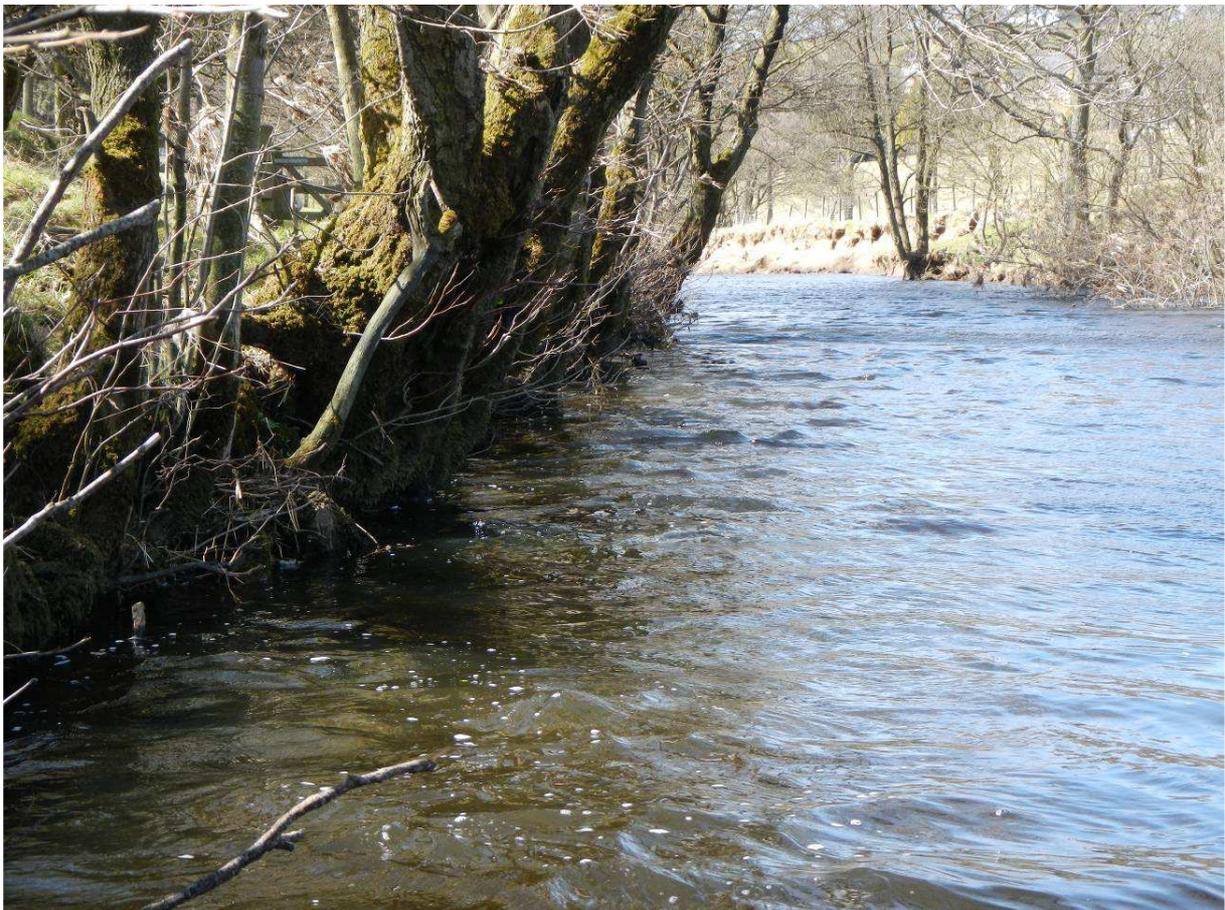
**Figure 7. Upstream of Newton Bridge on the Hodder, where low level branches have been removed, lifting the tree canopy well above the optimum height for trout habitat and optimal fish holding capacity.**

As on the Ribble, in many areas, the low hanging tree branches have been removed, and it is highly recommended that this practice is ceased. Selective coppicing of suitable bank side tree species, along with laying (willow, hazel and elm) would help to promote low level re-growth through new branches.

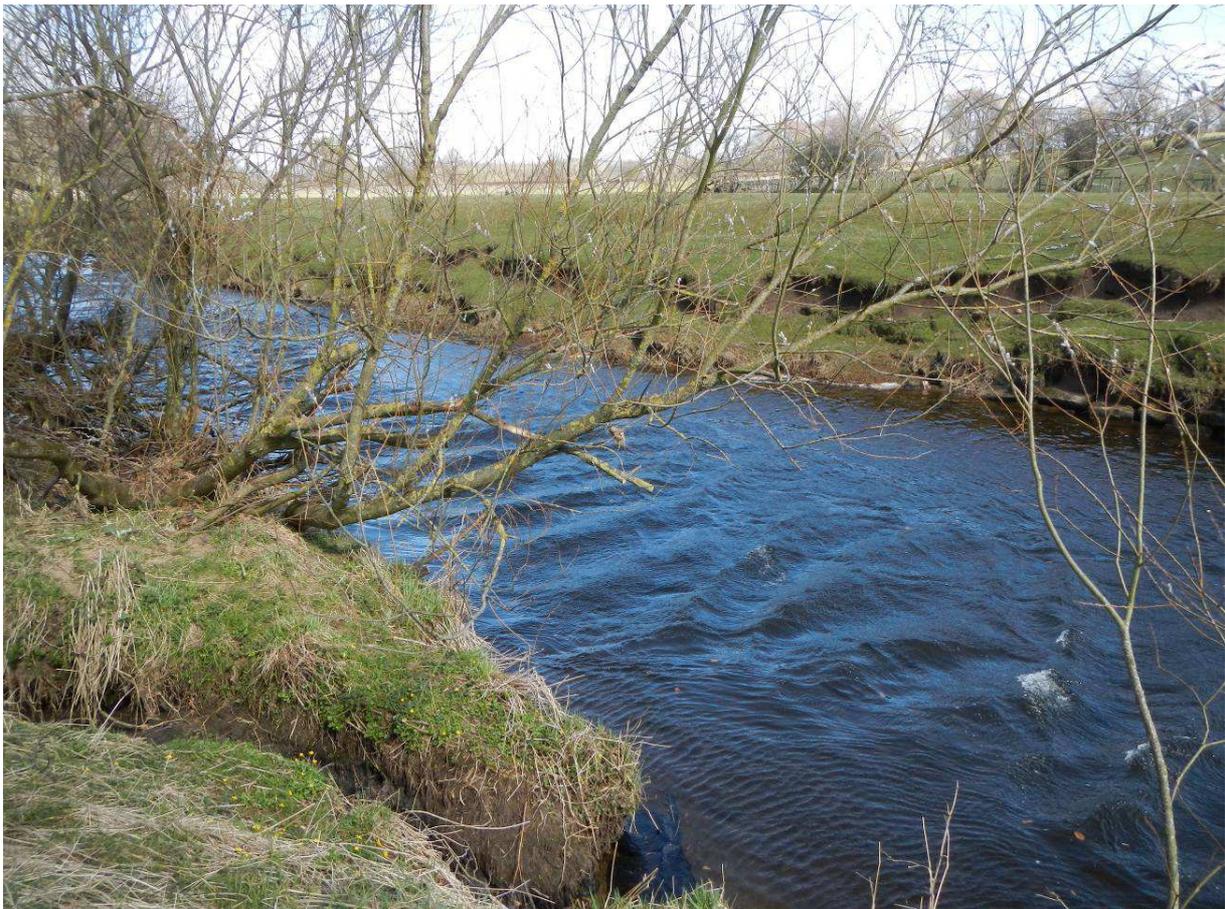
Some areas of higher quality habitat were available in the section downstream of Newton Bridge, primarily where willow and alder trees were present, providing cover and shelter amongst their roots and trailing limbs. Beneficial planting by LFFA members has also helped to enhance this habitat, providing additional cover in several places. However, evidence of detrimental pruning of the willow trees was also observed on the RB (Figure 8). Regardless of whether this was undertaken by the farmer or angling club members, discussion with the responsible party and education of the negative impacts of removing cover would be highly beneficial.

**Figure 8. River bank willow trees that have been recently pruned. The upstream end of these trees provide good cover through roots and branches, but recent pruning has degraded the quality of habitat they provide.**

Additional planting would be highly beneficial, and while this can be undertaken along the water line, keeping the saplings as far away from livestock as possible to reduce their impact, the buffer fencing described previously will be vital to long term success of tree planting schemes and habitat enhancements, and ultimately, key to reducing bank erosion.

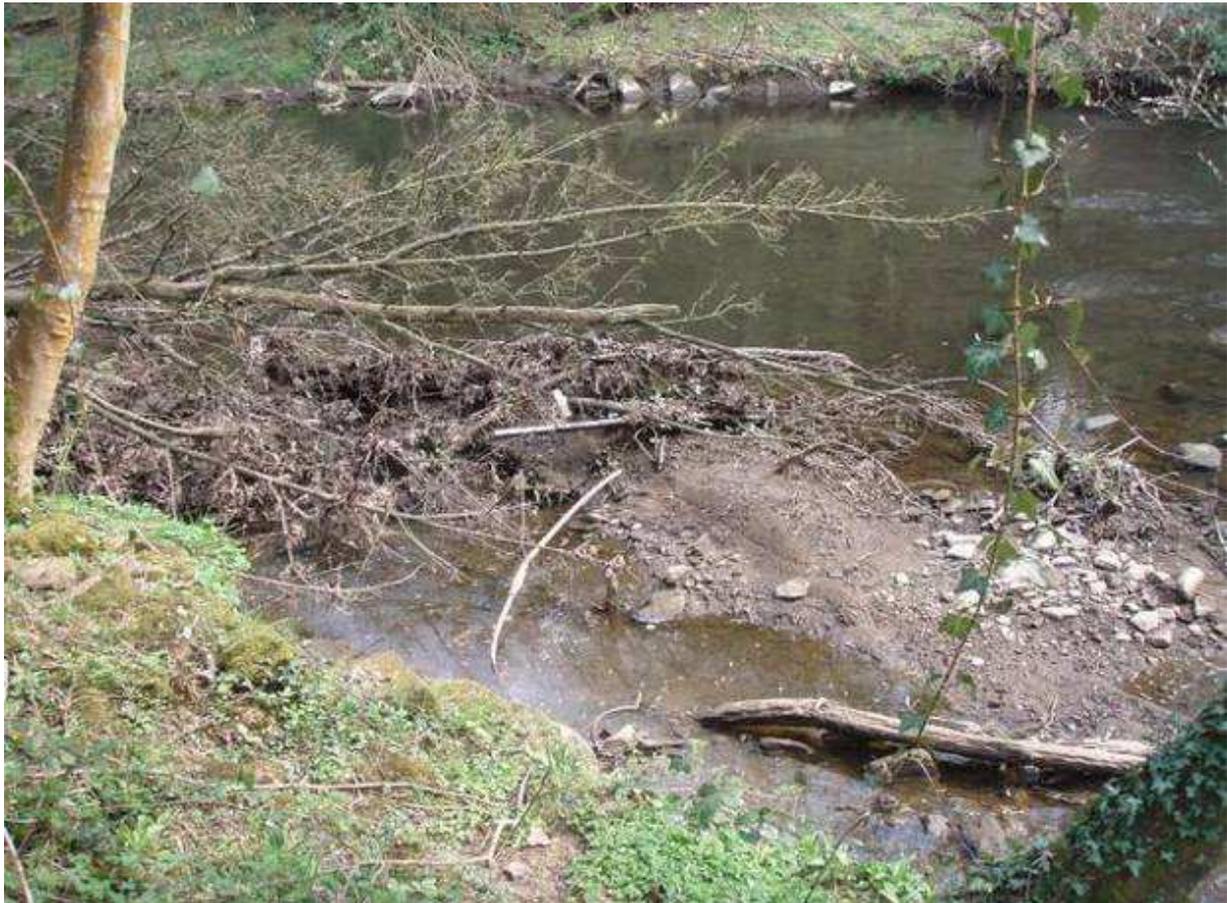
**Figure 9. Note the narrowing effect through significant gravel and sediment accumulation (centre and right of shot) in the sheltered area downstream of the tree kicker. This same area provides significant shelter for smaller fish in high flows.**

Tethering some of the felled trees and branches to their stumps, to create tree kickers (Figures 9 & 10) would also be beneficial. These would provide cover and shelter from flows for fish, while also increasing valuable flow diversity and creating areas within the river margins for sediment storage.
