Advisory Visit

River Aire

08/04/2015

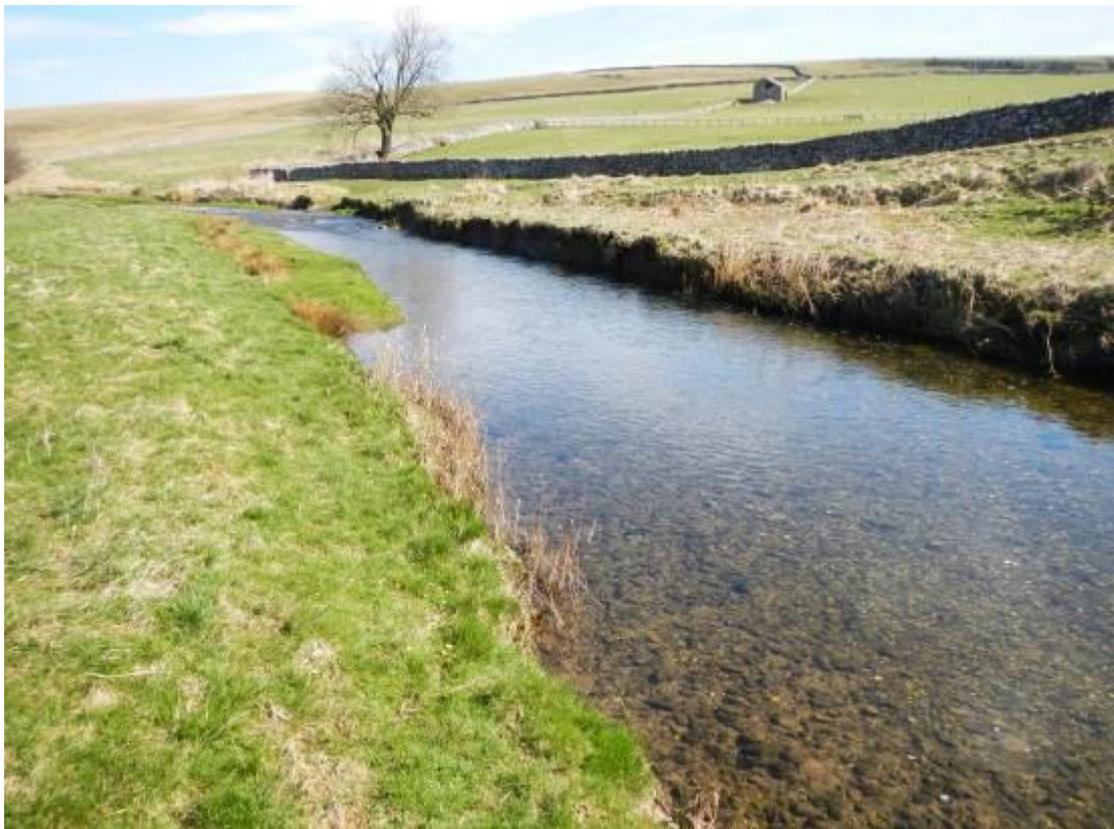
Figure 1. Looking upstream at a general lack of trees and herbaceous vegetation along grazed river banks. Even the more lightly grazed LB (right of shot) fails to support regeneration of trees/saplings and has a low diversity of riverbank plant species.

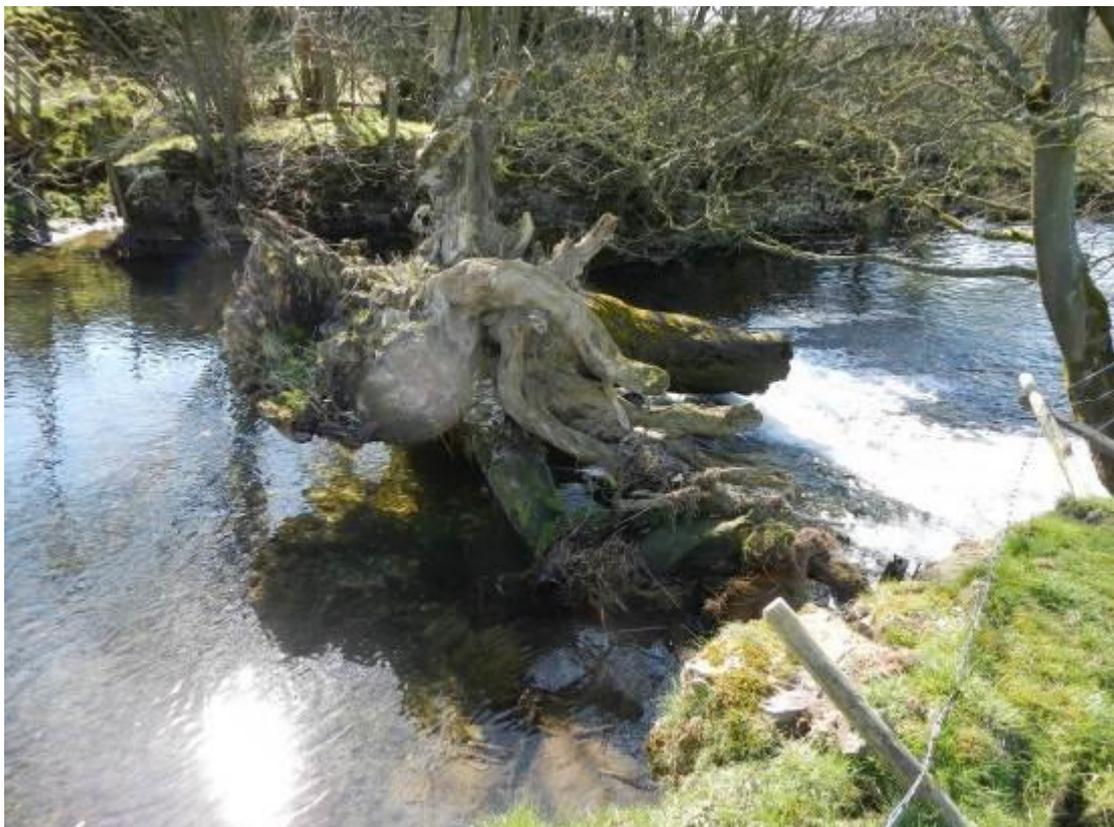
A medium sized weir (Figure 2) c.200m U/S of Mark House Lane creates a potentially serious impact upon the river, both in terms of compromising the natural geomorphology and by creating a barrier to fish passage. Upstream of the bridge, the walled, overly wide channel cross-section has already started to naturally adapt and narrow itself, but the impact upon sediment transport and channel gradient remain. Equally, the significant barrier to fish migration both U/S and D/S is likely to prevent optimal habitat utilisation and increase the susceptibility of fish stocks to predation around the structure because of the barrier adjoining deeper water with no

refuge. The location of the weir just U/S of the property on the LB also potentially places that property at a greater risk from flooding if the weir forces flows out of bank towards the property.

A large tree stump lodged on the weir demonstrates its potential to accumulate debris, which could also increase the risk of localised flooding. Rather than complete removal of the stump, it could be better employed as in-channel large woody debris (LWD) by securing it in place along the LB downstream. Erosion to the RB of the pool (Figure 3), where a tree has been washed out, and failure of the bank to naturally re-grade is another symptom of the livestock grazing. Had the bank been better vegetated, the slumped material would be more likely to remain in place as and stabilised, resulting in far less land loss.

Figure 2. Medium sized weir that poses an increased risk of fish predation in the impounded section, impacted geomorphology and, potentially, flooding of nearby property. The stump can be employed as valuable habitat along the LB downstream.

The two weirs noted during the visit both appear to now be redundant. This being the case, it is strongly advised that their removal is seriously investigated. The impact of these structures upon the natural function of the river is high, inhibiting natural sediment transport and causing an impoundment to flows. The barriers create ideal conditions U/S and D/S for predators to hunt fish in, locally increasing the impact of predation.

Weir removal is likely to be costly (£5k-20k depending on contractor and how the process is managed), but funding may be available through the Environment Agency or Rivers Trust to assist, and it should be recognised that the structures are a long term liability that will degrade over time, potentially causing greater issues in the future. The weir upstream of Mark House Lane may also be creating an added flood risk to local housing but elevating water levels and diverting more water down the mill race area towards the property.

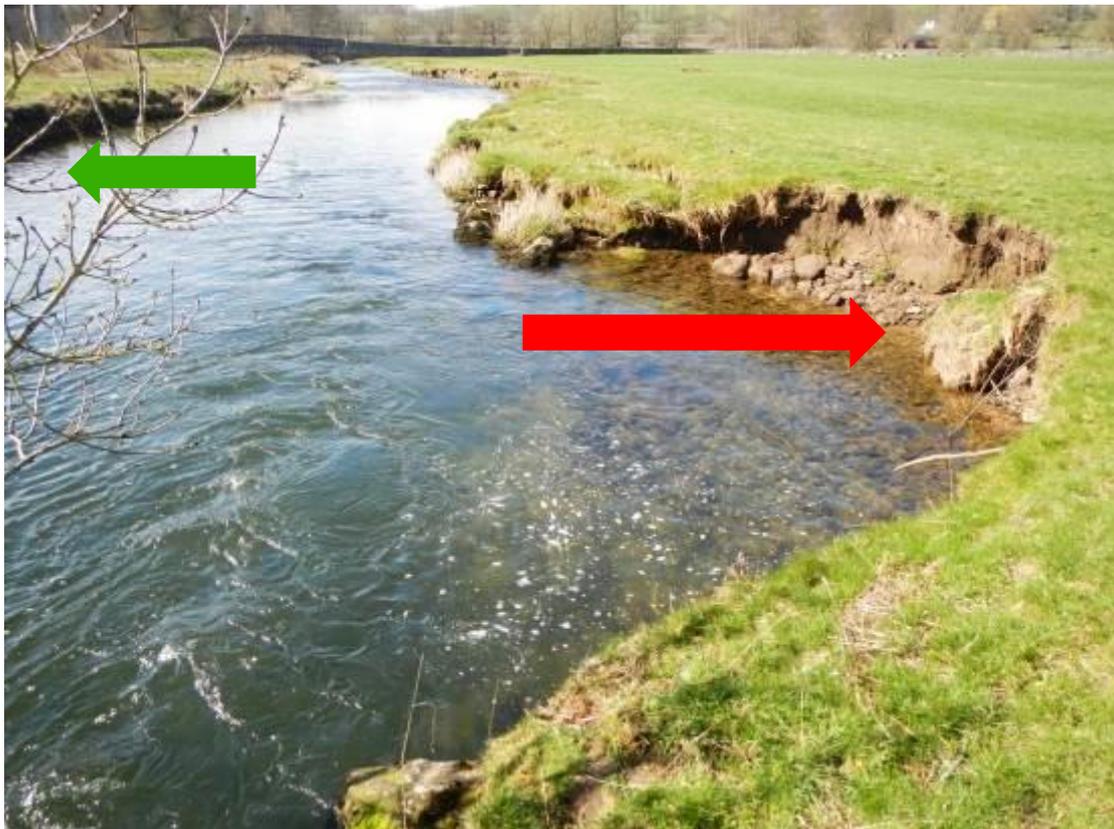
Figure 3. Erosion where a tree has washed out and the bank, lacking in vegetation, has eroded and failed to naturally re-grade (red arrow). If removed from the weir U/S, the tree stump would be beneficially employed as LWD along the LB of the pool (green arrow).

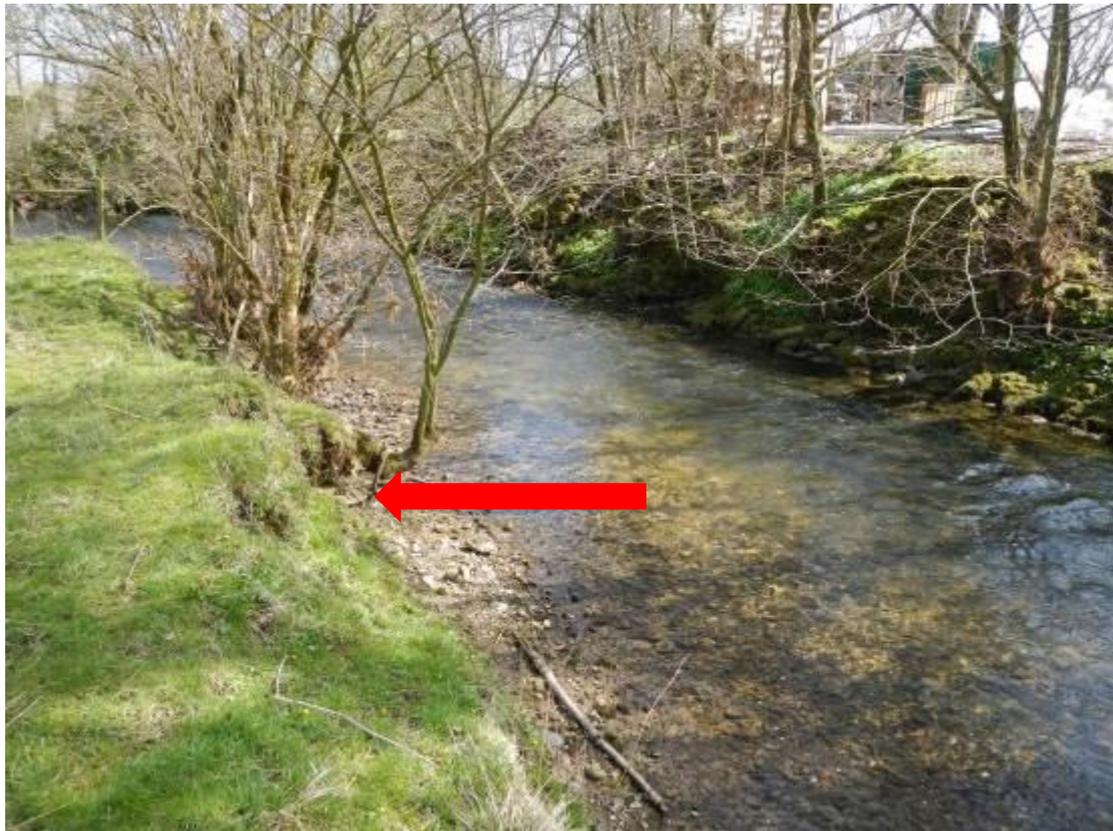
Downstream of Mark House Lane, the available habitat improves greatly, with good low-level cover and trailing branches (Figure 4). The cover, structure and bank stability provided are not the only benefits of such habitat, as the leaf litter and woody material that they introduce to the river channel also increase its productivity and the species it supports. For example, stone turning in the upstream, nearly treeless, section to observe the invertebrate life revealed mayflies, caddis flies, and midges in abundance but low diversity, whereas freshwater shrimp (*Gammarus*) and a greater variety of net-spinning caddis flies reliant upon detritus (leaf litter and associated fungi and bacteria) as a source of food were found within the tree-lined section. This demonstrates another further benefit, in addition to shading, which helps to keep the river cool in low flows and bright conditions.

Figure 4 shows that grazing along the grass bank is still causing issues with the bank stability and habitat; there are still far fewer shrubs along that bank. Furthermore, erosion around the base of the existing shrubs, exacerbated by grazing and trampling, jeopardises their future as they are likely to be washed out in subsequent high flows. Also note how, in a more natural width river cross-section, a deeper channel is maintained by the flow and fine sediment has a lesser impact upon the overall substrate.

Figure 4. Higher quality habitat through a greater abundance of trees and cover. A narrower channel facilitates better sorting of the substrate, but grazing on the true LB still compromises bankside trees and shrubs (red arrow), and thus bank stability. Left unchecked, this is likely to lead to channel widening and habitat degradation.

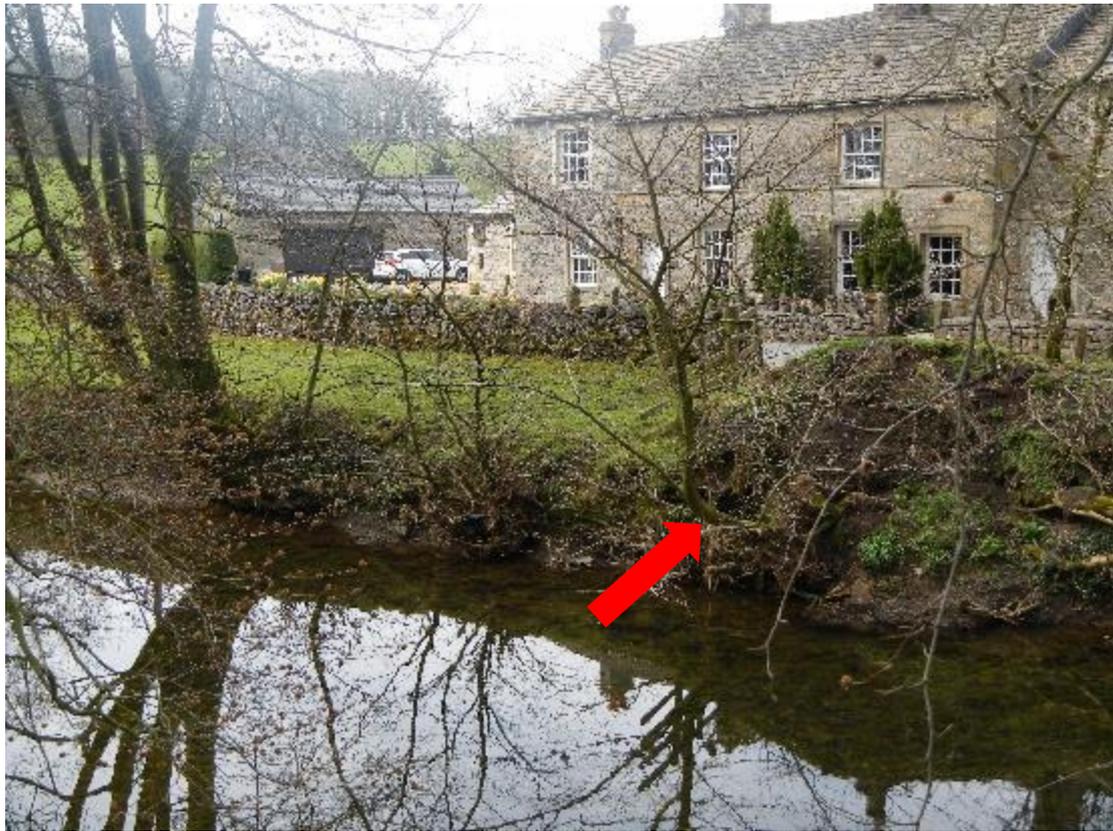
Throughout the less intensely grazed or wooded sections of the river, bankside trees and shrubs provide vital fish holding features (Figure 5) but there is potential for further improvement. Where present, the pliable species such as willow (*Salix* spp.), hazel (*Corylus avellana*), elm (*Ulmus minor* var. *vulgaris*) and hawthorn (*Crataegus monogyna*) can be laid into the channel (parallel to the bank, or at an angle of up to 40° from it), like laying a hawthorn hedge, keeping the shrub alive but increasing valuable low-level and trailing cover. Note the mound of garden waste that has accumulated on the LB, probably over many years, and poses a potential impact on the river as a source of sediment and pollution. This should be stopped – many individuals see a river as a conveyor for rubbish with no regard to the potential impacts upon its ecology.

Figure 5. A good range of trees and shrubs which provide valuable habitat and could further enhance the area if a few specific shrubs were laid into the channel (e.g. red arrow). The dumping of garden waste on the LB which is ending up in the channel should be stopped.

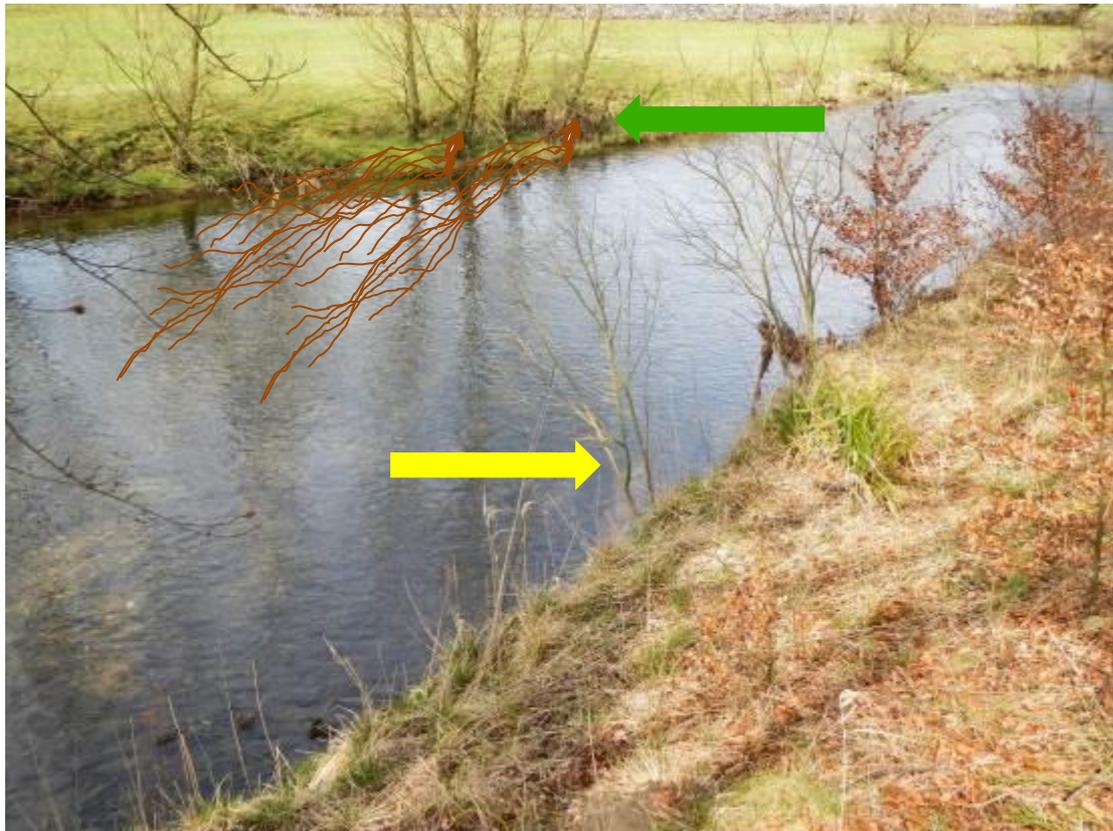
Figure 6. Mature willows that can be laid into the channel to take up capacity, increase bed scour and provide cover (green arrow/brown outlines). Small shrubs that could be laid/trained over to provide low cover and fish holding lies (yellow arrow).

The willow laying is designed to replicate the natural process which occurs with certain willow species as they grow and break/fall into the watercourse, as has naturally occurred on the LB (Figure 7). Also note that, in the absence of grazing, the willow has been able to become established, and how the better vegetated bank is a naturally sloping profile (low susceptibility to erosion). This is in contrast to the heavily grazed RB with little vegetation and ash tree (*Fraxinus excelsior*) which is likely to fall into the channel and destabilise the rock-lined bank.

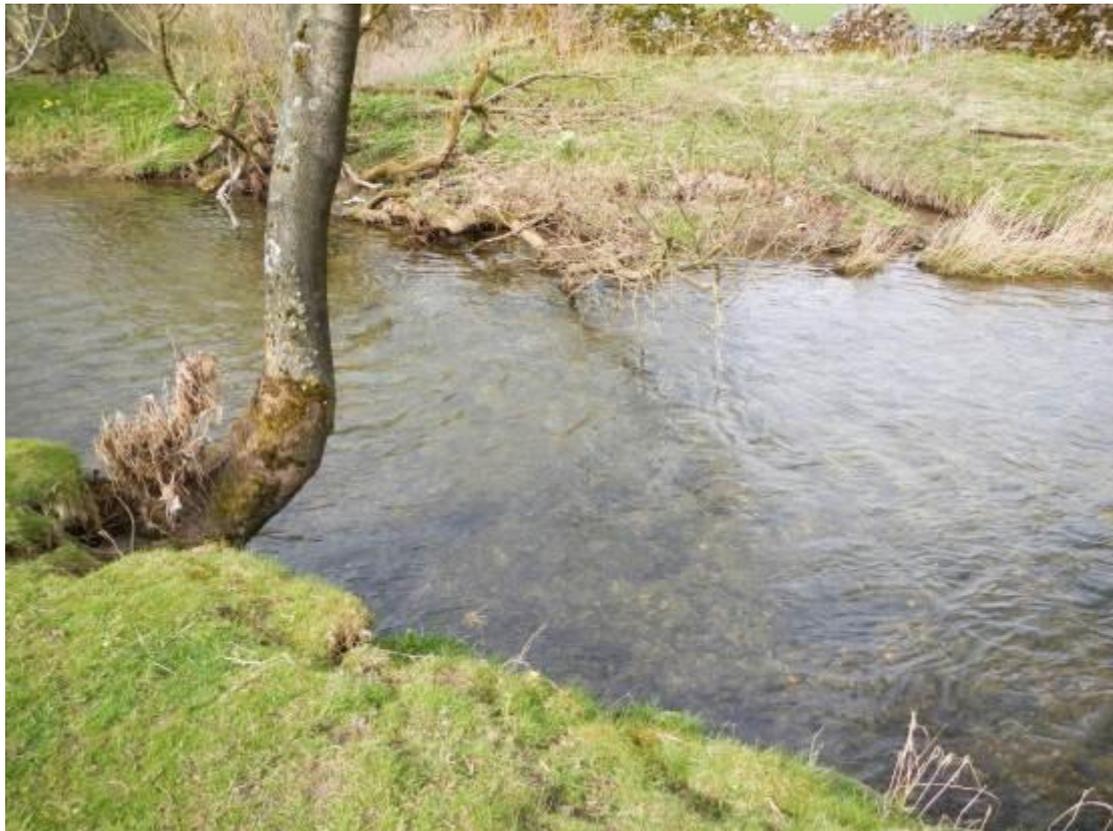
Figure 7. Well-vegetated far bank with self-set willow and naturally graded bank. The near bank is walled and grazed, making it susceptible to erosion. In time the tree is likely to fall into the channel and due to the wall, destabilise a large area that will then continue to erode into a large scar (as has happened in Figure 3).

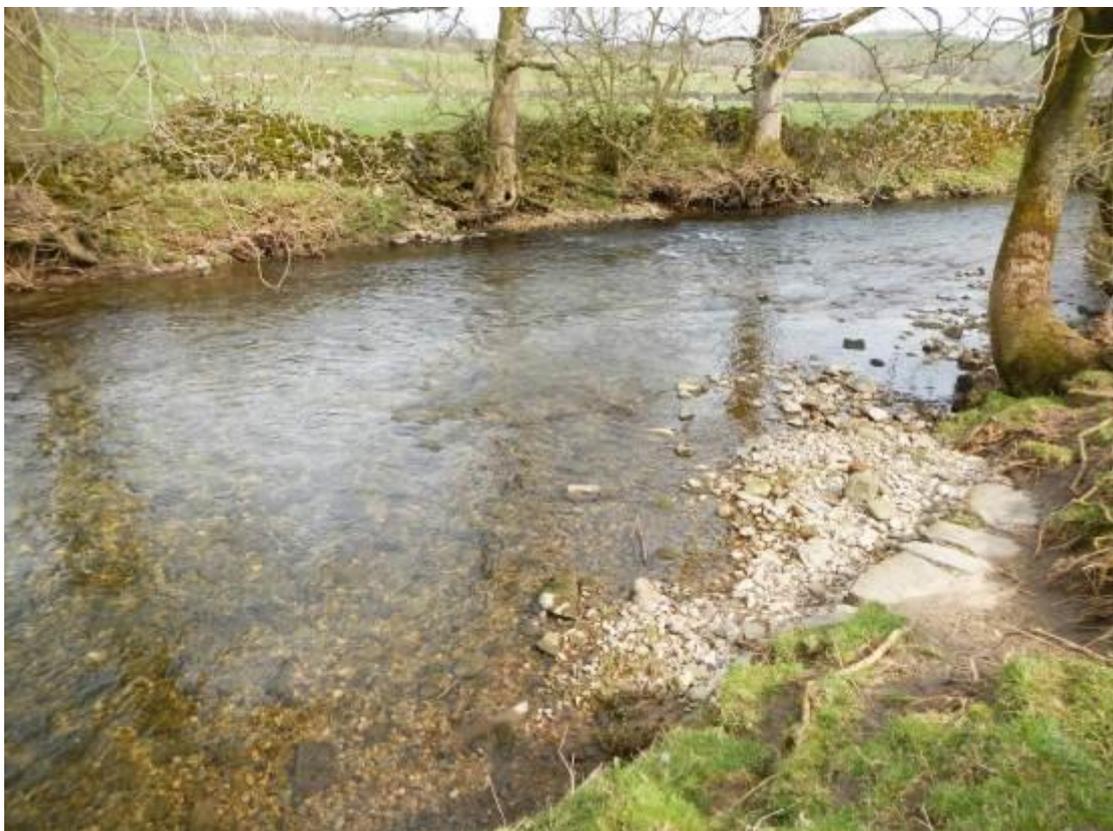
Just downstream, there was obvious evidence of historic detrimental tree management where many of the low-lying branches have been removed (Figure 8). This is usually undertaken to improve angler access and aid casting, but is catastrophic for habitat, removing the vital trailing and low-level branches that enable areas to hold fish. The exposed roots and bare earth on the near bank also indicate that the area is actively eroding and the inhibition of vegetation becoming established on the depositional material (gravel bar) is preventing the channel from narrowing to an appropriate width. As a consequence, the over-wide channel creates a water depth that is insufficient to hold adult fish.

Figure 8. Slightly over-wide section lacking in water depth where grazing and associated inhibition of gravel bar stabilisation and erosion are preventing natural channel narrowing.

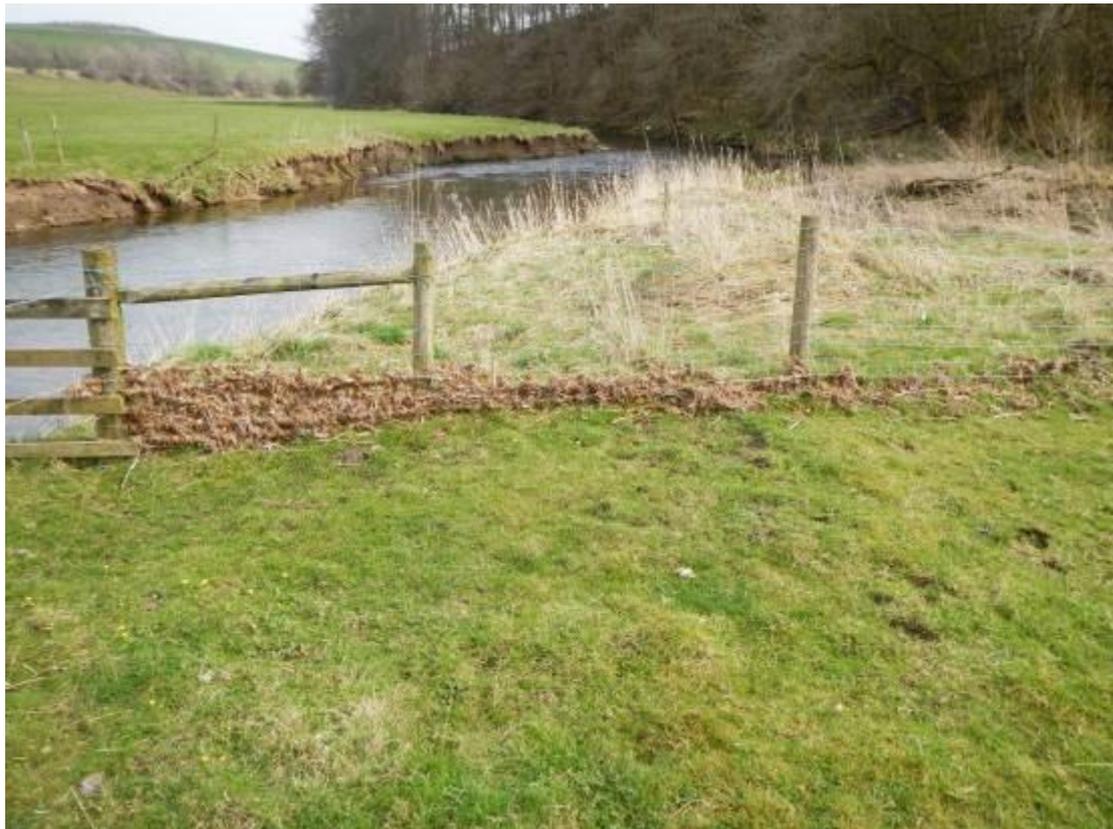
Downstream, fencing resumes on the RB (Figure 9) and continues along a short wooded section. Again, the contrast between grazed and un-grazed land is clearly evident, with a much greater erosion on the grazed areas, less cover and a lack of trees. This is despite the fact that the un-grazed tree-lined bank is much steeper, and without the root structure within it should be more susceptible to erosion. Planting willow whips in the banks and along the waterline would greatly enhance the fish-holding capacity – but would require protection from livestock grazing to allow them to establish.

Figure 9. Grazing in the foreground (RB) and background (LB) seriously denude bankside habitat, which is in contrast to the well-vegetated fenced area and woodland (background RB).

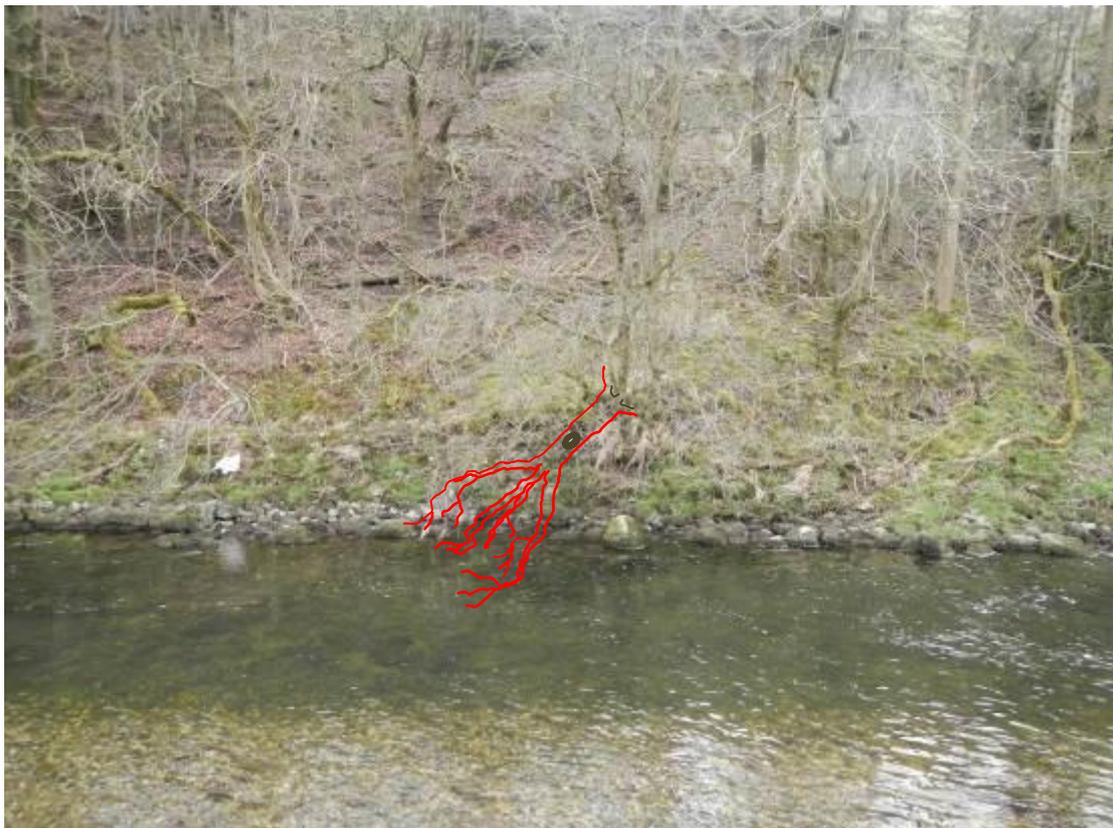
Figure 9. Good quality pool habitat but lacking in cover. Laying the hawthorn (centre of shot – red outline) down into the channel would enhance the fish holding features.

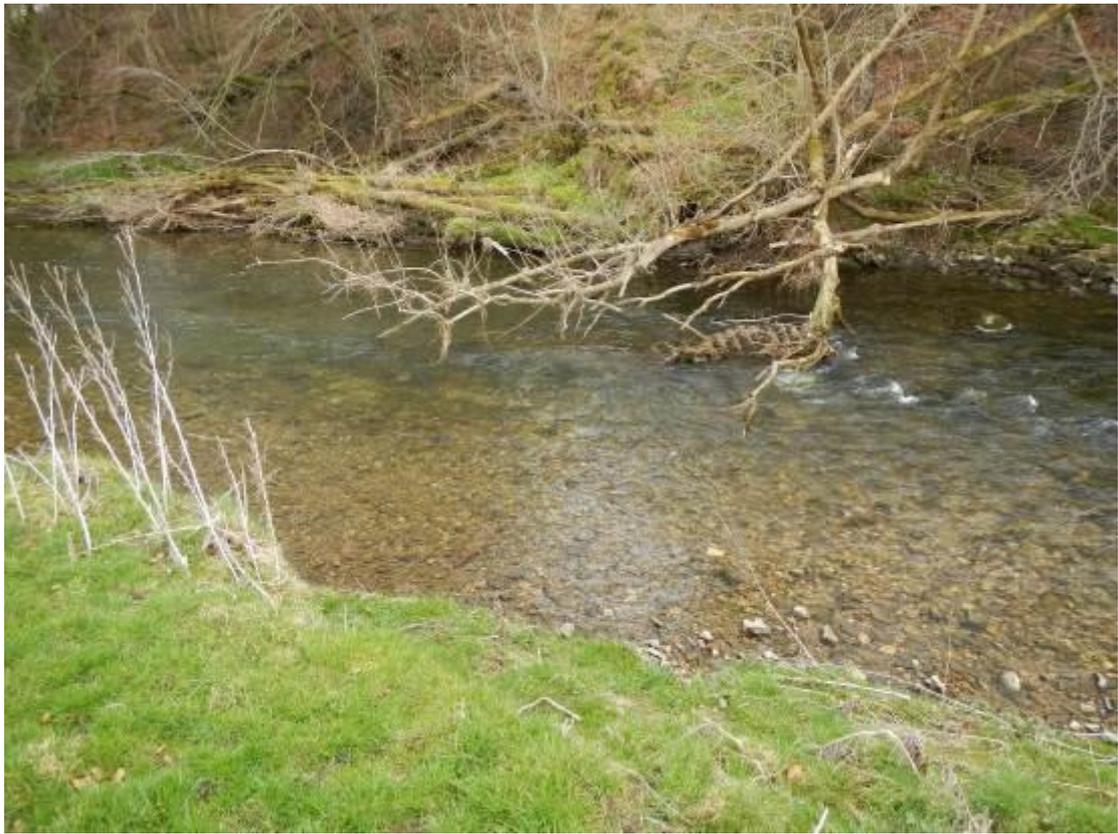
Figure 10. Naturally occurring LWD – a natural enhancement to the river that will greatly increase the fish holding capacity.

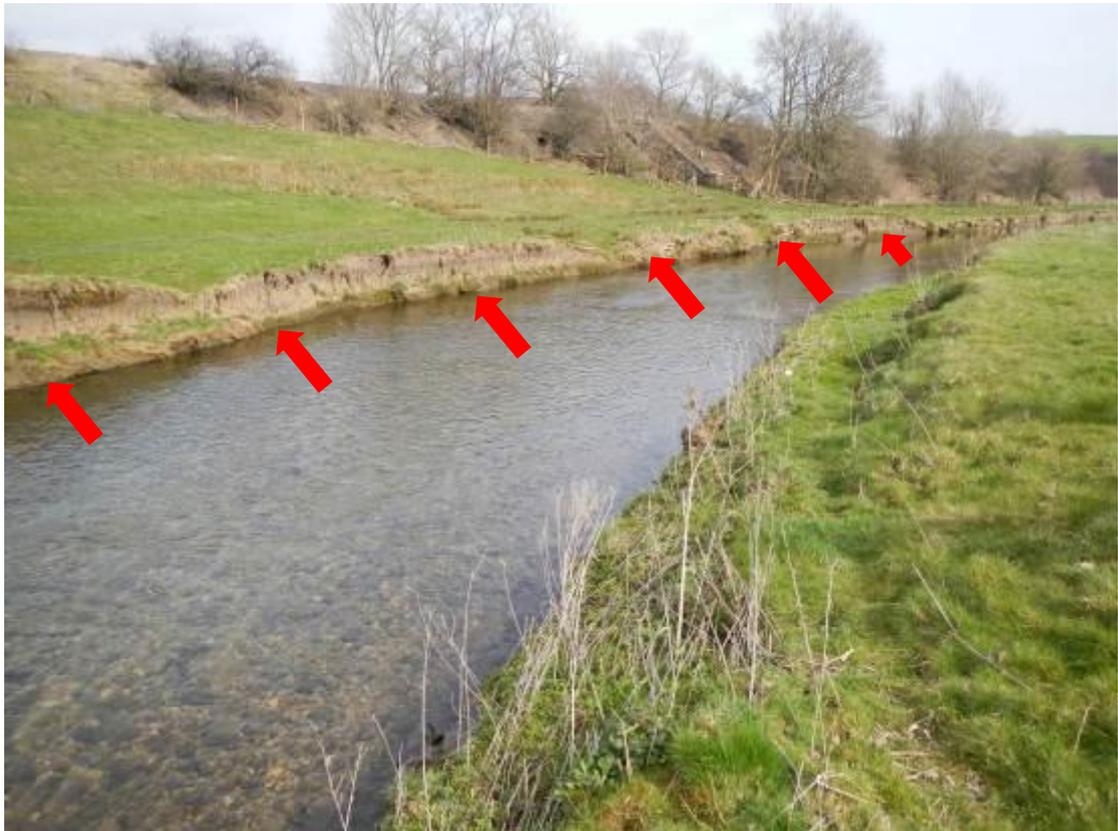
Where dual bank grazing resumes (Figure 11), habitat quality drops dramatically, and although deep water is present, capable of

supporting large adult fish, it is unlikely to support many due to the absence of cover. The open nature of the pool there makes fish an incredibly easy target for piscivorous birds (goosander were observed). Buffer fencing and planting would easily rectify the situation.

Figure 11. A significantly underperforming section of river that could support good numbers of adult fish, with the installation of fencing, and tree planting. Planting willow whips along the far bank as indicated with red arrows would start the improvement, with each shrub (once established) capable of holding an additional fish.

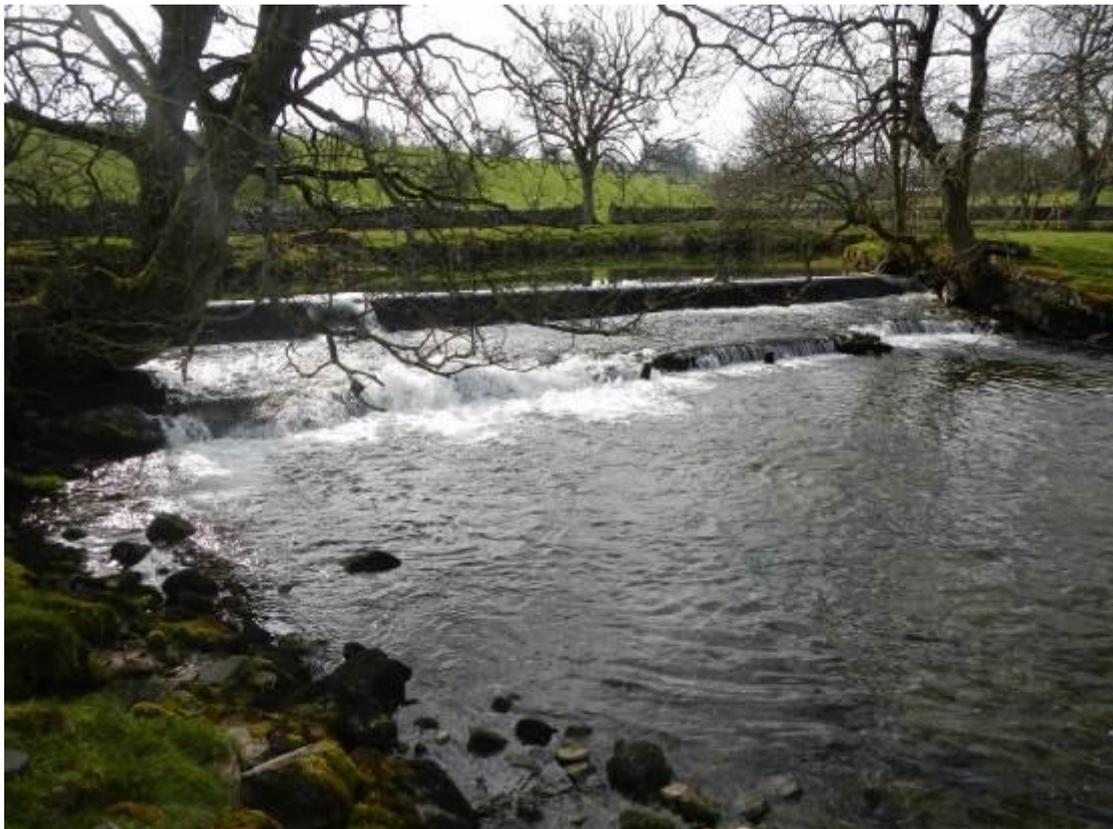
Approximately 150m downstream of the A65, another weir creates problems (Figure 12) and, in conjunction with the weir upstream of Mark House Lane, affects the entire fishery by restricting fish movements into and out of the short c.2.5km length of river between them. The impact of this is even more significant when considering that the habitat within the 2.3km length is currently sub-optimal and there is only limited spawning potential on the main river and two notable tributaries (Gill Syke & Otterburn Beck).

Removal of any redundant weir is always greatly beneficial to river geomorphology and ecology, but removal of these two particular weirs would be of great benefit to the fishery. Some of the impounded pool habitat upstream of the weirs would be lost, but by reinstating the natural scour and depositional features in that area, natural pools would form and be maintained. This is in contrast to an impounded pool which accumulated sediment, progressively filling in and shallowing over time.

Figure 12. Major obstruction to fish passage – a seemingly redundant weir c.150m D/S of the A65. This should be removed if at all possible.

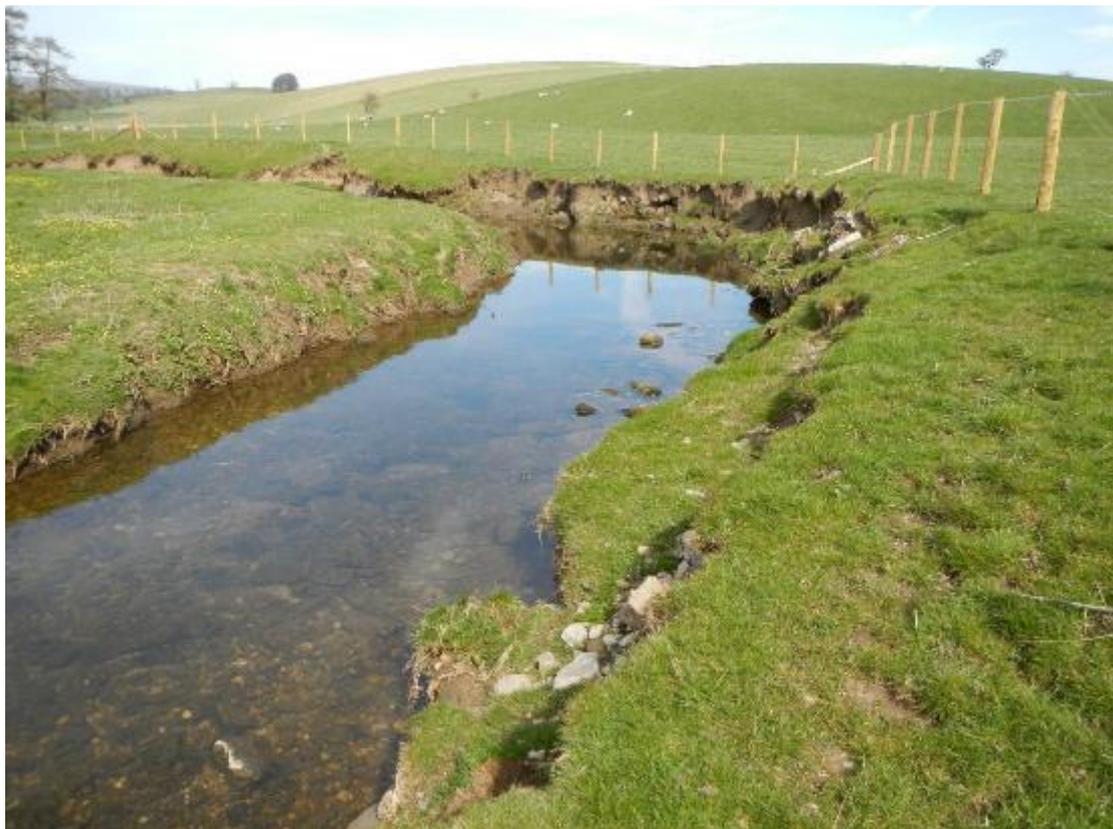
revealed a similar history to that of the main river, with obvious signs of straightening and long-term grazing pressure that has denuded and de-stabilised the banks, leading to significant erosion (Figure 13). The section upstream of the road bridge is subject to recent improvements, with a fenced buffer zone installed along the watercourse.

Figure 14. Obvious signs of heavy grazing, but, with the exclusion of livestock, the area should rapidly re-vegetate and the habitat greatly improve.

Providing that this riparian strip is maintained free from livestock, noticeable improvements are likely to occur very rapidly; the sediment input should reduce, the channel is likely to naturally narrow in places, and the bed is likely to become better sorted, with coarse substrate maintained free from fine sediment. This will greatly enhance the tributary as a spawning and nursery area. It will be worth monitoring the improvements to vegetation and bankside stability over the up-coming growing season; improvements that should be aspired to on all other grazed land around the fishery. In the absence of livestock, planting of willow whips in the eroded bank faces and along the waterline is also encouraged to accelerate bank consolidation.

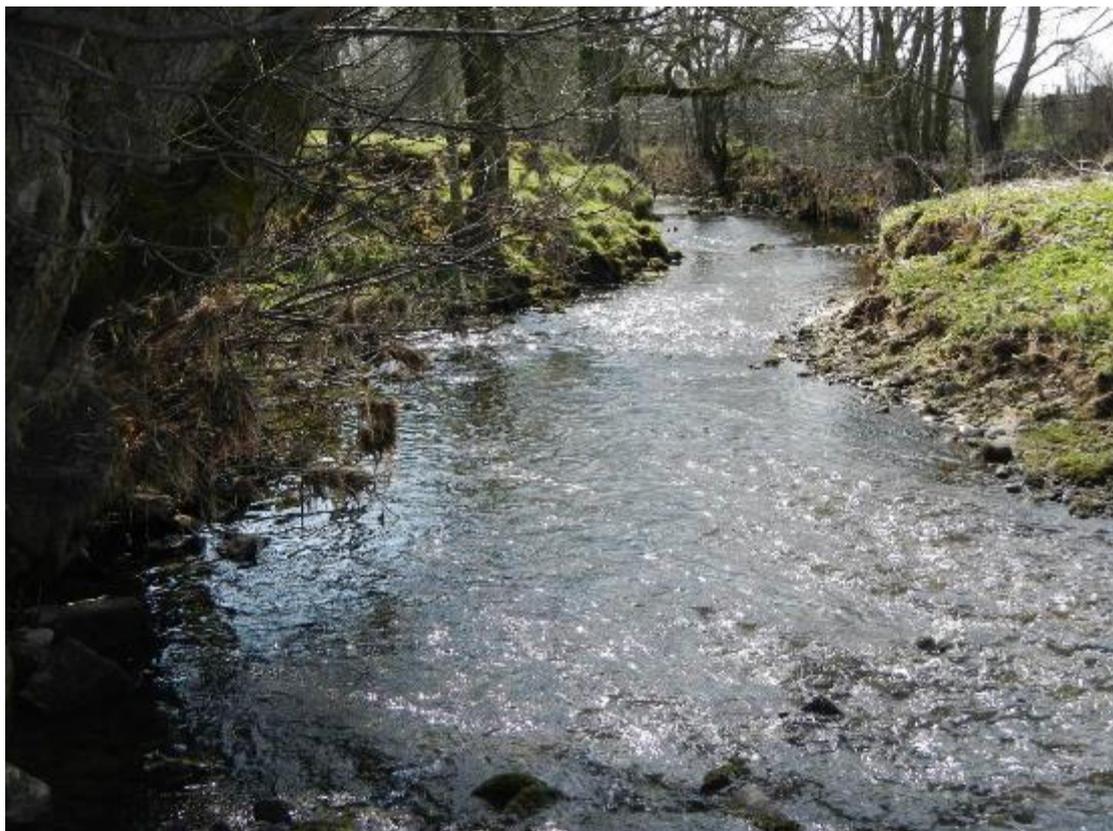
The general form of the Beck does provide some valuable juvenile habitat, with good glides and riffles (Figure 15), although considerable sediment input from upstream was very evident, coating many of the rocks and accumulating in between (Figure 16). It may be that erosion further up the Otterburn Beck catchment is also contributing and it is recommended that an investigation is made into the possible extent of erosion and fine sediment input upstream.

Figure 15. The lower section of Otterburn Beck – some good juvenile habitat but would benefit from fencing to protect trees and allow natural regeneration.

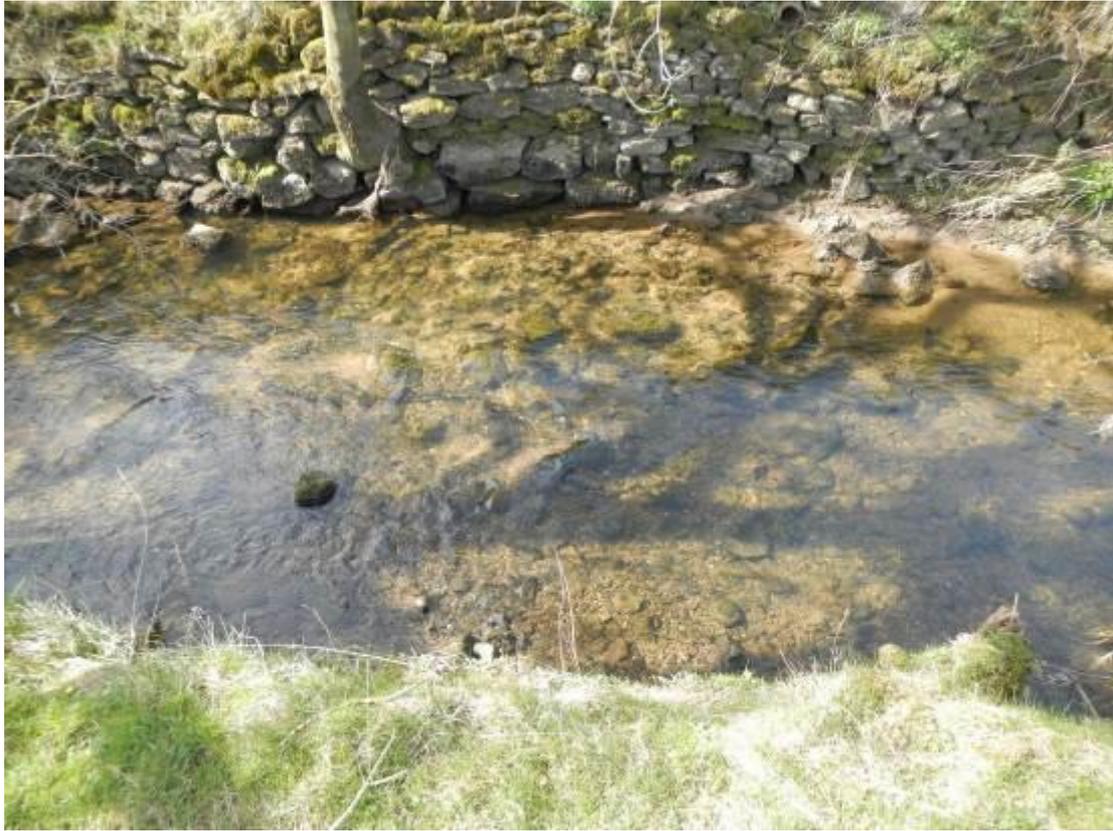
Figure 16. Obvious signs of sediment deposition across the bed of Otterburn Beck.

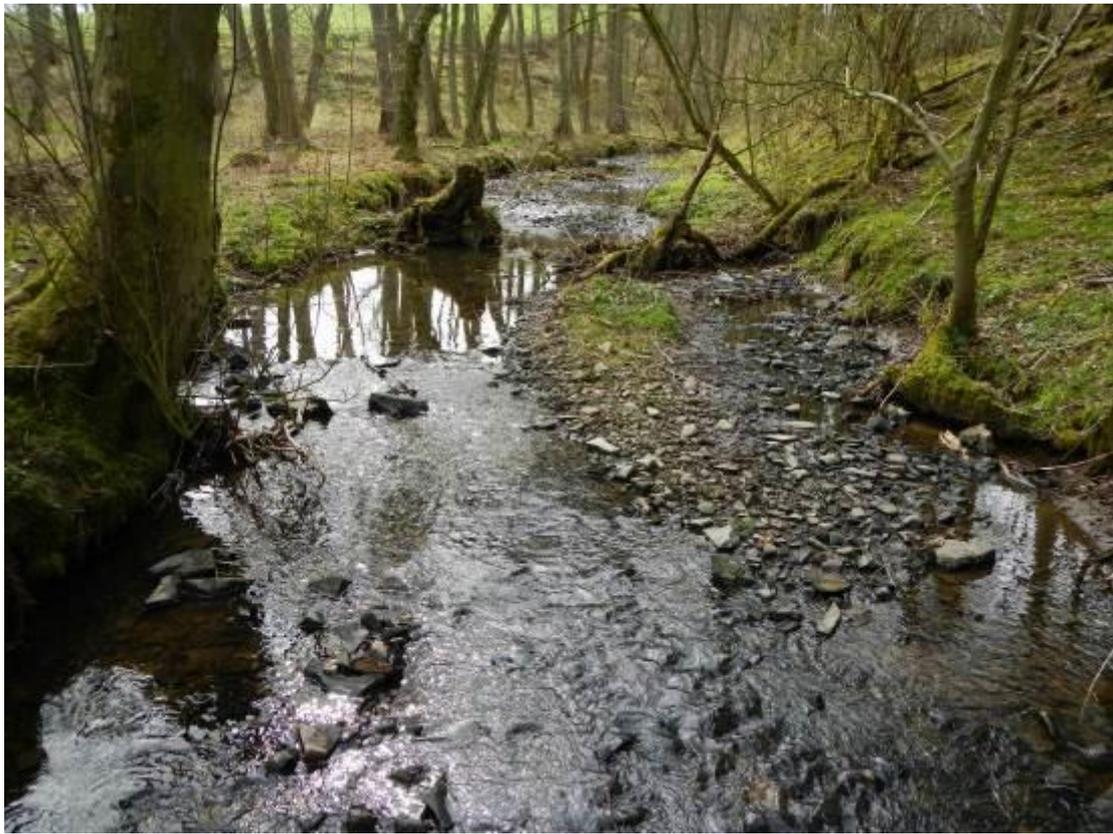
Figure 17. Relatively good quality habitat with many of the required features that are naturalising following historic channel realignment and modification. Further assisted naturalisation will be of great benefit.

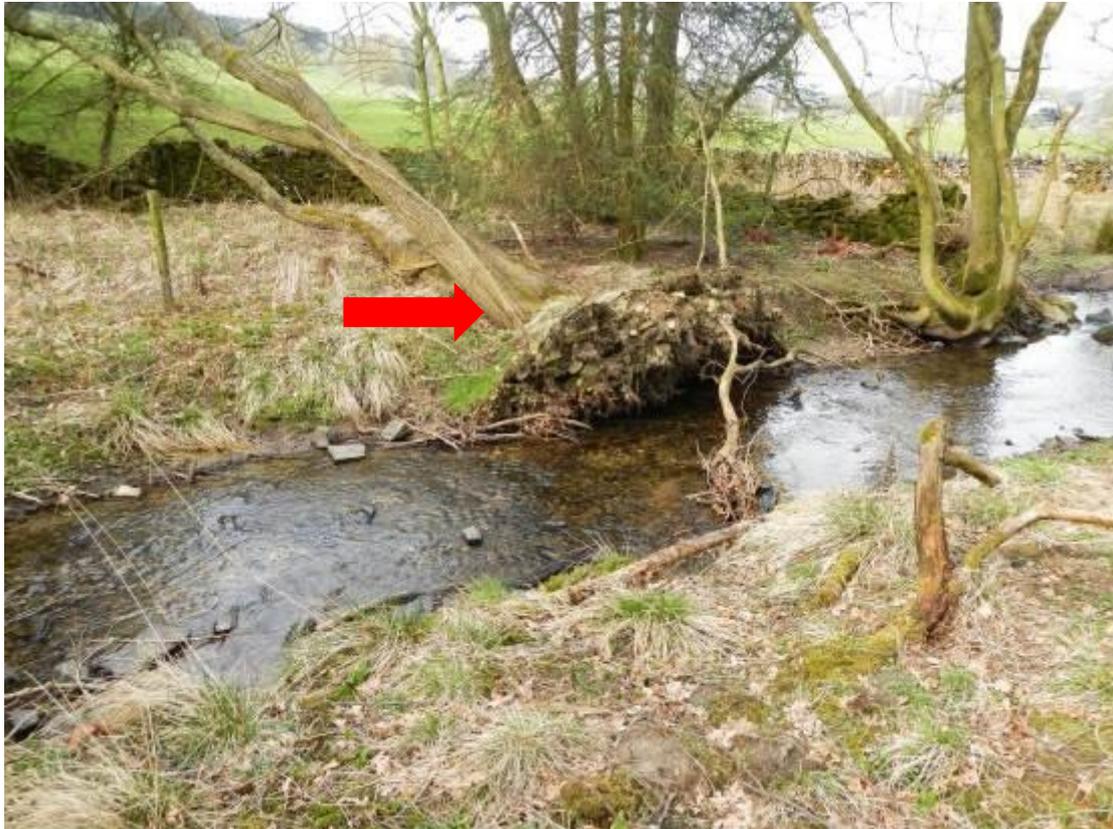
At the downstream end of the wood, a large crack willow has fallen (Figure 19) and creates a great source for pieces of LWD that could be staked into the channel at various points U/S, and being crack willow, are likely to regrow. Cutting this tree as a low coppice should also allow the stump to be righted, reinstating valuable in-channel habitat.

Figure 19. Fallen willow creates a great source for LWD and, if coppiced (red arrow), could be righted to reinstate valuable in-channel habitat.

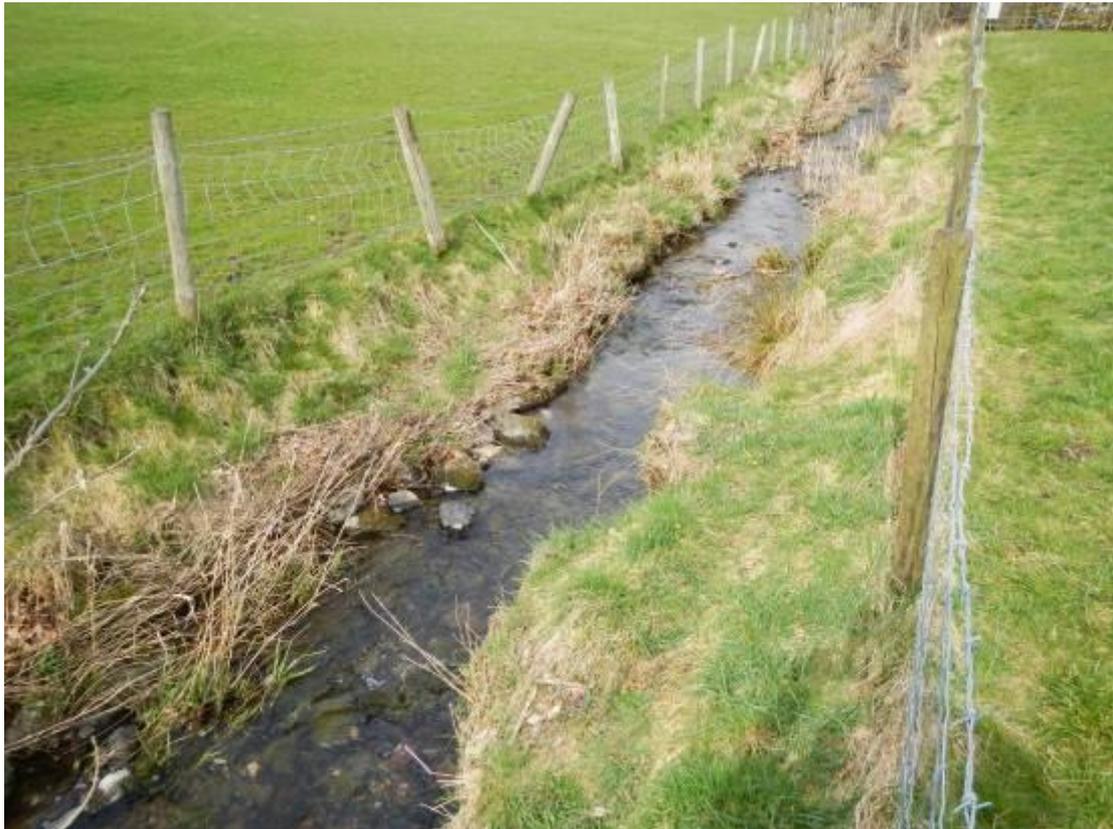
Downstream of the wood, the channel continues in a straightened course, but at a more natural width (Figure 20). Buffer fencing either side in most areas also demonstrates the major benefit to habitat from stock exclusion as the channel does provide some good juvenile habitat. In areas where the fence has not been maintained and stock are gaining access a significant drop in habitat quality was noted – this should, ideally, be addressed by full stock exclusion. Increasing cover would further benefit the area, and mixed deciduous planting (or even willow whip planting) within the buffer to provide shade and structure in which fish can shelter from high flows would be worthwhile.

Figure 20. Narrower (but still straightened) channel D/S of the wood with improved bankside vegetation as a result of buffer fencing. Additional planting would be beneficial to create shade, cover and structure/shelter.

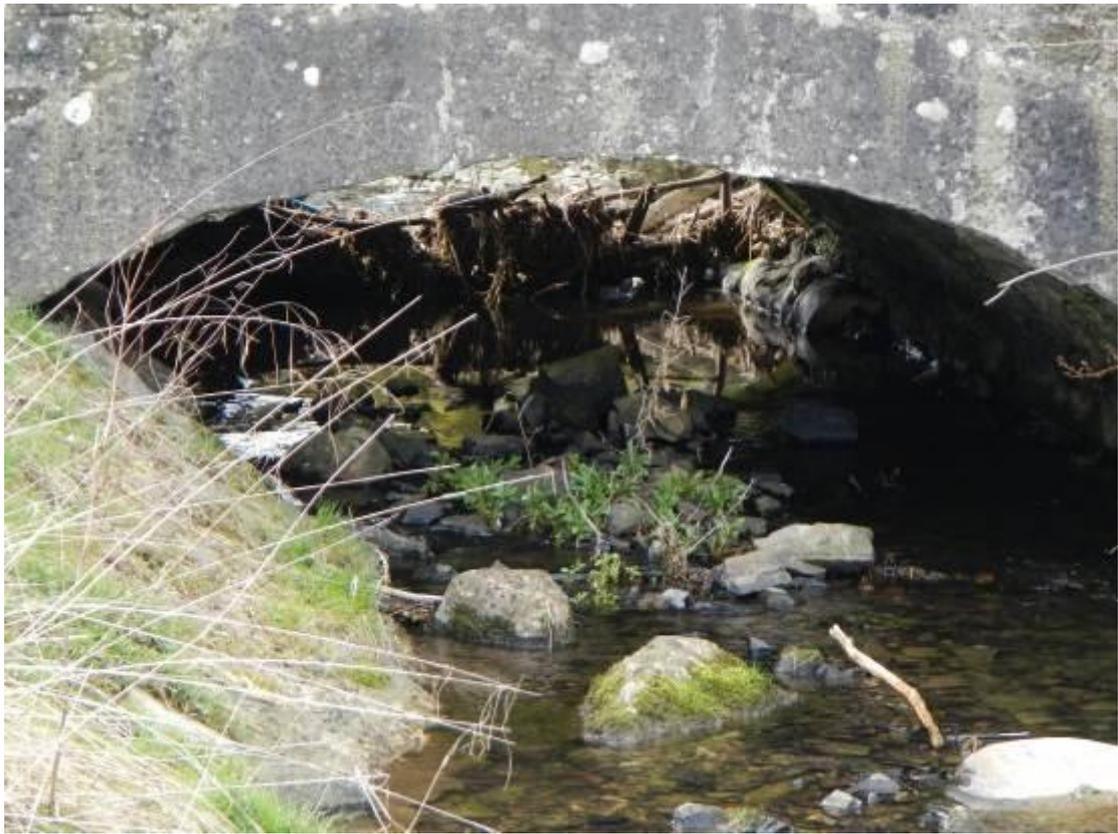
The farthest upstream obstacle is the road bridge, which is blocked by debris on a gate employed to exclude live stock from going under the bridge (Figure 21). This could easily be rectified by installing a water gate, but in the short-term, by regular clearing of the debris.

Figure 21. Looking upstream, under the road bridge at a debris clogged gate. U/S and D/S fish access here should be maintained.
