Advisory Visit

River Aire

08/04/2015

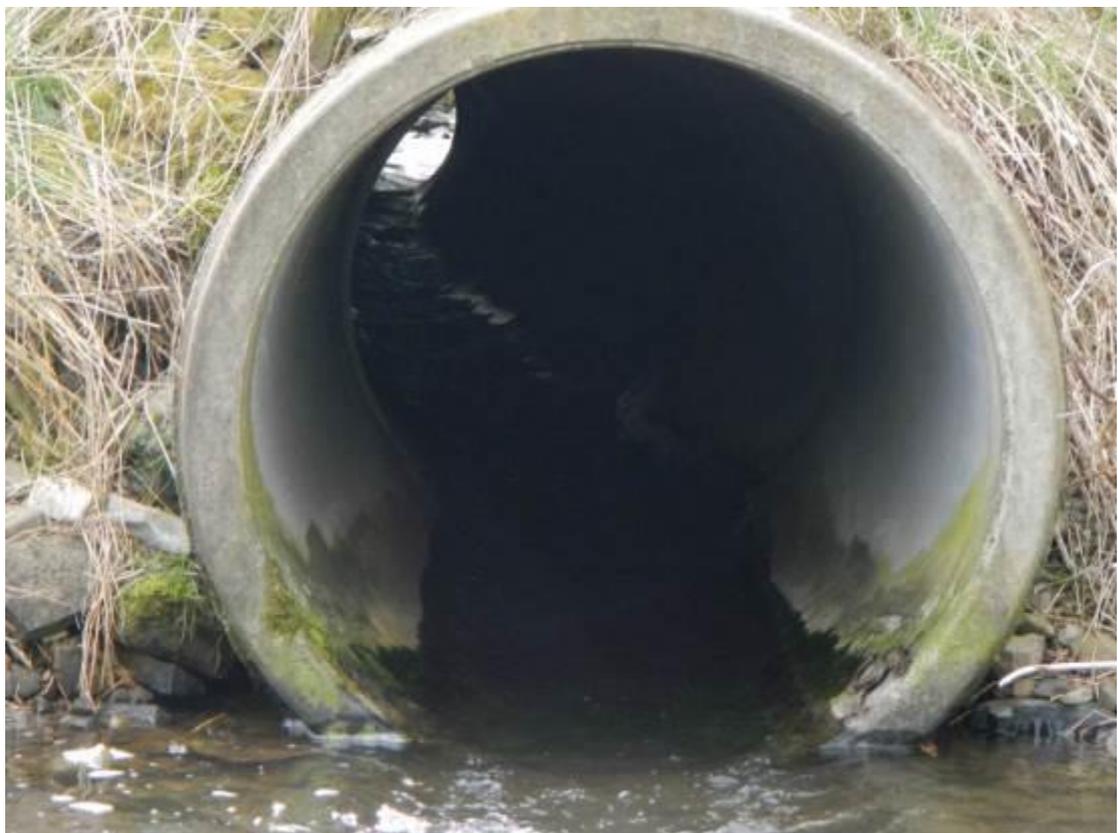
Downstream of the bridge, two sections of pipe culvert that enclose the watercourse for a much greater distance than is required further obstruct fish passage. As there are two, it is hard to actually understand their full purpose, when one short section would have been sufficient to provide stock and vehicular access. The culverts have not been installed in an environmentally sensitive manner; they should be over-capacity to allow installation at least 1/3 below the bed level, to reduce unwanted bed scour (can leave the pipes perched) and to allow formation of natural bed material within the culvert.

Figure 22. The upstream one of the two pipe culverts where the confined nature of the pipe and steep, smooth bed restricts access for fish of all sizes, at all flows.

Removal of any unnecessary culverts, un-natural channel sections or obstructions is always advisable. In this case, it may be that removing the larger, upstream culvert could be undertaken, retaining the shorter, less obstructive one downstream for access. This would be a great improvement to Gill Syke and could greatly improve spawning opportunities and wild fish stock recruitment in the area.

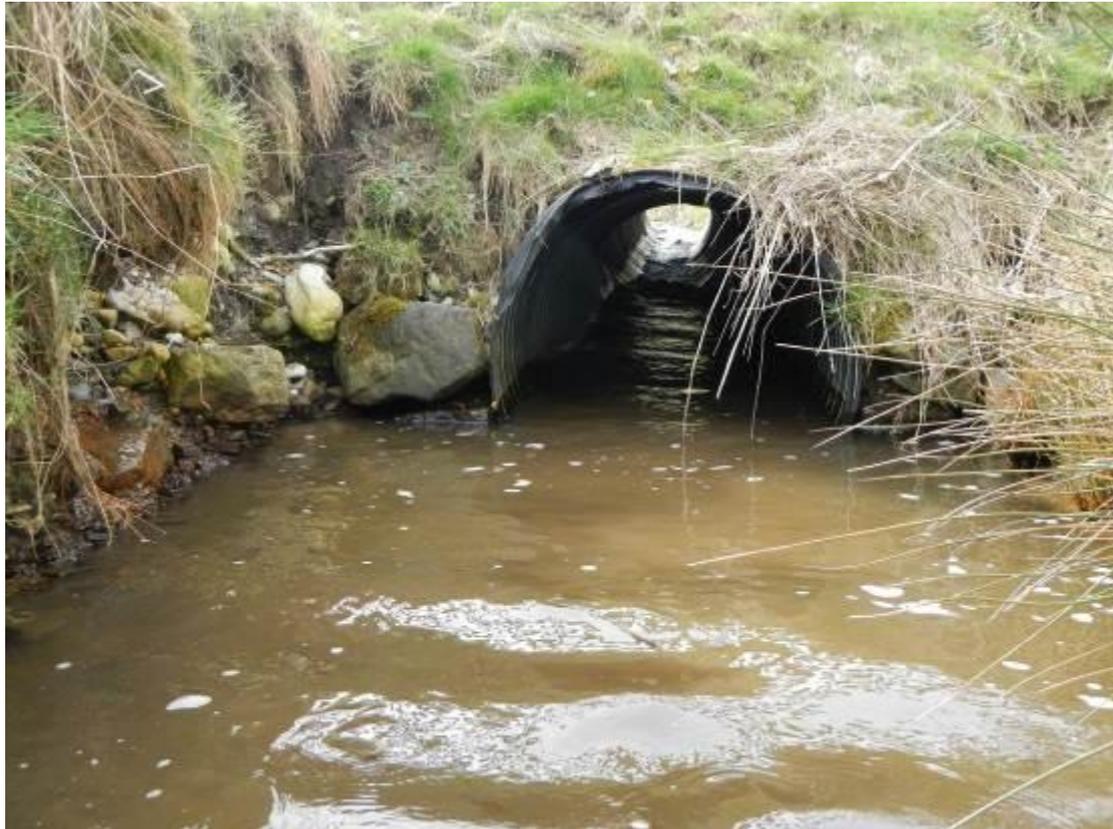
The downstream culvert has much the same issues as the other, although is slightly less of an obstacle owing to the fact that it is shorter, on a shallower gradient and extends progressively below the bed towards the D/S end (Figure 23). It is, however, still an obstacle and far from ideal. High flows fluming through the pipe will impede fish passage, potentially right at the times when fish require access upstream for spawning.

Figure 23. The downstream culvert. Slightly less of an issue, but far from ideal. At least the D/S end is sunk below bed level.

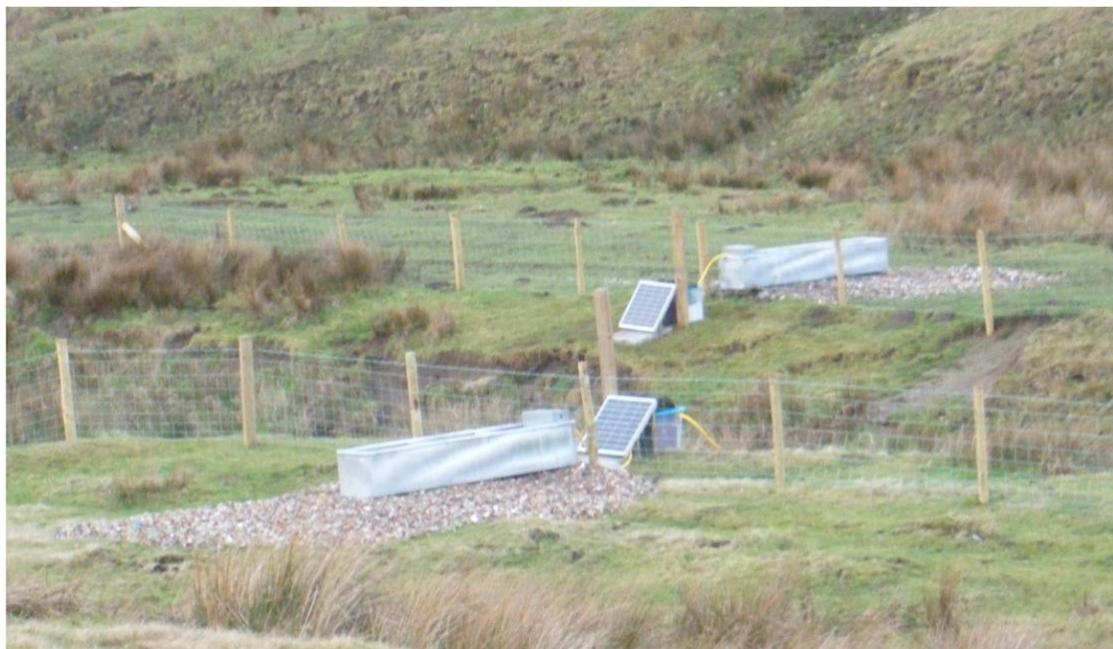
Photograph 25. Solar panel powered pumps employed to fill standard water troughs. Photograph courtesy of Ribble Rivers Trust.

Effective fencing to exclude livestock from the riverbank is one of the two greatest improvements that could be made to habitats on the river; the other being weir removal. Excluding livestock from the watercourse via buffer fencing will be key to major improvements in wild fish stocks. Ideally, fencing should completely exclude livestock from the river bank which may then require solar pumps (Figure 24) or pasture pumps (Figure 25) to supply water for drinking at several locations.

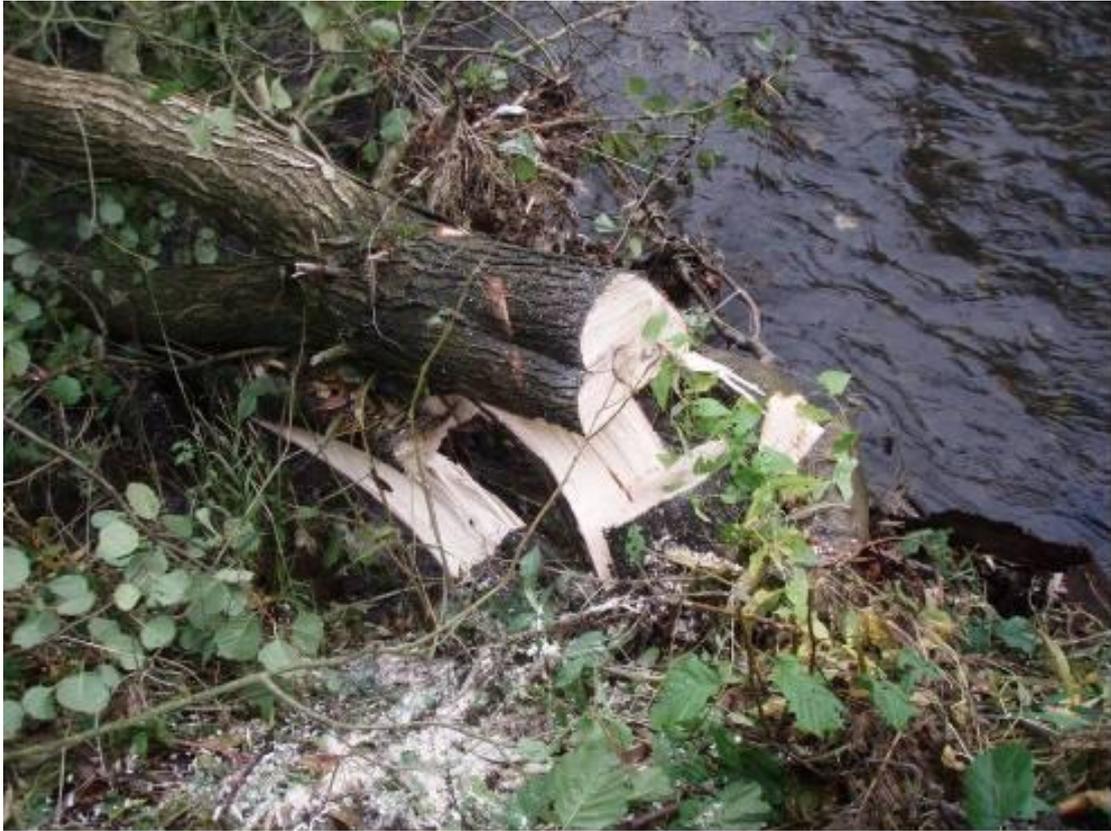
Photograph 26. Hinged willow.

The process involves cutting part way through the stem/trunk, a little at a time (like laying a hawthorn hedge), until it can be forced over into the channel (Figures 26 & 27). The depth of the cut should be limited to only that which is required to bend the limb over, as this will retain maximum strength in the hinge and maintain the health of the tree/shrub. Alternatively, on smaller shrubs cutting the stem/trunk at a very shallow angle and then putting an axe blade into the cut and hitting it with a hammer can also help the laying while retaining a good strong hinge.

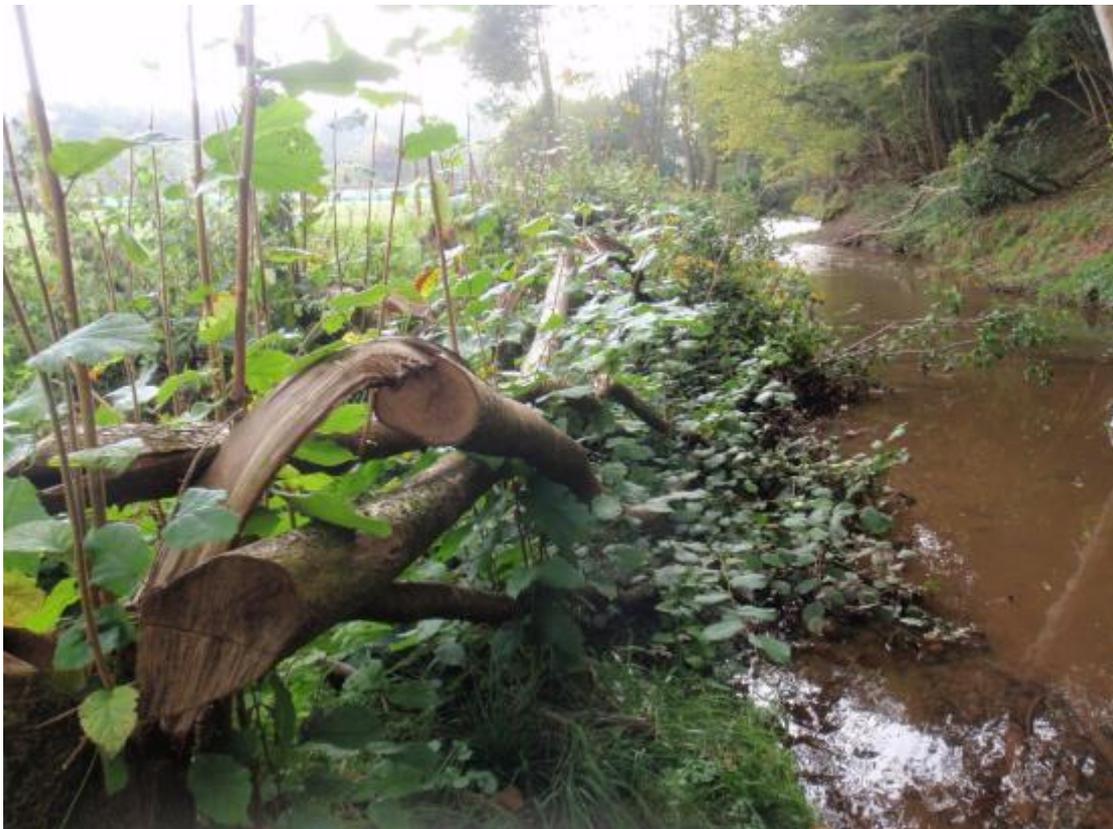
Photograph 27. Hinged hazel.
