Advisory Visit

River Aln

Northumberland

15/06/2015

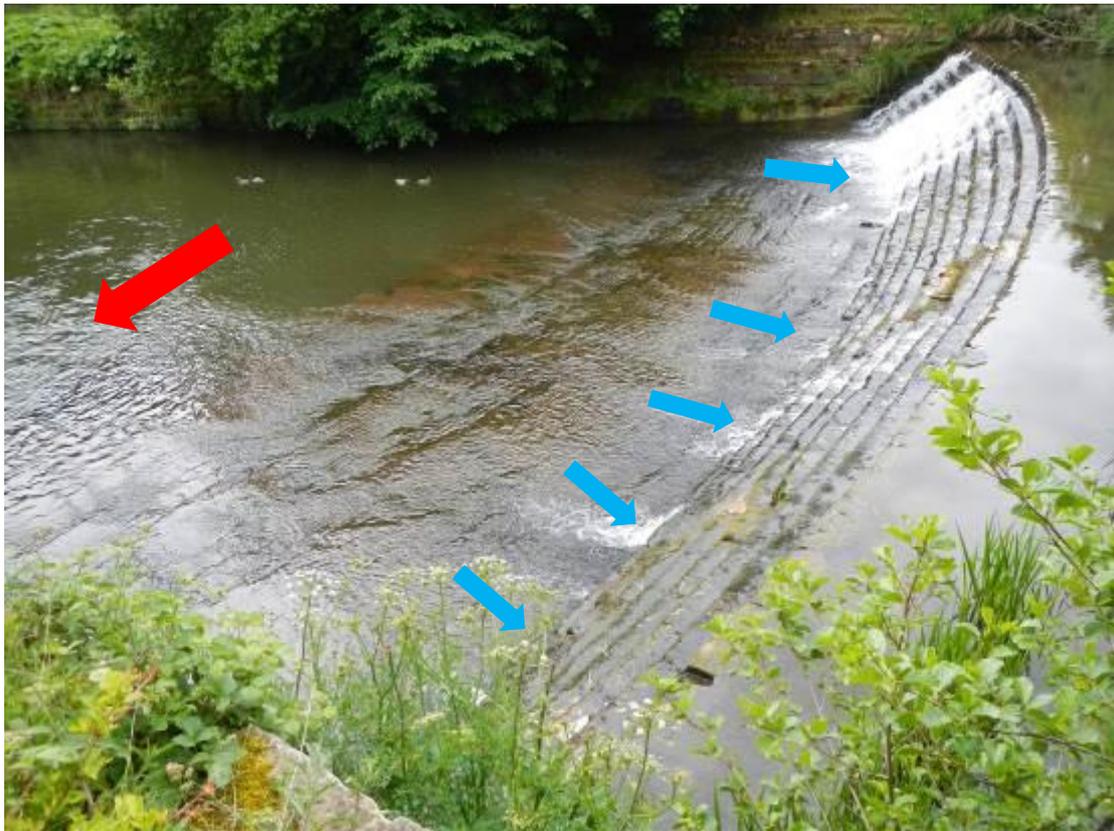
Denwick Bridge forms the upstream boundary of Aln Angling Association waters; however, as Denwick Upper Weir (Photo 1), just upstream of Denwick Bridge, will inevitably have an impact upon the river system, it was worth inspection. The weir is one of several on the river from the Capability Brown era that fragment habitat and impound long sections.

Photo 1. Denwick Upper Weir. The weir is a complete barrier to fish passage but has a pool traverse pass around the LB side. Approximately 8 fish were observed to be queuing up at the outflow to the fish pass in the area marked by a red arrow suggesting a likely issue with fish passage. In high flows, fish are likely to follow the main river flow to the weir and miss the fish pass, only to be blocked by the weir in the area marked by blue arrows.

Addressing the significant issue posed by numerous weirs on the River Aln system is of primary importance if fish stocks are to be optimised. As these weirs are of historical importance, and so unlikely to be removed, the impounding effect and loss of habitat is difficult to mitigate, but the issue of habitat fragmentation by inhibited fish passage is something that must be minimised. This is something that should be coordinated between the Angling Association and the Alnwick Castle Estate.

The same is true for the Denwick weirs (Upper and Lower) which can be clearly observed as issues for fish and eel passage. A non-exhaustive list of improvements that could be made there are listed in Table 2.

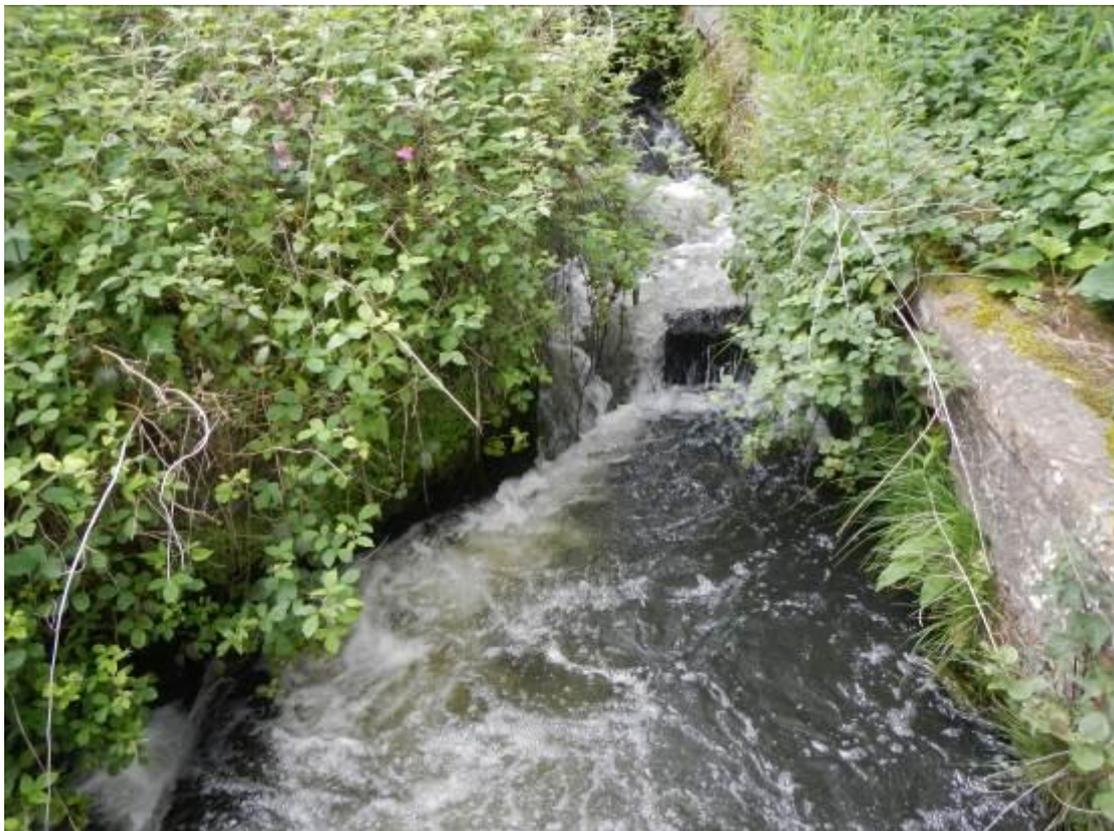
A rudimentary pool and traverse fish pass exists around the weir (Photo 2), although the parameters of the pass are well outside current best practice guidelines for migratory and non-migratory fish. The pools are on the smaller side of what is required (reducing the space for fish and flow dissipation), the ascent into the first pool is of greater than optimal height and distance and the step is uneven and elongated, all of which inhibit fish passage (Photo 3). The discharge from the pass is also downstream of the weir toe, likely to avoid the shallow weir apron downstream, but this also means that in high flows fish are likely to pass the smaller fish pass discharge and follow the main river flow to the weir, where they would be unable to ascend.

It was also noted that the upstream inlet to the pass was partially blocked, creating another obstruction and reducing the efficacy of the pass. It is important that this, and any other fish passes, are better maintained in future for the benefit of fish stocks.

These issues are substantiated by the fact that several medium sized salmon (c. 2.5-3.5kgs) were observed to be queuing up in the outflow of the pass, but not attempting to ascend it. These fish were probably taking advantage of the oxygenated water emanating from the pass, but their presence in numbers below the pass indicates that numerous fish had not been able to, or not chosen to, ascend it at the time of the observation.

Photo 2. Pool traverse pass around Denwick Upper Weir. The pool sizes are smaller than ideal for large migratory salmonids; the small pool size also reduces the energy dissipation effect on flows within the pass.

Table 2. Fish passage improvements			
	Denwick Upper Weir - Pool Traverse Pass	Denwick Lower Weir - Pool Traverse Pass	Denwick Lower Weir - Eel Pass
Short-term	Clear debris from the upstream inlet		Ensure the upstream inlet is maintained free from debris
	Install a nappe at the downstream entrance to	Install a nappe at the downstream entrance to create a	Extend crawling medium to meet the

create a chute flow, rather than a cascade	chute flow, rather than a cascade	downstream water level
Long-term	Fully appraise the fish pass design and, ideally, install a pass of more appropriate dimensions for passage of all species.	Fully appraise the fish pass design and, ideally, install a pass of more appropriate dimensions for passage of all species. As a minimum: Install at least one, possibly two additional pools to the lower end of the pass so that it meets the downstream water level.	Extend the eel pass substrate and housing to below the downstream water level at all flows

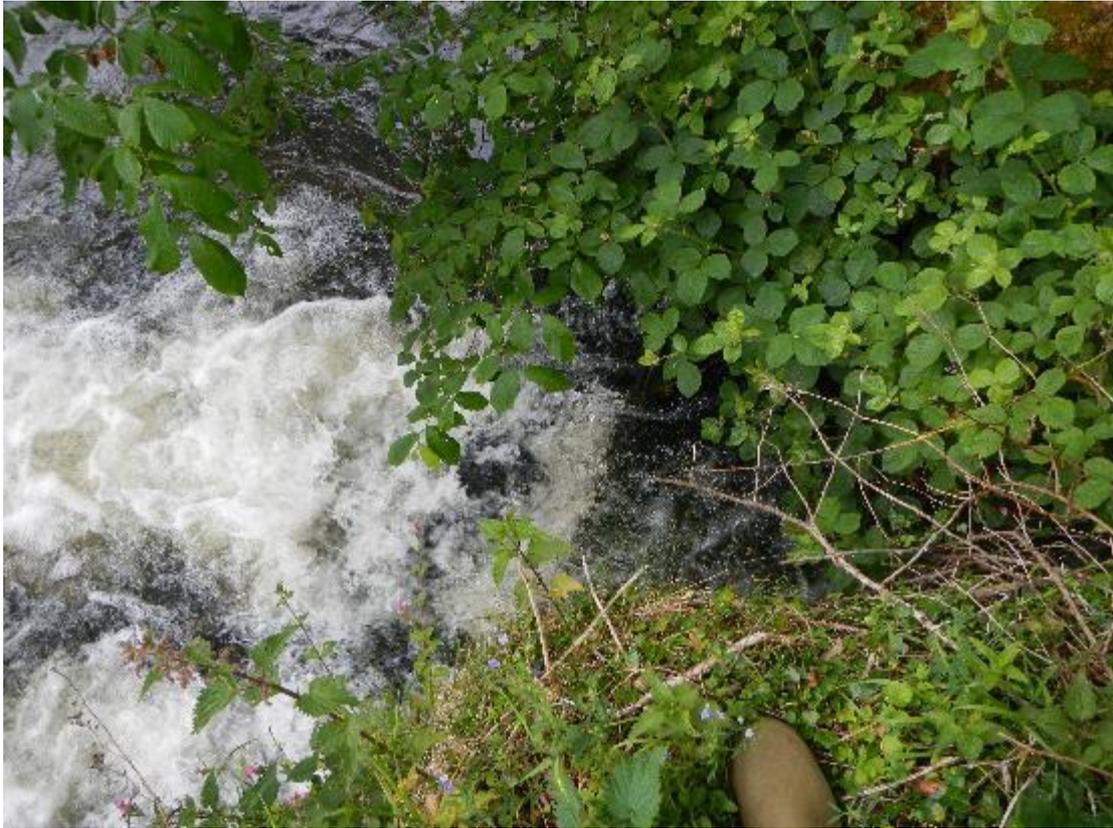
Photo 3. The downstream outlet of Denwick Upper Weir fish pass. The step here is too high and uneven, crossing a multi-level surface. This greatly reduces the ability of fish to enter the pass.

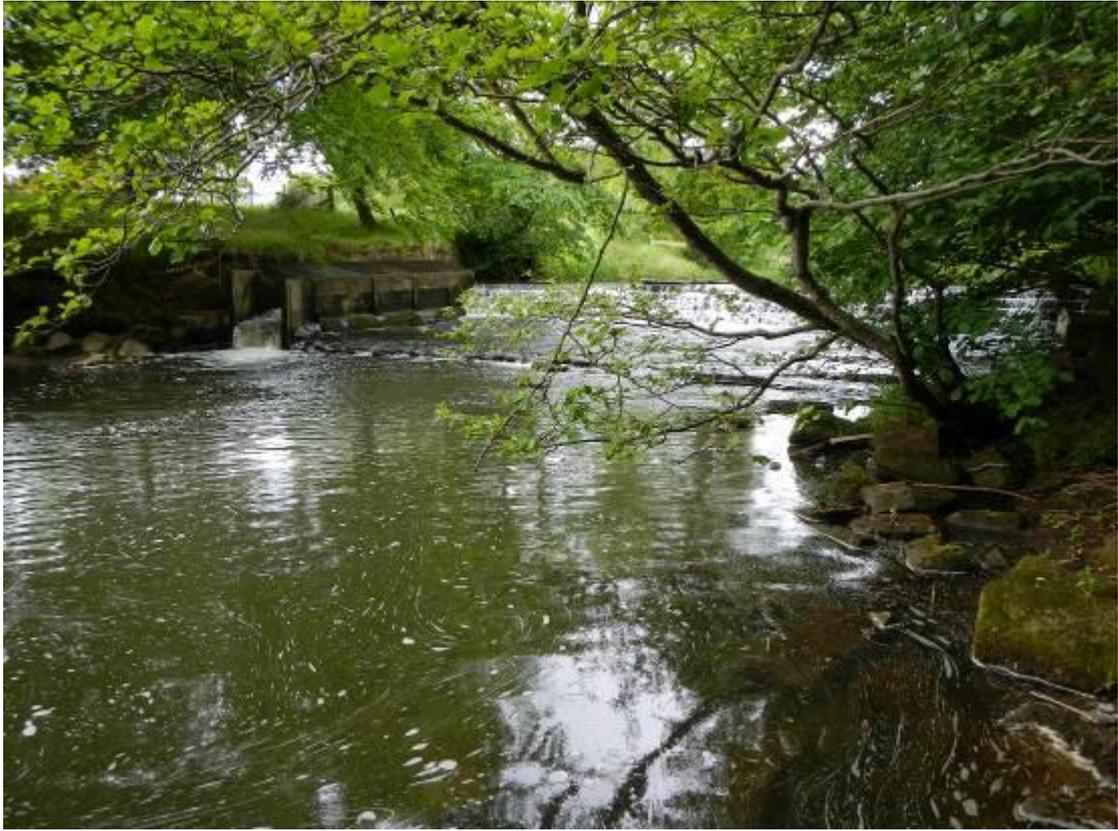
Downstream of the weir is a short impounded section to Lower Denwick Weir (Photo 4) which has a pool traverse fish pass installed on the RB (Photo 5), along with an eel pass on the LB (Photo 6). Both passes have become perched, well above the downstream water level, and are not operating at optimal efficiency (not at all in the case of the eel pass). It appears as though the water level downstream has dropped since the passes were built; however, there is no obvious reason for this to have happened other than low summer flows suggesting the passes were not set to a low summer flow (as per best practice). Modification is required to make them operational in lower flows.

Photo 4. Lower Denwick Weir with a pool traverse fish pass on the true RB (background).

A nappe could be installed on the downstream end of the fish pass to remove the angular step and avoid the cavitation that is occurring behind the discharge, thereby improving its passability. However, ideally, one (preferably two) additional pool(s) should be installed to extend the pass below the downstream water level and reduce the height of the initial jump into the pass. This would also greatly increase its suitability for smaller fish. Attempts have already been made to extend the eel pass, although not far enough to make it passable in the flows observed during the visit. This too requires improvement.

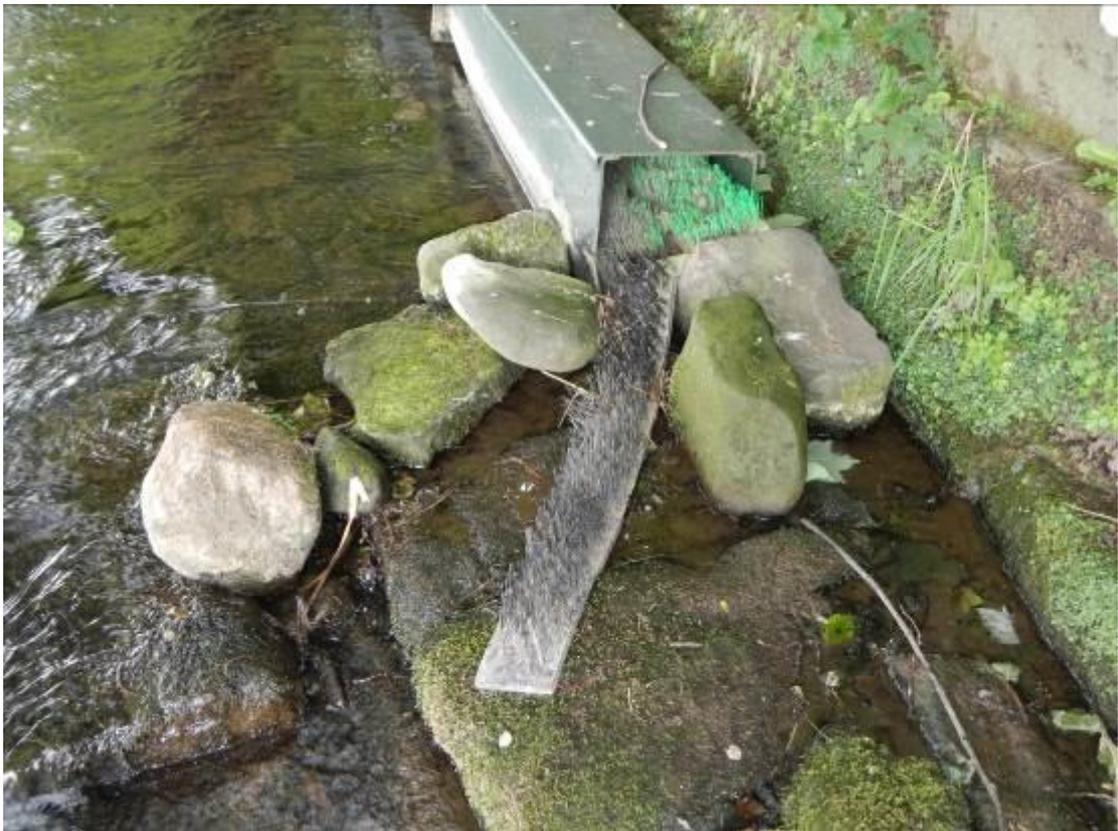
Photo 5. Eel pass on the true LB at Lower Denwick Weir. This is significantly perched above the water level and requires extending to meet the water level in all flows. Past attempts at a temporary fix are now also left high and dry. It is now an appropriate time to undertake a proper fix and extend the pass to the downstream water level as it is currently ineffective.

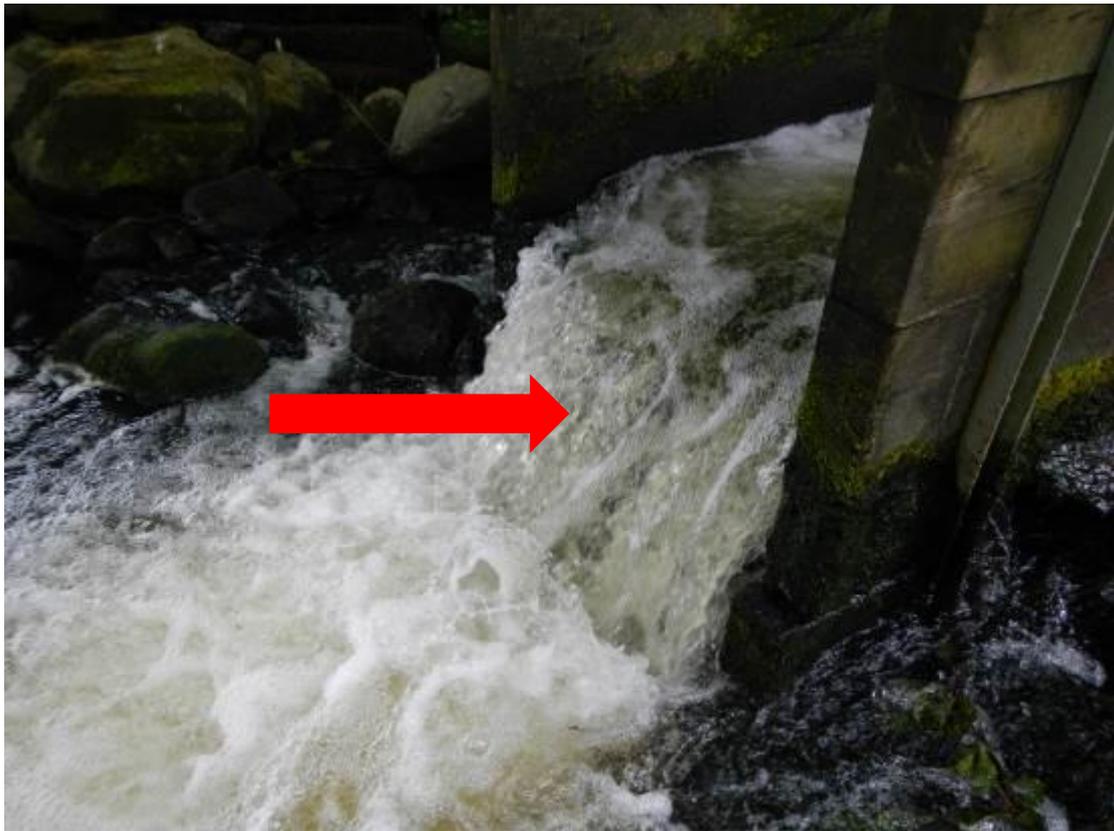
Photo 6. Discharge of the pool traverse pass at Lower Denwick Weir. The white water visible at the overspill from the lowest pool indicates that there is a gap behind the water (red arrow) meaning that fish have to jump the significant distance into the pool. The installation of an adherent nappe here would allow larger, more powerful fish to swim up within the water column and may serve as a short-term improvement. However, the pass ideally requires one or two additional pools to reduce the significant jump into the pass.

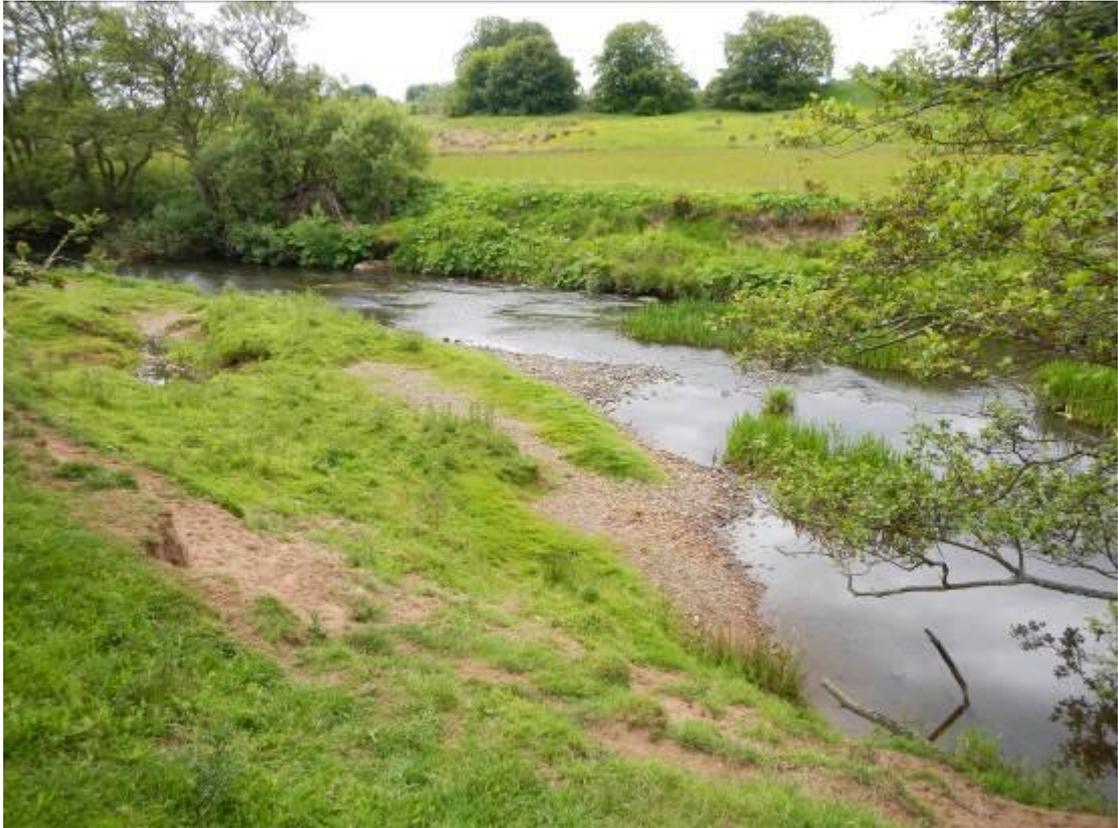
Downstream of the weir, the channel morphology diversifies and the first signs of gravel bars were observed. The channel is over-capacity from past dredging and realignment from its original course, but the natural narrowing effect of the gravel deposition, coupled with encroachment of emergent vegetation, has led to the formation of riffles where fish are reported to spawn (Photo 7). (N.B. The narrowing and deposition is somewhat inhibited on both banks by grazing, which prevents the deposited material from being consolidated by vegetation into new river bank).

Photo 7. The first notable, natural geomorphological features, where gravel depositions have begun to narrow the over-capacity realigned channel. The accelerated flow caused by the narrowing creates some potential for fish spawning, but egg and alevin (egg sac fry) survival is likely to be compromised by sediment and algal covering. Preventing livestock access would assist the natural narrowing process.

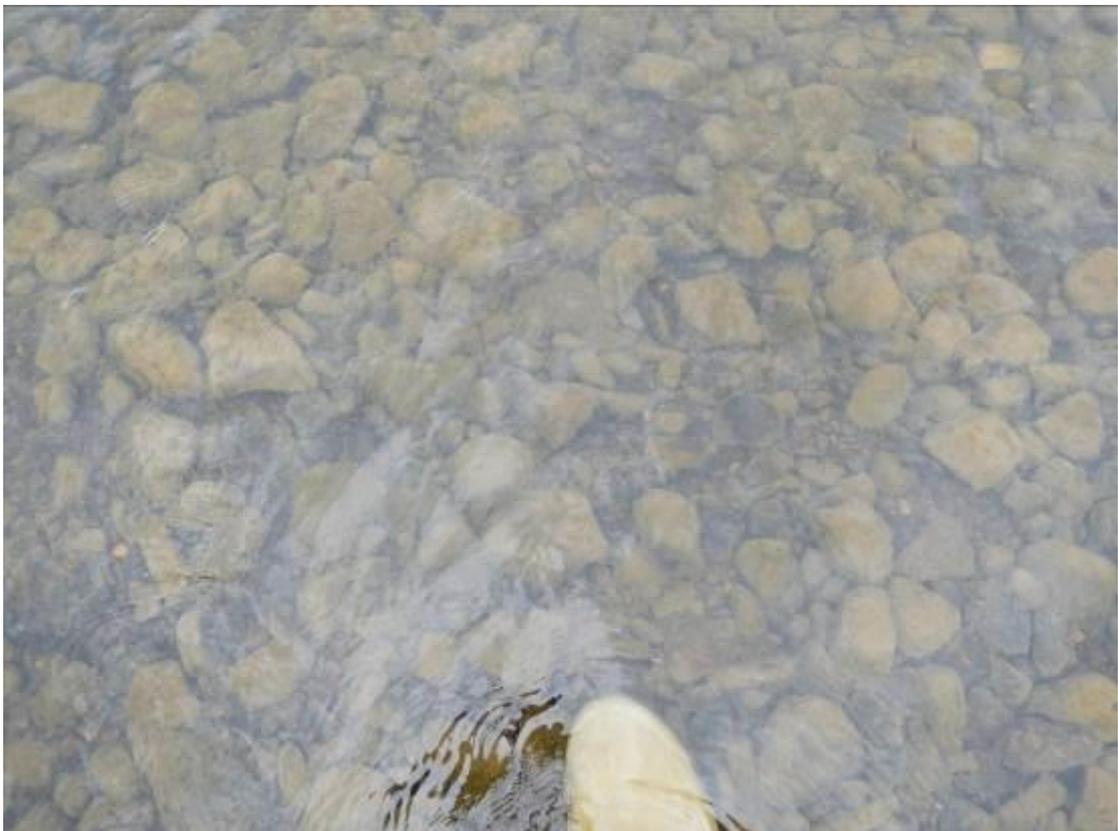
The quality of the gravel for spawning is greatly diminished by the heavy sediment loading and an algal coating (Photo 8) which indicates sediment and nutrient inputs must be occurring upstream, especially as they are not alleviated by the long impounded sections upstream which should help to settle both out of the water column.

Photo 8. Large gravels of a suitable size for larger salmonid spawning but the brown appearance is due to a heavy silt and algal loading.

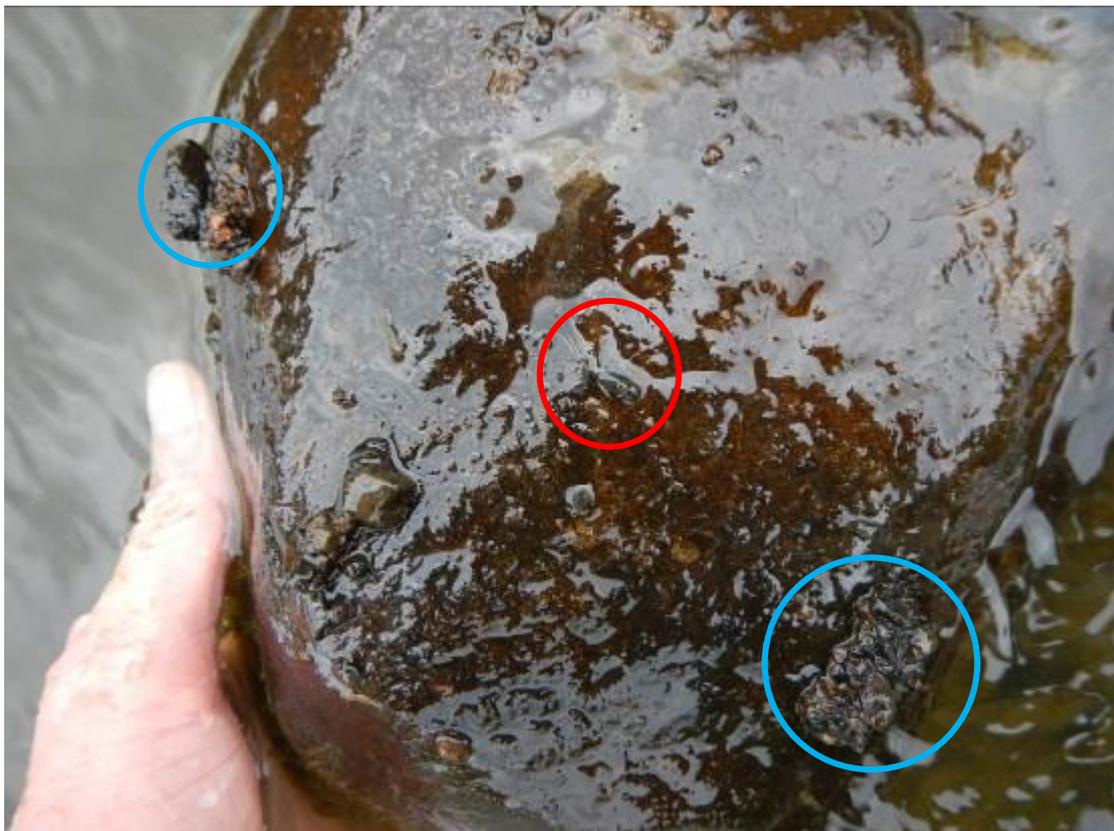
Despite the sediment and algae, valuable invertebrate communities were observed by stone turning, with cased cassis flies (Trichoptera) and mayfly nymphs (Ephemeroptera) observed. Both of these would, however, benefit from reduced sediment and nutrient inputs.

Photo 9. Stone turning revealed both mayfly (red circle) and caddisfly (blue circles) nymphs.

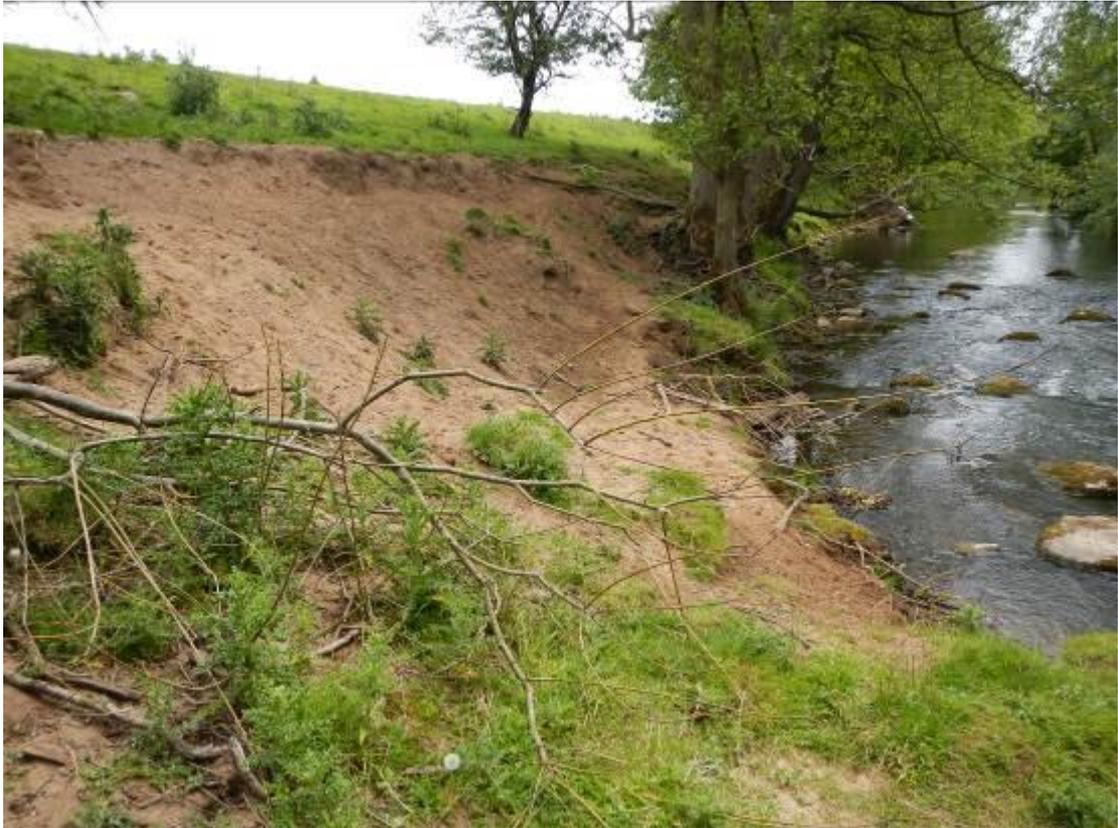
Livestock access to the river bank in this area is having a significant impact upon habitat quality, with heavy grazing preventing the development of a rough herbaceous margin on the LB. Scarring from sheep trampling, which has contributed to the loss of vegetation diversity and promoted a near monoculture of grass (where still present), is also greatly increasing bank erosion and sediment input to the river (Photo 10). Furthermore, as the friable, sandy soils are readily washed away in high flows, the loss of bank material also places the mature trees in jeopardy of washout; these will not be replaced as the heavy grazing is preventing natural tree regeneration. Installing buffer fencing along all grazed sections would greatly reduce the rate of erosion.

Photo 10. Erosion through sheep grazing which leads to loss of land, sedimentation of the watercourse and, ultimately, loss of trees. Note how much of the bank around the tree roots has already been lost, which will destabilise the trees. The lack of natural tree regeneration also means that any mature trees that are lost will not be replaced.

It is recommended that stock-proof buffer fencing is installed along all grazed river bank sections to prevent livestock access and promote the kind of healthy, well vegetated and stable river banks present in the un-grazed riverbank sections, as seen in Photos 16, 17, 19, 20 & 21. This will promote natural tree regeneration, improve habitat quality and reduce land erosion to a natural low rate, saving the landowners and tenants from losing land.

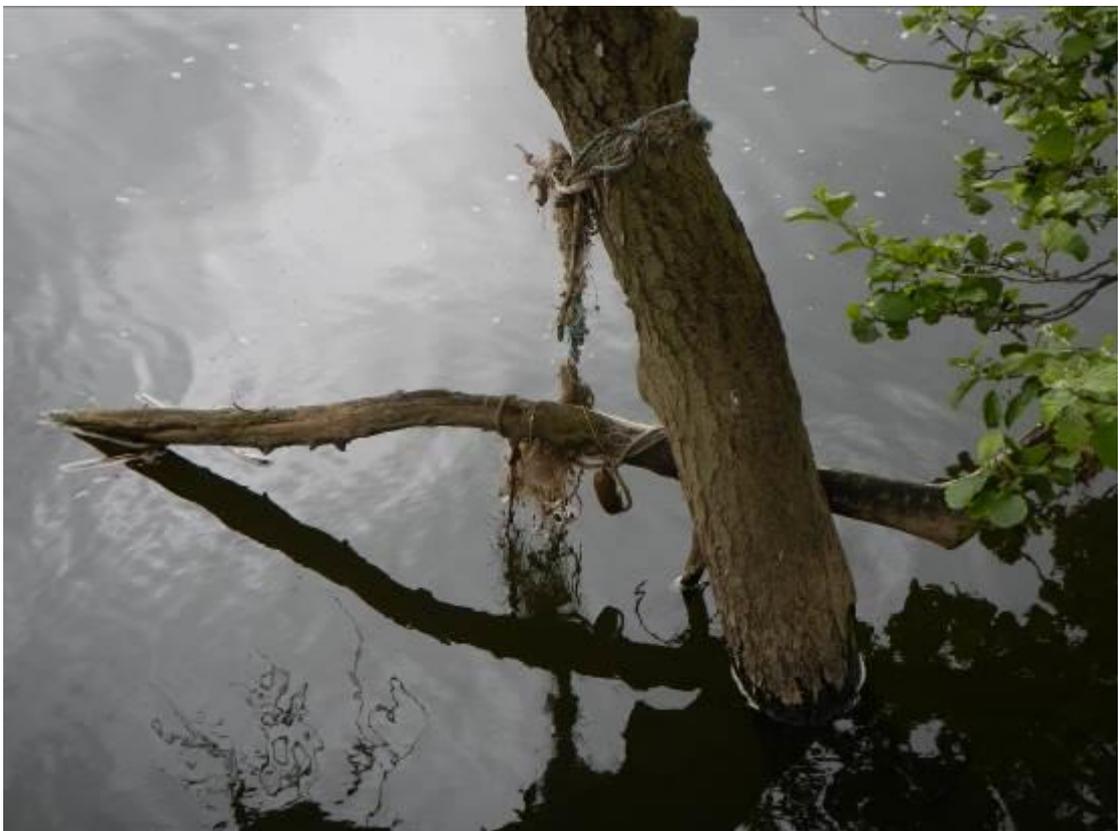
Signs of illegal fishing are well-evident on the reach, with the remains of an old net (including mesh, float and lead lines) hanging from a bankside tree. This highlights the fact that poaching on the River Aln is still an issue and something to watch out for, reporting it to the Environment Agency or Police (whichever is applicable) when observed.

Photo 11. The remains of a poaching net hanging in a bankside tree.

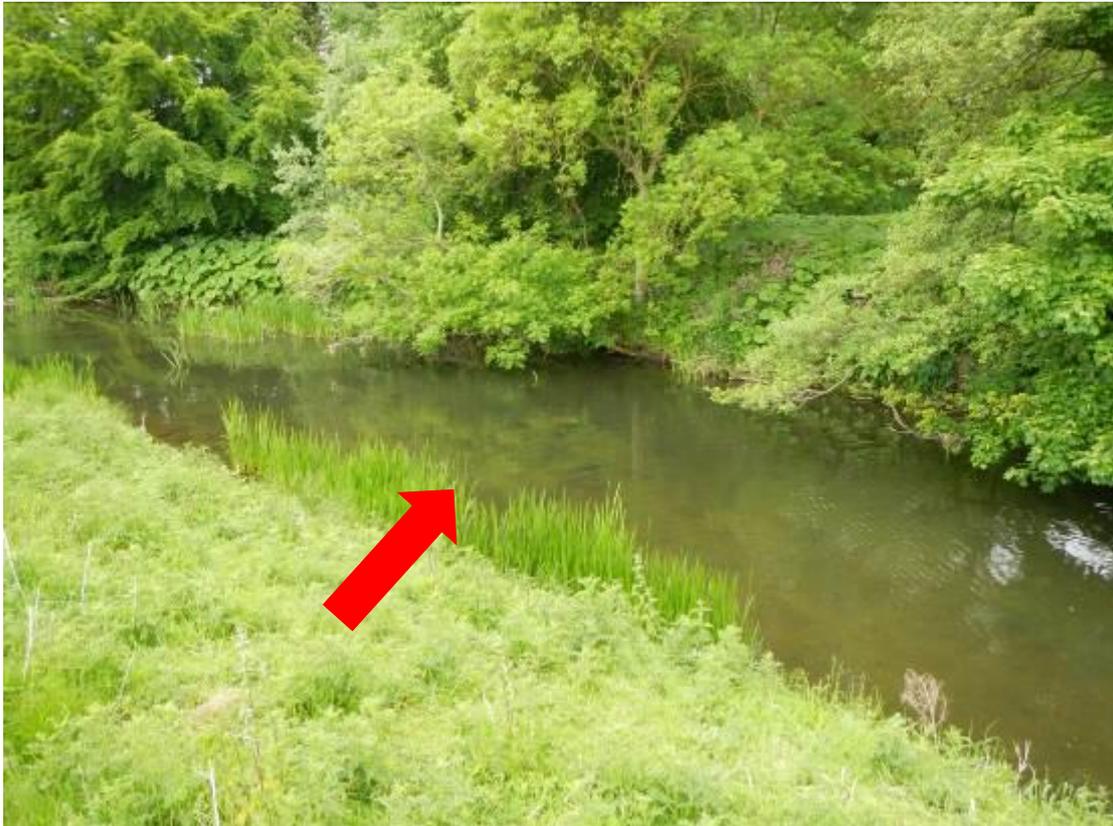
Sections of dredged, straightened channel are obvious throughout the reach, but where low-hanging and trailing trees are present, some potential adult trout and migratory fish holding water is available (Photo 12). Marginal and emergent vegetation helps to pinch the channel and, if promoted, will help the river adjust to more appropriate dimensions as it accumulates and consolidates sediment to form a new, narrower channel.

Photo 12. Some adult fish holding habitat, although the channel is over-wide. Beneficial natural narrowing through the encroachment of marginal vegetation (red arrow) is part of the river's natural recovery process.

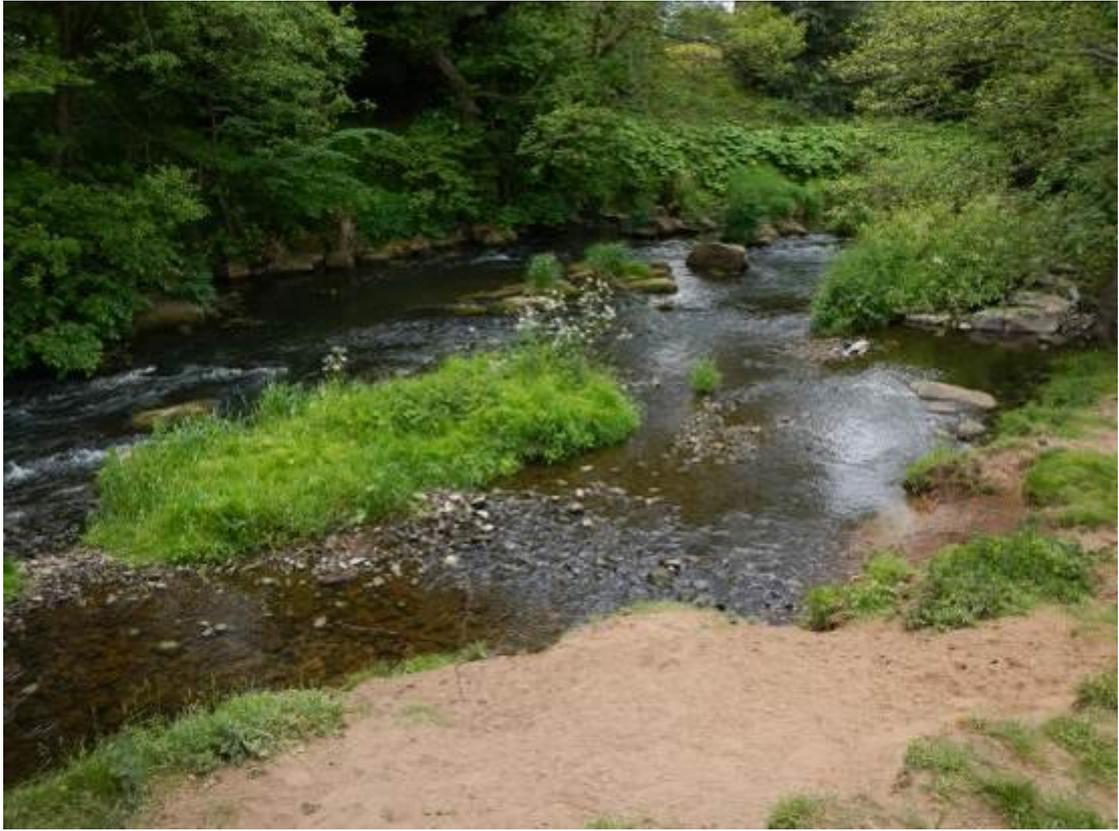
Areas of higher quality habitat are also present for both juvenile (Photo 13) and adult fish (Photo 14), although these areas could still be greatly improved. The shallow area upstream of the A1 road bridge would improve further if livestock were excluded from the bank as this would reduce erosion, prevent further channel over-widening and facilitate natural narrowing. The habitat along many other sections, particularly where mature willows (*Salix* spp.) are present (as in Photo 14) could also be improved by laying some or all of the tree into the water to increase the availability of low-level and trailing cover; this would provide shade and shelter for fish along with creating structure in which they can evade predators. In this way, bankside trees and large woody debris (LWD) can greatly reduce piscivorous bird predation.

Photo 13. Juvenile trout and salmon habitat that could be improved by excluding livestock from the riverbanks to reduce erosion and channel over-widening.

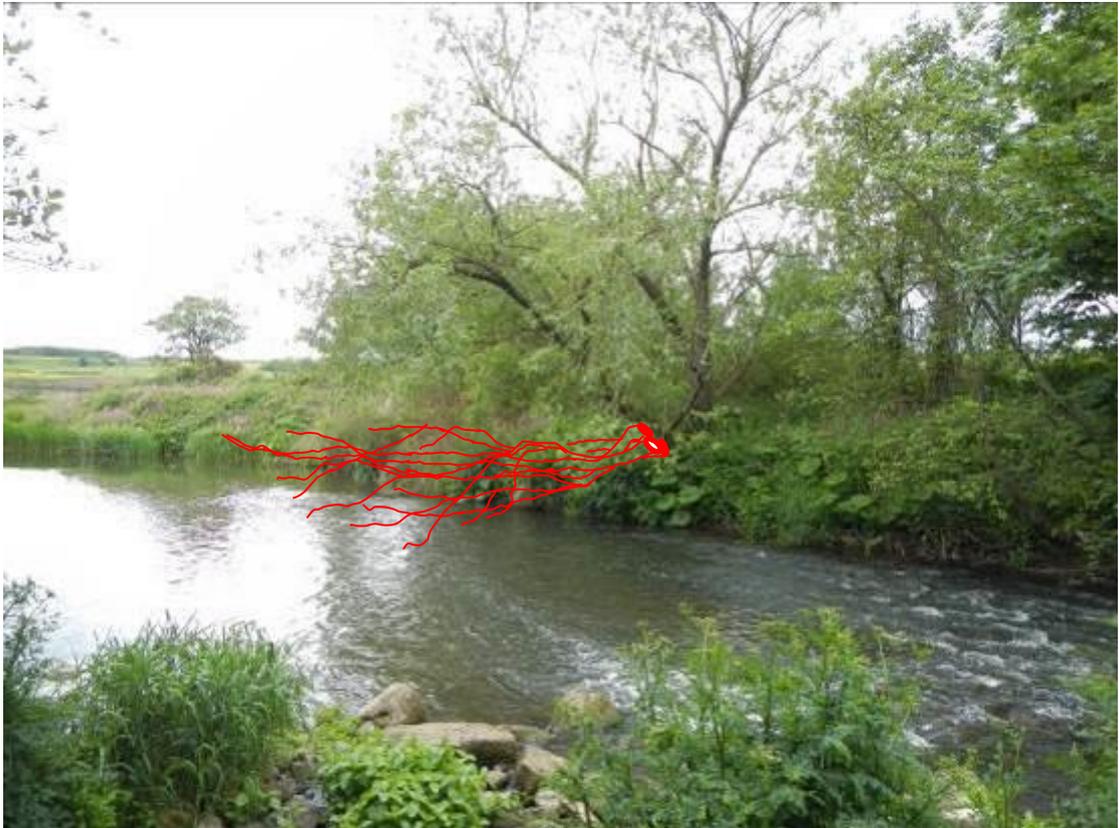
Photo 14. Good quality habitat for adult salmonids that could be improved further by laying one trunk of the willow tree into the channel to increase the availability of low and trailing branch cover (as demonstrated by the red outline).

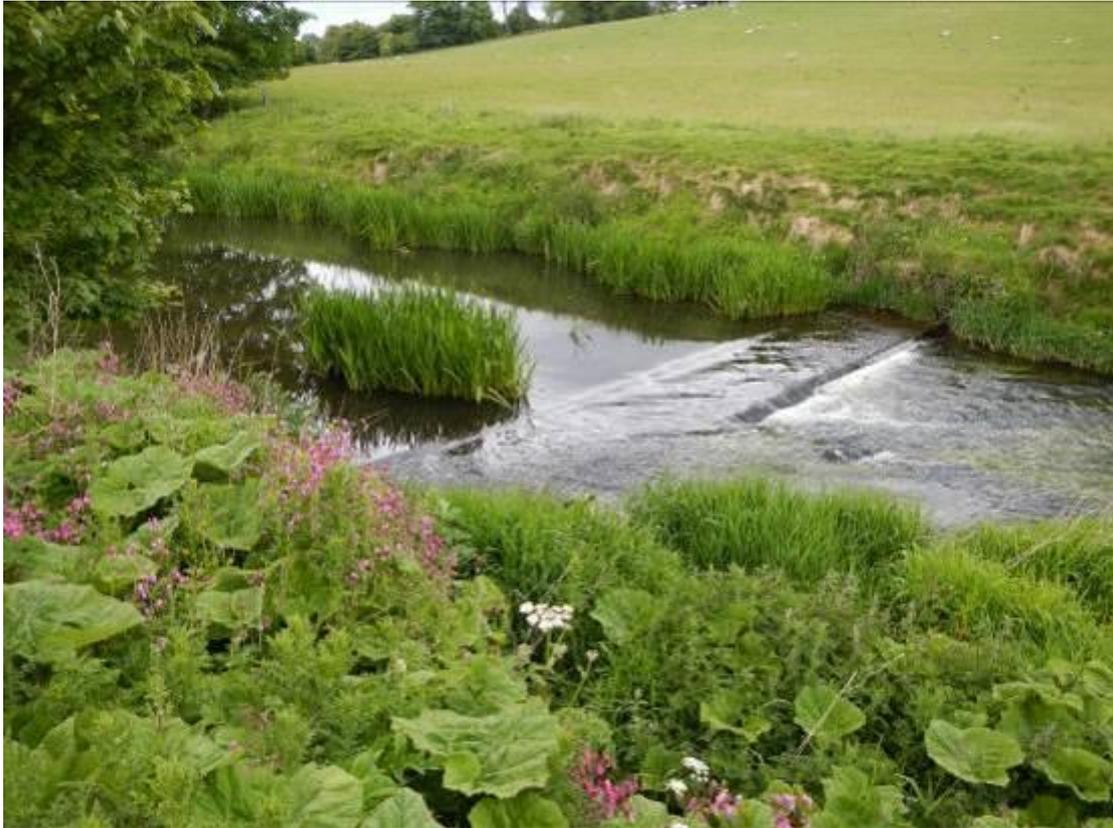
A short section of the river upstream of Hawkhill Bridge was not intended to be walked; however, a decision was made to backtrack up the river as far as an old weir (Photo 15). This was a worthwhile exercise as, although the weir is very low, it still impacts negatively on the river. The structure will certainly be difficult for smaller fish to pass, and potentially for larger fish in low flows (particularly salmon as they are less adept at traversing shallow water than sea-trout). Possibly more significantly, the weir also creates a fixed bed cross-section, impounding the river upstream and preventing scour and natural maintenance of bed dimensions, over-widening the channel, reducing the natural narrowing effect of emergent vegetation and inhibiting sediment transport downstream. For all of these reasons, redundant weirs should always be removed, if possible.

Photo 15. For the numerous reasons listed above, this weir upstream of Hawkhill Bridge should ideally be removed.

It is also recommended that the small weir c. 550 metres upstream of Hawkhill Bridge (NGR: NU2115012919) (Photo 15) is removed or at least notched to remove the central 1/3. The Council should also be contacted to discuss the issue of fish passage at the newly installed culvert (NGR: NU2111612226) on the small tributary, as loss of spawning tributaries can have a potentially significant impact upon fish stocks.

Planting is recommended wherever there is a lack of low cover and structure along the river margins, e.g. Photos 15 (if fenced), 16 & 24, and particularly where the bank is eroding (Photo 17). Most locally native deciduous species would be beneficial but willow is by far the easiest to transplant and manipulate.

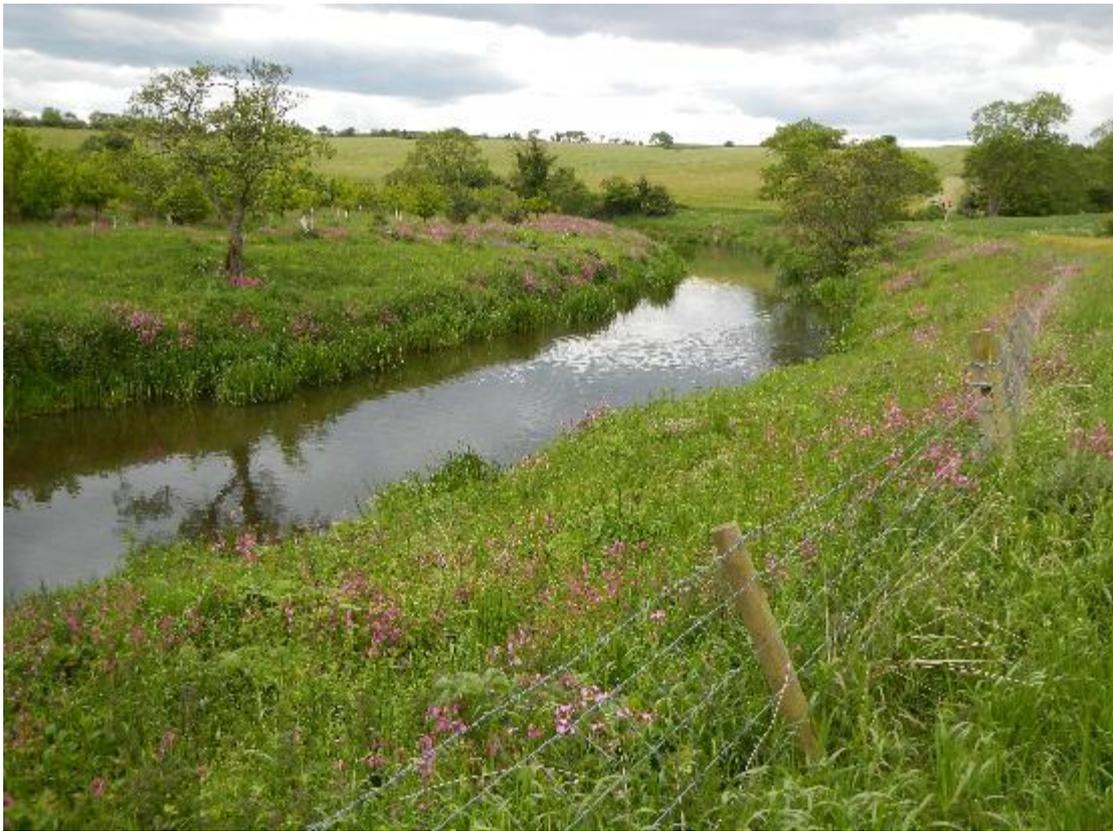
In the upper section of the Hawkhill Bridge to Greenrigg reach, realignment remains an impact and additional trees and LWD would be beneficial. However, a well-vegetated buffer strip provides excellent habitat for invertebrates, along with a host of other wildlife. The vegetation also provides excellent bank protection and, consequently, there is very little erosion. One notable area of erosion does exist, where a high, steep bank appears to suffer from waterlogging (probably over a band of clay) and undercutting on the outside of a bend, downstream of a long straightened (and so steepened) section that accelerates flows into the bend.

Photo 16. Superbly well vegetated river margins afforded by a generous buffer strip.

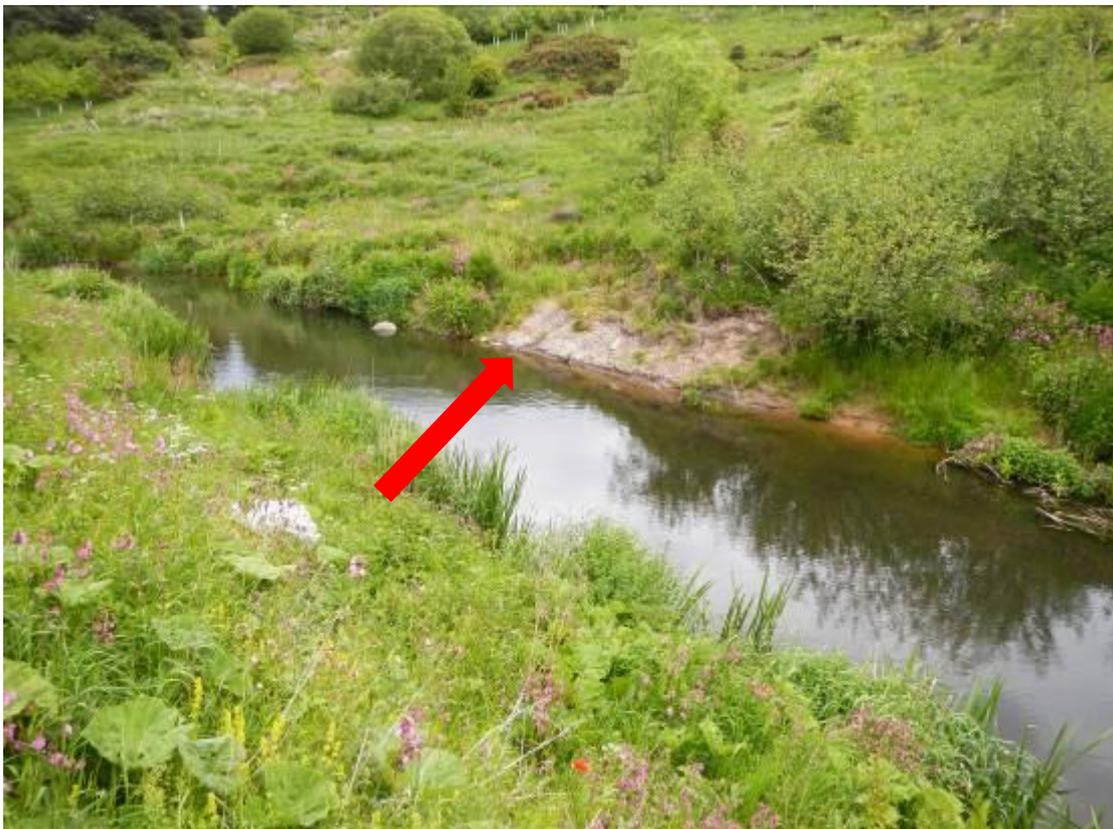
An arable field at the top of the bank may have field drains discharging onto the slope which would further contribute to the waterlogging. Although the bank appears subject to periodic slippage, it is not considered a major concern; the bank material remains relatively consolidated through the abundant vegetation and saplings and the slope is now reaching a more stable angle. Planting the toe of the bank with additional willow whips may further stabilise the toe, but even if small amounts of bank are lost occasionally, the overall impact on the river is likely to be minimal.

Photo 17. The base of a slumping bank which appears to be naturally regrading and stabilising over time (red arrow). Willow whip planting in this area would improve marginal habitat and potentially protect the bank toe, reducing erosion and slumping.

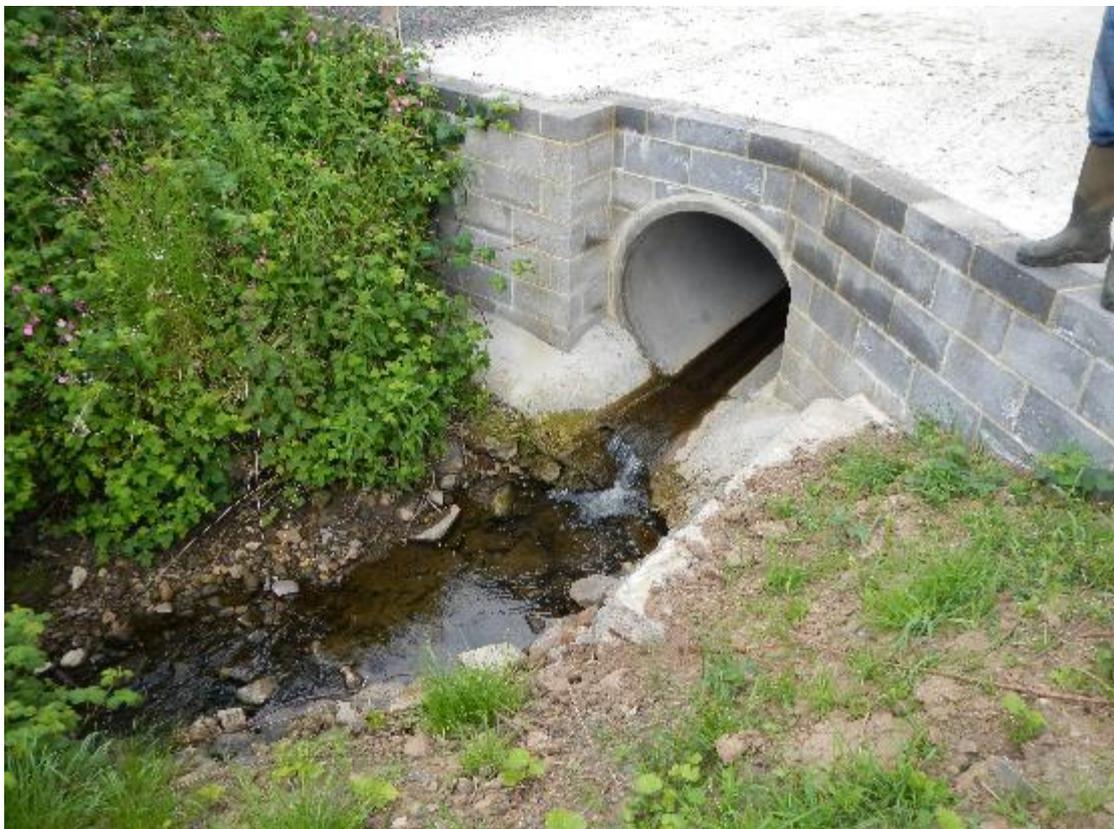
Approximately half way down the reach, a small tributary enters the river on the RB. This should ordinarily provide a potential spawning tributary for resident trout and sea-trout; however, recent culvert work has rendered the tributary almost impassable in most flows. This is one of the issues that can occur when appropriate fishery management advice is not given, or not adhered to during the Flood Defence Consenting process.

The issue could very easily have been avoided by simply over-sizing the culvert, so that it could be installed with at least 1/3 of its capacity below the natural bed level. This would allow adequate sediment transport and facilitate the formation of a natural bed (gradient/substrate) through the culvert. This would have prevented a step from developing at the outfall that causes issues with fish passage and ongoing maintenance issues for the landowner/tenant.

Photo 18. A poorly installed culvert that has resulted in a step and steep, confined channel which greatly inhibits fish passage into a potentially valuable spawning tributary. This issue should be raised with the local Council permitting team and the Environment Agency.

This issue should be raised with the local Council permitting team (and the Environment Agency fisheries enforcement team) as it is not acceptable and constitutes an offence under the Salmon and Freshwater Fisheries Act 1975 if fish passability at the location has been reduced by the new structure. Such developments should be seized by the permitting teams as an opportunity for improving fish passage, as is their duty as a competent authority.

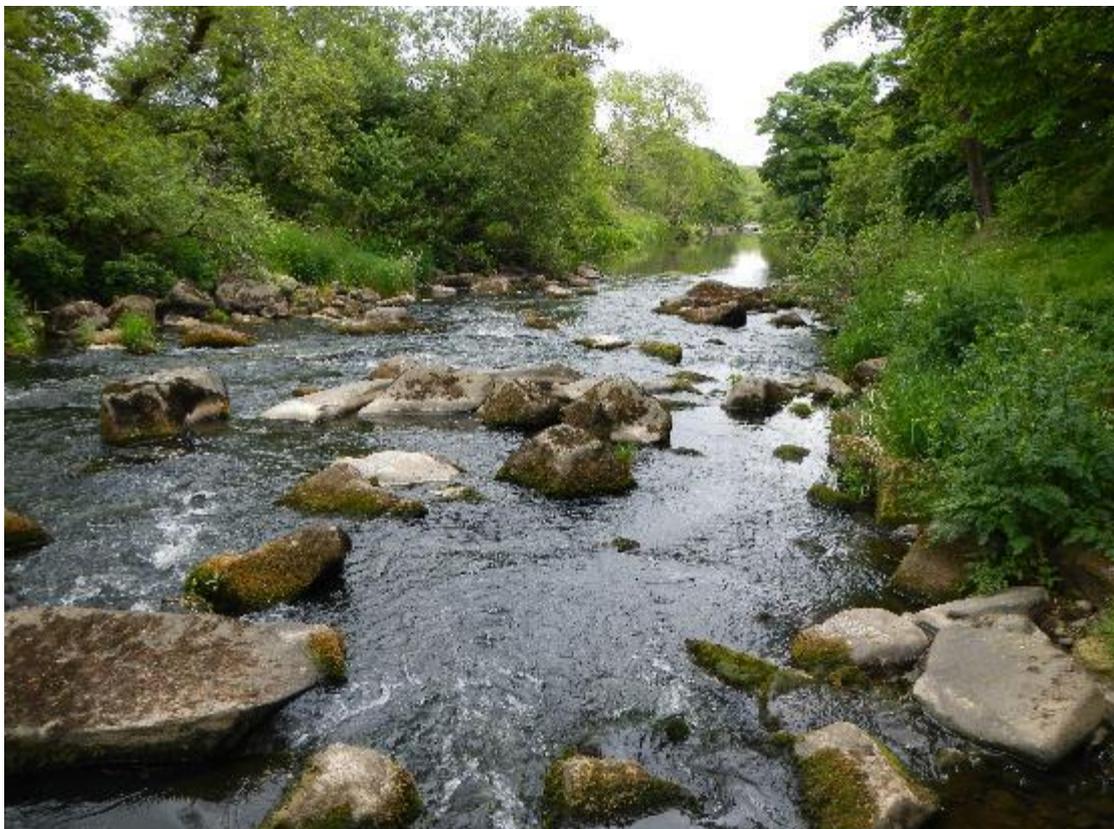
Downstream of the tributary, the river enters a steep, straight section (Photo 19) which, unlike many of the other straight sections, appears to be a natural gorge, as evident by surrounding topography and the higher quality river channel with natural substrate and dimensions. Through this section, excellent flow diversity creates abundant juvenile and adult trout habitats.

Photo 19. High quality, diverse habitat for all trout life stages through what appears to be a naturally straight gorge section, where little, if any, past channel maintenance appears to have been undertaken.
