Advisory Visit

River Aln

Northumberland

15/06/2015

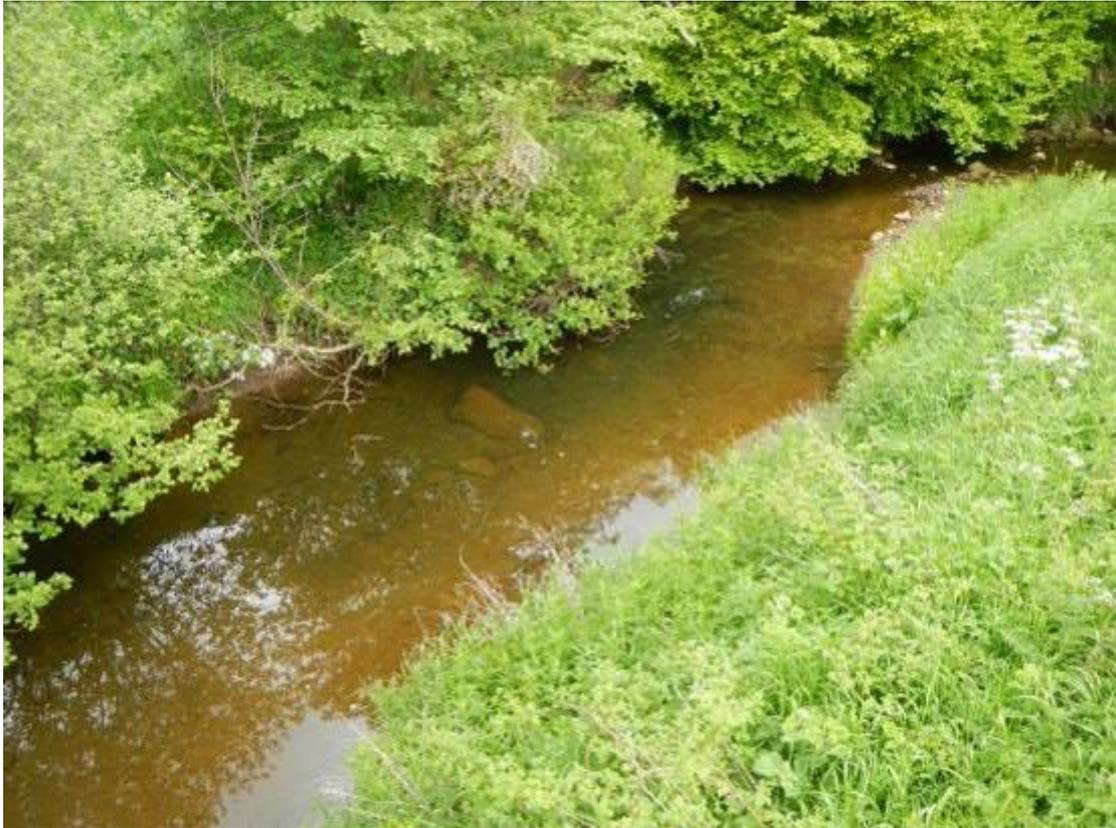
The Cawledge Burn enters the river at the downstream limit of this reach and provides another significant potential spawning tributary (Photo 20). The Burn has recently (2014) been reclassified as being in 'good' ecological condition from a classification of 'poor' in 2009. This suggests that the juvenile fish stocks have improved, as they now score as 'high', as do the invertebrate assemblages.

It is understood that fish passage improvement work has been undertaken on the Burn, and this may well have contributed to the improvement. Fish passage on small tributaries is a vitally important and often overlooked factor, affecting fish stocks through both spawning and juvenile habitat/dispersal. Another is sedimentation, which seems to be an issue, as observed by a significant coating of fine sediment on the substrate. This too should be looked into as a brief walkover of the burn may identify the erosion issues and/or runoff that is contributing.

Figure 20. The Cawledge Burn offers significant potential as a spawning tributary and juvenile nursery area but appears to be impacted by sedimentation.

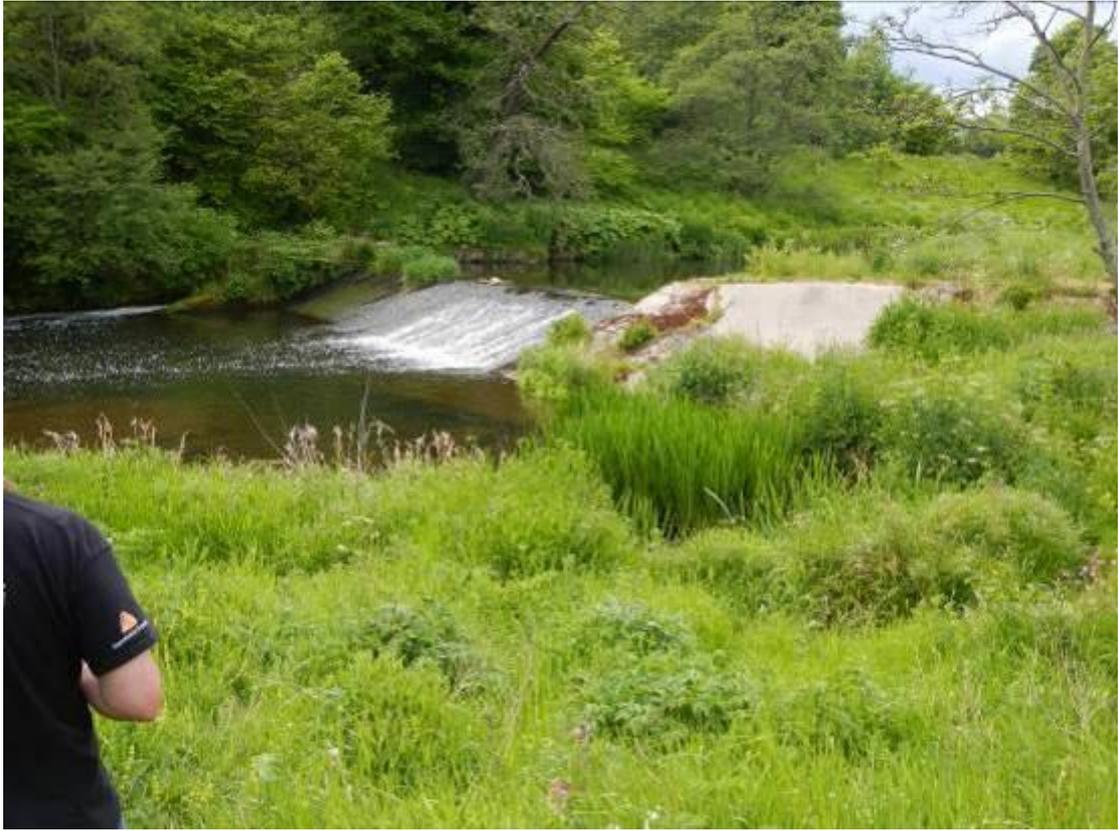
The weir itself is an impact upon the river, creating the impounded reach upstream, preventing natural sediment transport downstream and inhibiting fish passage (Photo 21). Unfortunately, the presence of the East Coast Railway main line bridge crossing, which is already showing issues of stability, is likely to be further destabilised by removing the weir and so the decision has been made to retain it. A reasonably effective Larinier-type fish pass has been installed on the weir which at least reduces the issue for the passage of larger fish – something attested to by the fact that migratory fish no-longer accumulate below the weir in large numbers as they used to. This further supports the fact that fish generally only accumulate downstream of an obstruction if it is a real issue for fish passage – not just because of lower flows.

Photo 21. Lesbury Weir - now far less of an obstruction since the installation of a Larinier fish pass.

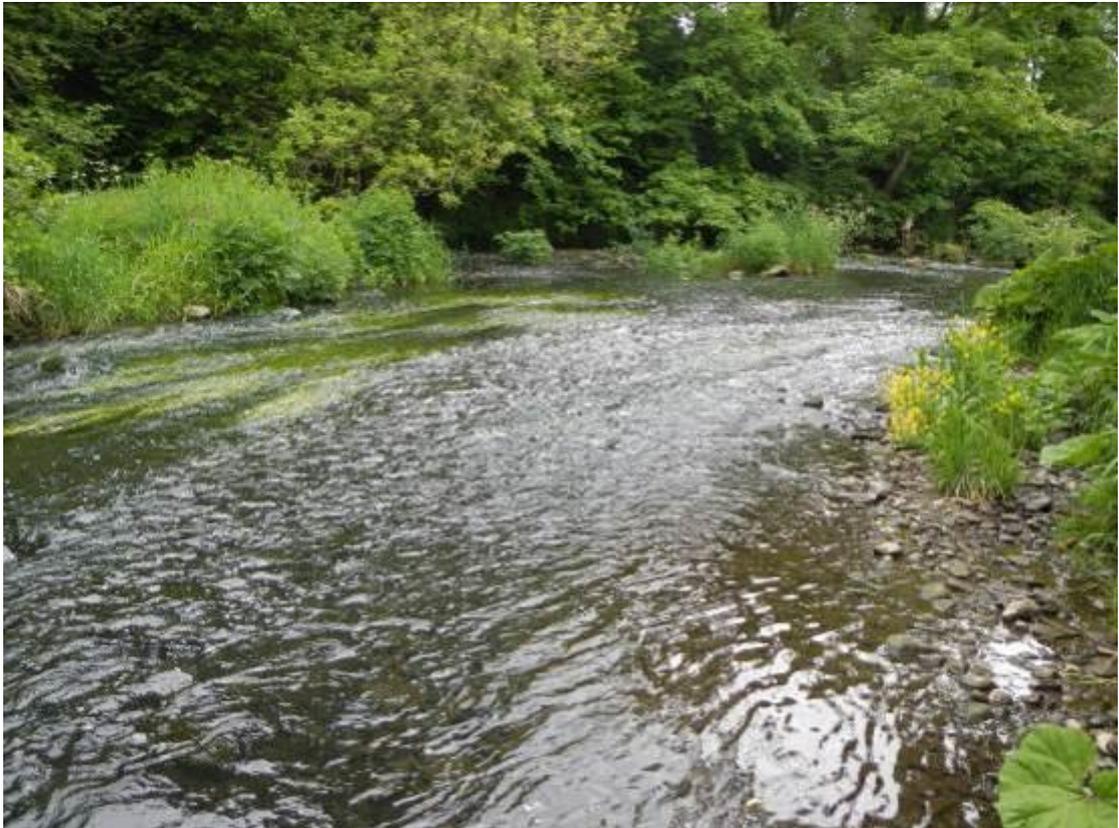
Downstream of the weir, high quality trout habitat is available, with a mixture of shallow gravelly riffles (ideal for many beneficial invertebrate species and fish spawning) (Photo 22), along with good pools and pocket water to hold both resident and migratory fish (Photo 23). Scouring in the weir pool is likely to have excavated and mobilised much of the gravels deposited within this area, somewhat mitigating the interruption of sediment transport there.

Photo 22. Good juvenile and potential spawning habitat downstream of Lesbury Weir.

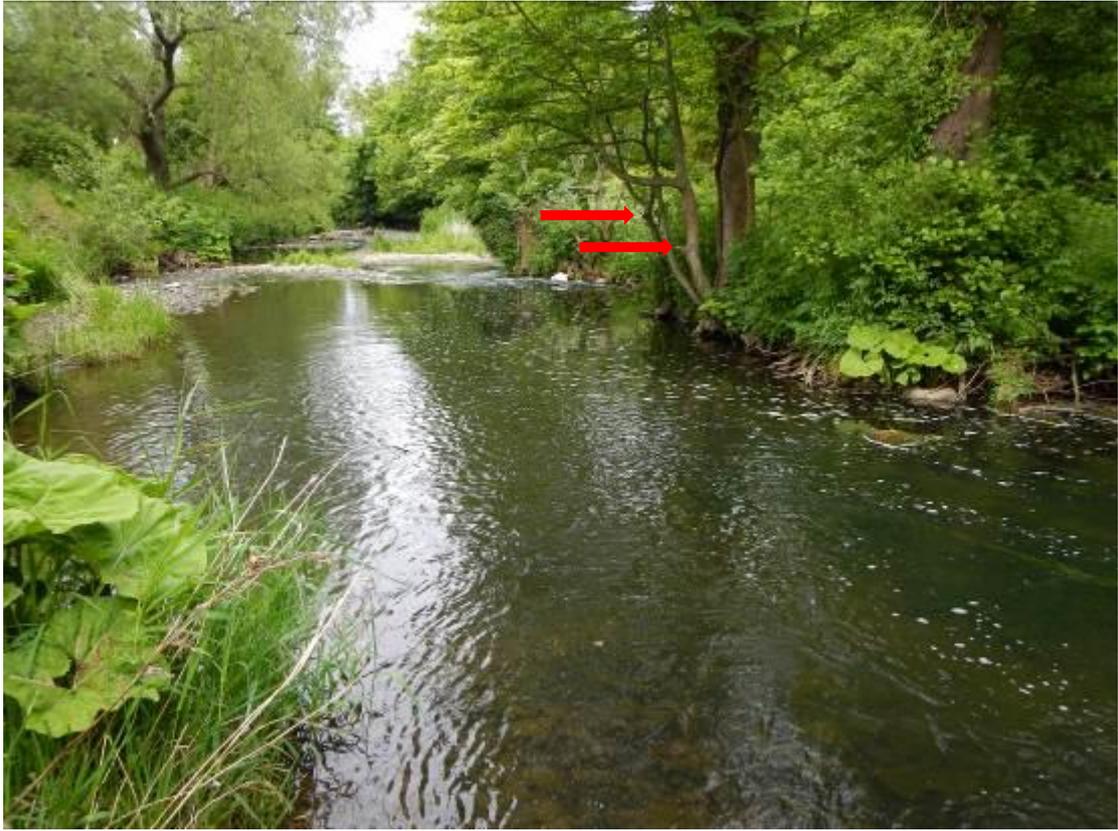
It was noted that pruning has been undertaken on some of the trees which has denuded the pool habitat of important low-level cover. This type of pruning should be avoided; it may fishing easier but it permanently lifts the tree canopy, greatly reducing the quality of cover it provides and the fish holding capacity of the pool. Coppicing could be undertaken on these trees to lower the canopy by encouraging low-level regrowth.

Photo 23. Good quality pool habitat that has been degraded somewhat by the pruning of beneficial low cover branches over the pool (red arrows). This type of action should be avoided as it greatly reduces the fish holding capacity of the pool for both resident and migratory fish. Coppicing of the trees could be undertaken to promote low-level regrowth.

In any areas where tree canopies have been lifted by pruning (e.g. Photo 23), selective coppicing could be undertaken to stimulate low level regrowth, although this should be undertaken sparingly to preserve mature tree habitat. Coppicing work should be undertaken in the dormant season (ideally Dec - Feb) to prevent killing the tree.

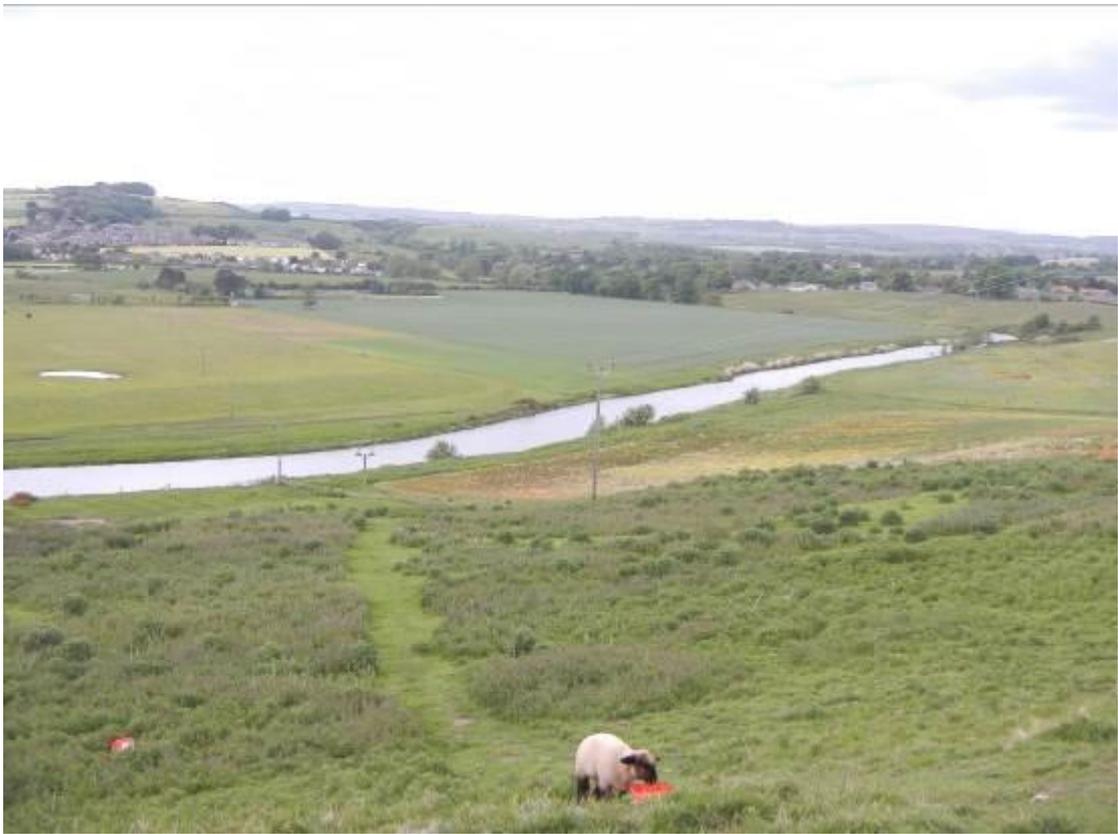
A cursory inspection was also made of the lower, tidal section of the river, from the top of the hill between Steppey Lane and Dutches's Bridge (Photo 24). Being tidal, the section is difficult to undertake improvements on but restricting livestock access to the river bank would allow the development of a healthier marginal fringe. Within buffer fenced areas, tree planting to increase shade and cover would potentially allow the relatively open areas to hold more fish, particularly in areas already recognised as holding fish.

Photo 24. Looking down at the tidal river. Stockproof buffer fencing would benefit the grazed banks and planting of mixed deciduous trees (particularly crack willow which will grow over/into the channel) within the buffer would improve cover and shade in the channel.

Planting is recommended wherever there is a lack of low cover and structure along the river margins, e.g. Photos 15 (if fenced), 16 & 24, and particularly where the bank is eroding (Photo 17). Most locally native deciduous species would be beneficial but willow is by far the easiest to transplant and manipulate.

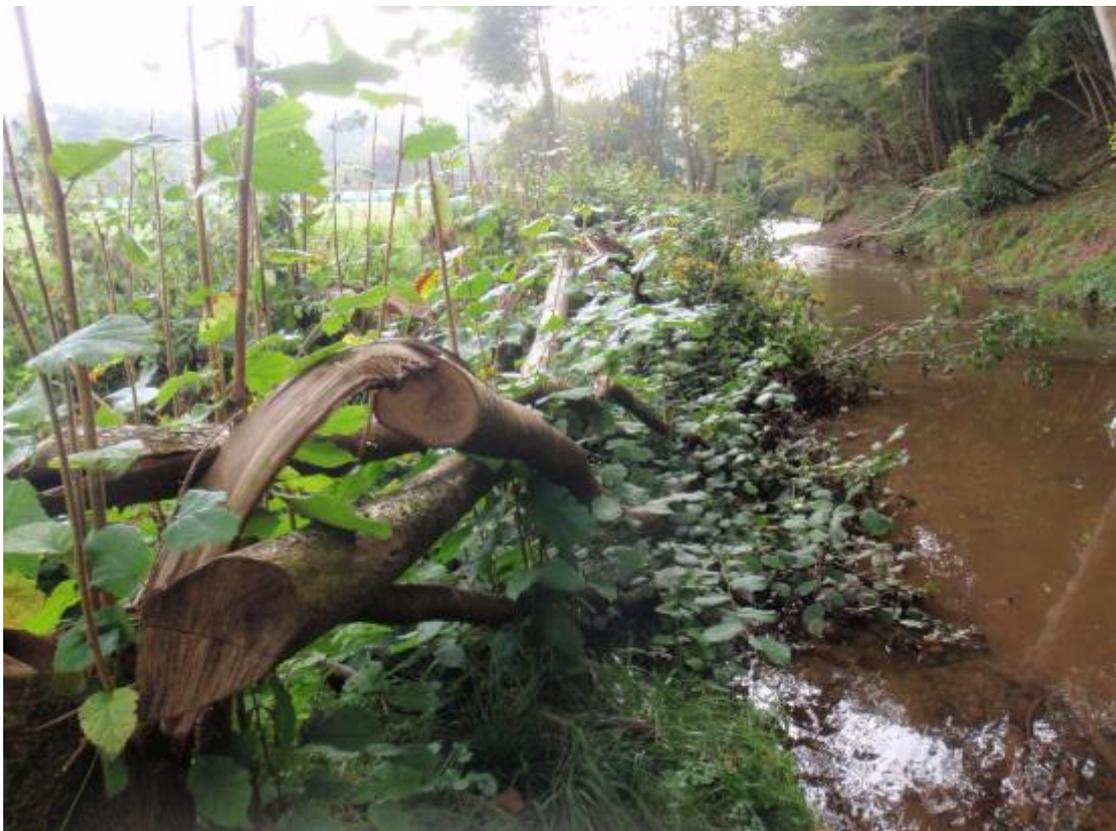
The process involves cutting part way through the stem/trunk, a little at a time (like laying a hawthorn hedge), until it can be forced over into the channel (Photos 25 & 26). The depth of the cut should be limited to only that which is required to bend the limb over, as this will retain maximum strength in the hinge and maintain the health of the tree/shrub. On smaller shrubs, simply cutting the stem/trunk at a very shallow angle and then putting an axe blade into the cut and hitting it with a hammer can also help the laying while retaining a good strong hinge.

Photograph 26. Hinged hazel.
