Pont and Blyth Investigation

River Blyth – from Hartford Bridge to Tidal Limit

(Waterbody ID - GB103022077050)

Date – 01/03/12

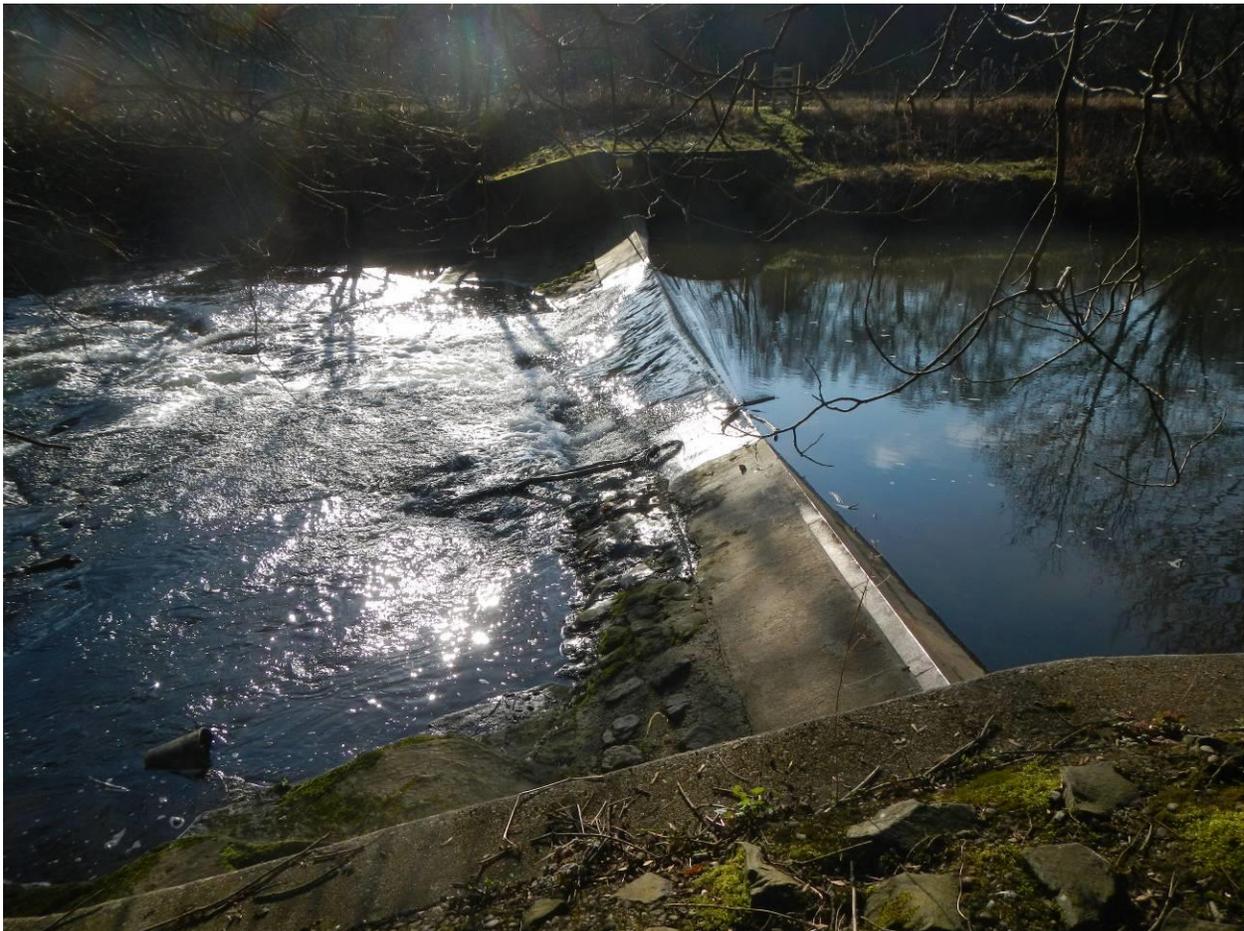
The first 100m downstream of Hartford Bridge is notably impounded by the Hartford Gauging Weir, which also creates a significant obstruction to fish passage through the river system (Picture 1). Although only around 1m high, the steep c.45° angle, sheer face, and lack of water depth over and below the weir, make it impassable to most (if not all) fish in low to medium flows.

It is known that larger migratory salmonids can ascend the weir during high flows, but the structure poses a major behavioural barrier, only passable in specific flow conditions. The weir is also likely to be a significant obstacle to brown trout (*Salmo trutta*), grayling (*Thymallus thymallus*), eel (*Anguilla anguilla*), lamprey (*Lampetra fluviatilis* and *L. planeri*) and minor species.

Picture 1. Hartford Gauging Weir, a significant obstacle for fish passage on the river.

river such as the Blyth, with other anthropogenic habitat degradation, the issue has increased significance. If this weir is no longer used for gauging, full removal should be considered, or alternative methods for flow gauging explored. If this is not possible, a fish pass is essential.

The two primary issues are Hartford Gauging Weir (NZ2435880050) and Humford Weir (NZ2613579746). Consideration of the possibility for removal of both of these structures is strongly recommended. The potential restrictions are likely to be, scheduling, or listings on Humford Weir and the potential requirement for gauging at the Hartford site. It may be possible that more advanced, modern gauging techniques with a reduced impact on the channel could be employed for gauging at the Hartford.

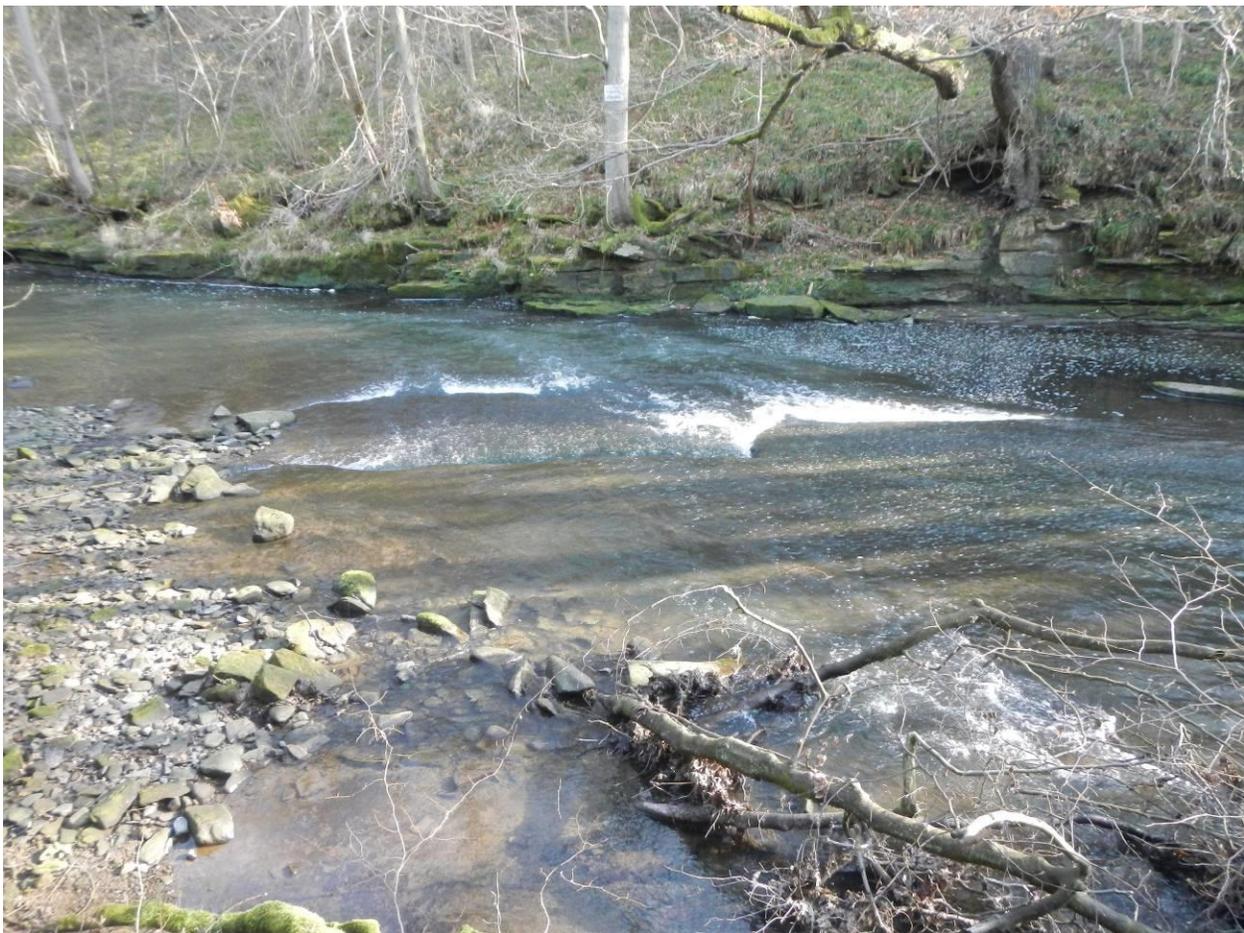
Downstream of the weir habitat quality improves significantly for salmonids, but there is a notable lack of fine and medium gravel substrate. Bed composition is dominated by bedrock and cobbles for the first c.1500m downstream, with numerous riffles, glides and small pools within fissures in low lying areas of the rock. This is similar to the reach upstream of Hartford Bridge, but with areas of significantly narrower channel throughout the reach (6-9m wide), which create more dynamic flow and greater velocities (Picture 2). From c.500m downstream wider pools of c.10-15m also occur.

Picture 2. Diverse flow within a narrow channel, which creates good quality salmonid habitat. Note the retention of some mobile substrate to the left of shot, downstream of the LWD, in an otherwise smooth bedrock channel.

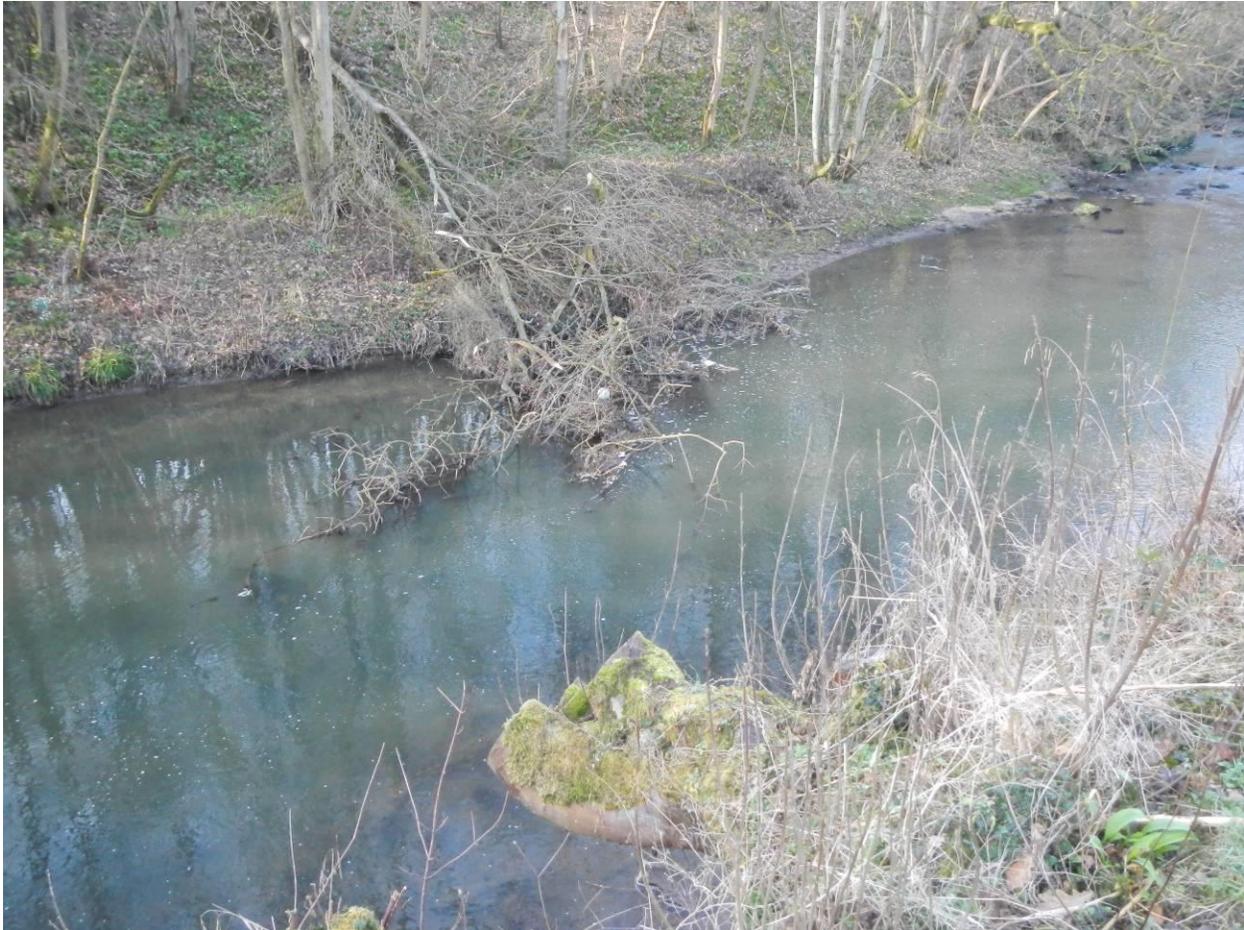
Picture 3. Fallen tree, being retained in place against other trees. The LWD created is restricting the channel, increasing flow diversity and providing structure within the pool that will vastly increase fish holding capacity.

Without the additional cover provided by the fallen tree in picture 3 the habitat would be of significantly lower quality as the wide slow nature of the pool provides limited cover or flow diversity. The tree branches provide some increased flow diversity, cover and shelter for fish and invertebrates to inhabit.

It is recommended that living trees and shrubs be retained, as they are naturally anchored in situ. Simple natural methods could also be employed to retain larger material and LWD in place, as seen in picture 3, where a tree has fallen into the River and the tip branches are creating excellent structure within a deeper pool. As the majority of the tree is on the bank and braced

against other trees it should be retained in place by the force of water acting on the fallen limb, which will pin it against the upright trees. Although this example is promoting structure and flow within a pool, replication of this scenario in shallower areas could be employed to retain gravels and promote retention of spawning substrate. In areas where the flood risk is greater, trees and branches could be retained with steel cable, and/or posts, or live trees of a suitable species (willow, hazel etc) could be hinged.

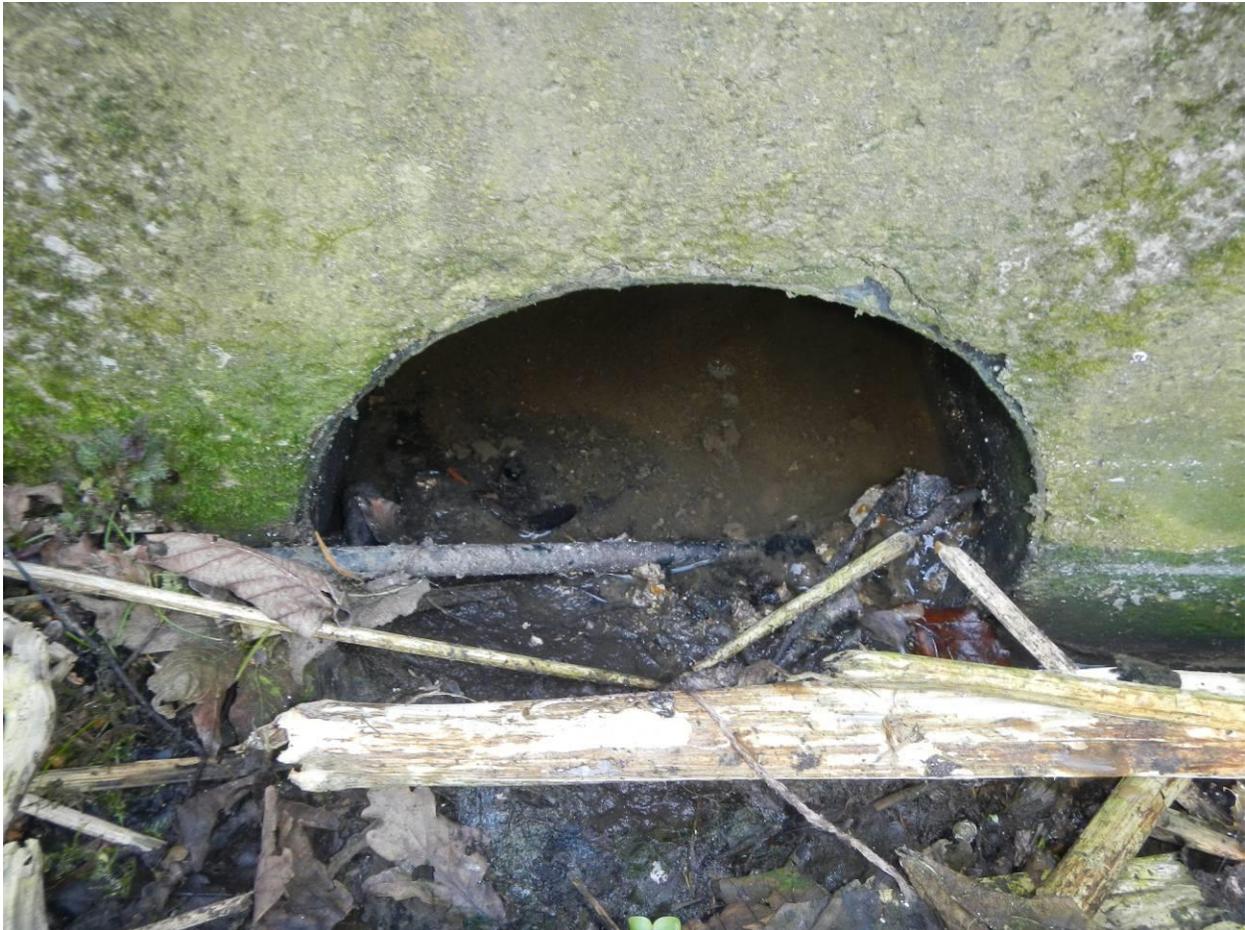
appeared to be discharging a high level of nutrients, and although the volume was not high at the time of the visit, this should be investigated, as there was a notable odour and accumulation of sewage fungus (Picture 4).

Picture 4. High nutrient discharge at NZ2477479647.

Investigation should also be made into the potential pollution from the outfall entering the river at NZ2477479647.

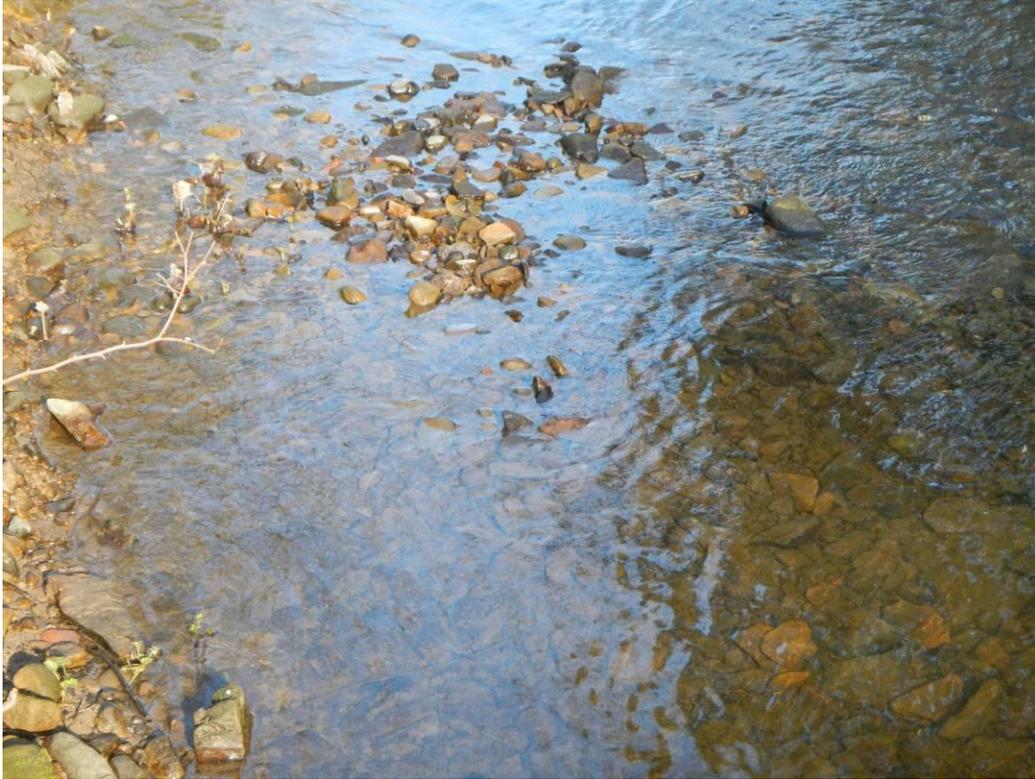
Further downstream a cluster of salmonid redds were observed (Picture 5). The area was not typically that of a salmonid spawning site, but the absence of suitable substrate appears to have necessitated utilisation of any suitable sized substrate. Unfortunately, the location means that some redds were already becoming exposed by receding water levels and their production is likely to be lost. This again highlights the importance of retaining gravel within the wetted channel if successful recruitment is to occur.

Picture 5. Salmonid spawning redds in the river margin, becoming exposed by receding water levels.

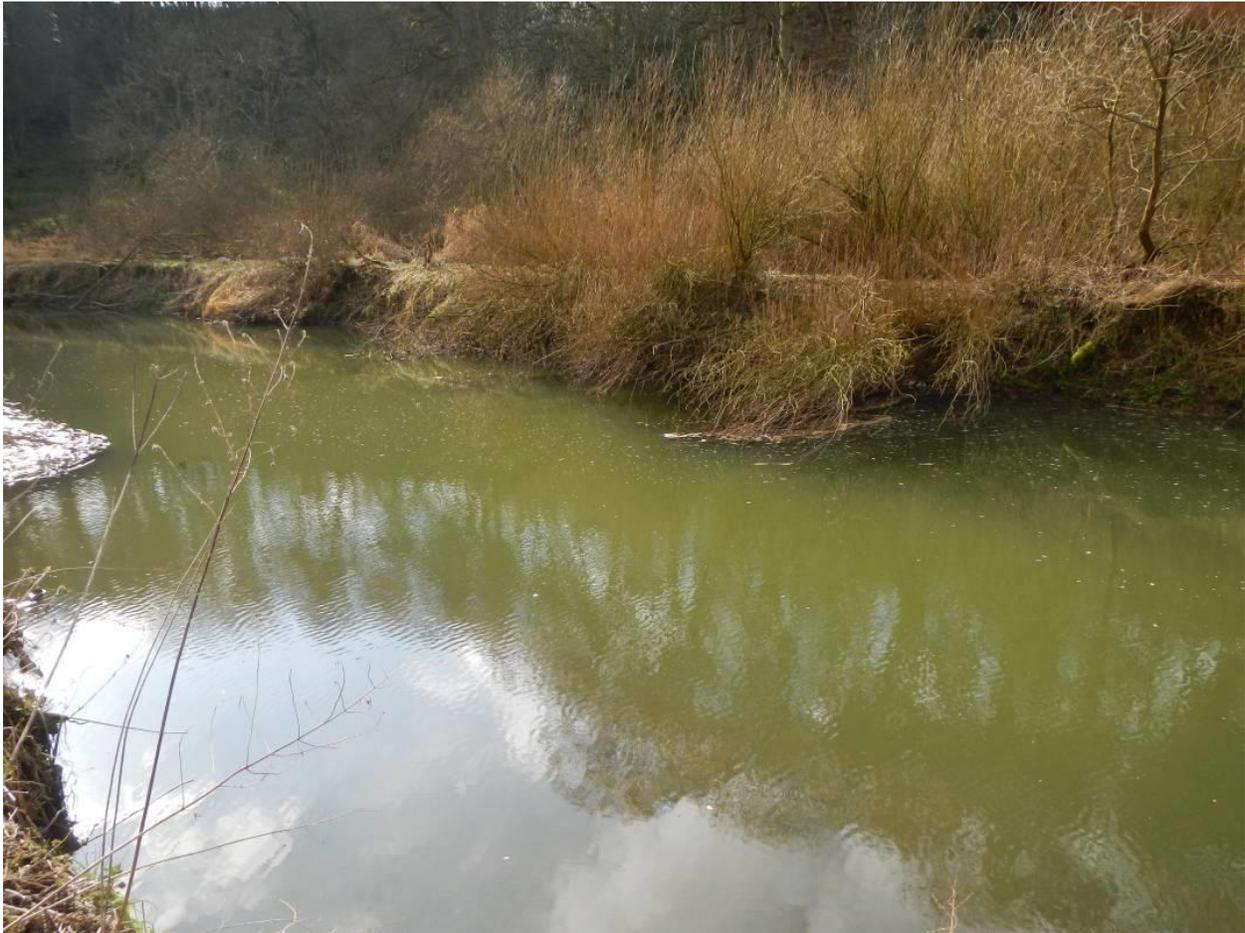
At a point approximately 2km downstream of Hartford Bridge the river character changed again, to a slow, straight channel, incised within its banks. It appears that the river has been realigned and dredged (Picture 7) for much of the 1km length down to Humford Weir (Picture 9, NZ2613079746). Old relict river channels were observed on either side of

Picture 7. Deeply incised channel with virtually no flow, typical of the reach above Humford.

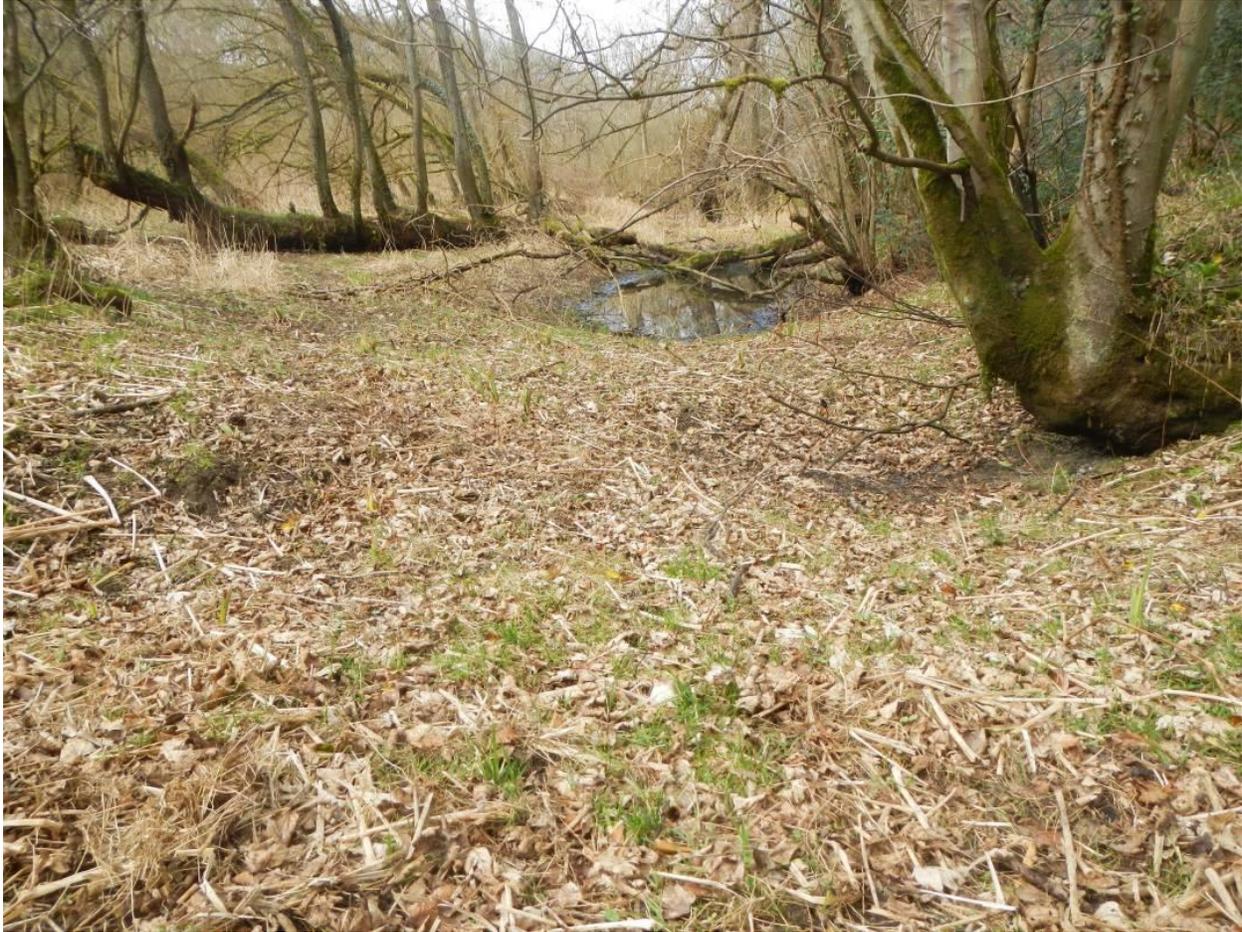
the river, perched above the current channel (Picture 8). The poor habitat present on this section is compromised further by the impounding nature of the weir. (It is possible that some of the channel upstream, in the reach already discussed, has also been realigned, as it is very straight, but the bedrock has restricted the extent of incision and makes it hard to ascertain)

Picture 8. An obvious relic river channel, set back from the current river course.

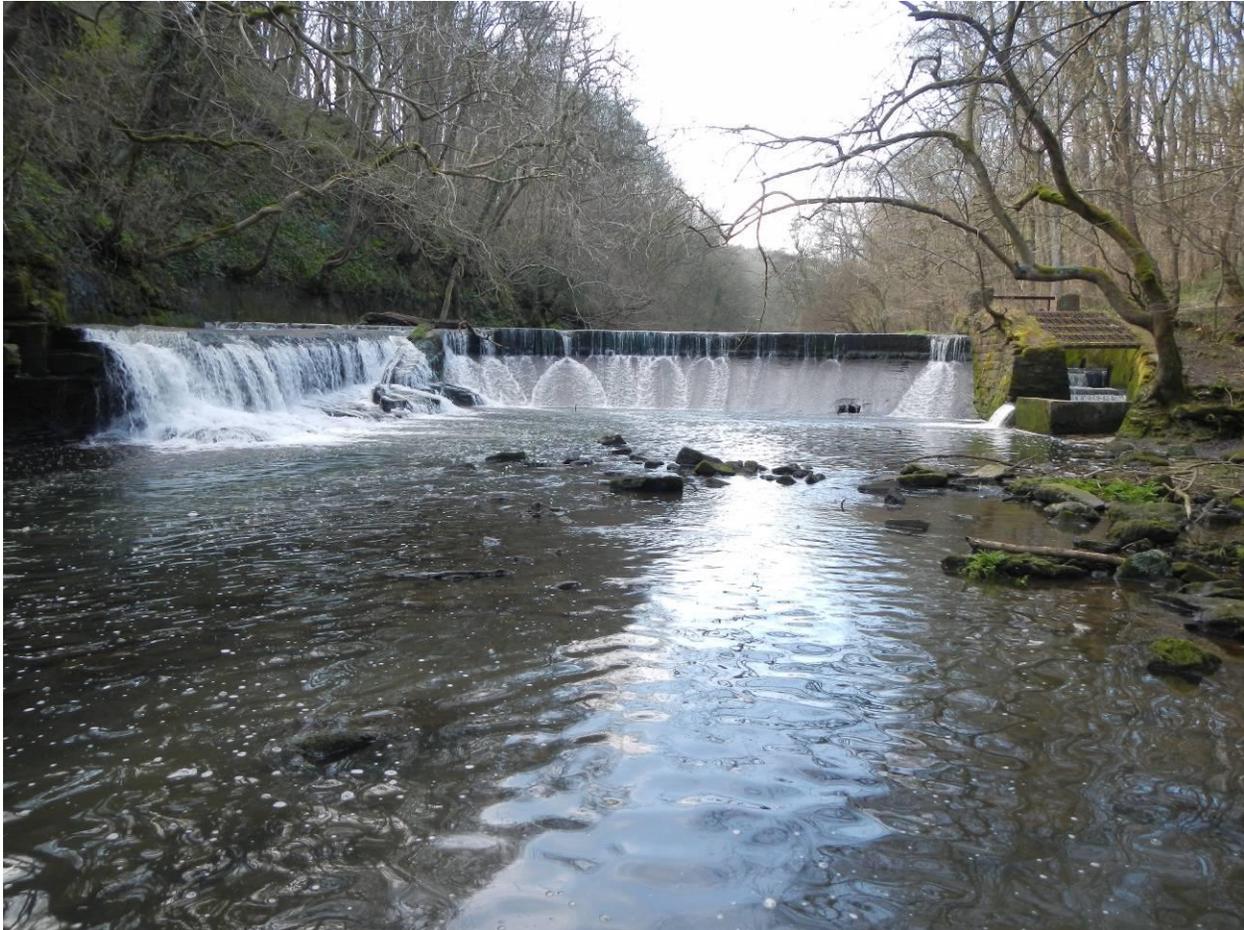
Picture 9. Humford Weir poses a significant barrier to fish passage and is a major impoundment to the River for up to 1km upstream.

Humford Weir poses a significant barrier to all fish species present in the River Blyth, and although large migratory salmonids can ascend the Weir in certain flows, the specification of the pass is well outside the Environment Agency's Fish Pass Manual V 2.0 guidelines.

On the day of the visit the entrance to the pass was at least 60cm from the river level, making the jump required well above the advisory maximum of 30-45cm for migratory and non migratory trout, pool traverse passes. This would remain the case, even with a significant raise in tail-water level. Two of the traverses between pools within the pass are also greater than 50cm, and as tail-water level is likely to rise more rapidly than head-water, this is likely to create a further obstruction for any fish that can enter the pass.

The dimensions of the pass are further outside the capabilities of juvenile trout, grayling and minor species, for which the weir and pass are a complete barrier in almost all flows.

For this reason it is strongly advised that the removal of Humford Weir is fully investigated. Little of the original structure appears to remain and most of the current weir comprises concrete. So, with no infrastructure upstream to be compromised by resultant channel re-grading, removal represents the obvious option. Investigation will be required to identify if any scheduling or listing exists for the structure, to ascertain whether removal is possible, but in the absence of such restrictions the weir should be removed, or at the very least lowered, or notched.

If removal is not possible there is a route that could be created through the concrete wall on the LB that is the full depth of the weir at that point. Some bank re-enforcement, or a managed retreat and some realignment of the footpath might be necessary.

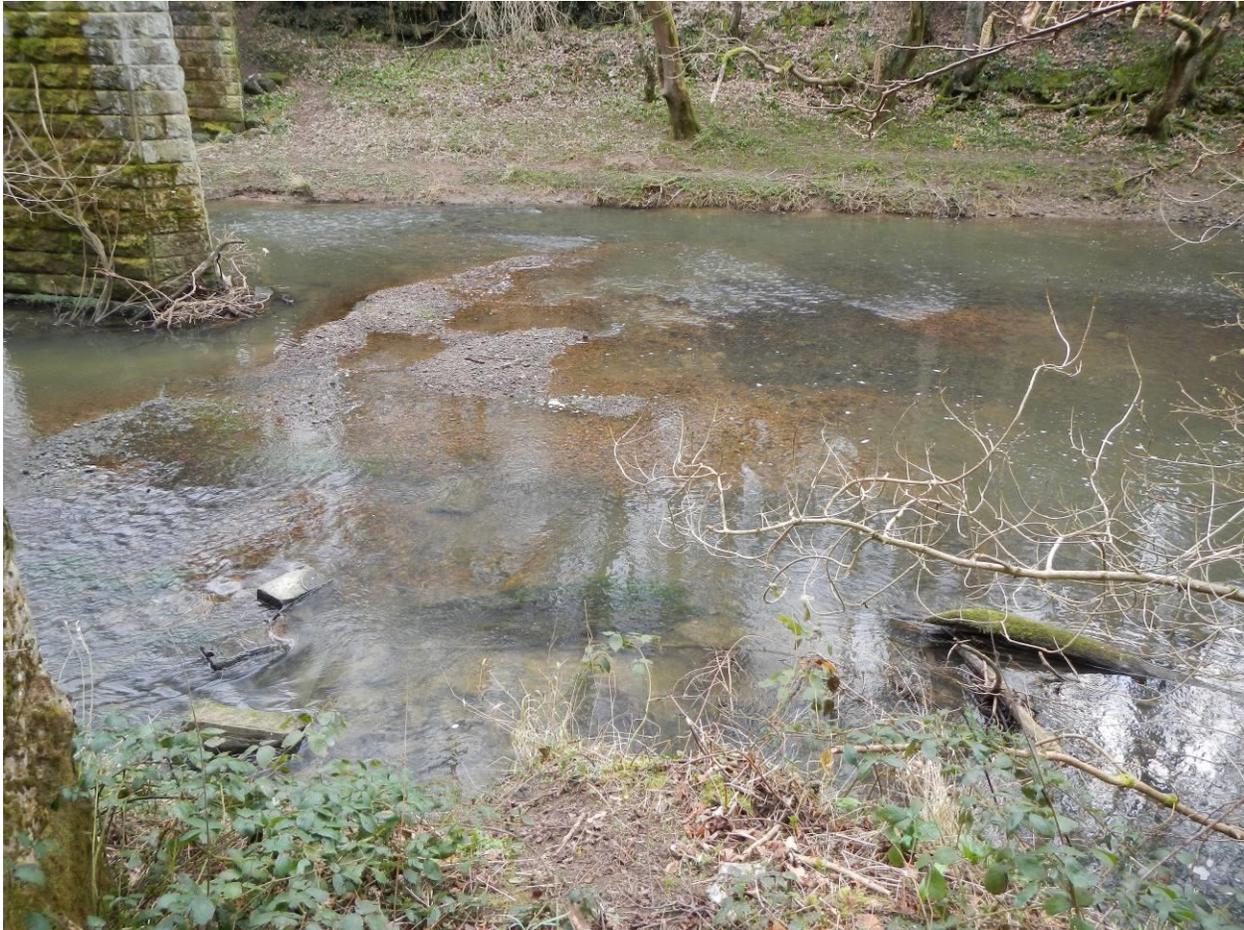
The issue for fish passage was further demonstrated within the first 100m downstream of the weir, where a vast array of different sized salmonid spawning redds were observed on the first suitable sized gravel (Picture 10). Most of the 13 obvious redds were that of large salmonids, but the five smaller redds were smaller, possibly those of smaller, resident trout.

The accumulation of gravels that supports the spawning area can be primarily attributed to two features within the channel; first, the presence of an old bridge footing towards the centre of the channel; and second, the presence of LWD on the LB at the head of the pool upstream, which will have reduced peak flows down the LB side.

Picture 10. One of the two most significant spawning area on the main River Blyth. The lighter patches are gravel that has been displaced by salmonids in the process of creating redds.

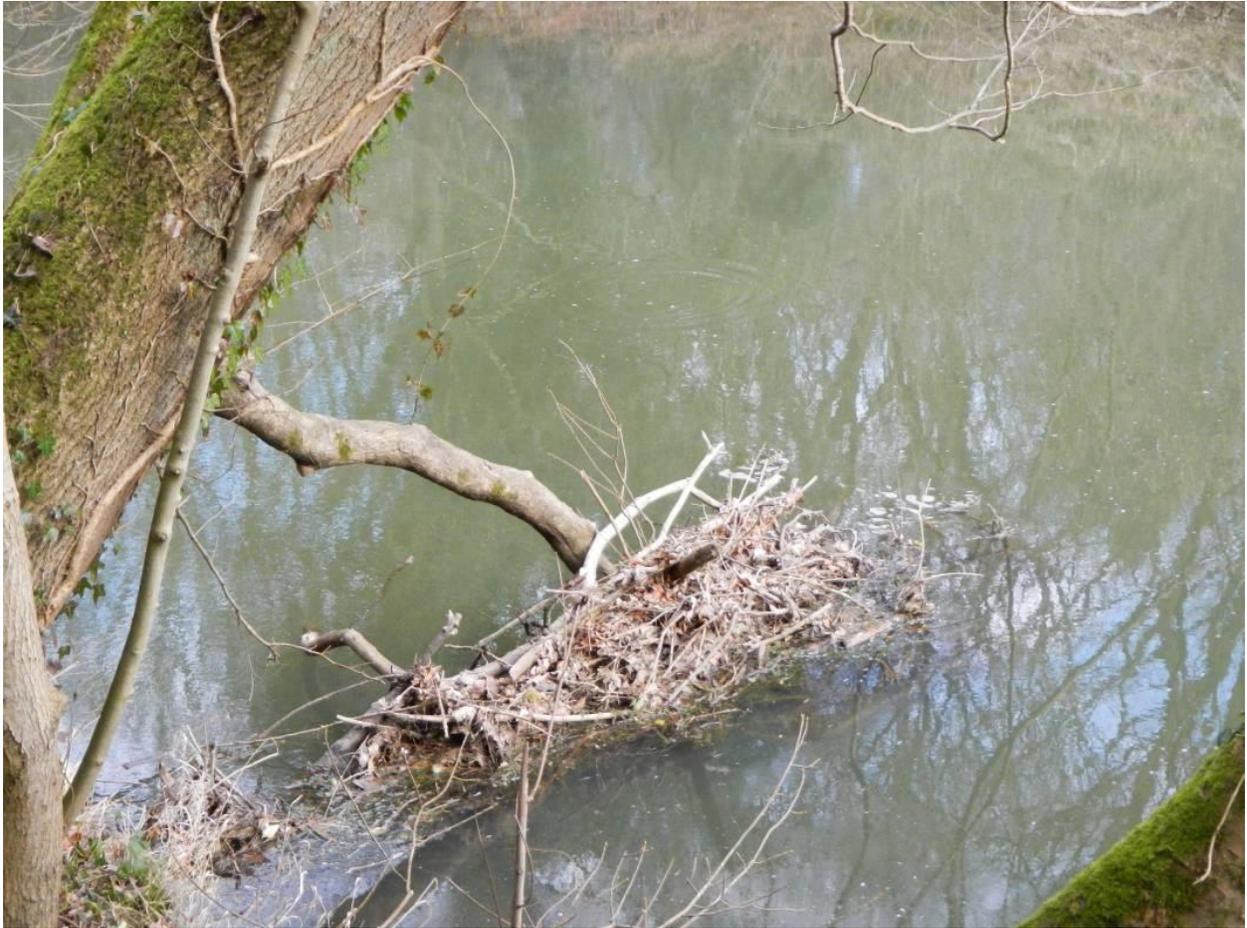
Between Humford Weir and Humford Stepping Stones the River increases in width to between 12m and 17m wide. Some longer pools were present within this reach, where again, the habitat quality becomes reliant upon LWD and trees to provide cover and flow diversity. This was perfectly demonstrated by one of only two fish seen rising all day, inhabiting a lie directly behind an accumulation of LWD (Picture 11).

Picture 11. LWD within the channel creating a trout lie in what would have otherwise been a sluggish featureless channel. The trout's rise form can be seen slightly above, centre of the shot.

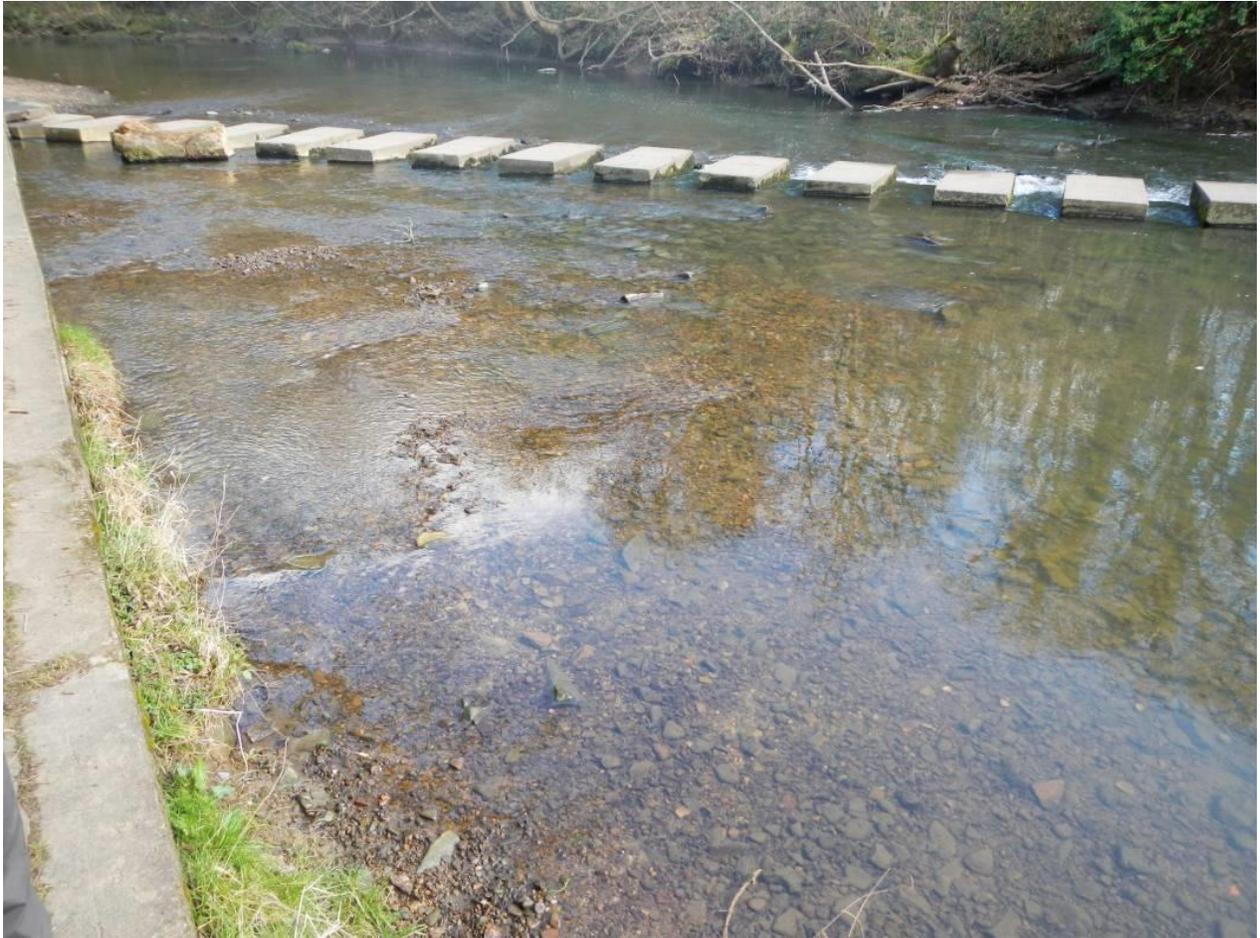
At Humford Stepping Stones the second significant spawning area was observed, directly upstream of the crossing, with further redds on the riffle upstream. The gravel aggregation on which the spawning has occurred can be mostly attributed to the presence of stepping stones, which are acting in a similar way to that described with LWD, by creating areas of both slack and faster water (Picture 12).

Picture 12. Area of spawning upstream of Humford Stepping Stones.

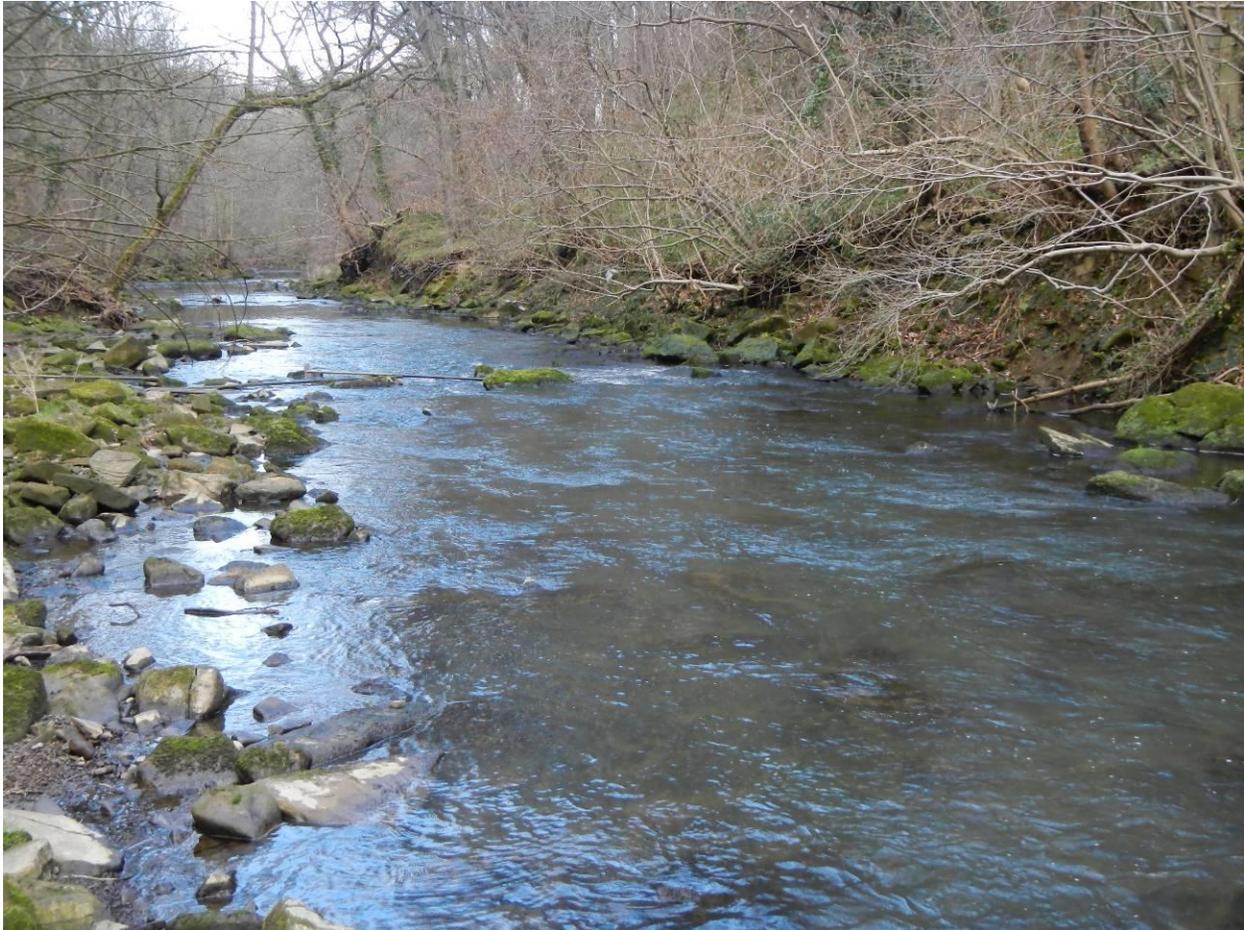
Downstream of the stepping stones the gradient increases, creating a narrower channel with a similar character to that below Hartford Gauging Weir. The channel reduces in width (6-8m), and becomes shallower, with a predominantly coarse cobble and boulder substrate (Picture 13).

Picture 13. Habitat typical of the lower reach (Humford Stepping Stones – Tidal Limit).
